## Large-scale bank restoration in the Overijsselse Vecht River

Book of Abstracts  
NCR DAYS 2023  
12-13 April | Radboud University

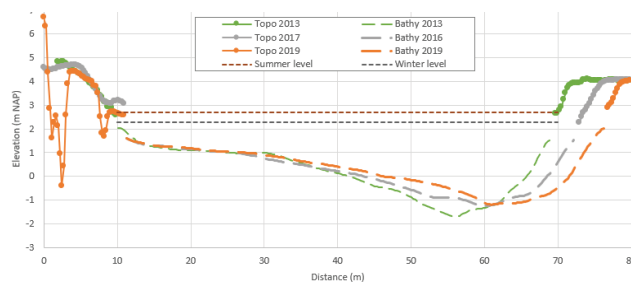
Figure 2. Cross section at one of the hotspot locations near Varsen (rkm 37.3-37.9). The topography above the water level is derived from stereophotographs, the bathymetry with echo-sounder surveys.

All unprotected banks were classified into five categories based on bankline retreat. Most banks showed a shift smaller than 2 m in the period 2013-2021. Some outer bends displayed more erosion, with more than 5 m of retreat (e.g. Varsen bend, Fig. 2).
