## Coupled effects of corrosion damage and sustained loading on the flexural behavior of RC beams strengthened with CFRP anchorage system

Composite Structures

# Coupled effects of corrosion damage and sustained loading on the flexural behavior of RC beams strengthened with CFRP anchorage system

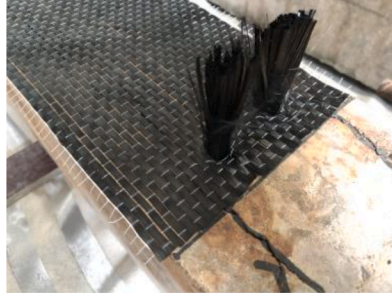
(a) Concrete drilling

(b) CFRP anchors inserted into concrete

(c) Bonding of the CFRP sheet and anchors with epoxy resin

Fig. 4. Anchors installation procedure.

- (1) Four holes with diameters of 10 mm diameter and depths of 35 mm were drilled into the bottom faces of the beams (as shown in Fig. 4a). To ensure a better adherence between the concrete surface and epoxy resin, pressurized air and a vacuum was used to remove concrete particles and dust from the drilled holes and the bottom surface of the beams.
- (2) Then, the surface of the concrete to be reinforced was prepared with a pneumatic needle scaler. This surface preparation removed the top surface of the weakened concrete, exposing the aggregates across the area where the CFRP sheets were to be bonded and also roughening the concrete surface [32].
- (3) Each drilled hole was then half-filled with epoxy resin, and a layer of CFRP sheet with a length of 1300 mm and a width of 150

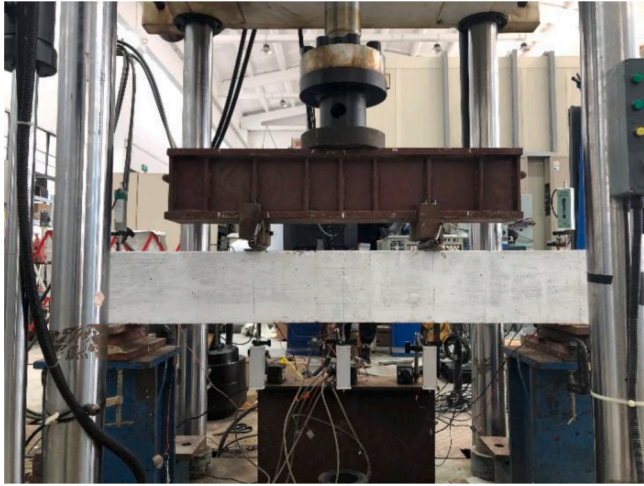
Fig. 5. Monotonic four-point loading of CFRP-strengthened RC beams.

To obtain the residual strength of laboratory beams, monotonic four-point loading tests were performed on all beams, as shown in Fig. 5. All tests were conducted with the MTS drive at a speed of 1 mm/min for displacement control. The deflections at the mid-span and two loading points of the beams were monitored by linear variable displacement transducers (LVDTs). One strain gauge was placed at the top of the test beam in the mid-span pressure zone. Five strain gauges were distributed evenly throughout the fiber of the CFRP-reinforced beam, as shown in Fig. 6.

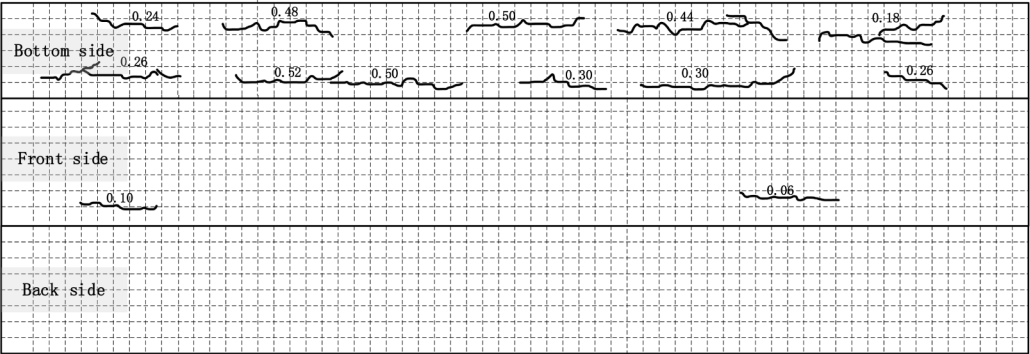
( a ) CS-5-NL

( b ) CS-5-HL

( c ) CS-10-NL

( d ) CS-10-HL

Fig. 7. Corrosion cracks patterns.

( e ) CS-20-NL

( f ) CS-20-HL

The concrete cover started to crack with the accumulation of damage induced by corrosion. After each beam reached its corrosion time, the RC beams were removed from the reaction tank and the reddish-brown corrosion products at the cracks on the concrete surface were washed out. In order to evaporate the moisture on the concrete surface, the tested beams needed to be placed in a natural environment for 12 h. All cracks on the bottom and sides of each beam were depicted on square grid paper following the crack direction, and the maximum width of each crack was measured using a crack gauge, with each grid corresponding to a 50 mm × 50 mm area of the realistic beam. It was observed that the overall trend of longitudinal cracks was along the direction of the longitudinal tensioned reinforcement at the bottom of the beam. The length of the cracks in the pure bending zone at the bottom of the beam was the longest, and the width of the cracks was greater, and the widest part of the cracks was generally near the span position of the beam. The corrosion cracks patterns are shown in Fig. 7.

Table 3 lists the maximum corrosion crack width,  $w_{max}$ , for each beam. The values of the maximum crack width were 0.64, 1.08, and 1.42 mm for groups A, B, and C, respectively; hence, the crack width increased proportionally as the corrosion duration increased. Besides, it can be obviously observed that the crack width of beams exposed to the sustained loading was larger than that of beams without the sustained loading with the same corrosion duration. For instance, at low levels of corrosion, the corrosion crack width was 0.64 mm for beam CS-5-HL, an increase of 22.2% compared to beam CS-5-NL (Fig. 7a, b). At a severe level of corrosion, however, the corrosion crack width was 1.46 mm for beam CS-20-HL, almost the same as beam CS-20-NL (Fig. 7e, f). This implied that in the early phases of corrosion, the sustained loading causes the cracks to grow faster, thereby speeding the corrosion further, expanding the fractures; however, when it reaches a high degree of corrosion, sustained loading has only a partial effect on corrosion crack width.

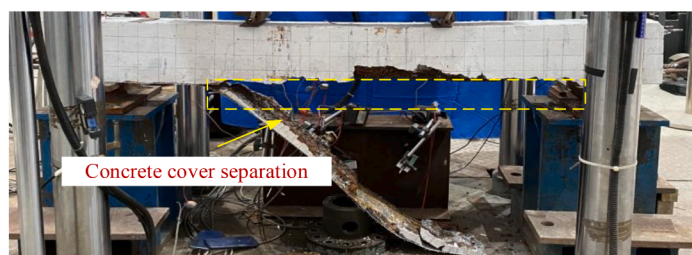
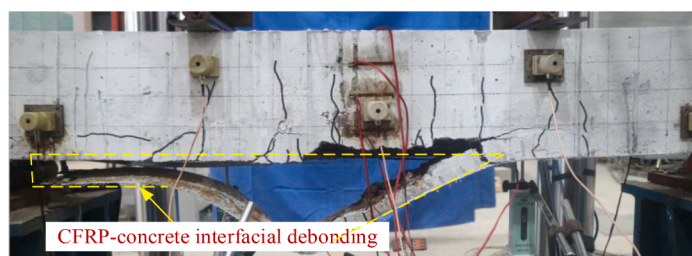
(a) CC in Beam UU

(b) CSS in Beam CS-5-NL

(c) CD-AP(CB) in Beam CS-5-HL

(d) CD-AP(BF) in Beam CS-10-HL

(e) MC-FR in Beam CS-20-HL

Fig. 9. Modes of failure.

The failure modes of all nine test beams are summarized in Table 2. Photographs of typical failure mechanisms are shown in Fig. 9. The beam UU (control) and the CU (corroded unstrengthened) have similarities in crack patterns and failure modes. They failed by yielding tensile bars followed by the crushing of top concrete (referred to as "CC" for simplicity in Table 3). Large transversal cracks occurred at the constant moment zone as the load exceeded the cracking load. (see Fig. 9a). On the other hand, the failure modes of corroded beams strengthened with the CFRP anchorage system were diverse. The failure modes were affected by several factors, including the parameters of the CFRP anchor system and the corrosion-damaged degree of steel bars. To achieve a better understanding of the failure mechanism of CFRP-strengthened beams and the combined effects of accelerated corrosion and sustained loading, all distinct failure modes are explained in detail as follows.

This type of failure was reported for beam CS-5-NL, as shown in Fig. 9b. In this mode, it can observe that the concrete cover at the bottom was coming off extensively (referred to as CCS). It is worth noting that there was no debonding at the interface between the CFRP sheet and the concrete. This failure mode was more brittle than that of other strengthened beams, probably due to the fact that the corrosion cracks and flexural cracks being interlinked, causing the concrete to fall off at the bottom.

This type of failure occurred at the CFRP/matrix interface with debonding between the CFRP sheet and the concrete substrate near the end of the sheet, followed by anchors pull-out nearby (referred to as CD-AP), as shown in Fig. 9c, d. The debonding was caused by the propagation of flexural cracks to this thin layer of the matrix and the relative deformation between the fabric and the matrix. Debonding was caused by the extension of bending cracks into the thin layer of the substrate and the relative deformation between the fabric and the substrate. This damage pattern was observed in CS-5-HL, CS-10-NL, CS-10-HL and CS-20-NL beams. In terms of CFRP anchors, two main failure modes were observed in this study: a combination of pull-out and concrete cone failure (CB), CFRP-to-epoxy bond failure (BF), as shown in Fig. 9c, d. It should be noted that the addition of anchors retarded the debonding of the carbon fiber fabric and the damage mode shifted to progressive

As shown in Fig. 9e, this type of failure occurred in the beam with a high degree of corrosion, i.e. CS-20-HL. With increasing load, the concrete matrix at the span of the sheet/concrete interface started to crack progressively, followed by fracture of the CFRP sheet. Neither interfacial debonding nor anchors pull-out was observed during the loading process. Instead, the CFRP sheet ruptured near the loading point. This failure mode was mainly attributed to the stress concentrations in the span of the CFRP sheet caused by the cracked concrete.
