## Historical Wooden Pile Foundations in Amsterdam

### An Integrated Approach for the Estimation of Structural Performance and Residual Service Life

# Historical Wooden Pile Foundations in Amsterdam: An Integrated Approach for the Estimation of Structural Performance and Residual Service Life

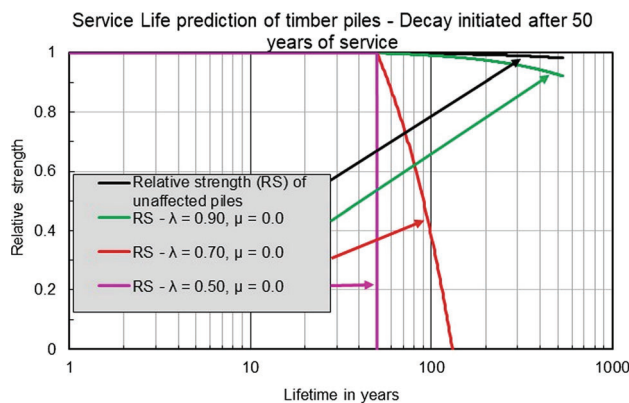
**Fig. 5.** Lifetime prediction of timber piles. Scenario: Biological decay initiated after 50 years, decayed wood has 0% strength of non-decayed wood, Cross section reduced by 10% (green line), 30% (red line) and 50% (pink line) [8]

In Fig. 5 an example is given for Service life calculation taking in consideration dead load, assumed live loads and biological decay with associated decay rates [8]. It can be clearly observed that the residual carrying capacity decreases over time while the accumulated damage increases (relative strength reduces).

In this example, it is assumed that the remaining strength of decayed wood is zero, which is a safe approximation, so  $\mu = 0$ . However, if that would not be the case, then the value of  $\mu$  can be easily adapted in the model, and the remaining service life will automatically increase. By the way the model is formulated (Eq. 2), the stress on the remaining sound cross section will automatically increase when the decay progresses, so for each period  $\Delta t$ , the damage increase  $\Delta\alpha$  will increase a bit more as the stress ratio  $\sigma(t)/f(t)$  increases with the ageing process, see Fig. 6. From the analysis it follows that if half of the original cross section is degraded at  $t = 50$  years, the residual lifetime drops to 0 almost instantly, but if it is reduced by 30% (so 70% remaining), the residual lifetime is still considerable with almost 100 years before structural failure. This shows that time to failure processes are really sensible for the load level on the one hand, directly influencing the remaining service life. These processes are logarithmic on the time-scale. For foundations the main load component is dead load. Variable loads from traffic are also present, but over the history of 100–300 years are less relevant. More important is to get an accurate estimate of the constant dead load over the pile's history. In that case the damage Eq. (2) is more straightforward to solve regarding the applied load. The failure process is then governed for long term static loading, without having the complexities of random variable loading. The assessment of parameters affecting the load bearing capacity is however, complex. Measurable assessment parameters are very limited, since only a very small 'window', approx. 10% of the whole pile at the top, is available for the assessment, and from this assessment, an estimate for the entire pile must be made.
