## **CITY-SCALE DAMAGE ASSESSMENT USING VERY-HIGH-RESOLUTION SAR SATELLITE IMAGERY AND BUILDING SURVEY DATA FOR THE 2021 HAITI EARTHQUAKE**

**Abstract:** *After an earthquake, a rapid identification of the damaged building stock is crucial to prioritise rescue operations, ensure primary services to the most affected regions and support reconstruction. Whilst in-situ reconnaissance missions provide invaluable data on the intensity and distribution of earthquake-induced structural damage, the process of collecting field observations is often dangerous, expensive, and is usually undertaken a few weeks after the disaster. Spaceborne Synthetic Aperture Radar (SAR) can remotely provide imagery data of wide affected areas, enabling to reach locations that are difficult or dangerous to access with traditional survey methods. Furthermore, SAR-based observations are independent from daylight illumination and clear-weather conditions. Thanks to the recent availability of Very-High Resolution (VHR) SAR satellites, post-disaster imagery data with sub-metre resolution are now available within a few hours after a major earthquake, opening unprecedented opportunities for complementing in-situ ope

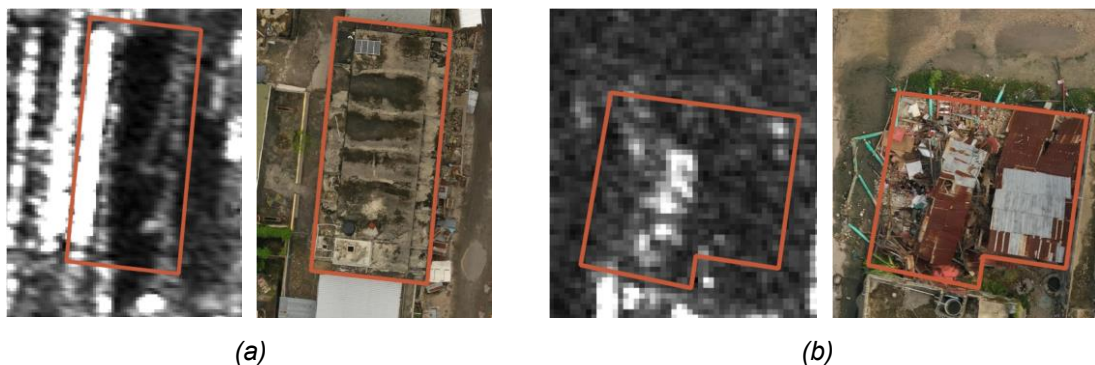
Figure 1: Examples of (a) an intact building in VHR SAR data and drone orthophoto and (b) a collapsed building in VHR SAR data and drone orthophoto. The VHR SAR data is Capella imagery acquired over Les Cayes, Haiti (© 2021 Capella Space All Rights Reserved).

SAR satellites use a side-looking imaging geometry, which means that the sensor is oriented sideways with respect to the flight direction. Due to this side-looking geometry, the appearance of urban structures in SAR images is affected by some geometric distortions including shadowing, foreshortening, layover, and multi-bounce reflections (Hanssen, 2001). For an idealised flat-roof building, four types of reflections can be typically recognised (Balz and Liao, 2010; Brunner *et al.*, 2010): (i) layover area, (ii) corner reflection, (iii) roof area and (iv) shadow area. The first structural element interacting with the radar signal is the dihedral corner reflector created at the intersection of the building wall facing the SAR sensor and the surrounding ground. The dihedral corner reflector typically produces a very strong reflection called double bounce, which appears as a very bright linear region in the SAR image. The second contribution is the reflection produced by the building roof. This reflection is usually weaker than the dihedral corner reflection and results in lower intensity pixels in the SAR image. Depending on the height of the building, the reflection produced by the building roof could be recorded before the double bounce generated at the intersection of wall and ground. If this happens, a layover effect can be observed before the dihedral corner reflection, resulting in relatively high intensity pixels in the SAR image. Finally, the last contribution is associated with the part of the building hidden from radar illumination, i.e., shadowing effect. Since for such an area no backscattering signal is recorded, part of the building will appear as dark in the radar image.

Whilst intact buildings are usually characterised by well-defined shapes with sharp edges and strong backscattering, in presence of collapsed or heavily damaged buildings, the four regions of reflections will no longer be recognisable (Brunner *et al.*, 2010). For example, the bright layover area and strong double-bounce line might disappear partially or completely (Wu *et al.*, 2016; Gong *et al.*, 2016). The building shape will lose regularity, with debris behaving like corner reflectors and producing very localised strong reflections (Kuny *et al.*, 2015). Examples of intact and collapsed buildings are shown in Figure 1. This suggests that texture properties of VHR SAR imagery could be used to distinguish between damaged and not damaged buildings.
