Comparing overflow and wave-overtopping induced breach initiation mechanisms in an embankment breach experiment

Abstract. As part of the SAFElevee project Delft University of Technology collaborated with Flanders Hydraulics Research, and Infram B.V. in the preparation and execution of a full scale embankment breach experiment in November 2015. This breach experiment was performed on an 3.5m high embankment with a sand core and clay outer layer situated along the tidal river Scheldt in Belgium near Schellebelle. During the experiment a wave overtopping simulator and overflow simulator were used to initiate a breach. Both simulators were placed near the top of the waterside slope. The use of the simulators facilitated comparison between the effects of continuous overflow and the effects of intermittent wave overtopping. This paper presents the data collected during the experiment, describe the development of hypotheses on the failure processes using the latest insights, and comment on the failure initiation process of a grass covered flood embankment with a clay outer layer and a sandy core.

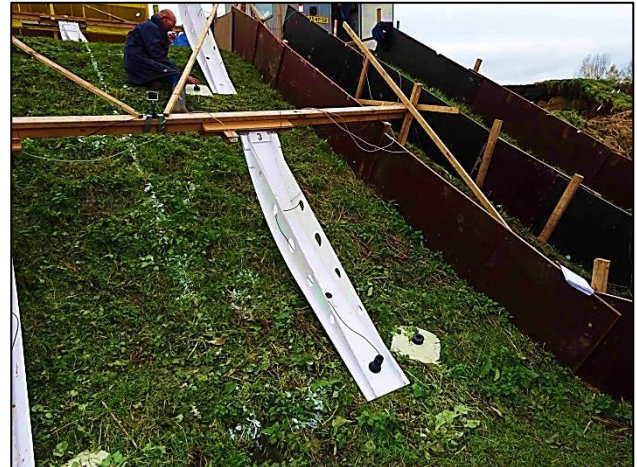
Figure 2. Setup for performing hydraulic measurements during wave overtopping tests.

To assess the roughness parameters on the embankment, hydraulic measurements were performed with waves of respectively 500, 1000, 1500, 2000, 2500, 3000, and 3500 l/m. During the hydraulic measurements the flow velocities were continuously measured at the bed and surface of the waves using paddle-wheels. To measure the change in depth profile of a wave over time, a surf-board like construction was used (see Figure 2). The

water depth was derived from measuring the change in angle of the surfboards when a wave passed under it. The paddle-wheels were placed near the downstream tip of the surfboard, both in the embankment surface and on the tip of the surfboard. This way both the flow velocity at the bed and at the surface could be measured. The front velocity of the wave was derived by measuring the time lapse in signal from the surfboards and the known distance between two surfboards.

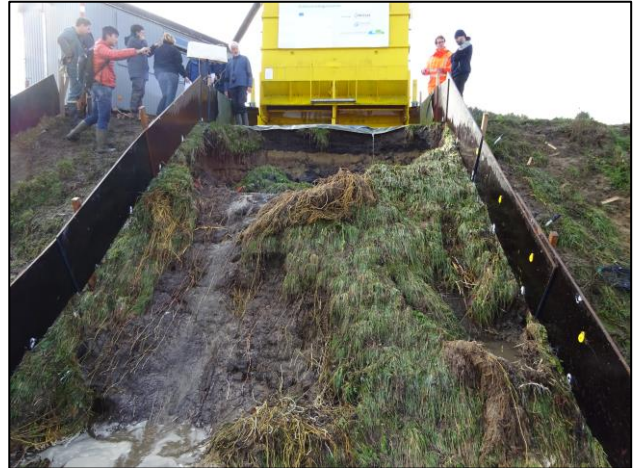
Figure 4. Overview picture taken at the end of the 25 l/m/s tests at the first test section

site. At the end of the 10 l/m/s test, the hole had grown to approximately 0.5m deep. During the 25 l/m/s the hole in on the slope increased in size. After 3 minutes, part of the grass cover came loose near the hole. After 12 min the sand layer was reached in the hole. Once the sand layer was reached a trench developed due to erosion downstream of the hole (see Figure 4)

Simultaneously headcut erosion caused for the upstream progression of the hole. The sand under the clay layer acted reasonably cohesive maintaining near vertical slopes. The processes observed during the retreat of the landside slope were similar to the underwater breaching process as observed during dredging at sand pits. Here the dilation of soil due to water infiltration in combination with the reduction of negative pore pressures determine the rate of erosion and prevent large scale slope failures from occurring.

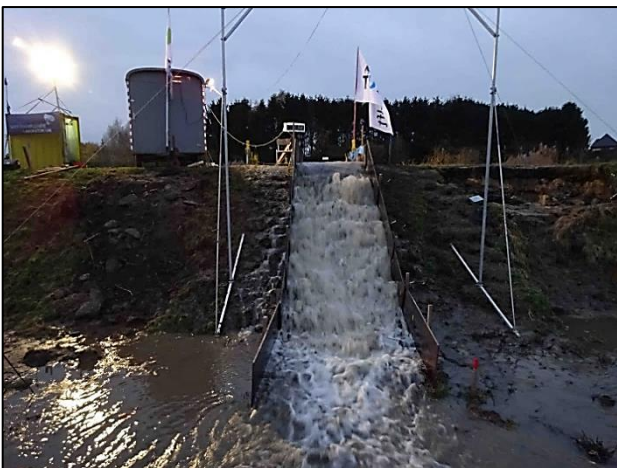
Figure 6. Observed aerated flow during the overflow experiment

Due to limitations in the minimum allowable frequency at which the pump could be operated, tests with the overflow simulator started at 10 l/m/s, followed up by 25, 50 l/m/s and 85 l/m/s. Contrary to expectations, the damage that occurred to the grass cover at overflow discharges of 50 l/m/s and 85 l/m/s was negligible. Instead of the theoretical nice smooth flow of constant density, during all overflow tests the flow became highly aerated down the landside slope (see Figure 6). This could be of influence to the spatial velocity distribution down the slope. Between changes in the discharge the flow was stopped during which became apparent that contrary to the behaviour of grass during wave overtopping the grass cover remained in a flattened position and did not bounce back upwards. Another noticeable, and potentially important observable difference with the wave overtopping tests, was that during overflow the reattachment point of the flow was closer to the crest than during wave overtopping. The normal impact at the reattachment point is therefore also expected to be smaller during overflow than during wave overtopping. These differences with wave overtopping could potentially help in better explaining the difference in timing in failure initiation of the grass cover.
