# **Analysis of track and soil behaviour at transition zones**

**Case study near Gouda Goverwelle**

Analysis of track and soil behaviour at transition zones

Railway, transition zone, measurements, settlement, deflection

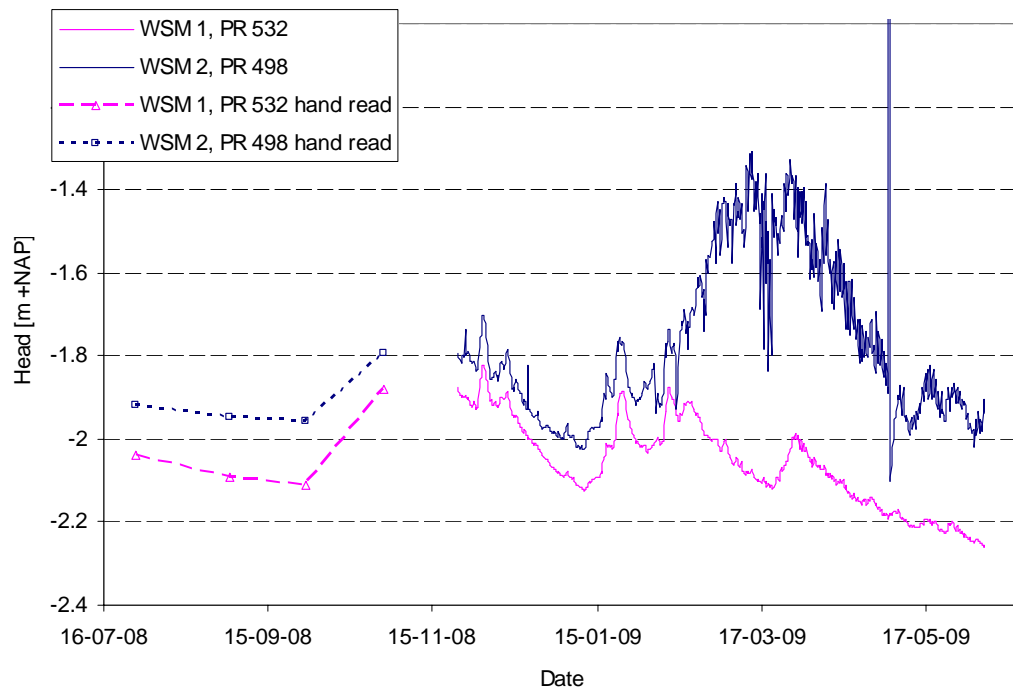
The long-term pore water pressure is measured during almost 1 year at two locations near the culvert (the first one just before the approach slab and the second one at the other side directly behind the approach slab). The first three months, only a few readings are available, later on four readings a day are available. The level of the two transducers is at NAP – 3 m. WSM1 is located at the eastern (Woerden) side of the culvert and WSM2 at the Gouda side.

Figure 3.4 Piezometric head in the embankment near the culvert

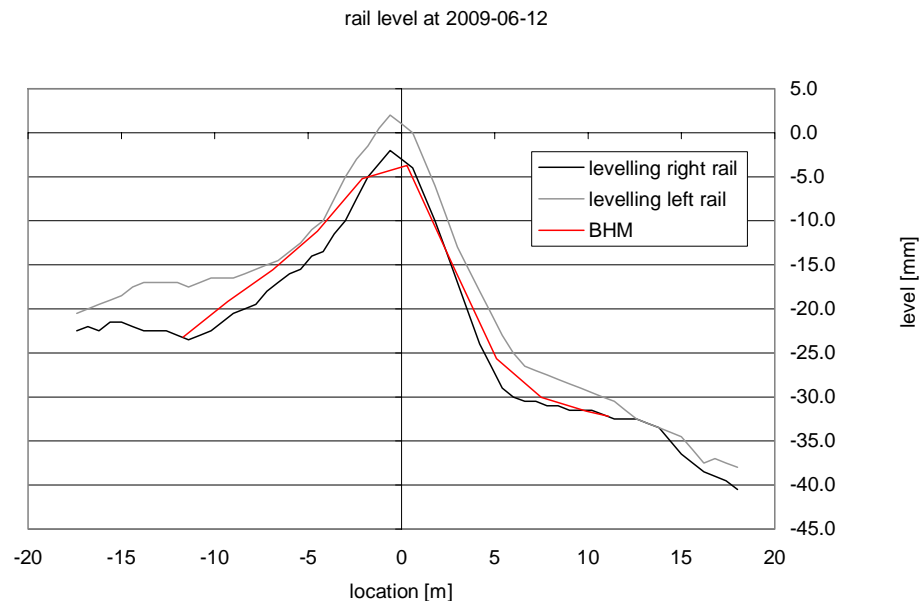
The reported track level compares well with the data from the manual levelling of the rails at 2009-06-12. Figure 4.1 shows the results of the levelling of the rails. In the BHM measurement not the actual level of the track but the relative level is given. The levels according to the BHM are corrected such that the first and last values match the values according to the levelling of the North (right) rail.

Figure 4.1 Height of rail according to levelling data

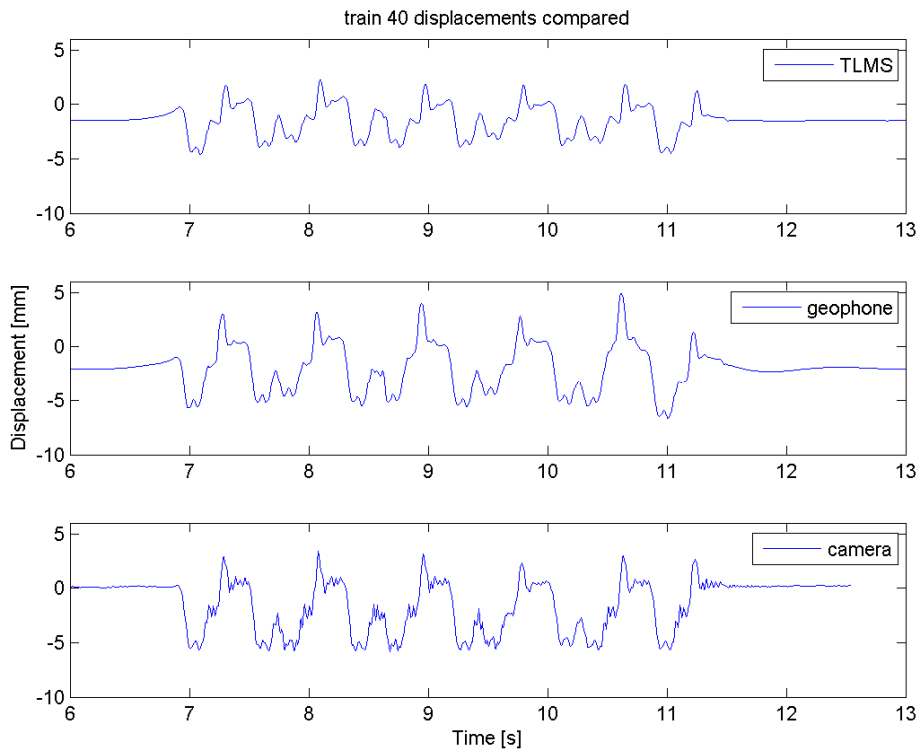
The differences between the displacement of the BHM and the camera measurement are larger. The peak values differ 20%, the details in the signals are more or less similar.

Figure 4.2 Displacement from three systems 5-6 m before the culvert, passage Train 40

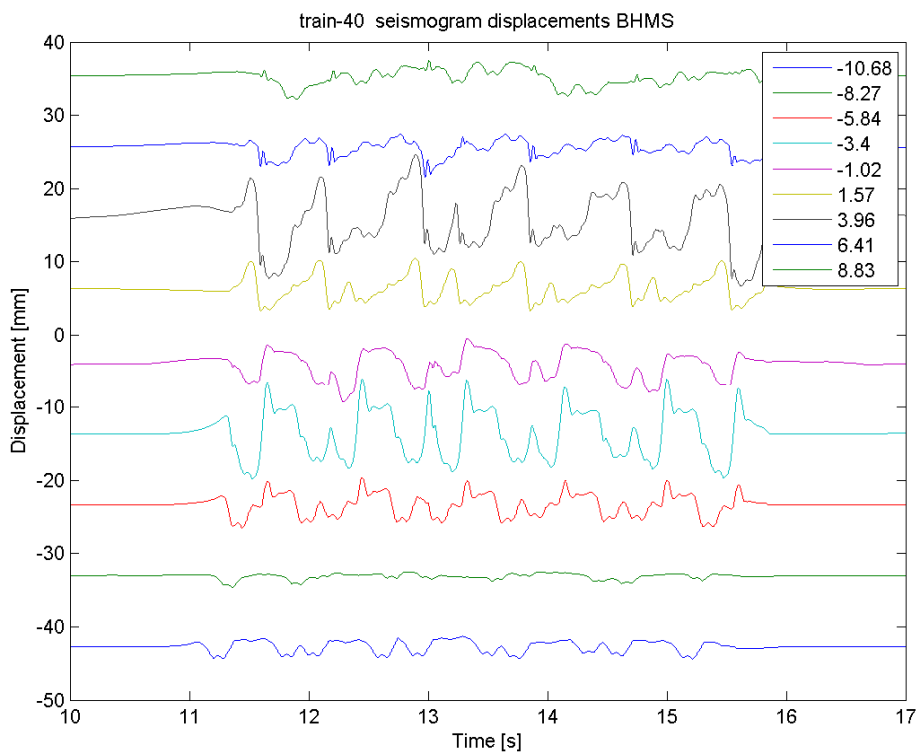
Figure 4.7 and Figure 4.8 show the seismograms of the track displacement measurements by geophones and accelerometers. Significant differences are observed. Since only one high speed camera was used, it is impossible to draw a seismogram of high speed camera results.

Figure 4.8 Displacement track under Train 40 from BHM

The signals of the BHM and geophones are not always reliable. It is not always clear beforehand, which signal is reliable. For Train 40 the signals before the culvert (the Woerden side) of the BHM seems to be better than the geophones, but behind the culvert (at the Gouda side) the opposite holds.

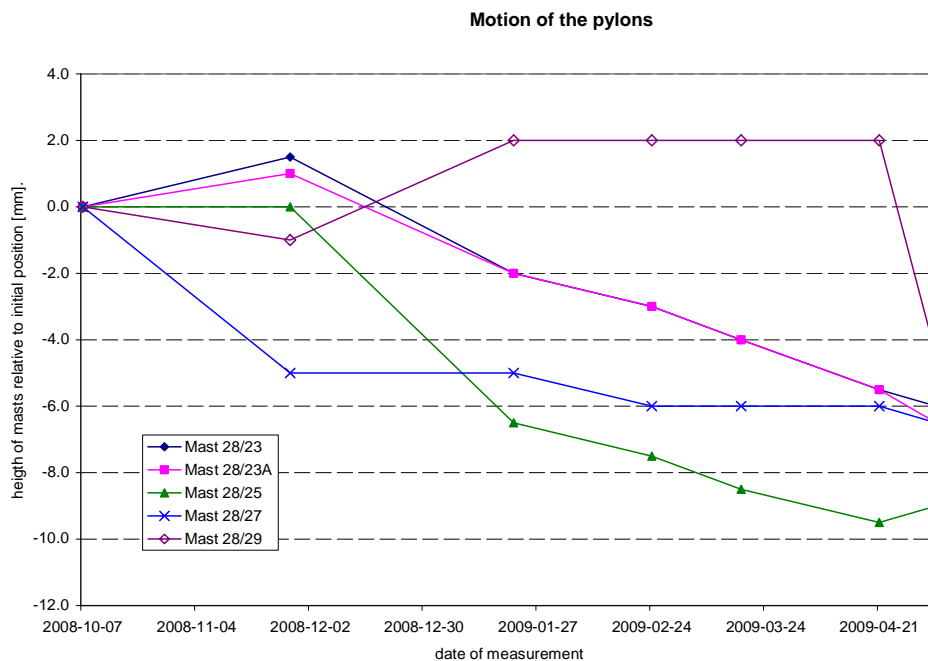
The settlement of the free embankment can be derived from the settlement of the pylons and from the settlement of the top of the rail.

Figure 5.1 Measured settlement of the pylons with respect to culvert

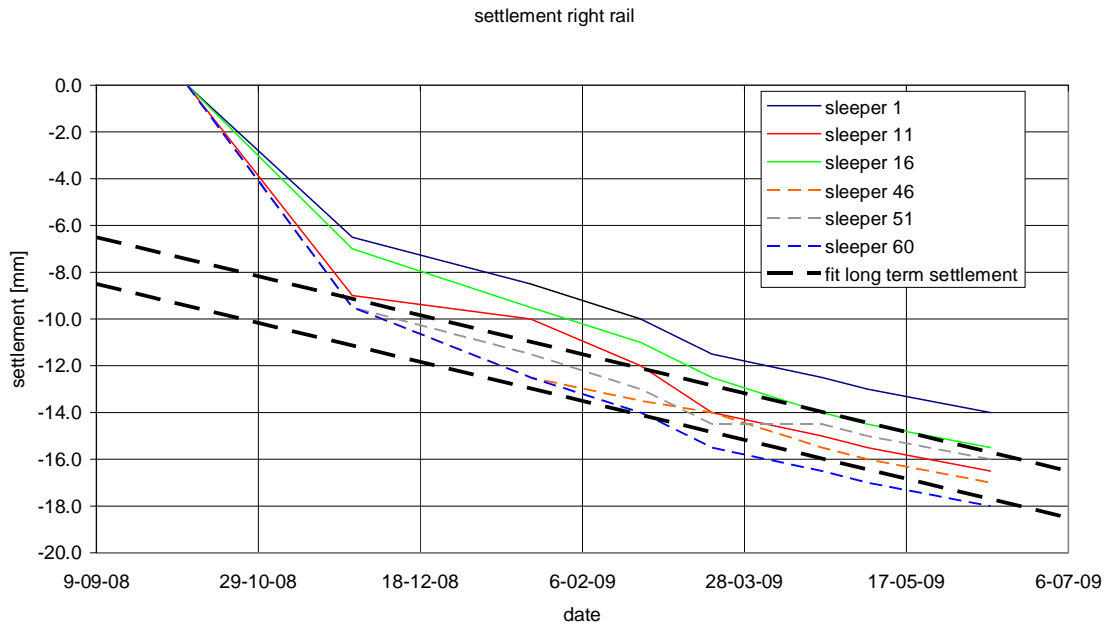
The settlement rate for the autonomous settlement is confirmed by the measurements of the track level. Figure 5.2 shows the settlement of the top of the rail with respect to the situation at 2008-10-07 (first measurement after tamping).

In the graph, two regimes can be observed. For the period after December 2008, a more or less constant settlement rate of about 1 mm/month is observed. This agrees well with the observed settlement rate of the pylons. This is called the autonomous settlement of the subsoil. The rate is equal for the Woerden and for the Gouda side of the culvert. In the first 1 to 2 months, the settlement rate is larger. This larger settlement rate is attributed to densification of the tamped ballast and is further discussed in section 5.3.

Figure 5.2 Settlement right rail at free embankment after tamping

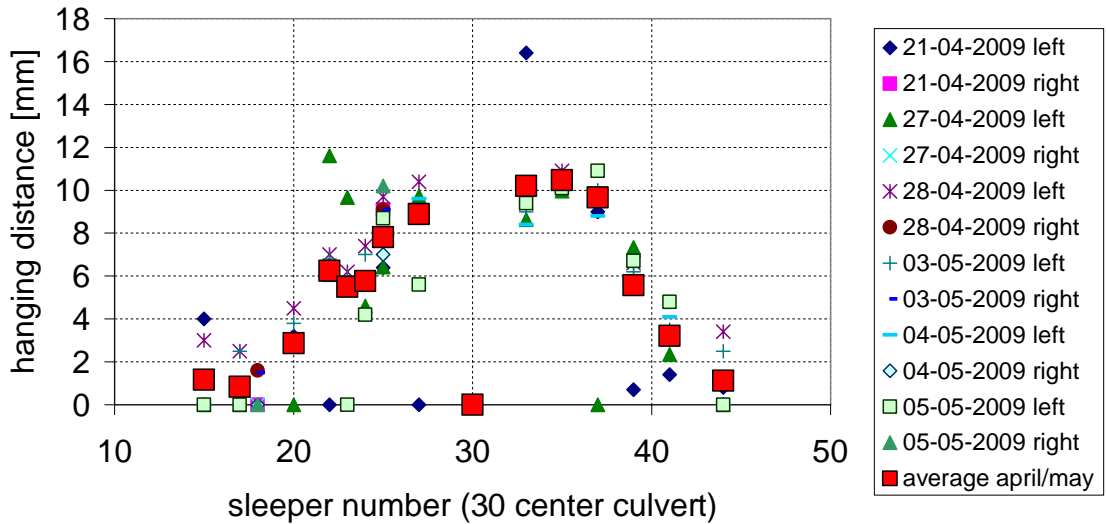
The hanging distance of 15 sleepers was measured directly using the Vortok hanging sleeper devices. Figure 5.7 shows the results of these measurements. The measurements started some time after the maintenance. Above the culvert, sleeper 30, no hanging distance is observed. A hanging distance of about 10 mm is measured above the approach slabs. The hanging distance decreases slowly with increasing distance from the culvert. At about 12 to 15 sleepers (thus 7-8 m), the hanging distance decreases to zero.

Figure 5.7 Hanging sleeper distances measured May/April 2008

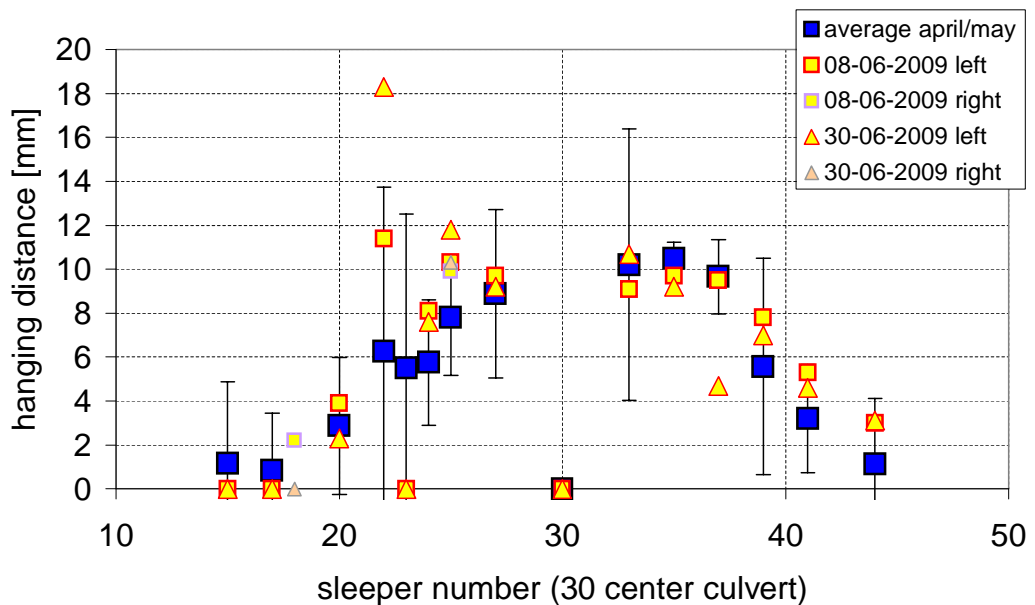
Figure 5.8 Changes in hanging distances after 4 and 7 weeks

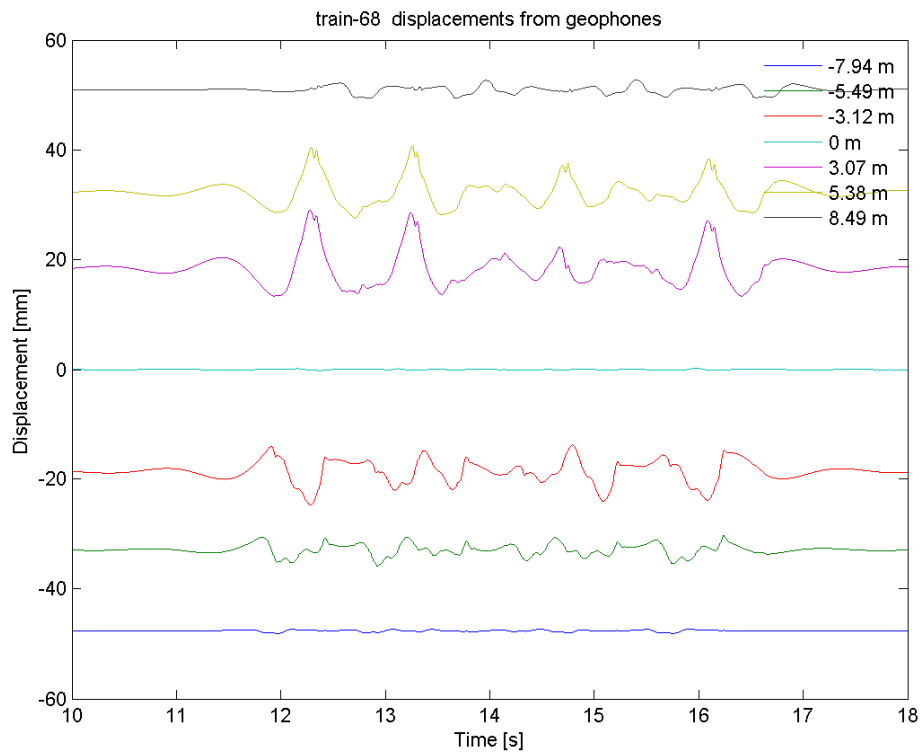
Figure 6.1 Track displacements seismogram Train 68, SGM 3 cars, 66 km/h

- Train 43 and train 68: SGM with 3 cars, speed 106 and 66 km/h.
- Train 40 and train 47: SGM with 5 cars, speed 110 and 67.
- Train 33 and train 50: mat V with 6 cars (speed 106) and 4 cars (speed 93 km/h).

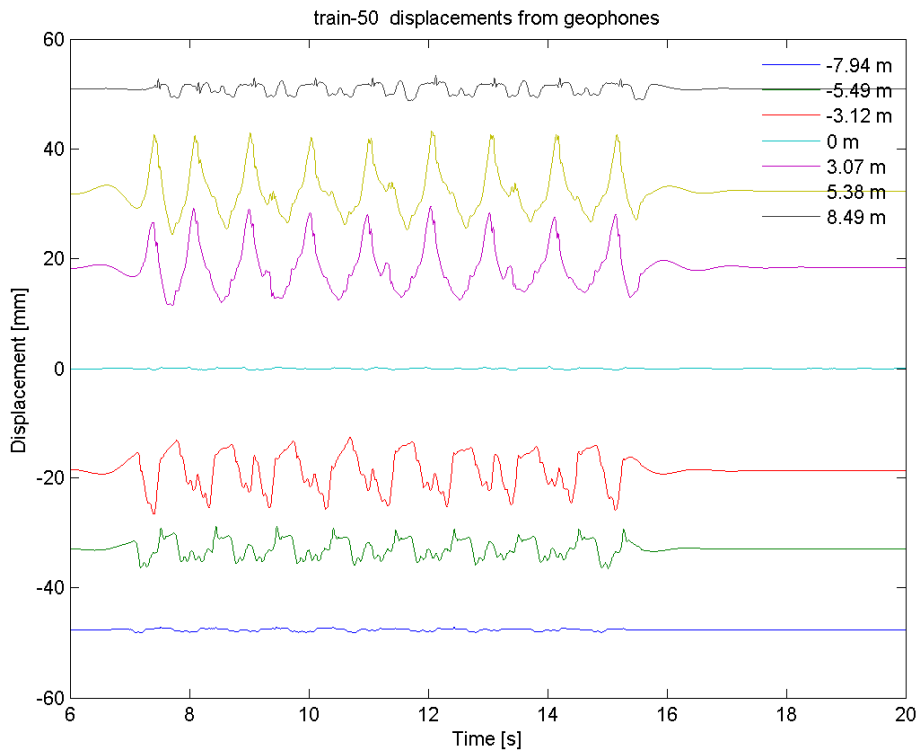
Figure 6.5 Track displacements seismogram Train 50, Mat V 2+2+2+2 cars, 93 km/h
