## Static and dynamic testing of delamination in hybrid SHCC/concrete beams

Cabboi, Alessandro; Harrass, Othman ; Sánchez Gómez, Sergio; Lukovic, Mladena

Composite Structures

Faculty of Civil Engineering and Geosciences, Delft University of Technology, Stevinweg 1, 2628CN, Delft, NL, Netherlands

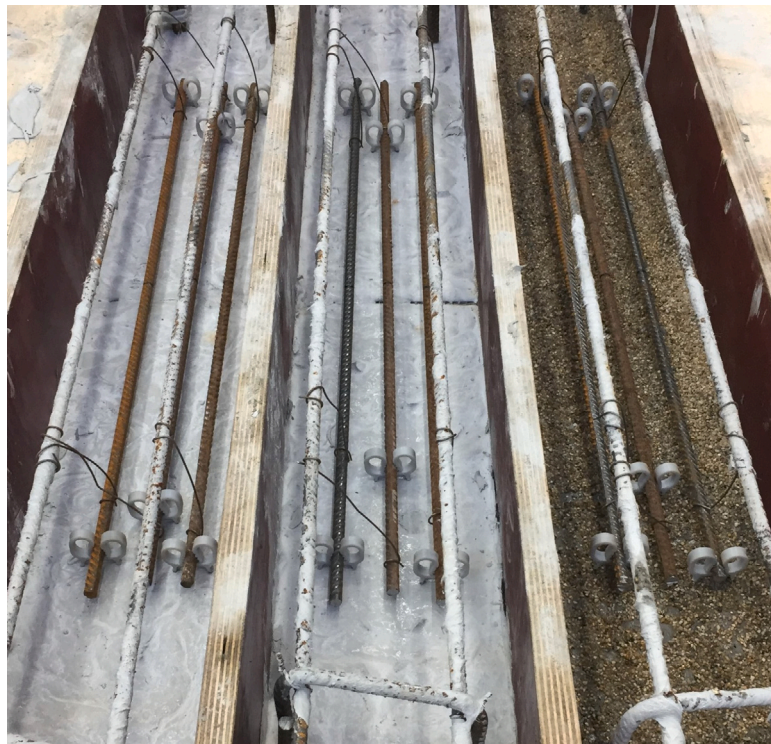
Fig. 3. Different types of interface preparation: smooth (“Reference” and “Curing”) and “Epoxy” sample with sand at the surface.

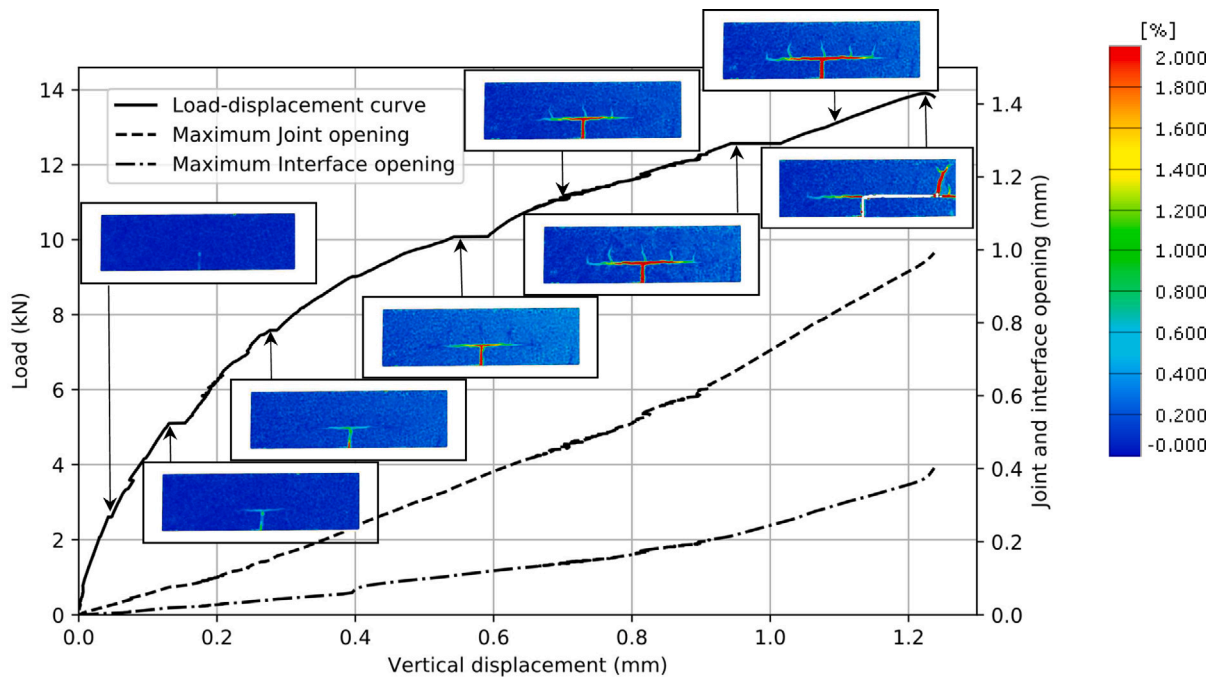
Fig. 6. Reference sample: load vs. displacement and load vs. joint and interface opening, with corresponding damage propagation obtained by the DIC. The legend on the right side indicates the equivalent von Mises strains. Note that the same legend is used in all the DIC graphs.

Fig. 6 refers to the Reference sample and provides an overview of the applied load levels, the corresponding measured vertical displacements, the joint and interface openings and the damage pattern revealed by the DIC. The measured vertical displacements refers to sensor v1, while the interface and joint openings refer to the maximum values obtained between the sensor pairs v5–v6 and v9–v10 (see Fig. 2). The DIC snapshots are linked to the legend, indicating the von Mises strains. Note that this legend is kept constant throughout the whole paper. The surface contours shown in the DIC snapshots refer to the constant bending moment region defined by the blue-marked region

in Fig. 2. It can be observed that the damage starts with a vertical crack localized at the location of the notch. Successively, delamination develops along the interface. Although delamination is the governing failure mechanism, the DIC results reveal that the sample exhibits also a combination of delamination and vertical, flexural cracking. This is especially visible for applied loads higher than 10 kN. The ultimate failure occurs due to delamination of the interface and rupture of the beam at the end of the coupling reinforcements, at a load level of approximately 14 kN, see also Fig. 7.

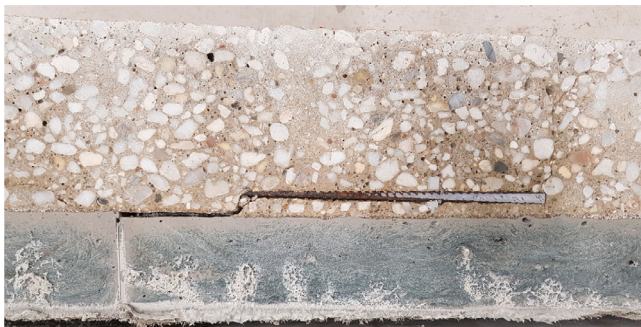
Fig. 11. Crack propagation in the Epoxy sample, within the beam, observed after cutting the sample in the middle.
