# AFP Defect Characterisation: The Importance of Testing Scale and Defect Interaction <sup>†</sup>

<sup>†</sup> Presented at the 15th EASN International Conference, Madrid, Spain, 14–17 October 2025.

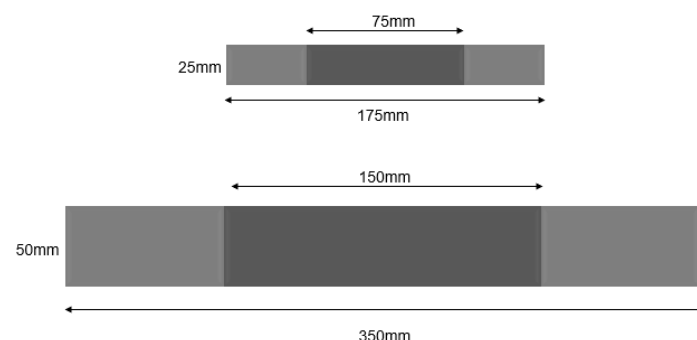
The specimen geometries and defect layouts were designed to investigate the influence of structural scale and defect interaction on the mechanical response of AFP-manufactured laminates. As shown in Figure 1, two nominal specimen sizes were employed: a small coupon with a gauge dimension of 75 mm × 25 mm, and a large coupon with a gauge dimension of 150 mm × 50 mm, corresponding to a four-fold increase in surface area.

**Figure 1.** Small and large specimens' dimensions.

The small coupons were designed first, and then used as the basis for the development of the larger specimens. Two distinct scaling strategies were adopted for the large coupons: (i) a direct scaled-up version of the small coupon, and (ii) a repeated configuration in which the small coupon layout was replicated two times along both specimen length and width, to preserve the same gap spacing and alignment pattern within the larger specimen.

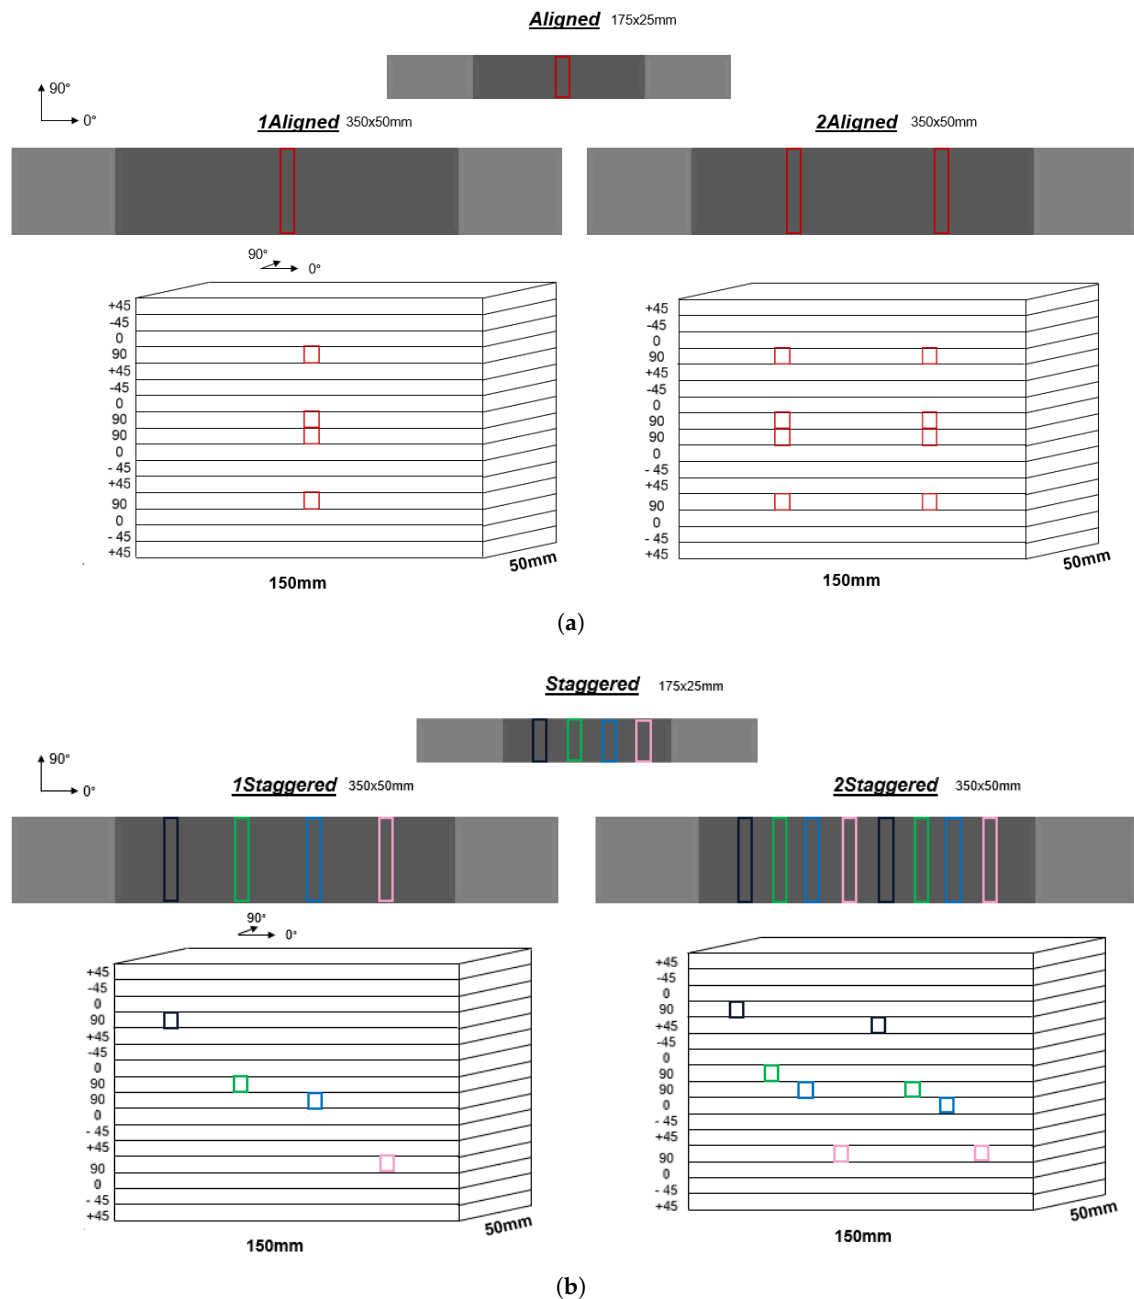
Figure 2a shows the configuration of the aligned group specimens. The *Small Aligned* specimen contained four aligned gaps located at the centreline of the specimen. The *Large 1Aligned* configuration was a scaled-up version of the *Small Aligned* specimen, maintaining four aligned gaps positioned along the centreline within the larger gauge area. The *Large 2Aligned* configuration contained eight aligned gaps arranged as two sets of four, representing a two-times duplicate of the *Small Aligned* layout along the width and length of the larger specimen.

Analogous to the aligned group, staggered configurations (Figure 2b) were designed to distribute defects along the specimen length. In the *Small Staggered* specimen, one defect was

placed in each of the four  $90^\circ$  plies, with a longitudinal offset of 12.7 mm between successive defects to ensure even spacing along the length. The *Large 1Staggered* specimen contained four staggered gaps distributed over the larger gauge length, maintaining the same relative offsets. Finally, the *Large 2Staggered* configuration incorporated eight staggered gaps, representing a double repetition of the *Small Staggered* pattern in both the  $0^\circ$  and  $90^\circ$  directions within the larger specimen.

**Figure 2.** Defect configuration schematic: (a) Aligned group.(b) Staggered group.

All configurations incorporated manufacturing gaps with a nominal width of 6.35 mm. To replicate AFP-induced placement defects, these gaps were introduced in the 90° plies of the layup  $[+45, -45, 0, 90]_{2S}$ , by deliberately not placing a single tow. The various configurations are summarised below.

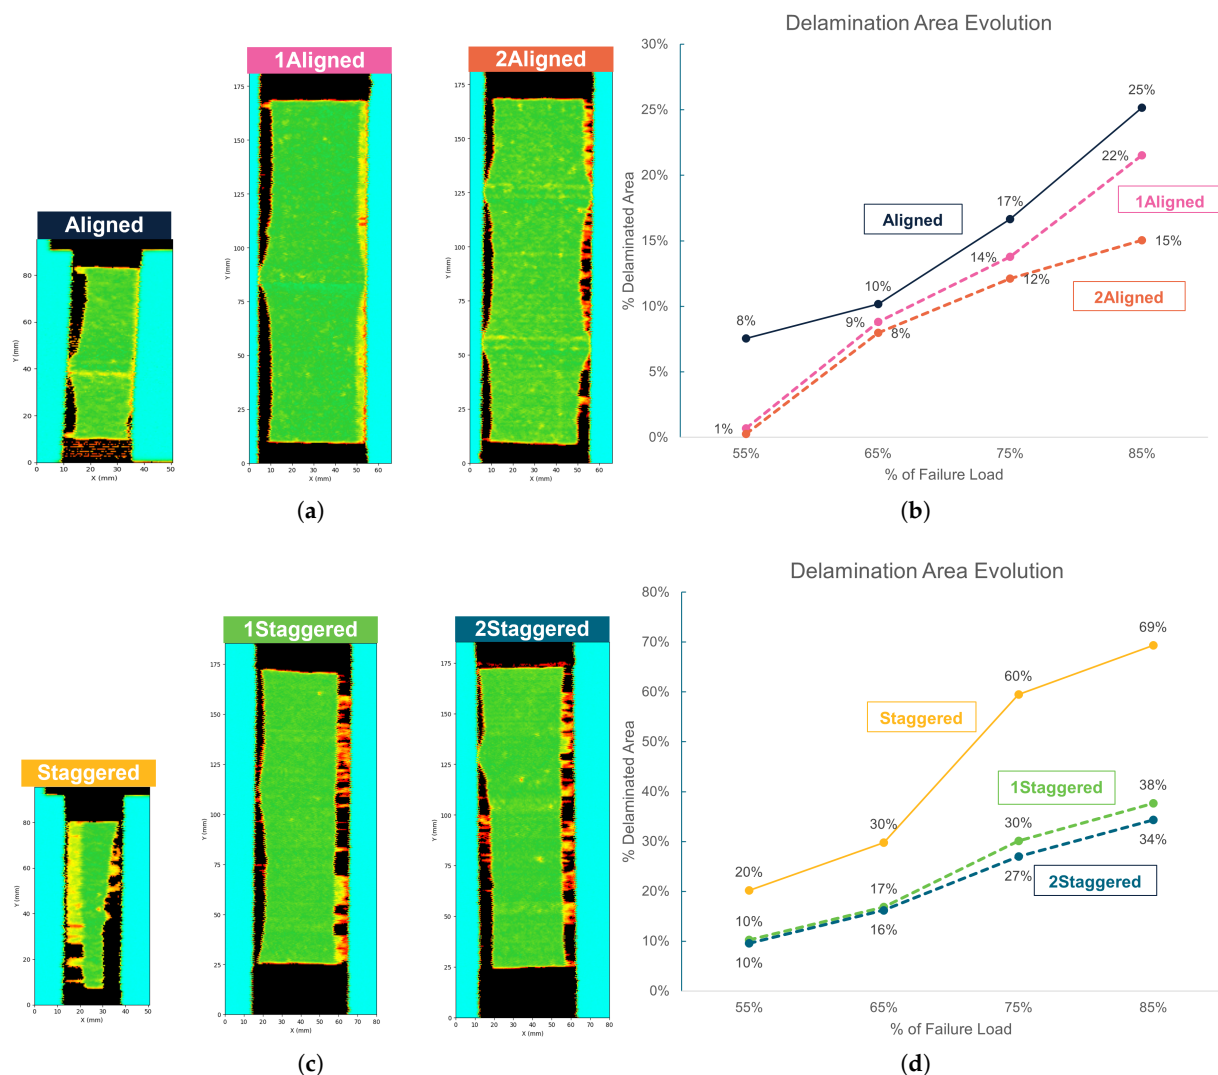
The delamination patterns were observed to be strongly influenced by the defect configuration. In the **aligned group** (Figure 3a), edge delamination consistently showed the same characteristic shape and was observed to terminate at the locations of the gaps. This behaviour can be attributed to the presence of the  $90^\circ$  ply gaps located along the laminate mid-plane. These gaps allow local bonding between the adjacent  $0^\circ$  plies, effectively arresting delamination growth at the  $0/90^\circ$  interfaces and creating a series of discrete delaminated regions bounded by the gaps.

**Figure 3.** Delamination evolution from C-scan data: (a) C-scan plots at 75% failure load (aligned group). (b) Delamination area evolution at different % failure loads (aligned group). (c) C-scan plots at 75% failure load (staggered group). (d) Delamination area evolution at different % failure loads (staggered group).

In contrast, for the **staggered group**, shown in Figure 3c, the gaps did not exert such a clear influence on the overall delamination shape. Instead, specimen dimensions appeared to play a more significant role in governing delamination area. As shown in Figure 3d, the delaminated area evolution, expressed as a percentage of the total surface area, reached

approximately 34% and 36% for the *Large 1Staggered* and *Large 2Staggered* specimens at 85% of the failure load. In comparison, the *Small Staggered* specimen exhibited substantially larger delaminated areas, up to 69% under the same load level.

To a lesser extent, a similar trend can be observed within the **aligned group** in Figure 3b. This is because the delaminated area remained relatively low, with the *Small Aligned* coupon reaching approximately 25% delaminated area at 85% of the failure load, compared to 69% for the *Small Staggered* specimen. These observations indicate that both defect interaction and specimen scale can influence delamination behaviour.

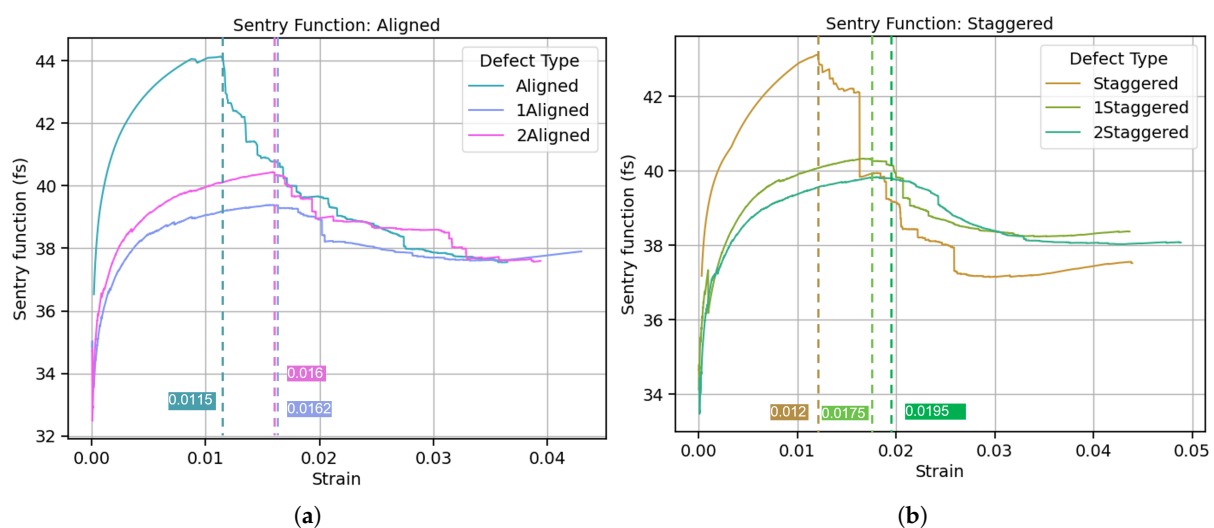
Figure 4 illustrates the comparison of damage initiation behaviour between the smaller and larger coupon configurations. The vertical markers in the plots indicate the strain levels corresponding to the first sudden drop in the sentry function, which were interpreted as the initiation points of macro-damage. In the **aligned group**, larger specimens exhibited damage initiation at higher strain levels compared with the smaller coupons. A similar trend was observed for the **staggered group**, suggesting that specimen scale influences the strain threshold for the onset of damage in AFP-manufactured laminates.

**Figure 4.** Sentry function with labelled first sudden drop: (a) Aligned group. (b) Staggered group.

In this study, particular attention was given to sudden drops in the sentry function. As the sentry function represents a ratio, an abrupt decrease indicates either a sharp increase in AE activity, or a sudden drop in stiffness. This suggests the occurrence of a significant event such as the initiation of macro-scale damage.
