Influence of the behaviour of calcium silicate brick and element masonry on the lateral capacity of structures

10th Australasian Masonry Conference

INFLUENCE OF THE BEHAVIOUR OF CALCIUM SILICATE BRICK AND ELEMENT MASONRY ON THE LATERAL CAPACITY OF STRUCTURES

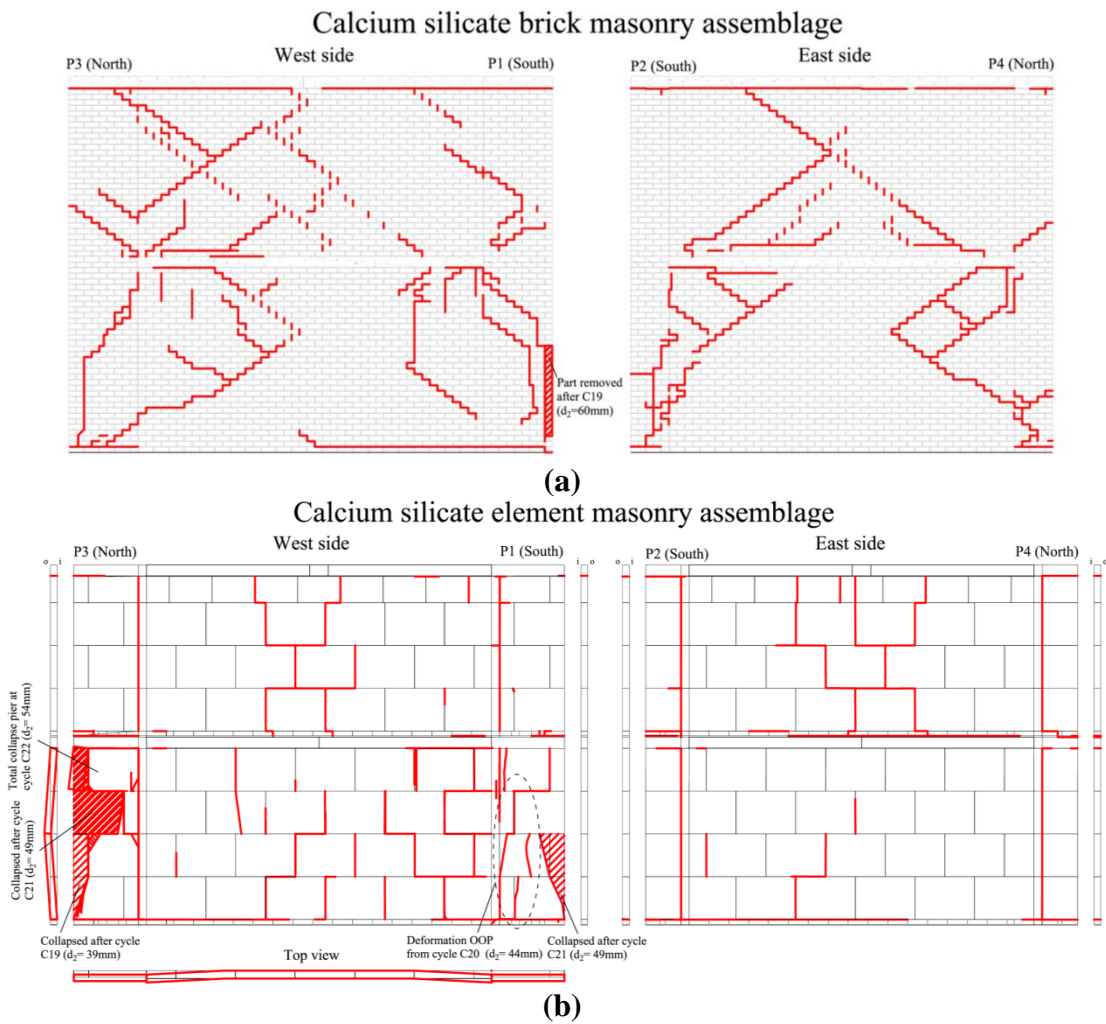
Figure 6: Crack pattern: (a) CS brick masonry; (b) CS element masonry.

In both cases, the failure mechanism was mainly governed by the in-plane damage of the facades piers at the ground floor (Figure 5, Figure 6). First, cracks occurred at the joint between the concrete floor and the masonry walls. Subsequently, diagonal/vertical cracks occurred in the wide pier P1 and P3 at the ground floor, while the rest of the structure was only slightly damaged. During the post-peak phase and prior to major damage in the narrow piers, the wide piers were subject also to a reduction in cross section that led to a further reduction in capacity. Both for the brick and element masonry the diagonal/vertical cracking occurred first in the head and bed joints. However, in the case of the CS element masonry assemblage, large out-of-plane deformation up to collapse of the piers occurred; this is caused by the large size of the masonry units.

By accommodating the in-plane deformation of the piers, the transversal walls deformed out-of-plane showing the effectiveness wall-to-wall connection in both cases. In the case of the CS brick masonry assemblage the running bond allowed a strong connection between the piers and the transversal walls and promoted the flange effect, which is of importance for the base shear capacity (Esposito et al., 2017a). In the case of the CS element masonry assemblage, although cracking occurred in correspondence of the vertical joints at approximately the peak load, the connection was still effective. This was caused by the presence of the steel ties and by the sliding friction mechanism at the vertical joint governed by the high friction coefficient of the CS element masonry. Additionally, the extensive damage of the pier and the detachment of masonry pieces that interlocked within the open cracked promoted local deformation at the end of the transversal wall for a length of approximately 1 m from each wide pier (Figure 6b).

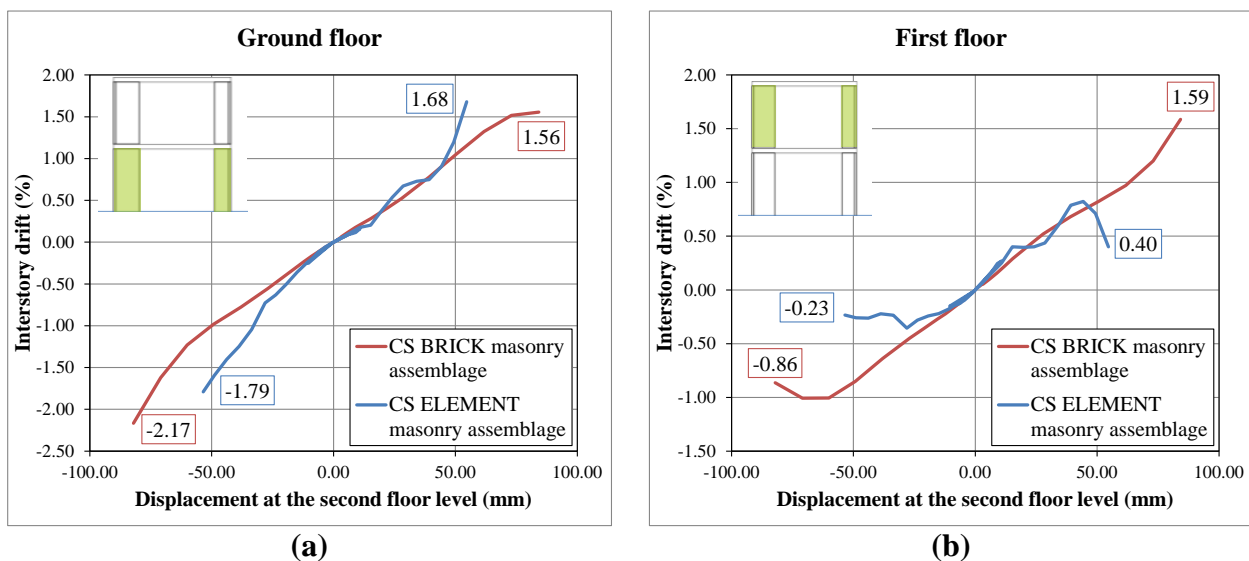
Figure 7: Comparison in terms of interstory drift: (a) Ground floor; (b) First floor.

Figure 7 shows the behaviour of the structure in terms of interstory drifts as a function of the displacement at the second floor level. They are calculated as the ratio between the relative floor displacement and the interstory height, which is 2.7 and 2.6 m for the first and second floor level, respectively. Although the CS brick masonry assemblage reached larger displacement at the second floor level (82 mm in comparison with the 54 mm of the CS element masonry assemblage), the two structures showed a similar interstory drift for the ground floor varying between 1.6% and 2.2%. A substantial different behaviour is observed at the first floor, where at the onset of damage of the wide pier the CS element masonry assemblage showed a nearly constant drift. This difference can be caused by the different load redistribution on the piers at the level of the first floor slab, which is consequence of the different construction detail. In the case of the CS brick masonry assemblage the piers are only horizontally connected to the floor by anchors, while for the CS element masonry assemblage the floor laid on top of the piers. Although in both cases the piers do not bear the floor in the undamaged configuration, for relative large displacement the load transferred by the first floor slab is directly redistributed to the piers in the case of the CS element masonry assemblage, while it is indirectly transferred via the transversal walls in the case of the CS brick masonry assemblage. Consequently, in the former case a concentration of displacement is observed at the ground floor leading to a soft-story mechanism.
