# Analysis of two coastal lagoons in Ghana

an investigation of boundary conditions for the redesign of two lagoons along the Ghanaian coast

Technische Universiteit Delft

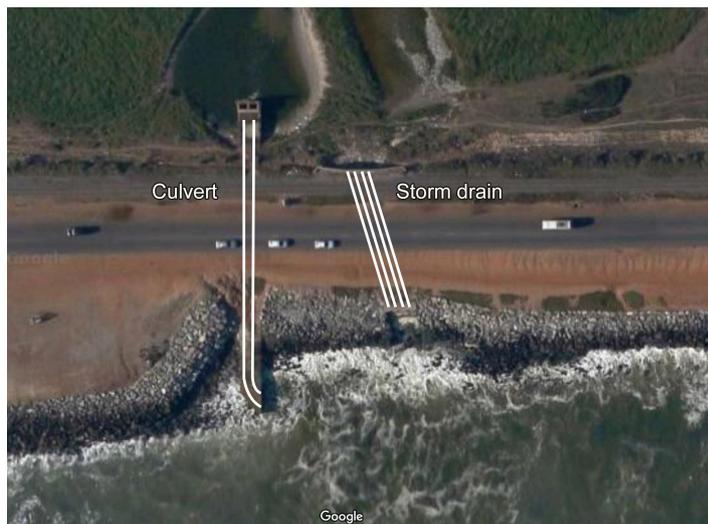
Two concrete structures are present in the mouth of the Sakumo Lagoon. Together, they regulate the rate at which water can flow in and out of the lagoon. Both of them are located southeast of the main basin, near the harbour of Tema. There is a culvert and a storm drain, as shown in figure 3.1.

Figure 3.1: Structures in the mouth of the Sakumo Lagoon

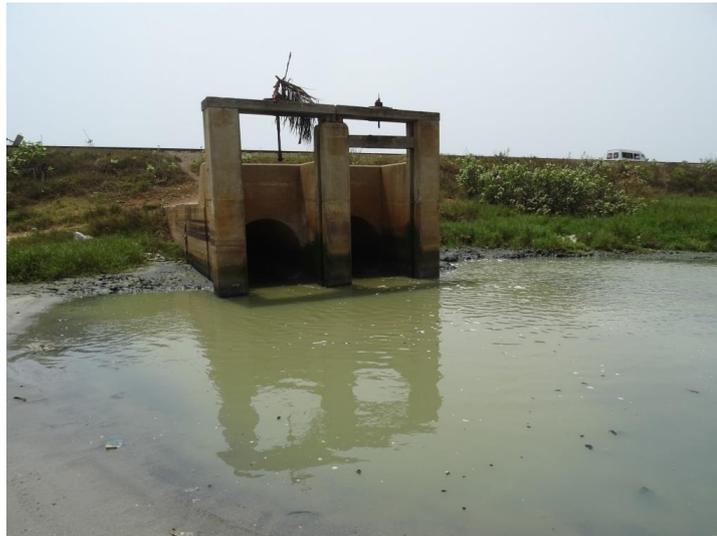
At low tide, the culvert structure is completely emerged from the sea, with only the occasional wave high enough to reach the structure. Because the water level in the lagoon is usually higher than the bottom level of the culvert pipes, water can freely flow out of the lagoon at low tide. During high tide, the

Figure 3.2: Culvert structure, seen from the lagoon side

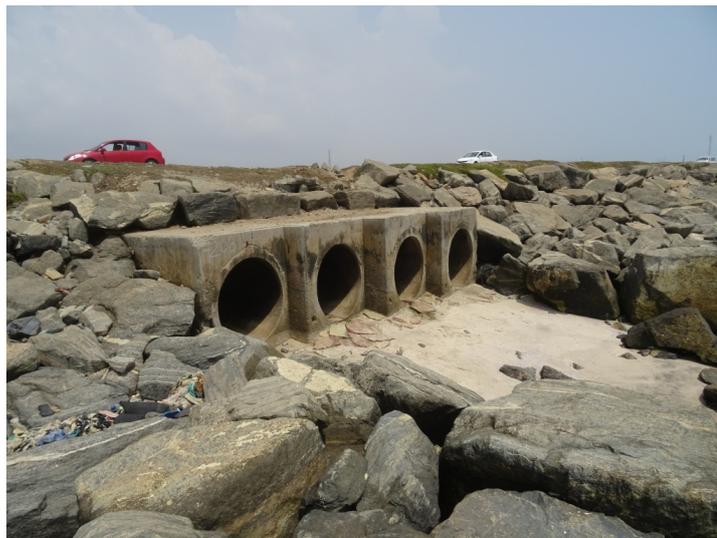
Figure 3.3: Storm drain, seen from the sea side

The storm drain is in a much better shape than the culvert. This can mainly be attributed to its age, but also since it is not as directly exposed to the wave action as the culvert. Nevertheless, the storm drain also shows some signs of concrete degradation. There are multiple noticeable brown spots on the surface, indicating corrosion of the reinforcement. This is also visible in the top right corner facing the structure from the sea side. There, a corner has broken off, exposing the rusted reinforcement bar underneath.

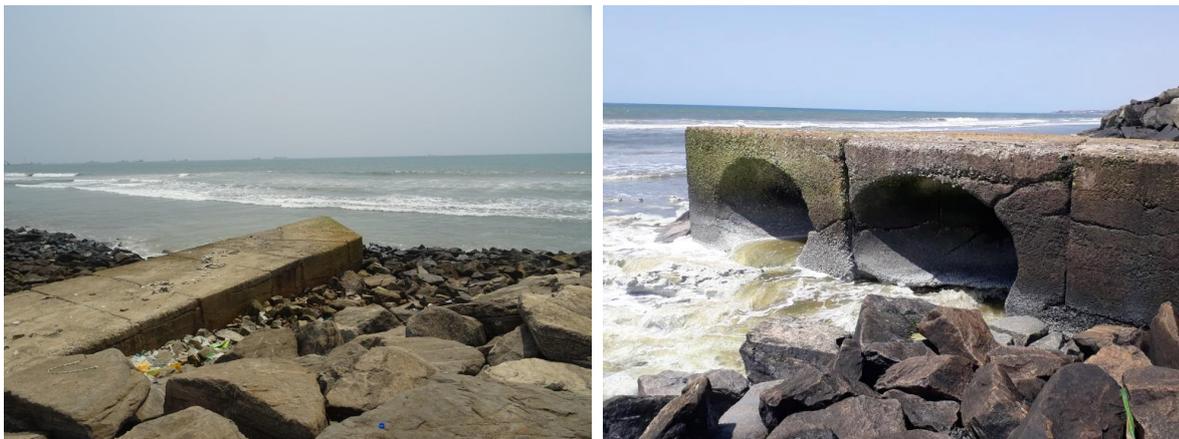
The culvert has been exposed to direct wave action for 65 years and shows severe signs of deterioration. At the entire seaside of the structure, the top layer of the concrete has been eroded, leaving the bare aggregate exposed. The aggregate is notably coarse, up to 50 mm from what can be seen. In some spots large chunks of concrete have broken off. Furthermore, the bottom part of the right outlet in figure 3.4b is completely eroded, exposing the rocks underneath the culvert.

Large cracks run along the entire structure, as can be seen in figure 3.4a. Most of them are straight and run around or along the entire culvert structure. This suggests that the cracks have formed along the seams of the structure.

(a) Overview of the sea side part

The culvert has exceeded its intended lifespan. Aesthetically, it is in bad condition. Large cracks, large chunks of broken off concrete, strong signs of corroded reinforcement and of course the faulty sluice gates make for a fragile looking structure. It is hard to say if it is structurally unsafe. Further investigation could prove useful in order to make a definitive statement on the structural integrity of the structure. However, its age and the fact that it is visibly in poor condition might be enough reason to replace it entirely.

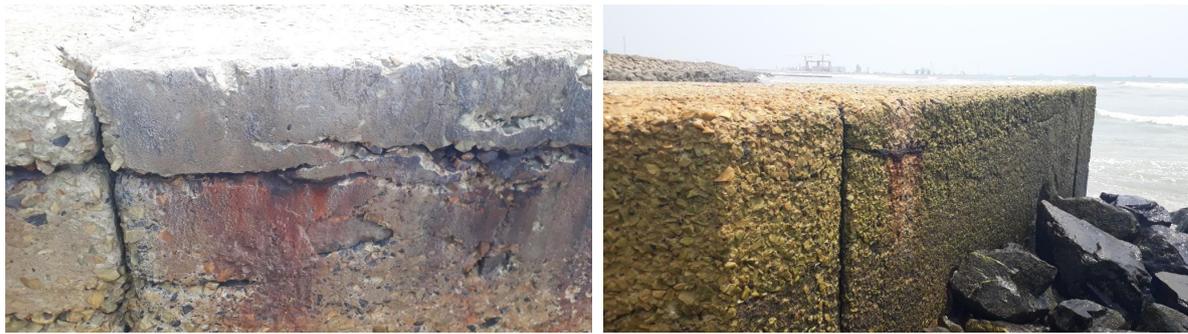
(a) Cracked concrete

Figure 3.5: Concrete degradation of the culvert structure

In marine environments, concrete is exposed to the corrosive and erosive effects of seawater. The main threats are rebar erosion due to chloride attack and erosion due to flow and wave action.

**Chloride attack (corrosion)** Under normal conditions, steel reinforcement in concrete is protected against further erosion by a protective layer of corrosion that naturally covers reinforcement steel (Neville, 1995). However, chloride ions disrupt this protective corrosion layer and cause the steel to corrode more if oxygen is available. This has two negative consequences. Firstly, it reduces the

effective area of the steel, weakening the reinforcement. Secondly, the rust takes up more volume than the original steel, leading to cracks in the surrounding concrete.

**Erosion** Apart from being corrosive, seawater can also contribute to erosion. Wind waves crashing on the surface of concrete will gradually knock off small pieces of mortar, exposing the coarse aggregate underneath. The sediment carried by these wind waves amplify this effect. This process is called abrasion erosion (Liu et al., 2006). Given enough time, this abrasion erosion can eat away large parts of the concrete. This leaves reinforcement bars exposed to direct seawater interaction, which in turn leads to an acceleration of corrosion.

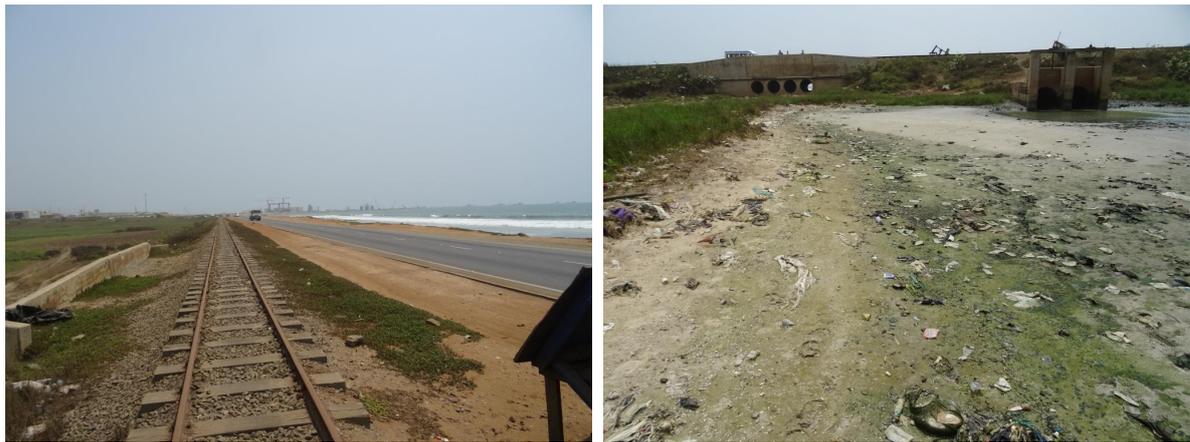
(a) Coastal road and rail road track

Figure 4.1: View of the embankment separating the lagoon from the sea

(a) Culvert structure protruding from the embankment

In 1953, a culvert and sluice structure was built, permanently connecting the lagoon to the sea through the sand dune (Ntiamao-Baidu and Gordon, 1991). It is the structure on the right in figure 4.1b. The culvert was built to enable the construction of the Accra-Tema road along the coast. This road runs over the sand dune along with a rusty railroad track, see figure 4.1a. The culvert prevents unpredicted flooding of the road (Pauly, 1975) and breaching of the embankment.

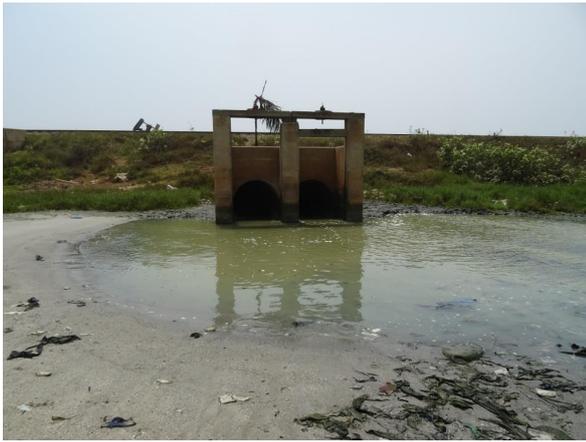
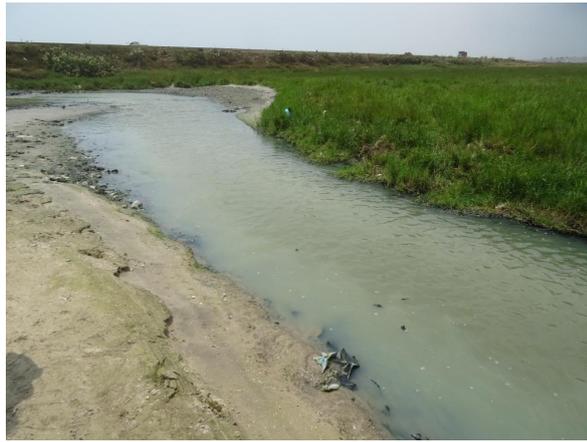
Figure 4.3: Overview of the mouth area of the lagoon

(a) Lagoon side of the culvert

(b) Stream running towards the culvert

On the lagoon side of the culvert, sluice gates were constructed in order to regulate the water exchange between the lagoon with and sea (see figure 4.3a). They were once used to retain a certain water level during the dry season (W. Ametefe, pers. comm.). Presently, in 2018, the sluice gates are not functioning any more. Ntiamao-Baidu and Gordon (1991) reads that the sluice gates were not functioning in 1991 and mr. Ametefe confirms that they have been out of order for more than 30 years.

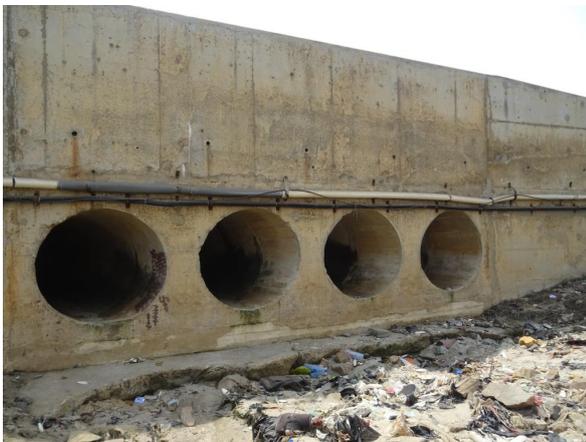
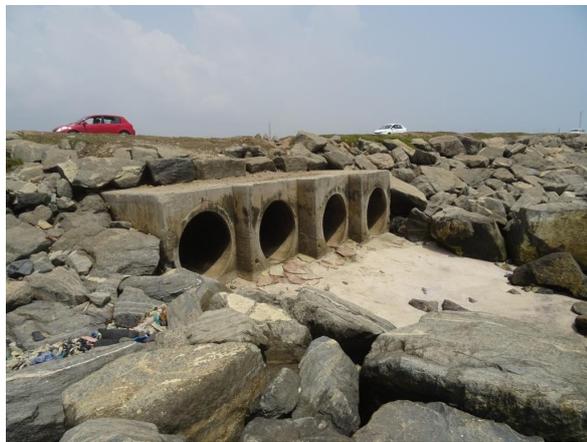
Figure 4.4: Storm drain

(a) Lagoon side

(b) Sea side

the same year, a storm drain was constructed 20 m east of the existing culvert to prevent future floods. The storm drain consists of four tubes with a diameter of 1.4 m. Their elevation is about one meter higher than the original culvert. It can be seen in figure 4.4. The tubes seem to be built at an incline, with a lower bottom level at the sea side in order to increase outflow capacity (personal observation). This was confirmed by (C. Amankwah, pers. comm.) but remained unclear in conversation with (W. Ametefe, pers. comm.), because the original design drawings could not be retrieved. Since the construction of the storm drain, there has not been a flooding as severe as in 1997 (C. Amankwah, pers. comm.).

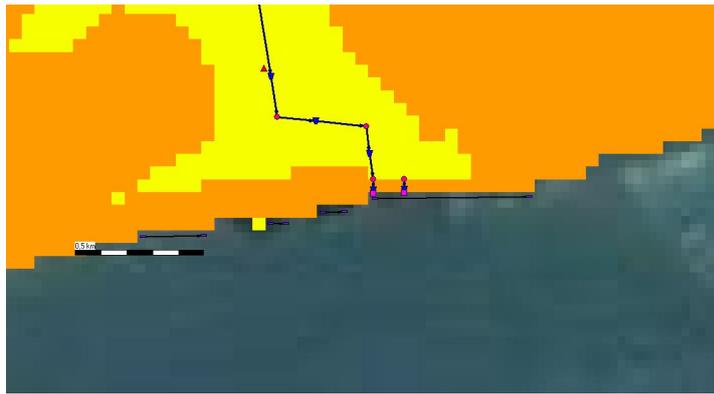
Figure 5.3: 1D elements and water level boundaries at the mouth of the Sakumo Lagoon

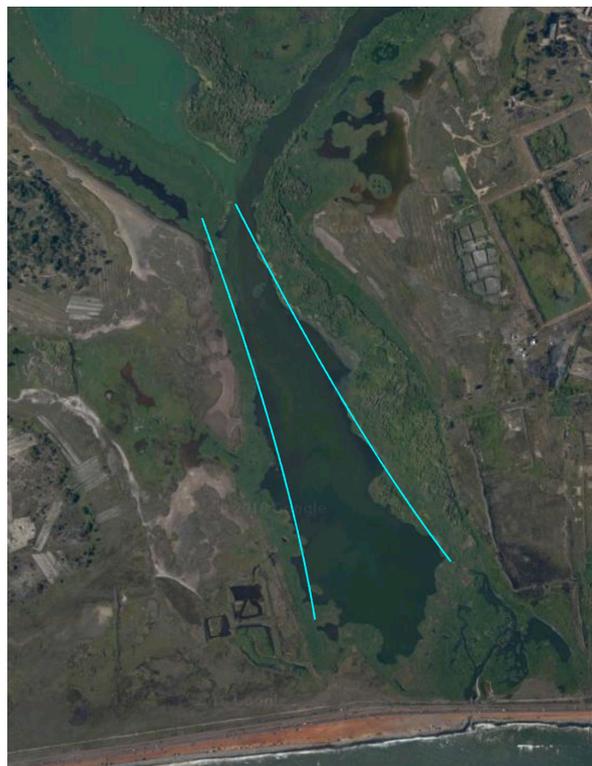
Little is known about mixing, salt intrusion and pollutant dynamics in coastal lagoons. However, much more is known about salt intrusion in estuaries. Because pollutants obey the same transport equations as salt, the Sakumo lagoon is simplified to an estuary with exponentially varying width. Because of this simplification, results provided in this section have questionable validity. Nevertheless, they can prove useful when compared to alternative design situations discussed in chapter 9.

Figure 6.1: Simplification of the Sakumo lagoon to an estuary with exponentially varying width

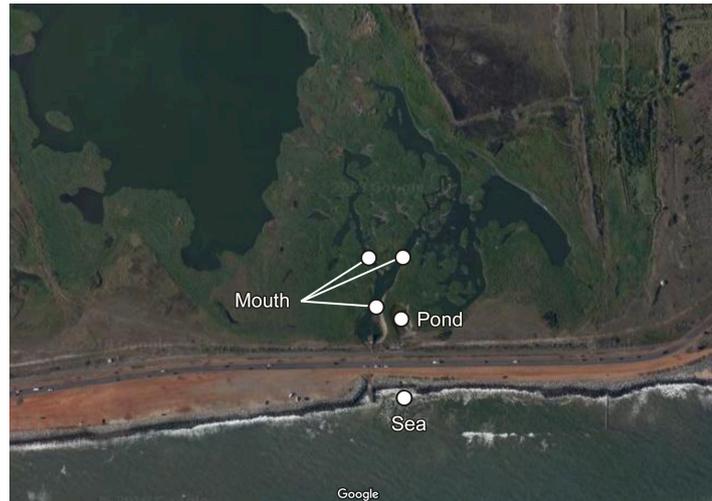
Figure 7.1: Measurement locations at the mouth of the Sakumo lagoon

Field work was done on 2 February 2018. This date was chosen because it was spring tide and maximum in- and outflows could be observed. Samples were taken at various locations. Three locations were sampled near the lagoon mouth, during both low water (10:08) and high water (16:30). Two more locations were sampled during high water. The first of these locations is a small pond separated from the main water body located near the lagoon mouth, the second location at the sea side of the embankment. The measurement locations are shown in figure 7.1.

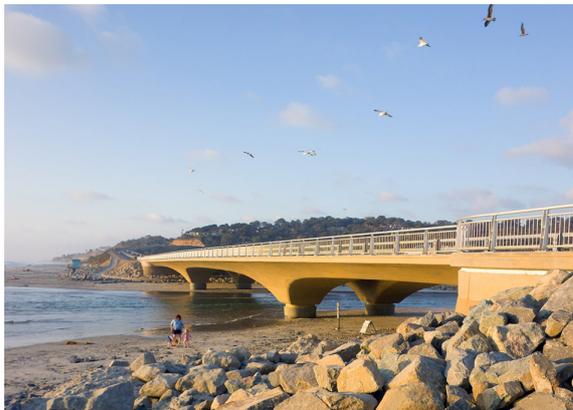
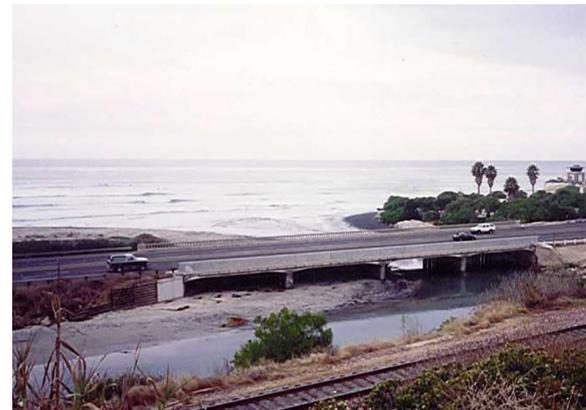
Figure 9.1: Examples of channelised lagoon mouths with bridge crossings.

(a) Bridge crossing the mouth of the Los Peñasquitos Lagoon in California, USA. Photo by Safdie Rabines Architects (2017)

(b) Bridge crossing the mouth of the San Elijo Lagoon in California, USA. Photo by Coastal Environments (2017)

The mouth of the Los Peñasquitos Lagoon (shown in figure 9.1a) features a 100 m long concrete bridge, supported by four pylons. On either side of the lagoon mouth, rubble scour protection is applied.

The San Elijo Lagoon has a similar, but smaller opening, along with a bridge that spans 50 m. It is shown in figure 9.1b. At either side of the opening, straight concrete walls serve as abutments.

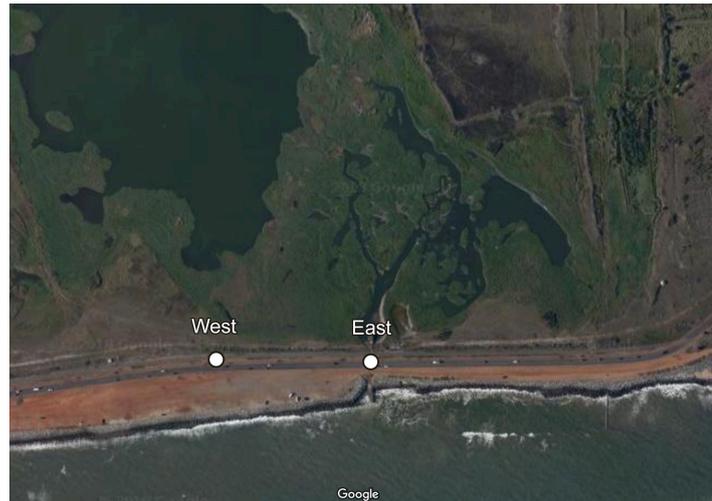
Figure 9.3: The two possible locations of the mouth of the Sakumo lagoon

Different mouth designs will be compared with regards to flood safety based on this once in 50 year rainfall event. The mouth designs assessed are culverts of various size and open connections with the sea of various widths, representing a channel with possible sand dune. The culvert and open connection will be placed at two locations in the current coastal road, shown in figure 9.3.

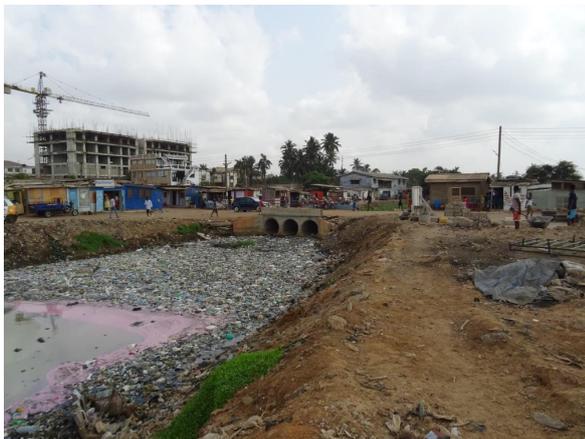
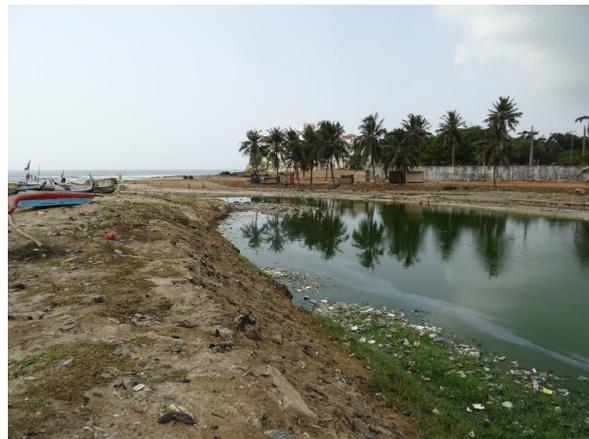
Figure 12.1: View on the upstream end of the lagoon

(a) The storm drain

(b) View on the basin, looking toward the southeast

**Klottey Lagoon** The Klottey Lagoon has an area of about 7500 m<sup>2</sup>. After running parallel to the shore for about 200 meters, the lagoon bends off to the south to meet the sea. Three big pipes at the upstream end connect the lagoon to its catchment. At the downstream end, it is connected to the sea through a concrete structure. On top of the bottom slab of this structure, sand has accumulated that closes off the lagoon in the dry season.

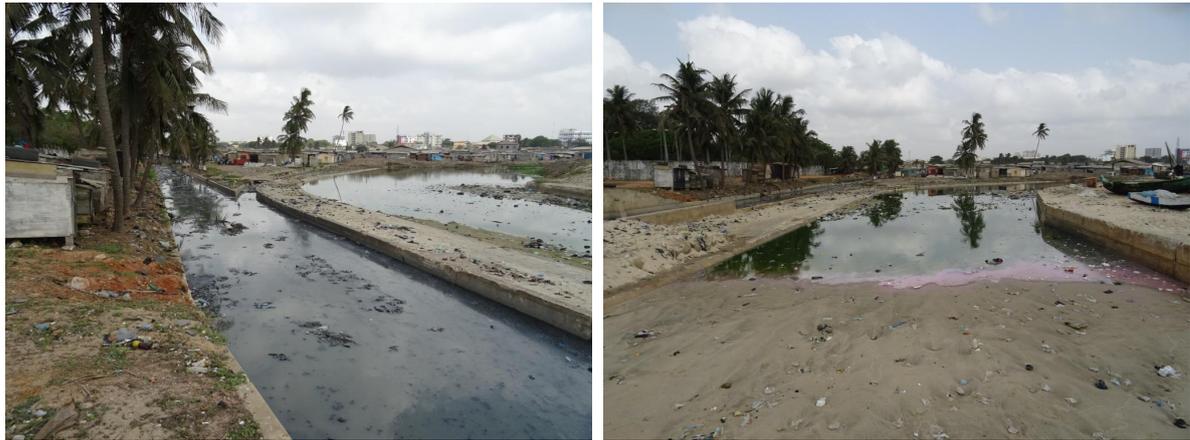
Next to the lagoon mouth, a city drainage channel discharges into the sea. The water of this drainage channel is severely polluted as it serves as a sewage drain. The mouth of the channel is filled with sediment. The water has made a path toward the sea through this layer of sand. The mouth of the city drain also has a discharge structure at the sea side. This structure inhibits the water of the drainage channel from flowing into the lagoon.

(a) The city drain

(b) Mouth of the Klottey lagoon

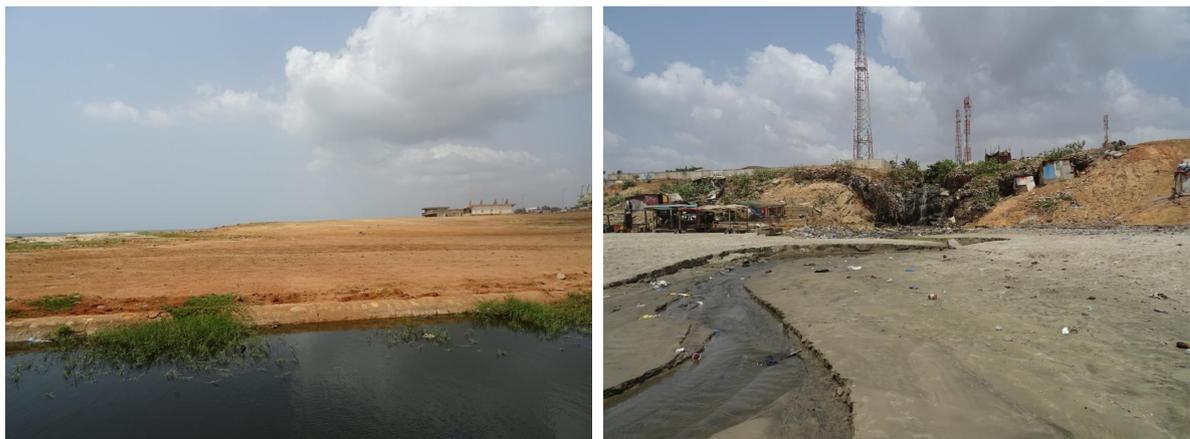
About five drainage streams were seen running over the beach into the sea. The most westward one was most clearly a city drain channel. The others were small streams running over the beaches to the sea. Two of the streams had concrete gutters laying nearby. These gutters are probably old drainage systems, which have broken down over time.

(a) View on the construction site

(b) A drainage channel running across the beach

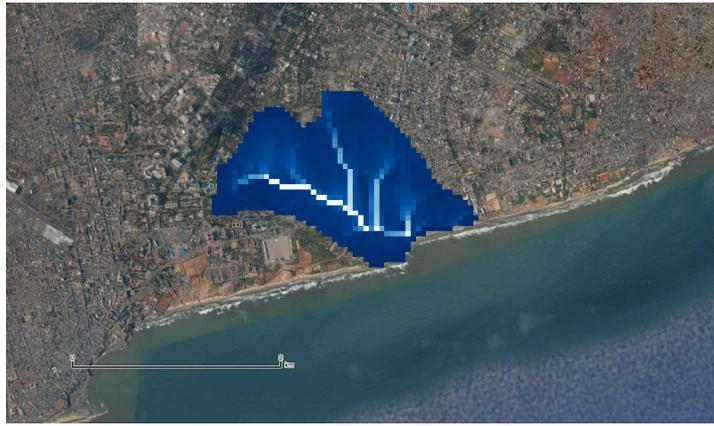
Figure 12.4: Flow pattern in the catchment of the Klottey lagoon

The catchment area of the Klottey lagoon was estimated from a Digital Elevation Model (DEM). The flow pattern was simulated from this DEM file using QGIS so that the catchment areas of various streams could be distinguished. This flow map is overlaid on a satellite image of the area in figure 12.4. The surface area was calculated from this flow map. This results in a surface area of 2.3 km<sup>2</sup>.

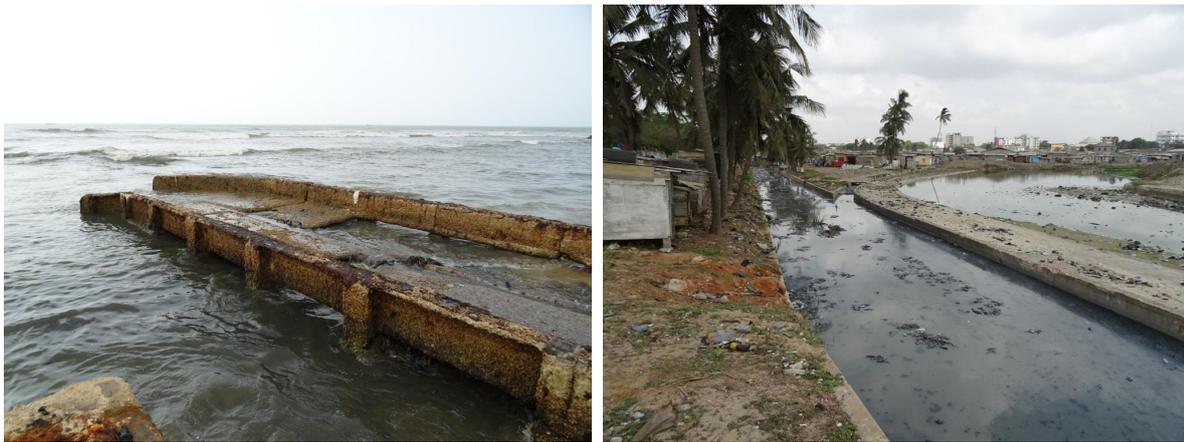
(a) Outflow end

Figure 12.5: City drain near the Klottey Lagoon.

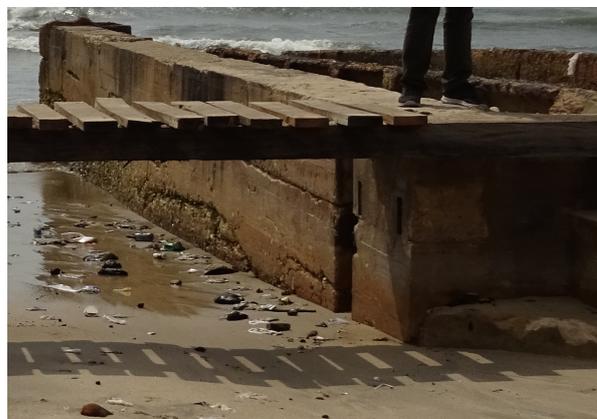
Figure 12.6: Slots in the concrete walls of the mouth of the Klottey lagoon

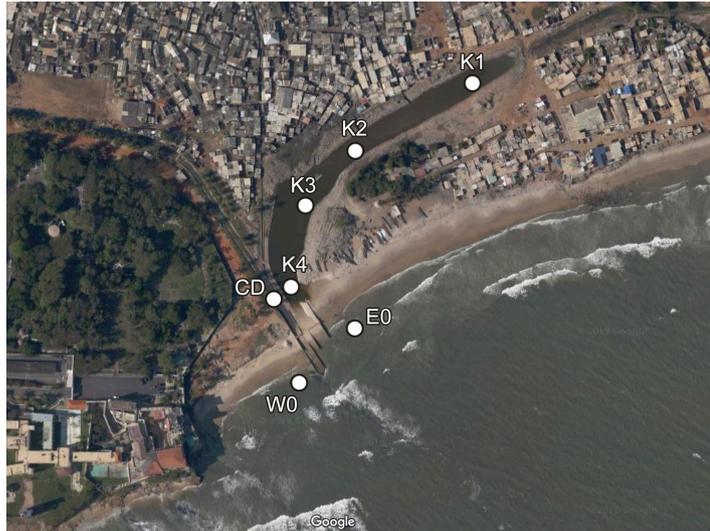
Figure 13.1: Water quality and sediment sampling locations in and near the Klottey Lagoon

Samples were taken on 4 different locations in the lagoon. One sample was taken near the mouth, one in the upstream end of the lagoon near the culvert, and two in between. An additional measurement was done in the city drain. Four samples were taken at sea. See figure 13.1 for an overview of these measurement locations.

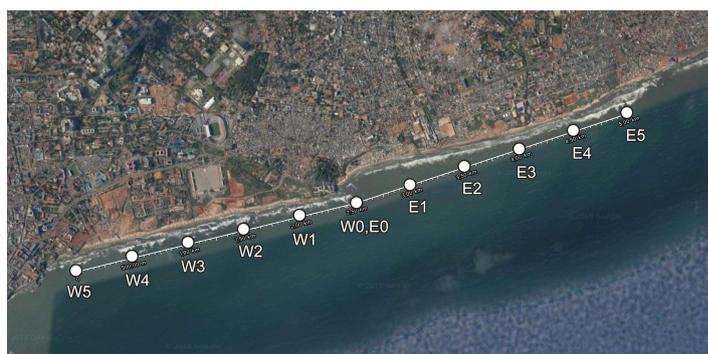
Figure 14.1: Overview of the sediment sampling locations

Sediment samples were taken on Monday 12 March 2018, on 12 locations along the coast near the Klottey lagoon and Marine Drive project area. Two samples were taken just west and east of the mouth of the Klottey Lagoon (locations W0 and E0). The rest of the samples were taken every 500 m over a length of 2.5 km in both eastward and westward direction. The samples were taken on the beach approximately at the edge of the surf zone.

See figure 14.1 for an overview of the measuring locations.

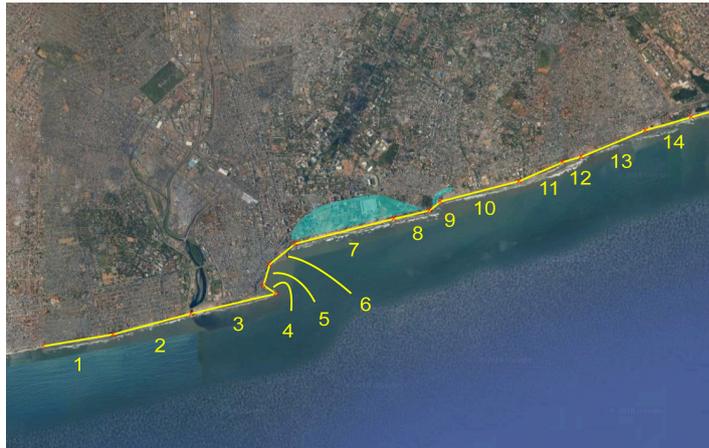
Figure 14.3: Shoreline schematization

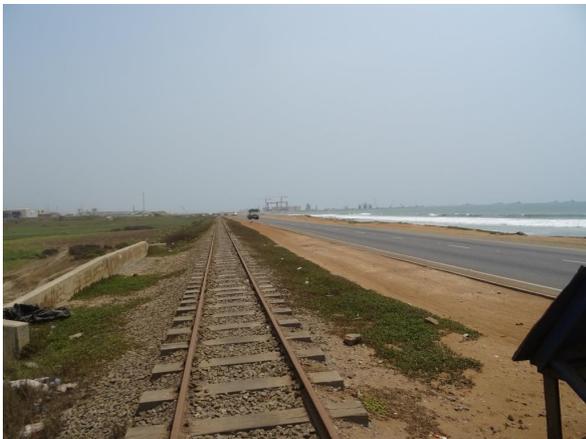
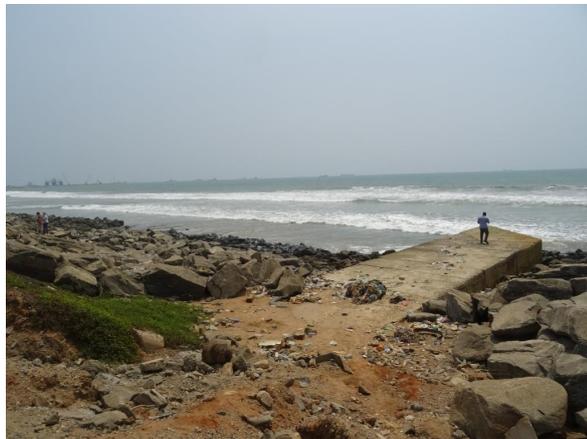
Figure A.1: View of the embankment separating the lagoon from the sea

(a) Coastal road and rail road track

(b) Sea-side of the culvert

The lagoon mouth was the first stop of the site visit. The coastal stretch, including the lagoon mouth, was reconstructed in or just before 1953. A two-lane coastal road runs over an earthen embankment. The sea side is protected from wave attack by a riprap revetment. A rusty rail road track runs along the coastal road. Supposedly, a train ran over this rail road track twice daily, transporting workers to and from the port of Tema. However, the train had an accident three months ago, and is temporarily not running.

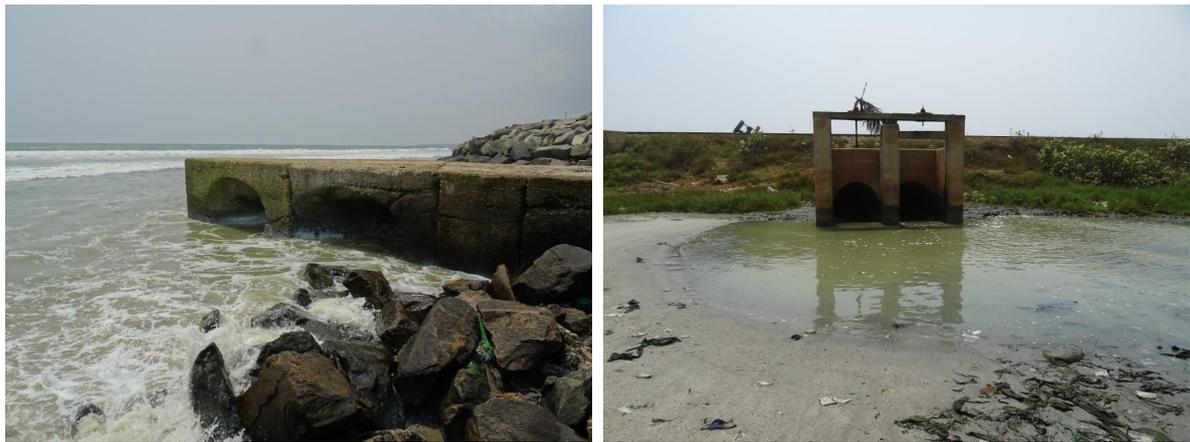
Figure A.2: Culvert openings

(a) Sea-side opening

(b) Lagoon side opening

The culvert is in quite a bad state. There once was a sluice gate structure on the lagoon side to regulate the water exchange between the lagoon and the sea. These gates were closed in the dry season in order to retain a certain water level in the lagoon. The gates are now gone and few parts of the hoisting mechanism are recognisable. The year of construction, 1953, is engraved on the structure. On the seaside, the culvert has been damaged badly due to the salt water and wave attack. The top layer of the concrete has eroded almost everywhere on the sea side of the culvert. Cracks in the concrete can be seen in multiple places, and iron stains indicate corrosion of the reinforcement bars. On the sea side, the bottom part of one of the tubes of the culvert was eroded completely.

The lagoon has two connections to the sea which lay in the embankment. The first structure is a concrete culvert which consists of two tubes with a diameter of 1.8 m that connect the lagoon to the sea directly. During the visit, water was flowing out of the lagoon via the culvert structure because the water at sea was lower than in the lagoon. With an occasional high wave at sea, water flowed into the lagoon via the culvert. From the lagoon to the sea, the tubes almost follow a straight line. The tubes are angled at the sea side, ending in openings directed to the east. This is to prevent sea water from hindering outflow of the lagoon after a heavy rainfall event. It is unclear whether the bottom of the culvert pipes are constructed horizontally or at an incline.

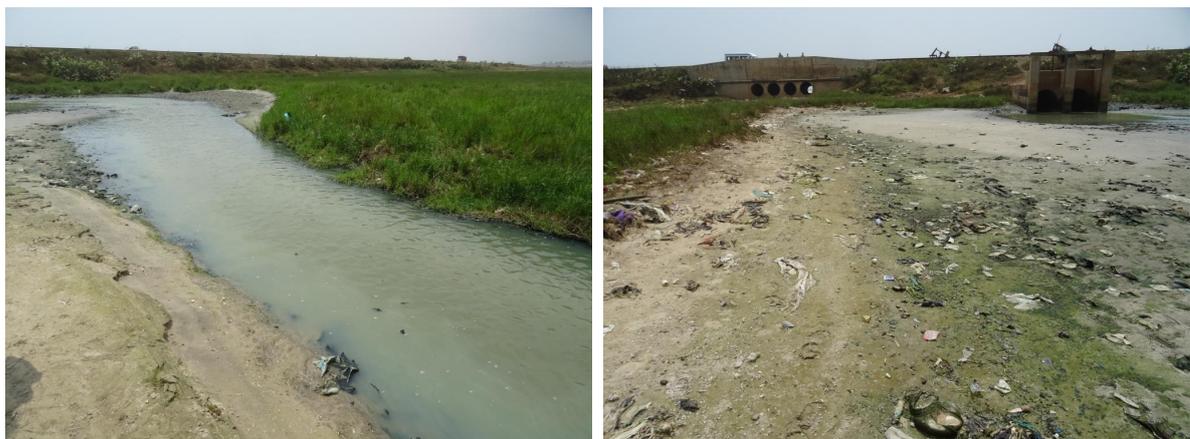
(a) Stream running towards the culvert

(b) Storm drain (left) and culvert (right) on the lagoon side

The water quality in the lagoon seemed poor. Debris, mostly plastic, could be seen everywhere. The water smelled bad and next to the culvert on the lagoon side, the bed was covered with a white substance. Two streams joined together just before the culvert on the lagoon side. Water from one stream was black, while the other stream consisted of white water. A lot of debris was scattered throughout the riprap on the seaside of the revetment.

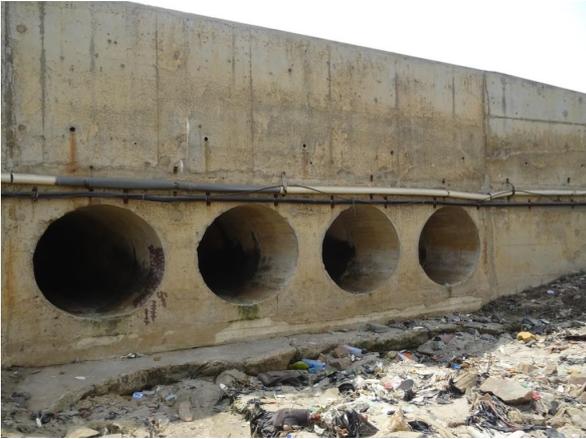
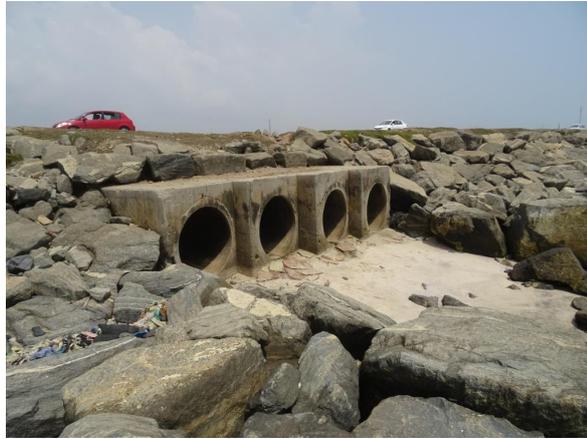
Figure A.4: Storm drain openings

(a) Lagoon side opening

(b) Sea side opening

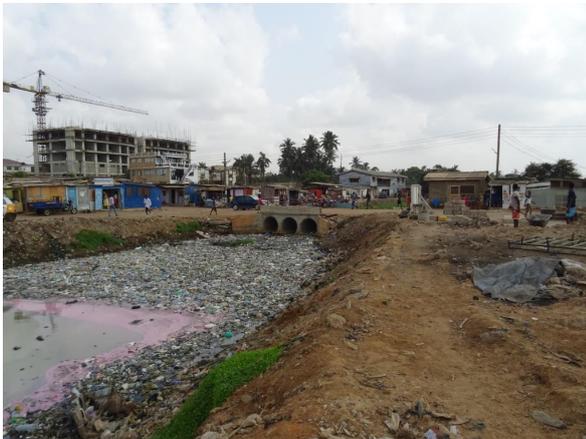
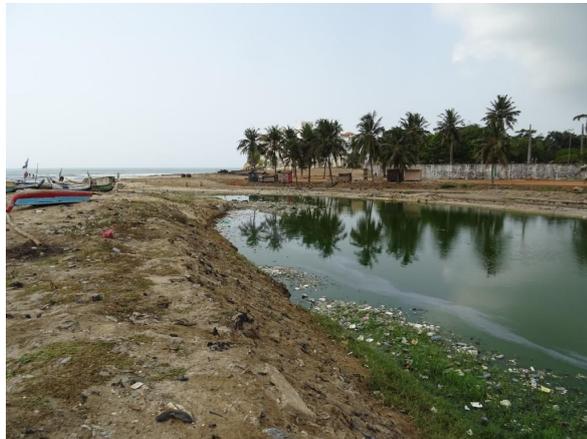
Figure B.1: View on the upstream end of the lagoon

Three big pipes are constructed at the upstream end of the lagoon, serving as a storm drain for the area. A lot of litter was floating in the water, mainly water bottles. The water itself looked green, with oil marks and pink foam floating on top. The site had an unpleasant smell. It could not be determined if the smell came from the water or from waste on the banks. A lot of garbage was laying on the banks, including plastic bottles and clothes.

(a) The storm drain

(b) View on the basin, looking toward the southeast

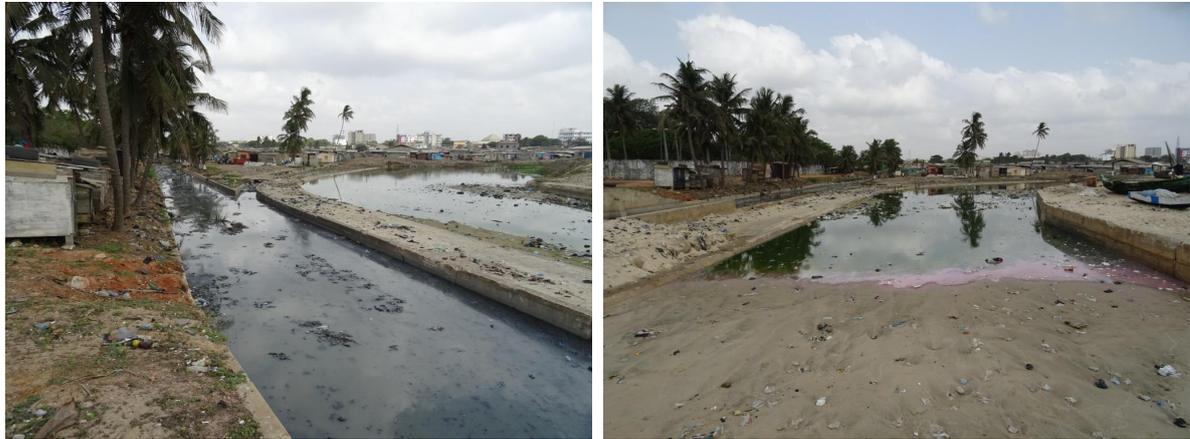
Next to the lagoon mouth, a city drainage channel discharges into the sea. The water of this drainage channel is of black colour and smells very bad. The mouth of the channel was filled with sediment. The water has made a path toward the sea through the layer of sand. The mouth of the city drain also has a discharge structure at the sea side. This structure inhibits the water of the drainage channel from flowing into the lagoon.

(a) The city drain

(b) Mouth of the Klottey lagoon

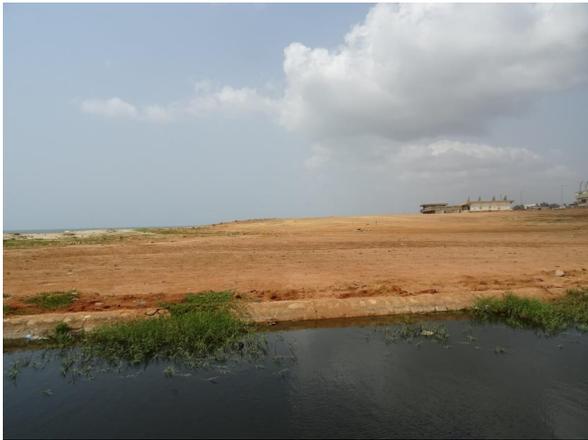
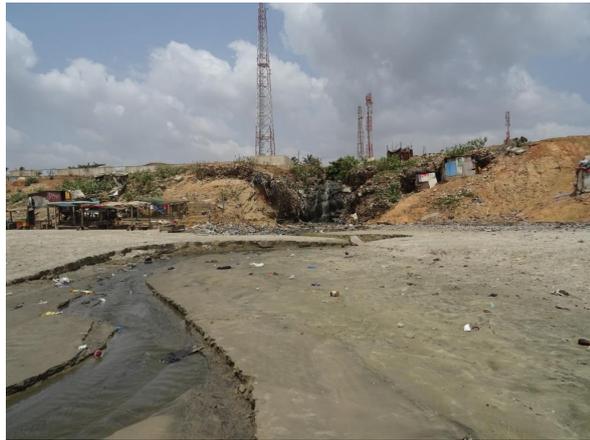
Figure B.3: View of the Marine Drive beach front

(a) View on the construction site

(b) A drainage channel running across the beach

Various types of litter were present across the beach. Most of the litter was piled up in heaps on the beach. The piles originate from fishermen emptying their nets on the beach, because these nets contain a lot of waste. The amount of garbage in the nets of the fishermen was more than twice the amount of fish.

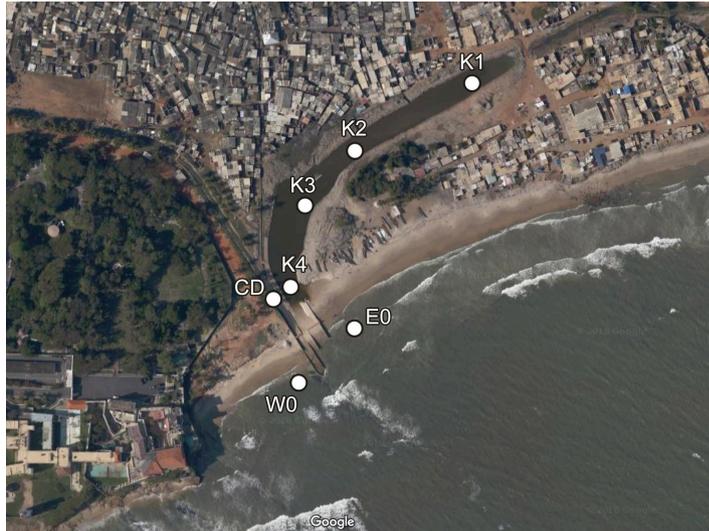
Figure E.2: Water quality and sediment sampling locations in and near the Klottey Lagoon

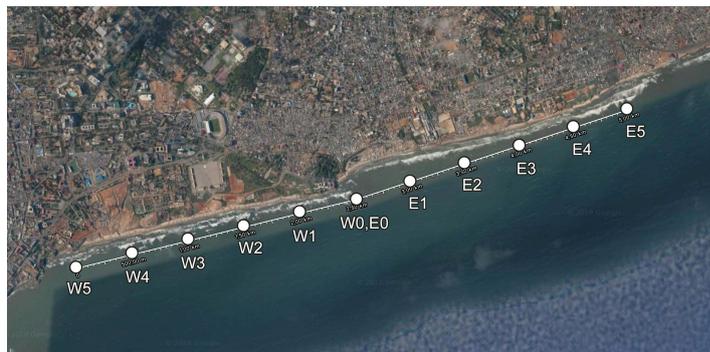
Figure F.1: Overview of the sediment sampling locations

In order to say something about the coastal erosion along the Klottey and Marine Drive beaches, sediment samples were collected. Samples were taken every 500 m along a 5 km stretch of coast. Each sample location was numbered, starting from the Klottey lagoon, ascending in eastern and western directions (E0-E5 and W0-W5 respectively, see figure F.1). These sediment samples were dried overnight in an oven. A portion of 100 g of every sample was then sieved using various available sieve sizes (see table F.1). After the sieving all partitions were weighed. The masses of these partitions can be found in table F.1. These measurements result in the sieve curves in figure F.2.
