**Towards a better understanding of failures occurring in sustainable
urban drainage systems**

Master Thesis Project

October 2019

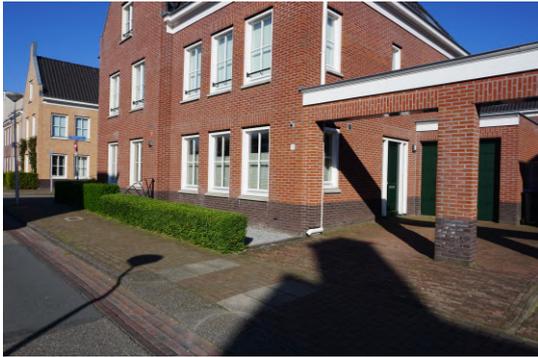
Figure 2.4: *Above-ground drainage from a private plot to the street*

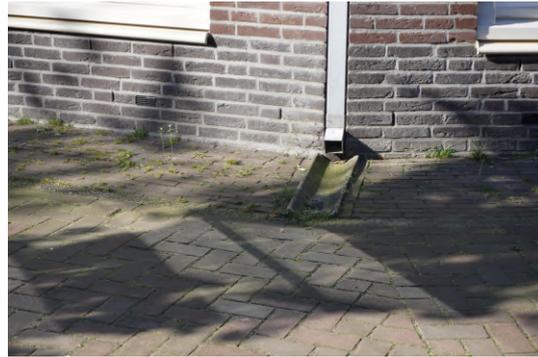
Figure 2.5: *Above-ground drainage from the house almost directly on the street*

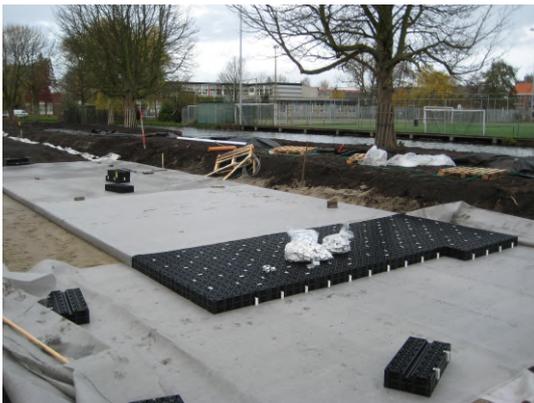
Infiltration crates are underground filtration facilities that are able to temporarily store and slowly infiltrate stormwater to the groundwater. Infiltration crates are plastic crates that are covered with geotextiles to prevent them from silting up. Crates form a good solution when there is no capacity to store water above the ground (Rainproof, 2019a). Crates can be constructed in all different shapes and sizes.

Figure 2.6: *Construction of infiltration crates at the Emmastraat in Gouda*

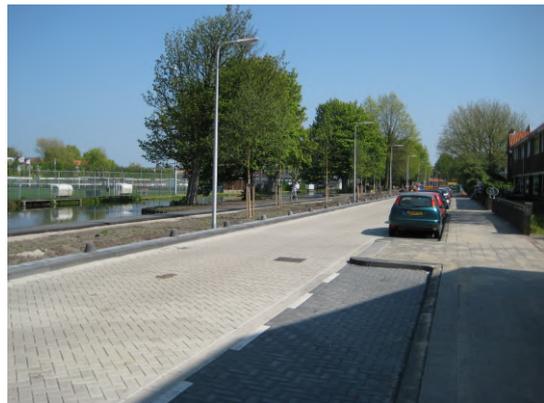
Figure 2.7: *Realization of crates constructed under the Emmastraat in Gouda*

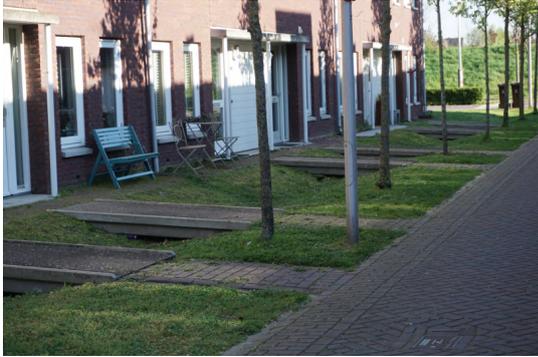
Figure 2.8: *Bioswale implemented in Utrecht*

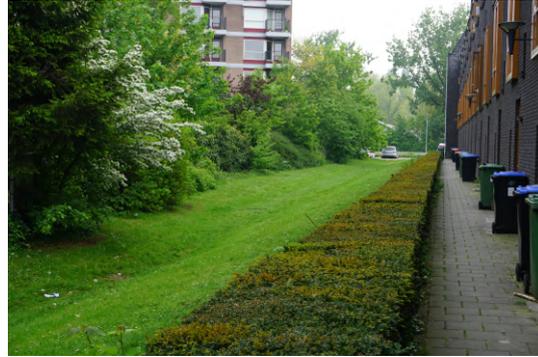
Figure 2.9: *Bioswale implemented in Dordrecht*

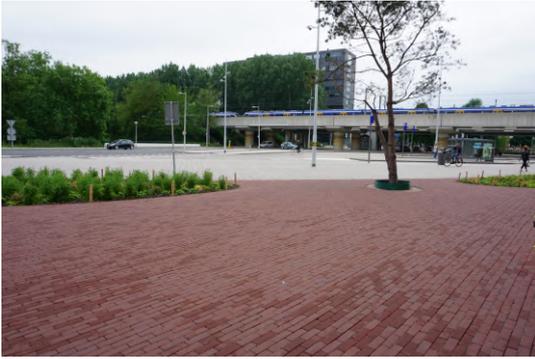
Figure 2.10: *Permeable pavement implemented on a square in Amsterdam*

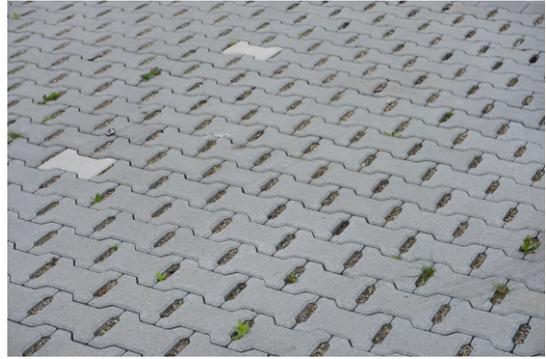
Figure 2.11: *Permeable pavement constructed at parking places in Zwolle*

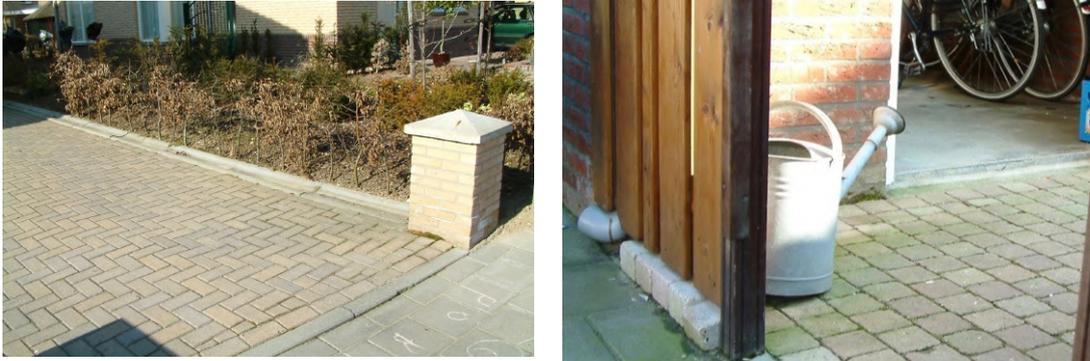
- **Conveyance:** The most common technical failures of conveyance systems are *Interference of an obstacle* (6/25) and *Insufficient slope* (5/25).

(a) Case #13: *Interference of obstacle*

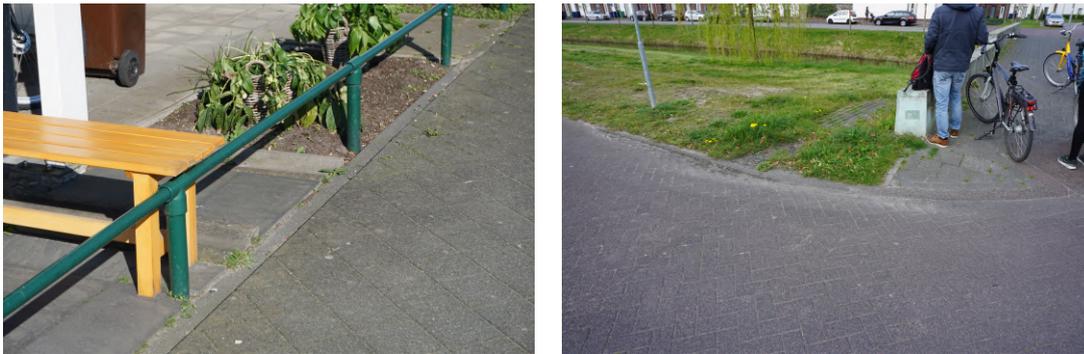
(a) Case #3: Interface between private or public space
(b) Case #17: Interface between green and road department from the municipality

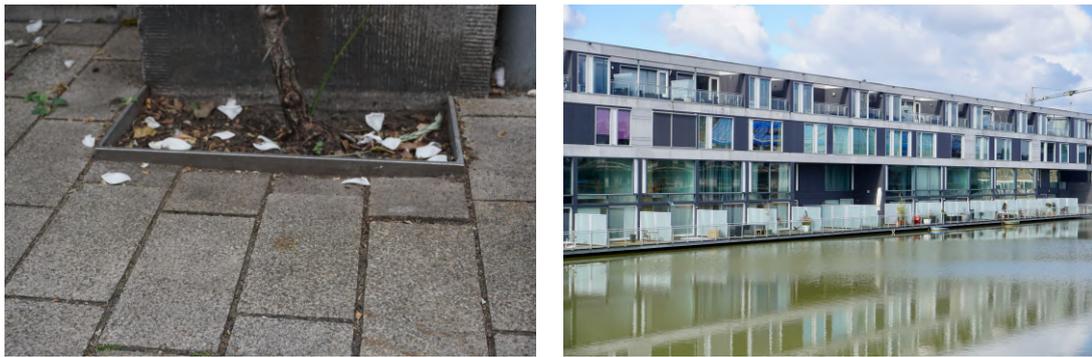
(a) Case #40: Minimal infiltration function (b) Case #50: Minimal storage function

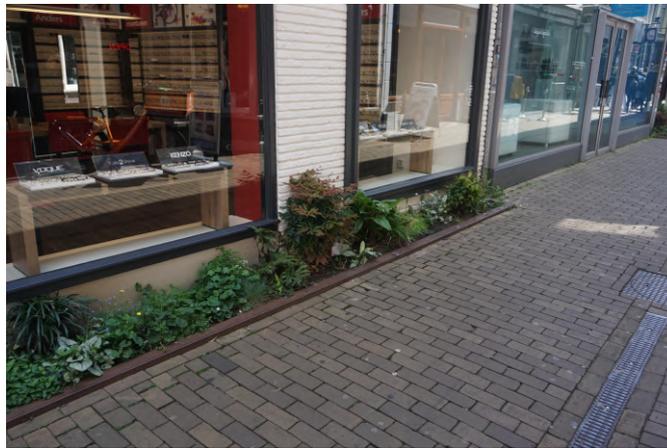
Figure 5.10: *Case #30: In this Case a façade garden is visible. Greenery traditionally have been separated from roads by raised sides (embedded practice). However, the raised sides in this Case make transport of water towards the facade garden impossible, whereby the facade garden can perform a minimal functionality.*

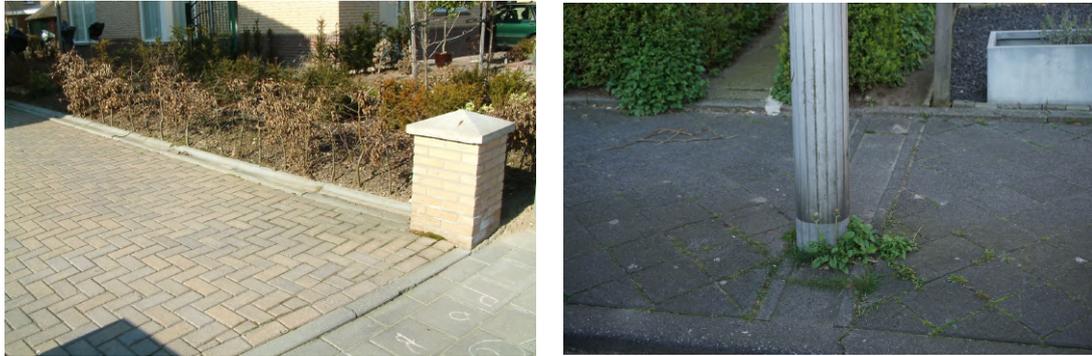
design, according to expert #3 due to the unfamiliarity of designers and constructors in adjusting the spatial design to the design of SUDS. The interviews revealed that the initial problem often starts in the design phase when a spatial design and SUDS design are not aligned (figure 5.11). Moreover, the experts explained that although the initial failure is made in the design phase, constructors also have a responsibility to compensate the failure during the construction of SUDS. Ideally, constructors would consult the designer and give feedback about the failure. However, as can be seen in figure 5.11, this often does not occur in practice.

(a) Case #13: Structure blocking open gutter (b) Case #7: Lamppost blocking open gutter

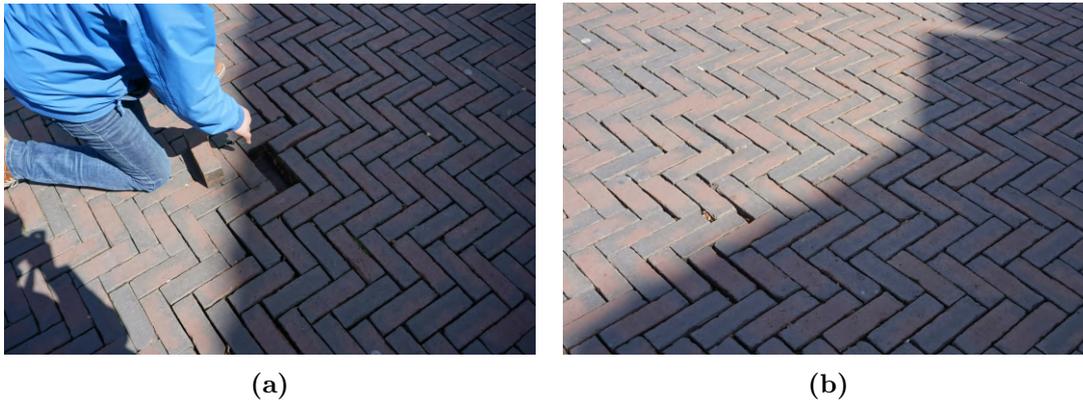
Figure 5.12: Case #29: The filling between the joints of permeable pavement bricks vanishes due to the load of cars and cleaning practices. There exists a lack of knowledge about the effects of other urban systems on the permeable pavement.

Several experts have indicated that the interactions of SUDS with other systems are hard to predict and cannot always be known in the design process because designers do not always have experience with particular systems. Expert #7 explained that a 2D design makes it difficult to see the interaction of different systems. The expert indicated that a 3D designs would help to discover interactions between systems in the design phase, however this development is not yet supported in every project phase. Figure 5.12 presents a case from the data set where traffic interactions with SUDS.

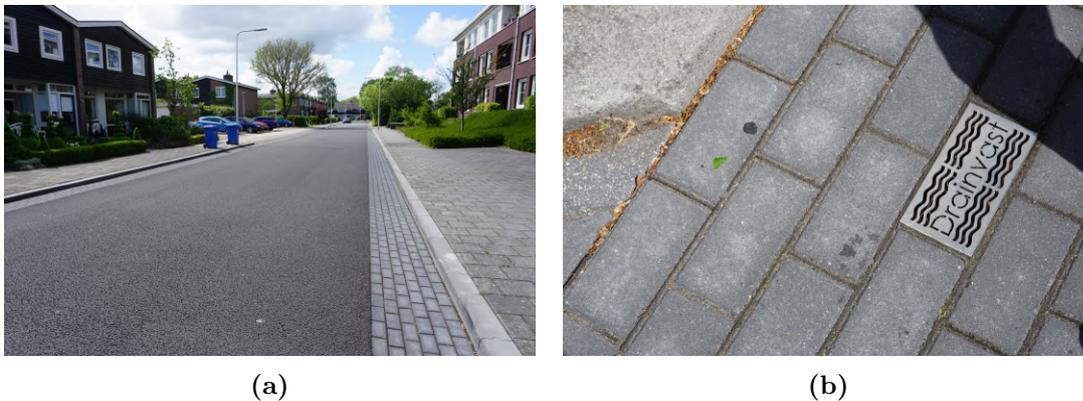
Figure 5.13: Case #33: The permeable pavement with drainvast joints aims to infiltrate the stormwater falling on the street. After small rainfall events, water remains present for at least one hour. There existed an incomplete knowledge about the internal technical processes. It is expected that the slow infiltration can be caused by the connection between the split and the granulate layer.

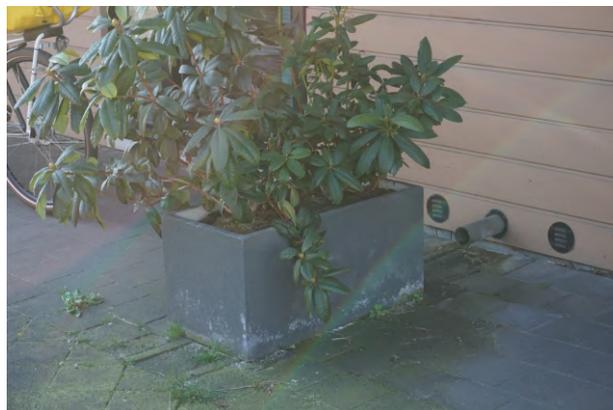
Figure 5.14: Case #8: Residents place flowerpot on the open gutter.

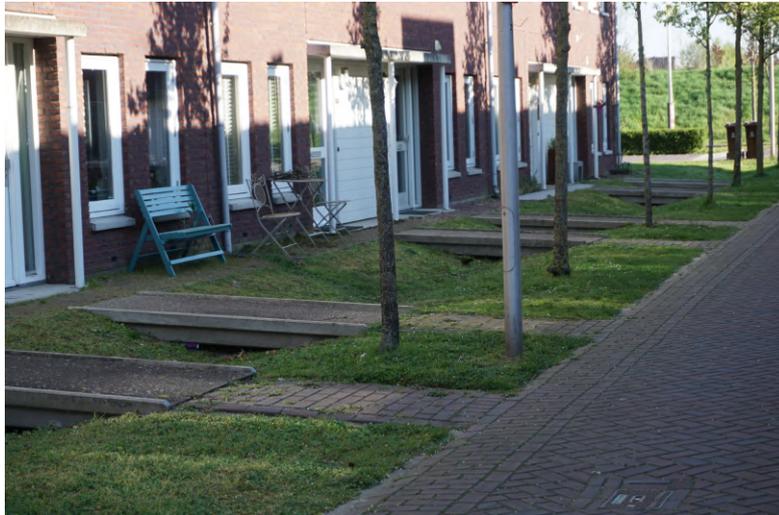
Figure 5.15: *Case #26: Vegetated swales are constructed in front of houses. However, these swales cannot be maintained properly, because mowing machines raise small stones that damage windows. Therefore, the maintenance becomes a time consuming and expensive matter.*

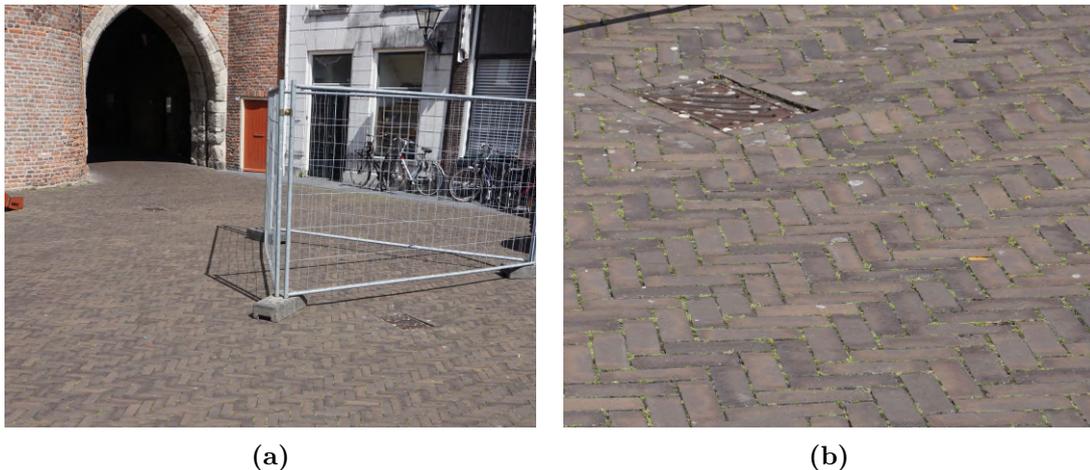
Figure 5.16: *Case #28: Next to the permeable pavement, a gully was constructed in order guarantee the drainage of stormwater. In order for the stormwater to reach the gully, the surface was laid with a small gradient towards the gully. Therefore, the water partly infiltrates via the permeable pavement and partly is drained via the stormwater sewer system.*

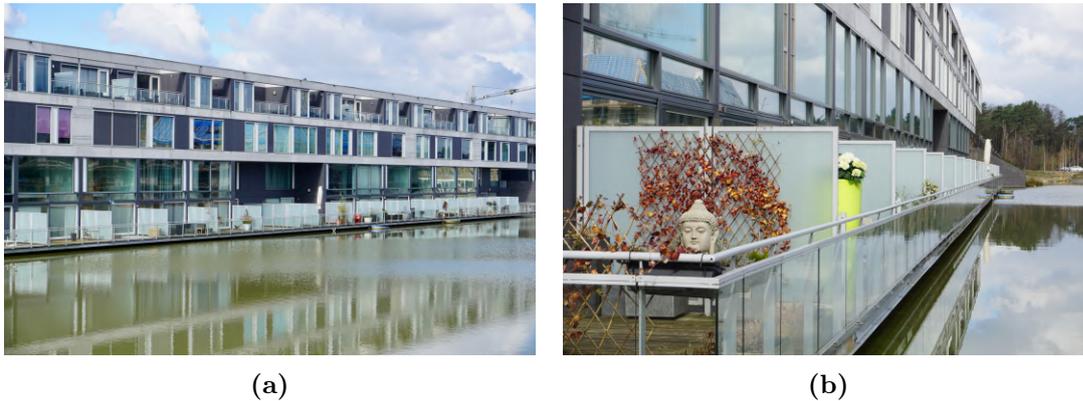
Figure 5.17: *Case #60: Due to a lack of communication between the architect and municipality, this water body has no storage capacity although it was intended as such.*

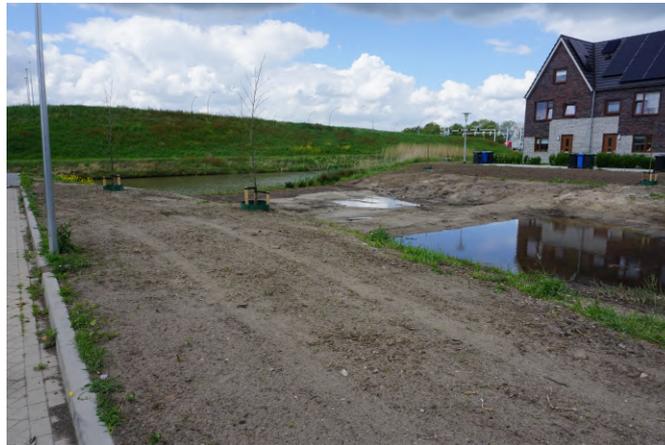
Figure 5.18: *In the sketch design phase it was decided to place the bioswale 30 cm higher, creating a playground for children that would be flooded two or three times a year at most. Due to a new staffing in the subsequent design phase that did not know the old principles, it was thought that the bioswales should be laid deeper so that there would always be water in the bioswale. The residents complained because they were promised a playground.*

Expert #7 explained that several teams work at different stages of the development process. There is no continuity, because employees from the design phase are not present in the construction phase for example. Therefore, the optimal knowledge transfer between project phases remains an illusion in practice. Moreover, expert #6 also described that different people are involved throughout the process. When something has been decided in the start of the project with certain people, it remains difficult to anchor these decisions in the next phase, when other people are involved. According to expert #6, preserving important decisions throughout the entire process is a major challenge.

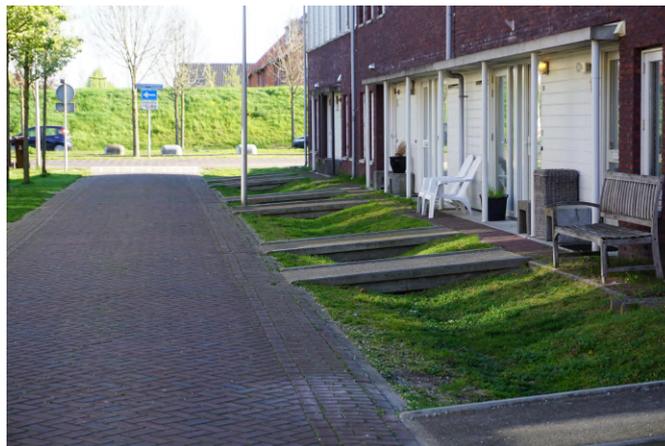
Figure 5.19: *In this case there exists unclarity between the residents and the municipality who is responsible for the maintenance of the small bridges, crossing the bioswales.*

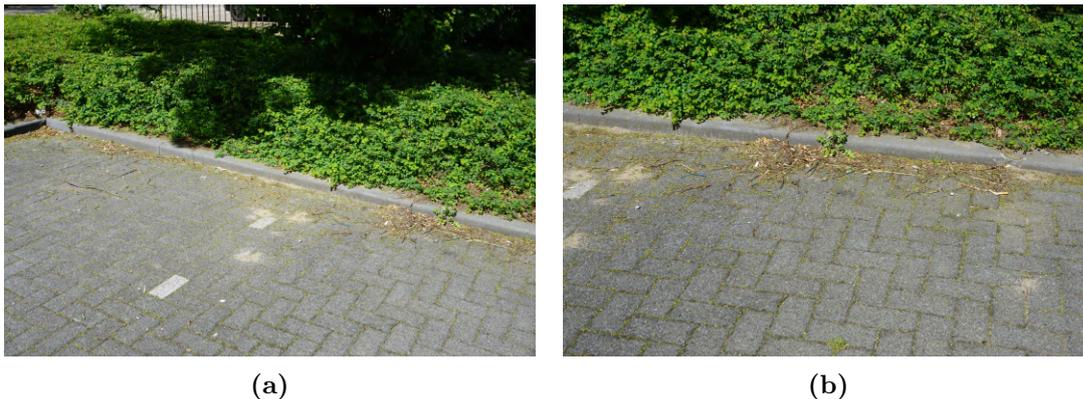
Figure 5.20: *Case #32: In this area porous pavement has been applied at streets and parking spots. When vegetation is constructed next to porous pavement, it happens that the porous pavement is blocked by leaves or dirt. This requires regular maintenance. However, operators are yet unfamiliar with the regular maintenance needs.*

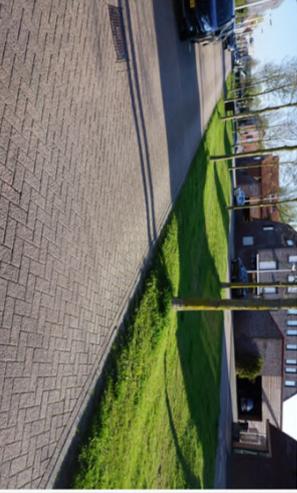
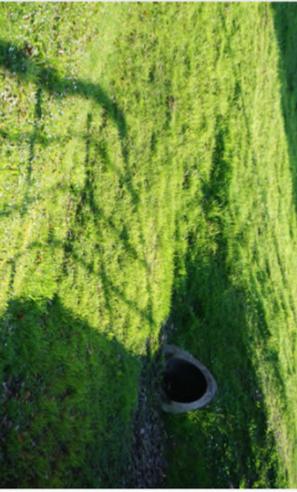
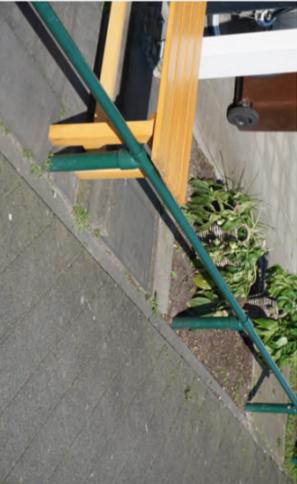
Figure D.1: Cases 1-3

Description	F.1	F.2	F.3
	Stormwater from the roofs and streets is transported via above-ground drainage towards a central bioswale with a large storage capacity of 24 mm. When the streetside of the bioswale is not maintained sufficiently, the grass becomes higher than de street. In this case the stormwater cannot reach the bioswale easily because it is blocked by the high grass.	In this park stormwater from roofs and streets is transported below ground by IT-sewers towards a central bioswale in the middle of the park. Stormwater first can infiltrate into to the ground through an IT-sewer and when it rains heavily the stormwater is transported to the bioswale. However, the opening of this pipe is large. Kids who play in the bioswale can crawl into the opening of the pipe. This can cause very dangerous situations. In order to reduce this problem, the municipally placed bars in front of the opening of the pipes.	In this street stormwater from roofs is transported above ground, via the front yard of the houses, towards the permeable pavement street where the stormwater can infiltrate. The curb is constructed lower than both the front yard and the street, which makes it the lowest point. When the water flows from the open concrete gutter towards the sidewalk, the water flows back into the garden. The reason behind this problem is the fact that constructors traditionally place curbs lower and than the streets because streets tend to subsid and the curbs do not. Because of these height differences the stormwater cannot easily flow to the permeable pavement en causes water nuisance in the front yards of the residents.

Function	Conveyance	Conveyance	Conveyance
Domain	Public (Municipality Green)	Public (Municipality Water)	Private (Residents)
Area type	Newly developed area (Vnex)	Newly developed area (Vnex)	Newly developed area (Vnex)
Problem	Water nuisance	Creating unsafe circumstances	Water nuisance
Location	Boundary street to open space	Open space	Boundary plot to street
Type of impact	Discomfort	Health impact	Discomfort
Technical failure	Interference of obstacle	Accessibility of drainage system	Insufficient slope
Failure occurred	User/maintenance phase	Design phase	Construction phase
Root cause	Unclearly about maintenance responsibilities for SUDS	Unintended actual use of SUDS by humans	Embedded practices of the urban sector
Root cause	Poor communication between different actors		
Picture

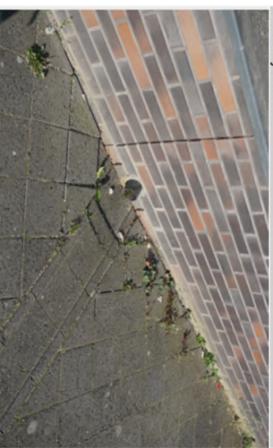
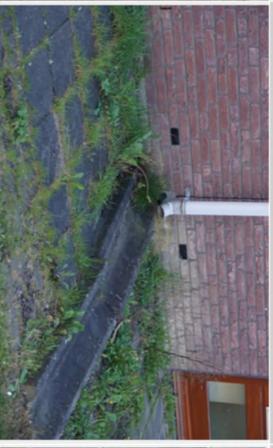
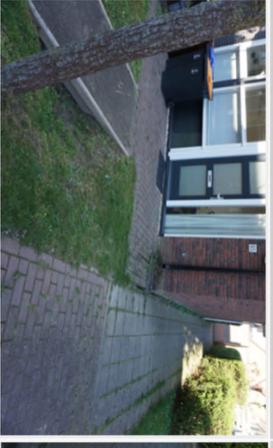
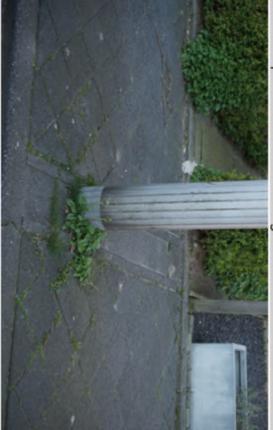
Figure D.2: Cases 4-7

<p>F.4</p> <p>Stormwater is above-ground drained via a lowered open gutter in the street. It can be seen that the tiles surrounding the opening of the downspout have sagged. This is due to the fact that the water washes away the sand under the tiles. On the interface between the house and the street, sand can not be well compacted. Because this sand is less compacted, it can subside in the user phase.</p>	<p>F.5</p> <p>In this street stormwater from roofs is transported above ground towards small bioswales in front of the houses. In this situation it can be seen that the gradient of the open concrete gutter, constructed to transport the water from the downspout towards the bioswale, is directed to the wrong side. The reason behind this is the local subsidence.</p>	<p>F.6</p> <p>In this street stormwater from roofs is transported above ground towards small bioswales in front of the houses. In this situation it can be seen that the open concrete gutter, constructed to transport the water from the downspout towards the bioswale, is not directed towards the bioswale but towards the plot. This is done because otherwise residents have to step over the open gutter when they want to reach the backpath.</p>	<p>F.7</p> <p>In this street stormwater from roofs is transported above ground towards a large central bioswale. In this situation it can be seen that a lamppost is placed in the middle of an open gutter. As a result of this, stormwater is not flowing in one line towards the bioswale.</p>

<p>Conveyance Public (Municipality Roads) Newly developed area (Vnex) Water nuisance Boundary plot to street Discomfort Local sagging Construction phase</p>	<p>Conveyance Private (Residents) Newly developed area (Vnex) Water damage Boundary house to plot Material impact Local sagging User/maintenance phase</p>	<p>Conveyance Private (Residents) Newly developed area (Vnex) Water damage Boundary house to plot Material impact Outlet not fitted correctly Construction phase</p>	<p>Conveyance Public (Municipality Roads) Newly developed area (Vnex) Water nuisance Street Discomfort Interference of obstacle Design phase</p>
<p>Lack of experience in constructing SUDS Incomplete knowledge about the interactions of SUDS with urban systems</p>	<p>Uncertainty about maintenance responsibilities for SUDS</p>	<p>Fitting SUDS to unforeseen circumstances</p>	<p>Unfamiliarity of integrating SUDS in spatial design Lack of experience in constructing SUDS</p>

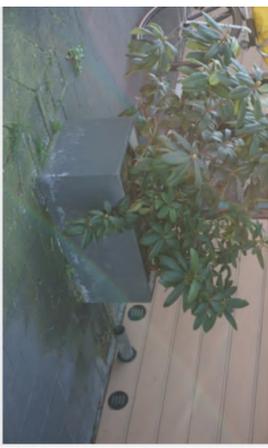
<p>F.8</p> <p>At this location the stormwater from the roof is above-ground drained via an open gutter towards an porous pavement street. In this situation it can be seen that the residents placed a large flowerpot directly on the open gutter.</p>	<p>F.9</p> <p>The overflow emergency outlet of the Meenhoven water body was constructed with culverts designed for a T = 2year storm, as normal stormwater drainage pipes. This design practice is embedded in the design of stormwater drainage pipes.</p>	<p>F.10</p> <p>In this street stormwater from roofs is transported above ground towards a central bioswale in front of the houses. In this situation it can be seen that the downspout is connected too close to the house, causing stormwater to reach the ventilation grid of the house. Because of this, water is can enter the house via the ventilation grid.</p>	<p>F.11</p> <p>In this street stormwater flows above-ground towards bioswales in front of the houses. At the boundary zone between the plot and the street it can be seen that tiles have subsided. This is due to the electrical box that is constructed on the street. Water can flow in the gap between the tiles and the box, and washes away the underlying sand.</p>

<p>Conveyance</p> <p>Private (Residents)</p> <p>Newly developed area (Vnex)</p> <p>Water nuisance</p> <p>Plot</p> <p>Discomfort</p> <p>Interference of obstacle</p> <p>User/maintenance phase</p> <p>Unintended actual use of SUDS by humans</p>

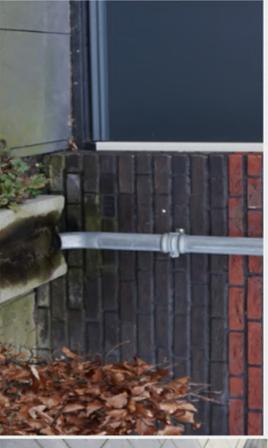
<p>Conveyance</p> <p>Private (Residents)</p> <p>Newly developed area (Vnex)</p> <p>Water damage</p> <p>Boundary house to plot</p> <p>Material impact</p> <p>Outlet not fitted correctly</p> <p>Design phase</p> <p>Incomplete knowledge about the interactions of SUDS with urban systems</p> <p>Unfamiliarity of integrating SUDS in spatial design</p>

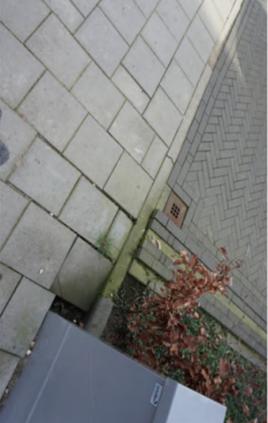
Figure D.3: *Cases 8-11*

<p>Conveyance</p> <p>Public (Municipality/ Roads)</p> <p>Newly developed area (Vnex)</p> <p>Water nuisance</p> <p>Boundary plot to street</p> <p>Discomfort</p> <p>Local sagging</p> <p>User/maintenance phase</p> <p>Incomplete knowledge about the interactions of SUDS with urban systems</p> <p>Lack of knowledge how to maintain SUDS</p>

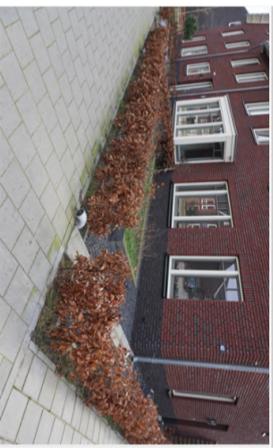
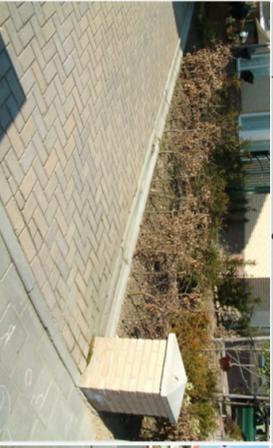
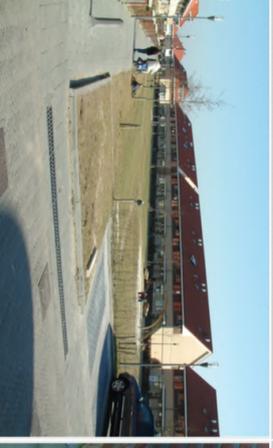
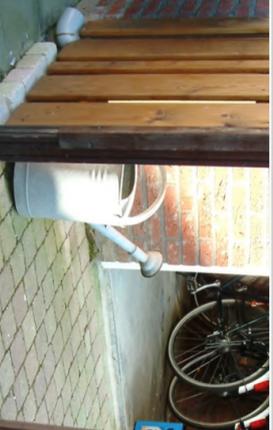
Figure D.4: Cases 12-15

<p>F-12</p> <p>At the boundary zone between the plot and the street is a pipe outlet visible. In this neighborhood stormwater is transported above ground towards a central bioswale. In this situation it can be seen that the stormwater falling at the back of the house is transported under ground towards the front of the house. As the water has to flow 'up' at the end, stagnant water remains present in the underground pipe.</p>	<p>F-13</p> <p>The stormwater is transported above-ground via an open concrete gutter. It can be seen that at the boundary zone between the plot and the street, an obstruction is blocking the waterway.</p>	<p>F-14</p> <p>Stormwater from houses and streets is transported towards a central bioswale. It can be seen that parking spots are constructed next to the bioswale. Raised edges have been laid to separate the parking facilities and the public space. As a result, the water can no longer run over the surface to the swale, but is transported to a gutter.</p>	<p>F-15</p> <p>In this situation, stormwater is transported to the backpath. Because of the incorrect gradient of the surface, stormwater flows back in the direction of the house. Resulting in water nuisance in the shed.</p>

<p>Conveyance</p> <p>Private (Residents)</p> <p>Newly developed area (Vnex)</p> <p>Water pollution</p> <p>Boundary plot to street</p> <p>Health impact</p> <p>Pollution</p> <p>Construction phase</p> <p>Fitting SUDS to unforeseen circumstances</p>	<p>Conveyance</p> <p>Private (Residents)</p> <p>Newly developed area (Vnex)</p> <p>Water nuisance</p> <p>Boundary plot to street</p> <p>Discomfort</p> <p>Interference of obstacle</p> <p>Design phase</p> <p>Unfamiliarity of integrating SUDS in spatial design</p> <p>Lack of experience in constructing SUDS</p>	<p>Conveyance</p> <p>Public (Municipality Roads)</p> <p>Newly developed area (Vnex)</p> <p>Minimal functionality of system</p> <p>Boundary street to open space</p> <p>No direct impact</p> <p>Interference of obstacle</p> <p>Construction phase</p> <p>Embedded practices of the urban sector</p> <p>Poor communication between different actors</p>	<p>Conveyance</p> <p>Private (Residents)</p> <p>Newly developed area (Vnex)</p> <p>Water damage</p> <p>Boundary plot to street</p> <p>Material impact</p> <p>Insufficient slope</p> <p>Construction phase</p> <p>Embedded practices of the urban sector</p>

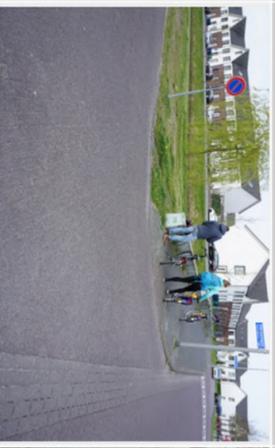
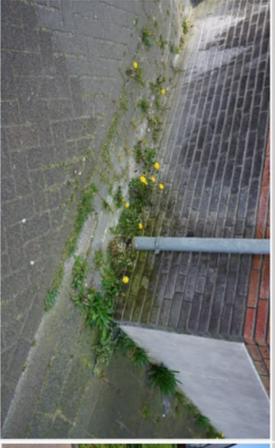
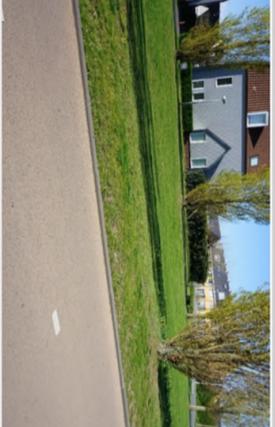
Figure D.5: Cases 16-19

<p>F.16</p> <p>The urban planner decided to raise the sides of the neighborhood by 30 cm to create an eye catching view. In the neighborhood with above-ground drainage, such height differences are disastrous and therefore caused problems with the above ground drainage.</p>	<p>F.17</p> <p>The stormwater falling on this street is above-ground drained by an open gutter towards the surface water body. In this situation it can be seen that the open gutter structure is not connected to the surface water body. Therefore, the stormwater flowing in the open gutter structure has no outlet point.</p>	<p>F.18</p> <p>The outlet of the downspout is constructed too close to the house, creating moisture spots on the house. Furthermore, the design of the outlet point vertically transports the stormwater on the ground, instead transporting the water under a certain angle.</p>	<p>F.19</p> <p>The greenery is separated from the cycle path by a raised curb. This makes the transport of water from the cycle path to the green no longer possible.</p>

<p>Conveyance Private (Residents) Newly developed area (Vnrex) Water nuisance Neighborhood Discomfort Insufficient slope Design phase</p>	<p>Conveyance Public (Municipality Roads) Newly developed area (Vnrex) Water nuisance Boundary street to open space Discomfort Incomplete design Construction phase</p>	<p>Conveyance Private (Residents) Newly developed area (Vnrex) Water nuisance Boundary house to plot Discomfort Outlet not fitted correctly Design phase</p>	<p>Conveyance Public (Municipality Roads) Newly developed area (Vnrex) Minimal functionality of system Boundary street to open space No direct impact Interference of obstacle Design phase</p>
<p>Poor communication between different actors</p>	<p>Lack of experience in constructing SUDS</p>	<p>Lack of experience in constructing SUDS</p>	<p>Embedded practices of the urban sector</p>
<p>NO PICTURE AVAILABLE</p>

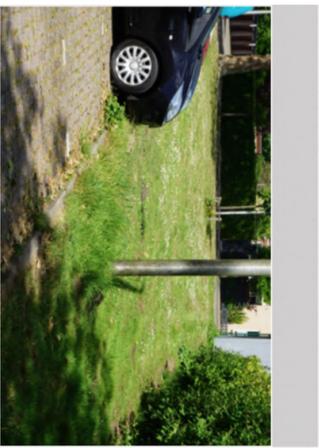
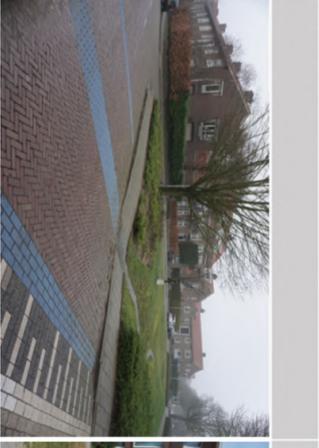
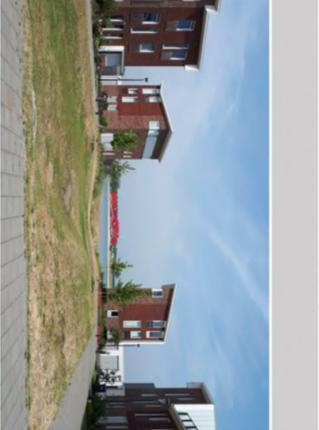
Figure D.6: Cases 20-23

<p>F-20</p> <p>The municipally included in their policy that greenery should be constructed at the same level as the street, so that water from the street can flow into the greenery in case of an rainfall event. Although this is specifically stated in the design drawings, contractors tend often still construct raised curbs.</p>	<p>F-21</p> <p>In this street, downspouts are disconnected to enable above ground drainage. It can be seen that tiles tend to subside and green rushes grow. Moreover, organic material from roofs is remains present on the surface. All these impediments can lead to discomfort by passers-by.</p>	<p>F-22</p> <p>The stormwater from this street is drained towards a large bioswale downstream of the street. In order for the water to reach the bioswale, the water has to move first vertically and than horizontally towards the swale. It can be seen the gradient of the horizontal part is not well constructed. Therefore the water stagnates downstream of the vertical part, resulting in a large puddle in case of rainfall.</p>	<p>F-23</p> <p>In front of these houses, a central bioswale is located. It can be seen that the roof of the houses is directed backwards, away from the bioswale. The design of the roof is not adapted to the design of the water system.</p>

<p>Conveyance</p> <p>Public (Municipality Roads)</p> <p>Retrofitted area (Cauliflower)</p> <p>Minimal functionality of system</p> <p>Boundary street to open space</p> <p>No direct impact</p> <p>Interference of obstacle</p> <p>Construction phase</p> <p>Embedded practices of the urban sector</p>	<p>Conveyance</p> <p>Public (Municipality Roads)</p> <p>Retrofitted area (Working-class)</p> <p>Water nuisance</p> <p>Boundary plot to street</p> <p>Discomfort</p> <p>Local sagging</p> <p>Design phase</p> <p>Incomplete knowledge about the interactions of SUDS with urban systems</p>	<p>Conveyance</p> <p>Public (Municipality Roads)</p> <p>Retrofitted area (low-rise garden)</p> <p>Water nuisance</p> <p>Street</p> <p>Discomfort</p> <p>Insufficient slope</p> <p>Design phase</p> <p>Incomplete knowledge about the interactions of SUDS with urban systems</p>	<p>Conveyance</p> <p>Public (Municipality Roads)</p> <p>Newly developed area (Vlnex)</p> <p>Minimal functionality of system</p> <p>Roof</p> <p>No direct impact</p> <p>Unfavorable roof design</p> <p>Design phase</p> <p>Poor communication between different actors</p>

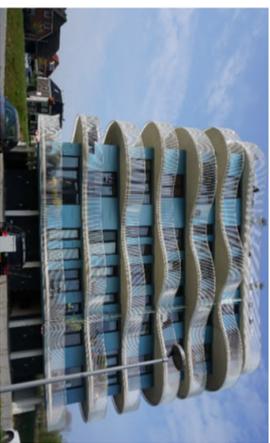
<p>F-24</p> <p>For this neighborhood a 'construction level' was issued by the municipality. The project developer who constructed the apartment that, constructed a storage area under the issued construction level. This storage area is lower than the rest of the area, which means that stormwater would flow into the storage area in case of heavy rainfall.</p>	<p>F-25</p> <p>New apartments were developed in Eindhoven at the Grasbaan. The developer was only allowed to build up to a certain height, so the roof line was set at a certain MAP height. The developer lowered his building block by 1 meter under the ground level so that he could build another floor. In a neighborhood where water is flowing above ground, the lowest places become prominent flooding locations. When the apartments were realised, residents have experienced flooding 1 or twice a year for multiple years. The worst of all is the psychological damage, the fact that people no longer dare to go on holidays.</p>	<p>F-26</p> <p>In this street, the stormwater from roofs is transported to a long bioswale very close to the front door of the houses. In order for residents to reach the street, small bridges over the bioswales are constructed. When maintenance of bioswales was carried out for the first time, small stones and other things fly up and damage the houses. The maintainability was not considered in the design.</p>	<p>F-27</p> <p>After the construction of this 'permeable pavement' it appeared that the 'normal' clay pavers were constructed instead of clay pavers with small tabs to keep clay pavers apart. The 'normal' clay pavers, lay too close to each other, making infiltration difficult. Therefore, the residents experience water nuisance often.</p>

<p>Conveyance</p> <p>Public (Municipality Roads)</p> <p>Newly developed area (Vnex)</p> <p>Water damage</p> <p>House</p> <p>Material impact</p> <p>Wrong construction level</p> <p>Design phase</p> <p>Poor communication between different actors</p>

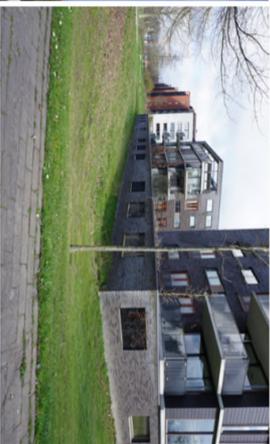
<p>Conveyance</p> <p>Private (Residents)</p> <p>Newly developed area (Vnex)</p> <p>Water damage</p> <p>House</p> <p>Material impact</p> <p>Wrong construction level</p> <p>Design phase</p> <p>Poor communication between different actors</p>

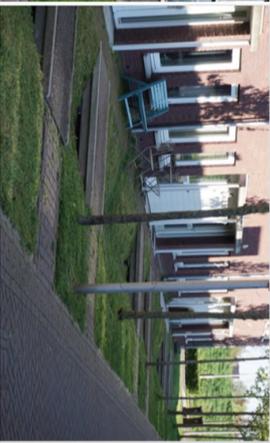
<p>Infiltration</p> <p>Public (Municipality Green)</p> <p>Newly developed area (Vnex)</p> <p>Causes nuisance in other domain</p> <p>Boundary plot to street</p> <p>Material impact</p> <p>Low maintainability</p> <p>User/maintenance phase</p> <p>Poor maintainability of SUDS</p>

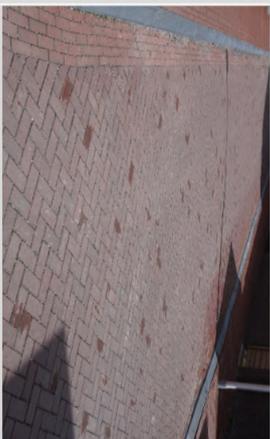
Figure D.7: Cases 24-27

<p>Infiltration</p> <p>Private (VE)</p> <p>Retrofitted area (Working-class)</p> <p>Water nuisance</p> <p>Street</p> <p>Discomfort</p> <p>Clogging</p> <p>Construction phase</p> <p>Poor communication between phases</p>

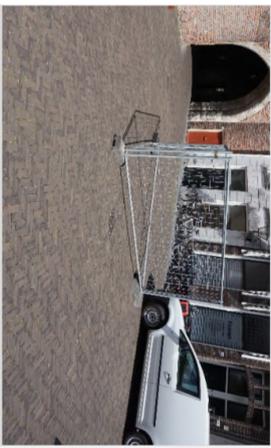
<p>F_28</p> <p>In the city center near an old monument, permeable pavement has been constructed. Due to uncertainty about the performance of the permeable pavement at that time, gullies were also constructed and the street laid under a small gradient towards the gullies. Because of that, the performance of the permeable pavement functionality is minimized.</p>	<p>F_29</p> <p>In this municipality many streets have been renewed and constructed with permeable pavement. It appeared that the joints filling between the clay pavers disappears completely at certain locations. The water infiltration function still works well only the loose bricks cause inconvenience in other fields. The reason for this problem is not yet figured out by the municipality. In order to minimize this problem, 'miracle sand' is applied to fill the gaps between the stones.</p>	<p>F_30</p> <p>Green facade gardens have been constructed in the city center to infiltrate stormwater that falls on the street. For practical reasons, raised edges have been constructed around the gardens. Therefore, water from the streets can no longer enter the garden. Therefore, the facade gardens has a minimal functionality.</p>	<p>F_31</p> <p>This square in front of an old church was retrofitted with permeable pavement of cobble stones. The church was transformed to an enormous bookstore, attracting many tourists. In the bookstore, the owner has a small cafe. He wanted to build a terrace for this cafe in front of the church, but the permeable pavement contained big holes which would be inconvenient for the tables and chairs. Because of his political influence within the municipality, the permeable pavement was removed.</p>

<p>Infiltration</p> <p>Public (Municipality Roads)</p> <p>Retrofitted area (Downtown)</p> <p>Minimal functionality of system</p> <p>Street</p> <p>No direct impact</p> <p>Incomplete design</p> <p>Design phase</p> <p>Undermine the functionality of SUDS by additional solution</p>

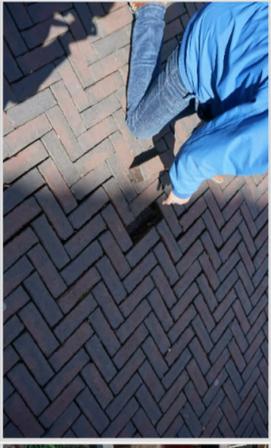
<p>Infiltration</p> <p>Public (Municipality Roads)</p> <p>Retrofitted area (Downtown)</p> <p>Causes nuisance in other domain</p> <p>Street</p> <p>Discomfort</p> <p>Poor split binding</p> <p>User/maintenance phase</p> <p>Incomplete knowledge about the interactions of SUDS with urban systems</p>

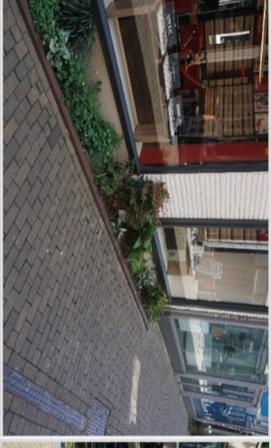
<p>Infiltration</p> <p>Public (Municipality Green)</p> <p>Retrofitted area (Downtown)</p> <p>Minimal functionality of system</p> <p>Street</p> <p>No direct impact</p> <p>Interference of obstacle</p> <p>Design phase</p> <p>Embedded practices of the urban sector</p>

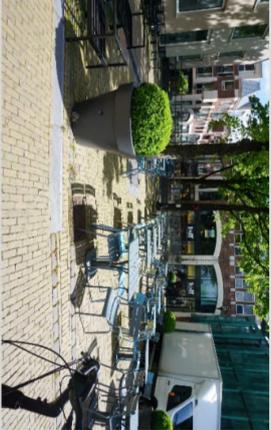
Figure D.8: Cases 28-31

<p>Infiltration</p> <p>Public (Municipality Roads)</p> <p>Retrofitted area (Downtown)</p> <p>Causes nuisance in other domain</p> <p>Open space</p> <p>No direct impact</p> <p>Decreased walkability</p> <p>User/maintenance phase</p> <p>Unintended actual use of SUDS by humans</p>

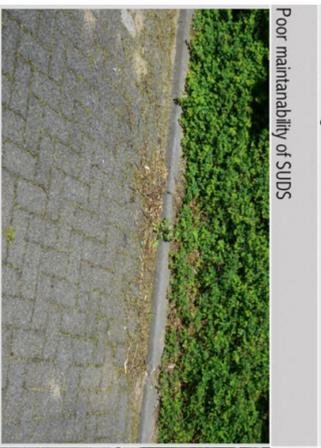
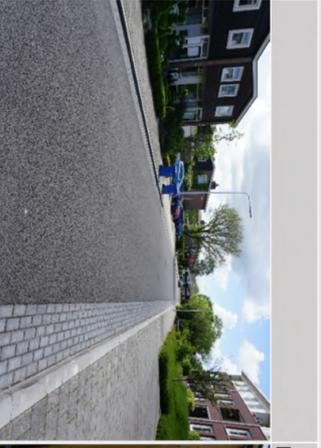
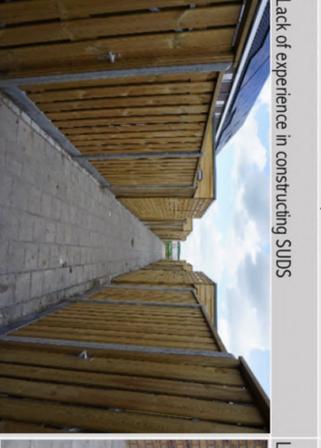
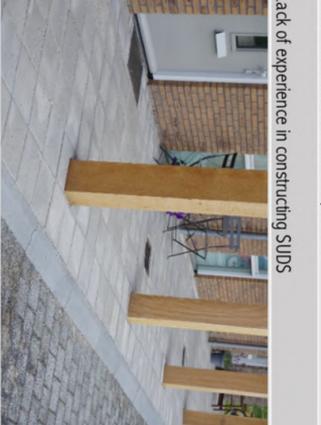
Figure D.9: Cases 32-35

<p>F-32</p> <p>In this situation porous pavement is constructed at parking spots. When vegetation is constructed next to the porous pavement, the porous pavement often gets clogged by vegetational remains. Maintenance should take place regularly in this situation. However, operators are not used to these new maintenance requirements.</p>	<p>F-33</p> <p>In this street gullies have been replaced by strips with permeable pavement on each side the street. The idea was to infiltrate the stormwater instead of transporting the water via the stormwater drainage system. Unfortunately, the system does not function as expected. After moderate rainfall events, water remains present on the street for minimal 1 hour. It is expected that the slow infiltration can be caused by the connection between the split and the granulate layer. To improve the infiltration, drainbreaks were installed for venting, which slightly accelerated the infiltration rate. Still the</p>	<p>F-34</p> <p>In this area all the stormwater is transported to underground infiltration crates. In the technical PVE (made by the municipality) nothing was specifically mentioned about what type of surface material should be used. Therefore the constructor could choose what to do, and made the decision to construct gullies instead of permeable pavement.</p>	<p>F-35</p> <p>In this area all the stormwater is transported to underground infiltration crates. In the technical PVE (made by the municipality) nothing was specifically mentioned about what type of surface material should be used. Therefore the constructor could choose what to do, and made the decision to construct gullies instead of permeable pavement.</p>

<p>Infiltration Public (Municipality Roads) Retrofit area (Working-class) Water nuisance Street Discomfort Clogging User/maintenance phase Lack of knowledge how to maintain SUDS</p>	<p>Infiltration Public (Municipality Roads) Retrofit area (Low-rise garden) Water nuisance Street Discomfort Clogging Design phase Incomplete knowledge about the technical performance of SUDS</p>	<p>Infiltration Public (Municipality Roads) Newly developed area (Vinex) Minimal functionality of system Street No direct impact Wrong construction material Construction phase Poor communication between phases</p>	<p>Infiltration Private (Residents) Newly developed area (Vinex) Minimal functionality of system Plot No direct impact Wrong construction material Construction phase Poor communication between phases</p>

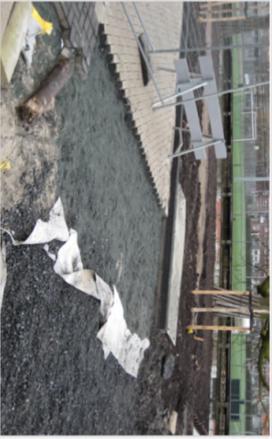
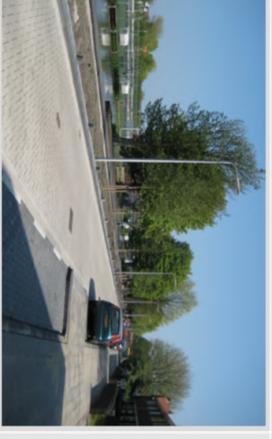
Figure D.10: Cases 36-39

<p>F-36</p> <p>There is little surface water present in this neighborhood. To increase the storage capacity, the municipality implemented two storage systems as pilot project. Below the first half of the street crates were placed and below the other half of the street Argey material (particles that can fill up water) was placed. On top, permeable pavement was laid, to make infiltration possible. Some problems arised in the user phase. Firstly, in the user phase the maintenance department had difficulties in maintaining these types of constructions. In addition, the joint filling between the stones disappeared.</p>	<p>F-37</p> <p>There is little surface water present in this neighborhood. To increase the storage capacity, the municipality implemented two storage systems as pilot project. Below the first half of the street crates were placed and below the other half of the street Argey material (particles that can fill up water) was placed. On top, permeable pavement was laid, to make infiltration possible. Some problems arised in the user phase. Firstly, in the user phase the maintenance department had difficulties in maintaining these types of constructions. In addition, the joint filling between the stones disappeared.</p>	<p>F-38</p> <p>In this municipality two pilot projects were implemented. In the first pilot green parking spaces were constructed. This allowed stormwater to infiltrate into the subsurface. In the user phase of this project, problems occurred. The greenery was very difficult to maintain because many cars drove over it, women with heels crushed the grass and mud was formed. Due to the poor maintainability, the pilot project was stopped.</p>	<p>F-39</p> <p>In this municipality two pilot projects were implemented. In the second pilot a street was retrofitted with permeable pavement. A kind of gravel was used which scattered enormously in the summer months. This caused a thick yellow/white layer on the cars. This pilot project also was stopped.</p>

<p>Infiltration Public (Municipality Roads) Retrofitted area (Working-class) Causes nuisance in other domain Street Discomfort Poor spilt binding User/maintenance phase Incomplete knowledge about the interactions of SUDS with urban systems</p>

<p>Infiltration Public (Municipality Roads) Retrofitted area (Working-class) Water nuisance Street Discomfort Clogging User/maintenance phase Lack of knowledge how to maintain SUDS</p>

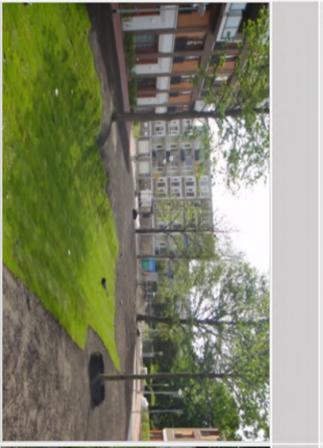
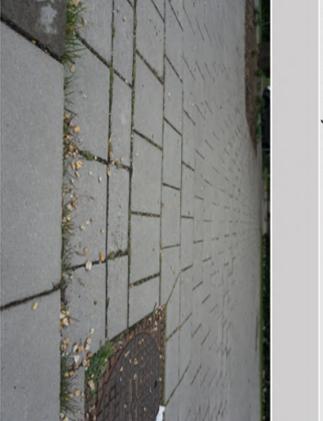
Figure D.11: Cases 40-43

<p>F-40</p> <p>Removing a strip of pavement along the facade of a building allows the rainwater from the facade to infiltrate into the ground. The plants in the facade gardens increase urban biodiversity. However, these façade gardens are shielded by an steel edge. This edge is constructed often higher than the street, making water conveyance towards the gardens impossible. This minimized the infiltration of water.</p>	<p>F-41</p> <p>In this situation, subsurface storage crates have been installed in combination with an bioswale. Unfortunately various problems have occurred with this system. Firstly, the crates have been partially laid below groundwater level. Secondly, there were illfit connections attached to the crates, causing dirty water from the houses ending up in the crates. Thirdly, the infiltration rate is too small due to clogging. A T = 1 year rain event could be processed very tightly. Therefore water nuisance was present several times.</p>	<p>F-42</p> <p>In this situation part the surface has been lowered and covered with small gravel stones to make infiltration of stormwater possible. Two types of problems occur in this system. Firstly, the infiltration capacity is very low (13 mm/h) due to high groundwaterlevels and clogging of the subsoil. Secondly, the small gravel stones spread easily, making maintenance of the surrounding area more difficult.</p>	<p>F-43</p> <p>In this situation part the surface has been lowered and covered with small gravel stones to make infiltration of stormwater possible. Two types of problems occur in this system. Firstly, the infiltration capacity is very low (13 mm/h) due to high groundwaterlevels and clogging of the subsoil. Secondly, the small gravel stones spread easily, making maintenance of the surrounding area more difficult.</p>

<p>Infiltration</p> <p>Private (Residents)</p> <p>Retrofit area (Downtown)</p> <p>Minimal functionality of system</p> <p>Boundary house to street</p> <p>No direct impact</p> <p>Interference of obstacle</p> <p>Design phase</p> <p>Embedded practices of the urban sector</p>	<p>Infiltration</p> <p>Public (Municipality Water)</p> <p>Retrofit area (Working-class)</p> <p>Minimal functionality of system</p> <p>Open space</p> <p>No direct impact</p> <p>Clogging</p> <p>Design phase</p> <p>Incomplete knowledge about the technical performance of SUDS</p>	<p>Infiltration</p> <p>Public (Municipality Roads)</p> <p>Retrofit area (Urban)</p> <p>Causes nuisance in other domain</p> <p>Open space</p> <p>Discomfort</p> <p>Wrong construction material</p> <p>Design phase</p> <p>Incomplete knowledge about the technical performance of SUDS</p>	<p>Infiltration</p> <p>Public (Municipality Roads)</p> <p>Retrofit area (Urban)</p> <p>Water nuisance</p> <p>Open space</p> <p>Discomfort</p> <p>Clogging</p> <p>User/maintenance phase</p> <p>Poor maintainability of SUDS</p>
