**Towards a better understanding of failures occurring in sustainable
urban drainage systems**

Master Thesis Project

October 2019

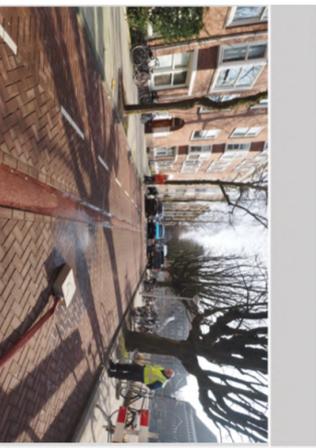
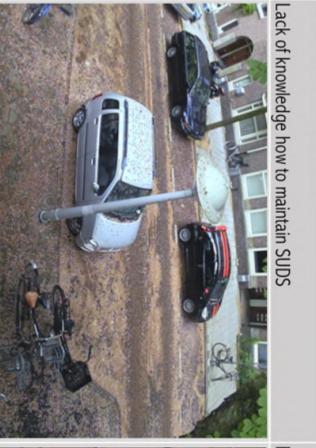
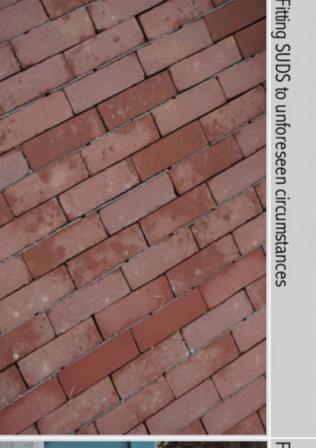
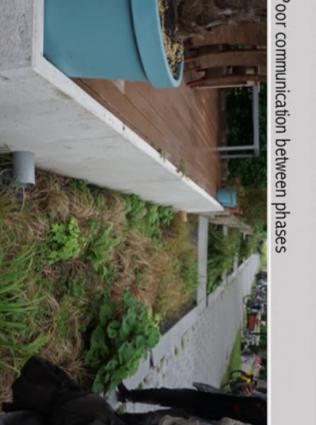
Figure D.12: Cases 44-47

<p>F.44</p> <p>In this street a pilot project has been initiated. The street profile is constructed with a strip of water-permeable pavement (Granudrain) in the middle of the road. The idea was that all the stormwater would flow into the infiltration strip and would infiltrate. Unfortunately, many problems have occurred in this system. A T=2 year rain event can not be processed because the infiltration capacity is only 10 mm/hour. Secondly, all the organic material flows to the infiltration system, which causes blockages and clogging in the system. Emergency gullies are installed.</p>	<p>F.45</p> <p>In this street a pilot project has been initiated. The street profile is constructed with a strip of water-permeable pavement (Granudrain) in the middle of the road. The idea was that all the stormwater would flow into the infiltration strip and would infiltrate. Unfortunately, many problems have occurred in this system. A T=2 year rain event can not be processed because the infiltration capacity is only 10 mm/hour. Secondly, all the organic material flows to the infiltration system, which causes blockages and clogging in the system. Emergency gullies are installed.</p>	<p>F.46</p> <p>Infront of the station, a square with permeable pavement and drainage joints from DrainVast has been constructed. Although the drain joints between the stones should ensure that no clogging occurs, this still happened. The reason for this failure was that the stones were 9.5 centimeters and the joints 8 centimeters. Because the joints were just a bit shorter, there was a small space where organic material accumulated. This resulted in clogging of the voids between the bricks, which lowered the infiltration capacity.</p>	<p>F.47</p> <p>In this case the stormwater from roofs and gardens (from apartments) is collected and transported towards a lowered green area. The problem is that nobody is maintaining these areas.</p>

<p>Infiltration Public (Municipality Roads) Retrofit area (Urban) Water nuisance Street Discomfort Clogging Design phase Incomplete knowledge about the technical performance of SUDS</p>	<p>Infiltration Public (Municipality Roads) Retrofit area (Urban) Water nuisance Street Discomfort Clogging User/maintenance phase Poor maintainability of SUDS</p>	<p>Infiltration Public (Municipality Roads) Newly developed area (Renewed) Water nuisance Open space Discomfort Clogging Construction phase Poor communication between phases</p>	<p>Infiltration Public (Municipality Roads) Newly developed area (Renewed) Causes nuisance in other domain Boundary plot to street Discomfort Wrong construction material User/maintenance phase Unclearly about maintenance responsibilities for SUDS</p>

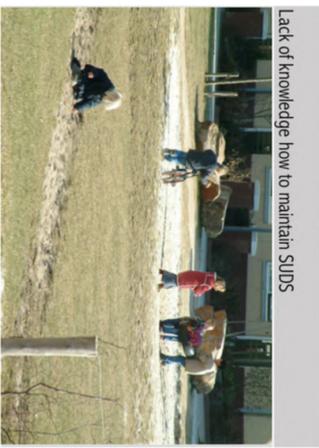
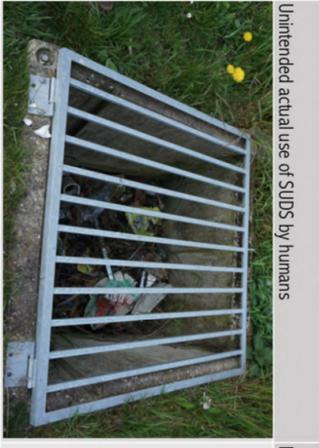
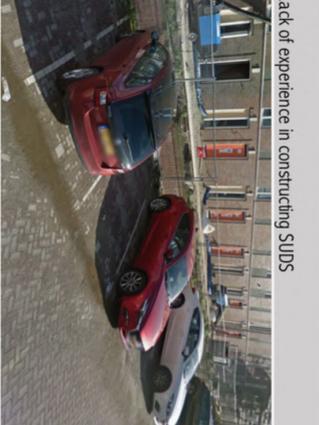
Figure D.13: Cases 48-51

<p>F-48</p> <p>In this situation a central bioswale has been constructed for three surrounding streets. It can be seen that the vegetation on the bioswale is at some point gone, only a sand layer remains. This can occur due to a lack of maintenance. The kids who play in the bioswale are playing in this sand, which could be harmful for their health.</p>	<p>F-49</p> <p>This central bioswale is the stormwater infiltration location for all houses and streets surrounding it. The overflow system is an concrete tank in the ground with a steel grid above it. This grid is only fastened to the concrete tank on one side. Therefore the grid can be easily lifted by people. Since the concrete container is quite large, dangerous situations could arise with children or animals. In addition, a lot of waste is collected in this concrete container.</p>	<p>F-50</p> <p>In a newly developed part of the city, a street has been constructed with permeable pavement. After the first couple of rainfall events, it was visible that water could not drain away. The norm was set for permeable pavements that the first 90 cm of the subsoil must contain sand. Closely under this 90 cm a silt layer is present. Therefore, the water could not drain away and accumulated in the cune. Afterwards, the permeable pavement has been re-laid and a drain installed.</p>	<p>F-51</p> <p>For a small newly developed neighborhood, permeable pavement has been constructed by a project developer. In the permeable paved street profile several height differences are present. Because of the height differences, the stormwater is naturally flowing towards the lowest location in the street. Because no subsurface drain was constructed, water remained on the surface long after the rainfall event. Water stagnated at the lowest location in the street profile and formed puddles. This lowest location is by a coincidence exactly the location where people step out of their cars. Afterwards, a drain has been constructed to resolve these problems.</p>

<p>Infiltration</p> <p>Public (Municipality Green)</p> <p>Newly developed area (Renewed)</p> <p>Creating unsafe circumstances</p> <p>Open space</p> <p>Health impact</p> <p>Poor water retention capacity</p> <p>Maintenance phase</p> <p>Unintended actual use of SUDS by humans</p> <p>Lack of knowledge how to maintain SUDS</p>	<p>Infiltration</p> <p>Public (Municipality Water)</p> <p>Newly developed area (Vine)</p> <p>Creating unsafe circumstances</p> <p>Open space</p> <p>Health impact</p> <p>Accessibility of drainage system</p> <p>Construction phase</p> <p>Fitting SUDS to unforeseen circumstances</p> <p>Unintended actual use of SUDS by humans</p>	<p>Infiltration</p> <p>Private (Project developer)</p> <p>Retrofitting area (Working-class)</p> <p>Water nuisance</p> <p>Street</p> <p>Water nuisance</p> <p>Unsuitable subsoil</p> <p>Design phase</p> <p>Incomplete knowledge about the technical performance of SUDS</p> <p>Fitting SUDS to unforeseen circumstances</p>	<p>Infiltration</p> <p>Private (Project developer)</p> <p>Retrofitting area (Working-class)</p> <p>Water nuisance</p> <p>Street</p> <p>Discomfort</p> <p>Incomplete design</p> <p>Design phase</p> <p>Incomplete knowledge about the technical performance of SUDS</p> <p>Lack of experience in constructing SUDS</p>

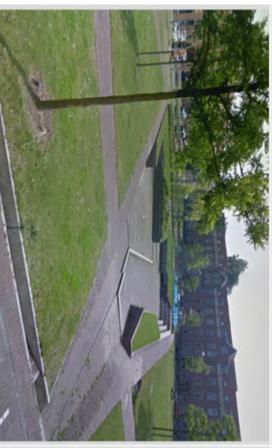
<p>Infiltration</p> <p>Public (Municipality/Water)</p> <p>Retrofitted area (Working-class)</p> <p>Water nuisance</p> <p>Open space</p> <p>Discomfort</p> <p>High groundwater level</p> <p>Design phase</p> <p>Incomplete knowledge about the interactions of SUDS with urban systems</p> <p>Unfamiliarity of integrating SUDS in spatial design</p>

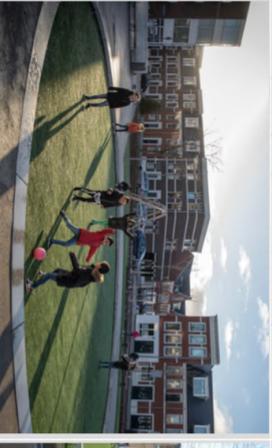
<p>Infiltration</p> <p>Public (Municipality/Water)</p> <p>Retrofitted area (Downtown)</p> <p>Minimal functionality of system</p> <p>Open space</p> <p>No direct impact</p> <p>Outlet not fitted correctly</p> <p>Construction phase</p> <p>Poor communication between different actors</p> <p>Lack of experience in constructing SUDS</p>

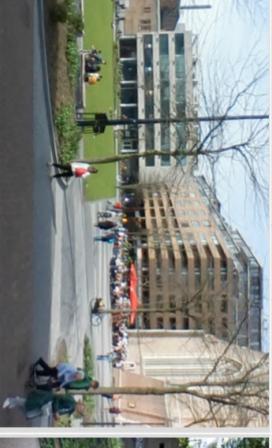
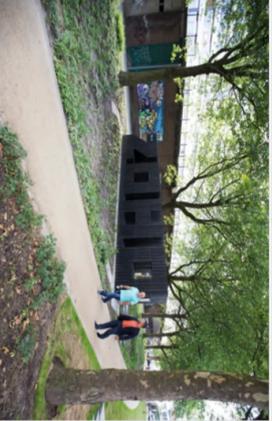
Figure D.14: Cases 52-55

<p>F-52</p> <p>A water square has been constructed with subsurface lava cases. Stormwater can infiltrate in the lava cases, whereas the lava cases would provide a temporarily storage function. The groundlevel beneath the water square is higher than expected, due to an unexpected water influx from the surrounding area. The square is located near the main flood defense, which is located next to a higher-lying area. The result is a high groundwater level in the section between the water square and the main flood defense, groundwater comes from the higher part to the lower part (the water square). Therefore, the water inside the lava crates can not fully infiltrate into the subsoil. The solution is found in pumping out the water of the crates every now and then.</p>	<p>F-53</p> <p>For water purification purposes, an infiltration construction with subsurface storage crates has been constructed under a square. The conventional stormwater system of the surrounding area is connected to this square. In the crate system an overflow has been constructed at the top of the crates. This means that the stormwater system has a high threshold. The groundwater level in the surrounding area has increased since the construction of the storage crates.</p>	<p>F-54</p> <p>Under a large city square with a church, lava cases have been constructed. Two large pipes are constructed to transport the stormwater falling on the church towards the lava cases. The subsurface storage crates were designed with a overflow point at the highest location in the subsurface storage crates, causing the pressure to build up in the cases, enabling infiltration towards the subsoil. During construction, an extra overflow system has been constructed by constructors at the lowest point in the lava cases, causing a minimalisation of the storage and infiltration function. However, no water nuisance or direct problems are experienced.</p>	<p>F-55</p> <p>A vegetated swale has been constructed in an Retrofitted area. During the construction of the swale, a gardener of the project developer mentioned that in order to grow plants, 80 cm of humus needs to be present in the bioswale. Instead of sand with a minimal fine fraction, humus has been applied. As a result, the water could not infiltrate well and remained present in the bioswale. To resolve this problem, a few gravel posts have been constructed. Because a drain already was constructed underneath the bioswale, the water could infiltrate in the sand layer.</p>

<p>Infiltration</p> <p>Public (Municipality/Green)</p> <p>Retrofitted area (Low-rise garden)</p> <p>Water nuisance</p> <p>Open space</p> <p>Discomfort</p> <p>Wrong construction material</p> <p>Construction phase</p> <p>Poor communication between phases</p> <p>Lack of experience in constructing SUDS</p>

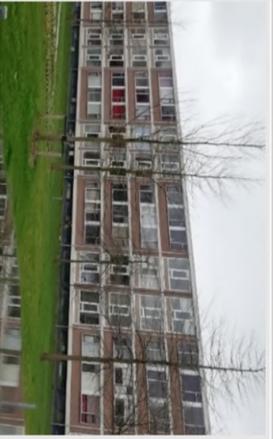
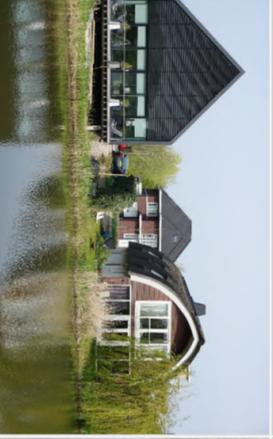
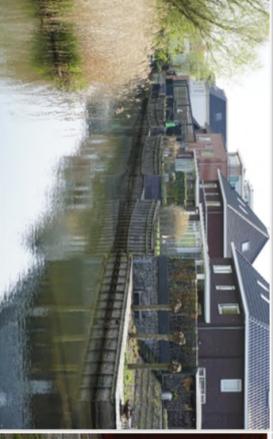
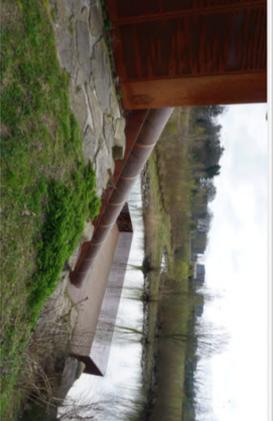
Figure D.15: Cases 56-59

<p>F.56</p> <p>A bioswale has been constructed in order for a high-rise residential building to disconnect its stormwater to. After the construction of the bioswale, the conventional stormwater pipes had to be retrofitted so that they would lead to the bioswale instead of the underground structure. This was more difficult than expected, because of the presence of indoor stormwater pipes. Moreover, this was the domain of the private property. The process slowed down and nobody felt responsible to further take up this issue. As a result, the bioswale is constructed but the stormwater is still transported via the conventional stormwater system.</p>	<p>F.57</p> <p>The 'living by the water' concept has been applied in this neighborhood. These houses have been designed and constructed by residents themselves. In this situation, one of the private houses has been constructed with a only a small height difference to the water. In cases of extreme rainfall, the surface water will rise and could cause flooding of this house. It can be seen that residents are not always aware of these watermanagement issues when constructing houses.</p>	<p>F.58</p> <p>As part of the 'living by water' concept, residents were free to design and construct their own backyard and thereby the connection to the water. Traditionally, waterways are constructed with sloping sides to make maintenance of the water way possible. However residents have created 2 meter return walls to enlarge their land.</p>	<p>F.59</p> <p>In order to create water storage, an artificial water system with large height differences has been constructed. From the lowest part of the plan, water is pumped up through a pumping station, it then falls via a waterfall to the middle level and continues its way via a naturally designed route to the low level.</p> <p>This artificial water system was designed with the idea that the pump is always running. Because water is flowing, a storage supporting disc of 10 centimeter is created in the system. When the pump is switched off, the water sinks in different places, resulting in one single water level. At that moment, as the overflow was located at the lowest point in the water system, the overflow discharges its water. Causing almost no water left in the system.</p>

<p>Infiltration</p> <p>Private (WE)</p> <p>Retrofitted area (High-rise)</p> <p>Minimal functionality of system</p> <p>Open space</p> <p>No direct impact</p> <p>Incomplete design</p> <p>Construction phase</p> <p>Poor communication between different actors</p>

<p>Storage</p> <p>Private (Residents)</p> <p>Newly developed area (Vnrex)</p> <p>Water nuisance</p> <p>Boundary house to water body</p> <p>Material impact</p> <p>Wrong construction level</p> <p>Design phase</p> <p>Poor communication between different actors</p>

<p>Storage</p> <p>Private (Residents)</p> <p>Newly developed area (Vnrex)</p> <p>Minimal functionality of system</p> <p>Boundary house to water body</p> <p>No direct impact</p> <p>Low maintainability</p> <p>Design phase</p> <p>Poor maintainability of SUDS</p>

<p>Storage</p> <p>Water board</p> <p>Newly developed area (Vnrex)</p> <p>Minimal functionality of system</p> <p>Transition area open space to water body</p> <p>Discomfort</p> <p>Incomplete design</p> <p>Design phase</p> <p>Incomplete knowledge about the interactions of SUDS with urban systems</p>

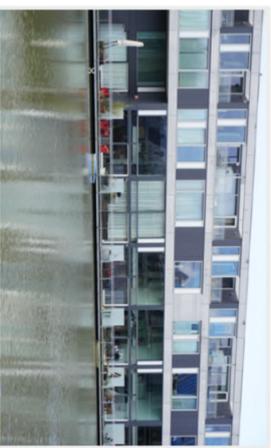
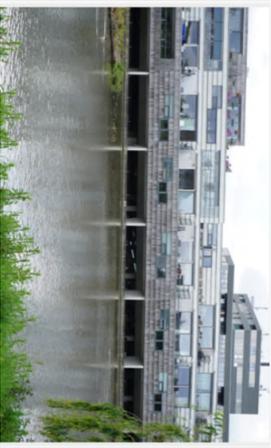
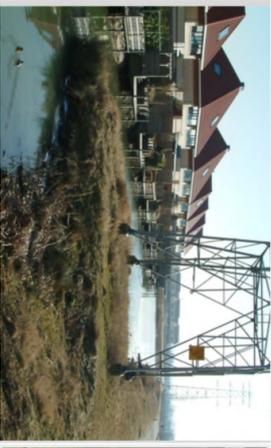
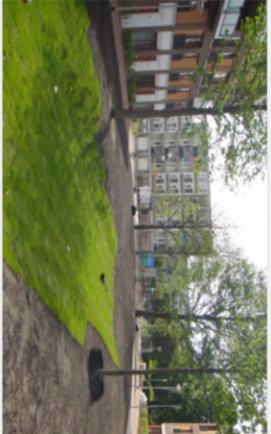
Figure D.16: Cases 60-63

<p>F.60</p> <p>The water storage for the newly constructed houses of this neighborhood is located slightly higher than its surroundings. This water storage pond has been combined with houses on the water. The architect stated that to live by the water, the distance between the living area and the water should not be more than 15 centimeters. Because of this decision, the water storage capacity was decreased from 50 centimeters to barely 15 centimeters. Therefore the original storage function of the water body was no longer sufficient. In order to solve this problem, a small that serves as emergency overflow was created.</p>	<p>F.61</p> <p>In this new neighborhood a shopping center has been built, with a deepened parking garage below. Directly next to the parking garage, surface water is located. The retaining wall of this parking garage has become a very determining factor for the final design of the complete water system of this new build neighborhood. The height of the retaining wall is the only factor that minimizes the storage ability of this water. If the wall had been made 20 cm higher, there would have been 20 cm more storage in the system. The whole system needs to be adapted to height of this wall.</p>	<p>F.62</p> <p>The idea in this situation was that that the electricity mast would already be removed before the construction of the houses. Therefore, the design of the houses was not adjusted to the electricity mast. When the design of the houses was already finished, it became clear that the electricity was not removed yet.</p>	<p>F.63</p> <p>In this situation, crates were installed in combination with an bioswale. Unfortunately various problems arose. Firstly, the crates were partially laid out below groundwater level. Secondly, there were illicit connections attached to the crates, causing dirty water from the houses ending up in the crates..</p>

<p>Storage</p> <p>Water board</p> <p>Newly developed area (Nhex)</p> <p>Minimal functionality of system</p> <p>Boundary house to water body</p> <p>No direct impact</p> <p>Limited feedback</p> <p>Design phase</p> <p>Poor communication between different actors</p>	<p>Storage</p> <p>Water board</p> <p>Newly developed area (Nhex)</p> <p>Minimal functionality of system</p> <p>Boundary house to water body</p> <p>No direct impact</p> <p>Limited feedback</p> <p>Design phase</p> <p>Poor communication between different actors</p>	<p>Storage</p> <p>Water board</p> <p>Newly developed area (Nhex)</p> <p>Causes nuisance in other domain</p> <p>Transition area open space to water body</p> <p>No direct impact</p> <p>Interference of obstacle</p> <p>Construction phase</p> <p>Fitting SUDS to unforeseen circumstances</p>	<p>Infiltration</p> <p>Public (Municipality Water)</p> <p>Newly developed area (Renewed)</p> <p>Water nuisance</p> <p>Open space</p> <p>Discomfort</p> <p>High groundwater level</p> <p>Design phase</p> <p>Incomplete knowledge about the technical performance of SUDS</p>

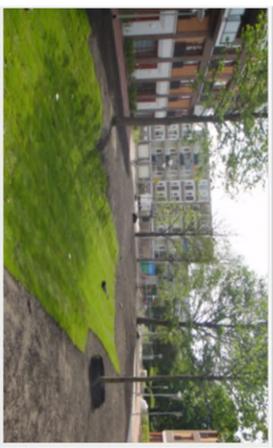
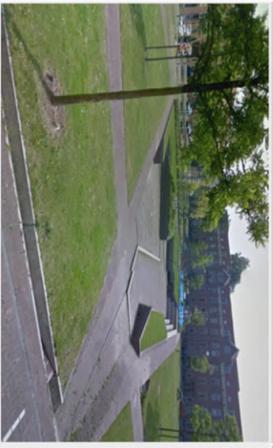
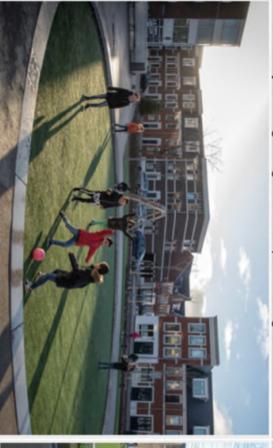
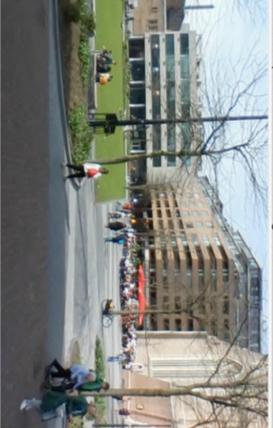
Figure D.17: Cases 64-67

<p>F.64</p> <p>In this situation, subsurface storage crates have been installed in combination with an bioswale. Unfortunately various problems have occurred with this system. Firstly, the crates have been partially laid below groundwater level. Secondly, there were illicit connections attached to the crates, causing dirty water from the houses ending up in the crates. Thirdly, the infiltration rate is too small due to clogging. A T = 1 year rain event could be processed very tightly. Therefore water nuisance was present several times.</p>	<p>F.65</p> <p>A water square has been constructed with subsurface lava cases. Stormwater can infiltrate in the lava cases, whereas the lava cases would provide a temporarily storage function. The groundlevel beneath the water square is higher than expected, due to an unexpected water influx from the surrounding area. The square is located near the main flood defense, which is located next to a higher-lying area. The result is a high groundwater level in the section between the water square and the main flood defense, groundwater comes from the higher part to the lower part (the water square). Therefore, the water inside the lava crates can not fully infiltrate into the subsoil. The solution is found in pumping out the water of the crates every now and then.</p>	<p>F.66</p> <p>For water purification purposes, an infiltration construction with subsurface storage crates has been constructed under a square. The conventional stormwater system of the surrounding area is connected to this square. In the crate system an overflow has been constructed at the top of the crates. This means that the stormwater system has a high threshold. The groundwater level in the surrounding area has increased since the construction of the storage crates.</p>	<p>F.67</p> <p>Under a large city square with a church, lava cases have been constructed. Two large pipes are constructed to transport the stormwater falling on the church towards the lava cases. The subsurface storage crates were designed with a overflow point at the highest location in the subsurface storage crates, causing the pressure to build up in the cases, enabling infiltration towards the subsoil. During construction, an extra overflow system has been constructed by constructors at the lowest point in the lava cases, causing a minimalisation of the storage and infiltration function. However, no water nuisance or direct problems are experienced.</p>

<p>Infiltration</p> <p>Public (Municipality Water)</p> <p>Newly developed area (Renewed)</p> <p>Water pollution</p> <p>Open space</p> <p>Economic impacts</p> <p>Illicit connections</p> <p>Construction phase</p> <p>Lack of experience in constructing SUDS</p>	<p>Infiltration</p> <p>Public (Municipality)</p> <p>Retrofit area (Cauliflower)</p> <p>Water nuisance</p> <p>Open space</p> <p>Discomfort</p> <p>High groundwater level</p> <p>Design phase</p> <p>Fitting SUDS to unforeseen circumstances</p> <p>Incomplete knowledge about the technical performance of SUDS</p>	<p>Infiltration</p> <p>Public (Municipality Water)</p> <p>Retrofit area (Working-class)</p> <p>Water nuisance</p> <p>Open space</p> <p>Discomfort</p> <p>High groundwater level</p> <p>Design phase</p> <p>Incomplete knowledge about the interactions of SUDS with urban systems</p> <p>Unfamiliarity of integrating SUDS in spatial design</p>	<p>Infiltration</p> <p>Public (Municipality Water)</p> <p>Retrofit area (Downtown)</p> <p>Minimal functionality of system</p> <p>Open space</p> <p>Discomfort</p> <p>Outlet not fitted correctly</p> <p>Construction phase</p> <p>Poor communication between different actors</p> <p>Lack of experience in constructing SUDS</p>

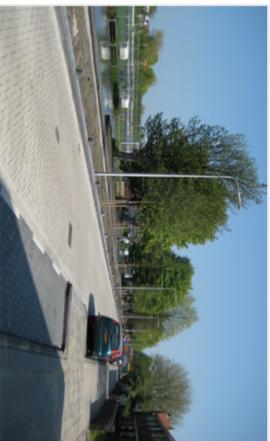
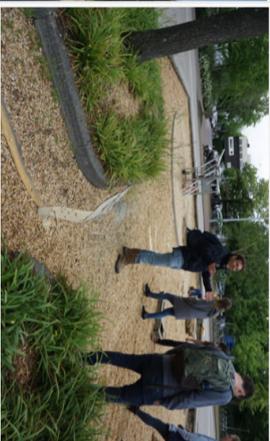
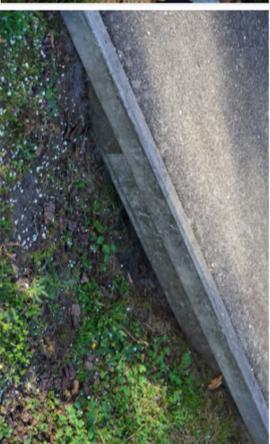
Figure D.18: Cases 68-70

<p>F-68</p> <p>There is little surface water present in this neighborhood. To increase the storage capacity, the municipality implemented two storage systems as pilot project. Below the first half of the street crates were placed and below the other half of the street Argex material (particles that can fill up water) was placed. On top, permeable pavement was laid, to make infiltration possible. Some problems arised in the user phase. Firstly, in the user phase the maintenance department had difficulties in maintaining these types of constructions. In addition, the joint filling between the stones disappeared.</p>	<p>F-69</p> <p>In this situation part the surface has been lowered and covered with small gravel stones to make infiltration of stormwater possible. Two types of problems occur in this system. Firstly, the infiltration capacity is very low (13 mm/h) due to high groundwater/levels and clogging of the subsoil. Secondly, the small gravel stones spread easily, making maintenance of the surrounding area more difficult.</p>	<p>F-70</p> <p>Bioswales are constructed in front of these houses. In order to get from the house to the streets, a small bridge has been placed. The bridge is located only a couple centimeters above the swale surface. This minimizes the storage capacity of th swales.</p>

<p>Storage Public (Municipality Roads) Retrofitted area (Working-class) Causes nuisance in other domain Street Discomfort Clogging User/maintenance phase Lack of knowledge how to maintain SUDS</p>

<p>Storage Public (Municipality Roads) Retrofitted area (Urban) Minimal functionality of system Open space Discomfort High groundwater level Design phase Incomplete knowledge about the technical performance of SUDS</p>

<p>Storage Public (Municipality Green) Newly developed area (Vinex) Minimal functionality of system Street No direct impact Interference of obstacle Design phase Incomplete knowledge about the interactions of SUDS with urban systems</p>
