## Impact of November 2023 Storms along the Southern Black Sea Coastline

**Abstract**—This study presents a comprehensive assessment of two successive storm events that impacted the Black Sea coasts in November 2023. Using a combination of meteorological and oceanographic datasets, satellite altimetry, and an extensive post-disaster field survey conducted at most of the affected regions along the Southern Black Sea coastline, the characteristics of storms and their impacts on coastal structures and communities are documented in detail. The storms, spaced just one week apart, generated significant wave heights exceeding 7–8 m offshore, wind speeds above 20–25 m/s, and widespread coastal inundation. Despite the limitations in the spatial resolution of global datasets, particularly in capturing localized wind and wave conditions, datasets provided valuable insights together with observational data. Field observations revealed recurring structural damages across the region, particularly the breakwater crown walls, due to high wave impact. At several harbors, displaced armor units contributed to damage. Inundation extends up to 270 m, highlighting the extreme wave run-up and overtoppin

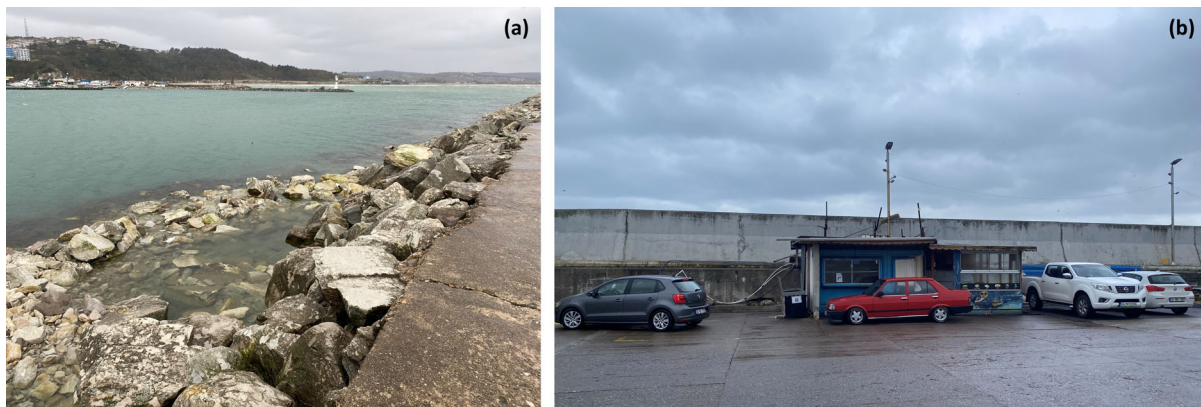
Figure 12

Sile Fishery Harbor is located in eastern Istanbul and is denoted as S2–S3 in Fig. 1b. Similar wind and wave characteristics to the Rumeli Fishery Harbor were estimated by the reanalysis dataset. The harbor is protected by two rubble mound breakwaters. Significant damage was observed on the rear side of the main breakwater due to extreme wave action (Fig. 12a). Additionally, the storm caused minor damage to a small shop located on the main breakwater (Fig. 12b). Inside the harbor, a small fishing boat sank as a result of storm waves that penetrated into the harbor area, noting that the mouth of the port is open to northwest direction.

To the east of the harbor, there is a natural bay. A rubble mound slope followed by recurved seawalls (+4.0 m above still water level, SWL) were constructed along the shoreline of this bay to protect the coastal road, which also provides access to the port area. In this region, significant wave overtopping was observed, leading to coastal inundation. The inundation distance at locations S2 and S3 were measured as 16 m and 24 m, respectively, also provided in Table 3.

Field survey at Sile Fishery Harbor: **a** Rear side damage of the main breakwater, **b** damaged small shop located at the crest of the breakwater

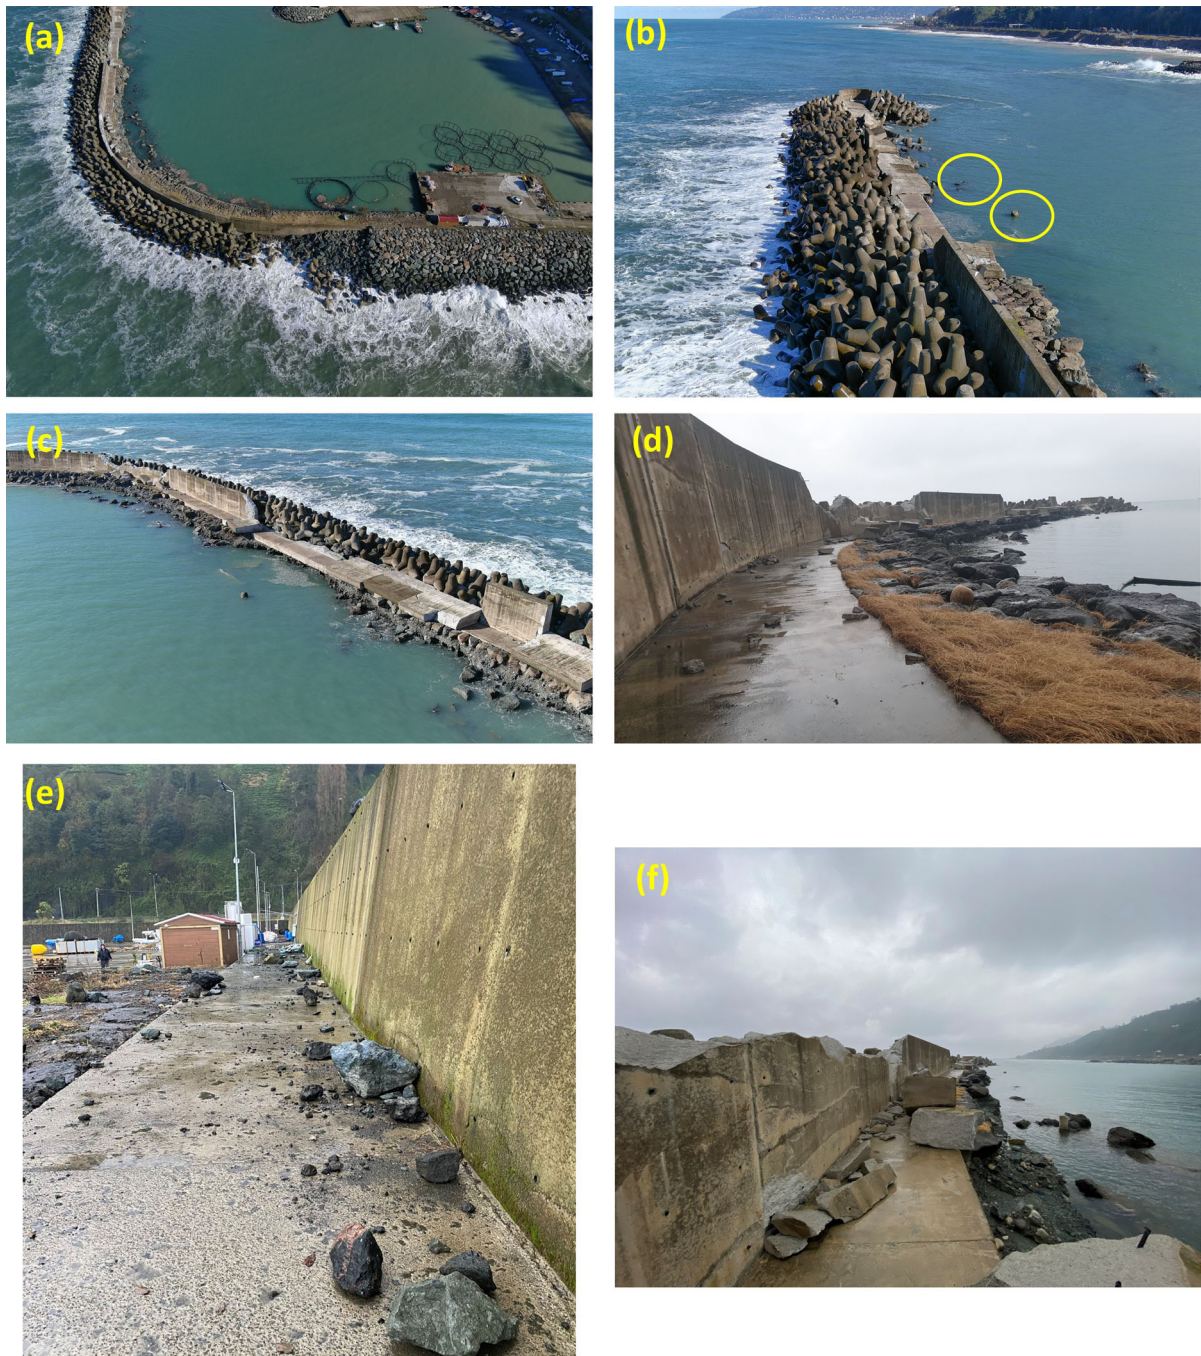
Figure 17

Two distinct types of crown wall damage were observed at this location. In some sections, the

Field survey at Rize Gundogdu/Bozukkale Fishery Harbor: **a** Aerial view showing the damage at the main breakwater, **b** aerial view showing the damage at the main breakwater indicating the tetrapods thrown away to harbor side, **c** aerial view showing the overturned crown walls, **d** close-up view of the damage, **e** rocks thrown onto crown wall at shallower sections, **f** breakage of crown wall strips. (Drone images were kindly provided by Lead Engineer Akif Karanis from Ministry of Transport and Infrastructure, XI. Regional Directorate)

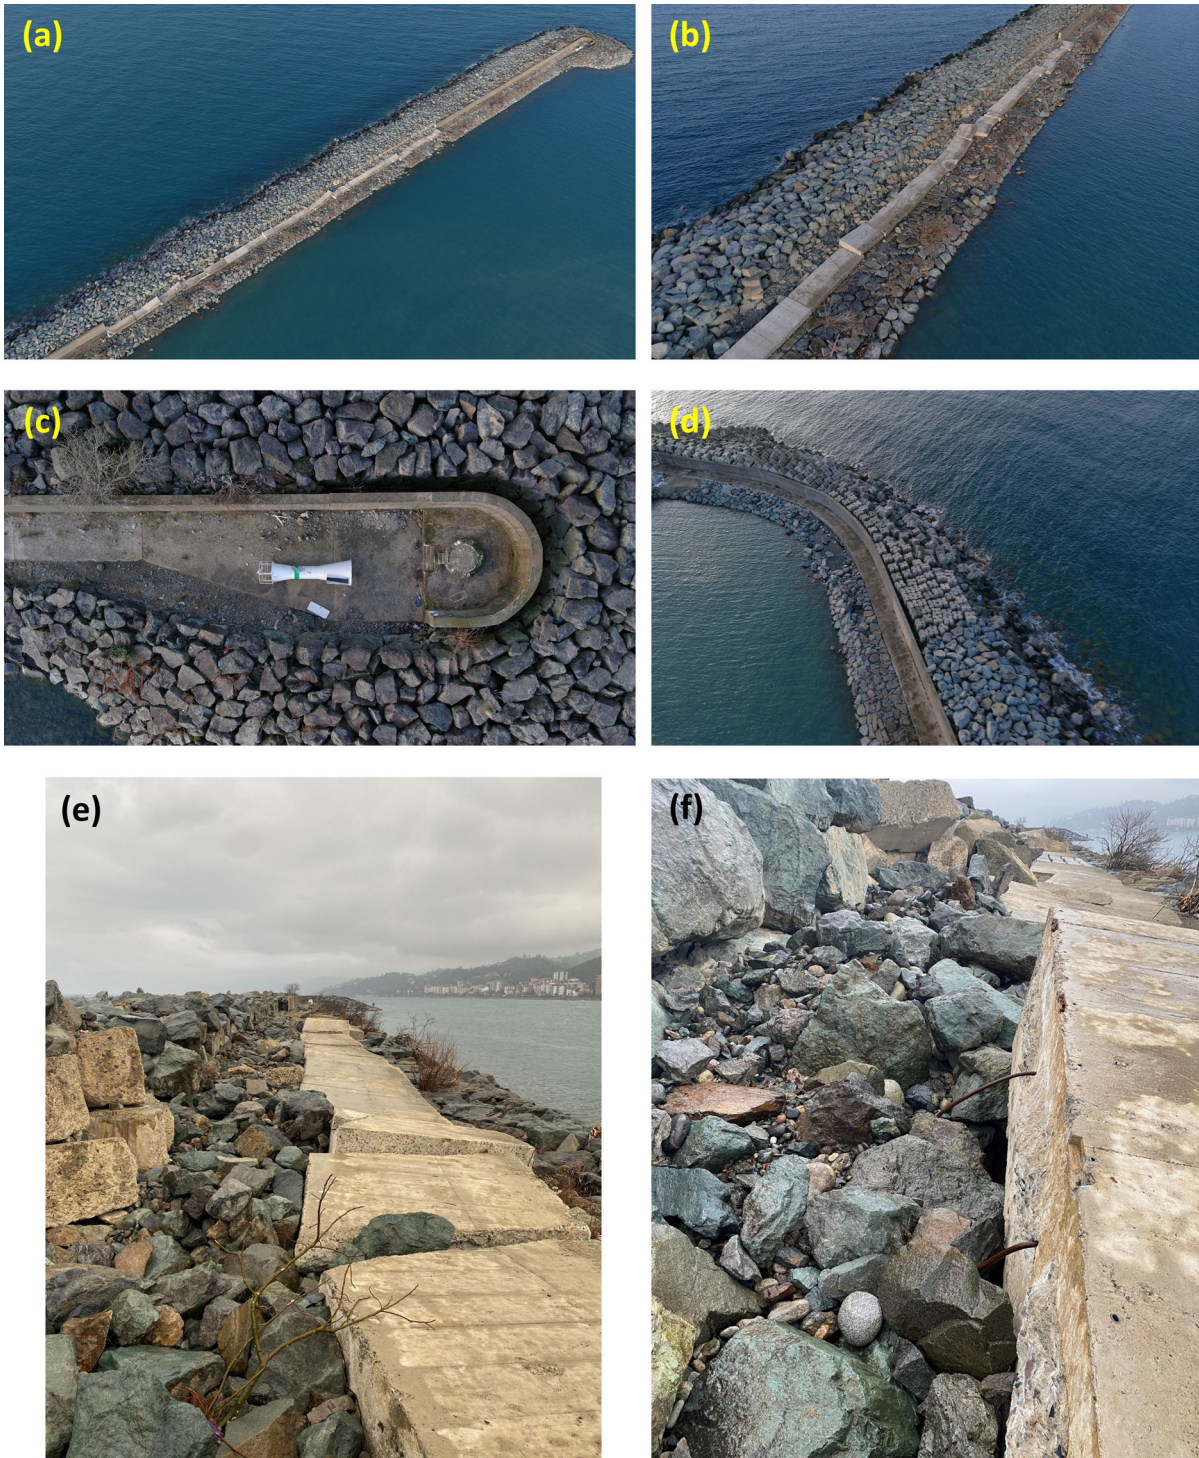
The main breakwater was constructed using Antifer units along the shallower trunk sections and rock armor at the deeper sections toward the head (Fig. 18d), likely due to budget constraints. The vertical components of the crown wall were overturned at their connection points, particularly in the region where the armor layer consisted of rocks (Fig. 18a, b, e, and f). The failure mechanism of crown wall is similar to what was observed at several previously investigated sites. The navigation beacon was also overturned during the event (Fig. 18c). The (weak) reinforcement bars connecting the horizontal

and vertical components are visible in Fig. 18f. The failure of the crown wall extended over a 111 m stretch along the main breakwater. In addition, the

armor stones were thrown into the harbor, and the rear side of the breakwater was almost entirely destroyed.

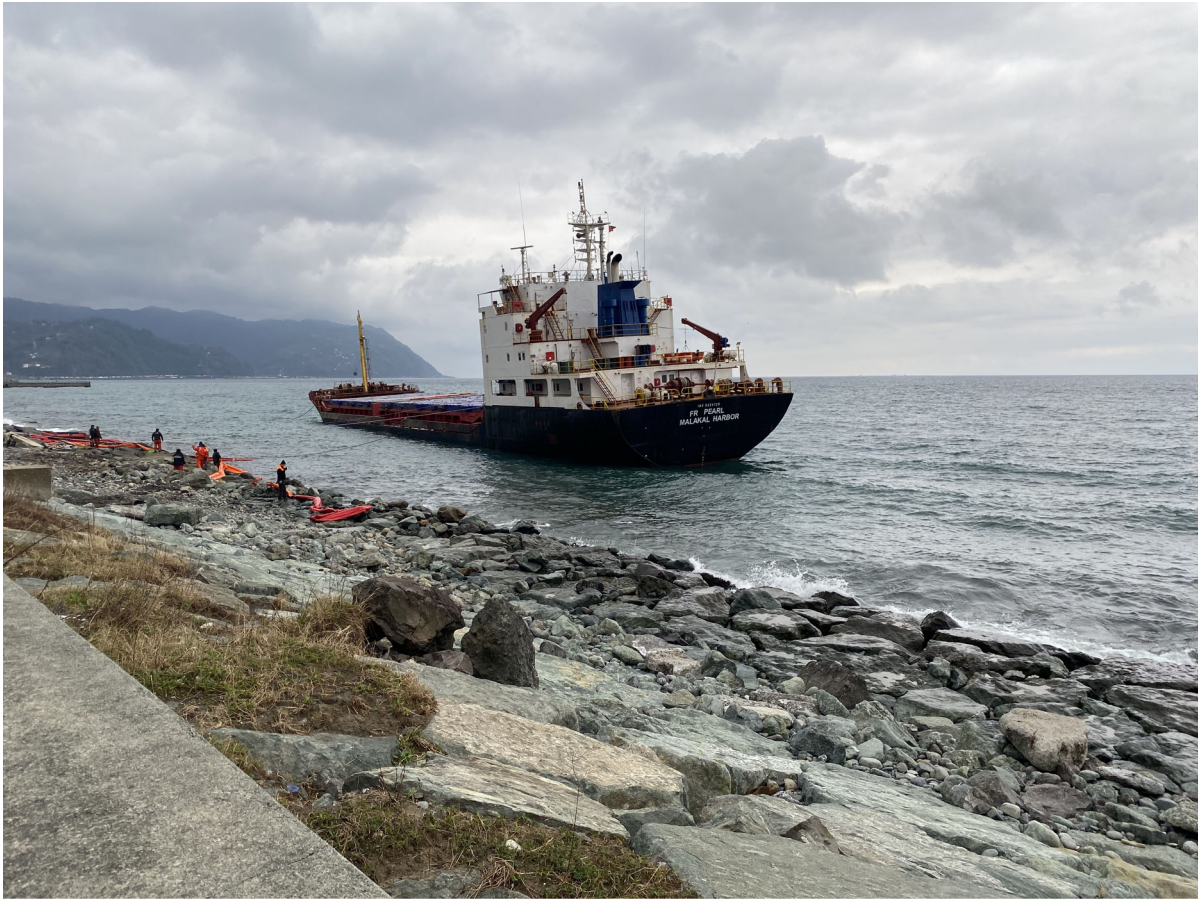
Figure 19  
Grounded vessel in Hopa (Location S21)
