MAST II - Berm Breakwater Structures

Stability of Toe and Scour Protection

Final Report

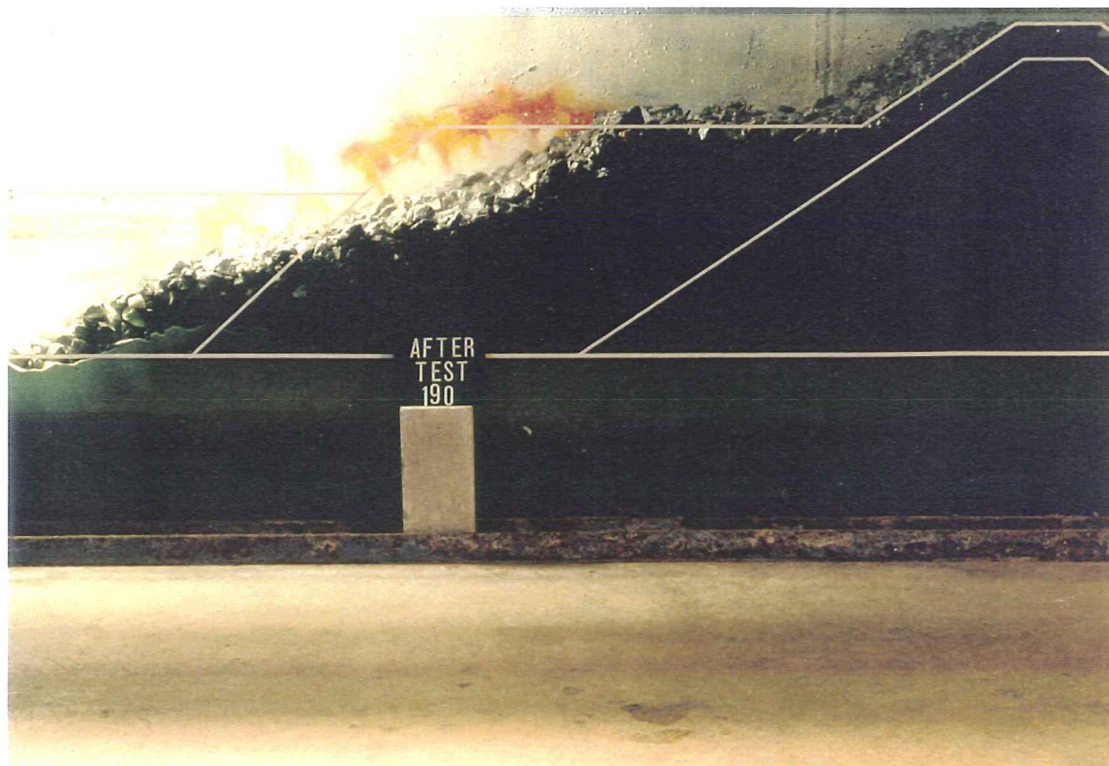
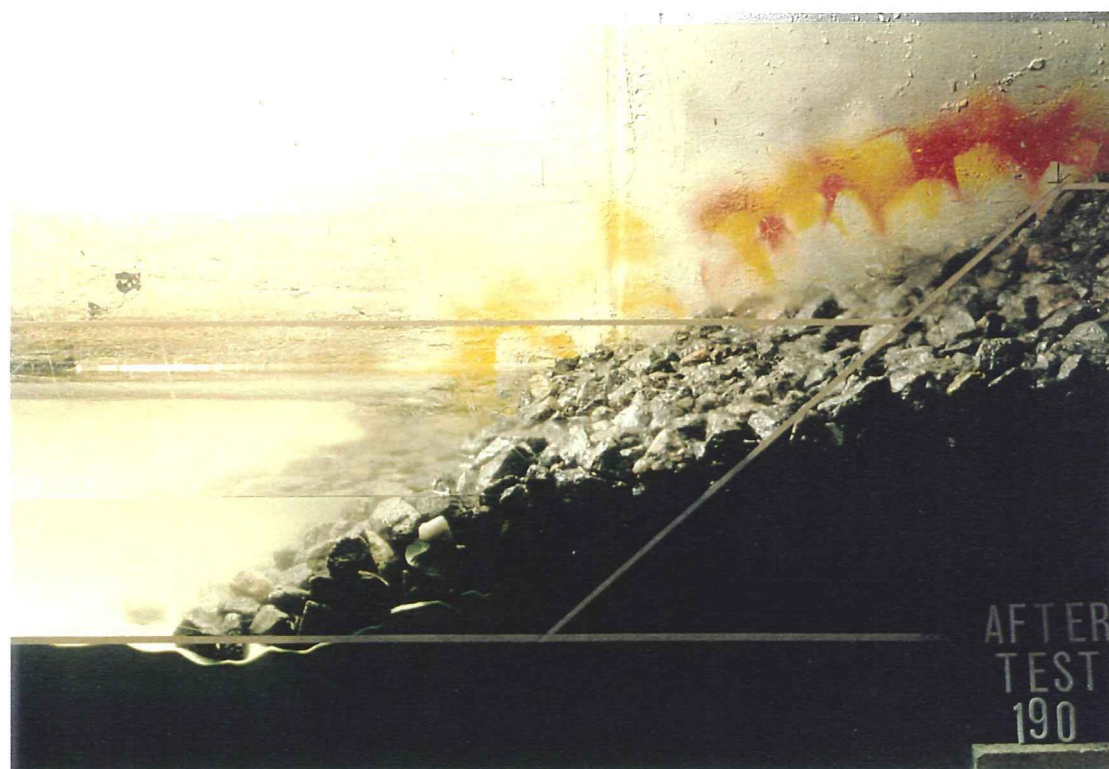
Profile 1 - After additional 10,000 waves with $H_o=3.5$, $S_m=0.05$

Only a very little scouring took place during the first five tests with $S_{om}=0.05$, ie for wave conditions up to $H_o=4.0$. Testing was extended to include another 10,000 waves with $H_o=3.5$, but only a small scour hole (about 0.03 m deep) developed in front of the berm. Sand was deposited inside the berm as seen from photos in Appendix B.

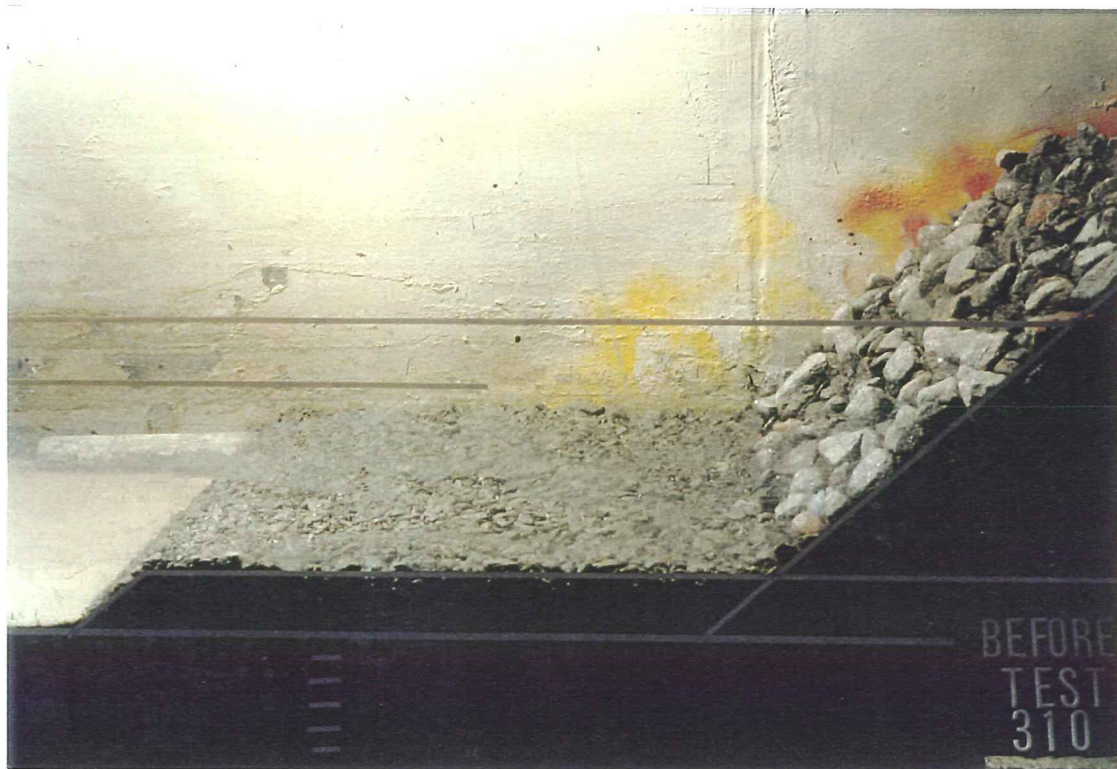
Profile 3 - Before testing

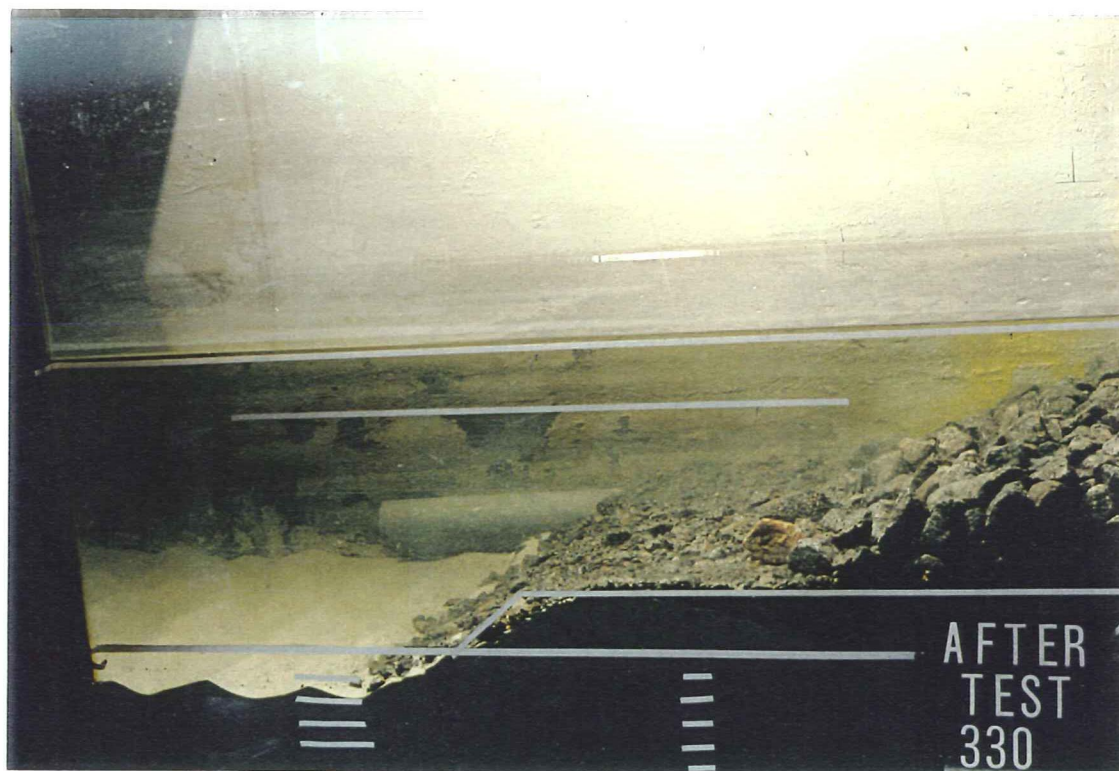
Profile 3 - After test with $H_o=4.0$, $S_m=0.03$

Based on the findings of the two first test series, it was decided to continue testing only with wave steepnesses of $S_{om}=0.03$ and 0.02. After testing with $H_o=4.0$, the outer edge of the scour protection layer was smoothed out and a scour hole with a depth of about 0.04 m was registered in front of the scour protection layer.

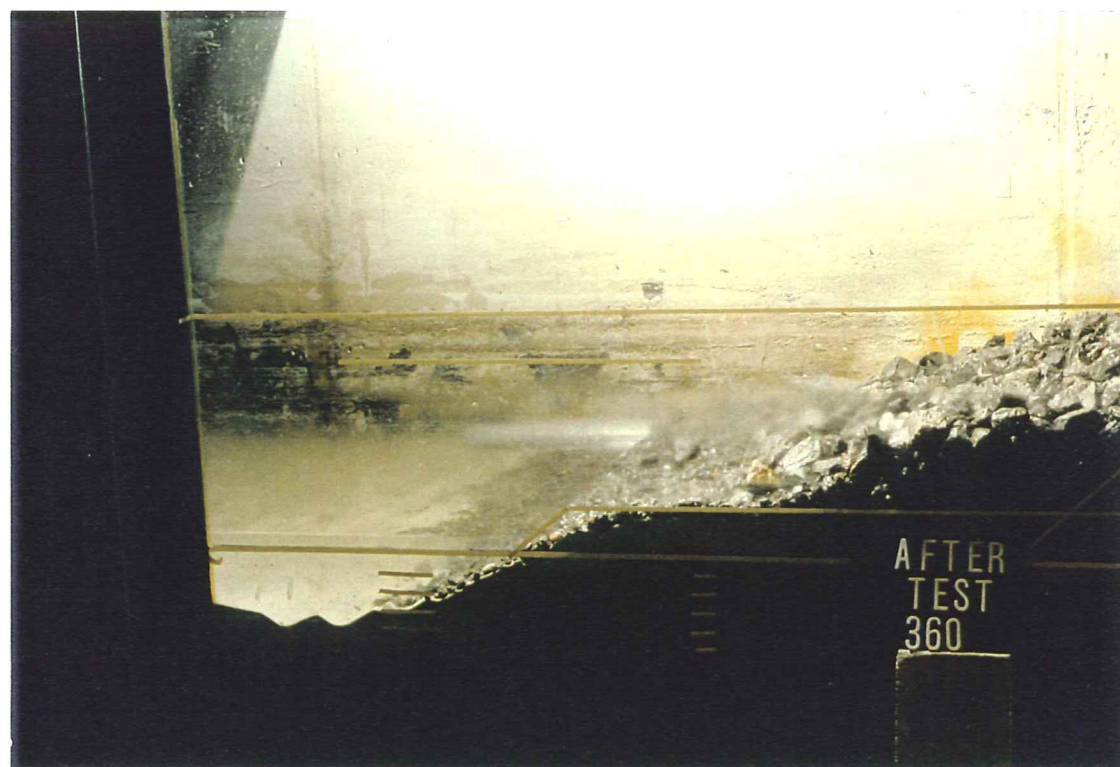
Profile 3 - After additional 4,000 waves with $H_o=3.5$, $S_m=0.02$

The depth of the scour hole increased to about 0.05 m after another 2,000 waves with $H_o=4.0$. A significant increase in the extent and depth of the scour hole was found after exposure of 4,000 waves with $S_{om}=0.02$ and $H_o=3.5$; scour hole depth increased to 0.08 m and somewhat more smoothing out of the outer edge of the protection layer was found.

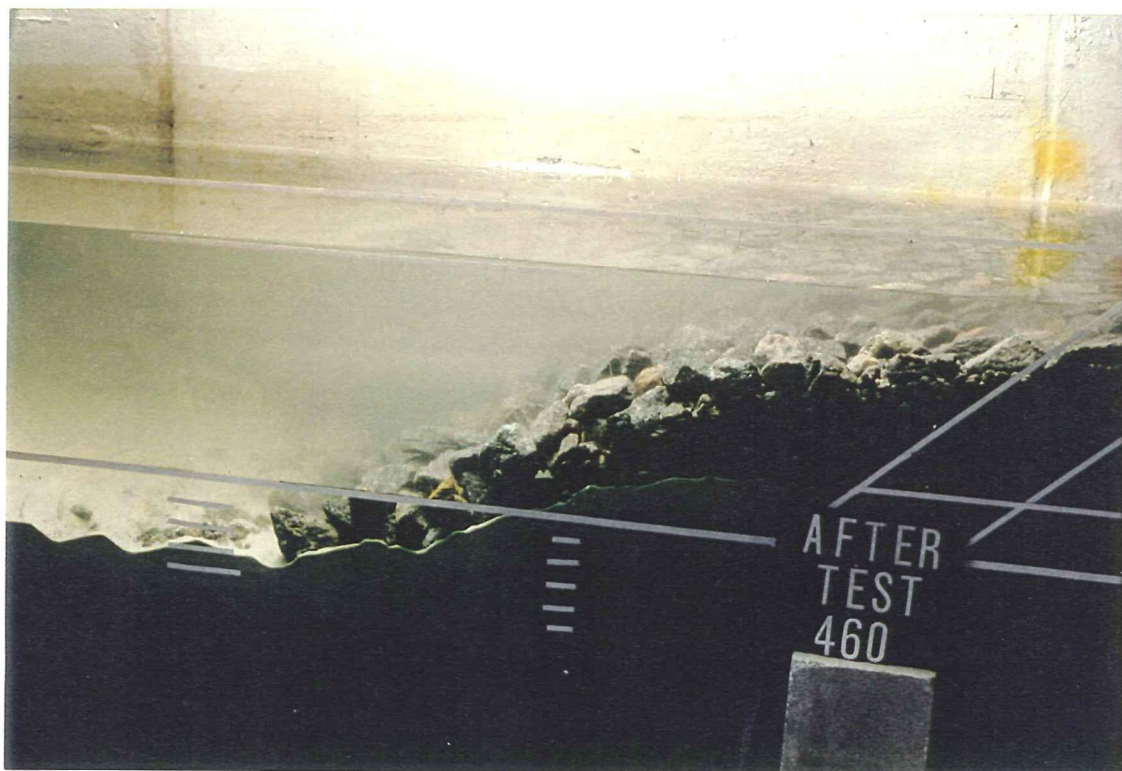
Profile 4 - After additional 4,000 waves with $H_0=3.5$, $S_m=0.02$

After testing with $H_o=4.0$, a scour depth of about 0.04 m was found in front of the developed toe consisting of finer material covered with berm stones. A scour hole depth of 0.06 was measured after another 2,000 waves with $H_o=4.0$. After additional 4,000 waves with $S_{om}=0.02$ and $H_o=3.5$, the extent and depth of the scour hole was increased (a scour depth of about 0.07 m was measured).

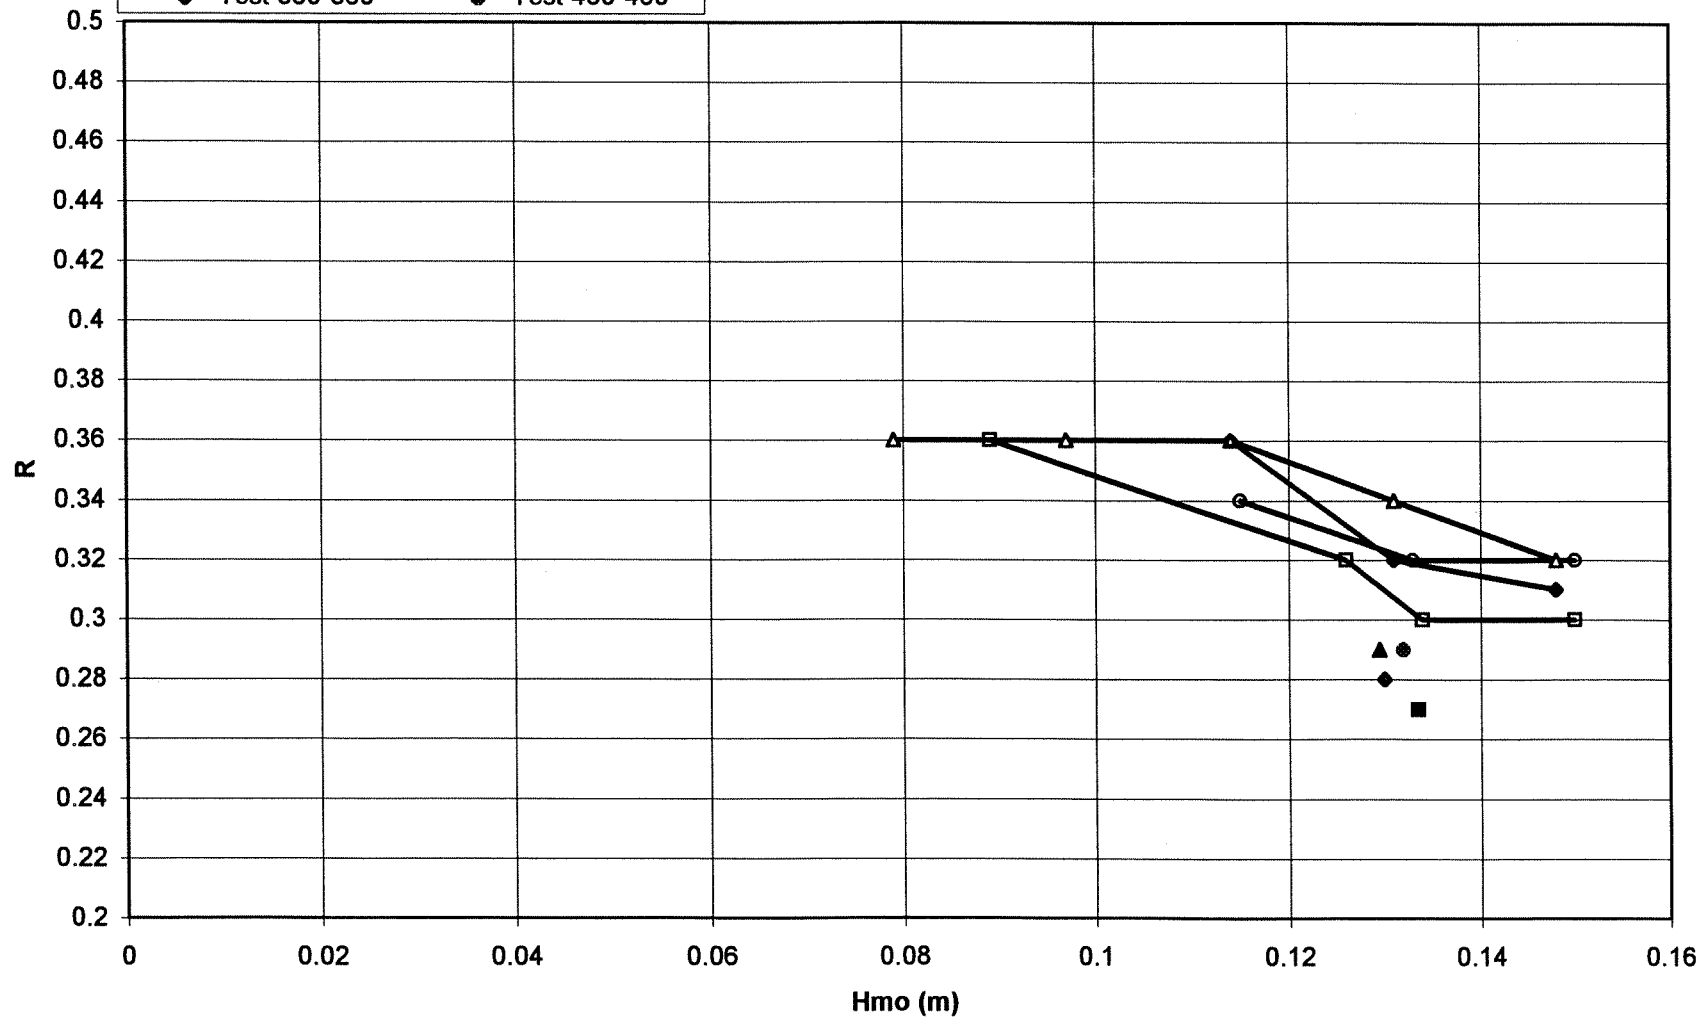
Reflection vs Hmo (Deep Water)

- Test 120-150
- Test 310-330
- Test 160-190
- Test 350-360
- Test 210-250
- Test 410-430
- Test 270-280
- Test 450-460

Comparing test series 1 and 2 showed that the reflection coefficient was larger for the tests with the longest wave periods, ie lowest wave steepness. No significant difference in the reflection coefficient was found between the last three test series, for which the reflection coefficient varied from 0.37 to 0.43 for the tests up to $H_o=4.0$, whereas a decrease was found for the additional tests due to the more reshaped profile.
