## Choosing Mortar Compositions for Repointing of Historic Masonry Under Severe Environmental Conditions

Groot, C.J.W.P.; Gunneweg, Jos

Historic Mortars

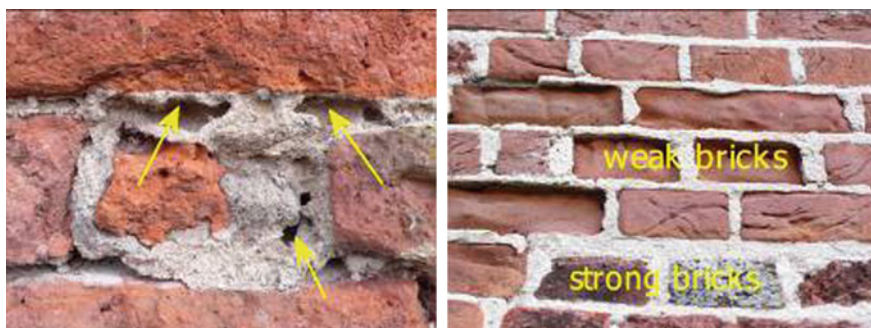
**Fig. 2** Cases of NaCl damage. Left: voids in the repointing stemming from leaching of calcium chloride from the air lime repointing. Right: weathering of underfired brick through NaCl crystallization-dissolution cycling

Salts may have a harmful influence on the durability of the mortar as well as the brick. The influence of sea salt (containing a high content of NaCl) can be observed in many buildings, especially on the North sea coast of the Netherlands. In Fig. 2 two examples are presented of damage caused by NaCl.

Figure 2 (left), shows damage to a pure air-lime repointing mortar. In this case the highly soluble chemical compound calcium chloride ( $\text{CaCl}_2$ ) is formed with calcium from the mortar binder and chloride from the seasalt. Rain, subsequently, causes the leaching out of the mortar. The binder choice is obviously an important parameter in limiting salt damage.

Figure 2 (right), presents damage to fired clay bricks by NaCl. In this case the underfired bricks are apparently not strong enough to resist the crystallization-dissolution cycling caused by NaCl. The stronger bricks don't show damage (compressive strength values of 10–15 MPa are suggested by practice as strong enough to withstand salt damage through crystallization-dissolution cycling).

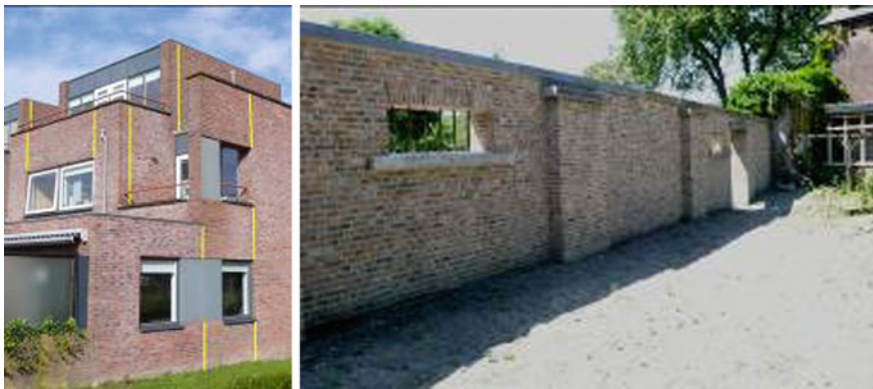
**Fig. 3** Left, the yellow lines indicate the dilations applied in a modern masonry. Right, a wall without dilation in traditional masonry (Color figure online)

Differences in macro deformation behaviour of modern (left) and traditional masonry (right) is shown in Fig. 3. The fear of cracks, apparently a risk in modern cement masonry, is solved by extensively applying dilations. The long wall constructed with a traditional natural hydraulic lime mortar, NHL3.5 type St. Astier, (right) does not need any dilation.

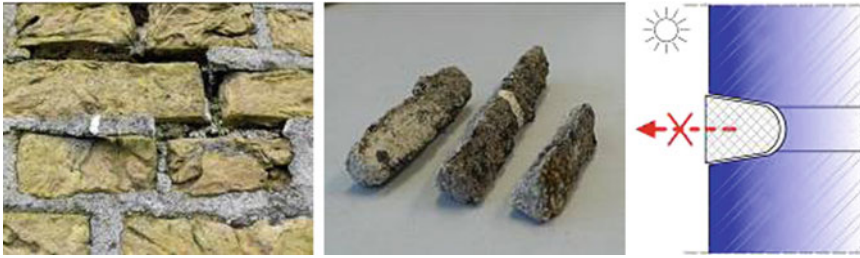
**Fig. 4** Detachment of repointing caused, in particular, by thermal deformation enhanced by a wrong cross-sectional form (V-shape instead of rectangular) of the repointing

At meso scale thermal resp. moisture deformation may as well be a serious cause of damage (see Fig. 4). Not only do material properties such as the (linear) thermal respective moisture expansion coefficient play a role in the detachment process, but so does the execution technique in for example the pointing.

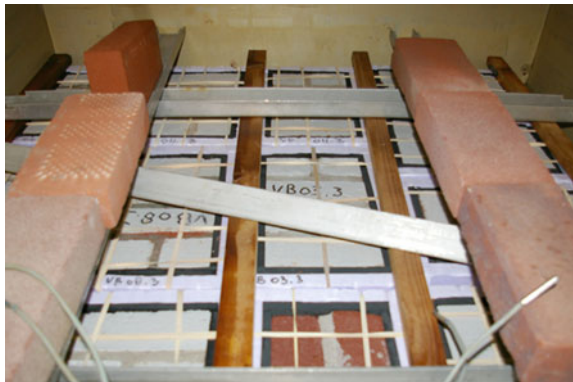
**Fig. 5** The test specimens in the freeze-thaw container

The freeze-thaw tests were based on the test set-up used in the EU-Pointing project (Wijffels et al. 2001). In this test the freeze-thaw cycle is applied from one side of the test specimen, and fresh water is used in the test. Precise details on the freeze-thaw cycle tests are given in (Groot and Gunneweg 2012) (Fig. 5).
