Monitoring the Concrete Slab Bridge on Balladelaan in the Netherlands using Embedded Ultrasonic Sensors

Abstract

2 The Bridge on Balladelaan in Amersfoort, the Netherlands

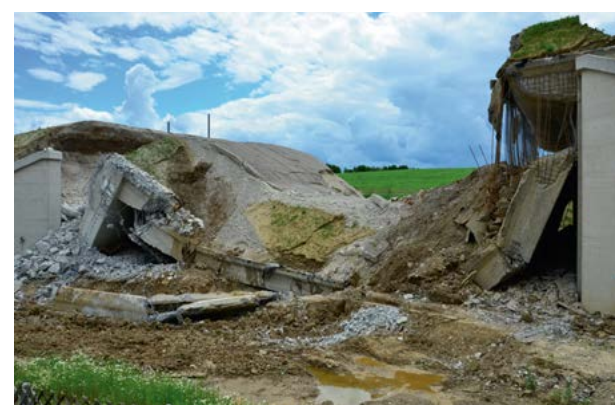
Figure 2. Photo of the collapsed Weiselburg bridge and an indication of its failure process [7].

Unlike bending failures, which typically exhibit warning signs, shear failures in concrete members without shear reinforcement are brittle and occur suddenly. Upon failure, a critical shear crack initiates from an existing flexural crack inside the bridge deck, making it difficult to detect on the surface. A notable example of such a failure is the collapse of the Weiselburg Bridge in Austria in 2020 [7], as illustrated in Figure 2.

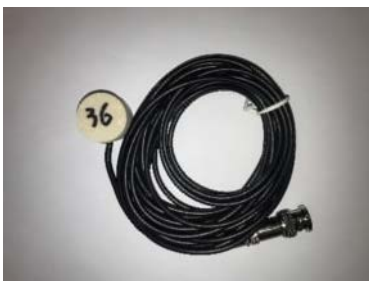
Figure 3. Photo of a Smart Aggregate (SA).

Smart Aggregates (SAs), first introduced by Song et al. [8], are embeddable piezoelectric sensors designed for the long-term monitoring of concrete structures. A photograph of an SA is shown in Figure 3. These sensors can be embedded within concrete prior to casting in new constructions or installed into drilled holes in existing structures. Leveraging the reversible piezoelectric effect, SAs serve dual functions: they act as actuators to generate high-frequency elastic waves and as receivers to detect these waves within the concrete. This functionality enables SAs, when installed in multiple locations, to monitor crack development across a specified area of the structure.

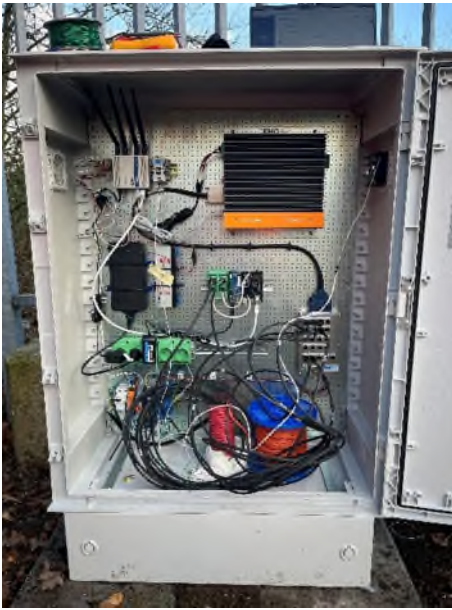
Figure 4. Photo of the equipment cabinet on the fenced terrain.

The monitoring system comprises a data acquisition (DAQ) system for signals received by the SAs, an ARM embedded board for temperature measurements, and a 4G router with a SIM card for communication. The DAQ system, designed and patented by Delft University of Technology (TU Delft), is optimized for ultrasound-based monitoring of concrete structures.

The DAQ system includes a pulser, pre-amplifiers, and multiplexers. Thanks to the specialized circuit board design, the pulser can generate square pulses with a magnitude of up to 300 V without interfering with the received signals. The system supports a maximum sampling rate of 3 MHz, which is well-suited for the requirements of ultrasound-based concrete monitoring applications.

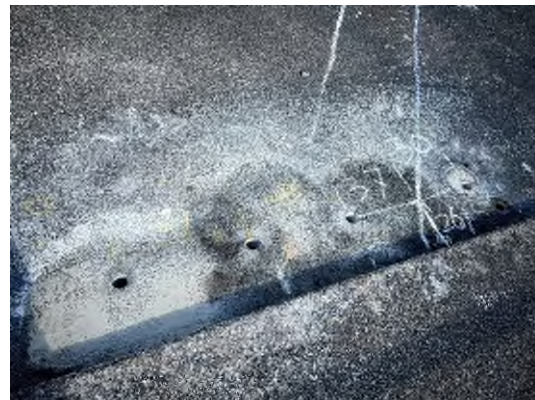
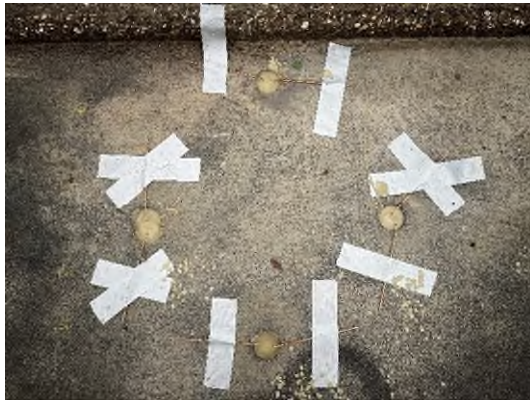
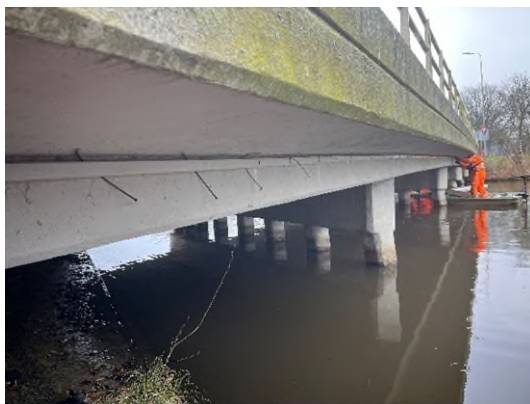
Figure 9. Photos for the installation process.

- Determining the rebar layout using a radar-based rebar detector.
- Identifying drilling locations based on the rebar layout.
- Drilling holes at the designated sensor locations, as depicted in Figure 9 (a).
- Installing sensors into the drilled holes.
- Filling the holes with high-strength mortar, as demonstrated in Figure 9 (b).
- Installing the data acquisition systems and organizing cables, as shown in Figure 9 (c).
- Installing the main station on the bank.

(a) Designated drilling locations after hole drilling.

(b) Fresh high-strength mortar after hole filling.

(c) Installation of data acquisition systems and Organizing cables.
