BITENHOF-NOORD

the reuse of low valued buildings

Cultural Value Assessment

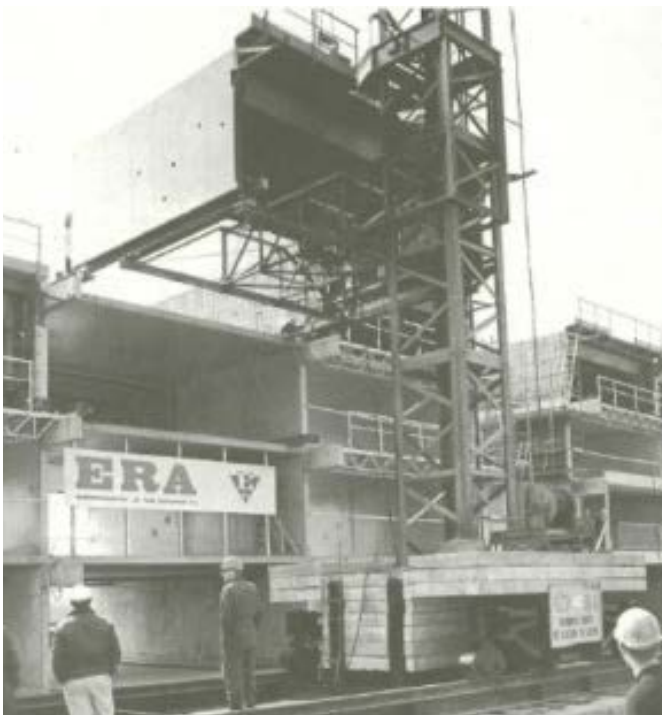
Fig. 2: Steel moulds (era contour, 2016)

The buildings on the chosen site are constructed in the ERA-system (van Eesteren Rationale Aanpak), a building system, in which large steel tunnels with a span of 7.8 m are placed on site and are used to pour concrete in-situ (Fig. 2). The system was developed in the 1960's by J. P. van Eesteren and used by the contractor's company ERA (Priemus & van Elk, 1971).

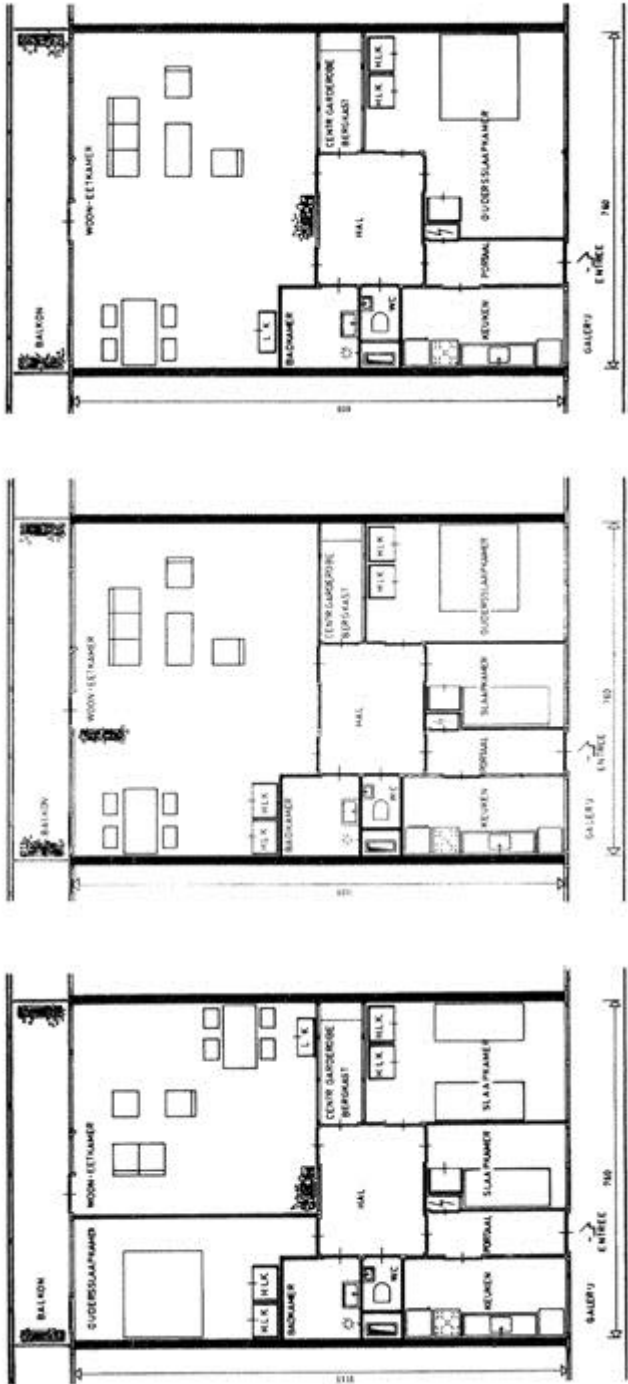
Fig. 3: Original floorplans, Ommoord (era contour, 2016)

The floorplans of the different buildings differ just slightly. The floorplan designed by R.H. Fledderus

(Rotterdam Ommoord: Een wederopbouwgebied van nationaal belang) remains its high flexibility till today (Fig.3).

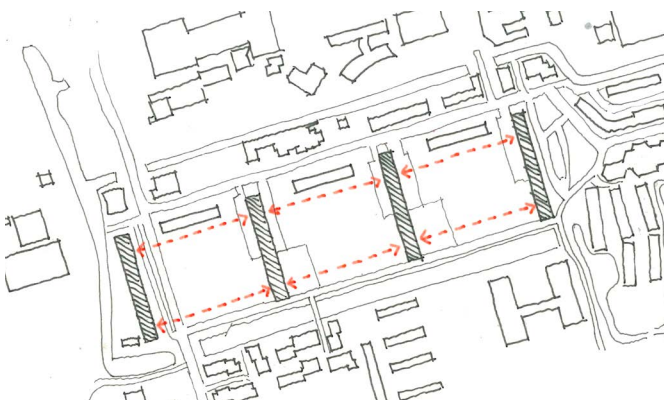
Fig. 6: Building composition - Buitenhof-Noord

After the second world war Delft expanded, like many places in the Netherlands. Delft expanded especially towards the south with the erection of a high number of mass housing. The neighbourhood Buitenhof-Noord is part of this city extension. The four ERA-buildings which are placed in parallel strips (Figs. 6+7+9) were, erected in 1969 (Bert Spaan, n.d.). The way the buildings are placed in its urban context and the fact that each building can host 196 households implies, that there was no intensive planning process as it was the case in Ommoord, which indicates furthermore, that the intention of the buildings, was mainly to provide many people with housing in a fast way.

As mentioned already, the ERA-buildings in Buitenhof-Noord are placed as parallel strips. This results in a couple of problems and causes the fact, that there is almost no value embodied in the layer of the site.

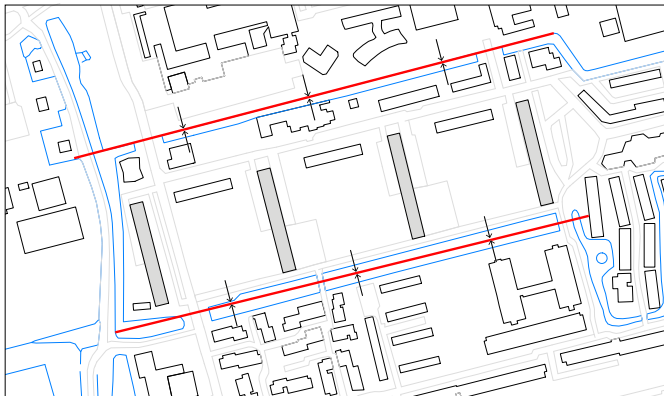
Fig. 7: Buitenhof-Noord - disconnection

The first problem at hand is, that the composition of the ERA-buildings together with low rise strips results in a disconnection (Fig. 7) from other parts of the neighbourhoods. This composition forms, green spaces between the high-rise strips, which can be perceived as left over spaces, which lack aesthetical and programmatic design (Figs. 8-10).

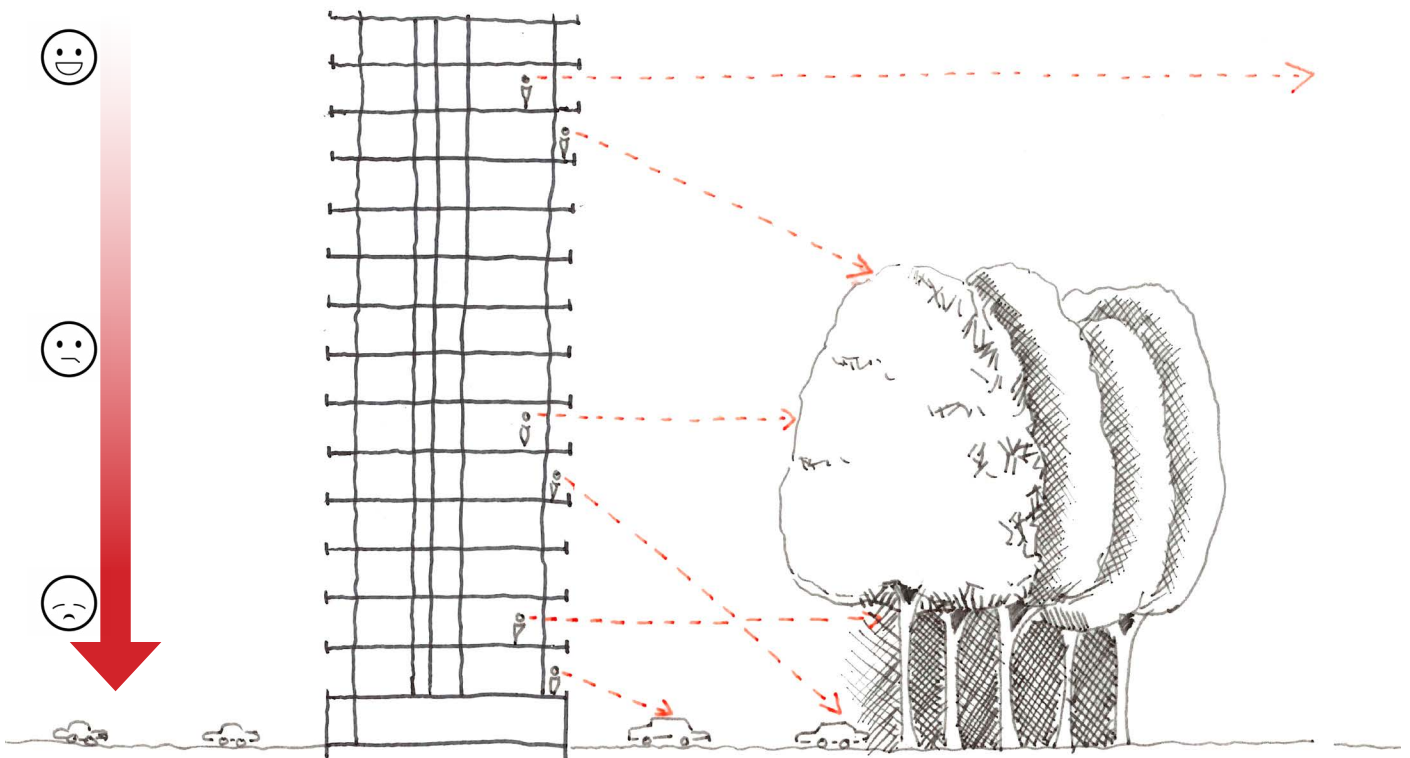
Fig. 11: Degradation of views

The biggest problem of the composition is the fact that the parallel placed buildings create a degradation of views. While the highest floors enjoy far and nice views, the lowest floors have views, which are just directed on tree trunks and the parking places. Simultaneously to the degradation of views, the quality of living degrades as well, which is displayed in a high moving rate at the lower floors (Fig. 11).

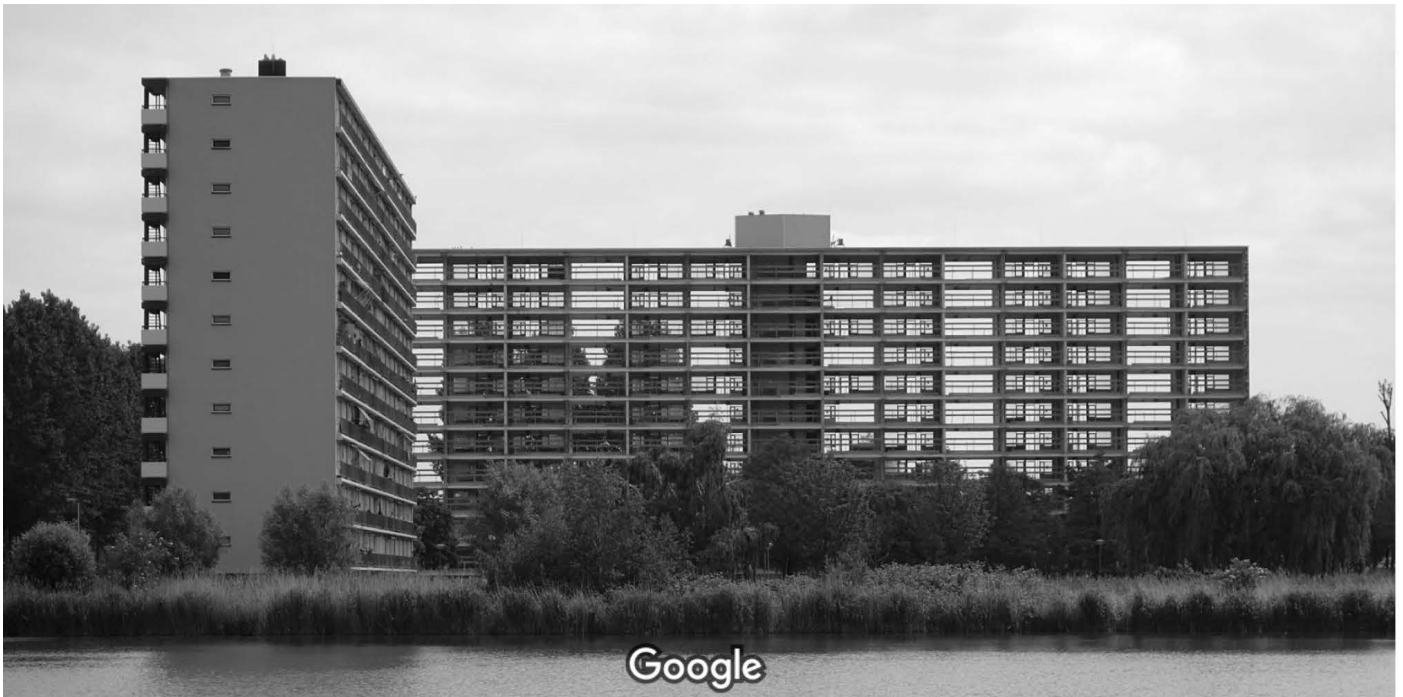
Fig. 12: Existing structure, Ommoord (Google)

Probably the most useful value of the ERA-buildings in Buitenhof-Noord is in the structure. The structure is still in perfect shape and remains its high use value till today (Fig. 12). The large span of the structure adds a high degree of flexibility to the buildings. Changes, like small openings in the loadbearing walls and the floor slabs, are possible to make, if those changes improve the quality of living for the inhabitants. Those structural changes cannot be done everywhere in the building, to not damage the stability of the structure (Fig. 13) (Dral, 2014).

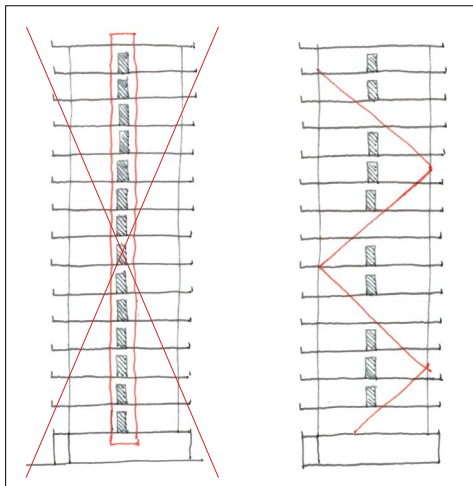
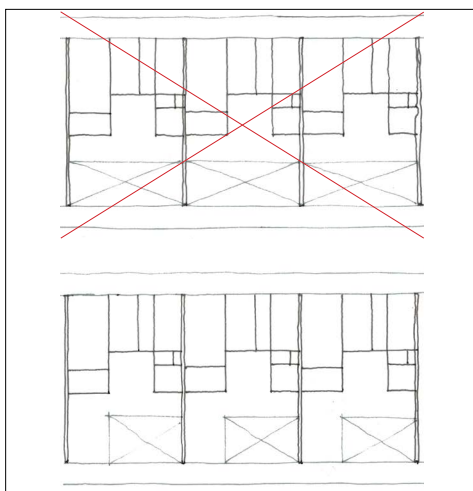
Fig. 13: Structural Intervention

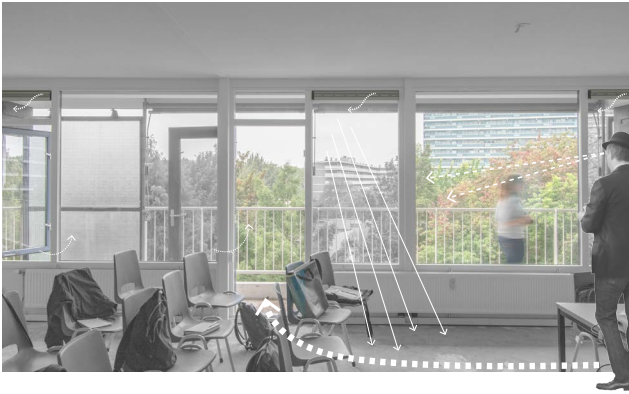
Fig. 14: Use value - skin

As the structure, the skin has a certain degree of use value. The façade remains its functions of having daylight, the possibility to ventilate and a certain degree of insulation (Fig. 14). But here lays also the potential to improve. The ventilation and the insulation properties can be improved. The large glass surfaces on the side of the balcony is highly valued, due to the huge amount of daylight which enters the apartments, in contrast to that the openness of the façade on the gallery side, is sometimes seen as a problem, due to the lack of privacy in the kitchen and in two of the sleeping rooms (Fig. 15). The façade should therefore be improved, in terms of privacy, insulation and ventilation, while remaining the quality of daylight.

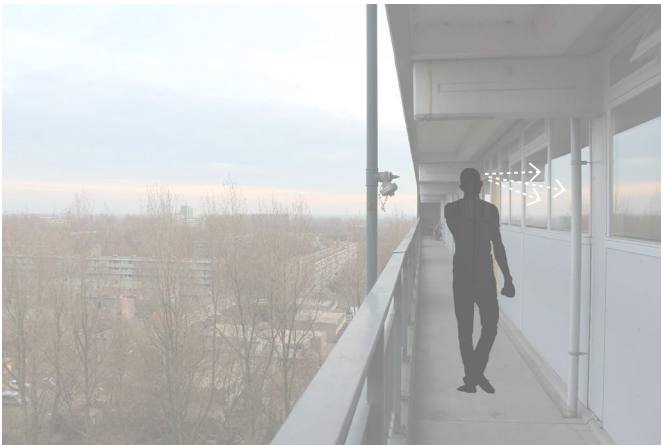
Fig. 15: Privacy problems

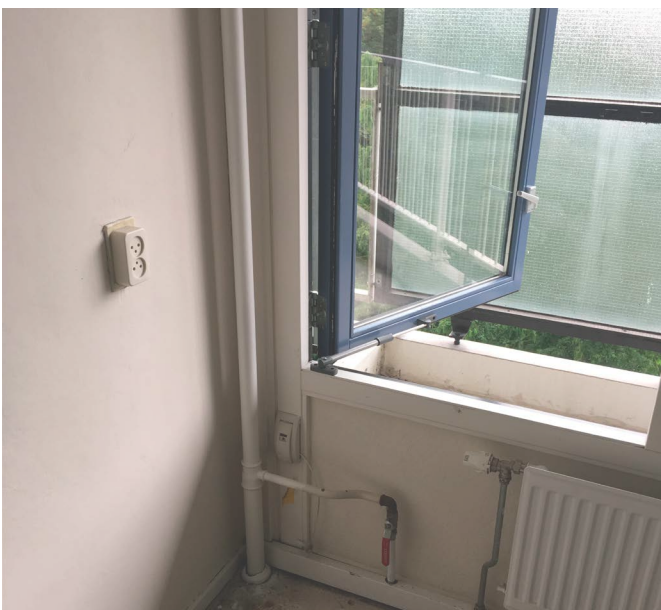
Fig. 16: Exposed pipes

The services of the buildings have again just use value. Nevertheless, the services need to be replaced at some points, since they are outdated. Improvement can be done especially in the heating and the ventilation system. The improvement of the services gives also the possibility to hide exposed pipes and to improve the aesthetics of the apartments (Fig 16) and to improve the energy efficiency of the buildings.

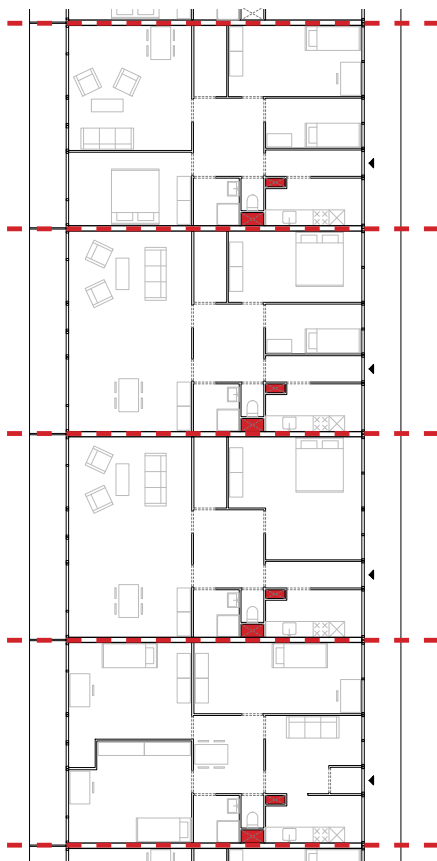
Fig. 17: Original floorplans

The original space plan is from high use value as well. The layout of the apartments around a central hall way functions very well. In Buitenhof-Noord changes were made, to transform the apartments in shared flats for students. Those changes seem to be provisional solutions and lower the clarity of the floorplan. In many single and two persons' household's rooms end up unused due to their small size and proportion (Fig. 17). Changes in the floorplans could be made to meet the needs of the users and contemporary living standards. Besides a bigger variance of different floor plans could suit more different user groups. The highly valuable flexibility of the floorplan makes those changes easy (Figs.

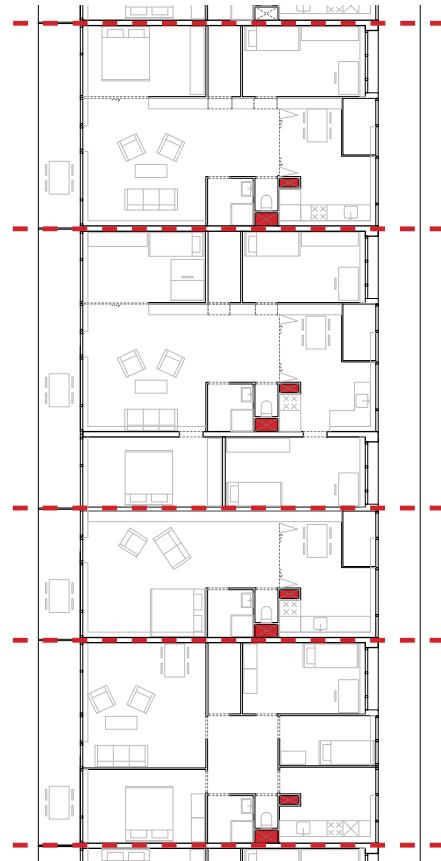
Fig. 18: Possible Interventions

18+19). The inner walls of an apartment are not loadbearing and can be rearranged. This flexibility is just limited by the vertical shaft and the meter cupboard. One apartment itself might be very flexible but ends at the edge of an apartment. This results in one type of apartment which is repeated and does not serve different user groups. The aforementioned changes in the structure would make it possible to serve different user groups and change the social mixture in the neighbourhood.

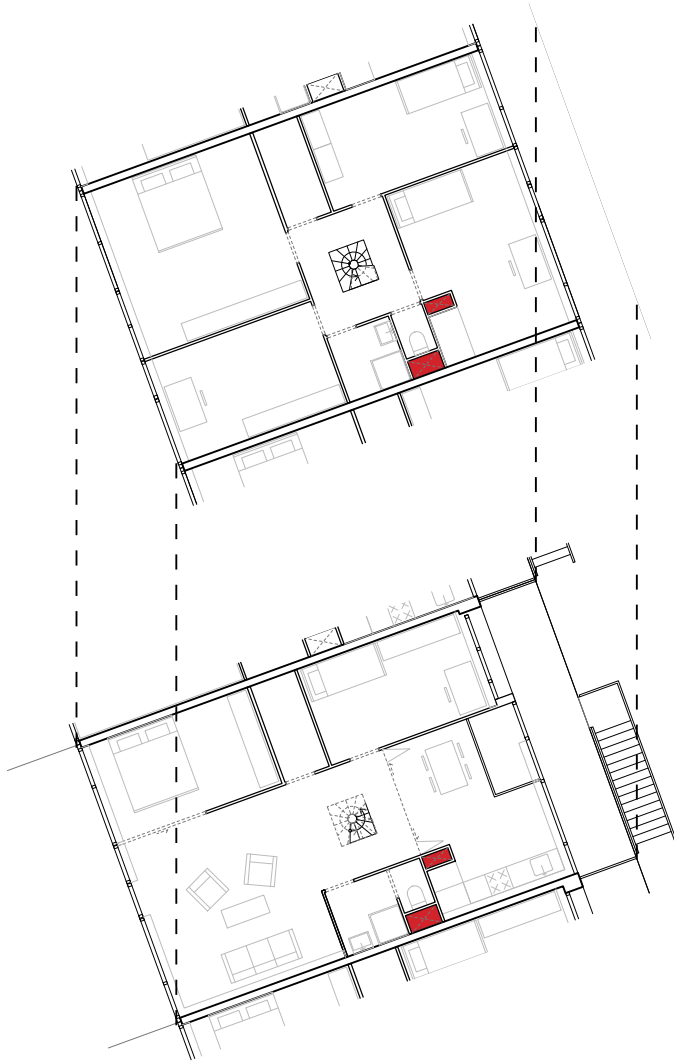
Fig. 19: Possible combination of apartments
