Acoustic emission based health monitoring of RC corroded beams strengthened by CFRP anchorage system under bending loads

Composite Structures

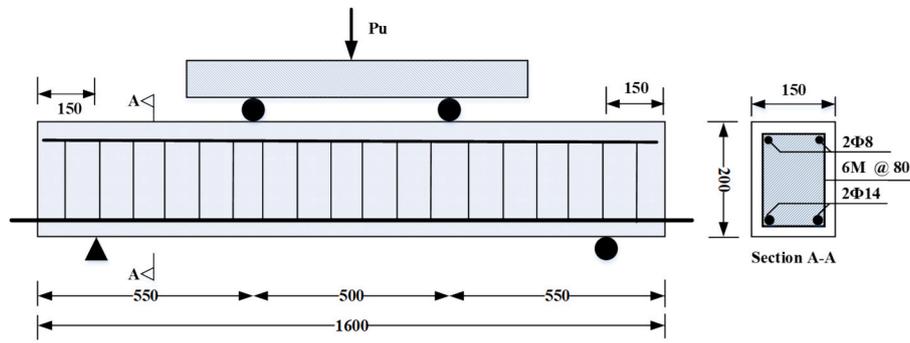
Fig. 1. Dimensions and reinforcement details of RC beams.

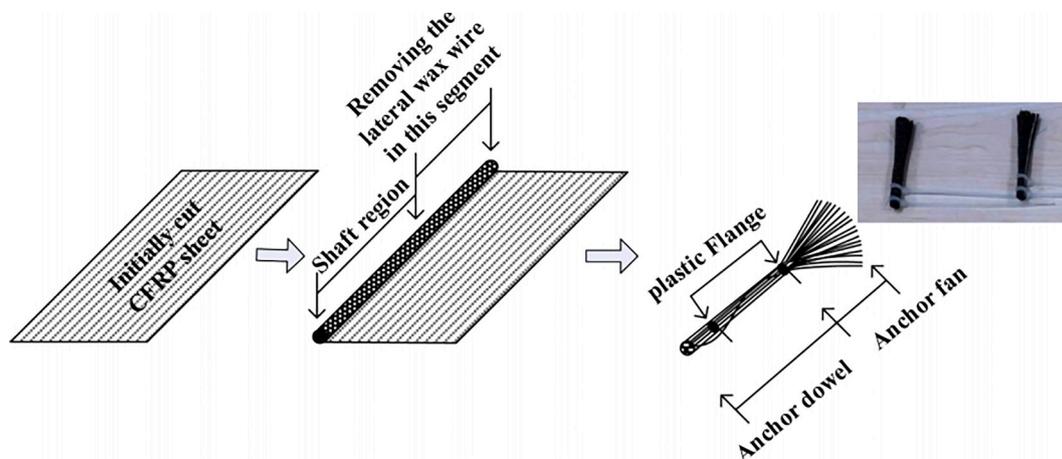
Fig. 2. Construction of CFRP anchors.

a designated depth of 35 mm, which facilitates proper bonding between the fiber bundle and the anchorage zone. The carbon fiber bundles are then impregnated with epoxy resin up to the anchorage depth, enhancing the bond between the CFRP and the concrete substrate. After the first impregnation, the epoxy resin is allowed to set, ensuring initial adhesion before a second impregnation is applied to further reinforce the bond. This multi-step process is critical to achieving a strong and durable connection between the CFRP anchors and the concrete structure.

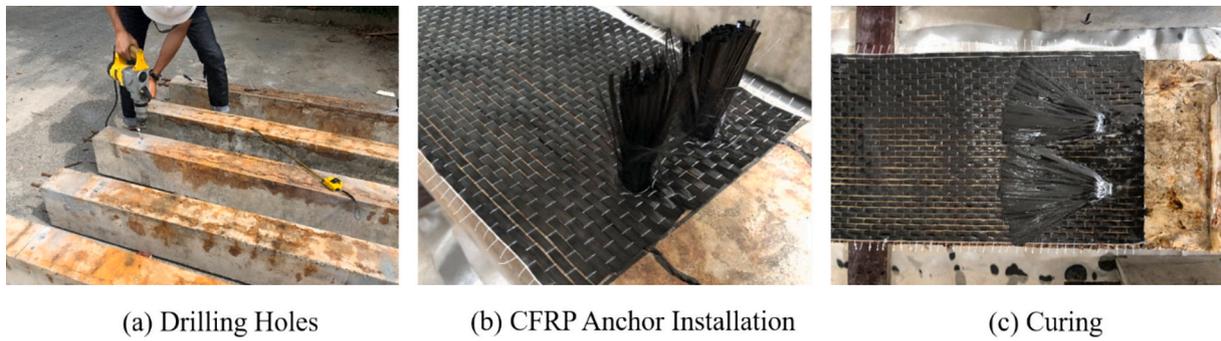
Fig. 3. The procedure of CFRP anchorage system installation.

The installation process of CFRP anchors for reinforcing RC beams following corrosion involves a series of carefully executed steps to ensure optimal bonding and structural performance. Initially, surface preparation is conducted by cleaning the concrete surface with an angle grinder to remove dust and contaminants, leaving it flat and dry to facilitate proper adhesion. Next, holes are drilled in the RC beams at the specified locations for the carbon fiber anchor placement, as illustrated in Fig. 3(a). It is crucial to clear the drilled holes of any debris or dust to create a clean bonding surface. Once the primer has solidified, the CFRP sheets are swiftly bonded to the surface of the RC beams. Epoxy resin is evenly applied to the CFRP sheet, and a roller is used along the fiber texture to eliminate air bubbles and ensure a smooth bond. The pre-drilled holes are then filled with epoxy resin, and the dowel end of the CFRP anchor is inserted to achieve full bonding, as shown in Fig. 3(b). The ends of the anchor are pressed firmly against the CFRP sheet to ensure thorough impregnation of the resin. After installation, the reinforced beams are left to cure at room temperature for seven days to allow the CFRP anchorage system to fully consolidate, as depicted in Fig. 3(c). This meticulous process results in enhanced structural reinforcement, significantly improving the durability and strength of RC beams, particularly after exposure to corrosion.

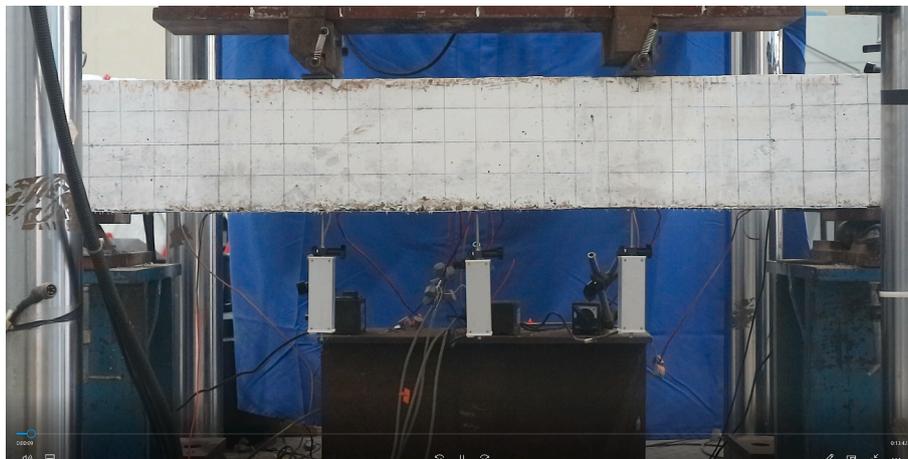
Fig. 4. Diagram of the loading device.

In this study, the loading test was conducted at the Laboratory of Engineering Structural Performance Evolution and Control, Tongji University, utilizing an electro-hydraulic servo testing machine with a maximum load capacity of 2,000 KN. To ensure proper contact between the loading device and the RC beam, two pre-loading stages were performed before the formal loading, with the pre-loading value set at 5 % of the theoretically calculated ultimate load of the beam. Subsequently, a displacement-controlled loading scheme was employed, with a loading rate of 1 mm/min, until the specimen failed. During the loading process, high-definition cameras were strategically positioned on both sides of the loaded test beam to enable comprehensive recording of the entire process. This allowed for accurate observation and analysis of the crack development and failure mode of the RC beams. The loading device setup is presented in Fig. 4.

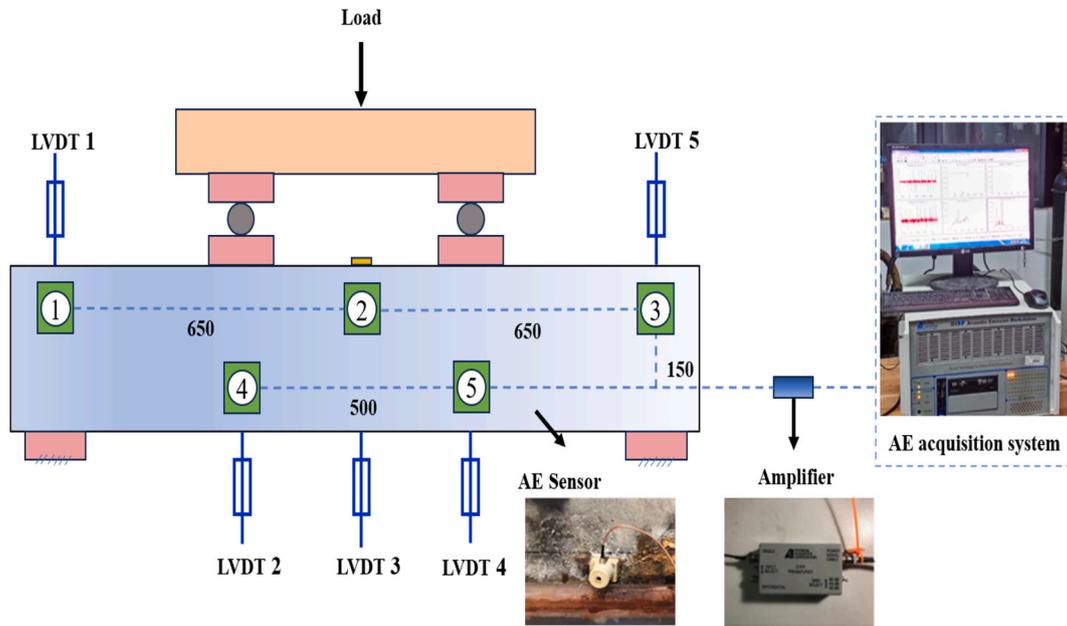
Fig. 5. Test setup for the AE health monitoring.

Before the actual AE monitoring commenced, the sensitivity of the AE sensors underwent verification using a pencil lead break test. During the flexural testing of RC beams corroded to different ages, AE signals were continuously recorded throughout the entire duration of loading.

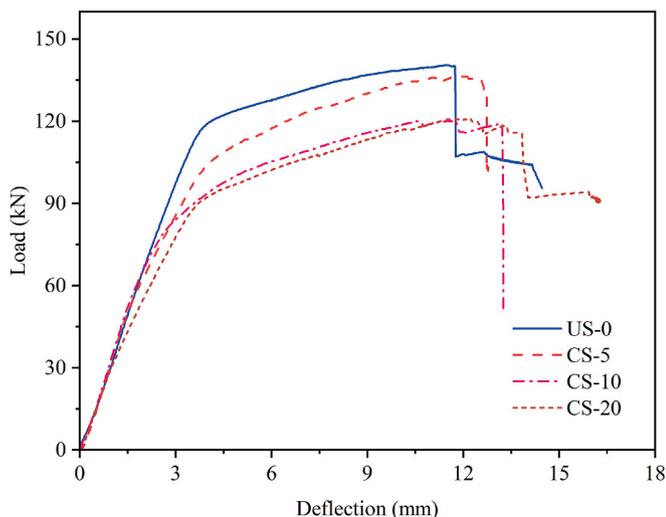
Fig. 6. Load–deflection curves of specimen.

During the monotonic four-point loading test, the mid-span deflection of the four specimen beams was carefully recorded. The load–deflection curves of the test beams are presented in Fig. 6. Notably, the flexural response of the CFRP-strengthened beams exhibited a consistent pattern, closely related to the duration of accelerated corrosion, i.e., the degree of corrosion of the specimen beams. As observed in Fig. 6, the load capacity of the specimen beams gradually decreased with increasing degrees of corrosion, narrowing the performance gap between adjacent specimens. Table 3 provides a summary of the yield load P_y and ultimate load P_u of all specimen beams. A comparison with the pristine specimen beam (US-0) revealed that the yield load and ultimate load of corroded beams (CS-5, CS-10, CS-20) decreased by 12 %, 23 %, 19 % and 6.0 %, 14 %, 22 %, respectively.

To assess the flexural ductility of the specimen beams, the flexural ductility index (ΔI) was calculated by taking the ratio of the mid-span deflection at the ultimate point (δ_u) to the mid-span deflection at the yield point (δ_y). The flexural ductility index for each specimen beam is presented in Table 4. It is observed that the yield deflection (δ_y) initially decreased and then increased, while the ultimate deflection (δ_u) continued to increase with increasing levels of corrosion. Moreover, compared to the pristine specimen beam (US-0), specimen beam CS-5 and CS-10 exhibited significantly improved ductility performance, with enhancements of 11.0 %, and 20.0 %, respectively. However, the ductility performance of specimen beam CS-20 decreased by 26 %. In the mild corrosion range (≤ 10 %), corrosion product-filled microcracks synergize with the anchoring system to increase the specimen beam ductility index (ΔI), with CS-10 exhibiting the highest ductility due to the optimal failure mode (progressive debonding), but this increase in ductility is an unsustainable pseudo-safety; at corrosion rates of up to 20 %, the loss of rebar cross-section with pre-damage resulted in an inverse decrease in ductility of 26 %.

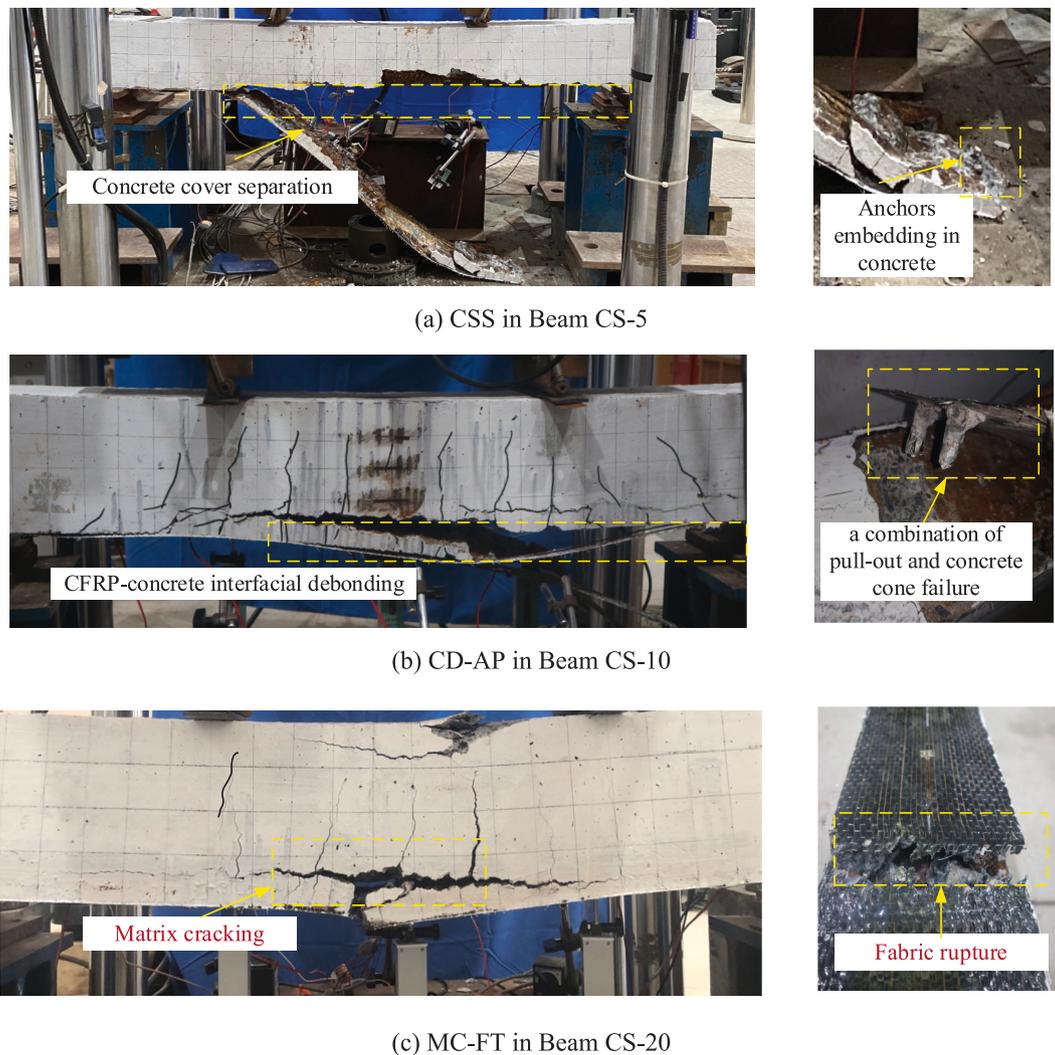
Fig. 7. Modes of failure.

Table 3 illustrates the three primary failure modes observed in the four specimen beams, namely, concrete cover separation (CCS), debonding of CFRP sheet followed by pulling out of anchors (CD-AP) and matrix cracking and fiber tearing (MC-FT), as depicted in Fig. 7. A detailed description of these three failure modes is provided below. The CCS failure mode was observed in specimen beams US-0. In this mode, extensive spalling of the concrete cover at the bottom of the beams was evident. Notably, no debonding was observed at the interface between the CFRP sheet and the concrete. The failure exhibited a more brittle behavior, likely due to the interconnected corrosion cracks and flexural cracks, leading to the detachment of concrete at the bottom.

The CD-AP failure mode was observed in specimen beams CS-5 and CS-10, where debonding occurred between the CFRP and concrete matrix near the end of the sheet, followed by anchor pull-out in close proximity. The debonding in the CD-AP mode was initiated by the propagation of bending cracks into the thin layer of the substrate, coupled with the relative deformation between the CFRP and the concrete matrix. It is crucial to note that the anchors played a vital role in retarding the debonding of the fabric, resulting in a shift from brittle cover separation to a more progressive debonding of the fabric. As a result, the specimen beams showed higher ductility in contrast to those that failed due to concrete cover separation (CCS).

The MC-FT failure mode of concrete matrix cracking and fiber tearing involves CS-20 beam with high degree of corrosion. As load increased in this failure mode, cracking began gradually in the concrete matrix at the interface between the CFRP sheet and concrete, followed by the tearing of CFRP sheet. Unlike other failure modes, no interface stripping or anchor pulling was observed during this process, and the tearing of CFRP sheets mainly occurred near the loading point. This failure mode is mainly due to the span stress concentration of CFRP sheets caused by concrete cracks, indicating that the failure risk of CFRP reinforced beams may be directly determined by the material strength under high corrosion conditions.

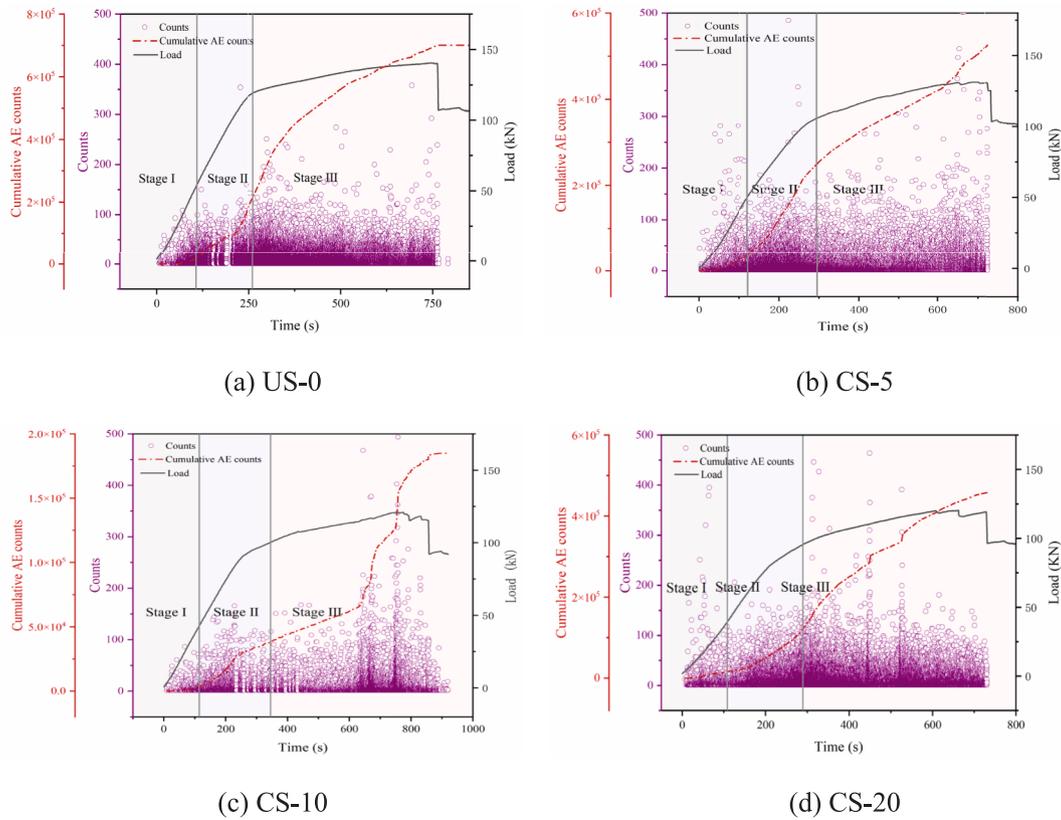
Fig. 8. Variation characteristics of the cumulative AE ringing counts and loads over time for CFRP beams with four levels of corrosion.

Fig. 8 illustrates the loading behavior of CFRP-strengthened reinforced concrete beams subjected to varying levels of corrosion, represented through AE activity and corresponding load-time curves. The data analysis in Fig. 8 divides the loading process into three distinct stages: the initial damage stage (Stage I), the damage development stage (Stage II), and the continuous damage stage (Stage III). This classification aids in a better understanding of the influence of corrosion on beam performance.

In Stage I (Initial Damage Stage), Fig. 8(a) shows that AE signal intensity remains low, and cumulative AE counts exhibit a slow increase, indicating that the concrete structure primarily undergoes initial elastic deformation. At this stage, microcracks and voids may undergo compression or closure, but no significant damage is observed. From the figure, the AE activity for the uncorroded beam (US-0) and corroded beams is similar during this phase, suggesting that corrosion has minimal influence on internal damage during initial loading. In Stage II (Damage Development Stage), AE activity increases markedly, with cumulative AE counts rising sharply, particularly in beams with corrosion levels of 5%, 10%, and 20%, where the curves exhibit a steeper slope. This indicates a significant acceleration in the initiation and

propagation of cracks within the concrete matrix, as well as possible localized debonding at the CFRP-concrete interface. As the load continues to increase, the beam's stiffness gradually decreases, with more pronounced visible cracking, especially in beams with moderate to severe corrosion (e.g., CS-10 and CS-20). It is evident from the figure that higher corrosion levels lead to a more rapid increase in AE counts, reflecting the accumulation of more severe internal damage. During Stage III (Continuous Damage Stage), the cumulative AE count continues to increase, though at a slower rate compared to Stage II, indicating that the internal cracks are approaching a saturation point and the failure mechanisms are stabilizing. The figure shows that, following the peak load, the uncorroded beam maintains relatively high load-bearing capacity, while corroded beams exhibit a significant reduction in peak load, especially for the CS-20 beam, which demonstrates a rapid drop after reaching its peak. This behavior indicates accelerated failure of the structure. Notably, severe corrosion (20%) leads to premature failure at lower load levels, accompanied by increased AE activity, indicating intensified damage processes such as concrete matrix cracking, CFRP tearing, and interface debonding.

From Fig. 8, it is evident that corrosion has a substantial adverse impact on the overall performance of CFRP-strengthened beams, particularly under moderate to severe corrosion conditions. As the corrosion level increases, AE activity during Stages II and III rises significantly, with the cumulative AE count curves becoming increasingly steeper, suggesting more aggressive crack initiation and

propagation, and accelerated damage accumulation. Furthermore, as corrosion levels rise, the peak load shows a noticeable decrease, with the CS-20 beam exhibiting the most significant reduction. This can be attributed to the reduction in steel reinforcement cross-sectional area due to corrosion, as well as the weakening of the bond between the steel and concrete, which in turn accelerates structural damage, reduces stiffness, and decreases load-bearing capacity. These observations underscore the detrimental effects of corrosion on the performance of CFRP-strengthened beams, especially in accelerating crack growth and reducing structural integrity. The results emphasize the importance of effective corrosion mitigation measures to maintain the durability and stability of CFRP-reinforced concrete structures over long-term service.

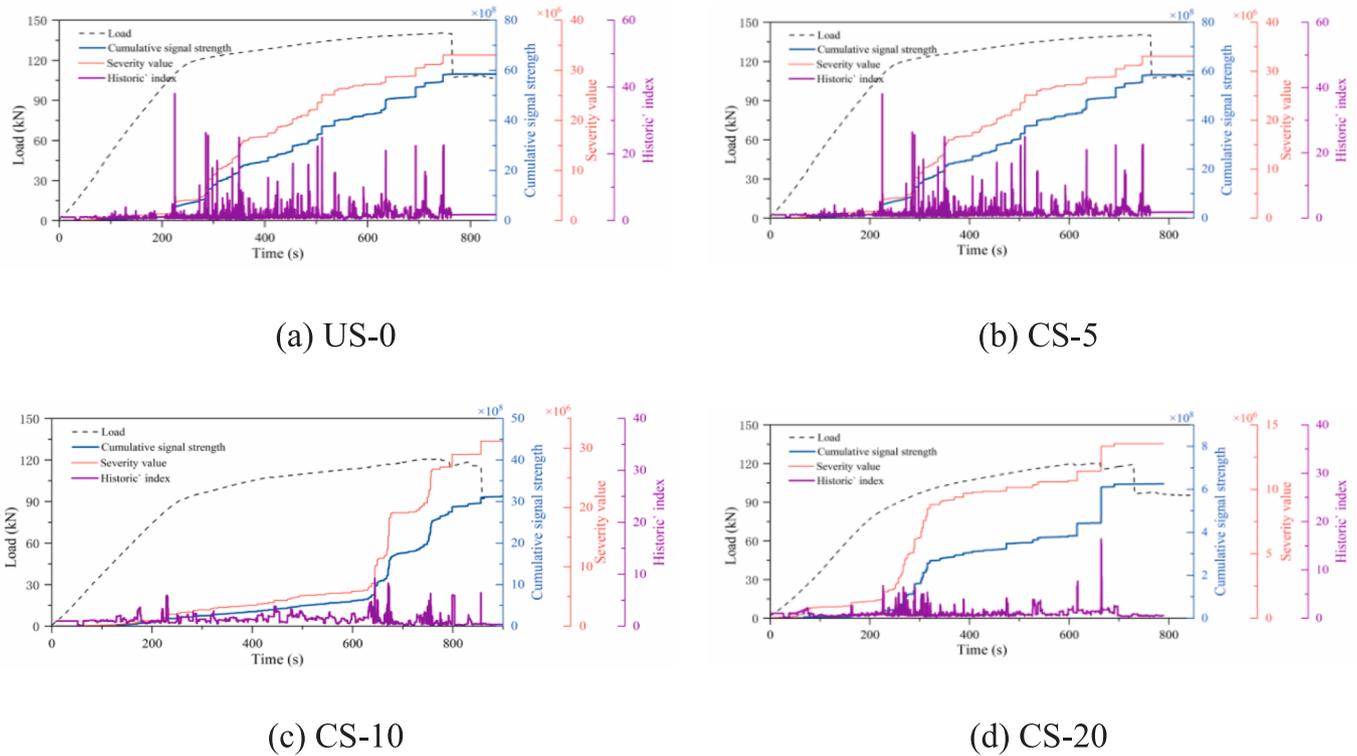
Fig. 9. Variation of S_r , HI and cumulative signal strength of CFRP beams with 4 levels of corrosion.

Fig. 9 shows the graphs of cumulative signal strength, S_r and HI with time under the condition of gradually increasing load. It can be observed that the changes in CSS and S_r of the specimens with different corrosion levels exhibit clear patterns during the loading process. CSS and S_r are key indicators for assessing crack propagation and damage accumulation, and their changes are directly related to the occurrence, development, and debonding of CFRP. For the uncorroded beam (US-0), CSS gradually increases in the early loading stage, while the S_r remains stable during the initial crack initiation phase, indicating that the cracks

are still in the early stage of development. Between 450 s and 550 s, there is a significant increase in both CSS and S_r , corresponding to crack propagation and CFRP debonding, especially as the cracks start to expand significantly, leading to an increased release of energy. In the lightly corroded beam (CS-5), CSS and S_r exhibit a substantial increase in the late loading stage (after 600 s), indicating that crack propagation severity intensifies, with CFRP debonding and transverse cracks in concrete becoming the main sources of energy release during the crack expansion process. For the moderately corroded beam (CS-10), both CSS and S_r are relatively low during the early loading stage, reflecting the inhibition of initial crack growth due to corrosion. However, between 600 s and 700 s, as loading continues, the cracks begin to propagate rapidly, resulting in significant increases in both S_r and CSS. This suggests that under corrosion conditions, CFRP reinforcement debonding and tearing influence crack propagation. In the heavily corroded beam (CS-20), both CSS and S_r remain at low levels throughout the loading process, indicating that cracks had almost fully developed before loading, thus significantly restricting further crack growth and energy release in the subsequent stages. The debonding and tearing of CFRP also played a role in inhibiting energy release.

The historic index (HI) reflects the level of crack activity, particularly the accumulation and progression of damage. From Fig. 9, it can be seen that the changes in HI also exhibit distinct patterns across different specimens. For the uncorroded specimen (US-0), HI remains relatively stable during the initial loading stage but increases significantly between 450 s and 550 s, indicating a high level of crack activity and intensified damage propagation. In the late stage, further crack growth results in more energy release, consistent with the substantial increase in CSS and S_r curves. In the lightly corroded specimen (CS-5), HI shows significant fluctuations during the middle and late stages, especially after 600 s, reaching its highest value, which suggests increased crack activity. The presence of light corrosion accelerates crack initiation and development. In the moderately corroded specimen (CS-10), HI remains stable during the early loading stage but fluctuates significantly in the late stage, indicating that the initial crack growth is inhibited by corrosion, but crack activity increases as loading continues. In the

heavily corroded specimen (CS-20), HI remains at a low level throughout the loading process, with a maximum value of only 15, indicating that cracks were highly developed before loading, resulting in reduced crack activity in the subsequent stages. This trend is consistent with the low levels observed in CSS and S_r .

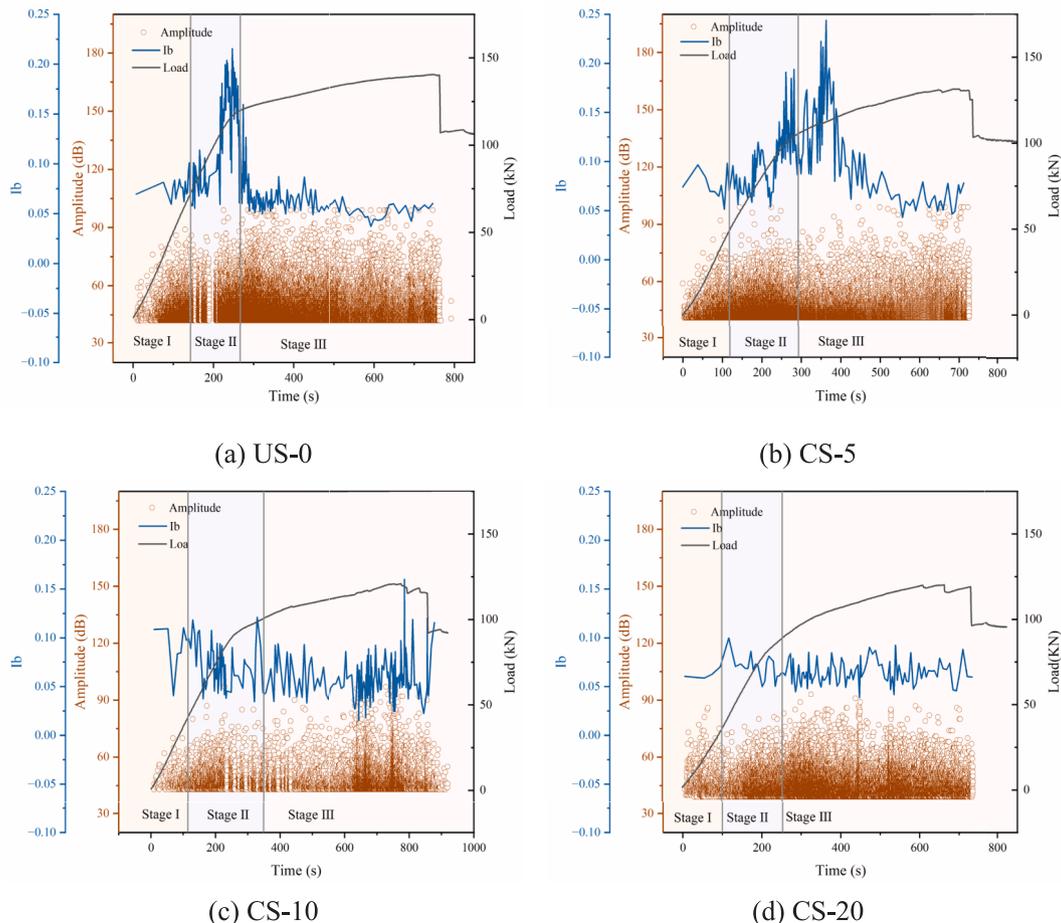
Fig. 10. Variation of *Ib* values and amplitudes of CFRP beams with 4 levels of corrosion.

Fig. 10 illustrates the magnitude strength, *Ib*-value curves and loading curves for four CFRP-reinforced beams with different levels of corrosion. From the *Ib*-value curves, it can be observed that the beams with no corrosion (US-0) and slight corrosion (CS-5) exhibit similar

trends, while the beams with moderate corrosion (CS-10) and severe corrosion (CS-20) share another similar pattern. This suggests that different corrosion levels lead to distinct damage behaviors in these beams. For the non-corroded (US-0) and lightly corroded (CS-5) beams, during the initial phase (Stage I), the *Ib*-value remains at a low and stable level, indicating that the structure is primarily undergoing elastic deformation with minimal crack formation and internal damage. As loading progresses into Stage II, the *Ib*-value starts to show significant fluctuations and a sharp increase, marking the initiation and propagation of internal cracks and accelerated damage accumulation. This phenomenon is particularly evident in CS-5, where the intense fluctuation of the *Ib*-value persists for a longer duration and exhibits higher amplitude compared to US-0. This suggests that light corrosion may enhance the ductility of the beam, allowing for extended crack propagation and greater energy absorption during this stage. This enhanced ductility might be due to changes in the bond behavior between the steel reinforcement and the concrete caused by light corrosion, enabling the structure to absorb more deformation energy during crack propagation. Moving into Stage III, the *Ib*-value gradually decreases in amplitude and becomes more stable, indicating that the crack development is reaching saturation, damage accumulation is slowing down, and the structure is approaching failure.

In contrast, the moderately corroded (CS-10) and severely corroded (CS-20) beams exhibit a different damage evolution pattern. Throughout the entire loading process, these specimens show *Ib*-values that fluctuate sharply but without prominent peaks at higher levels, suggesting that extensive corrosion in the early stages has caused the cracks to nearly fully develop at the beginning of the loading process, leading to limited further crack propagation. It is notable that the fluctuation intensity and amplitude of the *Ib*-value for CS-10 are significantly higher than those

for CS-20. This could be attributed to two factors: the more severe corrosion in CS-20, which results in a reduced cross-sectional area of the steel reinforcement and consequently lower load-carrying capacity, and the relatively better ductility of CS-10, which allows for more significant crack development.

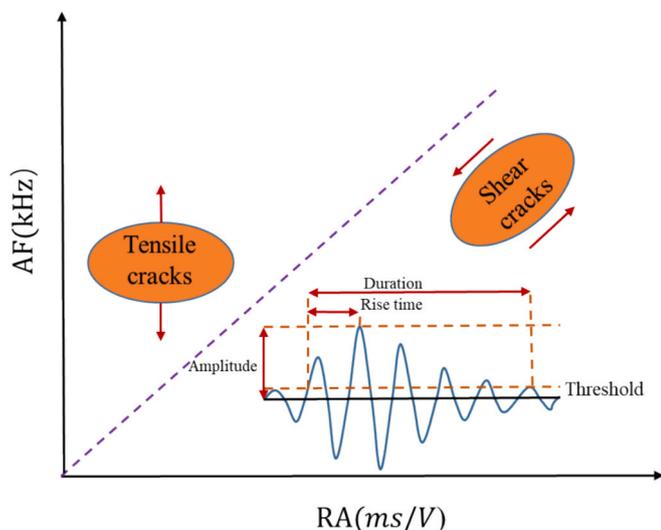
Fig. 11. Crack Mode Classification.

As illustrated in Fig. 11, scatter plots using RA and AF data provide a method for crack classification. According to the crack classification method of JCMS-III b5706, signals with low RA values and high AF features suggest the initial formation or through-thickness propagation of tensile cracks. Conversely, high RA values and low AF features generally indicate the early stages or through-thickness extension of shear cracks. This classification method enables accurate crack type identification at the onset of material failure, supporting more precise damage diagnosis.

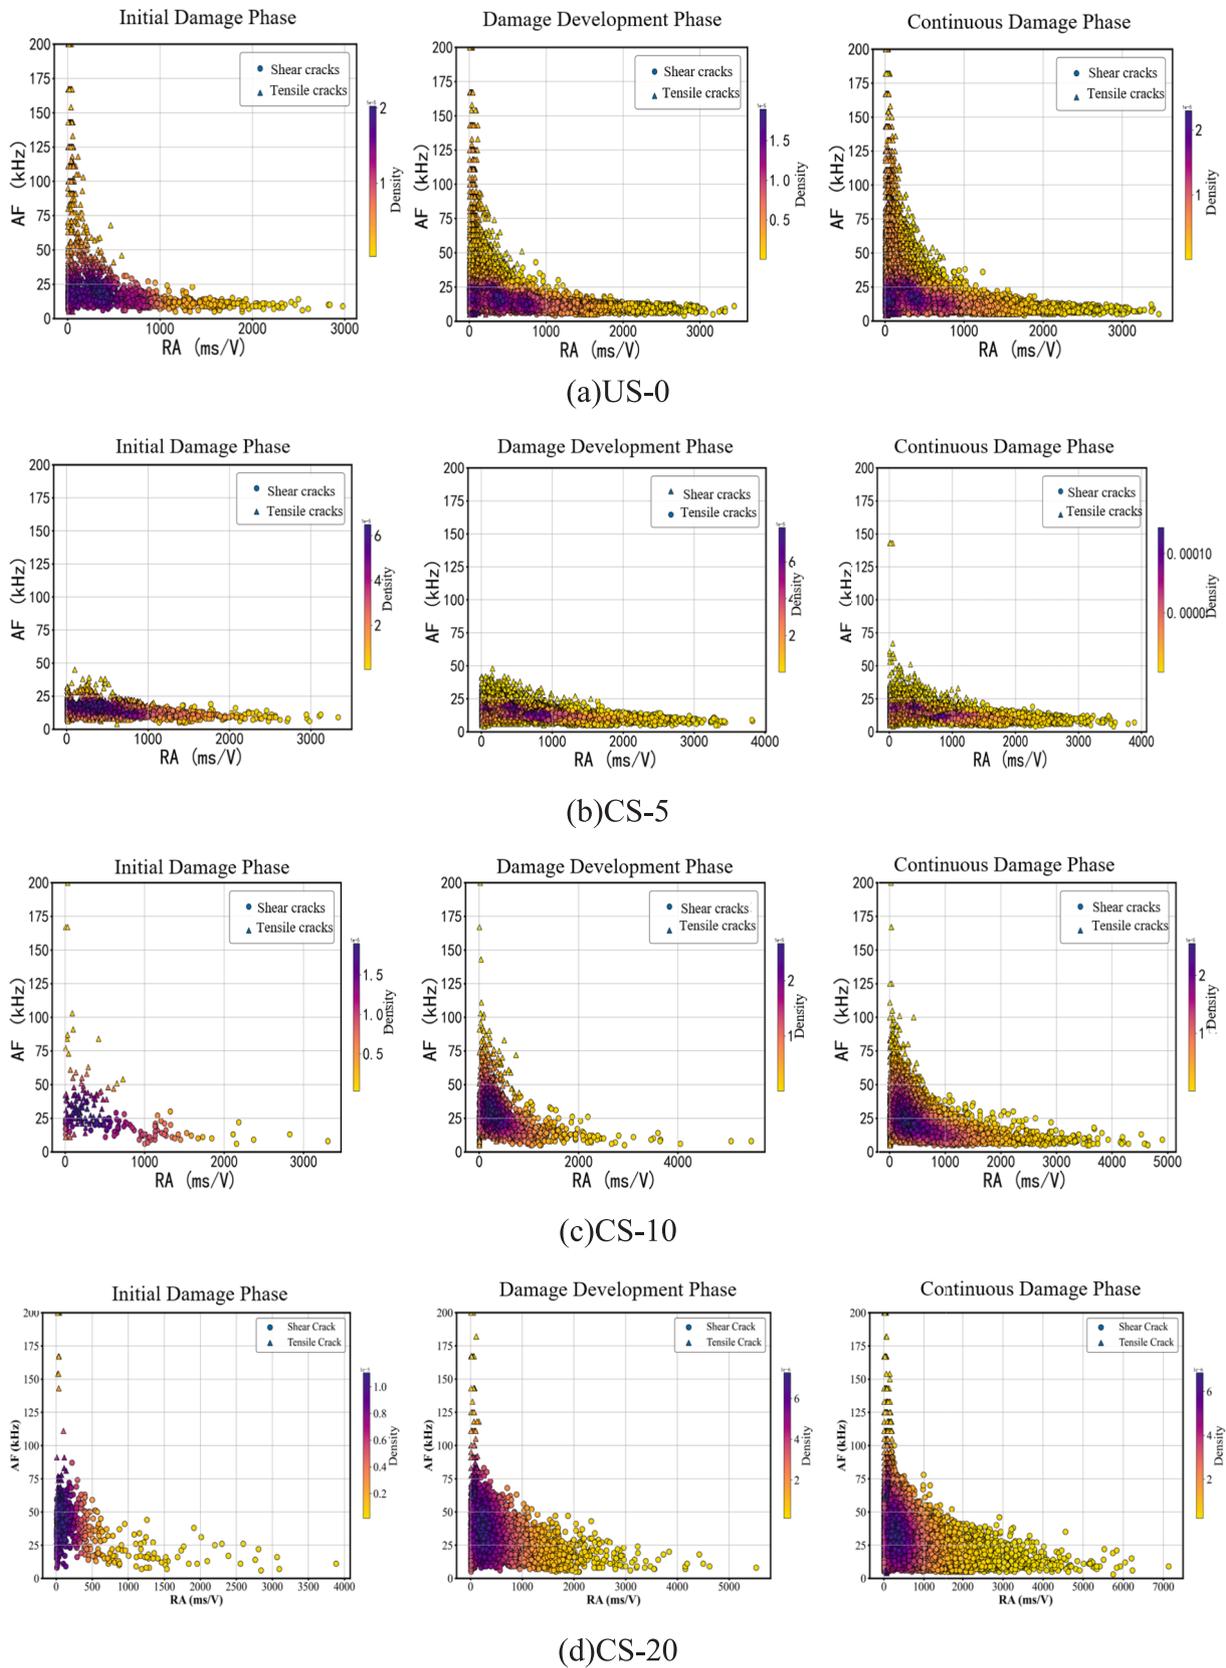
Fig. 12. Tensile and shear crack distribution of CFRP beams at different damage stages for four corrosion levels.

Fig. 12 illustrates the distribution of tensile and shear cracks at different damage stages of the test beams, highlighting the evolution of crack patterns within the concrete matrix of beams reinforced with the CFRP anchoring system during four-point bending. The results clearly indicate that the number of tensile crack events is substantially higher compared to shear crack events, suggesting that the structural response under loading is predominantly characterized by tensile failure. Moreover, during the continuous damage stage, the number of both crack types increases significantly, surpassing those observed during the initial damage and damage development stages. This observation corresponds with the finding that crack propagation predominantly intensifies during the continuous damage phase.
