Bank erosion in regulated navigable rivers

Bank Erosion in Regulated Navigable Rivers

Dissertation

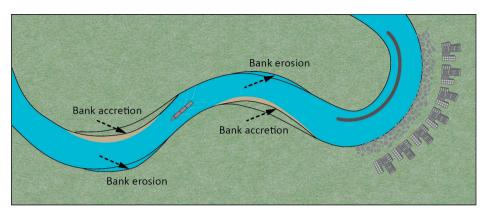
Figure 1.2. Schematic navigable river with naturally evolving banks and a stabilized stretch.

Alluvial river channels migrate as a result of two processes occurring at their margins: bank erosion and bank accretion (Figure 1.2). Bank erosion is typically a cyclic process that comprises the collapse of a soil mass after flowing water scours the bank toe and steepens the bank front. The fallen material gradually disaggregates and is transported away, which enables subsequent erosion of bank material until another failure occurs (Thorne and Tovey, 1981). Bank accretion involves several factors and processes, including lateral deposition of sediments in sequences of high and low flows, and colonization by vegetation of emerging surfaces to form new floodplain areas (Page et al., 2003; Wintenberger et al., 2015).

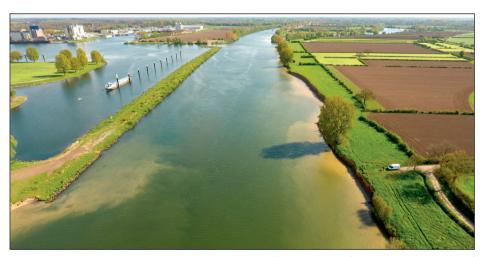
Figure 1.3. Re-naturalized bank in the Meuse River (right-hand side) opposite to the port of Gennep.

In this context, scientific knowledge is crucial to provide a basis for the success of restoration practices, e.g. on hydromorphology, ecological processes, or physical-biological feedbacks (Dufour and Piégay, 2009; Wohl et al. 2015; Gurnell et al., 2016). To improve the natural value of trained rivers, the traditional revetments protecting the banks against currents or ship waves (see e.g., scheme in Figure 1.2) were recently changed for nature-friendly alternatives searching to balance technical and ecological requirements (Boeters et al., 1997; Rauch et al., 2014; Heibaum and Fleischer, 2015). Particularly after the WFD (2000), several countries across the EU implemented bioengineering protections or the complete removal of revetments, such as Austria (Liedermann et al., 2014), Germany (Schmitt et al., 2018) and France (ONEMA, 2018). In the Netherlands, the Meuse River constitutes an outstanding example of systematic rehabilitation, where bank protections were removed along 80 km between 2008 and 2020 (www.rws.nl/maasoevers). An example of the latter is shown in Figure 1.3.

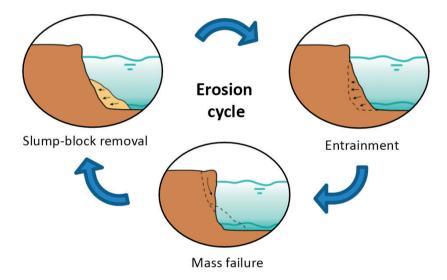
Figure 1.4. Schematic bank erosion phases: Slump-block removal (left), entrainment of bare bank (right), and incipient mass failure (centre).

The process of bank erosion typically occurs in cycles of fluvial entrainment of the bank and near-bank bed material, bank collapse, and slump-block disintegration and removal (Thorne and Tovey, 1981). Figure 1.4 illustrates these phases for homogeneous cohesive banks with varying water levels. Entrainment occurs when shear stresses exerted over soil particles and near-bank bed material exceed the threshold for detachment and initiation of motion, respectively (Arulanandan et al., 1980; Clark and Wynn, 2007; Kimiaghalam et al., 2016). This process steepens the bank that eventually fails due to geotechnical instability (Osman and Thorne, 1988; Langendoen and Simon, 2008). The wasted bank material lying at the bank toe, in the form of a wedge or blocks, needs to be removed before further entrainment can happen (Wood et al., 2001; Parker et al., 2011; Patsinghasanee et al., 2018).

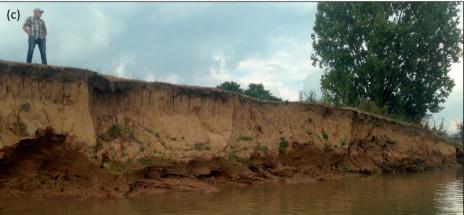
Figure 1.5. Signatures of different types of mass failures: (a) rotational slip, (b) toppling, (c) incipient cantilever (note the man is one meter away from the bank edge).

The bank size, geometry, geotechnical parameters (mainly internal friction angle and cohesion), stratigraphy, and erodibility of each sedimentary layer in alluvial rivers lead to different geotechnical failure mechanisms (Thorne and Tovey, 1981; Thorne and Osman, 1988b; Thorne, 1990; Darby and Thorne, 1994; Langendoen and Simon, 2008; Midgley et al., 2012). For instance, rotational failures are common in high banks because shear stresses in the soil increase faster over the depth than soil shear strength (Terzaghi et al., 1996). Planar failures occur with steep slopes, e.g. higher than 60°, that are often present in cohesive soils and river bends (Osman and Thorne, 1988). These failures can happen in any plane along the bank height and not necessarily passing through the bank toe. Toppling is typical of low banks, where tension cracks occupy a significant extent of the bank height and stability depends more on tensile than shear strength (Thorne and Tovey, 1981). Figure 1.5 provides examples of different types of failures.

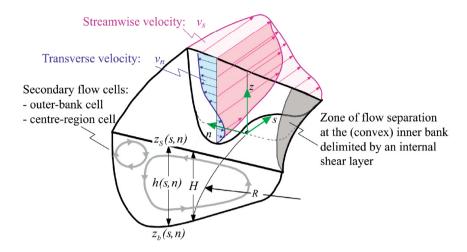
Figure 1.7. Conceptual scheme of flow features at channel bends (source: Blanckaert et al., 2012). Note the secondary flow cell forming at the top of the outer bank, typical of sharp bends.

Currents act during the entrainment and block removal phases of the erosion cycle by inducing shear stresses due to the velocity gradients in the near-bank region. The distribution of horizontal velocities in a river cross-section is strongly influenced by water depth when rivers have large width-to-depth ratios (say W/h > 10), which are typical of lowland rivers (Uijttewaal, 2014). These flow conditions are normally described with depth-average schematizations. However, the near-bank region always presents three-dimensional flow features with a significant vertical-velocity component (Knight and Shiono, 1990; Knight, 2013). This responds to secondary flows and turbulent coherent structures, as observed in the field by Thorne (1978) and Anwar (1986) and in laboratory experiments by Blanckaert et al. (2010, 2012). These features have different intensities depending on the river planform and become stronger at sharp bends (Figure 1.7).

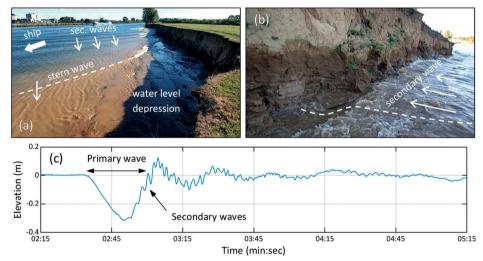
Figure 1.8. (a) Primary and secondary waves after a ship passing. (b) Secondary wave impacting a bank with signatures of erosion and undermining. (c) Example of water level fluctuations with respect to river stage due to a passing ship.

Ship waves can impose significant loads onto banks and affect all phases of the erosion cycle, depending on the location of their impact. Sailing vessels generate waves classified as primary and secondary (CIRIA et al., 2007), which act at the level of the river stage. The primary wave consists of a water level depression caused by increased flow velocities around the ship after the Bernoulli principle, with associated front and stern waves (Figure 1.8a). This wave increases as the vessel breadth, draught, length and speed increase, and as the distance to the bank reduces (Bhowmik et al., 1982). Secondary waves are created by the hull discontinuity in the flow and typically propagate at 35° with respect to the sailing direction (CIRIA et al., 2007). Primary and secondary waves can cause bank erosion by steering shear stresses onto banks throughout their propagation and breaking (Figure 1.8a,b).

number of waves depend on every hull design and sailing condition. Furthermore, primary waves are sometimes followed by damped oscillations (Figure 1.8c).

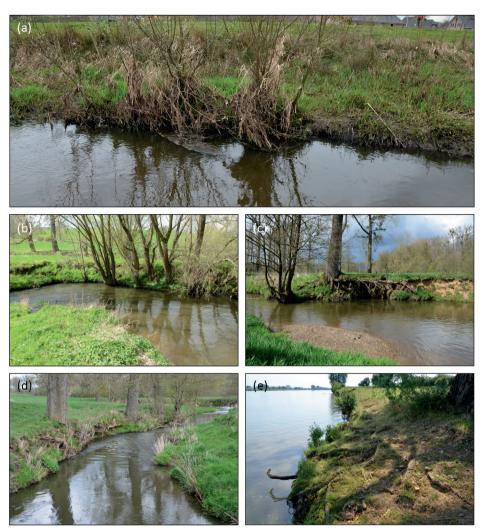
Figure 1.9. Examples of different types of root-reinforced banks in lowland rivers in the Netherlands. (a) Grass, herbaceous plants (trimmed), and saplings, with roots reaching bank toe (Lunterse Beek, 05/04/2016). (b) Closely spaced trees at bank toe (Geul River, 17/04/2016). (c) Undermined large tree with shallow roots and smaller trees at bank toe (Geul River, 17/04/2016). (d) Closely spaced trees with continuous roots along the bank reaching the bank toe (Geul River, 17/04/2016). (e) Isolated tree with shallow roots (Meuse River, 19/07/2016).

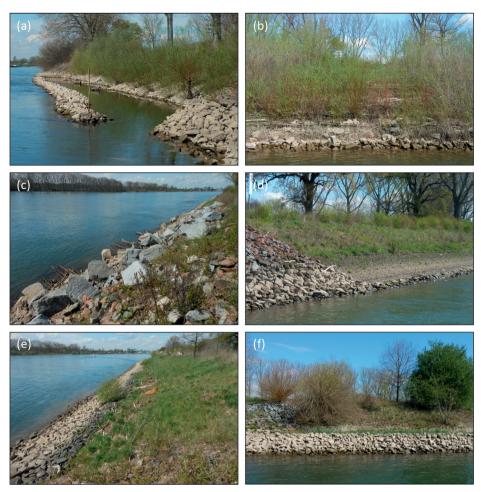
Figure 1.10. Nature-friendly bank protections in test sections on the Rhine River near Worms, on 12/04/2016, after 4.5 years of installation. (a) Stone pre-bank, shallow water zone with dead trunks, and bank with riprap, willow branch cuttings, living fascines, and brush and hedge layers. (b) Willow brush mattresses transversally installed. (c) Riprap with gravel fill, groups of individual stones, and dead wood fascines. (d) Reed gabions and stone mattresses on granular filter, plant mats and hedge layers (note riprap with dead wood on the left). (e) Riprap with top soil alginate mixture, hydroseeding, and individual plants. (f) Riprap and pavement with reeds. Descriptions based on Heibaum and Fleischer (2015).

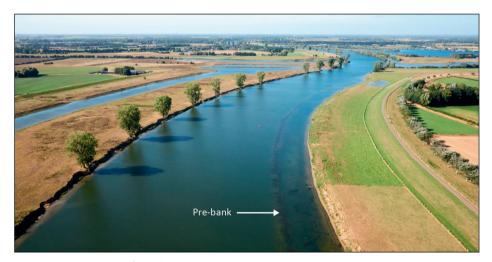
Figure 1.11. Example of a submerged pre-bank protection at Balgoij, the Meuse River, constructed in 2012 to reduce erosion in front of the dike on the right-hand side (28/09/2016). The left eroding upper bank had the riprap removed in 2013 from 0.5 meters beneath the regulated water level. Source: Rijkswaterstaat/J.v.Houdt.

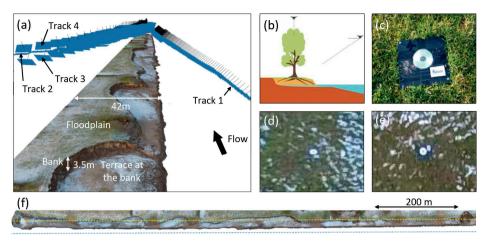
Figure 2.1. (a) Camera positions and orientations in perspective view. The digital surface model shows the low water condition during January 2017, which exposed a terrace at the bank toe. (b) Cross-sectional scheme of UAV paths. (c) Ceramic plaque with CD as ground-control point on the floodplain. (d) GCP in photograph from track 1. (e) Same GCP from track 2. (f) Top view of DSM with UAV track 1 in blue and tracks 2-4 in yellow.

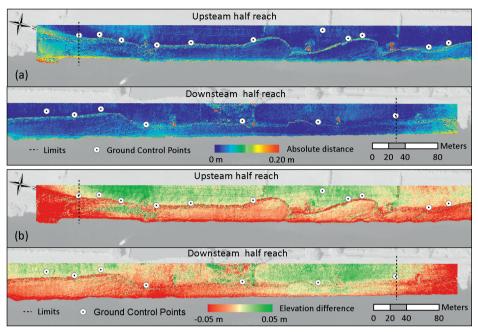
Figure 2.5. (a) Absolute elevation differences between SfM and ALS along the reach. (b) Signed elevation differences between SfM and ALS with a smaller scale range.

elevation corresponding to the GPS points, which confirms the bias observed in the comparison of bank elevations shown in Figure 2.5. and Figure 2.6.

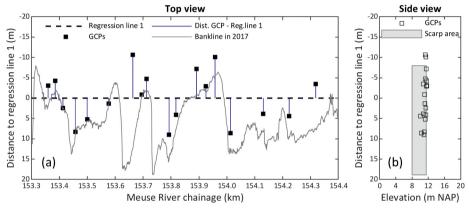
Figure 2.7. (a) GCP horizontal distances to the regression line and (b) respective positions in potential rotation plane from the regression line.

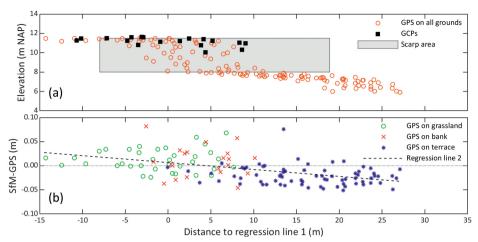
Figure 2.8. (a) Location of GPS measurements in potential rotation plane around regression line 1. (b) SfM DSM elevation errors across regression line 1, distinguished among areas of grassland, bank and terrace.

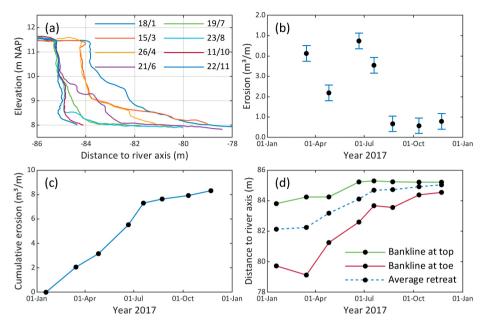
Figure 2.10. Sequential surveys at cross-section 4, Meuse River kilometre 153.9, over 2017. (a) Bank profiles from DSMs. (b) Eroded volume per unit width between consecutive surveys. (c) Cumulative erosion along surveys. (d) Bankline locations at the top and toe of the bank.

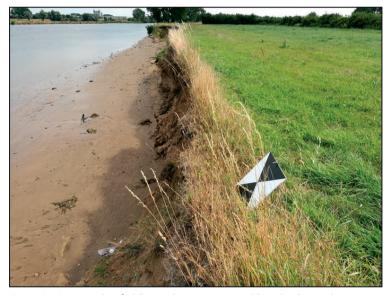
Figure 2.12. Example of oblique plaque supported by a back stand.

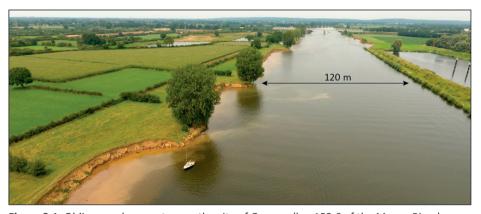
Figure 3.1. Oblique embayments near the city of Gennep (km 153.6 of the Meuse River).

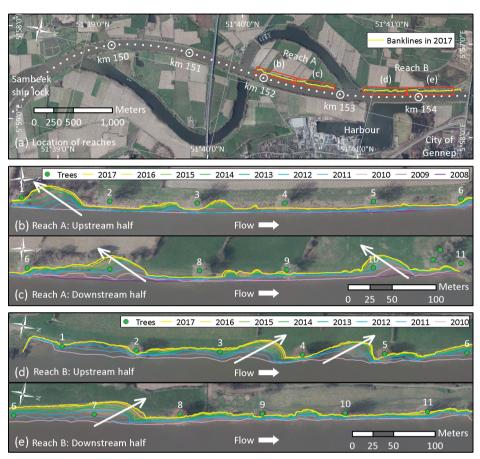
Figure 3.2. Bankline evolution of restored reaches presenting uniform retreat and embayments with different asymmetry. (a) Location of reaches. (b-c) Reach A at Noordereiland. (d-e) Reach B near Oeffelt and Gennep.

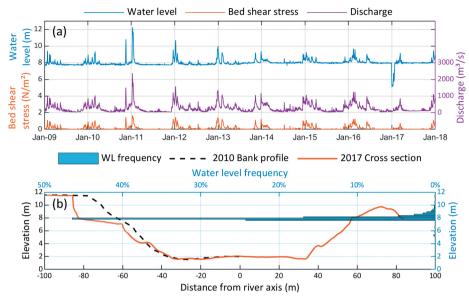
Figure 3.3. (a) Discharge, water level and bed shear stress in the period 2009-2017. (b) Water level frequency distribution over the same period, bank profile of mid-2010 and cross-section of January 2017 at km 153.940. Note vertical distortion of cross section.

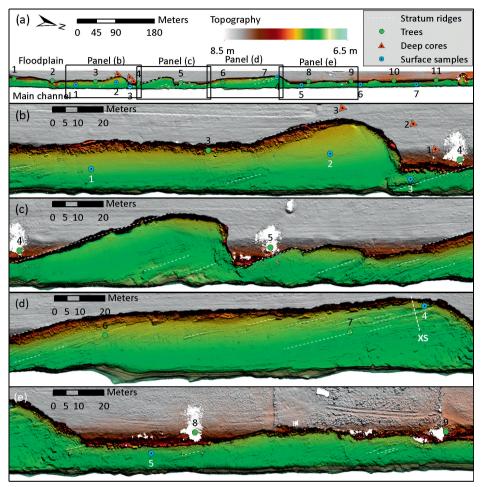
Figure 3.4. Topography of terrace evidencing stratification of the subsurface.

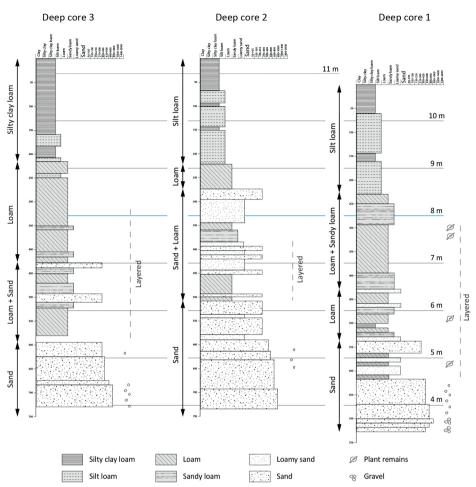
Figure 3.6. Stratigraphy of the deep cores (see Figure 3.4b for location) with references to dominant classes.

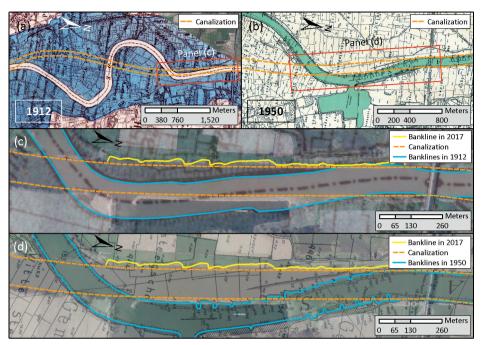
Figure 3.10. (a) Meuse River position in 1912 and later canalization. (b) Meuse River in 1950 and later canalization. (c) Reach B with 2017 banklines along canalized river and 1912 channel position. (d) Reach B with 2017 banklines along canalized river and 1950 channel position. Background images corresponds to aerial photo of 2017 and translucent maps of 1912 and 1950.

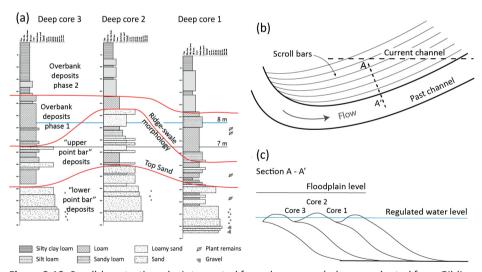
Figure 3.12. Scroll-bar stratigraphy interpreted from deep cores (schemes adapted from Gibling and Rust (1993) and Morrison (2017)).

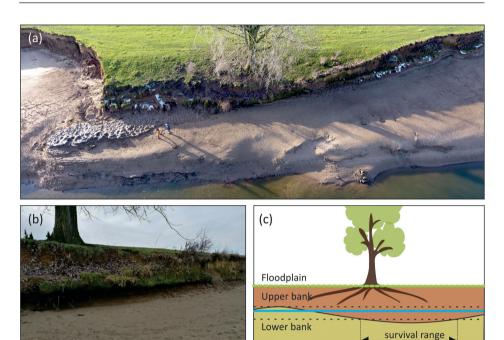
Figure 3.13. Terrace and upper bank at extraordinary low water level. (a) Cohesive layer along the upper-bank toe delaying erosion near tree 4 (note two people on terrace for scaling). (b) Tree 4 with incipient undermining along the oblique bankline. (c) Relative position between tree roots at the upper bank and strong cohesive layer at toe.

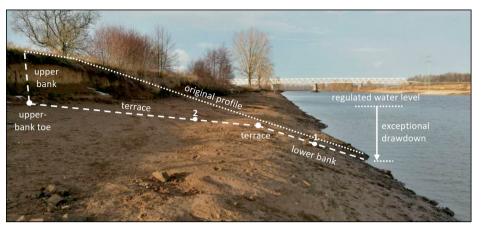
Figure 4.1. Bank terrace of Meuse River (km 154.1), visible after a ship accident that lowered the water level by 2.6 m from the regulated stage.

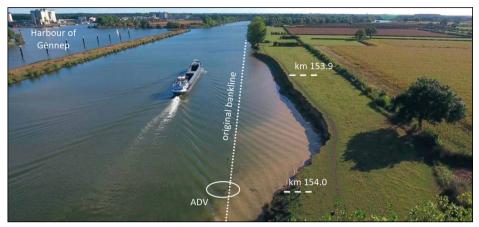
Figure 4.2. Upstream view of study site. Secondary waves of empty ship propagating over terrace and reaching upper-bank toe. Acoustic Doppler velocimeter (ADV) fixed to frame and navigation pole.

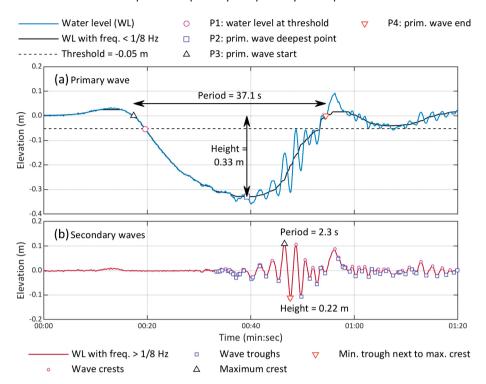
Figure 4.3. Quantification of period and height of (a) primary and (b) maximum secondary wave.

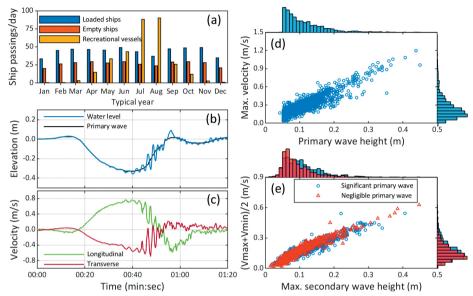
Figure 4.5. (a) Daily ship passings during a typical year. (b) A primary wave with secondary waves during the rising limb. (c) Longitudinal and transverse components of the velocity evidence overlapping water motions, with positive signs in downstream direction and towards the bank, respectively. (d) Maximum horizontal velocities induced by primary waves near terrace toe. (e) Amplitude of the horizontal orbital velocity near terrace toe produced by the highest secondary wave per ship.

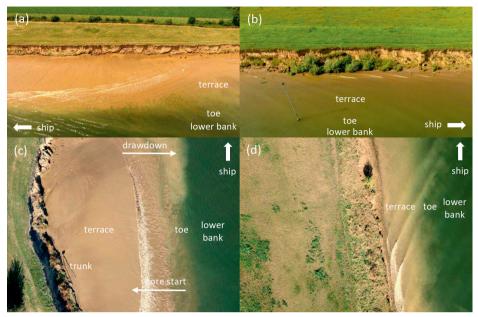
Figure 4.6. (a) Primary wave propagating over terrace as secondary waves break over it, km 153.9 on 21/06/2017. (b) Secondary waves breaking near the upper-bank toe, km 153.5 on 23/08/2017. (c) Primary wave ejecting sediments from terrace, km 153.6 on 10/10/2018. (d) Secondary waves breaking at upper-bank toe over gravel layer, km 154.3 on 10/10/2018.

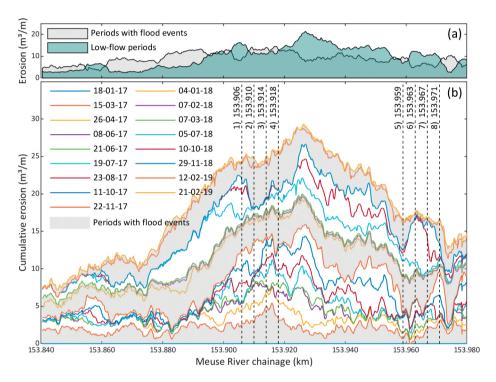
Figure 4.7. (a) Upper-bank erosion during periods with and without floods at largest embayment from 18-01-17 to 21-02-2019. (b) Upper-bank cumulative erosion at largest embayment throughout 17 surveys (note 18-01-17 series lying on x axis). This stretch can be located in Figure 4.11a and Figure 4.4 based on chainage, i.e. the reference kilometres along the River.

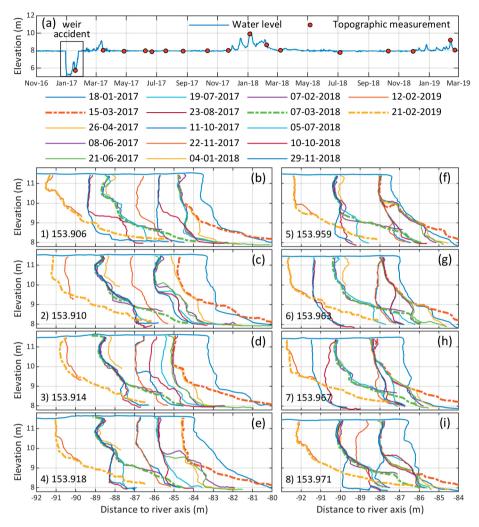
Figure 4.8. (a) Water level at km 153.940. (b-i) Upper-bank profile evolution of sections indicated in Figure 4.7b (dashed profiles indicate post-flood surveys).

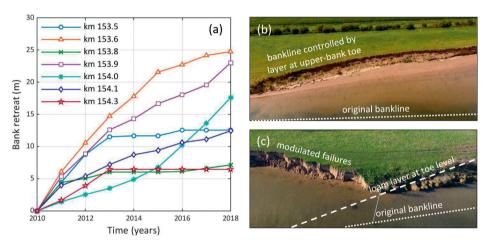
Figure 4.9. (a) Different cumulative bank retreats at key locations affected by floodplain heterogeneity and vegetation at upper-bank toe. Examples of (b) encounter of less erodible layer at km 153.8 and (c) encounter of more erodible layer at km 154.0.

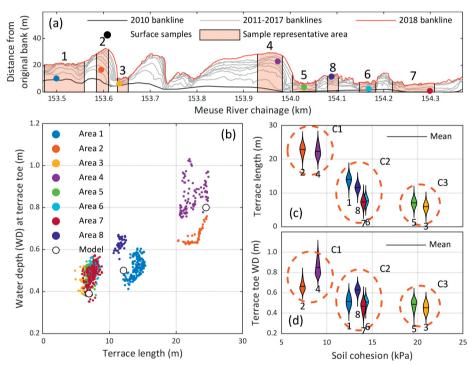
Figure 4.11. Terrace characteristics at zones with different lithologies after seven years of development. (a) Location of surface samples and respective representative areas, with bankline evolution. (b) Terrace length (see Section 4.2.3) and toe water depth (point 2, Figure 4.1) after seven years. (c) Kernel density function of terrace length per lithological cohesion, bandwidth = 0.20. (d) Kernel density function of water depth at terrace toe per lithological cohesion, bandwidth = 0.03.

Figure 5.9. Terrace lengths and toe water depths after two years of riprap removal at Neerloon and Sint Agatha reaches, compared to Oeffelt cases after seven years of restoration (see Figure 4.11 for coloured series).

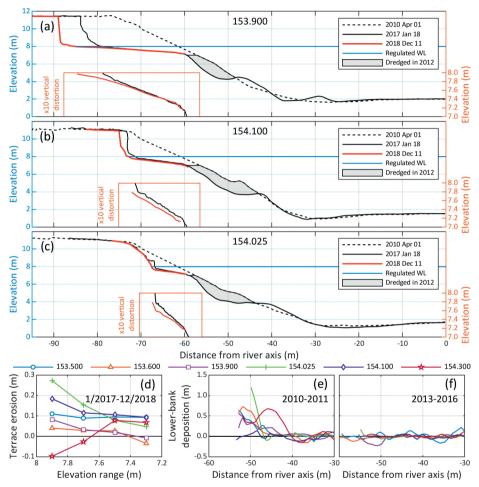
Figure 4.12. Characteristic bank profiles of areas with (a) high, (b) middle, and (c) low erodibilities. Morphological changes of (d) terrace and (e-f) lower-bank at key cross sections (indicated by chainage km).

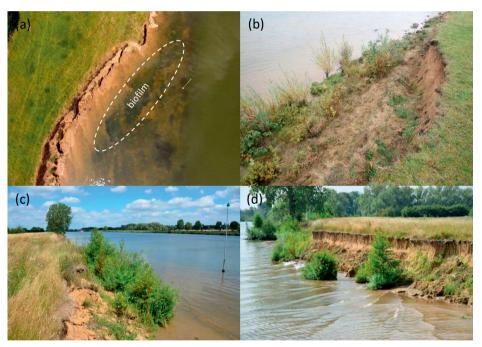
Figure 4.13. (a) Biofilm growing on terrace (July 2018). (b) Plants growing on upper-bank toe at km 153.5 (Nov. 2016). (c) Vegetation at same location reaching ~3 m high on July 2019. (d) Vegetated patches showing different erosion rates than bare soil.

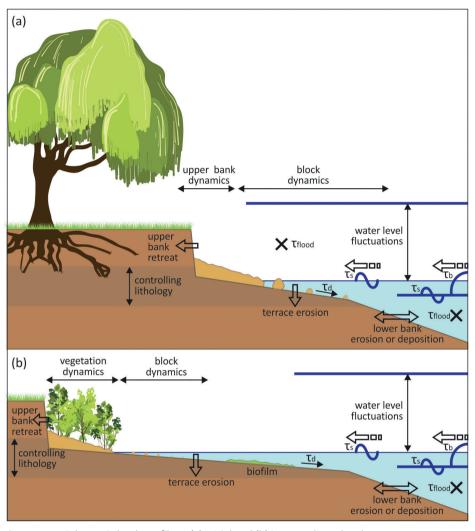
Figure 4.14. Schematic bank profile at (a) initial and (b) intermediate development stages. $\tau_{a'}$, $\tau_{b'}$, and τ_{s} stand for shear stresses respectively induced by primary wave drawdown, primary wave bore, and secondary waves.

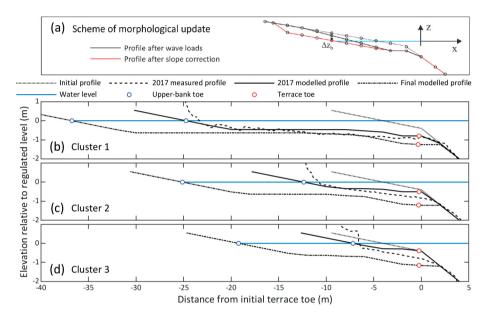
Figure 4.15. (a) Model schematization and long-term upper-bank erosion prediction for soils of clusters (b), 2 (c) and (d) 3, with τ_c = 8,12 and 18 Pa, respectively. Measured profiles on 2017 respectively correspond to km 153.975, 153.100, and 154.025, where samples 4, 8 and 5 were taken.

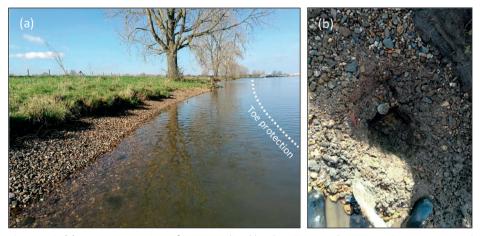
Figure 5.2. (a) Downstream view of re-naturalized bank at Sint Agatha, presenting an armoured terrace. (b) Terrace top soil next to upper-bank toe, composed of a gravel-sand mixture.

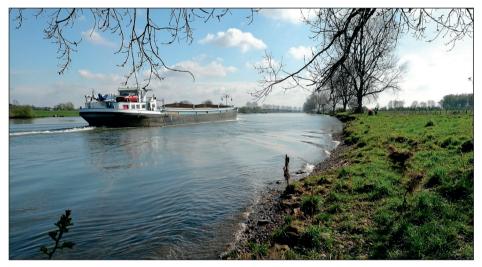
Figure 5.3. Upstream view at Sint Agatha bank where ship waves dissipate over armoured terrace.

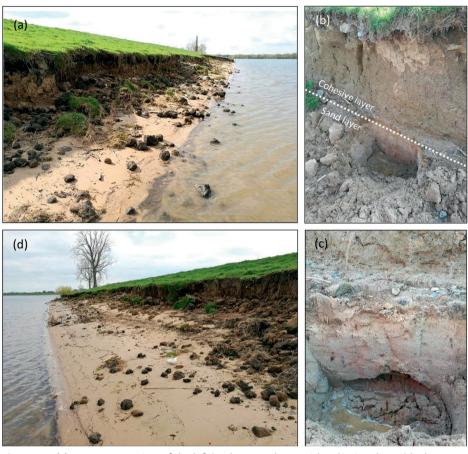
Figure 5.7. (a) Downstream view of the left bank at Neerloon, with cohesive slump blocks over a sandy terrace (April 5, 2019). (b) Composite structure with transition at the upper-bank toe. (c) Lower sand layer collapsing by own weight at same location, after few minutes of excavation. (d) Upstream view of stretch with longer terrace than panel a) on same day.

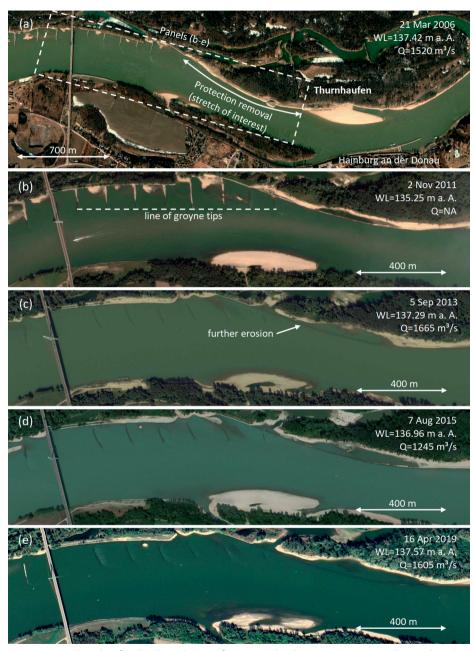
Figure 5.10. Thurnhaufen bank evolution after upper-bank protection removal, Danube River. (a) 21/03/2006. (b) 02/09/2011. (c) 05/09/2013. (d) 07/08/2015. (e) 16/04/2019. Source: Google Earth.

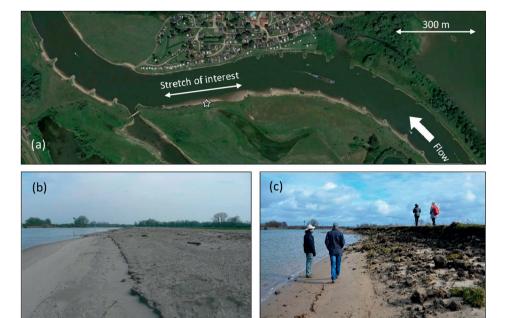
Figure 5.13. Re-naturalized bank opposite to Fortmond, IJssel River. (a) Bank location, with star showing where photos of panels b and c were taken. (b) Upstream view on 13/04/2010, after protection removal (courtesy of Margriet Schoor), and (c) during site visit on 22/03/2016, with Maarten Kleinhans, Wim Uijttewaal, Margriet Schoor, and Alessandra Crosato.

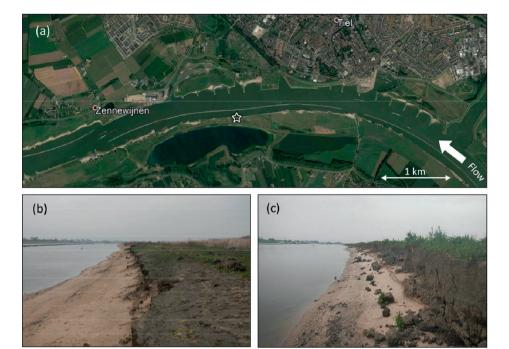
Figure 5.14. New bank behind longitudinal training dam near Tiel, Waal River. (a) Bank location, with star at km 917.5 indicating where photos of panels b and c were taken (source: Google Earth). (b) Upstream view on 19/12/2015 and (c) on 10/05/2016. Courtesy of Frank Collas.
