Static strength and fatigue life of pinned hybrid titanium-composite single-lap-shear joints

Kralovec, Christoph; Dengg, Andreas; Schagerl, Martin; Schiller, Arne; Bisagni, Chiara; Loebbecke, Miriam; Haubrich, Jan; Hanelt, Robert

Composite Structures

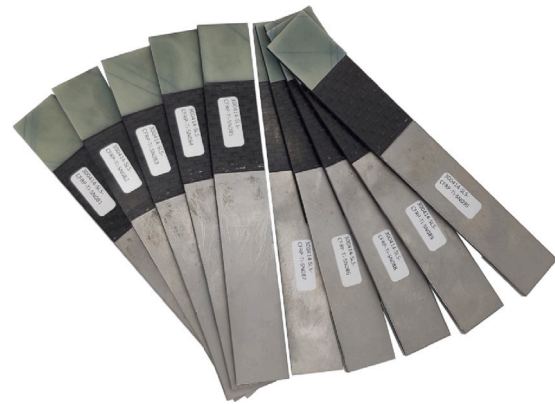
Fig. 2. Photographic image of pinned hybrid titanium-CFRP SLS joint.

The tested pinned hybrid SLS joint specimen is presented in Figs. 1 and 2. The specimen geometry is based on ASTM D5868 [14]. The metallic adherend consists of a Ti6Al4V sheet strip (thickness 1.6 mm) that is covered in the bonding area by a single laser powder bed fusion base layer of Ti6Al4V. This design was selected to save manufacturing time and maintain the comparability of the joint test results with fully additively manufactured parts. The pin geometry is a simple spike shape with a diameter of 0.5 mm and a total height of 1.8 mm (75% of CFRP adherend thickness). Tip and root fillet ($r = 0.5$ mm) were designed for better fiber bundle opening and penetration into the CFRP

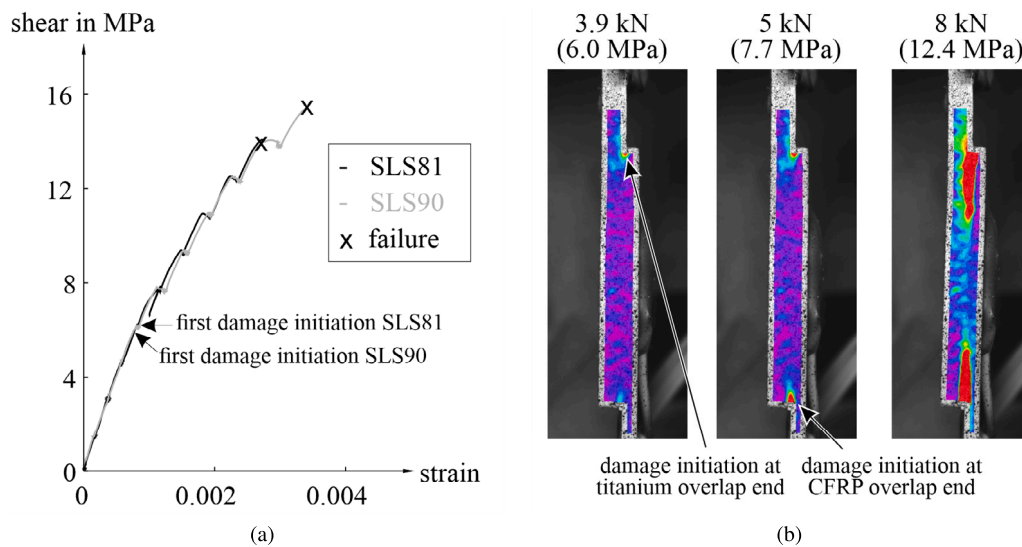
Fig. 6. (a) Average shear stress over average strain results of static tests with specimens SLS81 and SLS90, and (b) DIC principal strain evaluation results of SLS90 for damage initiation loads (3.9 kN/6.0 MPa and 5 kN/7.7 MPa) and a load (8 kN/12.4 MPa) with propagated damage (red: value \geq DIC evaluation threshold).

The static test results are summarized in Table 2, including the principal strain thresholds used for DIC-based damage initiation evaluation. For further analysis and better comparability to other studies with differing bond dimensions, Fig. 6a shows the stress-strain results

of the statically loaded pinned hybrid SLS specimens. The stress is the average shear stress over the bonding, given by the crosshead loading and the pristine bonding area ($25.4 \times 25.4 \text{ mm}^2$, i.e., the average shear stress does not reflect the true stress increase in the bondline when damage propagates). The strain is the average strain over the defined DIC extensometer (cf. Fig. 5). The stiffness behavior of the specimens is initially linear. Also load holding periods after every 1 kN of load-increase did not affect this behavior (cf. measurement data point accumulations at 1.55 and 3.1 MPa before first damage initiation at 6 and 6.2 MPa, respectively). After first damage initiation, specimen stiffness began to decrease with increasing load. Furthermore, stiffness degradation during load holding periods indicated damage propagation without load increase (cf. average shear stresses drop at 7.8, 9.3, 10.8, 12.4, 14.0 and 15.5 MPa). The SLS81 even failed during a load holding period. Fig. 6b shows exemplarily the DIC principal strain evaluations of SLS90 for the first damage initiation (titanium adherend overlap end) at 3.9 kN tensile load (6 MPa average shear stress), the second damage initiation (CFRP adherend overlap end) at 5 kN tensile load (7.7 MPa) and a propagated damage at 8 kN tensile load (12.4 MPa). The damage evaluation thresholds were found by observing the load-normalized local principal strains along the bond line. Initially, the normalized strain distribution showed little change with increasing load (changes were assumed to be mainly driven by the geometric nonlinear effect of joint rotation). The first sudden and disproportionate strain deviation from the initial distribution was considered to be indicative of damage initiation (found to always be very local at the overlap ends). The threshold for further damage propagation evaluation was set between the highest strain value before and the highest strain value after the sudden strain deviation (values see Table 2). Due to the adherend stiffness imbalance the highest strain was always at the titanium adherend overlap end, where also the first damage initiation took place for both specimens. However, with further load increase a second damage initiated at the CFRP adherend overlap end and the initiated damages propagated until final failure of the specimens. This was found to be similar for both samples (cf. Table 2) and shows a large

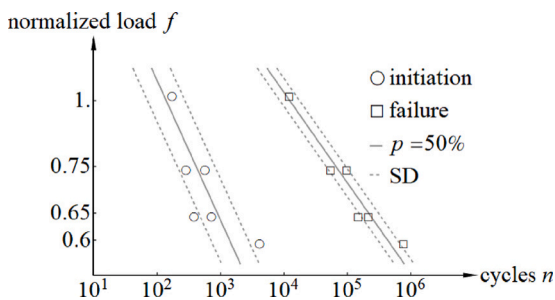
Fig. 9. Fatigue damage initiation and failure results for SLS84 to SLS89 and exponential fitting function ($p = 50\%$) with standard deviation (SD).

and final failure, respectively, were considered to be of the classical exponential form $f = cn^{-1/k}$, where f is the cyclic load, n is the number of cycles and c, k are the fitting parameters. This relation can be rewritten in the double-logarithmic domain for cycles until damage initiation and final failure by $\log(n) = d - k \log(f)$, where $d = k \log(c)$. The fitting parameters k and d were found for $p = 50\%$ probability of occurrence by a least-squares-fit with respect to the cycle numbers of the six considered specimens (log-normal distribution of the measurement values was assumed) [23]. The calculated fitting parameters, the standard deviations of the residuals and the coefficients of determination for both damage initiation and final failure are presented in Table 4. Both fitted functions show a reasonable standard deviation and coefficient of determination and are plotted in Fig. 9. The final failure cycle numbers scatter significantly less and show a much higher coefficient of determination than the damage initiation cycle numbers. This larger scatter of the damage initiation results may be explained by, (i) its susceptibility to manufacturing imperfections, and (ii) the difficult determination of the moment of the first damage initiation, in particular, as only one side of the SLS specimens is observed by the DIC system. However, it may be discussed if a cyclic load close at the static damage initiation load can be considered a fatigue load. Nevertheless, the fitted function correlates the results well and furthermore enables to investigate the transition between static and fatigue loading. Generally, all load levels showed damage initiation at low cycle numbers. This also applied to comparatively low peak loads.

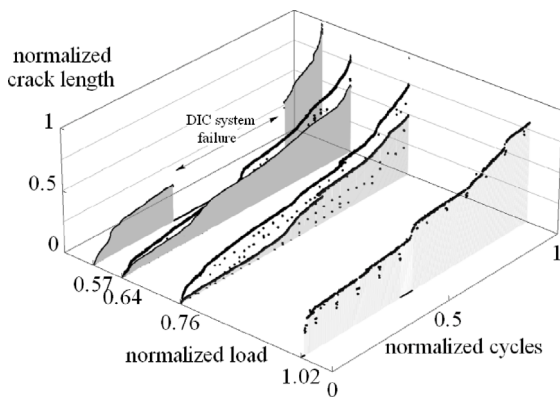
Fig. 10. Fatigue damage propagation over number of load cycles until failure for SLS84 to SLS89 (DIC evaluated at every 16th load cycle; normalized by the overlap length and the cycles to failure, respectively).

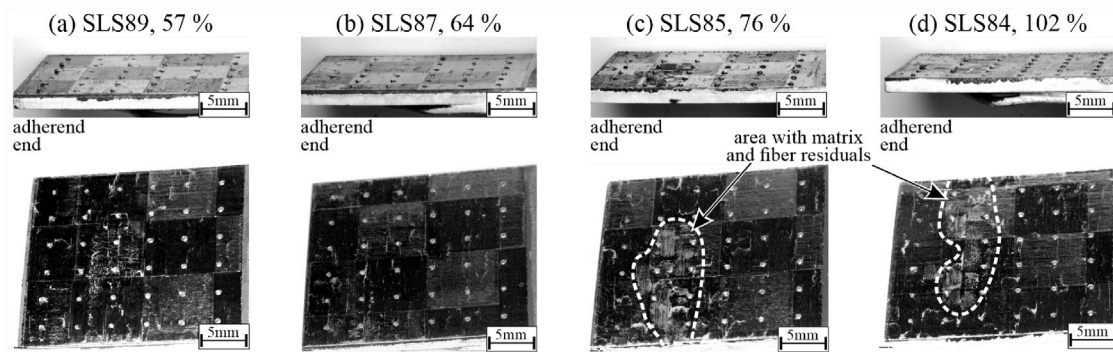
Fig. 11. Photographic images of debonded titanium adherend faces of SLS specimens fatigue loaded by (a) 57%, (b) 64%, (c) 76%, and (d) 102% of the averaged static damage initiation load.

This assumption is also supported by the photographic images of the debonded faces presented in Fig. 11. Until final joint rupture the debonding propagation of all six SLS specimens was dominated by adhesive failure (i.e., CFRP matrix separated from titanium). For load levels at and above 76% fatigue load at the area of final rupture some of the CFRP matrix and fibers remained on the titanium adherend (cohesive failure mode). Independent of the bonding failure, all pins ruptured and remained in the CFRP. However, a closer look at the debonded surface also showed different pin failure modes. While the pins at the adhesively failed bonding featured fatigue cracks at different locations, the pins at the cohesively failed bonding ruptured at their shaft. These different failure modes and planes of the pins may be explained by the different loads to which the pins were subjected to when the debonding crack faces separated. This separation of the crack

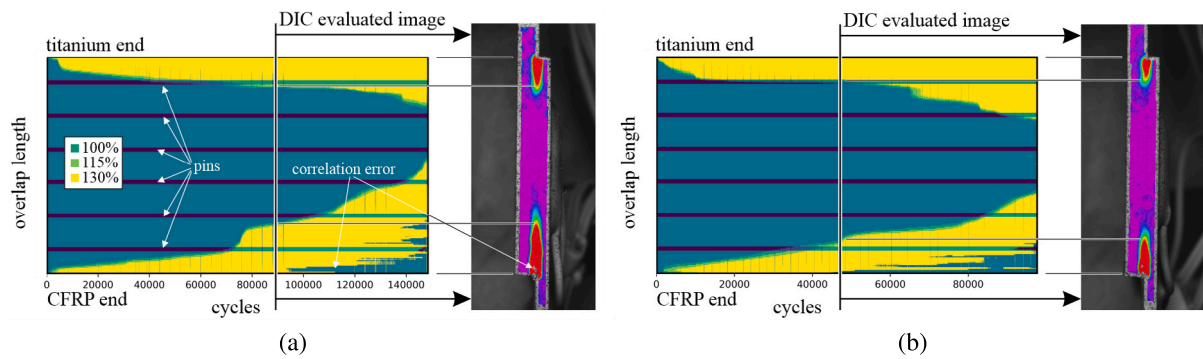
Fig. 14. SLS debonding crack propagation over load cycles evaluated by DIC principal strain thresholds of specimens loaded by (a) 0.64%, and (b) 0.76% of averaged static damage initiation load; color shading in DIC image represents principal strain (red: value exceeds threshold); color shadings in damage propagation plots represent a value higher than 100%, 115%, 130% of the strain threshold.

More critical for the results may be the influence of the selected threshold values used to evaluate the principal strains. The method seems generally sensitive to damage onset, as the thresholds were found individually for every specimen by strain deviations from its pristine condition. However, this comes with the danger that the damage evaluation was influenced by the selected threshold or corrupted by measurement noise. To identify the threshold dependency, three different thresholds were used (the defined value and two higher ones: 115% and 130%). The results clearly show the expected influence (shorter crack lengths for larger threshold values) of the changed thresholds (cf. Fig. 14). However, when compared to the evaluated cycle numbers the
