## A comparative study between low- and high-tech methods for the detection and mitigation of illicit connections in stormwater systems

Remy Schilperoort<sup>a</sup>, Johan Post<sup>a</sup>, Martijn Klootwijk<sup>b</sup>, Bas Hoefijzers<sup>b</sup>, Arjo Hof<sup>c</sup>, Bert Palsma<sup>d</sup>, Imke Leenen<sup>e</sup>, Heike Schmitt<sup>f</sup>, Hetty Blaak<sup>f</sup>, Sharona de Rijk<sup>f</sup>, David McCarthy<sup>g,h</sup>, Konstantinos F. Makris<sup>ic a, \*</sup> and Jeroen G. Langeveld<sup>IWA a,i</sup>

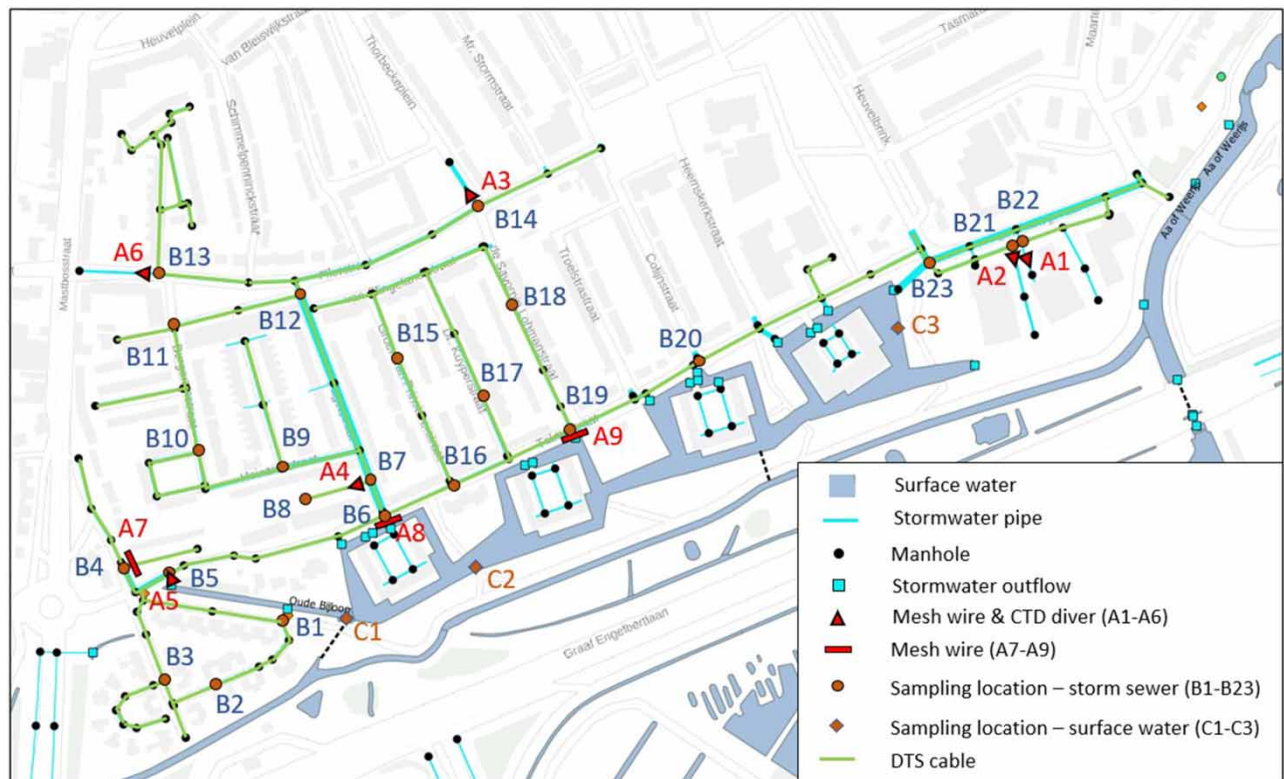
**Figure 1** | Catchment area De Heuvel with type and locations of the applied methods/techniques.

The study was conducted in the stormwater system of catchment De Heuvel in the municipality of Breda, the Netherlands. The catchment is a residential area of 15 ha with storm sewers discharging to a local pond in the southern part of the catchment (Figure 1). The stormwater system has a length of approximately 5.5 km and consists of several parts. The central section (4.5 km) drains under gravity to one of the nine outlets of the central pond. The outlets are fitted with nonreturn valves to prevent inflow from the pond into the system. The southwest part of the system consists of an infiltration transport sewer (0.5 km) with an internal overflow to the central section of the system and an external outfall to the receiving pond. Furthermore, four ‘islands’ in the area each have their own stormwater system (in total 0.5 km) and outlets; these sewers are not connected to the municipal system and were not included in the study.

Six conductivity sensors (CTD divers<sup>®</sup>, van Essen Instruments) were utilized, measuring high-frequency conductivity and temperature at various locations in the stormwater system (Figure 1). The idea behind the use of CTD divers in the search for illicit connections is that, due to a different composition, wastewater discharges may be observed as a temporary increase in conductivity and/or temperature. The CTD divers were attached to (a selection of) the same setups as used for the wire screens, hence measuring at the same locations (A1–A6).

from the pond (C1–C3) are shown in Figure 1. The DTS monitoring was performed between October and December 2019 yielding a total of 26 days of data fit for data analysis (DTS data collected during storm events are not suitable for analysis). The wire screens and CTD divers were installed on 28 October 2019. The screens were inspected on 7 November and prior to their removal on 20 November 2019.

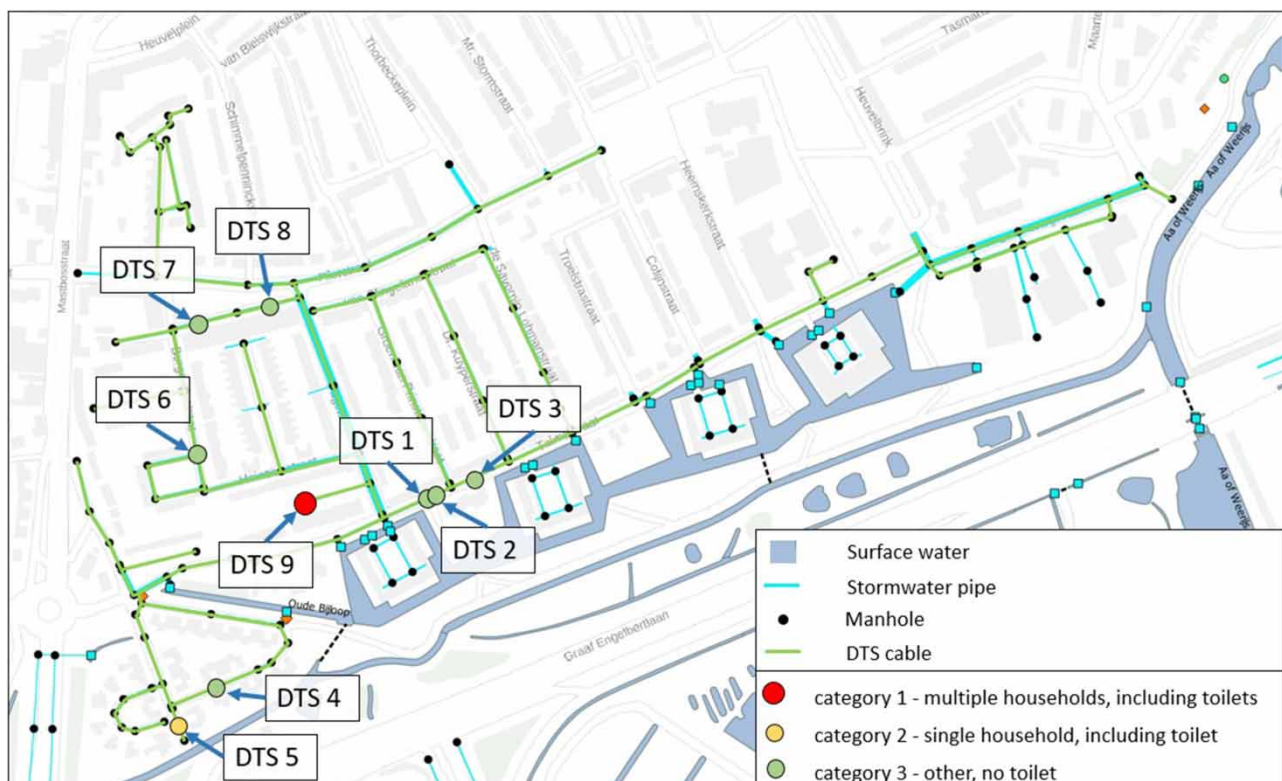
**Figure 2** | Results of DTS monitoring with categorization of illicit connections.

Frequent and/or large temperature deviations in the DTS measurements were found at nine locations in the sewer system (Figure 2). These locations were further examined by conducting systematic appliance discharges (e.g. in toilets, bathrooms, washing machines) in the houses around the detected discharge points.

Location DTS 9 proved a large illicit connection with all wastewater from a three-storey building (three households) misconnected to the storm sewer. This illicit connection was repaired in March 2020. At location DTS 5, a visual inspection of the manhole revealed that wastewater (including fecal material) was present in the stormwater system, but the exact source could not be determined during the site visit. As a result, this illicit connection was not (yet) repaired by September 2022.

The other seven locations proved to be misconnections in the in-house plumbing, resulting in nonfecal discharges (e.g. washing machines) to the stormwater system. Locations DTS 7 and DTS 8 were repaired, and the other locations were not due to the practical (in)feasibility of repair (as judged by the municipality).

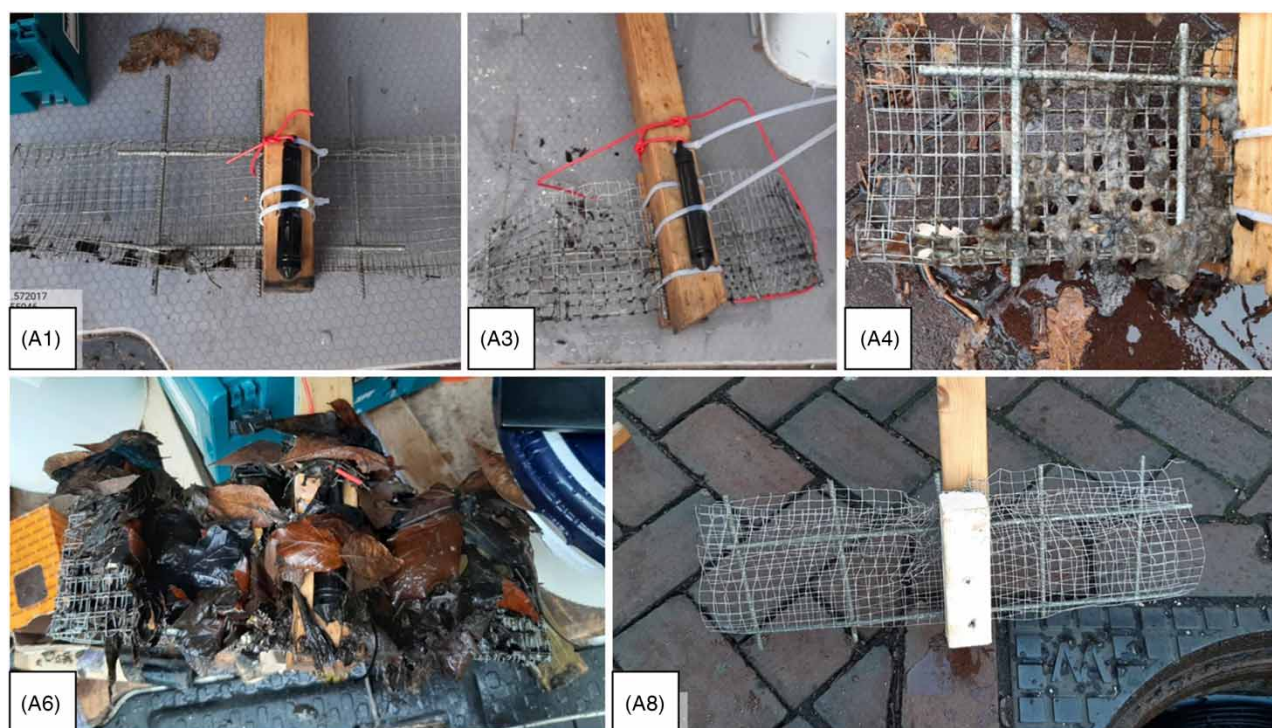
**Figure 3** | Mesh wire screens during inspection in November 2019.

Figure 3 shows a selection of results of the wire screens. No signs of fecal contamination (i.e. no toilet paper or fecal matter) were found on the majority of the inspected screens, although (remnants of) leaves were found at some locations. Only the screen at location A4 (downstream of DTS 9 where sewage was detected) showed clear traces of greasy contamination and a distinct sewage smell during the inspections.

The mesh wire screens are limited to illicit connections that generate coarse contamination. As a result, discharges from a washing machine are not detectable. The wire screen at location A4 was installed one manhole downstream of a category 1 illicit connection (DTS 9) that discharged all wastewater from multiple households to the storm sewer. The contamination found on this screen was therefore in line with the presence of a misconnection. At the screen, at location A8 (situated approximately 30 m further downstream at the outlet to the pond), however, no contamination was observed. This is possibly the result of disintegration and dilution of pollutants in the relatively large in-sewer volume between the two screens (submerged 800 mm pipe, approximately 40 m<sup>3</sup>). Another possibility is that the upstream A4 screen held back most of the contamination. At the other screens at outlets to the pond (A5 and A9), no contaminants were observed, which is in line with only category 3 illicit connections upstream of these outlets.

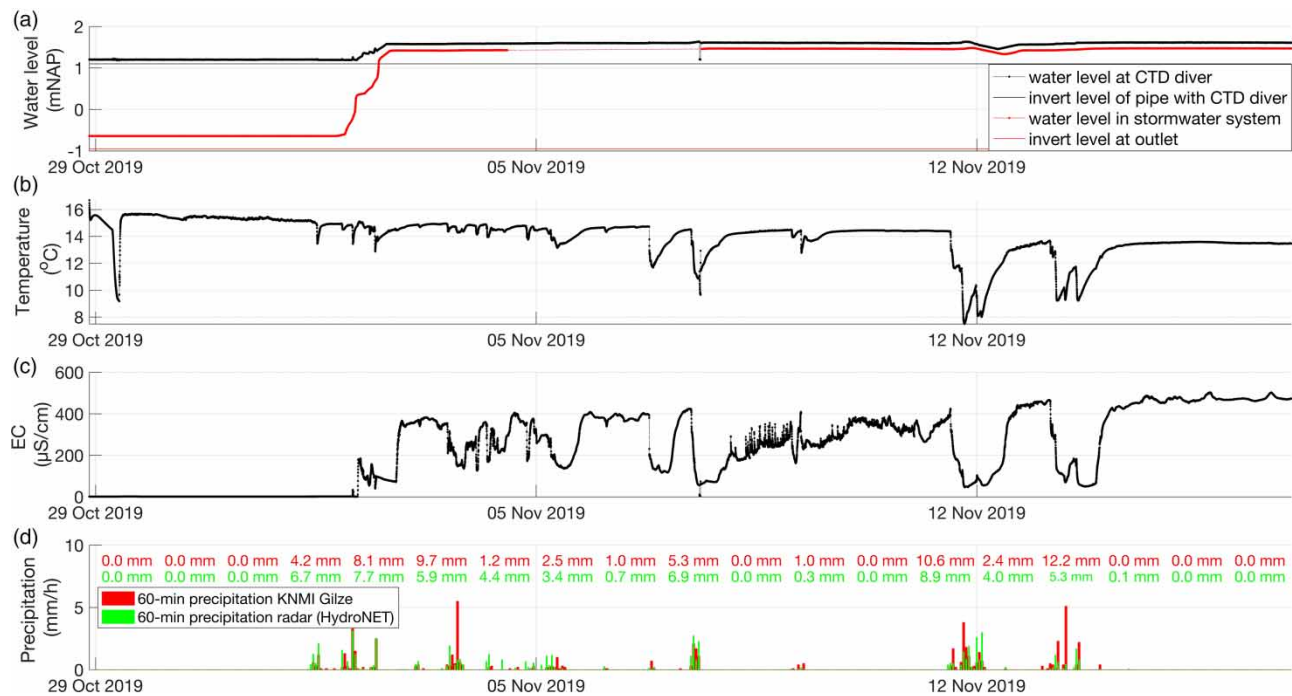
Figure 4 | CTD diver® data at location A4: (a) water levels, (b) temperature, (c) electrical conductivity, and (d) precipitation.

| Location | Pipe diameter (mm) | Water level (cm) at CTD | Results – observations |
|---|---|---|---|
| A4 | 250 | ~35 | Variations during dry weather as well as large absolute values ( <a href="#">Figure 4</a> ) |

For the conductivity and temperature measurements, the results were comparable to those for the mesh wire screens. The category 1 illicit connection at location DTS 9 was visible at location A4 via the EC signal (high-frequency variations and high absolute values during dry weather situations that fit the discharge of wastewater), but was not visible in the EC measurements at the downstream outlet A8. Again, the difference in hydraulic conditions is probably the explanation for this difference: the large upstream in-sewer water volume may attenuate the variations in EC signal to the point that these can no longer be distinguished in the data. EC monitoring at outlets proved insufficient in this sewer system to detect illicit connections. Similar to the wire screens, the absence of dry weather variations in the EC signals at locations without large upstream in-sewer volumes (A1, A2, and A6) confirms the earlier conclusion that no illicit connections are present in these pipes.

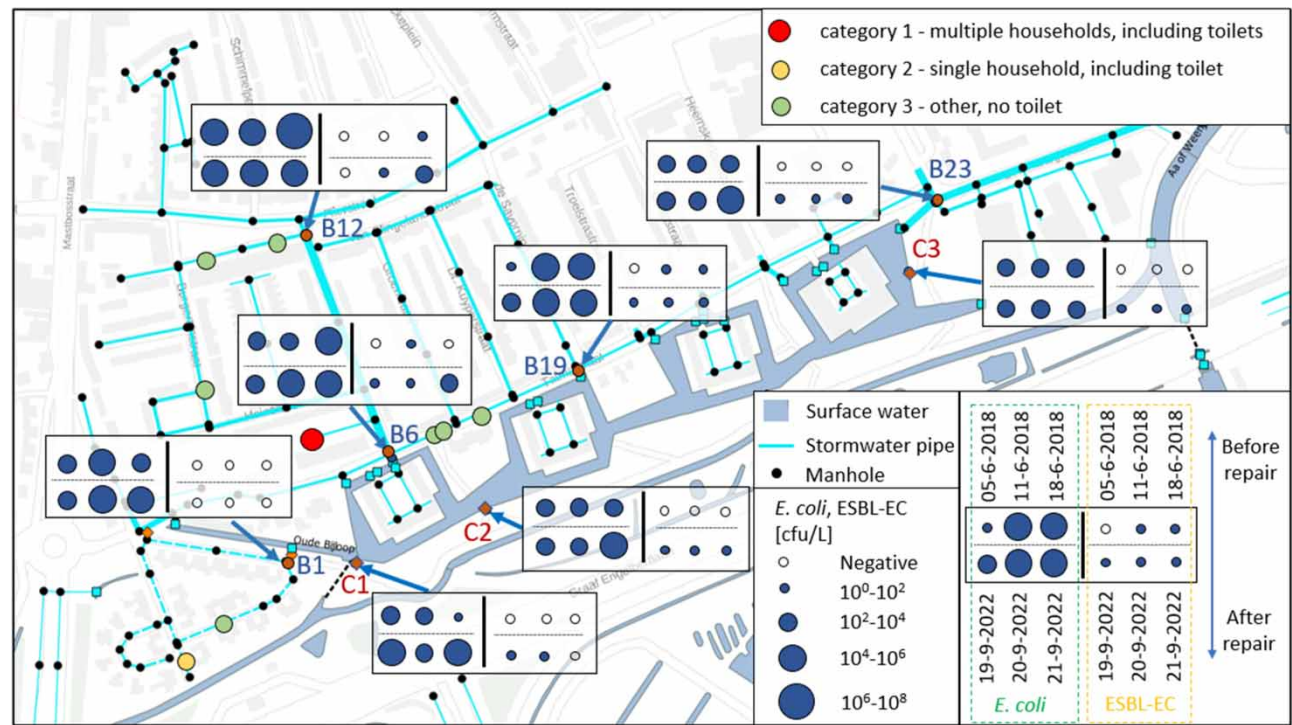
Figure 5 | *E. coli* (per location left-hand side) and ESBL-EC (right-hand side) concentrations in June 2019 (before repair of illicit connections, per location upper row) and in September 2022 (after repair, bottom row). Results are categorized according to their (log)value. Analysis results are given in Table S1 in Supplementary Material. The locations of the illicit connections found with DTS are also indicated in the figure.

[Figure 5](#) shows an overview of the analysis results for *E. coli* and ESBL-EC for samples collected before and after the repair of illicit connections. *E. coli* was detected in all samples from the stormwater system as well as from the pond. Removal of illicit

connections did not result in the expected reduction of *E. coli* concentrations. In contrast, the average storm sewer concentrations were about three times higher in 2022 compared to that in 2019 (geometric mean  $5.7 \times 10^3$  vs.  $1.9 \times 10^4$  cfu/L, respectively). Especially the consistently high concentrations at location B6 (two manholes downstream of the removed category 1 illicit connection) were unexpected.

For ESBL-EC, 23 of a total of 48 samples (48%) were found positive. Again, the removal of illicit connections did not lead to lower concentrations, but rather the contrary: the proportion of positive samples increased from 17% (2019) to 79% (2022). The share of ESBL-EC in the total amount of *E. coli* was approximately 0.001% for 1 sample, 0.01–0.1% for 9 samples, and 0.1–1% for 13 samples.

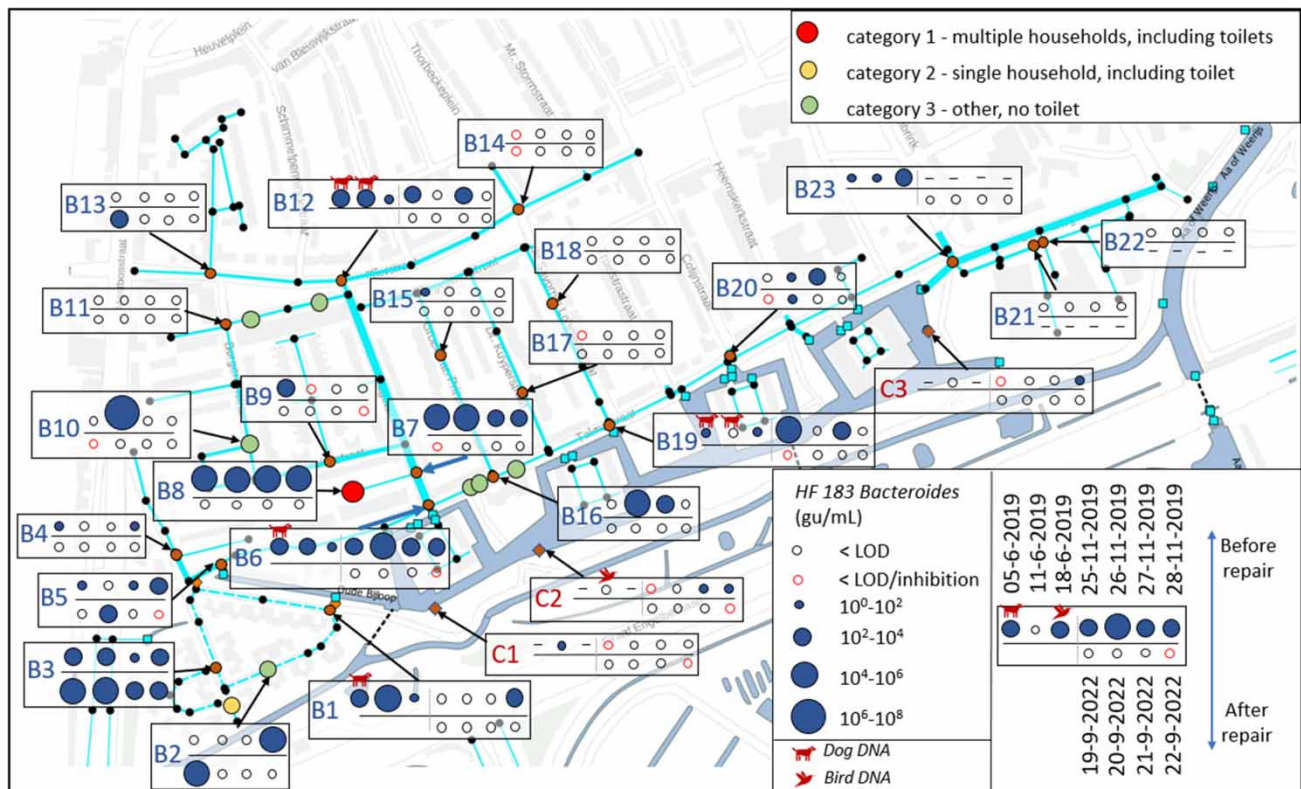
**Figure 6** | Human-specific DNA results before (June and November 2019, per location upper row) and after (September 2022, bottom row) repair of illicit connections. Dog and/or bird-specific DNA marker was analyzed only for samples collected in June 2019; a positive sample for these targets is indicated with a red symbol. Detailed analysis results are given in Tables S2–S4 in Supplementary Material. While the absolute concentrations might not be directly comparable due to the different methods used, the orders of magnitude of the results as shown in this figure are considered valid and as such allow comparison.

Figure 6 shows the results of DNA analysis for human markers. The human-specific DNA marker was found in 60 of a total of 214 samples (28%). There is a large difference between the samples before repair of illicit connections (44% positive) and after repair (8% positive). Moreover, five of the eight positive samples from September 2022 were collected at locations B2 and B3 near the unresolved illicit connection at location DTS 5 (yellow dot). The results at locations B8, B7, and B6 show a strong effect associated with the repair of the illicit connection at location DTS 9 (large red dot): consistently positive results before repair and consistently negative results after repair.

In June 2019, dog DNA marker was found in 6 of the 15 samples (40%), all collected from the stormwater system. Bird-specific DNA marker was found only in one sample from the pond (location C2).
