# Damage assessment of coastal structures in climate change adaptation

CoMEM Master Thesis

Ermano de Almeida Sousa

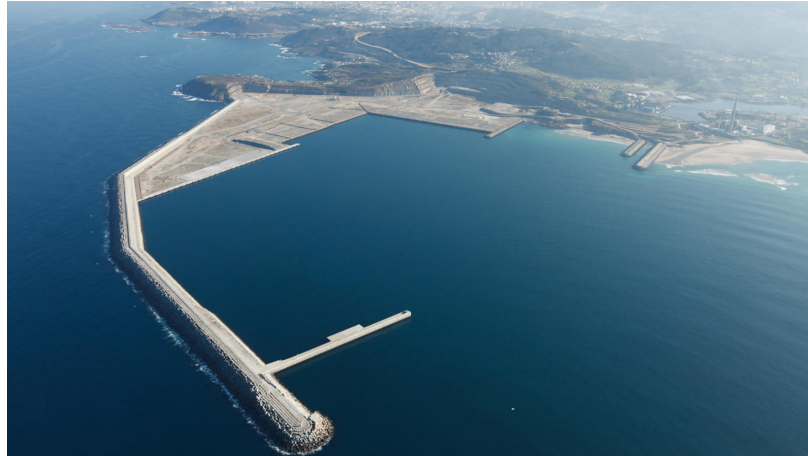
Figure 1.1: Punta Langosteira breakwater, singular coastal structure (Source: EFE).

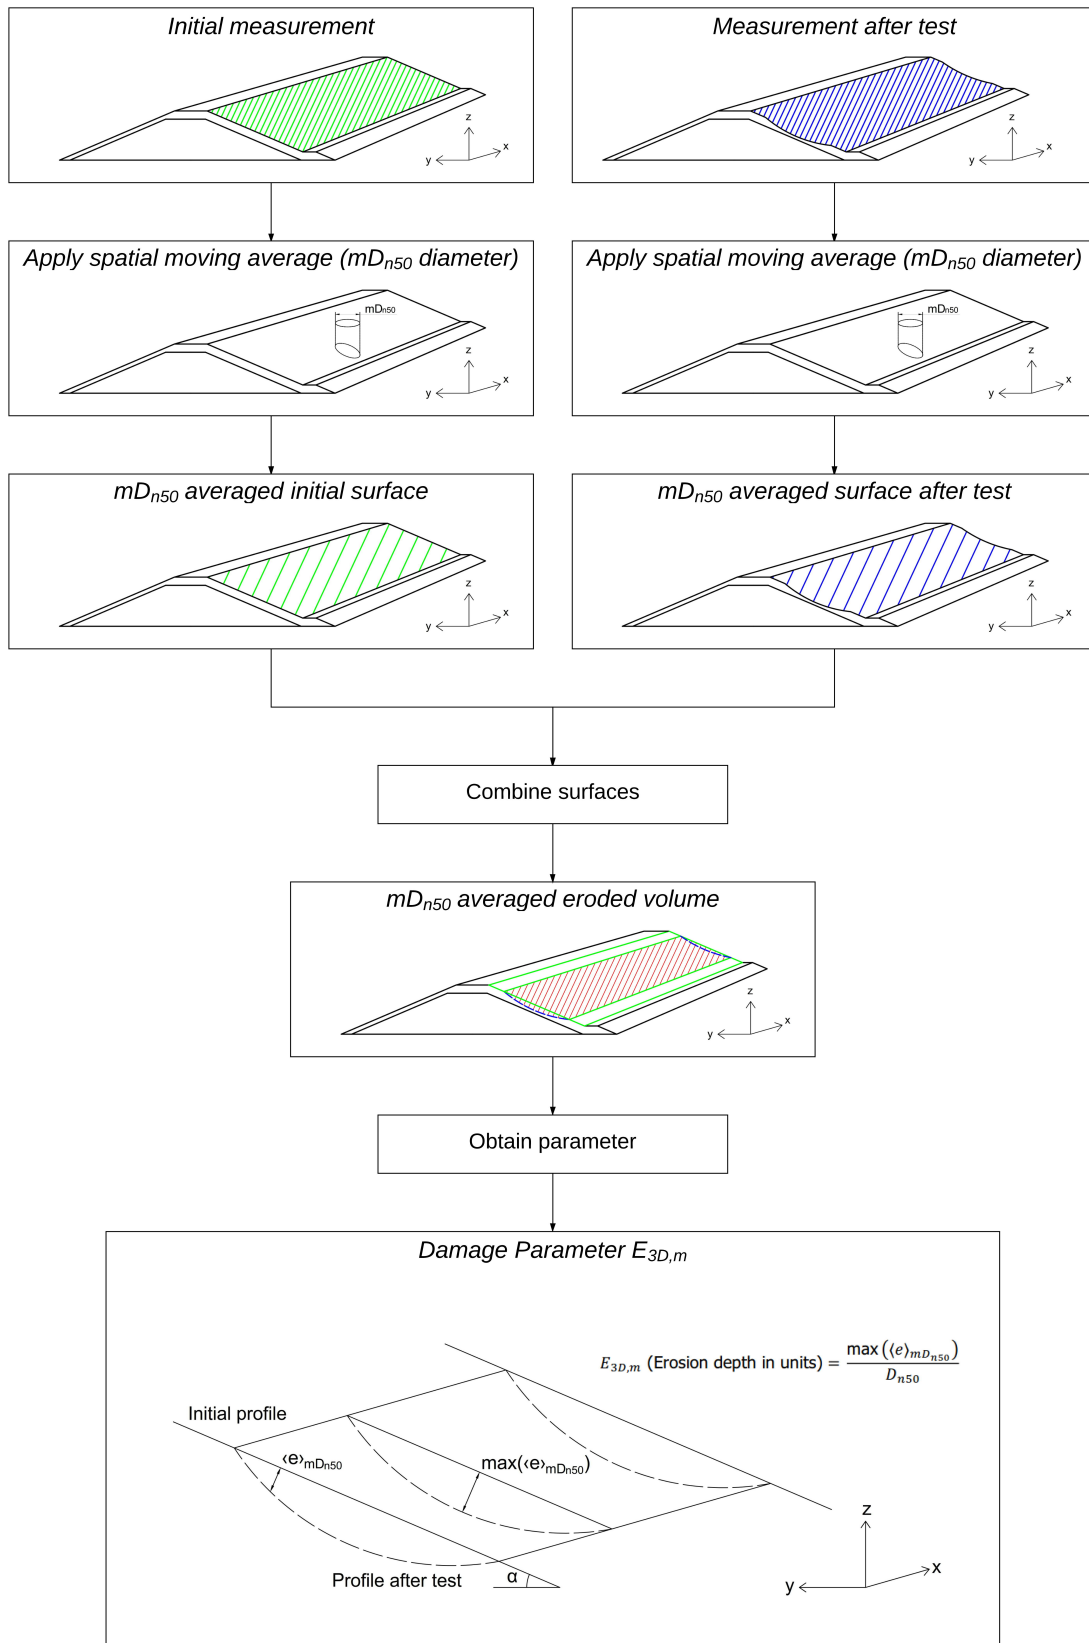
Figure 3.3: Process for obtaining  $E_{3D,m}$  damage parameter.

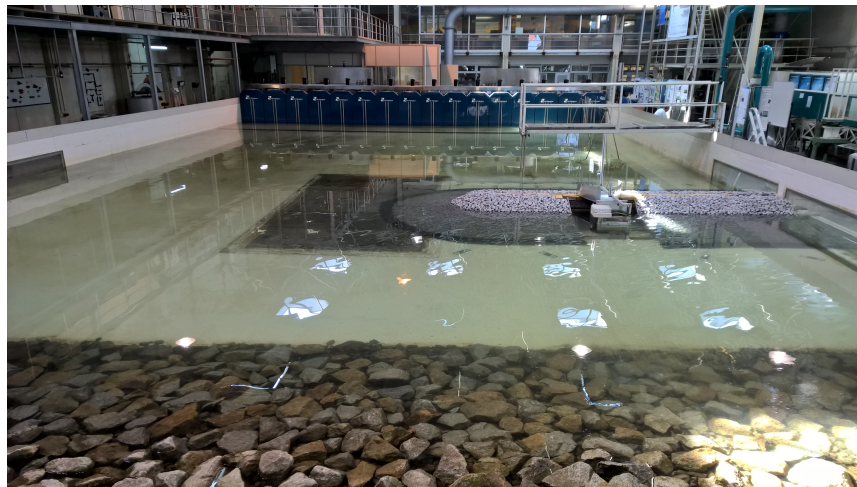
The UPorto deep water tests were carried out in a wave basin at the Hydraulics Laboratory of the Faculty of Engineering of the University of Porto. This wave basin is shown in Figure 4.1 before one of the test runs.

Figure 4.1: Wave basin used for the UPorto tests.

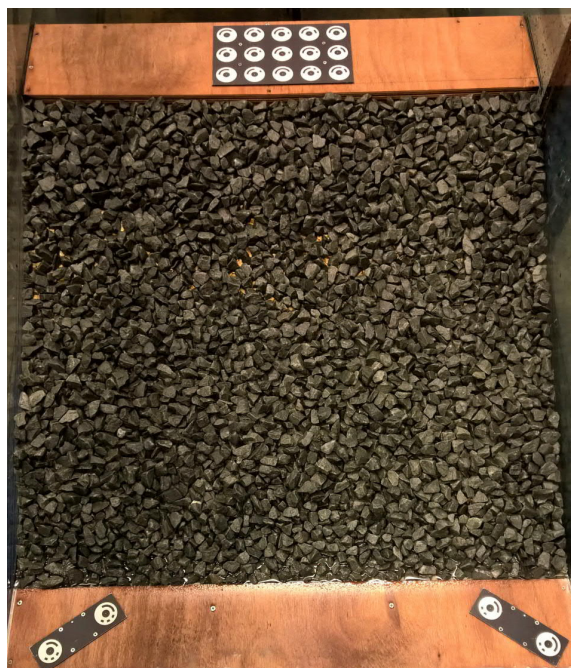
Before applying this parameter to calibrate the damage limits according to other parameters, a comparison with the currently used traditional characterization methods will be made. Such traditional methods considered slope surveys with different types of profilers (see Section 2.3.2) and the exposure of the filter layer for the failure limit:  $D_{50}/2$  for Thompson & Shuttler (1975),  $1D_{n50}$  for Melby & Kobayashi (1998) and no defined extent for the other authors (see Section 2.2). According to such methods, damage initiation and intermediate damage is based on defined parametric limits while failure is determined by the visual observation of images such as Figure 6.4 (where filter layer can be seen in white) or using cylindrical gauge with a hemispherical foot.

Figure 6.4: Deltares tests Series 1e - conditions after test run 4.
