# Fatigue strength of repaired welded connections made of very high strength steels

A.Akyel<sup>1</sup>, M.H. Kolstein<sup>1</sup>, F.S.K. Bijlaard<sup>1</sup>

<sup>1</sup>Delft University of Technology, Delft, Netherlands

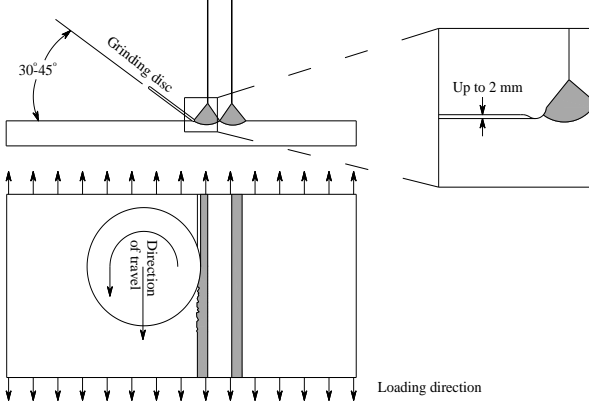
<p><b>Grinding:</b></p> <p>Applicable for the fatigue cracks with the depth up to 2 mm.</p> <ol style="list-style-type: none"> <li>1. Advantageous <ul style="list-style-type: none"> <li>▪ improve weld toe, reducing stress concentration</li> <li>▪ cost effective</li> </ul> </li> <li>2. Disadvantageous <ul style="list-style-type: none"> <li>▪ not possible to apply for complex joints</li> <li>▪ risk to mask the crack tip</li> </ul> </li> </ol>

the repair methods for shallow fatigue cracks. The grinding process is also used as a fatigue strength improvement method for welded connections by removing discontinuities at the weld toe and reshaping the weld to create a smooth transition between the weld material and the base material for the stress concentration reduction. According to Dexter, et al. (2013), the grinding method can be applied for the repair of fatigue cracks with a depth up to 2 mm. In addition, the execution of the grinding procedure for the fatigue strength improvement of welded connections is described by Haagenzen et al. (2001) in the IIW recommendations. Peening is a cold working process which creates a plastic deformation at the surface of the material by impacting a tool or metal balls and it is mainly used as a fatigue strength improvement method. The application process and quality control procedure are extensively given in the IIW recommendations [Haagenzen et al., 2001]. Peening is an effective method for repair of surface cracks with a depth up to 3 mm [Dexter et al., 2013]. The GTA process remelts a small amount of the weld toe and the base material by using a gas-shielded tungsten electrode to liquefy material and to re-establish the connection after the solidification. This method is effective for the repair of the surface cracks with a depth up to 5 mm. In addition, the GTA remelting process is also used as a fatigue strength improvement method by reshaping the weld toe to create smooth transitions between the base material and the weld material. The effectiveness of the method depends on the penetration of the remelting zone. Fisher, et al, (1994) concluded that the application with the argon helium shielding gas and a cone angle applied with 60° respect the material surface results in the most effective penetration of the remelting zone.

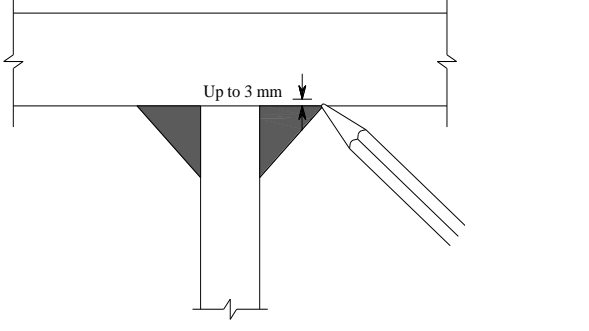
<p><b>Peening:</b></p> <p>Applicable for the fatigue cracks with the depth up to 3 mm.</p> <ol style="list-style-type: none"> <li>1. Advantageous <ul style="list-style-type: none"> <li>▪ improve weld toe, reducing stress concentration</li> <li>▪ introduce compressive stresses</li> </ul> </li> <li>2. Disadvantageous <ul style="list-style-type: none"> <li>▪ required highly skilled professionals</li> <li>▪ difficult to apply to complex joints</li> </ul> </li> </ol>

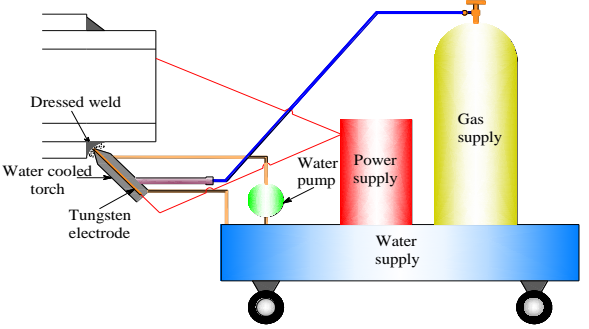
<p><b>Gas Tungsten Arc melting:</b></p> <p>Applicable for the fatigue cracks with the depth up to 5 mm.</p> <ol style="list-style-type: none"> <li>1. Advantageous <ul style="list-style-type: none"> <li>▪ improve weld toe, reducing stress concentration</li> <li>▪ no additional filler material required</li> </ul> </li> <li>2. Disadvantageous <ul style="list-style-type: none"> <li>▪ required highly skilled welders</li> <li>▪ difficult to apply to complex joints</li> </ul> </li> </ol>

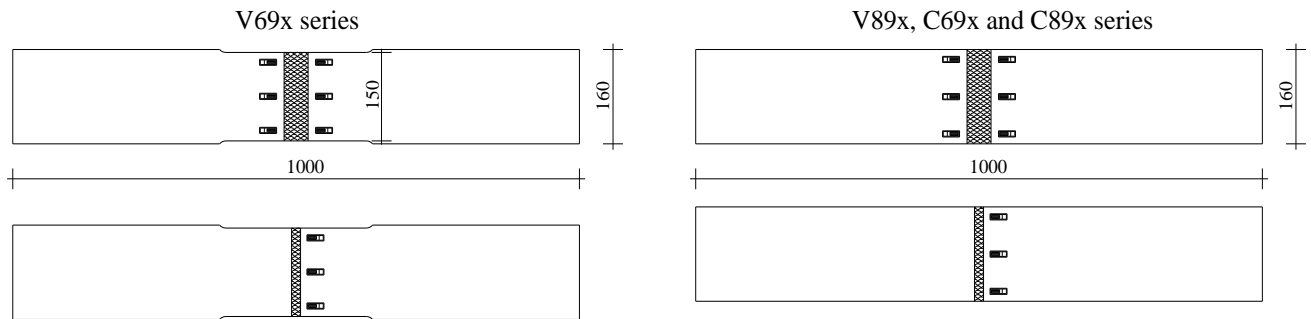
Figure 1. Geometry and dimensions of the test specimens.

The G10MnMoV6-3 and G18NiMoCr3-6 steel plates were cast with a thickness of 40 mm. The plates were quenched and tempered after casting and the thickness was reduced to 25 mm by machining from both sides of the plates. The cast plates satisfy the NDT requirements of SM1/LM1/AM1 for magnetic particle inspection according to EN 1369 (1996) and class 1 for ultrasonic inspection according to EN 12680-1 (2000).

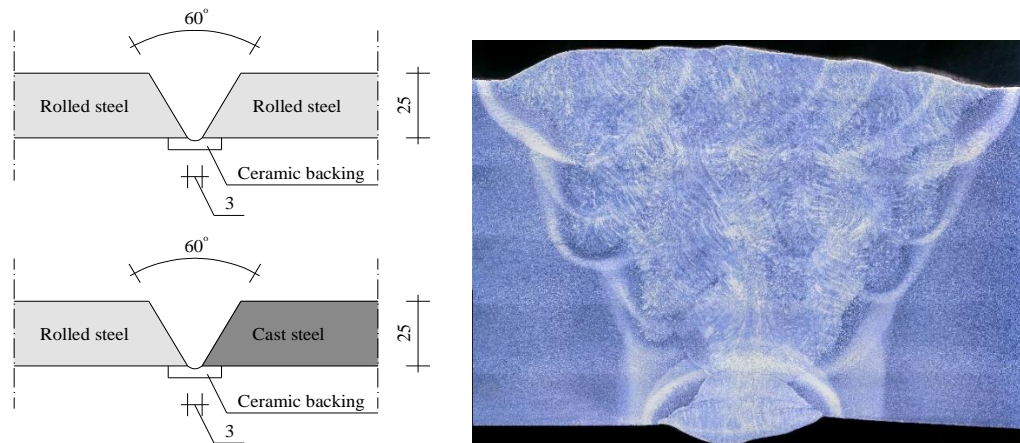
Figure 2. Weld configuration of the test specimens and a macro of the weld.

The rolled steel plates were flame cut and the weld edges of the rolled plates and the cast plates were machined to prepare a bevel angle of 60°. The prepared plates were welded by the FCAW process with a ceramic backing at the weld root. The individual test strips were plasma cut from the welded plates with a width of 160 mm and a length of 1000 mm (see Figure 1). Table 5 summarises the materials, weld parameters and geometry of the specimens for the test series of the current experimental program. Figure 2 illustrates the weld shape of the test specimens and a macro photo of the cross section of the weld, indicating the weld layers. Codes V69x and V89x are used for the specimens with rolled - rolled steel connections made of S690 and S890 respectively. Codes C69x and C89x denominate the hybrid specimens, cast – rolled steel connections, made of the steels with the nominal yield strength 690 MPa and 890 MPa respectively.

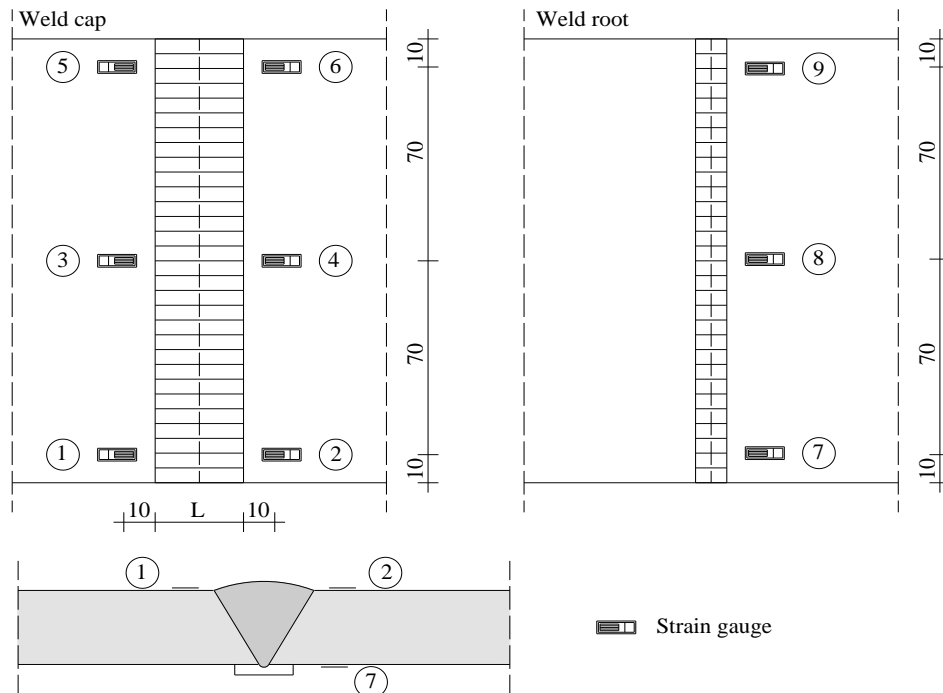
Figure 3. Strain gauge configuration on a test specimen.

Strain gauges are attached to the specimens to measure the strain distribution at the surrounding of the weld and to determine the fatigue crack initiation life of the specimens. By using these strain gauges, an alarm system has been set up to shut off the test rigs in case of 50  $\mu$ strain deviations of strain range measurements. Accordingly, the region of the strain gauge is visually inspected to discover the location of possible fatigue cracks. The strain gauges were applied 10 mm from the weld toe of the weld cap and the weld root. Three strain gauges were attached to each side of the weld toe of the cap and 3 strain gauges at one side of the weld toe of the weld root (see Figure 3).

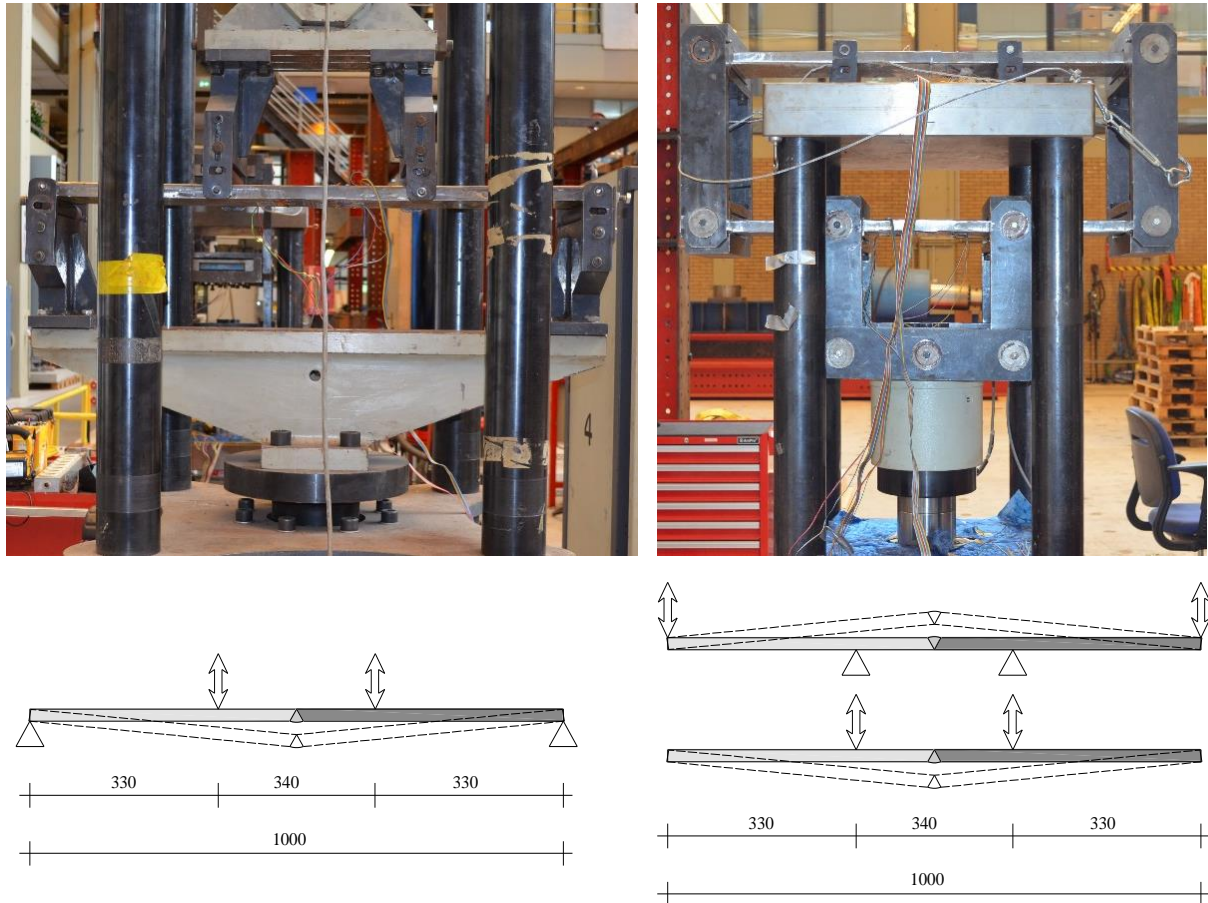
Figure 4. Four point bending test rigs for fatigue tests and the loading condition of the test specimens.

In the Stevin II laboratory of the Delft University of Technology, two four point bending test frames have been set up for the fatigue tests on the V-shape welded plate specimens. Figure 4 shows the fatigue test rigs where on the left side, a single plate setup is illustrated and on the right side, a twin plate setup is presented. By using these test setups simultaneously, a large number of tests can be performed in a relative short time. As the plates are loaded in the four point bending test frames, a continuous bending moment is present on the weld area, resulting in a compressive and a tension zone. The specimens are loaded such as the weld cap exposes to the tensile stresses. The fatigue test specimens are tested with stress ratio  $R = 0.1$  and with the loading frequency of 3 Hz.

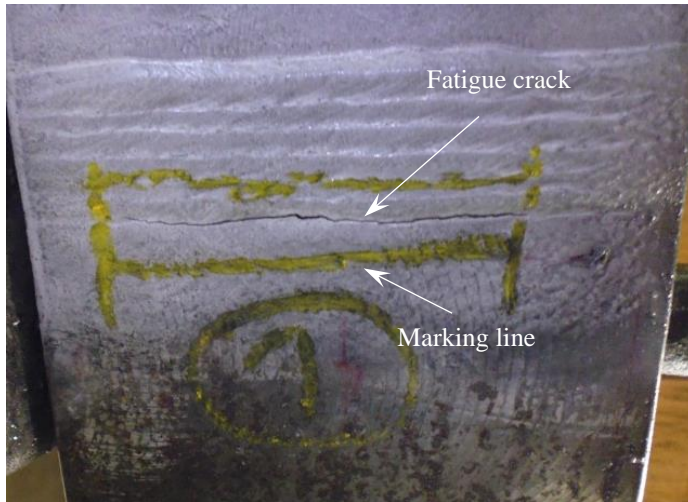
*Figure 5. Detected fatigue crack in a specimen and marking line.*

The performed visual inspection during the fatigue crack creation stage may lead to inaccurate crack length detection which depends on the visibility of cracks, accessibility to the crack locations and the person who performs the inspection. For the detection of an accurate crack length and all possible other small cracks, the application of a NDT method is essential. Accordingly, all fatigue damaged V-shape welded specimens were examined by a magnetic particle inspection and the detected cracks were marked to specify the crack boundary for the crack removal process (see Figure 5).

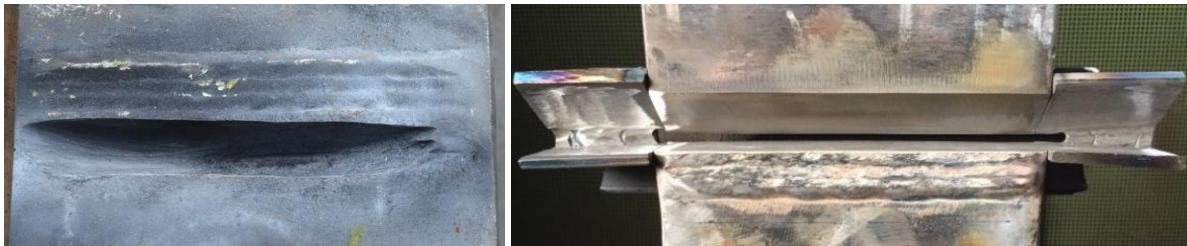
*Figure 6. A weld groove after crack removal process and attached temporary plate at the edge of a specimen.*

The fatigue crack removal process was executed with a disk and a burr grinder. The crack removal process was performed gradually and magnetic particle inspection took place regularly to avoid unessential material removal and a too deep weld groove. In the case of shallow cracks, the crack removal process was continued up to at least  $\frac{1}{3}$  of the material thickness to create an appropriate weld groove for a suitable weld quality. After the complete crack removal, the prepared weld groove was filled with the weld material by using the welding procedure of the original weld. For the repair of a weld toe fatigue crack at the edge of the plate, a temporary plate was attached to the specimen for providing a continuous welding and the temporary plate was removed after welding (see Figure 6).

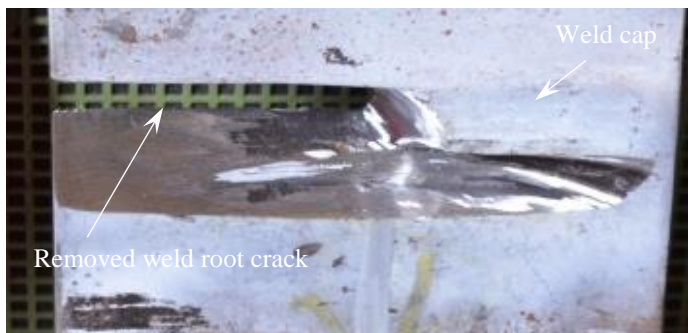
*Figure 7. Removal of the crack at the weld toe of the weld root.*

In general, V-shape welds are utilised for connections that are not possible to perform welding from both sides. It also means that the weld root is inaccessible for the fatigue crack inspections and these cracks may be visible when the cracks reach the weld cap. Consequently, the repair of these cracks can also be performed from the weld cap. During the fatigue crack creation stage, fatigue cracks were observed at the weld toe of the weld root, although the root of the weld was subjected to the compression stresses due to the loading. The fatigue cracks in the weld root have been repaired from the weld cap side by removing the material from the weld cap through the thickness of the weld.

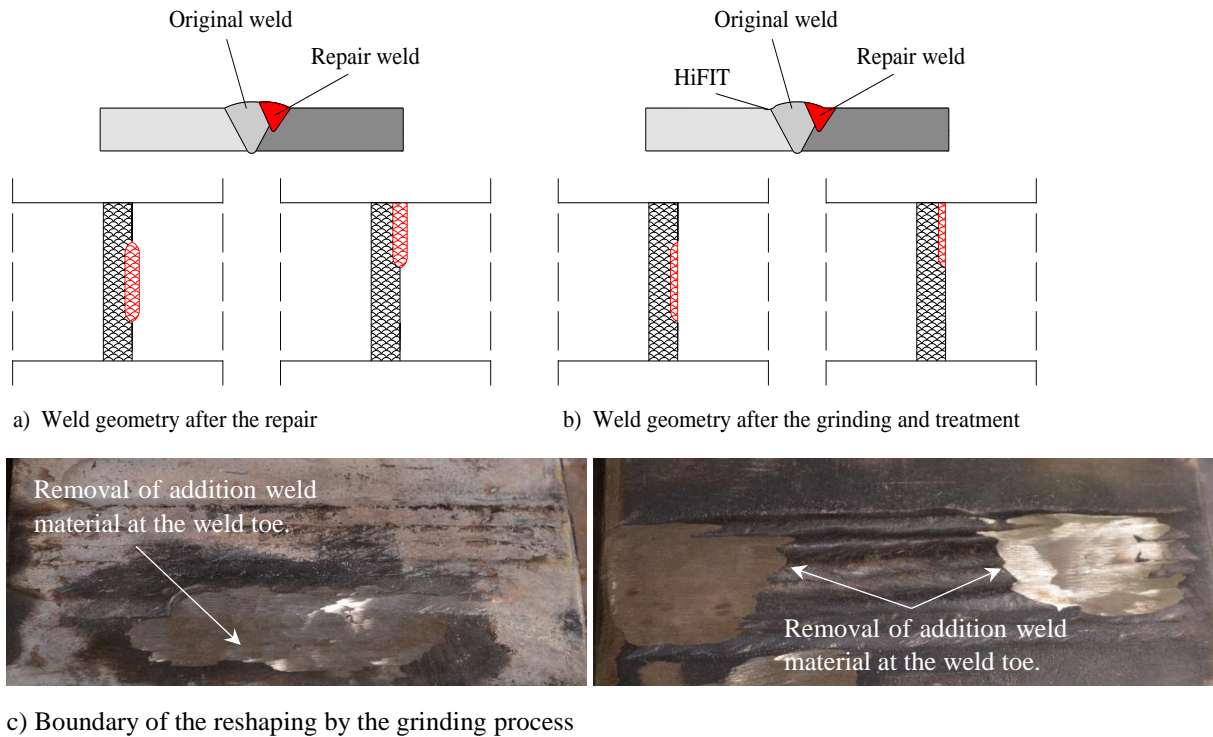
Figure 8. Weld shape after the repair and the repaired weld geometry after reshaping and HiFIT.

In practice, repair of fatigue cracks in structures is carried out at service conditions where the repaired connections are constrained by the surrounding structural elements. For the simulation of realistic repair conditions, the specimens were constrained during the application of the repair weld. The repair welds were examined by a magnetic particle and ultrasonic inspection for the weld qualification. After the repair of the weld toe cracks, the repair welds cause geometrical changes of the welded connection and it consequences a disruption of the stress distribution around the welded connection (see Figure 8a). Especially, the intersection between boundaries of the repair weld and the original weld cause a sharp geometrical change and consequently a high stress concentration. For the elimination of these undesired effects of the stress concentration, the repaired welded connections were reshaped by grinding to smooth transition between the original and repair weld (see Figure 8b). The grinding process is limited with the removal of the start-stop points of the repair weld and additional weld material at the weld toe (see Figure 8c). Furthermore, after the fatigue crack repair, the repaired side of the connection has a new weld toe and the other side of the weld contains the weld toe of the original weld which still contained the cyclic load history from the fatigue crack creation stage. According to the cumulative damage rule of Miner, fatigue crack initiation in the original weld toe is highly possible after the repair. The main purpose of the research is to investigate the fatigue strength of the repaired welded connections made of very high strength steels. Therefore, the cracks initiation in the original weld toe needs to be prevented. For this purpose, the weld toe of the original weld was treated by the high frequency impact treatment (HiFIT) weld toe improvement method.

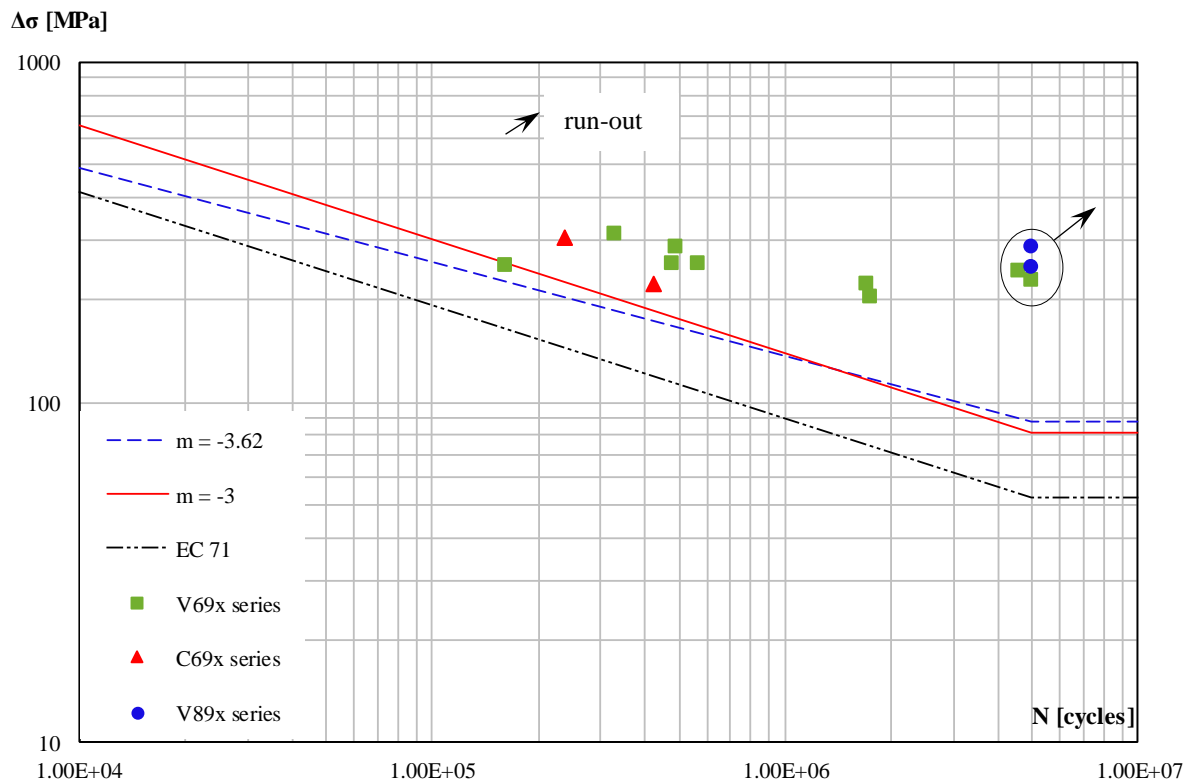
*Figure 9. S-N curves of weld toe cracks in rolled steels of the repaired V-shape welded specimens.*

Figure 9 presents the fatigue strength curves of the weld toe cracks in the rolled steel parts of the repaired V-shape welded specimens compared to the detail category 71 of EN 1993-1-9 (2006) which is recommended for the fatigue design of V-shape welded connections. The comparison shows that the recommended fatigue design curve of EN 1993-1-9 (2006) seems to be very conservative. Using a fixed slope of  $m = -3$ , the fatigue strength at  $2 \cdot 10^6$  cycles is 111 MPa while the design value of EN 1993-1-9 (2006) is 71 MPa and analysing the test results for a free slope of  $m = -3.62$  the fatigue strength at  $2 \cdot 10^6$  cycles leads to 114 MPa.

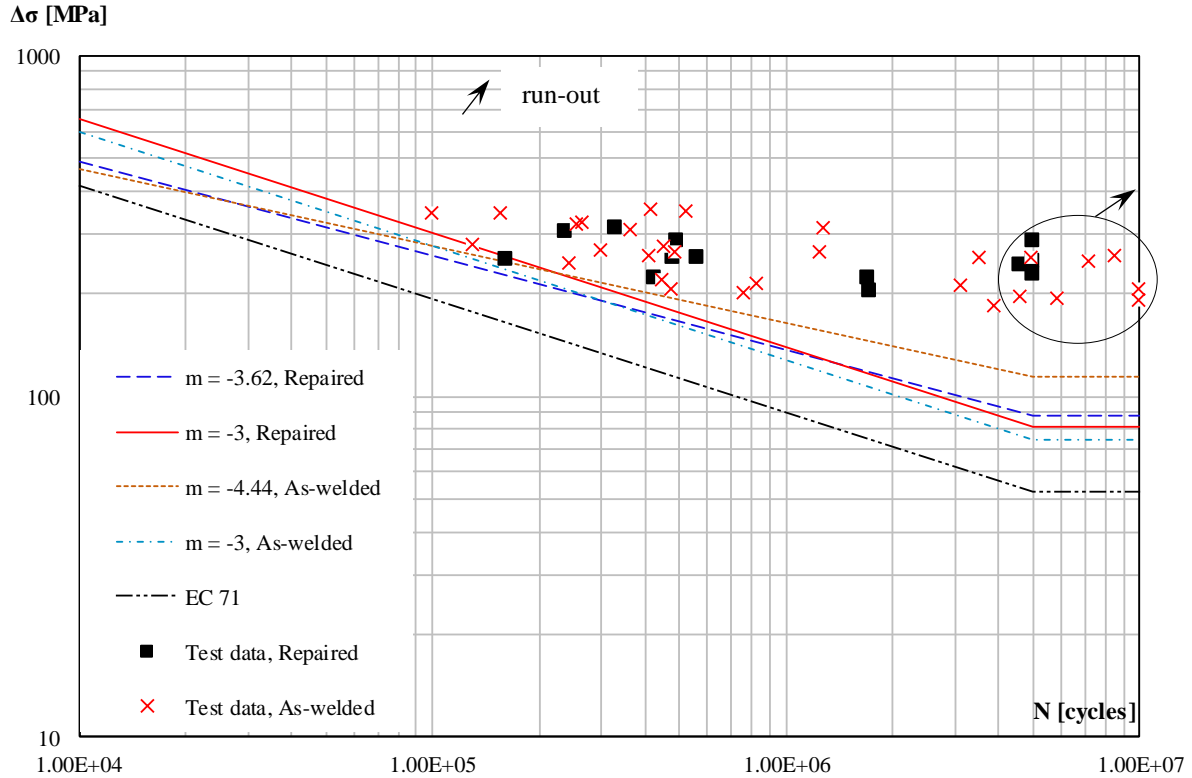
Figure 10. Comparison between S-N curves of weld toe crack in rolled steels of repaired and in the as-welded specimens.

Figure 10 compares the fatigue strength curves of repaired welded connections with the fatigue strength curves of welded connections in the as-welded condition. Due to a large number of run-outs in the test data of Pijpers (2011), a large deviation is determined between the fatigue strength curves with the free slopes. The fatigue strength at  $2 \cdot 10^6$  cycles is 102 MPa for the fixed slope of  $m = -3$  and 141 MPa for the free slope of  $m = -4.44$ . The fatigue strength curve with the slope of  $m = -3$  of the repaired V-shape welded specimens ( $\Delta\sigma_c = 111$  MPa) reasonably matches with the fatigue strength curve of V-shape welded specimens in the as welded condition ( $\Delta\sigma_c = 102$  MPa).

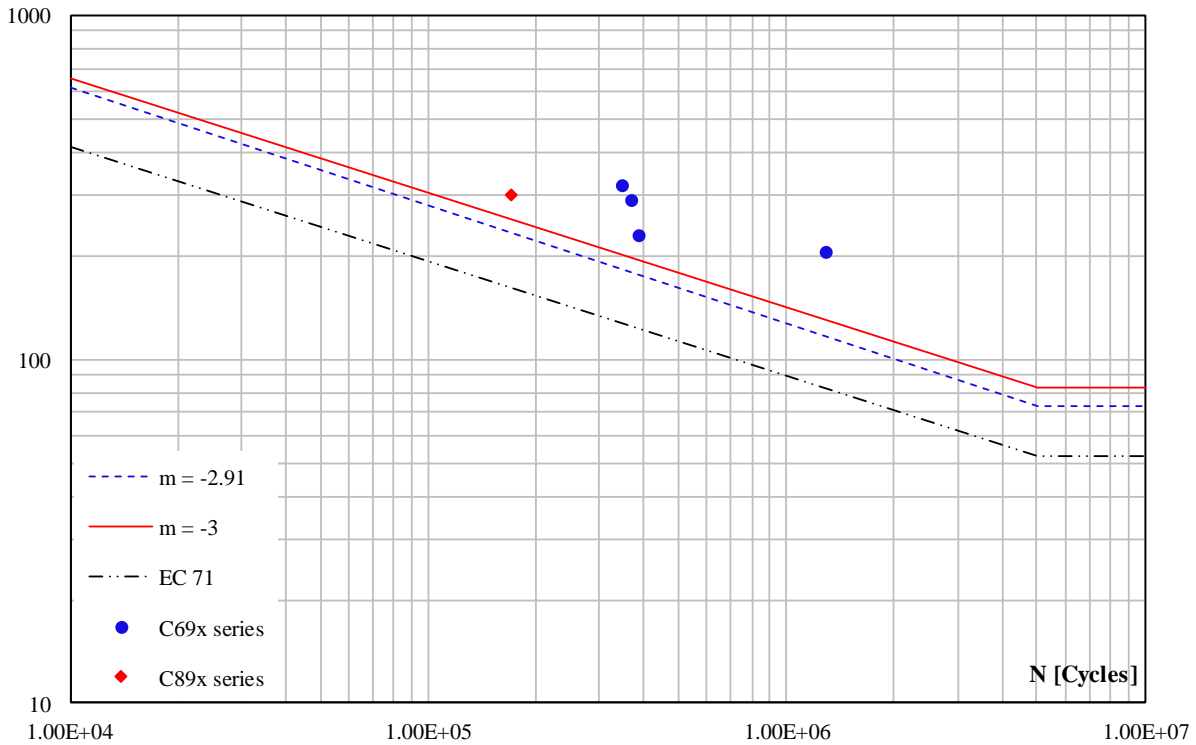
Figure 11 presents the fatigue strength curves of weld toe cracks in G10MnMoV6-3 and G18NiMoCr3-6 cast steel of the repaired V-shape welded connections. The comparison is made with the detail category 71 of EN 1993-1-9 (2006) and it was found that the design curve leads to conservative fatigue strength. For the fixed slope of  $m = -3$ , the fatigue strength at  $2 \cdot 10^6$  cycles is 112 MPa and the fatigue strength leads to 100 MPa at  $2 \cdot 10^6$  cycles for analysing the test results with a free slope of  $m = -2.91$ .

Figure 11. S-N curves of weld toe cracks in cast steels of the repaired V-shape welded specimens.

EN 1993-1-9 (2006) does not distinguish between the fatigue design of cast steels and rolled steels. The fatigue design recommendations for welded connections made of cast steels are given in DNVGL-RP-C203 (2016). According to this design recommendation, the fatigue design category of rolled steels can be used for the cast steels as well. The recommended design class in DNVGL-RP-C203 (2016) for V-shape welded connections is the same as detail category 71 of EN 1993-1-9 (2006). Consequently, the fatigue strength curves of the repaired specimens satisfy the requirements of DNVGL-RP-C203 (2016).

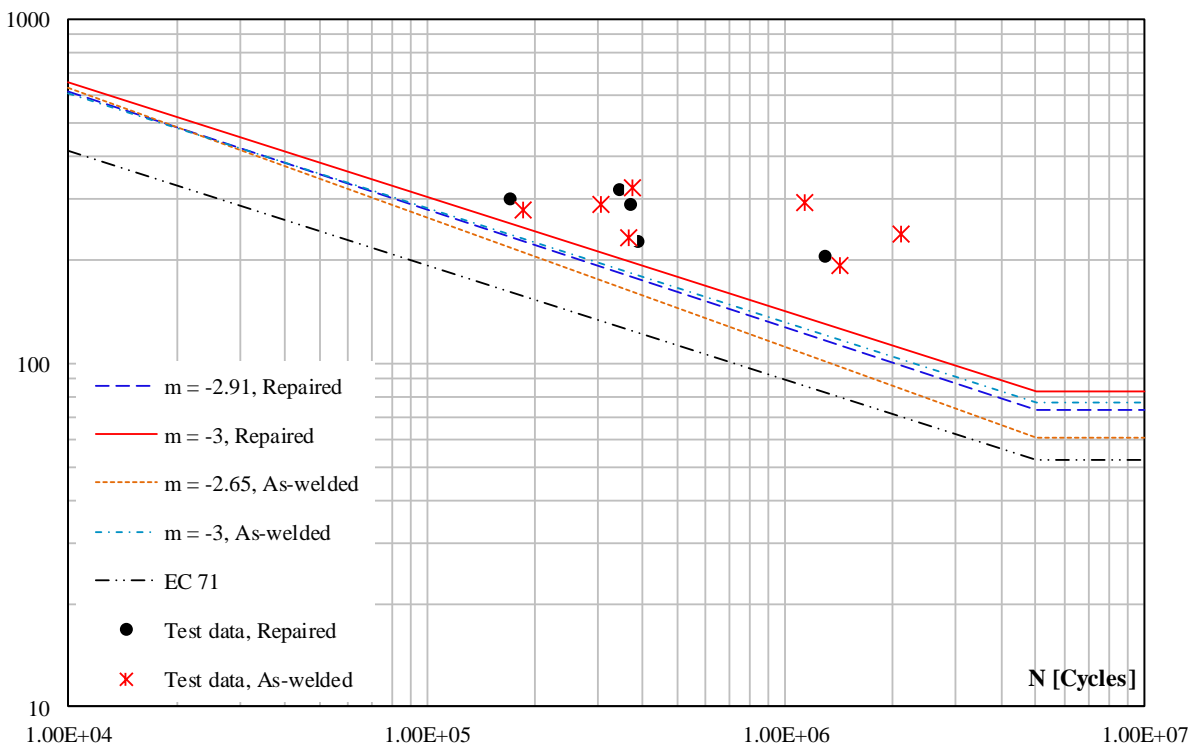
Figure 12 shows the comparison between the fatigue strength curves of the weld toe cracks in the cast steels side of the repaired specimens and specimens in the as-welded condition. The fatigue strength curves with the free slope show slight deviation due to different slope values. The fatigue strength curve of the repaired specimens with the fixed slope  $m=-3$  shows a good agreement with the fatigue strength curve in the as-welded condition with the fixed slope of  $m = -3$ . At  $2 \cdot 10^6$  cycles, the fatigue strength for the fixed slope of  $m = -3$  is 105 MPa and 86 MPa for the free slope of  $m = -2.65$ . In accordance with this, the fatigue strength of the fatigue damaged connection made of cast steels can be recovered with the established repair procedure.

Figure 12. Comparison between  $S$ - $N$  curves of weld toe crack in cast steels of repaired and in the as-welded specimens.

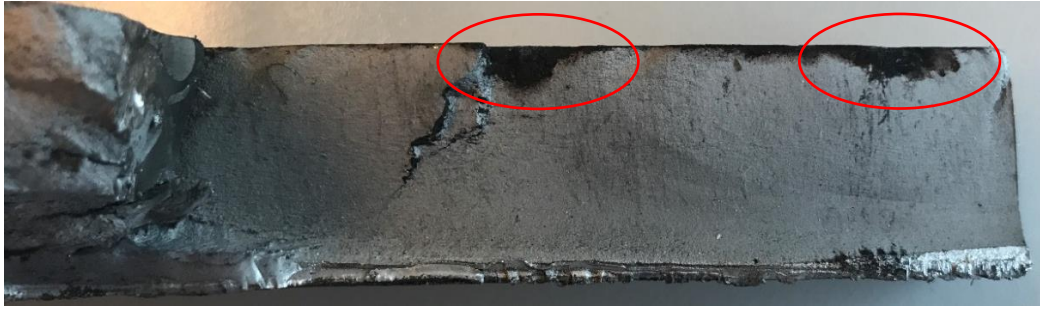
Base material cracks in rolled steel were observed in the majority of the test specimens containing S890. Using visual inspection, very highly corroded areas have been observed at the crack initiation locations (see Figure 13). It is assumed that the corrosion pits at the surface of the specimens caused the crack initiation. The base material failures were observed after the repair of the cracks in the welded connections. Therefore, the number of cycles at the crack creation stage is also included in the number of cycles at failure of specimens during the statistical analysis. The results of the statistical analysis on the base material failure in the rolled steel are given in Table 11.

Figure 13 Highly corroded areas at the crack initiation locations on the fracture surface of base material failure in S890.

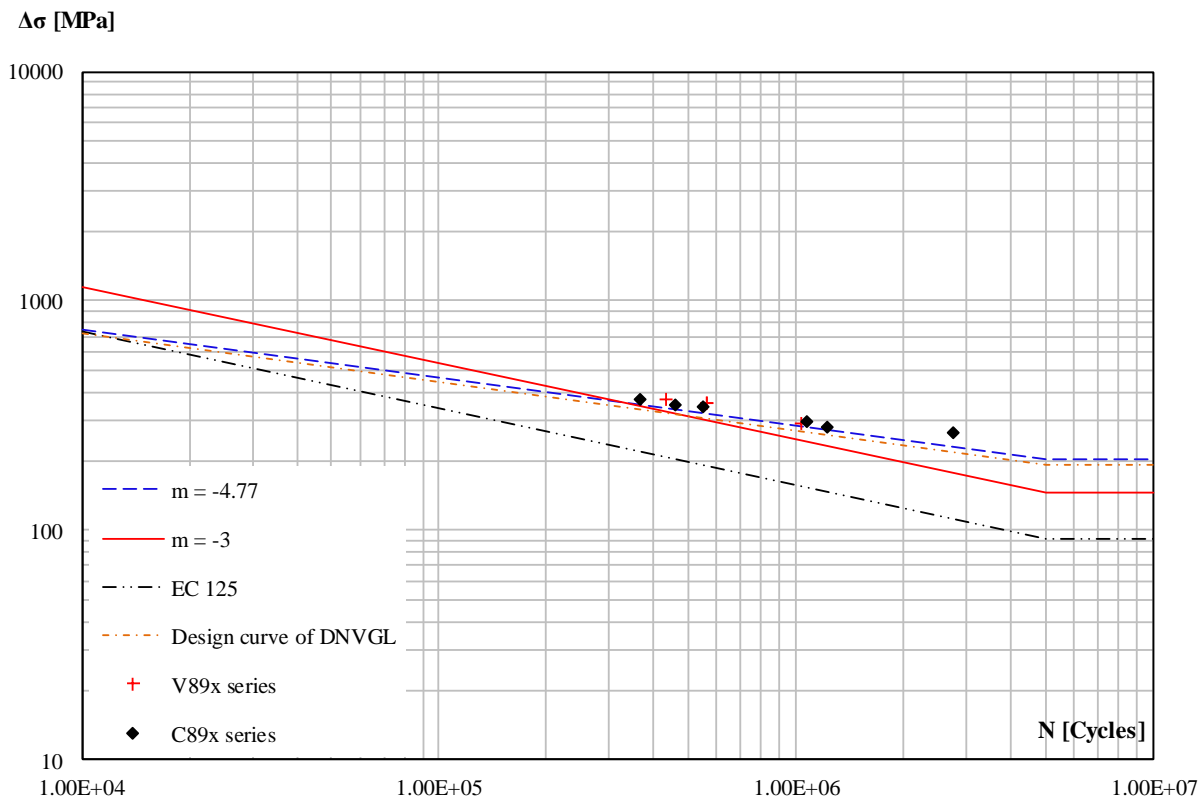
Figure 14 compares the fatigue strength curves of the base material cracks in S890 rolled steel with the detail category 125 of EN 1993-1-9 (2006) which is recommended for the fatigue design of the base material. The design curve of EN 1993-1-9 (2006) is found to be conservative. The fatigue strength at  $2 \cdot 10^6$  cycles is 197 MPa for the fixed slope of  $m = -3$  and 246 MPa for the free slope of  $m = -4.77$ .

Figure 14. S-N curves of base material cracks in rolled steels of the repaired V-shape welded specimens.

In EN 1993-1-9 (2006), no distinction is made between the fatigue strength of various steel grades and the given design curves are also used for the fatigue design of steels with the yield strength up to 700 MPa. However, DNVGL-RP-C203 (2016) proposes a fatigue design curve for the base material of high strength steels with yield strength above 500 MPa. The design curve has a slope  $m = -4.7$  and the characteristic stress range value at 2 million cycles  $\Delta\sigma_c = 235$  MPa. Figure 14 additionally compares the fatigue strength curve of the base material

crack in S890 rolled steel with the design curve of DNVGL-RP-C203. The fatigue strength curve with the free slope exactly matches with the design curve and the slope of the design curve,  $m = -4.70$  is very close to the slope of the fatigue strength curve of the test data,  $m = -4.77$ .

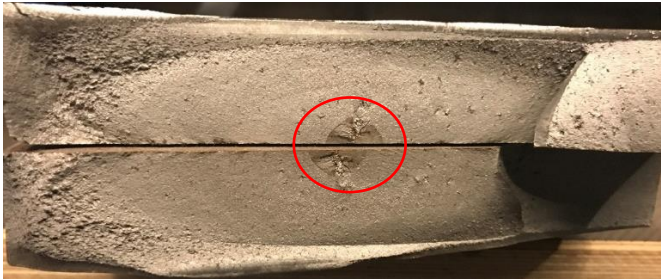
In the repaired hybrid specimens, the fatigue cracks were observed in the base material of G10MnMoV6-3 and G18NiMoCr3-6 cast steel grades. Internal imperfections were detected at the crack initiation region of these specimens (see Figure 15). The test data from both cast steel grades were combined and the statistical analysis performed on the test data with the inclusion of the number of cycles at the fatigue crack initiation. From the collected data, it can be seen that the base material failure of all these specimens took place at a similar stress range and number of cycles at fracture, which makes it difficult to determine a free slope for the data scatter. For this reason, the emphasise was put on the fatigue strength curves with the fixed slope  $m = -3$ . The results of the statistical analysis are given in Table 12.

Figure 15 Internal imperfection at the crack initiation location of the base material failure in cast steels.

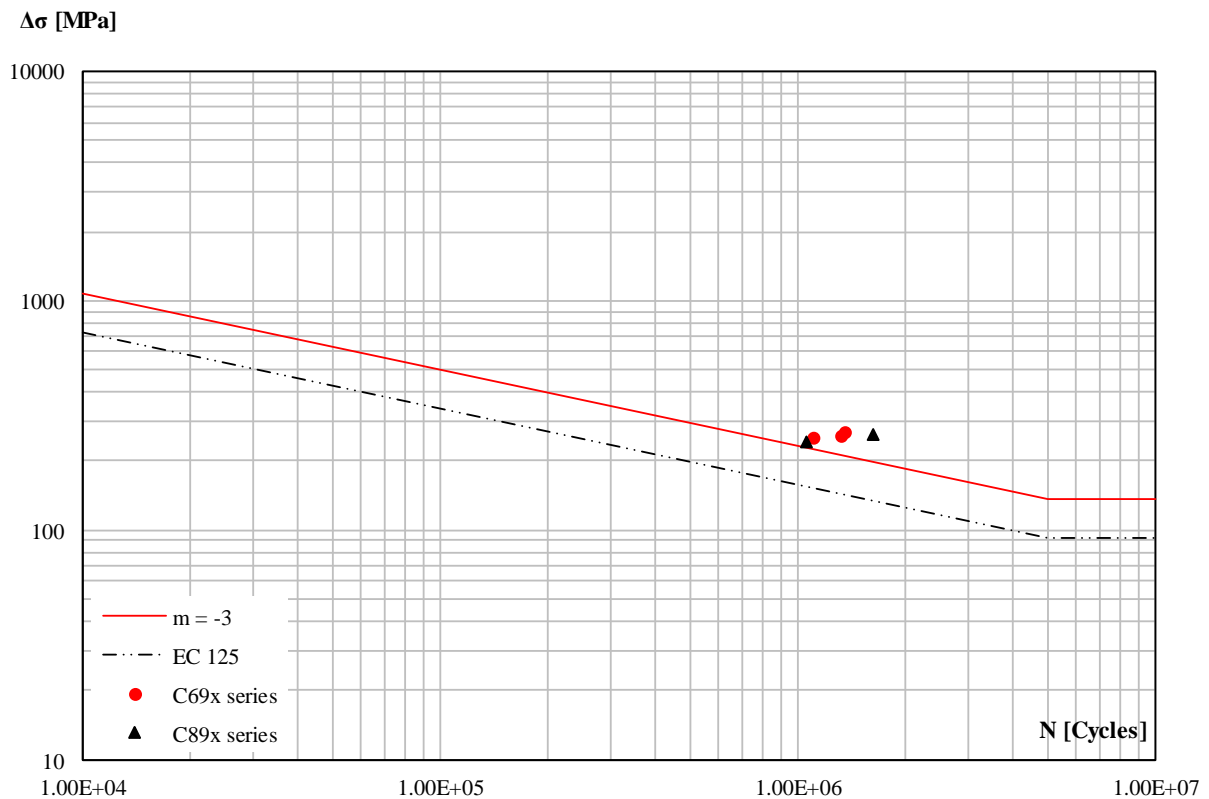
Figure 16. S-N curves of base material cracks in cast steels of the repaired V-shape welded specimens.

Figure 16 presents the fatigue strength curve of the base material cracks in the cast steels compared to the detail category 125 of EN 1993-1-9 (2006). The fatigue strength curve of the test data is located at the above of the design curve of EN 1993-1-9 (2006), which means that the design curve is conservative. The fatigue strength at  $2 \cdot 10^6$  cycles is 185 MPa for the fixed slope of  $m = -3$ .

EN 1993-1-9 (2006) states that the standard is applicable for structural steels and no distinction is made for rolled and cast steel grades. However, DNVGL-RP-C203 recommends the design curve C for the fatigue design of the base material of cast nodes. The design curve C is identical with detail category 125 of EN 1993-1-9 (2006). In accordance with this, the fatigue strength of the base material in the tested cast steels complies with the requirements of DNVGL-RP-C203 (2016).
