Workpackage 3: Development of Alternative Overtopping-Resistant Sea Defences

*Phase 3:
Wave Overtopping Erosion Tests at
Groningen Sea Dyke*

Final Report

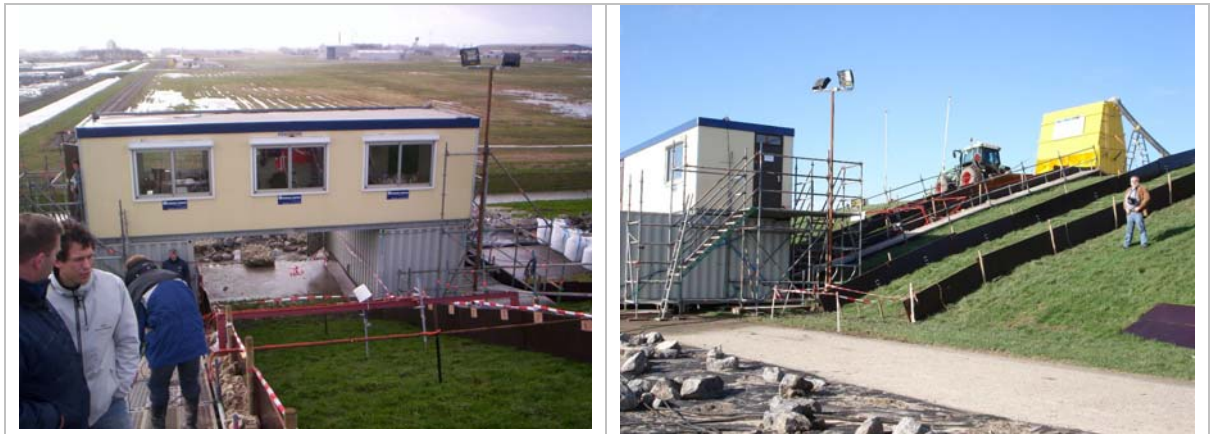
Figure 2-3: Impression of the test set-up with the measuring cabin on top the two containers

A photographic impression is shown in Figure 2-3.

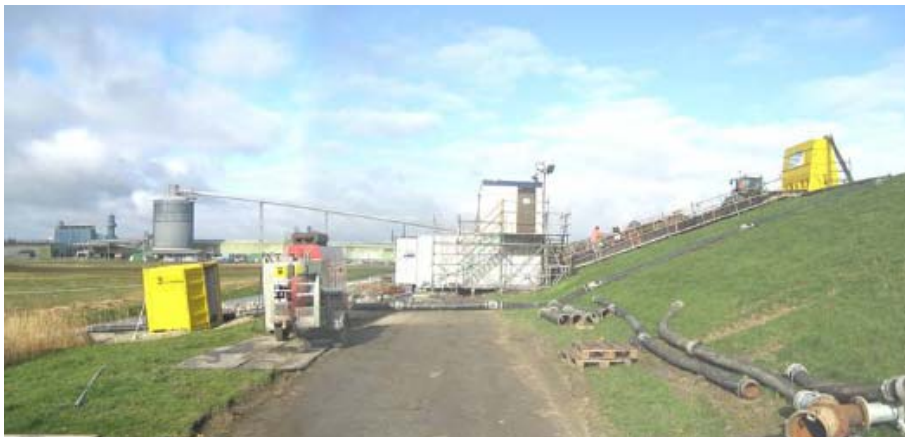
Figure 2-4: Overall impression of pumping system

An impression of the water circulation system is given in Figures 2-4 and 2-5.

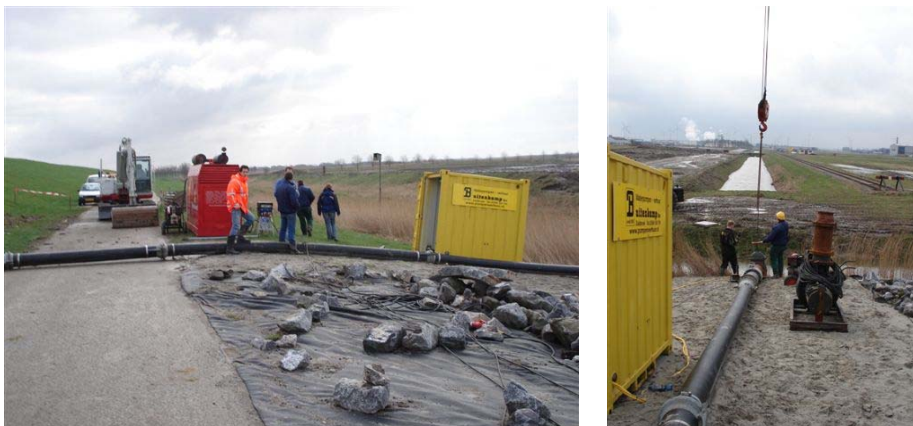
Figure 2-5: Impression of pumping system: control room (yellow box), power supply (red trailer) and hose system towards the simulator

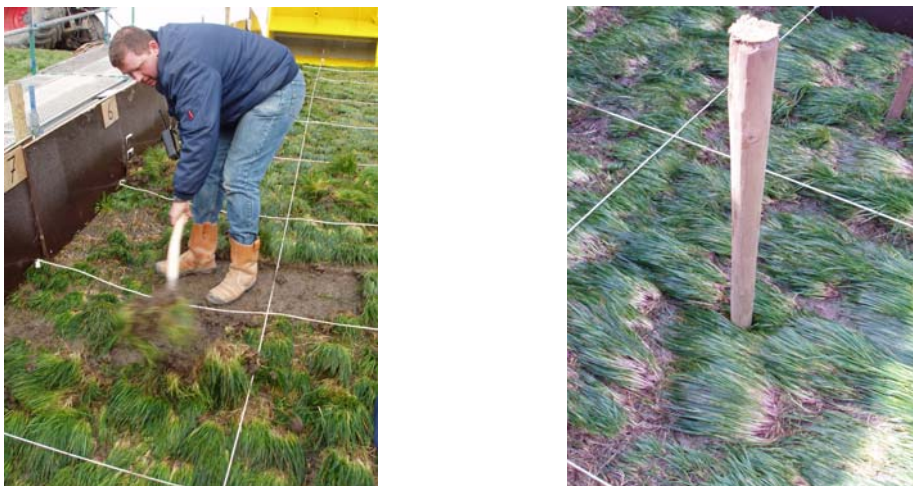
Figure 2-6: Introducing damage; removal of the upper grass layer with horizontal dimensions 1*1 m and placing a pole with a diameter of 0.07 m.

Even after the '50' l/s/m test, no major erosion occurred. Therefore it was decided to carry out the '50' l/s/m test with initial damage. This damage involved the removal of the upper grass layer with horizontal dimensions 1*1 m, application of a deep 15 cm hole at a bared spot with horizontal dimensions 0.4*0.4 m and introduction of two small holes 0,1m * 0,1 m and a pole and two pickets that were placed into the test section, according to Figures 2-6 and 2-7.

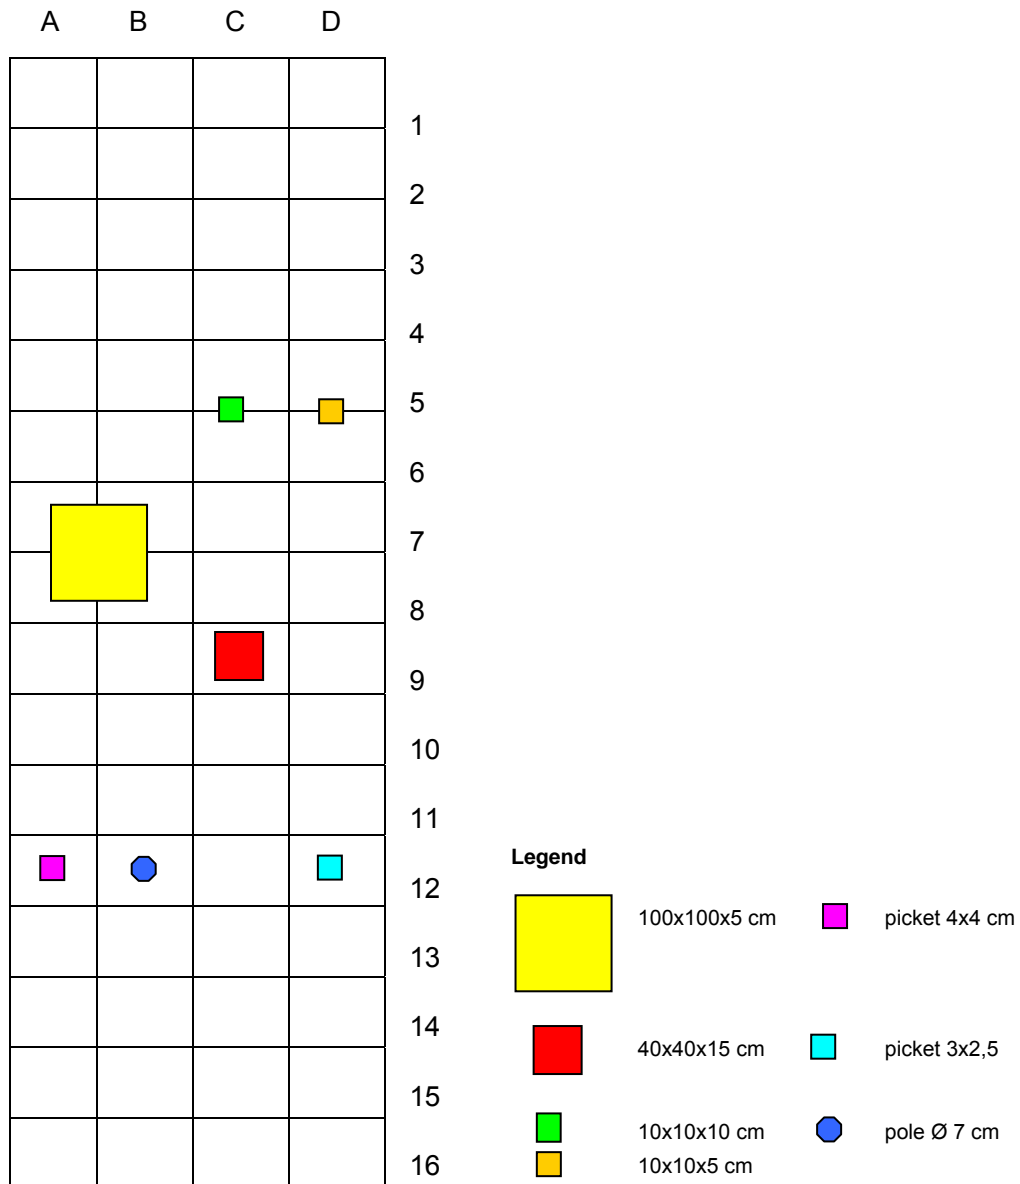
Figure 2-7: Pattern of initial erosion (depth x width x length) and obstacles introduced to the unreinforced and the reinforced test section

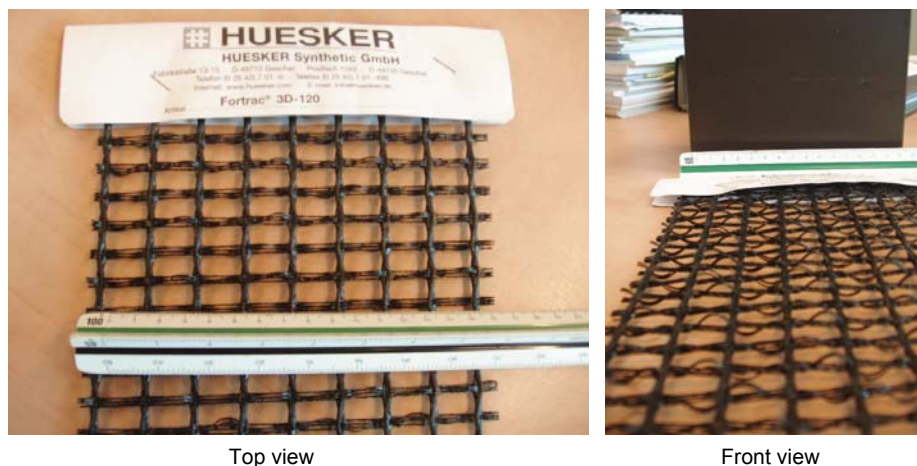
Figure 3-1: Selected Fortrac 3D-120 system

A proper geosynthetic for the tests was selected after extensive analysis of required functions, indicated hereafter as a Geogrid. The Fortrac3D-120 system of Huesker Synthetic (main office in Germany) was found to fit the requirements best. An impression of this Geogrid is given in Figure 3-1 below.

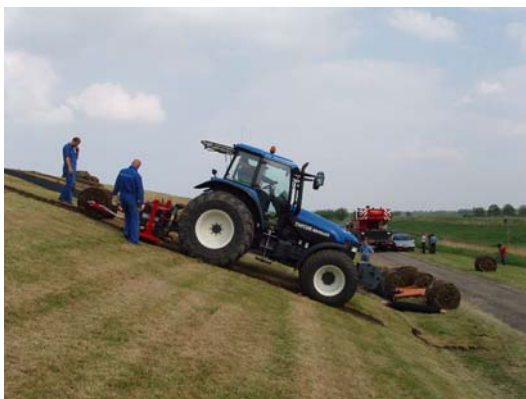
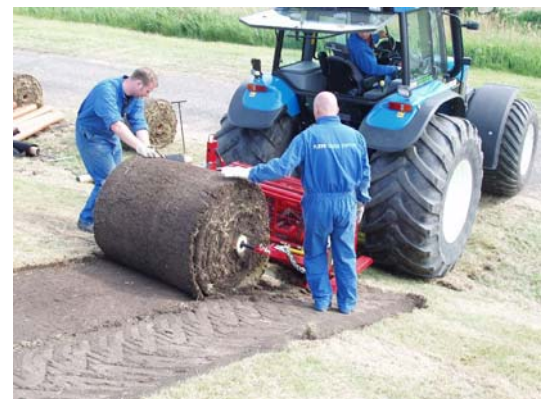
Figure 3-3: Finally selected methodology: cutting in downward direction

The placement of the Geogrid and the result after replacement of the grass rolls are shown in Figure 3-3 and 3-4.

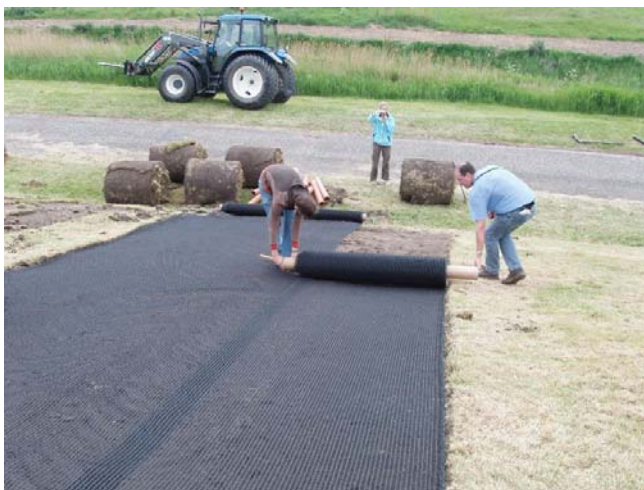
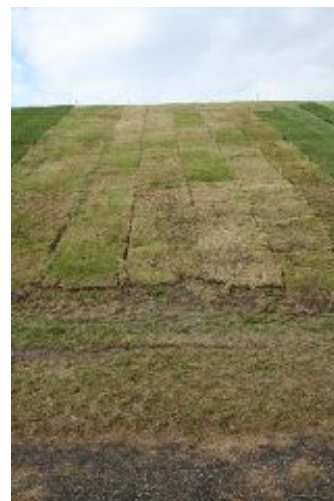
Figure 3-4: After placing the Geogrid (left), the test section was covered again with the grass from big rolls (right)

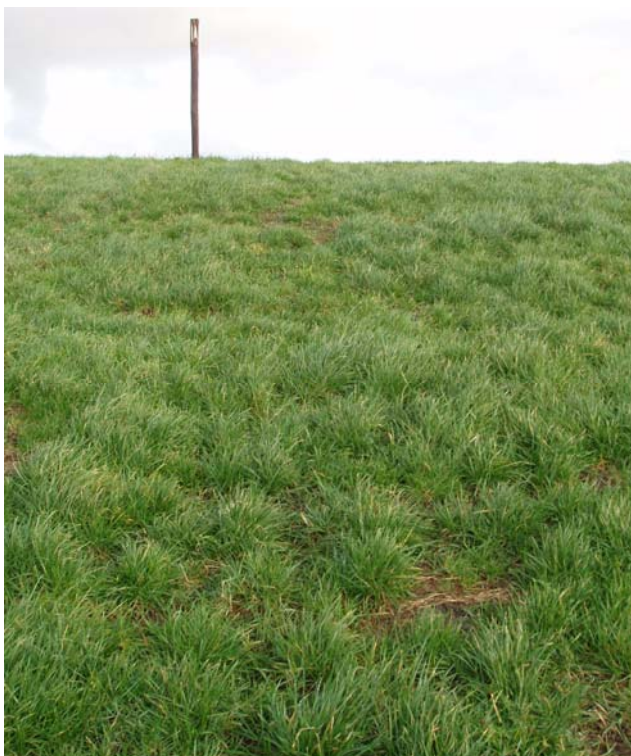
Figure 3-5: Impression of the SGR test section prior to testing (winter 2006-2007)

In spite of the intensive after-treatment, the grass suffered severely during the month of July 2006 due to the extremely hot and dry weather. However, thanks to the very wet and cool month of August and moderate temperatures in autumn, the grass recovered remarkably, resulting in an acceptable grass cover rate in October 2006 and in February 2007, see Figure 3-5 and Section 5.2. It should be remarked here that the reinforced section still showed a relatively large number of small bare spots. The unreinforced grass also showed some bare spots, but much less than could be observed at the reinforced section. In conclusion, the grass seemed to be intertwined reasonably at the SGR test section but the grass coverage was rather poor prior to the tests.

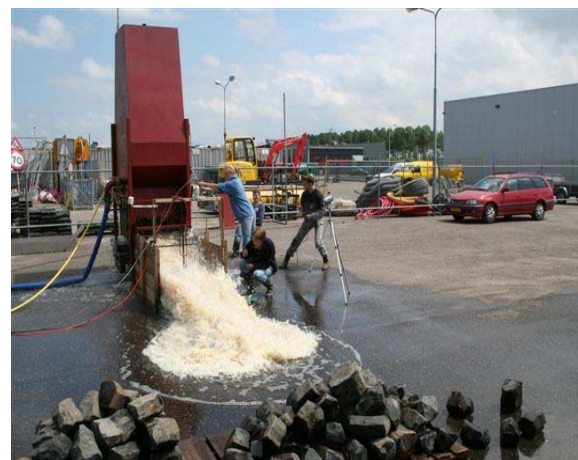
Figure 4-2: Design sketch of simulator and preliminary testing of prototype simulator

During the outflow, the pressure head decreases. Hence, the cross-section had to be wedge-shaped, as shown in Figure 4-2.

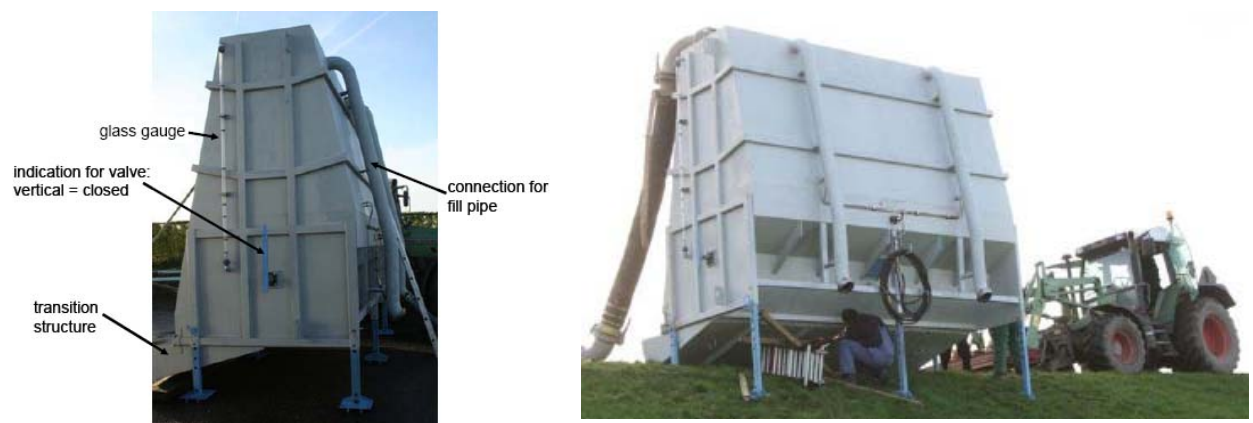
Figure 4-4: Side view of the simulator (left) and rear view (after placement for trial testing at the dyke)

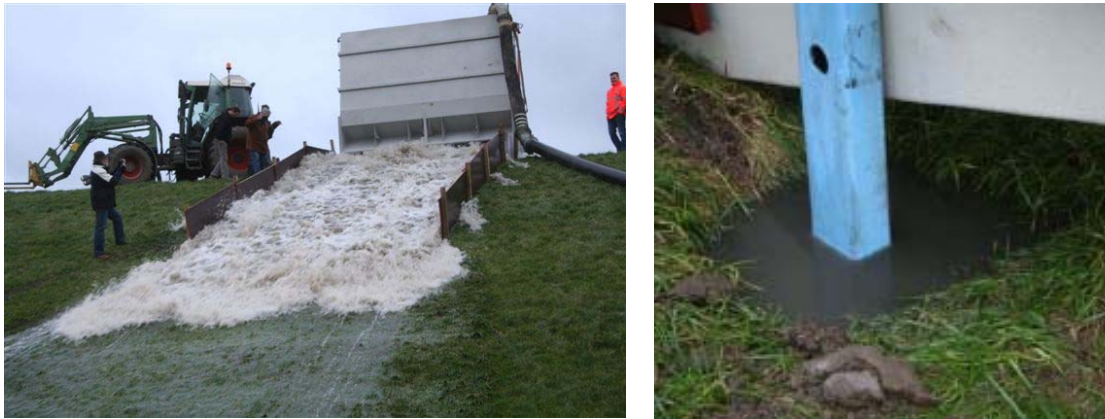
Figure 4-5: Trial testing of the wave overtopping simulator (left) and penetration of footing in subsoil (right)

The trial tests in December 2006 were successful and demonstrated the capabilities of the wave overtopping simulator, including the water circulation system. An impression of this performance is given in Figure 4-5. However, some improvements were necessary for final testing: e.g. the footings of the simulator penetrated too much into the subsoil, as is shown in Figure 4-5 as well.

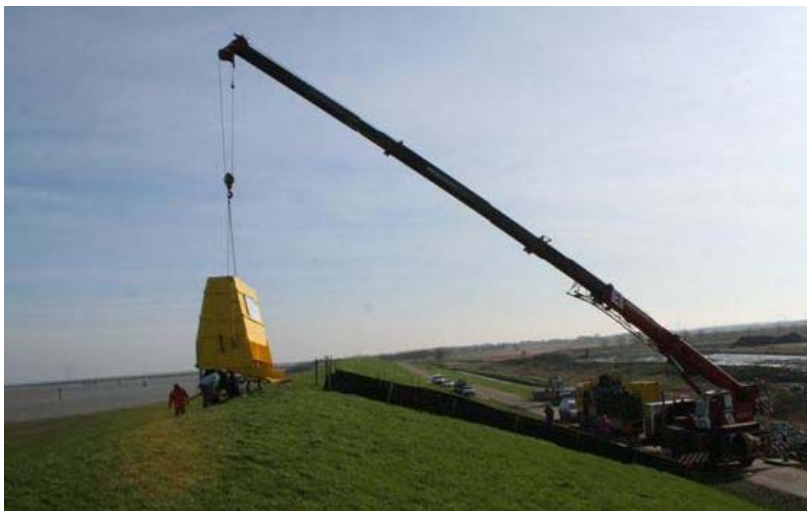
Figure 4-6: Placement of the simulator at the test site by a large crane

Placement of the simulator was done with a large crane, as shown in Figure 4-6.

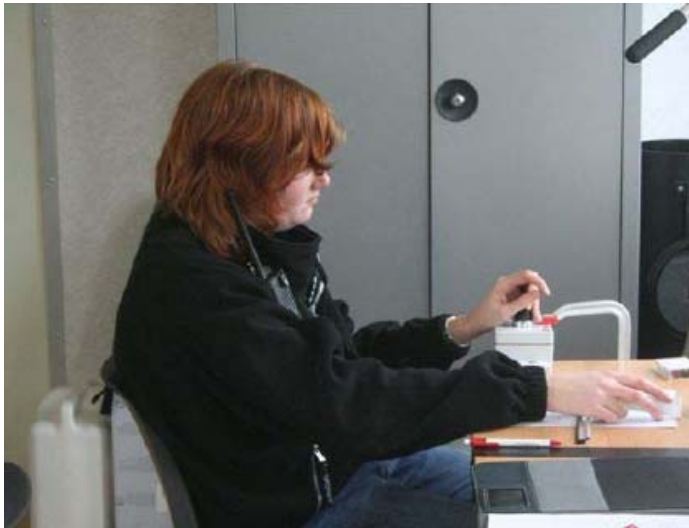
Figure 4-8: Joystick-operation of the wave simulator

The valve was opened hydraulically by means of tractor power. Initially the operation was done manually from the tractor. Prior to the actual tests however, joystick-operation was installed from the measuring cabin, as shown in Figure 4-8. This enabled accurate and well-controlled emptying of the wave simulator with the help of a list of opening times of the valve, in real time during the 6-hours period of the storm.

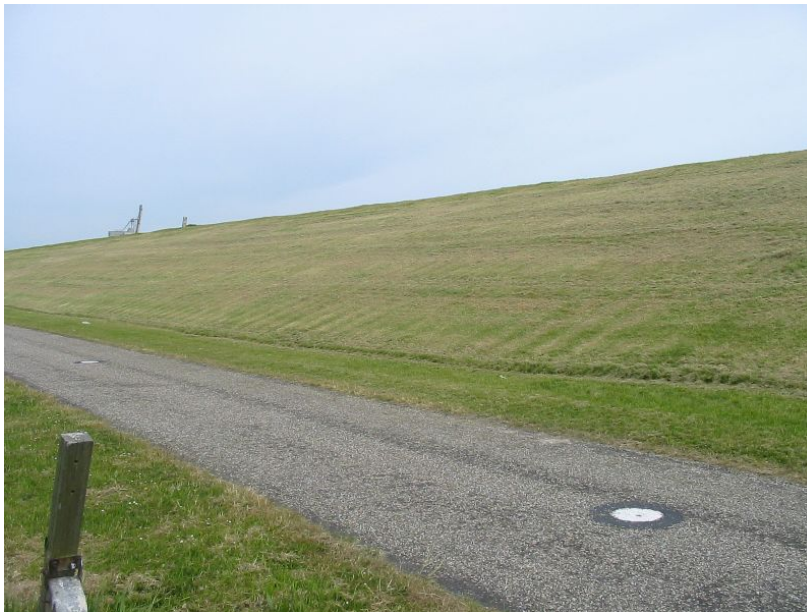
Figure 5-2: Overview of test section location before placement of the SGR (spring 2006)

The test sections are located at the dykes inner slope, which is facing the south. The slope of the dyke is 1:3. No activity of mice and mole has been observed. According to the water board the dyke slope has been pealed (in dutch: 'klepelen') every two or three weeks since the year 2000. Regarding the high mowing frequency and the abundance of nutrients because the hay is not removed, a shallow rooting grass vegetation can be expected.

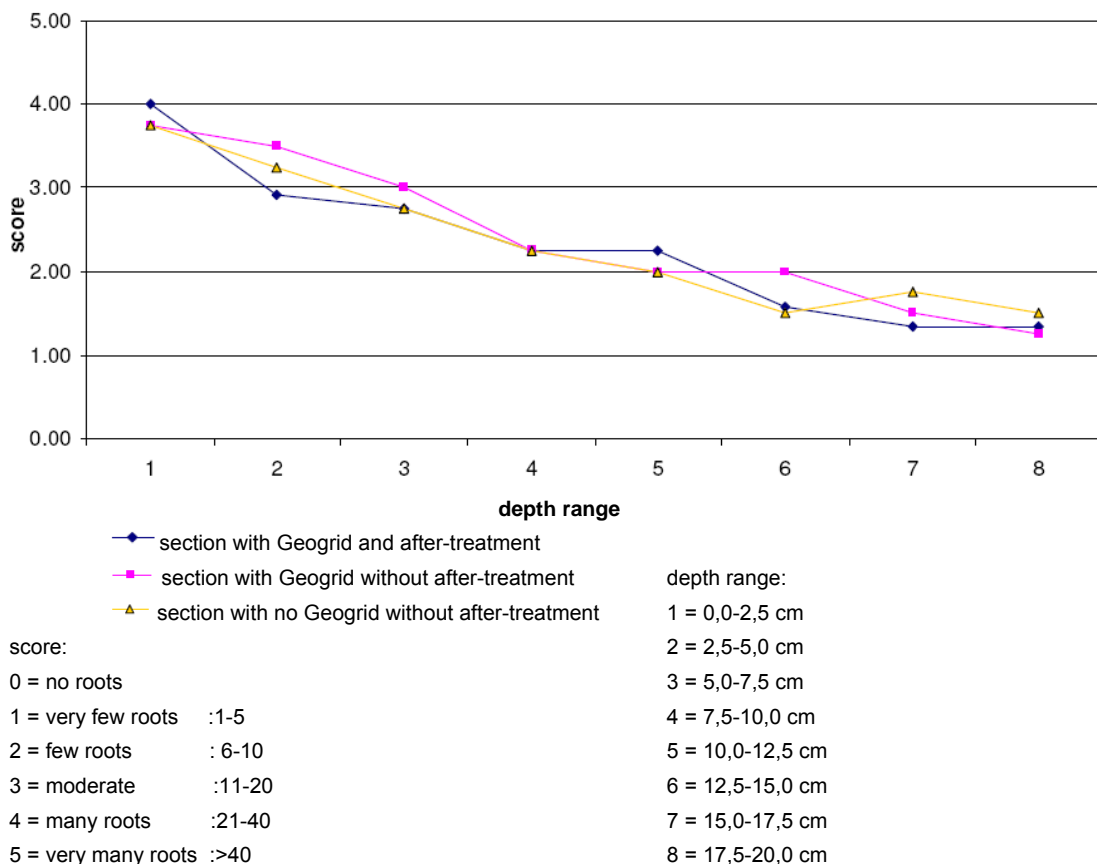
Figure 5-3: Root density February 2007 at three sections Groningen sea dyke

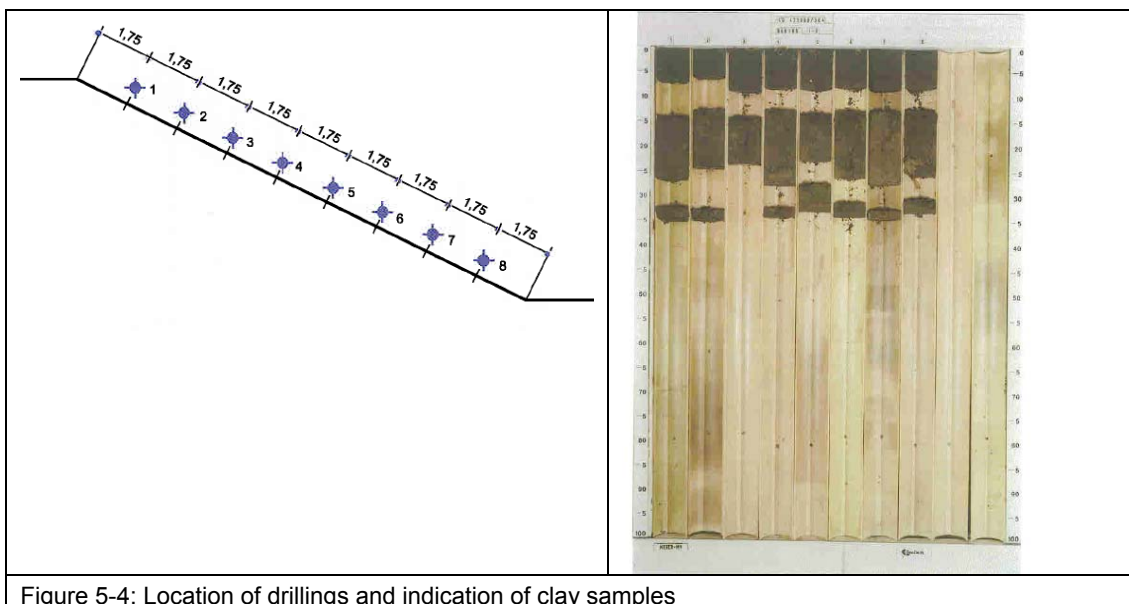
Figure 5-4: Location of drillings and indication of clay samples

A geotechnical investigation was carried out by GeoDelft within the framework of SBW 22 March 2007 (GeoDelft, 2007). Shallow drillings have been executed at 8 equidistant locations (1.75 m spacing) along the inner slope, east of the test sections. This location was outside of the influencing zone of the tests. The samples, taken from these drillings have been subject to direct shear tests, as well as to plasticity assessment by the 'Atterberg limits'. The shear tests were done at samples from a depth of about 0.30 m below the surface for drillings 1, 3, 5, 7 (in downward direction) and from a depth of about 0,10 m for drillings 2,4,6 and 8, see Figure 5-4.

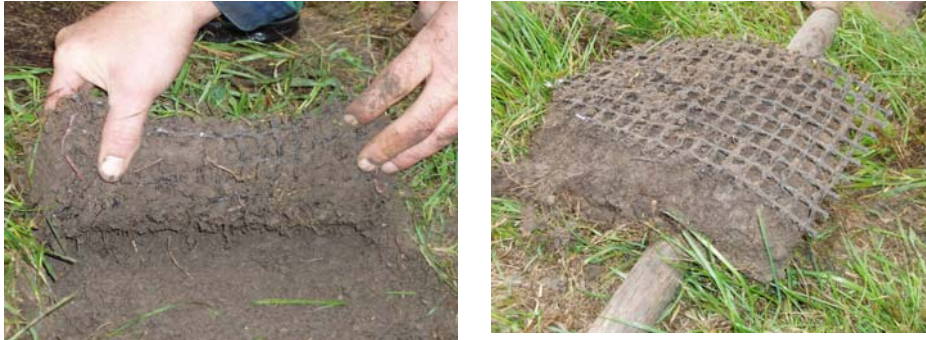
Figure 5-5: Details of dug up SGR samples of monitoring section 6 October 2006

In October 2006 the results of the dug up samples showed uncertain results. It was doubtful whether the roots would sufficiently intertwine with the Geogrid (Figure 5-5). In February 2007 the results of the dug up Smart Gras Reinforcement samples were more favourable. The (longer) roots of the grass had grown well through the Geogrid (see figure 5-6). Apparently the grass had managed to overcome the severe conditions in summer (long drought and high temperatures), favoured by the mild winter temperatures.

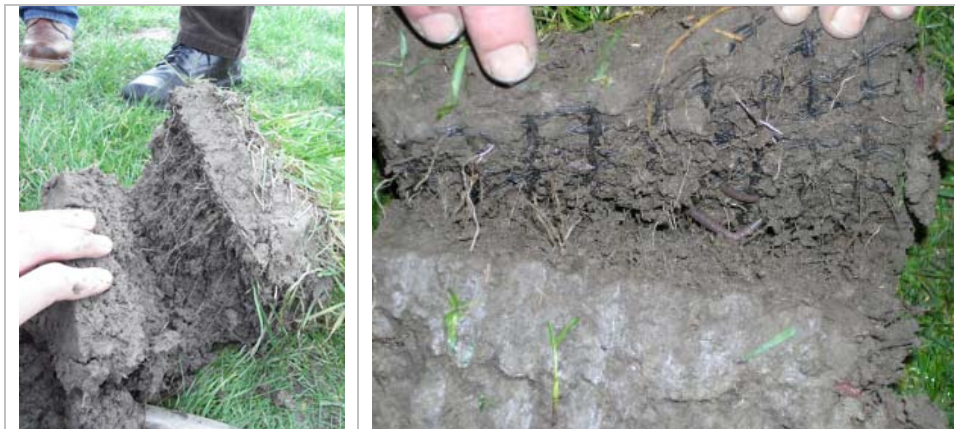
Figure 5-6: Details of dug up SGR samples of monitoring section 13 February 2007

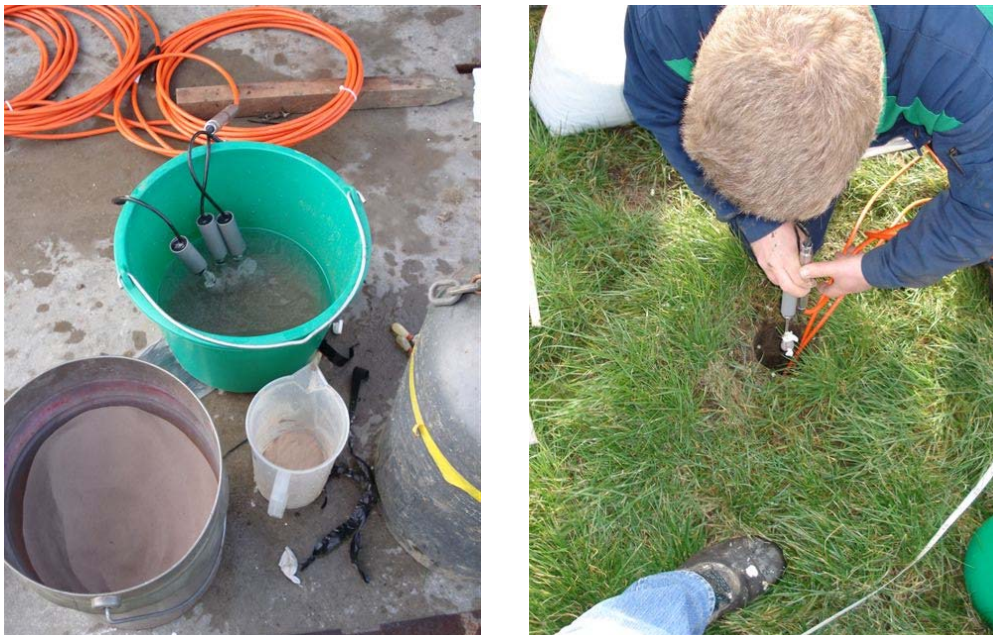
Figure 6-1: Preparations and placing of the water tension meters at the unreinforced test section

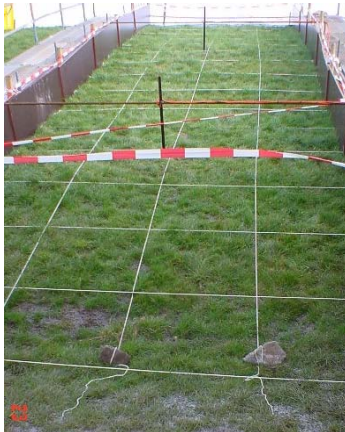
Figure 6-2a: Location of the water tension meters (poles)

An infiltration test with constant discharge was performed at 23 February 2007 at the unreinforced grass section, Figure 6-2a. Infiltration took place by pumping a constant flow in a perforated PVC-pipe, which was placed on top of the slope (Figure 6-2b). The flow rate has been measured by means of a flow meter and turned out to be constant in time at an average of 0,91 l/m/s. To determine the velocity by which the water infiltrated at 3 depths (0.4, 0.8 and 1.2 m) 2 sets of so called water tension meters were placed by GeoDelft (Figure 6-1). The locations of the two sets were at 1/3rd of the top and at 2/3rd of the top along the slope in the middle of the 4 meter wide dyke section (Figure 6-4). Each set consisted of three meters, extending 0.4, 0.8 and 1.2 m below the surface. Prior to the installation of the water tension meters, the grass cover layer was removed with a special cutting device and carefully replaced after installation of the meters. As to promote the conductivity with the surrounding soil, the ceramic tip of the meters was placed in sand with a diameter of 73 microns. The remainder of the drilling holes were sealed with clay granules that had a very low permeability after sufficient swelling (24 hours). Connecting cables were fixed to angled poles and transferred to the measuring cabin.

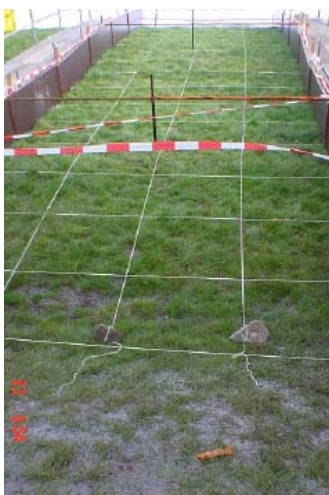
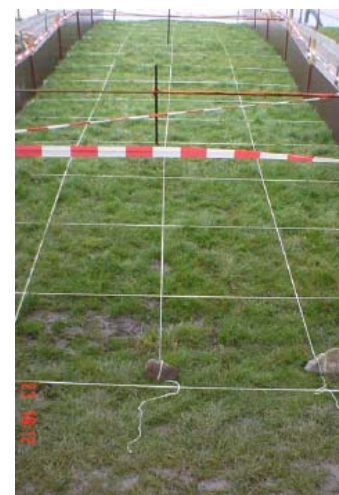
Figure 6-3a: 9:54 hr (after 1 hr)

Figure 6-3c: 16:12 hr (after 7 hrs)

The grass cover has been inspected prior, during and after the permanent infiltration test. It turned out that, apart from the existing bare spots becoming more visible by the adaptation of the grass swords to the flow, the grass cover had not been eroded by shallow sliding such as ‘turf sliding’ (this is sliding of a major part of the grass cover), see Figures 6-3a, 6-3b and 6-3c. After the test no damage such as cracks or surface erosion was visible at the outflow position at the inner crown line as well. During the test some loose ground particles were washed away from the slope surface. After the test the more heavy sand particles could be found in a small amount at the toe of the dyke.

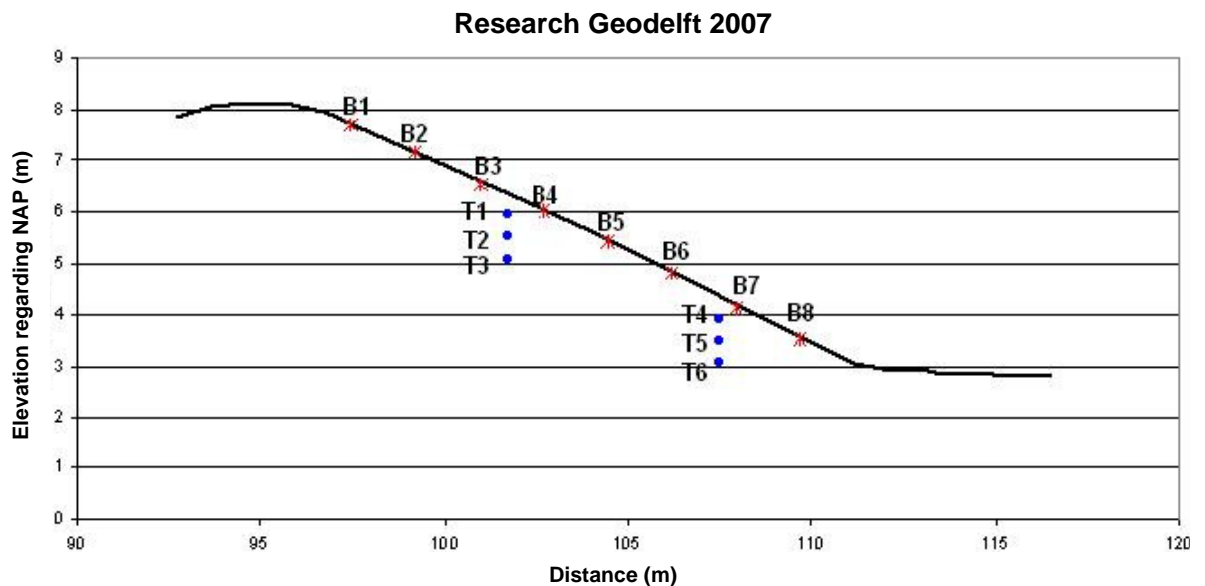
Figure 6-4: location of the water tension meters (T1 to T6) in the dyke (un-reinforced test section)

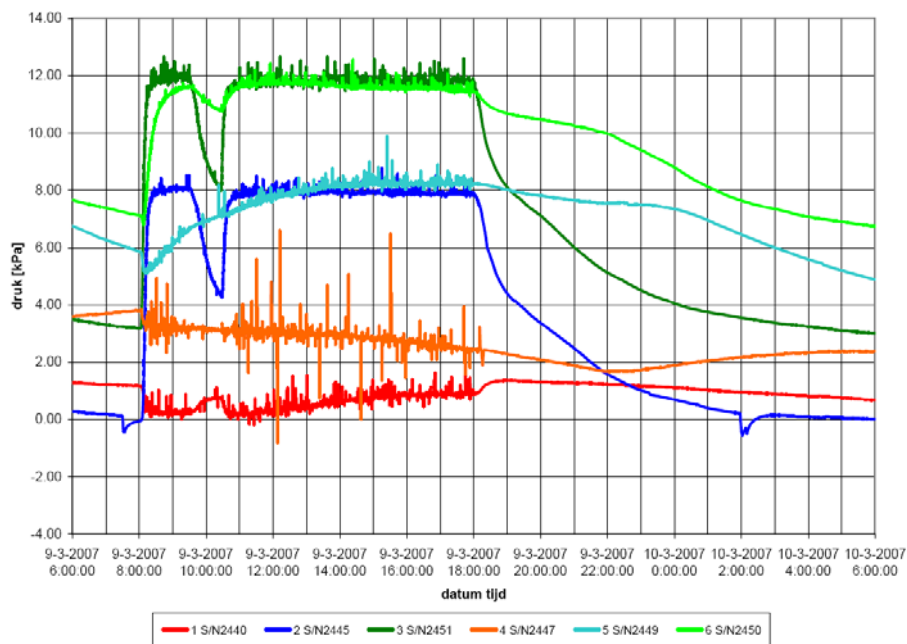
Figure 6-5: Illustrative result of the water pressure measurements

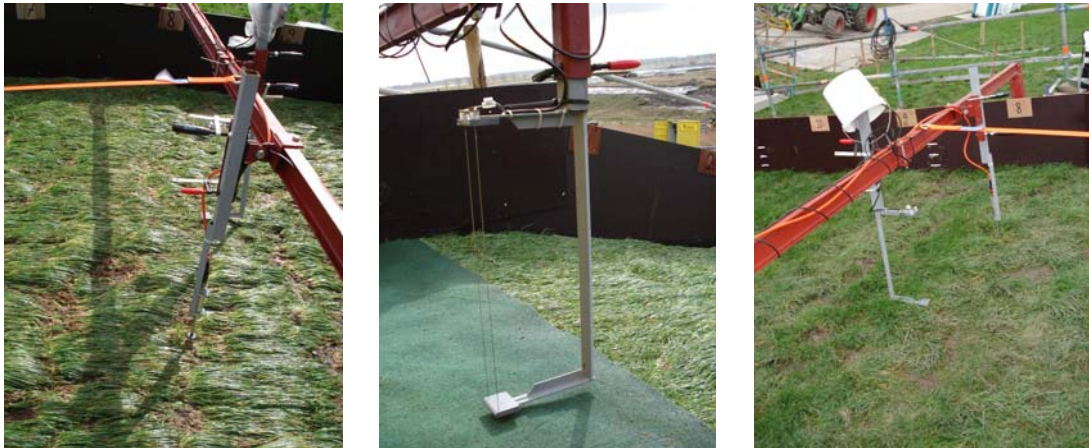
Figure 7-1: 1) velocity meter (EMS), 2) wave thickness meter (GHM) and 3) both meters fixed to a measuring frame

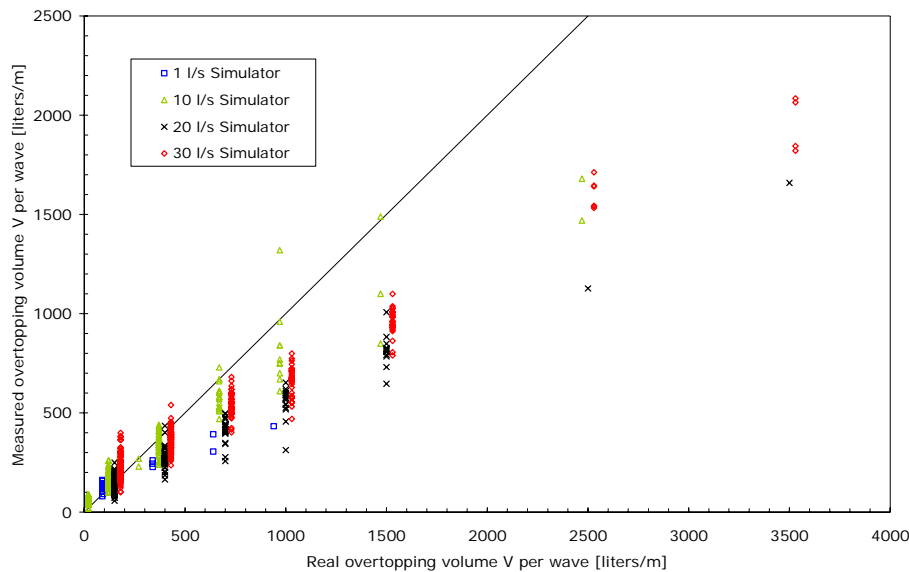
Figure 7-4: Calculated overtopping volumes from measurements versus actual volumes (unreinforced section)

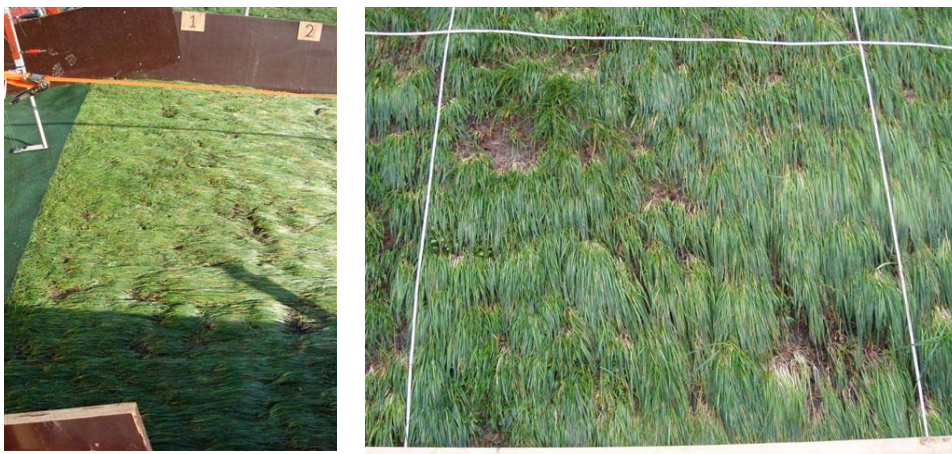
Figure 8-1: Example of a side-view picture taken and of a detailed picture at each square metre dyke after completion of the test.

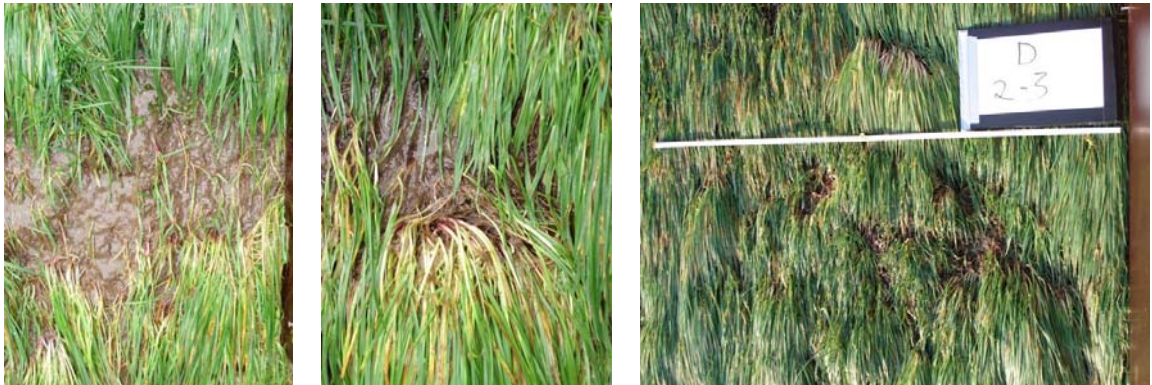
Figure 9-1: Detailed photographs of some bare spots after the 1 l/s/m test at the unreinforced test section

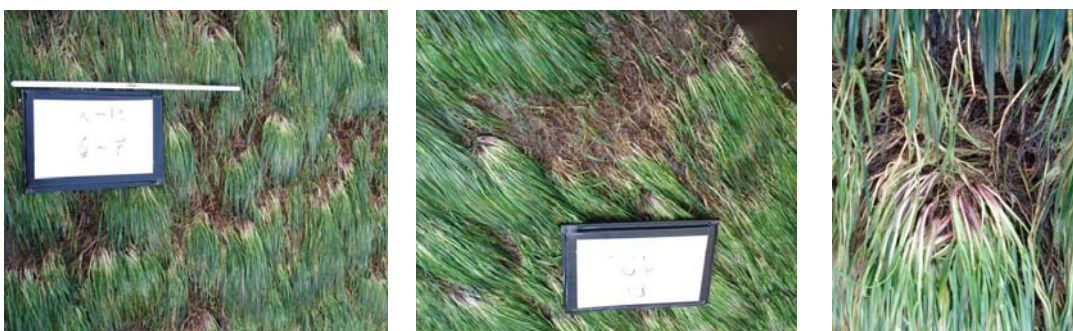
Figure 9-3: Detailed photographs of some bare spots after the 20 l/s/m test at the unreinforced test section

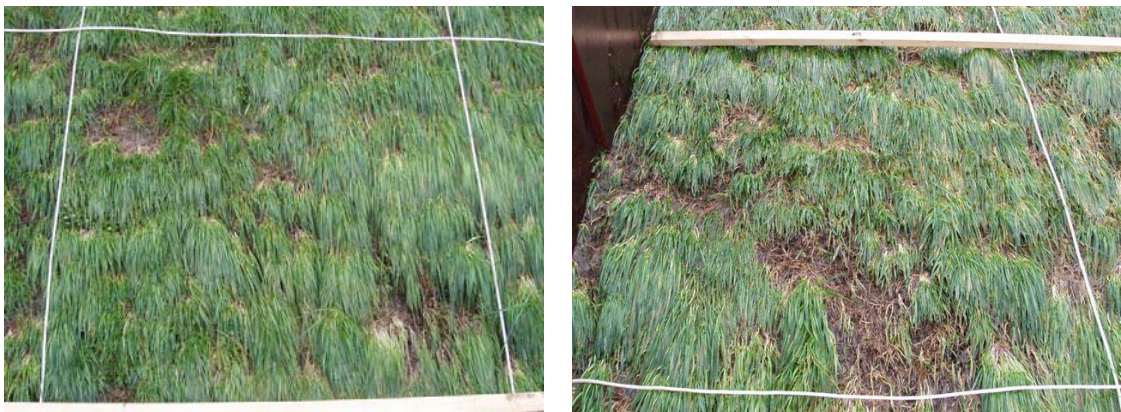
Figure 9-5: Detailed photographs of some bare spots after the '50' l/s/m test at the unreinforced test section

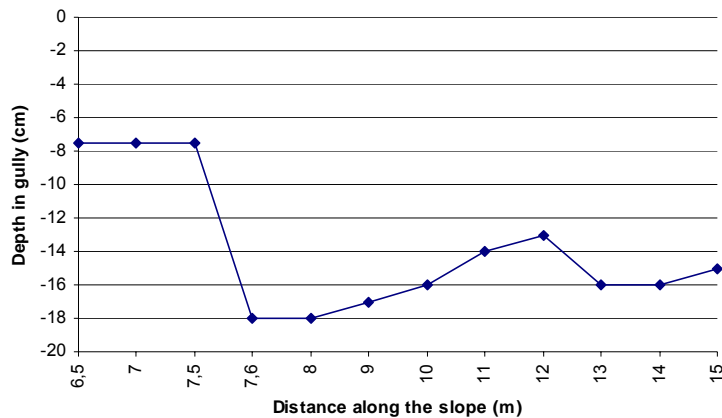
Figure 9-6: Measured erosion depths in the gully behind the artificially damaged spot (1 m x 1 m x 0,05m) at the unreinforced test section: the location where the gully starts is at 6.5 m

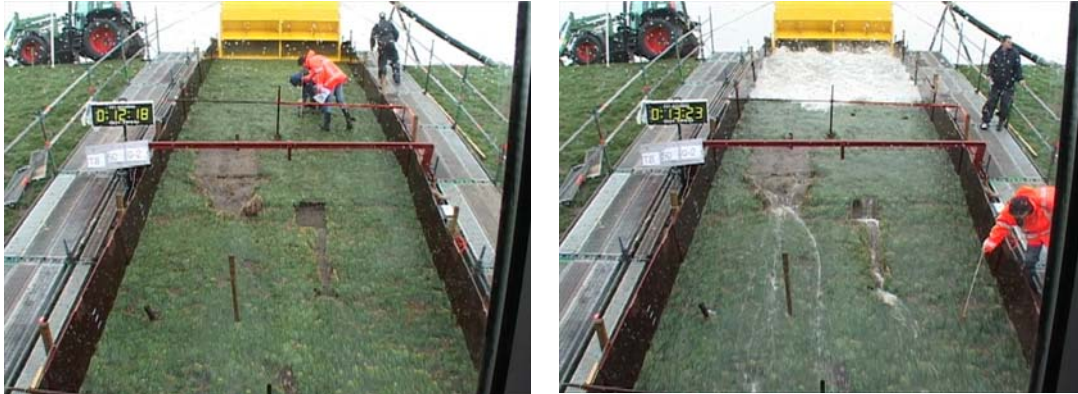
Figure 9-8: Start of the gully formation downstream of the damaged areas

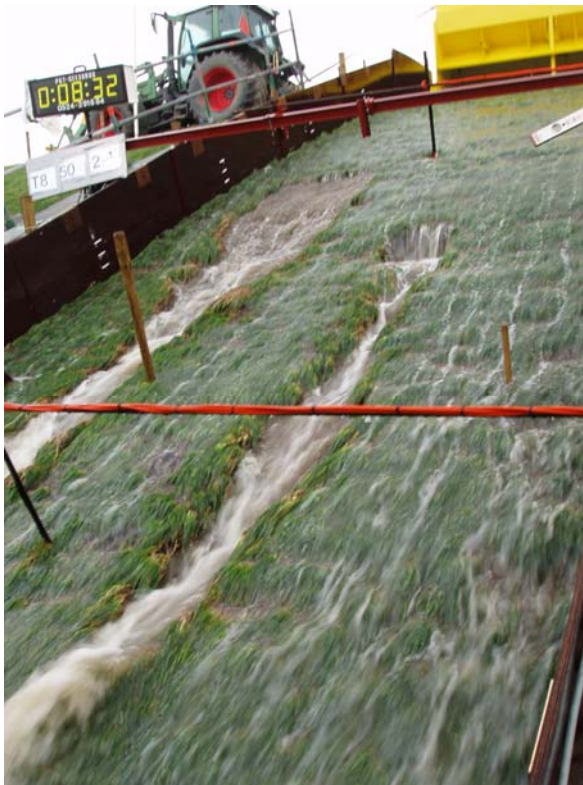
Figure 9-9: Typical flow concentration at the gullies

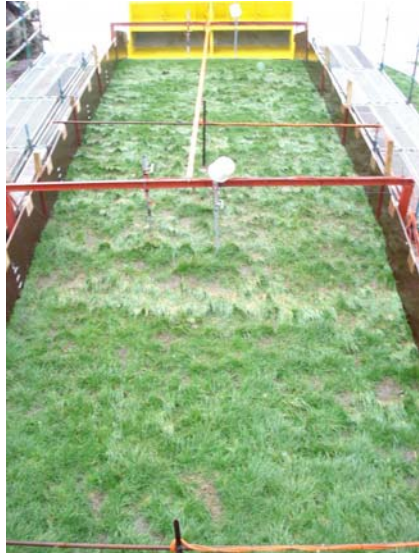
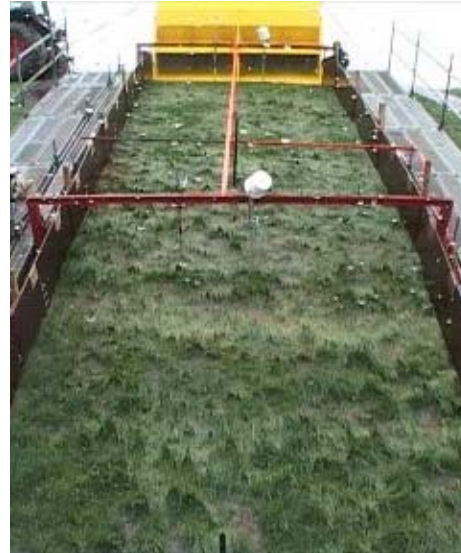
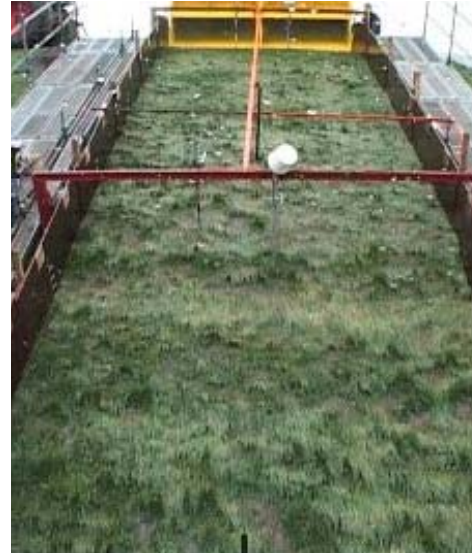
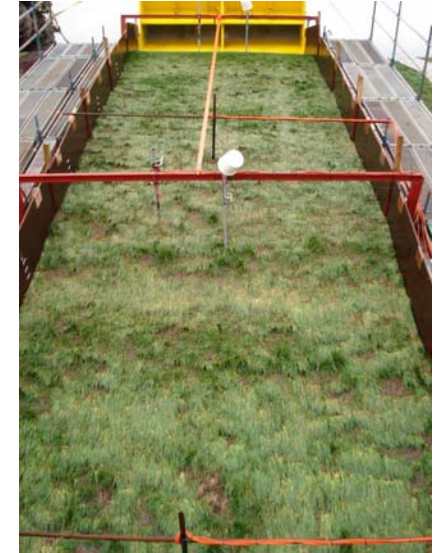
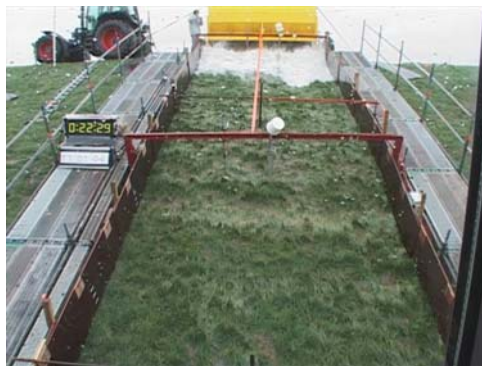
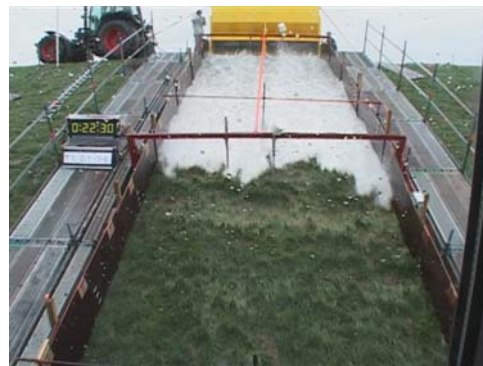
T1

Figure 9-10: Situation during overtopping of 0,1 l/s/m. The biggest wave shown here had a volume of 0.7 m³ per m width

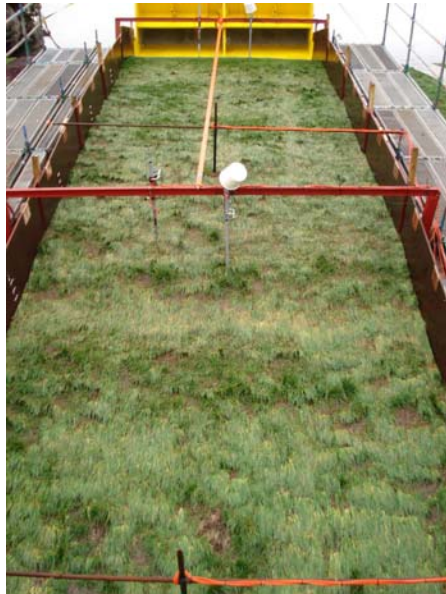
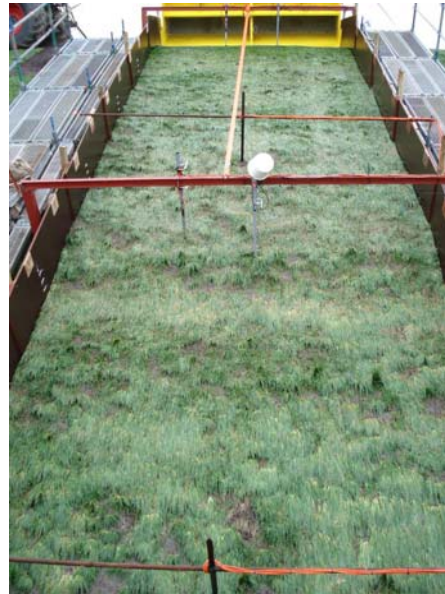
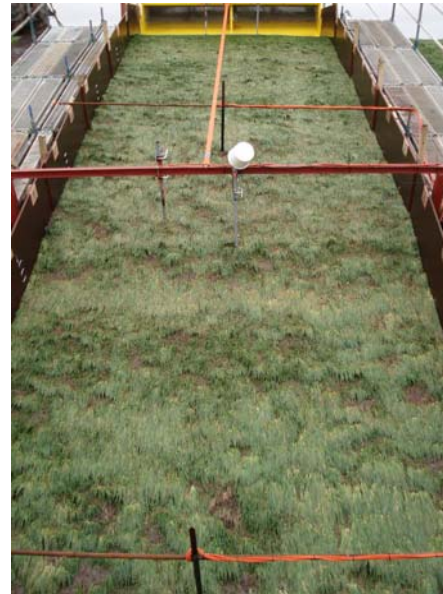
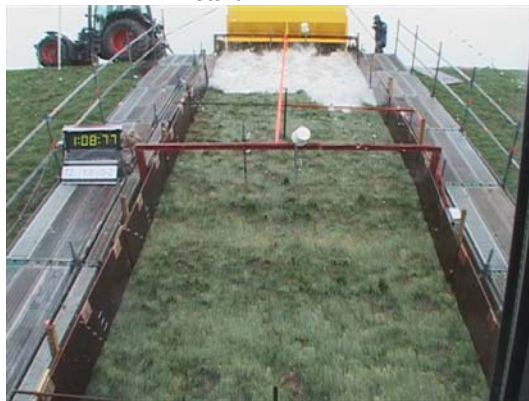
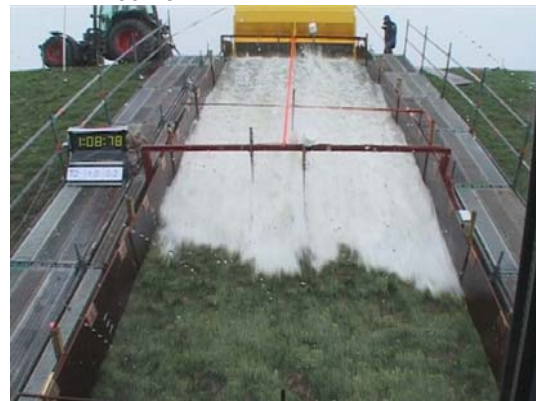
T2

Figure 9-11: Situation during overtopping of 1 l/s/m. The biggest wave shown here had a volume of 1 m³ per m width

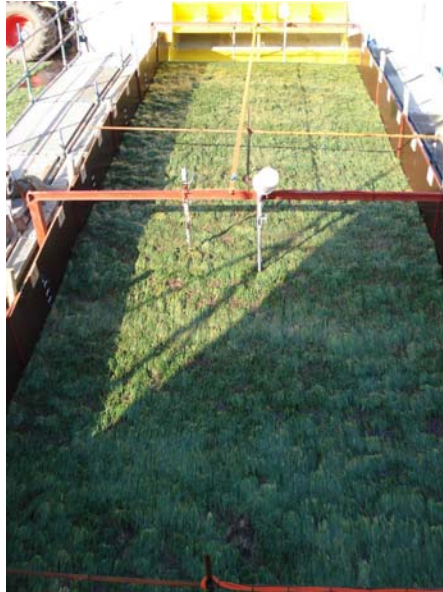
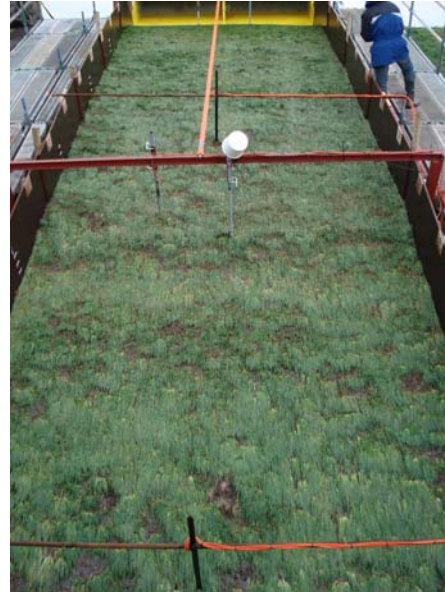
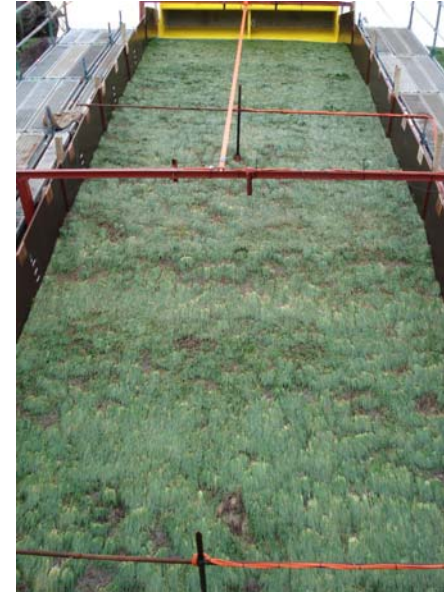
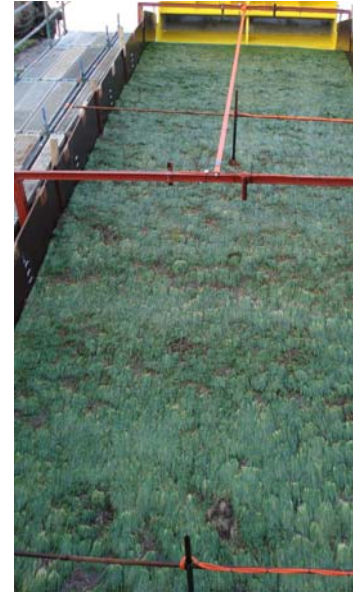
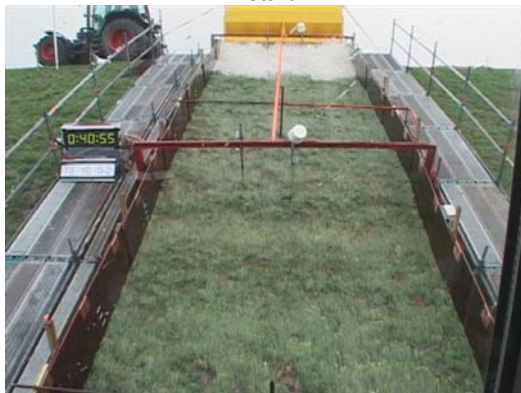
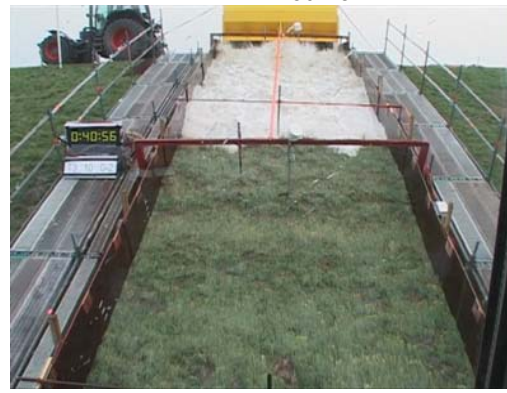
T3

Figure 9-12: Situation during overtopping of 10 l/s/m. The biggest wave shown here had a volume of 2.5 m³ per m width
