Workpackage 3: Development of Alternative Overtopping-Resistant Sea Defences

*Phase 3:
Wave Overtopping Erosion Tests at
Groningen Sea Dyke*

Final Report

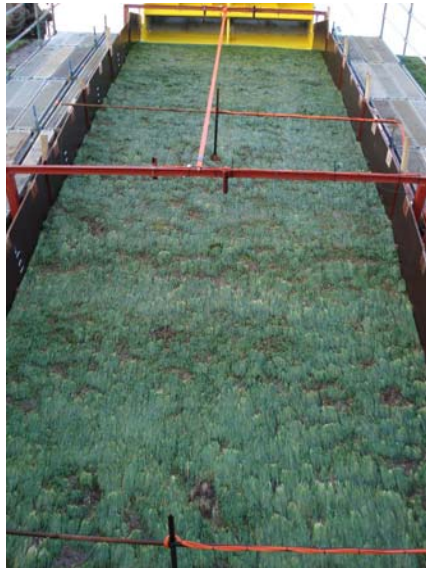
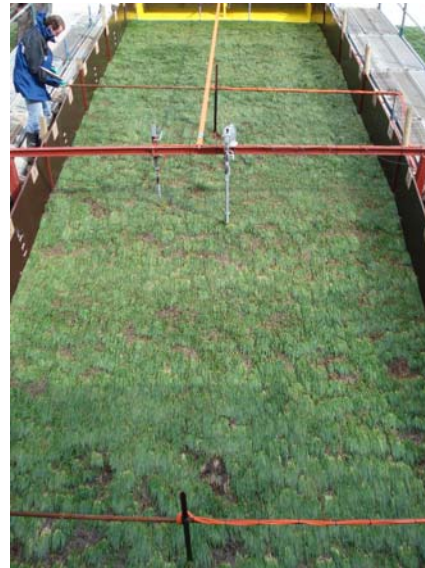
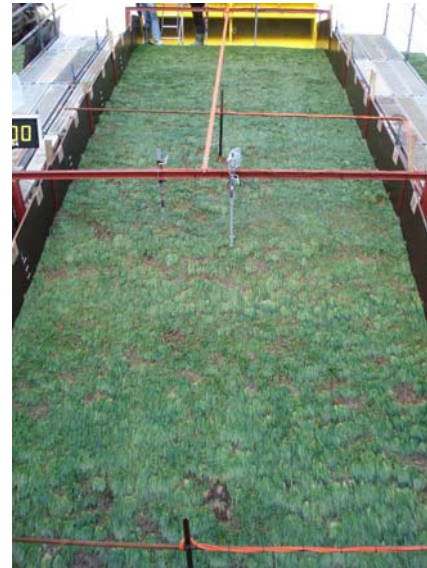
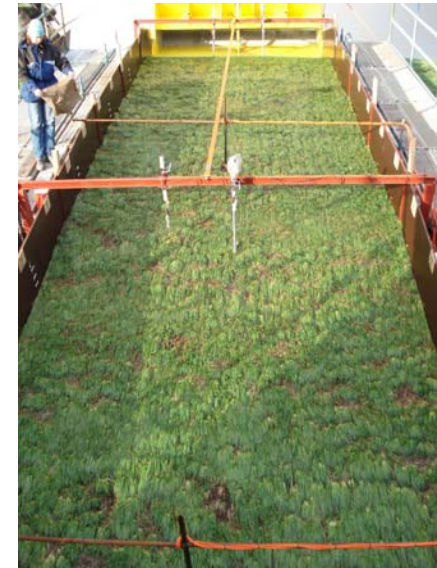
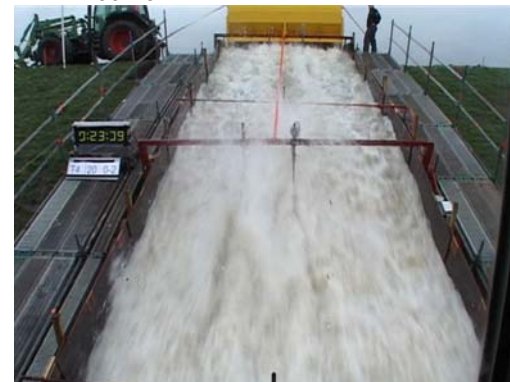
T4

Figure 9-13: Situation during overtopping of 20 l/s/m. The biggest wave shown here had a volume of 3.5 m³ per m width.

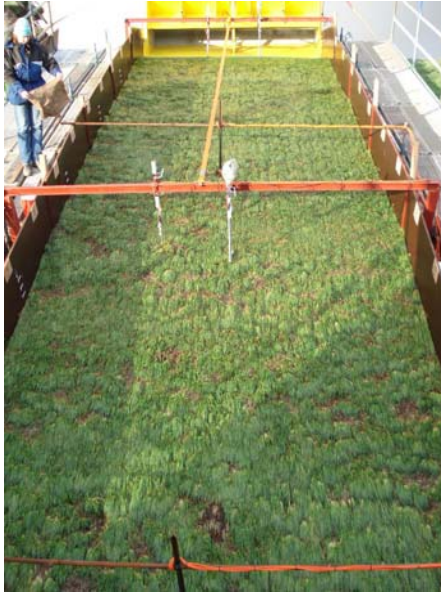
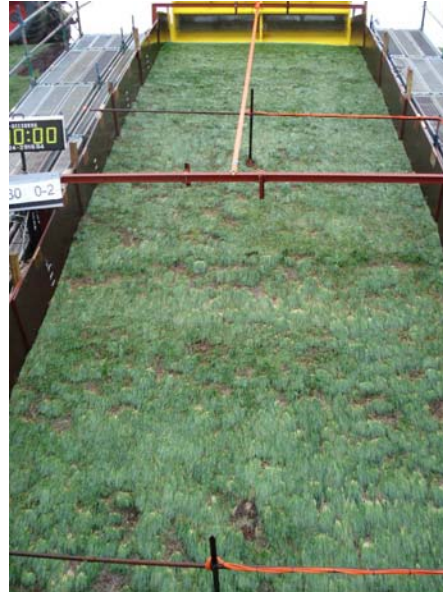
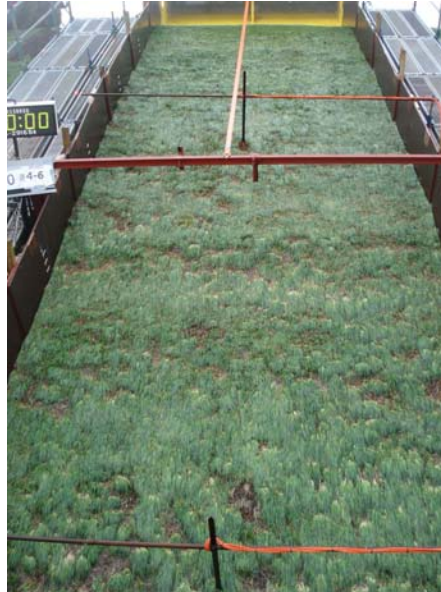
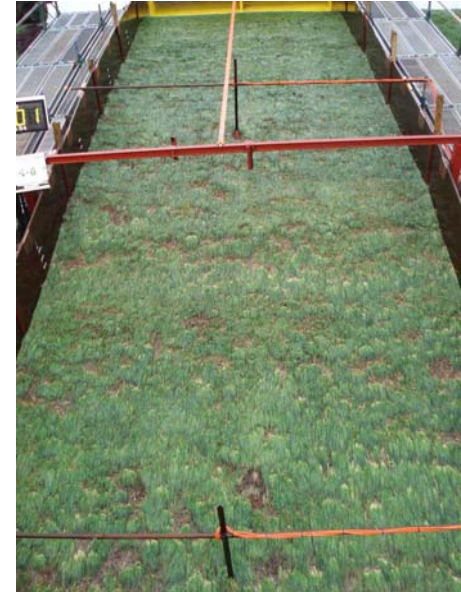
T5

Figure 9-14: Situation during overtopping of 30 l/s/m. The biggest wave had a volume of 3.5 m³ per m width (see Figure 9-10)

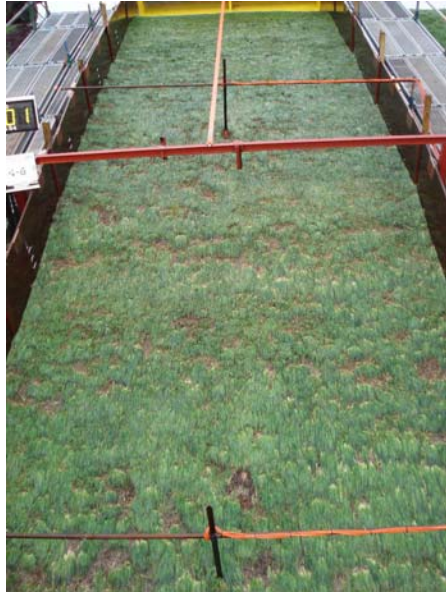
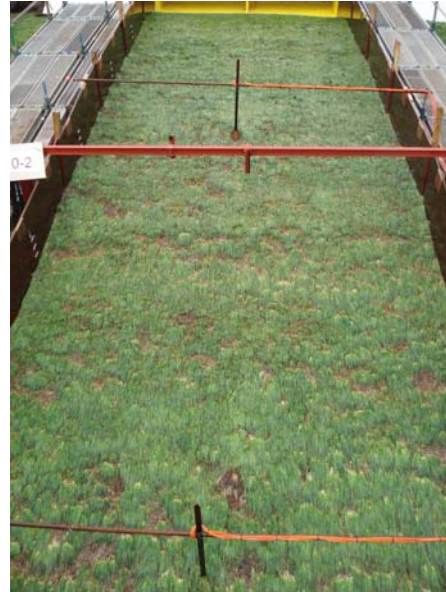
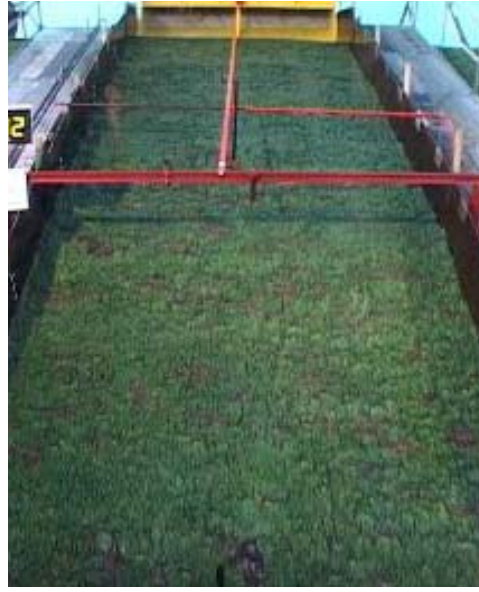
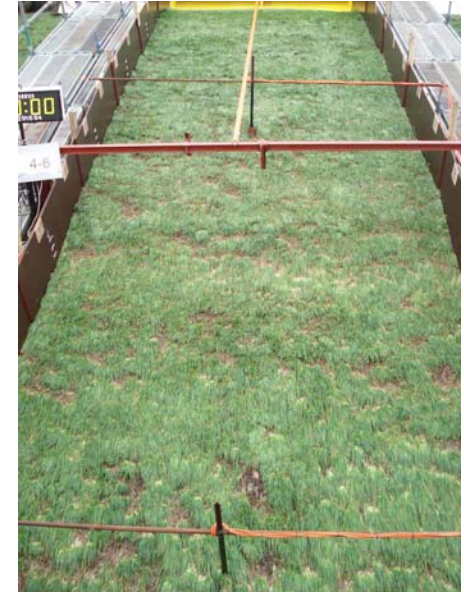
T7

Figure 9-15: Situation during overtopping of '50' l/s/m. The biggest wave had a volume of 3.5 m³ per m width (see Figure 9-10)

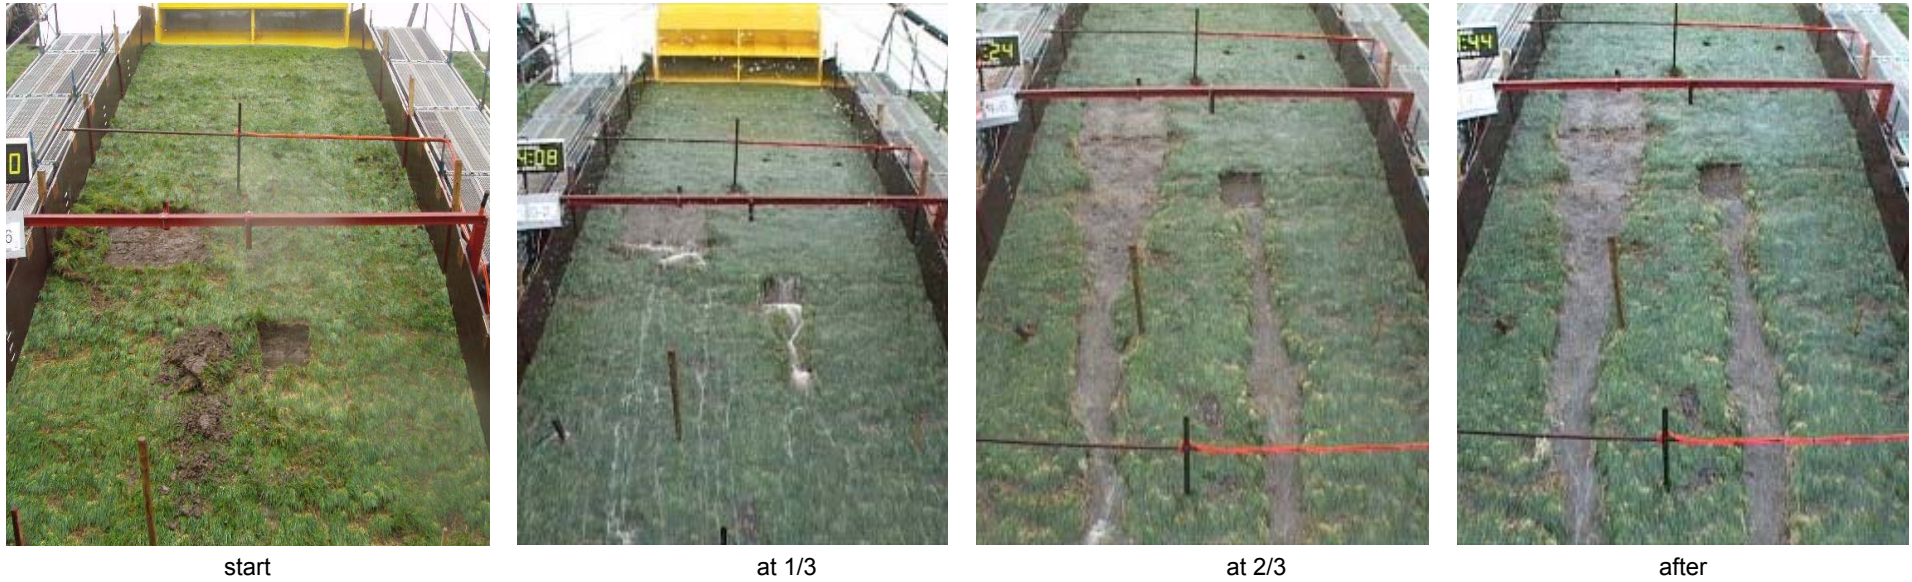
Figure 9-16: Situation during overtopping of '50' l/s/m with initial damage. The biggest wave had a volume of 3.5 m^3 per m width (see Figure 9-10)

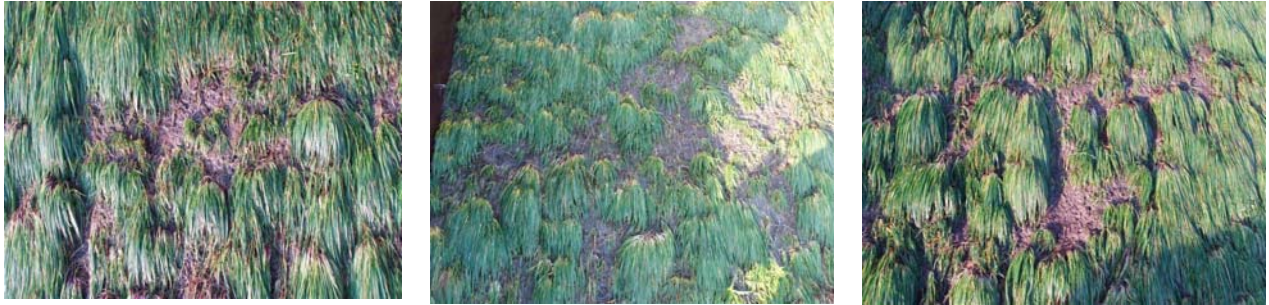
Figure 10-2: Detailed photographs of some bare spots after the 10 l/s/m test at the reinforced test section

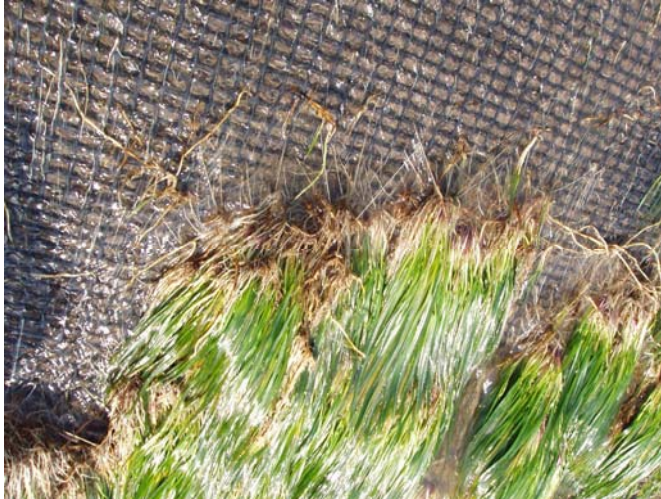
Figure 10-6: Anchoring of grass roots to the Geogrid near the artificially removed grass cover

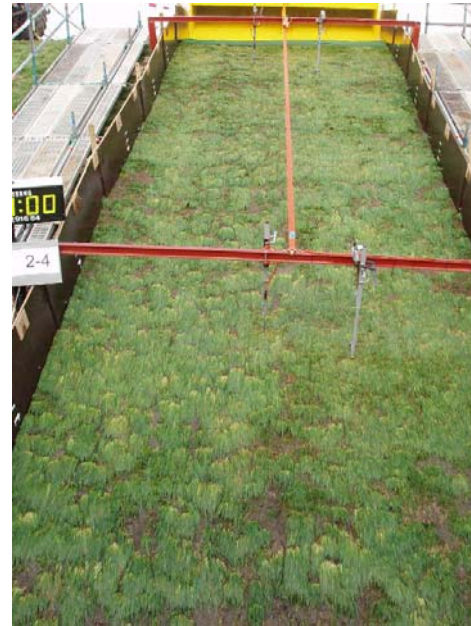
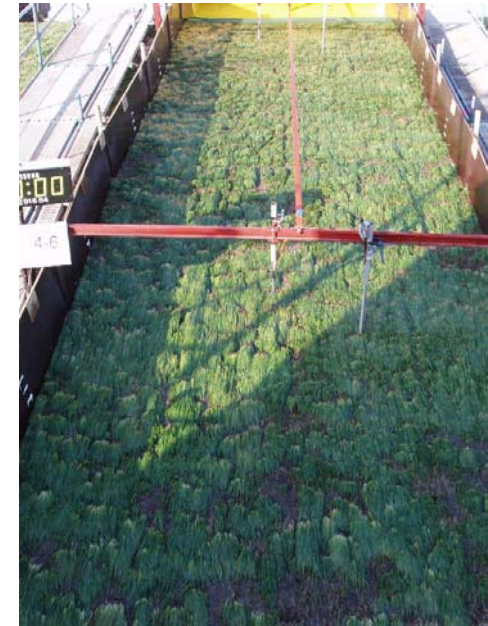
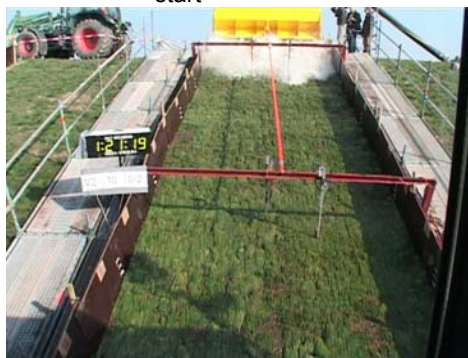
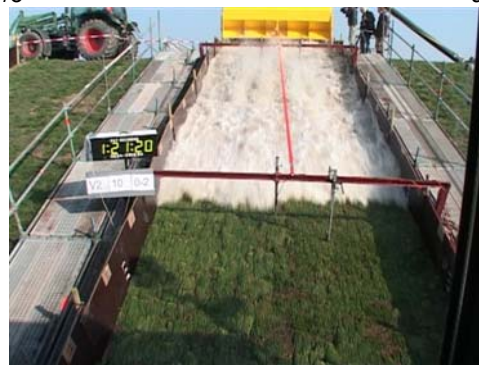
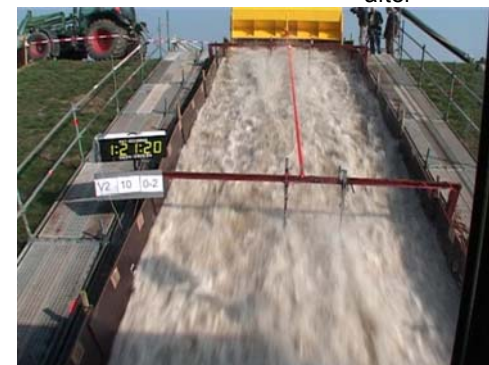
V2

Figure 10-7: Situation during overtopping of 10 l/s/m. The biggest wave shown here had a volume of 2.5 m³ per m width

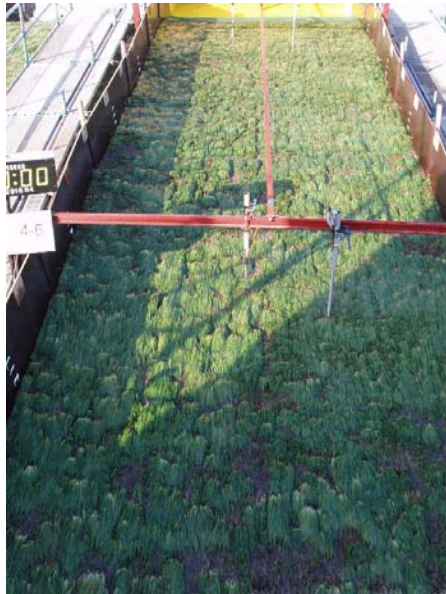
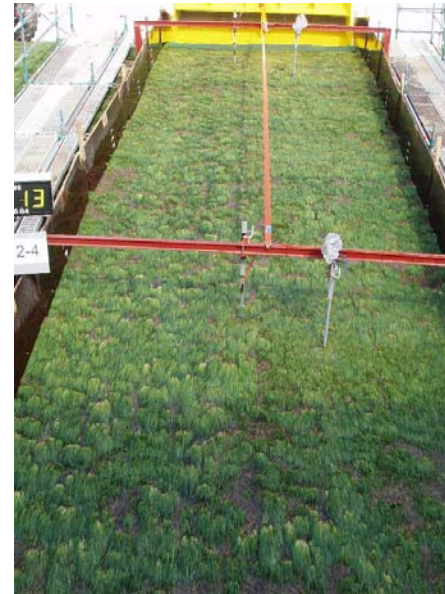
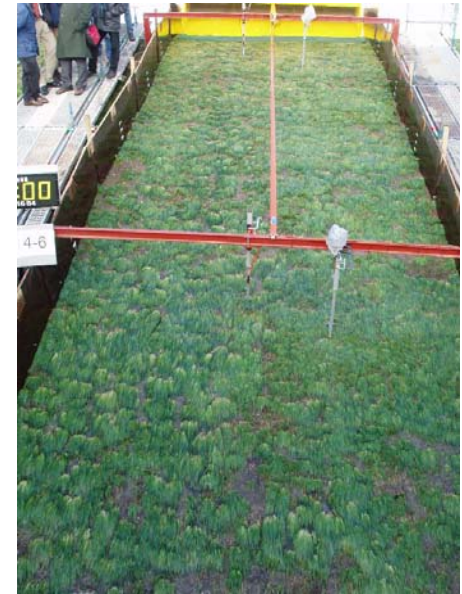
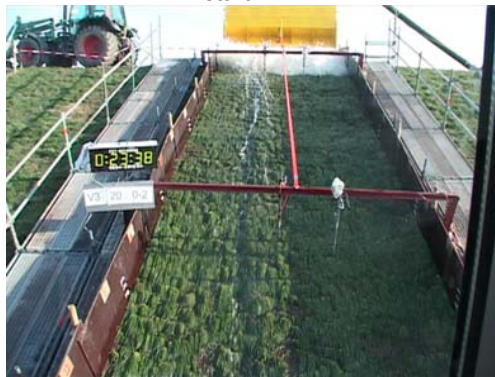
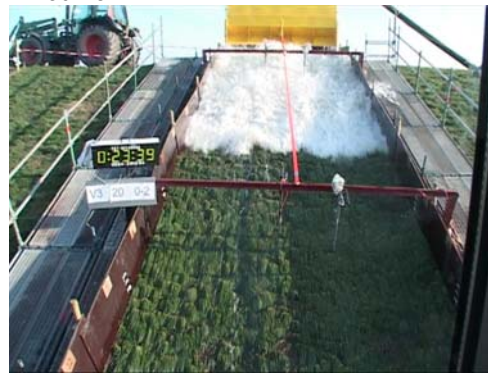
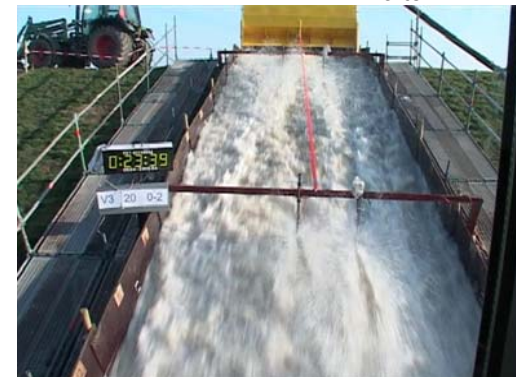
V3

Figure 10-8: Situation during overtopping of 20 l/s/m. The biggest wave shown here had a volume of 3.5 m³ per m width

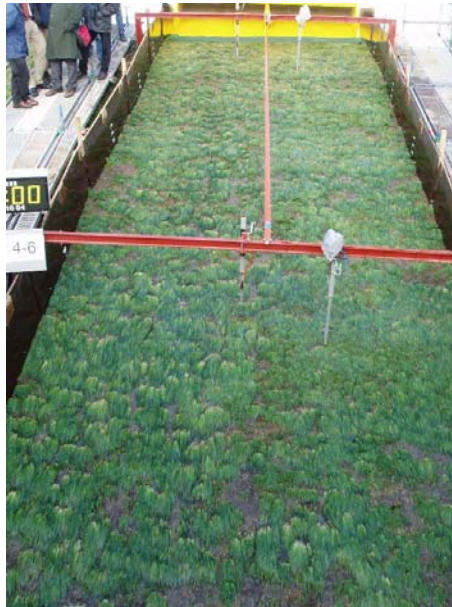
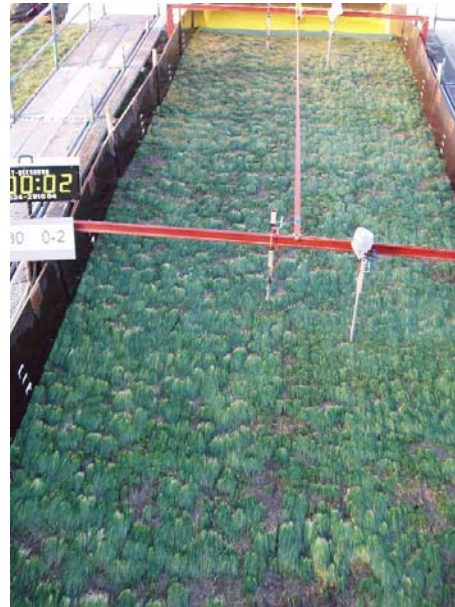
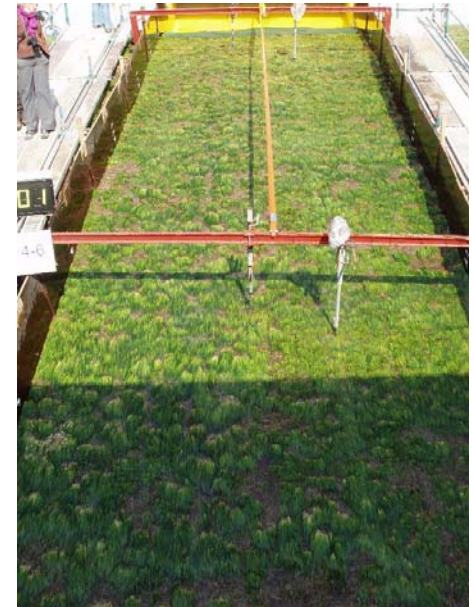
V4

Figure 10-9: Situation during overtopping of 30 l/s/m. The biggest waves had a volume of 3.5 m³ per m width (see Figure 10-8)

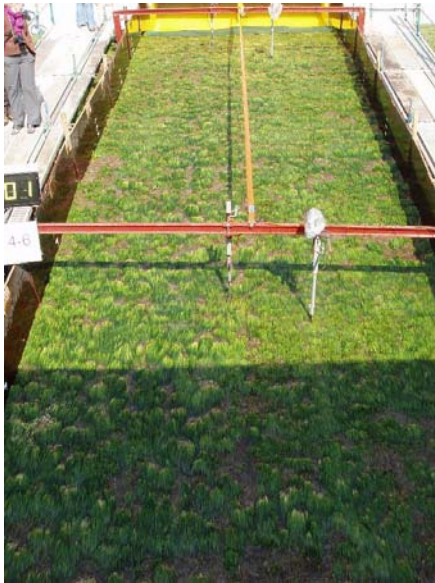
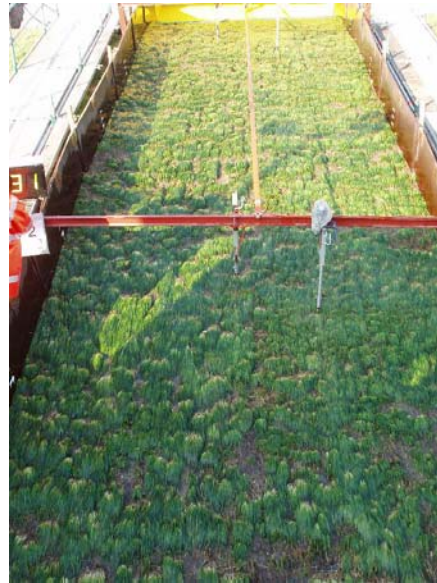
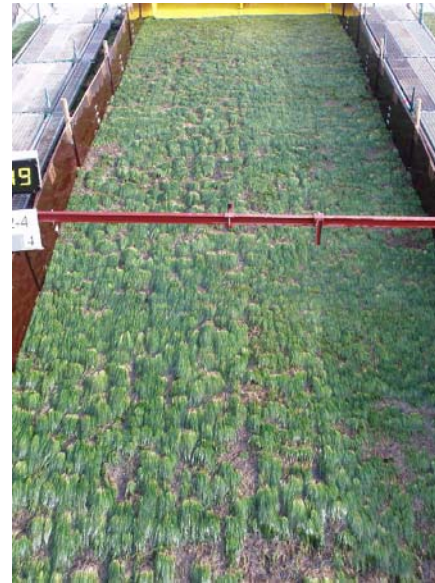
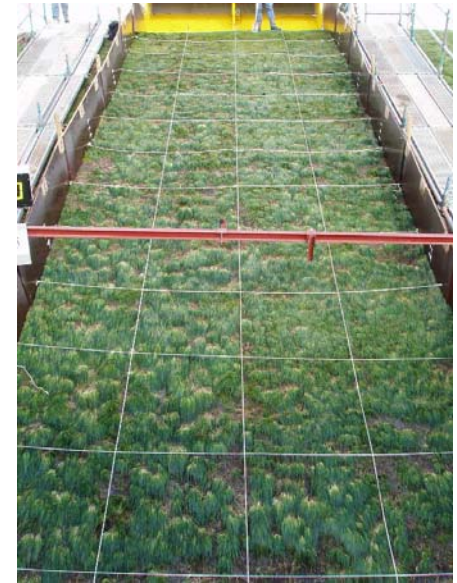
V5

Figure 10-10: Situation during overtopping of '50' l/s/m. The biggest waves had a volume of 3.5 m³ per m width (see Figure 10-8)

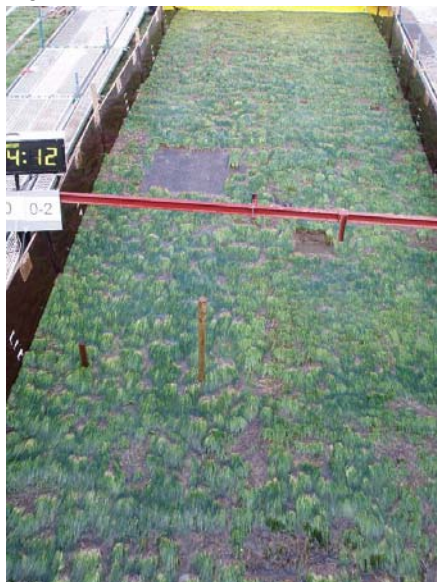
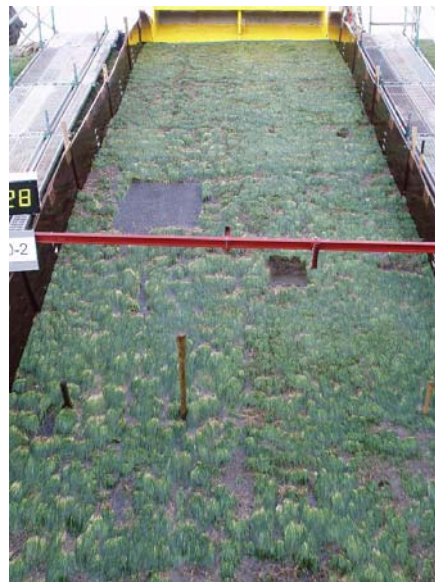
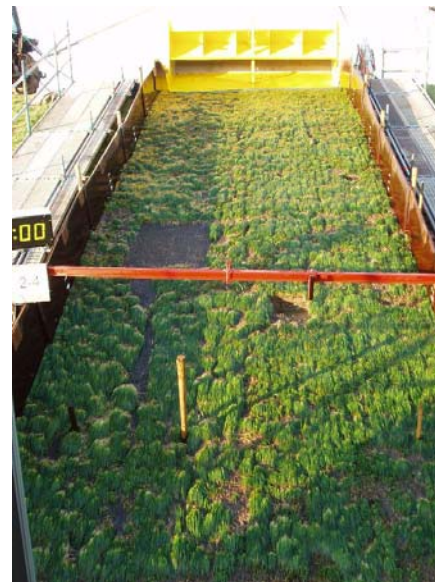
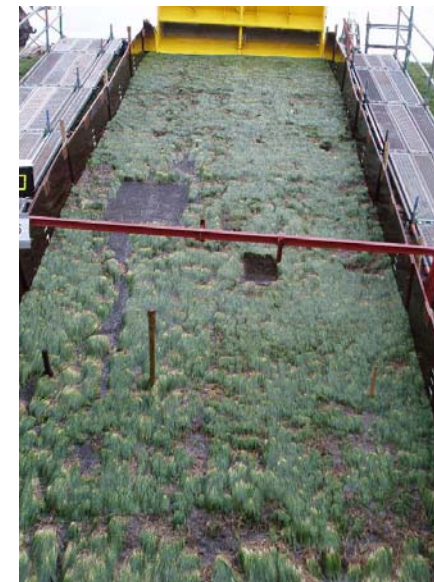
V6

Figure 10-11: Situation during overtopping of '50' l/s/m with initial damage. The biggest waves had a volume of 3.5 m^3 per m width (see Figure 10-8)

The progression of the erosion can be seen from Figure 10-11.

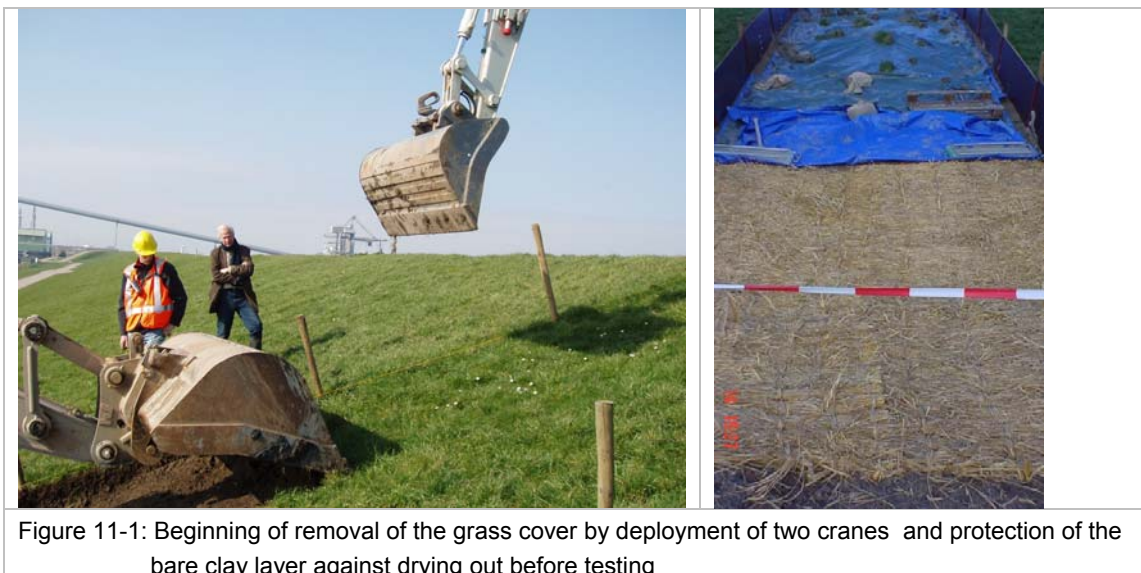
Figure 11-1: Beginning of removal of the grass cover by deployment of two cranes and protection of the bare clay layer against drying out before testing

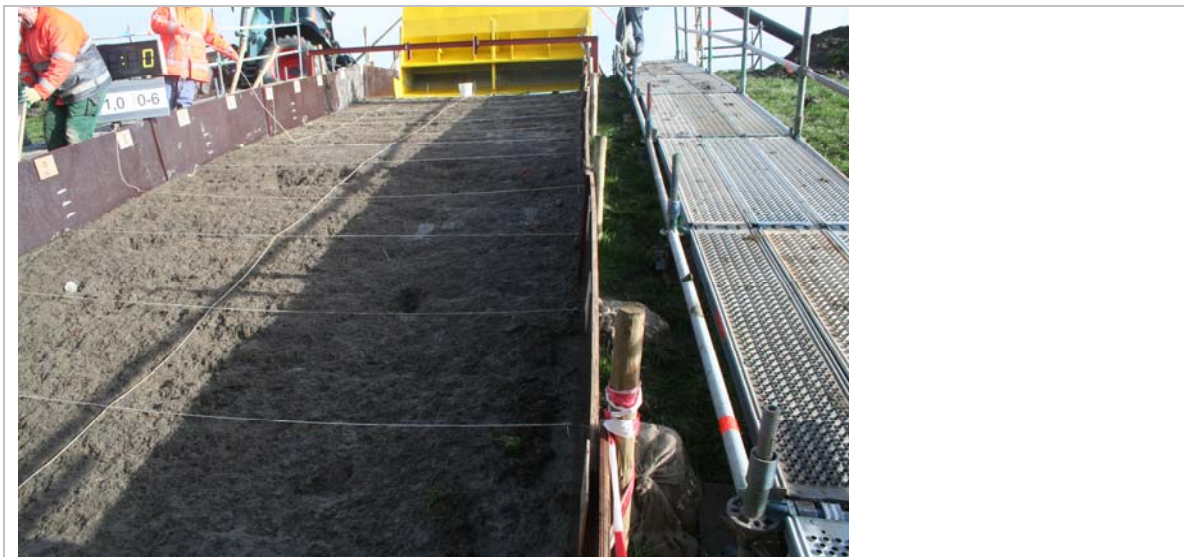
Figure 11-2: Impression of starting erosion of bare clay surface after interrupted 0.1 l/s/m test

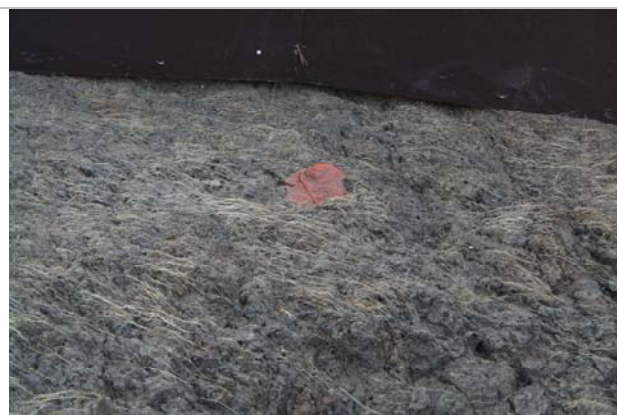
Figure 11-4: Remains of the root system becoming visible after some surface erosion

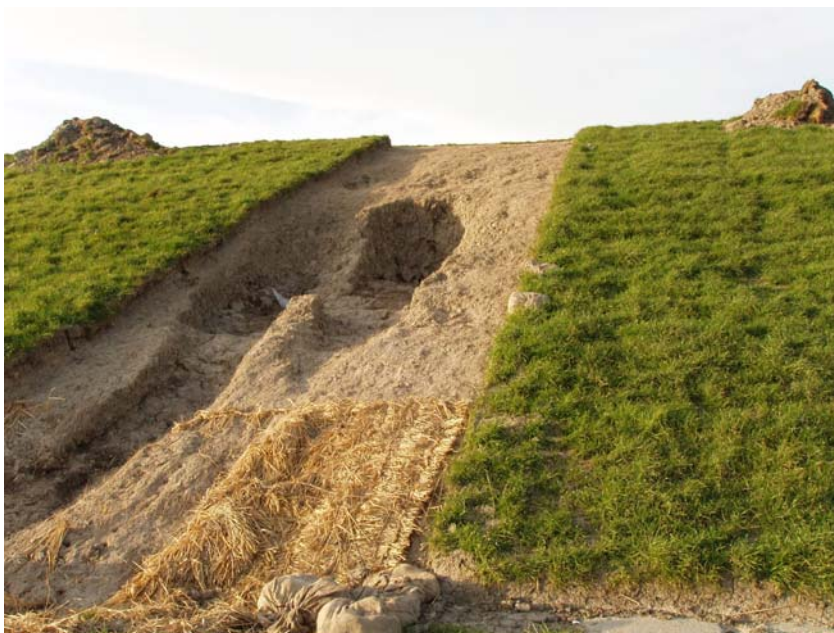
Figure 11-5: Deep scour holes after wave overtopping of 10 l/s/m

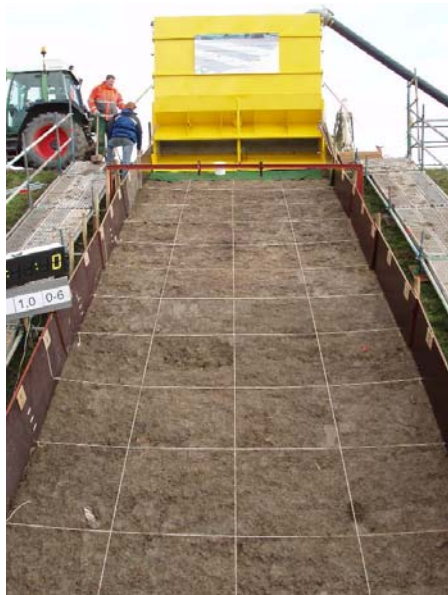
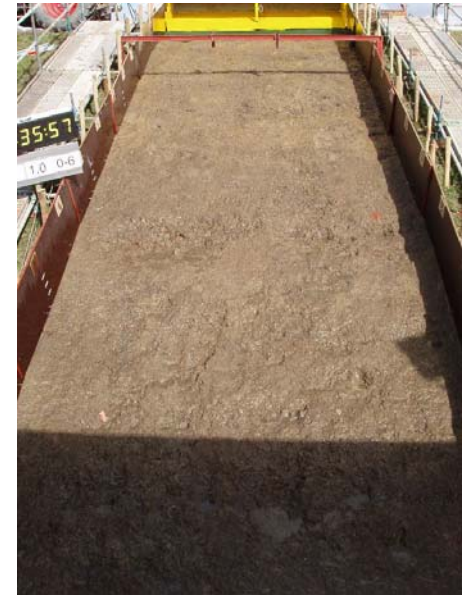
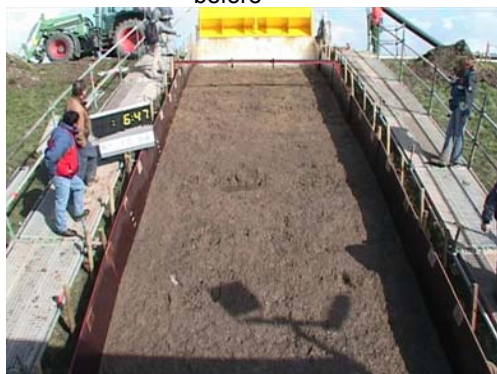
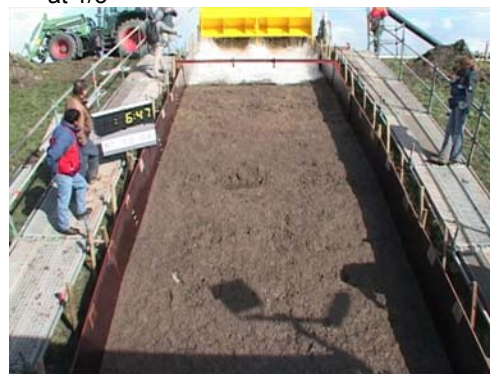
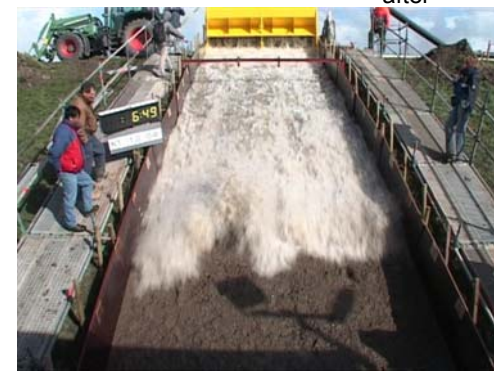
Figure 11-8: Situation during overtopping of 1 l/s/m. The biggest wave shown here had a volume of 1 m³ per m width

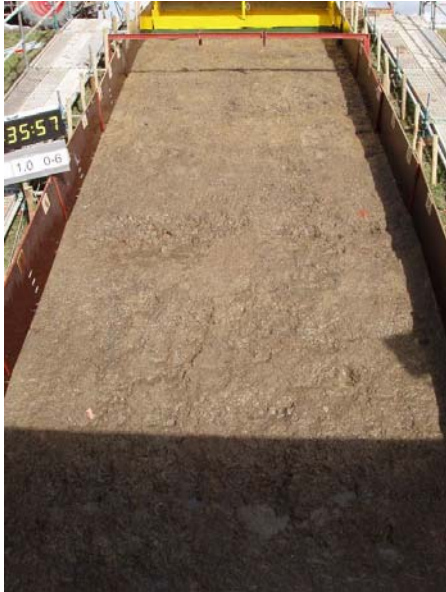
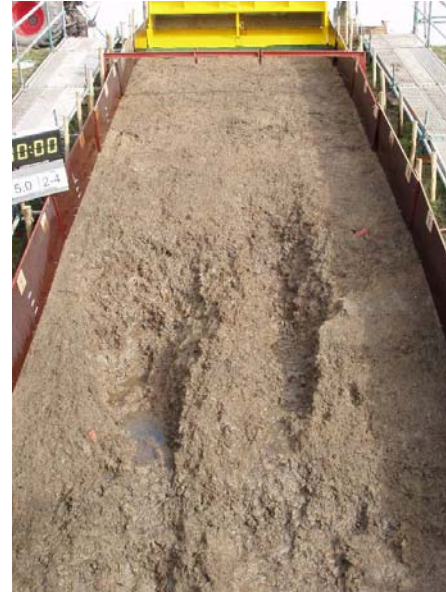
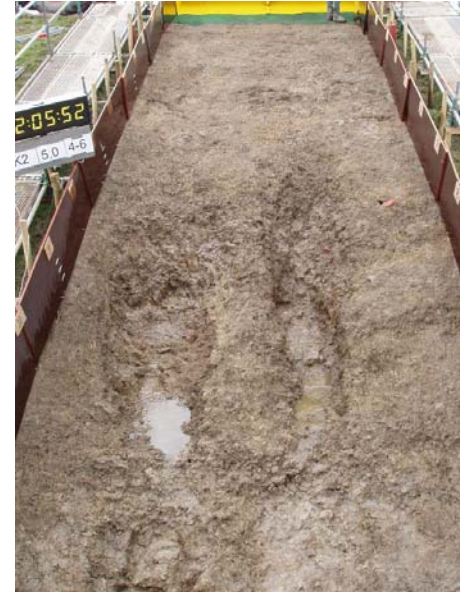
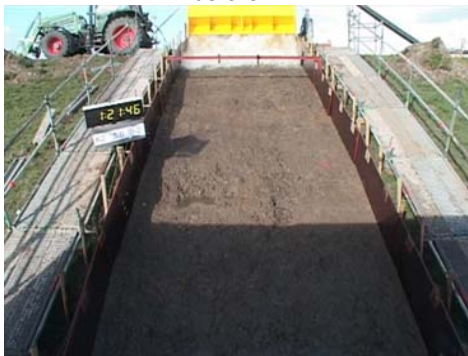
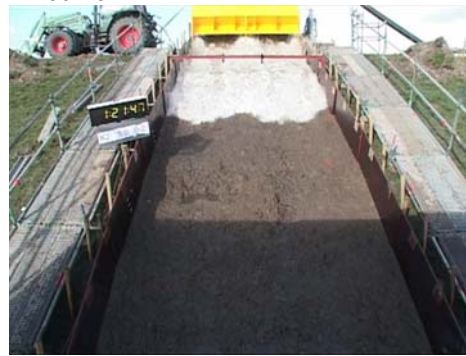
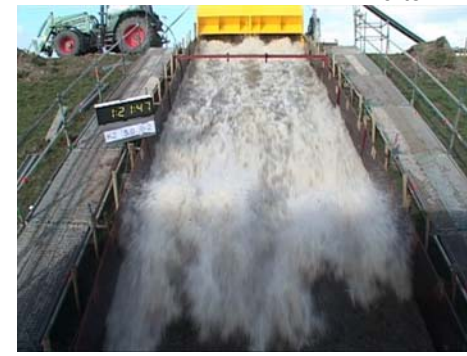
K2

Figure 11-9: Situation during overtopping of 5 l/s/m. The biggest wave shown here had a volume of 2.0 m³ per m width

The progression of the erosion can clearly be seen from the processed depth measurement data in Figures 11-6 and 11-7, as well as from the photographs in Figures 11-9 and 11-10.

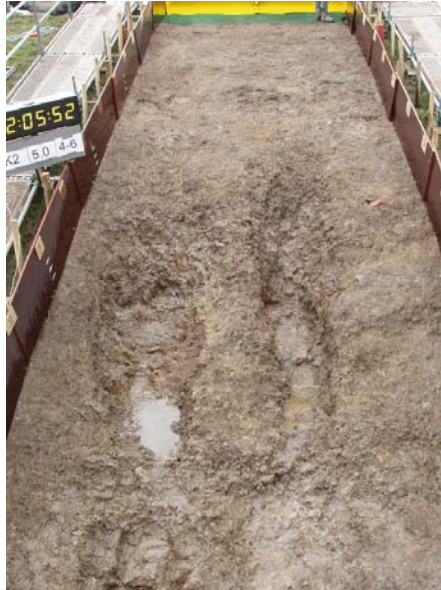
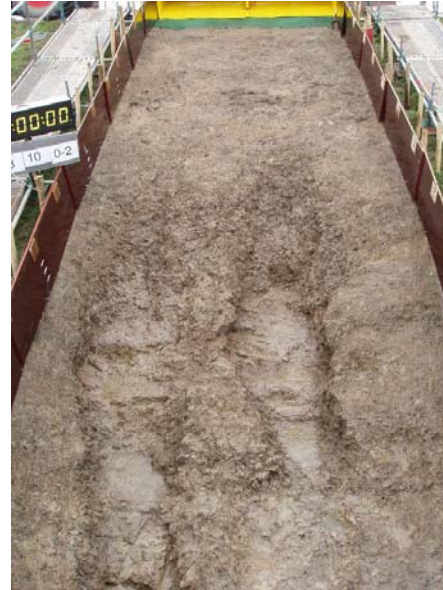
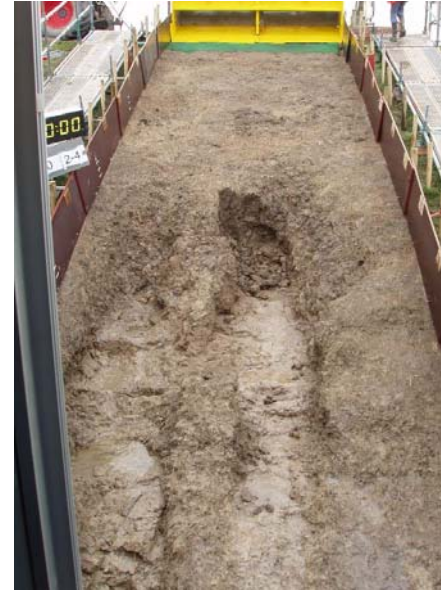
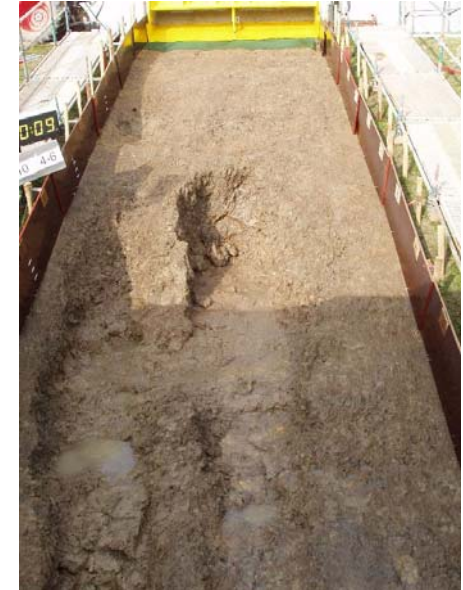
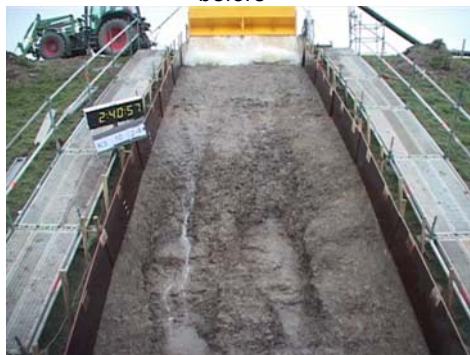
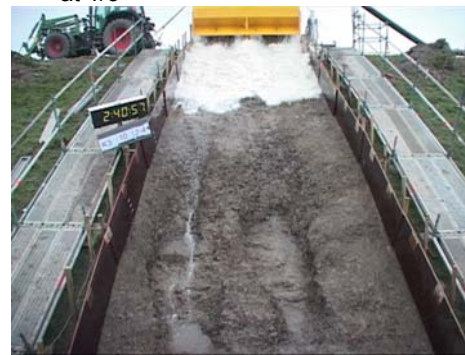
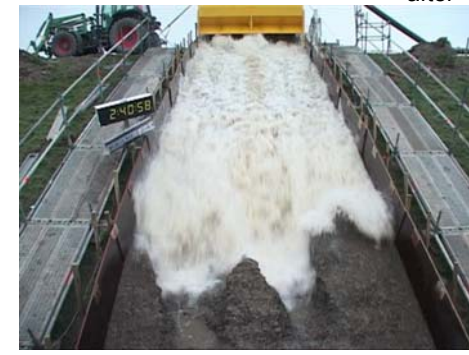
K3

Figure 11-10: Situation during overtopping of 10 l/s/m. The biggest wave shown here had a volume of 2.5 m³ per m width

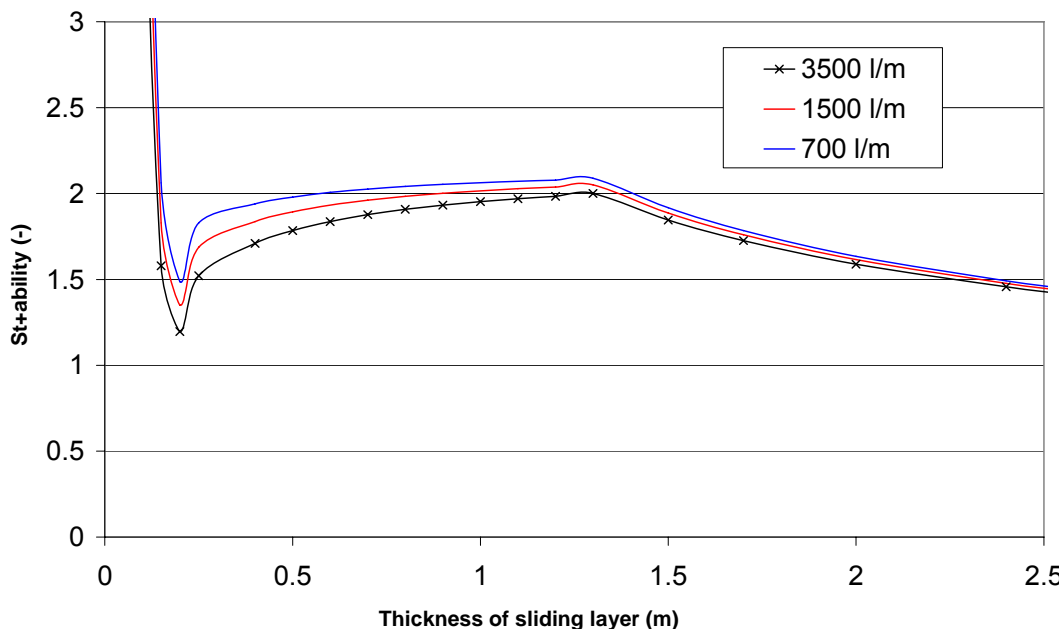
Figure 12-3: Stability coefficient (vertical axes) for different thicknesses of the turf layer that may potentially slide at different wave overtopping volumes in (SBW, 2007), based on (Young, 2005)
