<i>Project number</i>	C31B67
<i>File reference</i>	C31B67WP3-4
<i>Date</i>	10 August 2017
<i>Corresponding author</i>	Rita Esposito (r.esposito@tudelft.nl)

TU Delft Large-scale testing campaign 2016

QUASI-STATIC CYCLIC IN-PLANE TESTS ON MASONRY COMPONENTS 2016/2017

Authors: Rita Esposito, Geert J.P. Ravenshorst

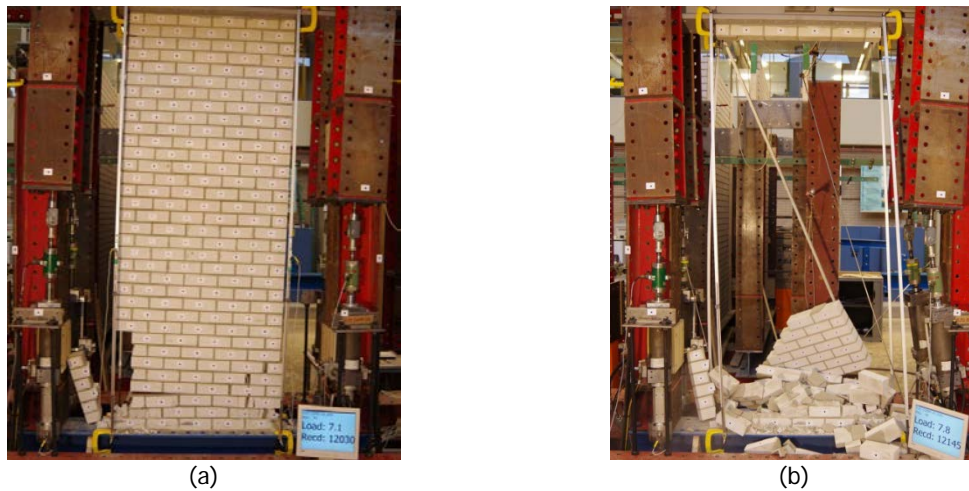
Figure 7 – Crack pattern of wall TUD_COMP-20: (a) Just before collapse; (c) At collapse.

The damage was mainly localised in the bottom part of the specimen (Figure 7). Horizontal cracks subsequently developed in the three mortar bed joints at the bottom of the wall. Thanks to the gradual development of these cracks, the wall was subject to pure rocking movement and its effective height was gradually reduced. For large displacement, splitting cracks at the bottom-left and bottom-right corner of the wall occurred, by leading to detachment of masonry portions (Figure 7b). In cycle C13 and C14, where the same displacement was applied, the phenomenon of toe crushing could be observed (Figure 8); the base shear force substantially for the same imposed displacement. This phenomenon led to instability of the wall for large displacement and its collapse (Figure 7c). Figure 9 show the energy dissipated during the test.

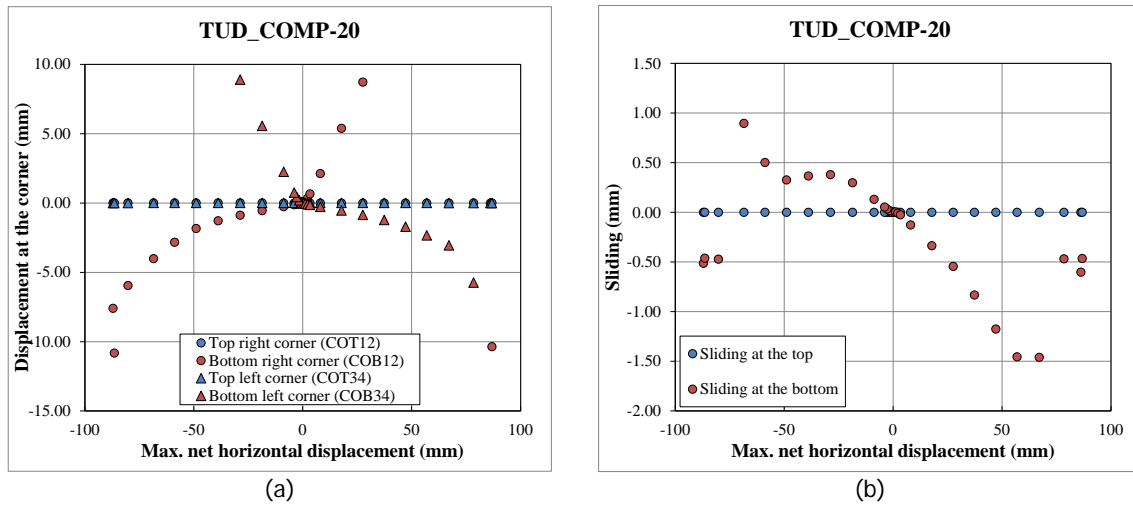
Figure 8 – Local deformation for wall TUD_COMP-20: (a) Crushing at the corners; (b) Sliding.

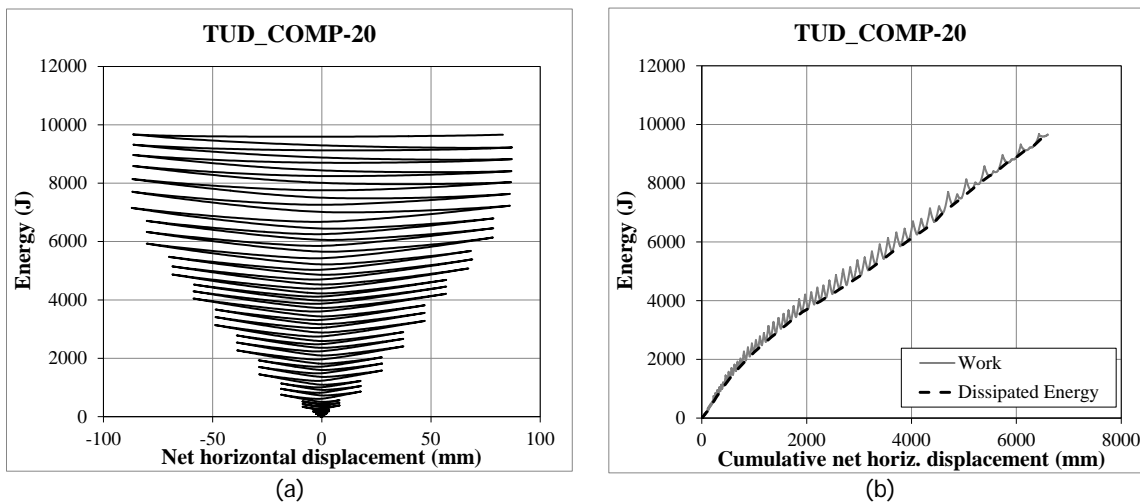
Figure 9 – Energy dissipation for wall TUD_COMP-20: (a) Energy vs. net horizontal displacement; (b) Work and dissipated energy vs. cumulative net horizontal displacement.

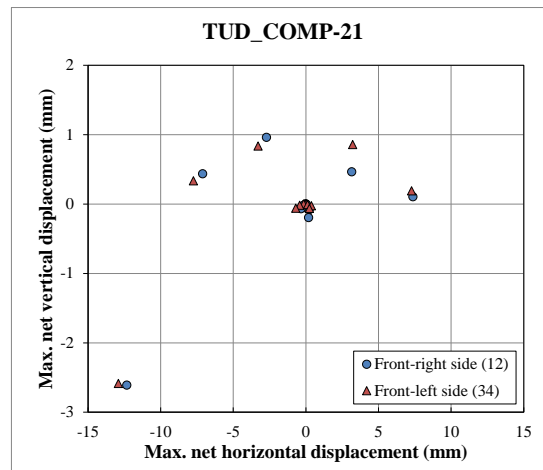
Figure 11 – Maximum net vertical versus horizontal displacement for wall TUD_COMP-21.

Figure 10 shows the in-plane behaviour of wall TUD_COMP-21 in terms of capacity curve and drift, while Figure 11 shows the relation between the net vertical and net horizontal displacement. The initial stiffness of the wall was estimated in cycle C2D and it is equal to $K = 160.6$ kN/mm. The wall TUD_COMP-21 shows a maximum bases shear force of +97.20 and -98.95 kN in the positive and negative loading direction, respectively. In cycle C2, the maximum base shear force is reached together with the starts of the dissipative behaviour (Figure 12); at this stage the formation of the diagonal cracks occurred. In the following cycles, although only an increment in 0.25% of drift was applied a substantial reduction in forced was obtained. A 20% reduction in base shear force was reached at a displacement of +3.2 and -3.1 mm for positive and negative loading direction, respectively. The wall was subject to a maximum displacement of 12 mm, corresponding to a drift of 0.47% (Figure 10b).

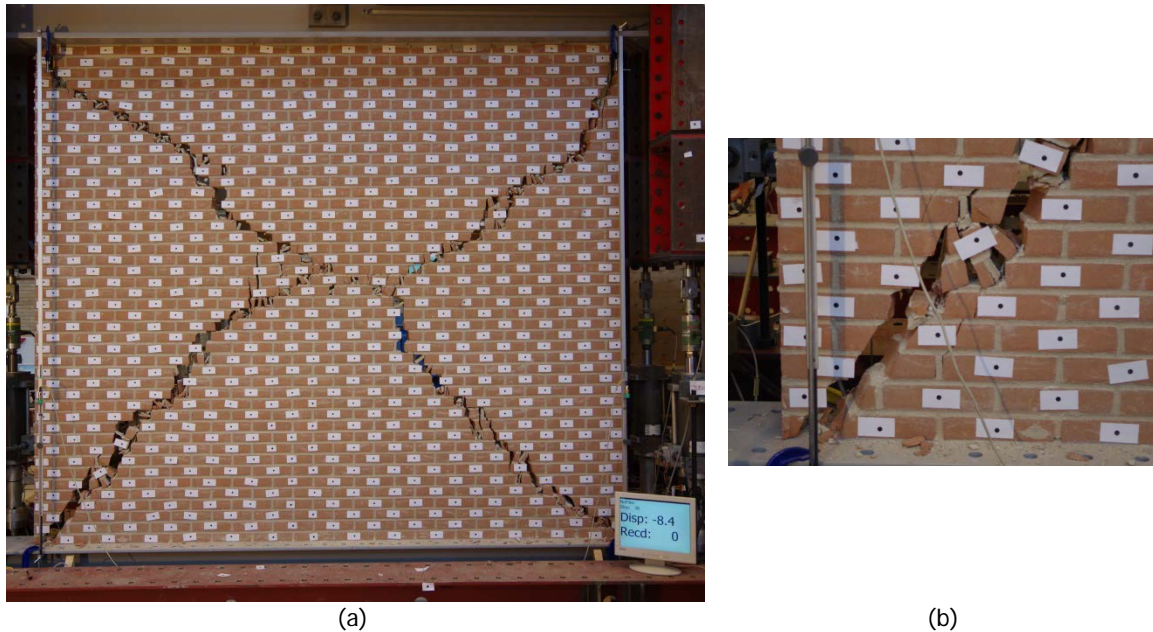
Figure 13 – Crack pattern of wall TUD_COMP-21 at the end of the test: (a) Overview; (b) Detail bottom-left corner.

The typical shear failure composed by two diagonal cracks occurred (Figure 13). The formation of step-wise cracks in the bed and head joint occurred in the central part of the wall, while at the corners the diagonal crack occurred also in the bricks. In the corners, it is possible to observe that the last and first brick courses, which are glued on the steel beams, were also damaged. Consequently, the two triangular portion of masonry on the left and right hand side of the wall created by the diagonal cracks results detached from the rest of the wall. This caused the formation of residual deformation in the net horizontal displacement of the wall in cycle C3 and C4.

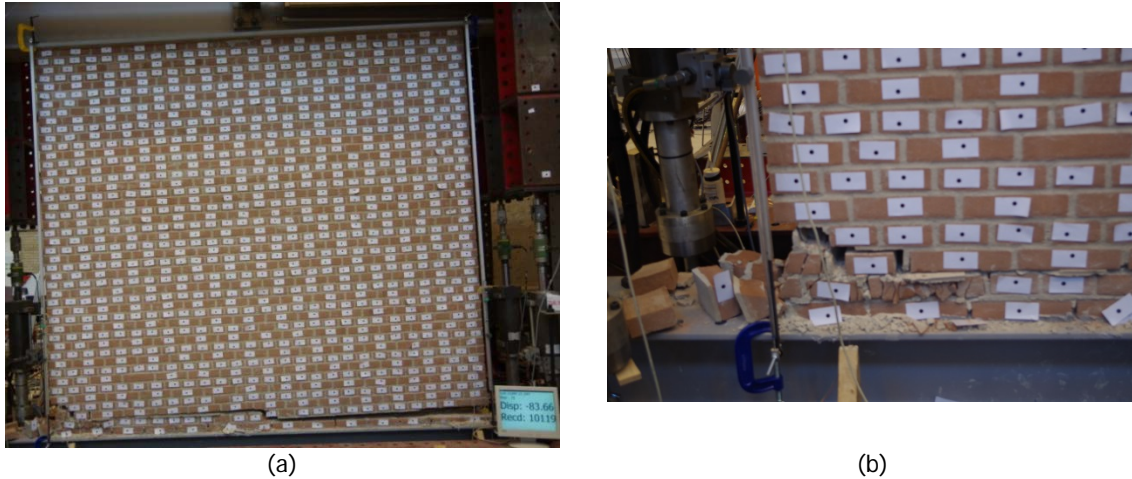
Figure 16 – Crack pattern of wall TUD_COMP-22 at the end of the test: (a) Overview; (b) Detail.

The wall showed a hybrid failure consisting in bed joint sliding at the bottom of the wall followed by crushing at the bottom-left corner (Figure 16). The formation of a horizontal crack at the first and second mortar bed joints occurred cycle C1 ($d_r = 0.1\%$). Figure 17a shows the local deformation measured by sensors 12-16 at the top and bottom corners; positive value can be interpreted as a measurement of crack opening, while negative values indicate crushing. The sliding of the wall over the first mortar bed joint was substantial (Figure 17b) leading to a difference between the jack's and the net displacements. The degradation of the capacity and the dissipation of energy (Figure 18) substantially increased in the last cycles due to the crushing at the bottom-left corner.

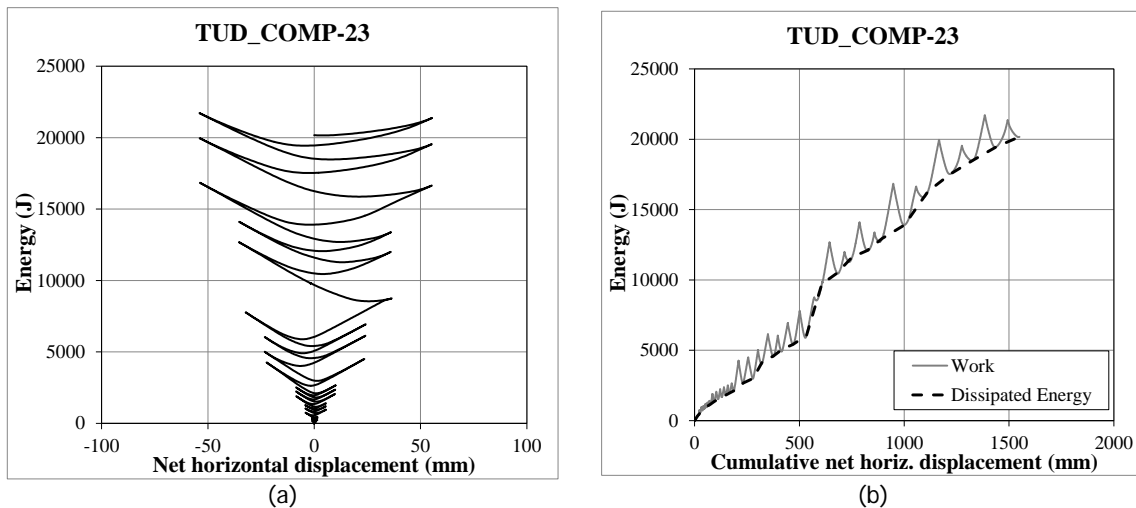
Figure 21 – Energy dissipation for wall TUD_COMP-23: (a) Energy vs. net horizontal displacement; (b) Work and dissipated energy vs. cumulative net horizontal displacement.

Figure 21 shows the energy dissipated during the test. It is possible to note that the failure of the lintel and the change in mechanism lead to a sudden increase in dissipated energy.

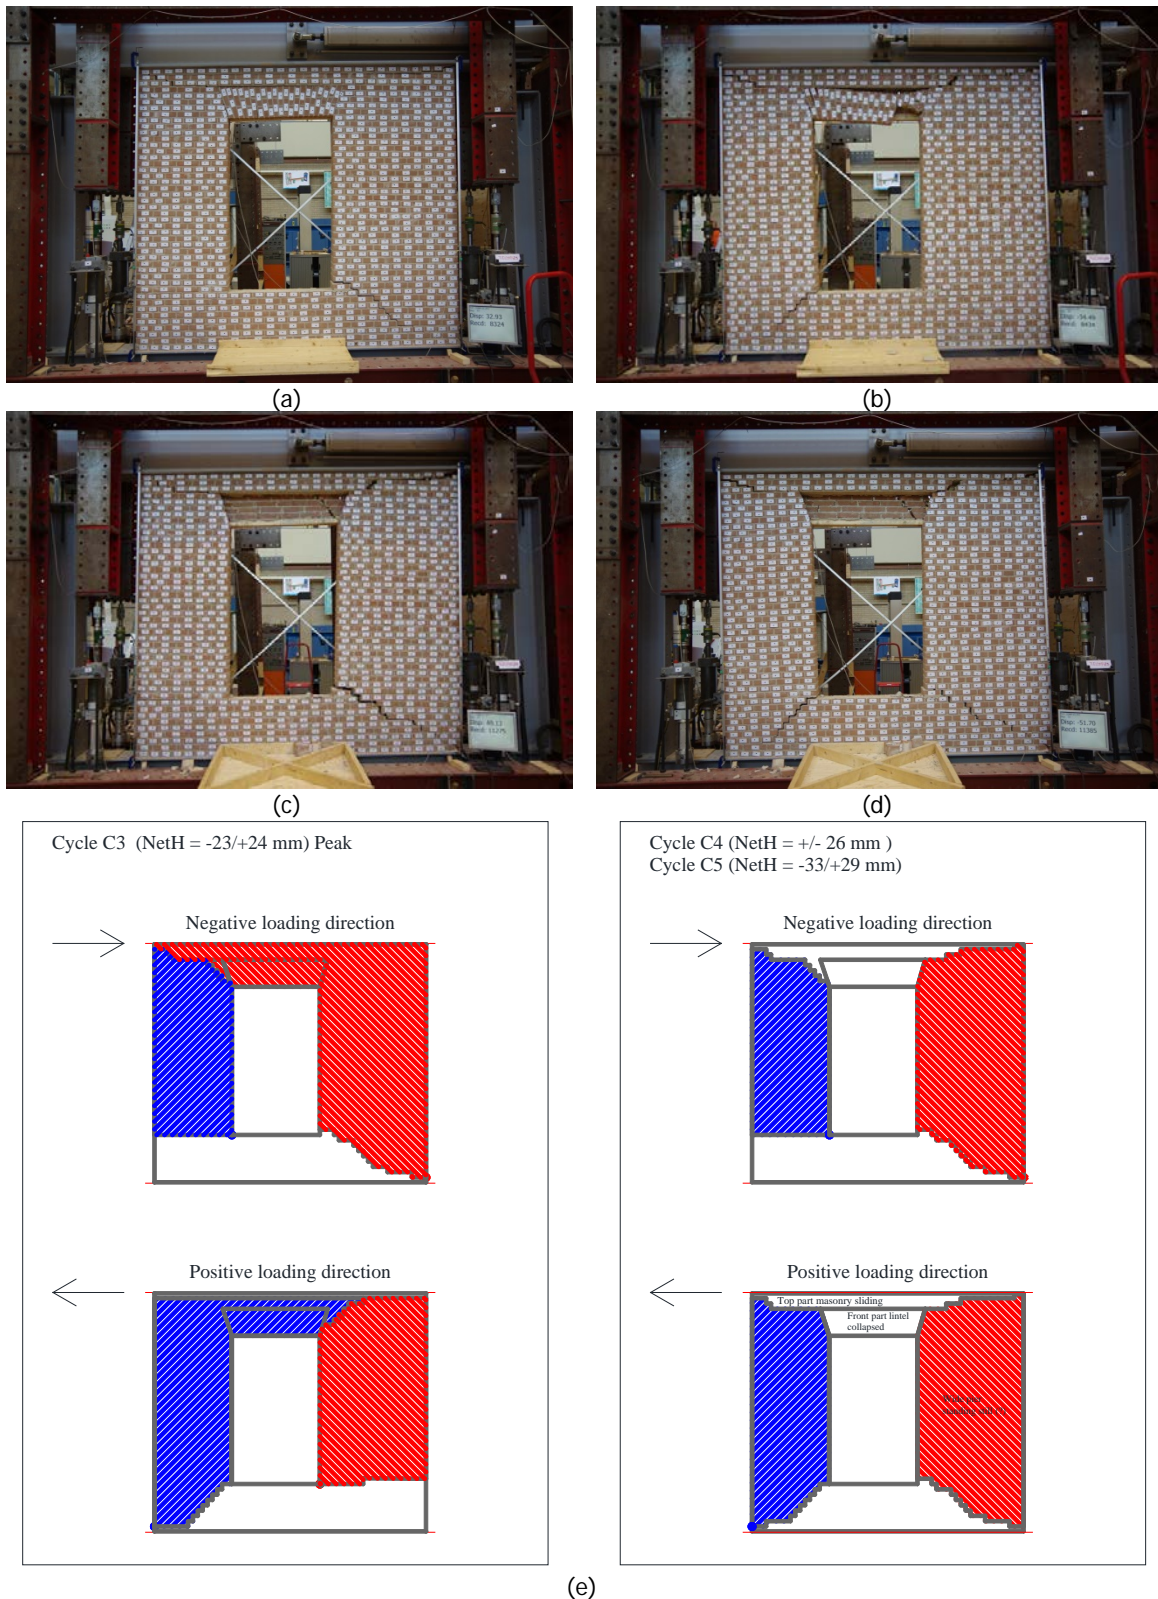
Figure 22 – Crack pattern of wall TUD_COMP-23 at the end of the test: (a)-(b) Crack pattern at failure of the lintel (cycle C4); (c)-(d) Crack pattern after failure of the lintel (cycle C5); (e) Overview.

The integrity of the wall was gradually loss due to failing of the lintel and formation of two separate piers (Figure 22). In the top part of the wall, diagonal step-wise cracks formed, starting from the lintel. On the contrary, in the bottom part of the wall two type of crack formed both of them starting from the opening corner: one horizontal crack and one step-wise crack. On the basis of the loading direction, the horizontal or the step-wise crack at the bottom of the wall were open, as shown in Figure 22c. In the pre-peak phase (cycle C3, Figure 22a,b), the portion of masonry above the opening was cooperating with one pier on the basis of the loading direction. After the failure in bending of the masonry lintel (cycle C4/C5, Figure 22c,d), two separate piers were visible. The top part of masonry between the lintel and the steel beam was sliding together with the top steel beam, being glued on it. After the failure of the front part of the lintel, nearly any horizontal displacement was observed for the wide pier on the front-left of the wall. This was caused by a progressive sliding of the timber beam, which was positioned on the back part of the lintel.

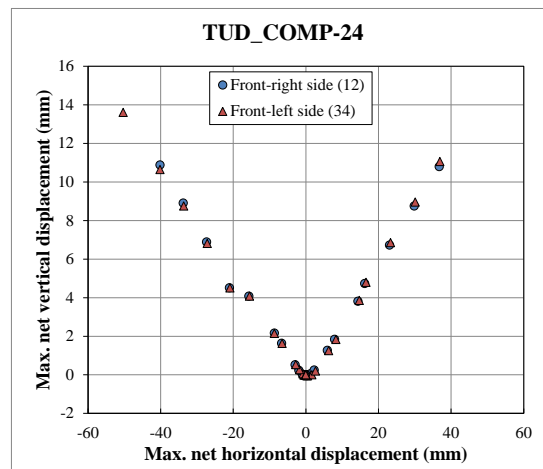
Figure 24 – Vertical versus horizontal displacement for wall TUD_COMP-24.

Figure 23 shows the in-plane behaviour of wall TUD_COMP-24 in terms of capacity curve and drift, while Figure 24 shows the relation between the net vertical and net horizontal displacement. The initial stiffness of the wall was estimated in cycle C2D and it is equal to $K = 42.79$ kN/mm. The wall TUD_COMP-24 shows a maximum base shear force of +21.62 and -21.46 kN in the positive and negative loading direction, respectively. In the post-peak phase, limited degradation in force could be observed that did not result in a change of energy dissipation mechanism (Figure 25). A 50% reduction in base shear force was suddenly reached in cycle C13. After this reduction the test was stopped due to instability of the specimen. A maximum drift of -3.45 and +1.82% was reached in the negative and positive loading direction, respectively.

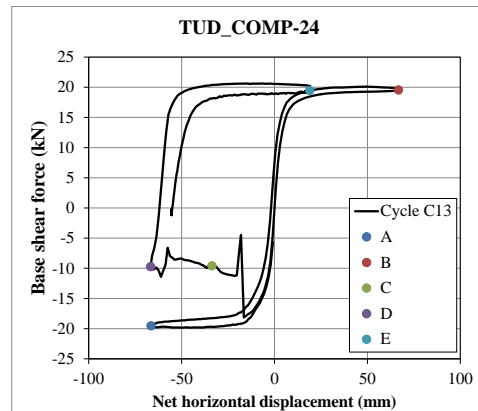
(b) Point A – $u = -66.4$ mm, $F = -19.5$ kN

(c) Point B – $u = +66.8$ mm, $F = +19.5$ kN

(d) Point C – $u = -33.7$ mm, $F = -9.6$ kN

(e) Point D – $u = -66.7$ mm, $F = -9.7$ kN

Figure 27 – Crack pattern of wall TUD_COMP-24 during cycle C13: (a) Capacity curve; (b)-(f) Crack pattern at selected points.

The wall TUD_COMP-24 showed an initial pure rocking mechanism followed by sliding over the bed joint and splitting failure at one corner. The first cracks occurred in the first and last mortar bed joint during cycle C3 ($d_r = 0.06\%$); this damage allowed the pure rocking deformation of the wall. Figure 26a shows the crack opening at the corners (sensors 12-15) measured between the kicker layer and the first masonry course, while Figure 26b shows the sliding (sensors 8-9) between the kicker layer and the masonry measured at approximatively half of the wall's length. Due to the high slenderness ratio of the wall, an out-of-plane rotation of the wall occurred which resulted in a misaligned between the wall and the kicker layer. In cycle C13 the main damage occurred in a rapid sequence (Figure 27). First sliding over the mortar joint occurred in the first two courses. Afterwards, vertical cracks in the element occurred in the two courses. Eventually, splitting over the thickness of the smallest element unit at the bottom course occurred with consequent loss

of part of it. By analysing the damage evolution together with the capacity curve in Figure 27a, it is possible to note that the 50% reduction in base shear force was caused by cracking in the elements (Point C in Figure 27a), while the splitting of the bottom unit occurred in the second run at the maximum negative displacement (Point D in Figure 27a).

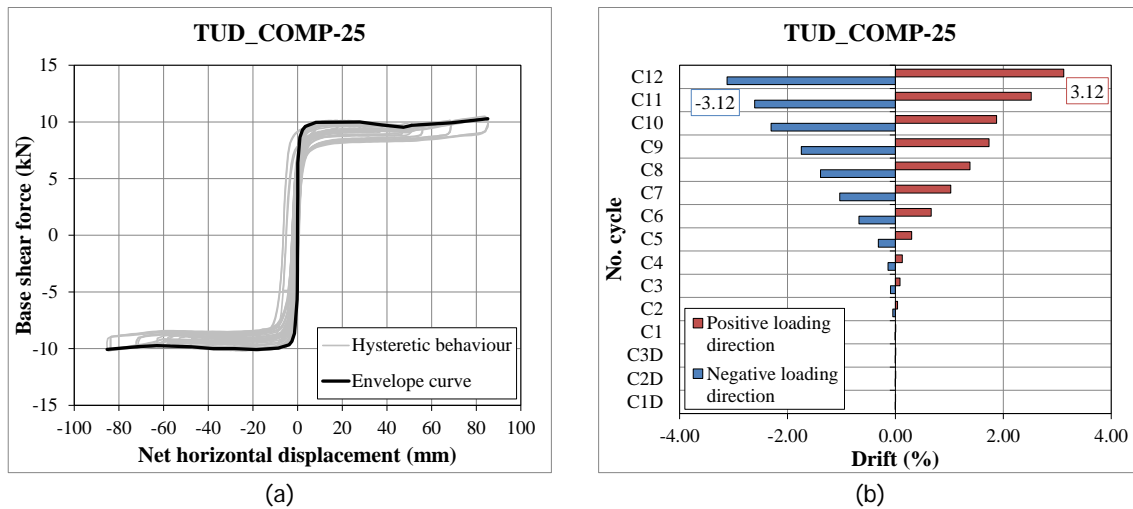
Figure 28 – In-plane behaviour of wall TUD_COMP-25: (a) Capacity curve; (b) Drift.

Figure 28 shows the in-plane behaviour of wall TUD_COMP-25 in terms of capacity curve and drift, while Figure 29 shows the relation between the net vertical and net horizontal displacement. The initial stiffness of the wall was estimated in cycle C2D and it is equal to $K = 6 \text{ kN/mm}$. The wall TUD_COMP-25 shows a maximum base shear force of +10.50 and -10.22 kN in the positive and negative loading direction, respectively. In the post-peak phase, no degradation in force could be observed that did not result in a change of energy dissipation mechanism (Figure 30). After achieving the maximum base shear force, an out-of-plane rotation of the wall occurred; this resulted in a misaligned between the wall and the kicker layer. The test was carried out up to a maximum displacement of -84.28/+85.29 mm corresponding to a drift of -3.06/+3.12 % was applied. Although no reduction in base shear force was achieved, the test was stopped because large in-plane deformation were reached and because out-of-plane deformations of the wall started to develop (Figure 31c).

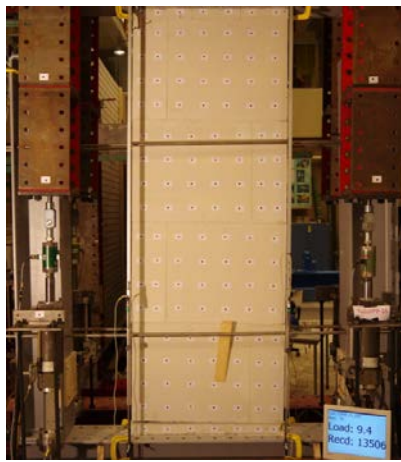
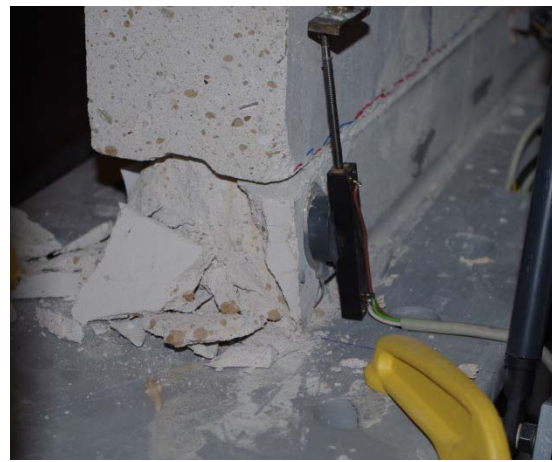
Figure 32 – Crack pattern of wall TUD_COMP-25 at the end of the test: (a) Overview; (b) Detail bottom-right corner.

The wall showed a pure rocking mechanisms. In cycle C2 ($d_r = 0.05 \%$), a first crack occurred between the bottom kicker layer and the first course of masonry. This crack could reach a maximum opening of approximately 25 mm as shown in Figure 31a. The sliding at this interface was limited (Figure 31b). Due to the high slenderness ratio of the wall and the pure rocking mechanism, out-of-plane deformation of the wall occurred allowing a misaligned between the wall and the kicker layer (Figure 32). The cracking and crushing of the bottom kicker (Figure 32) layer started during cycle 10 ($d_r = 2.1 \%$).

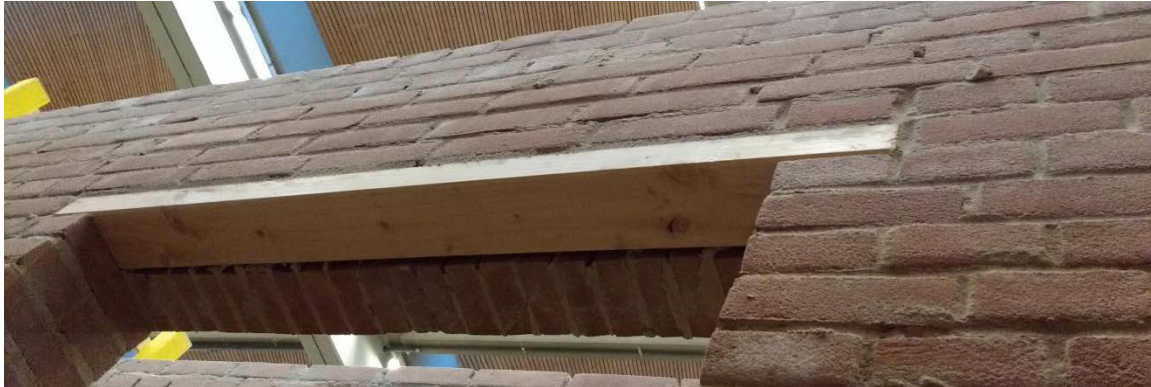
Figure 44 - Wooden beam to support masonry above window opening

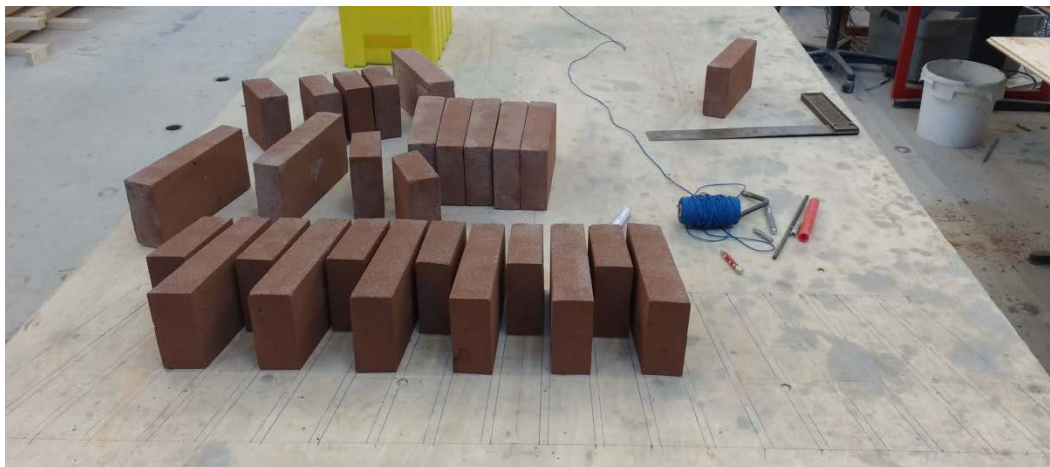
Figure 45 – Cutting template for jack arch

A cutting template is used to cut the bricks of the jack arch into the correct shape for the jack arch (Figure 45). Cutting was done with a saw in combination with water. The bricks are dried for a few days before used for construction. Figure 46 shows the complete pre-cut jack arch and Figure 47 shows the installation of the lintel.

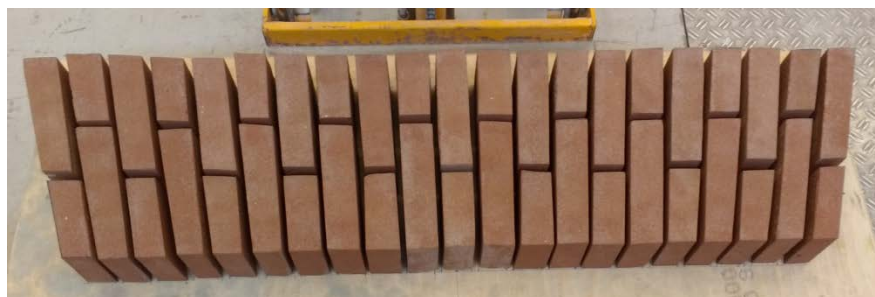
Figure 46 – Pre-cut jack arch

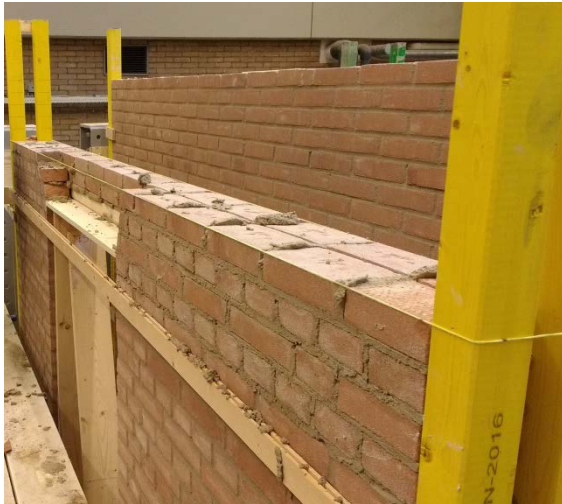
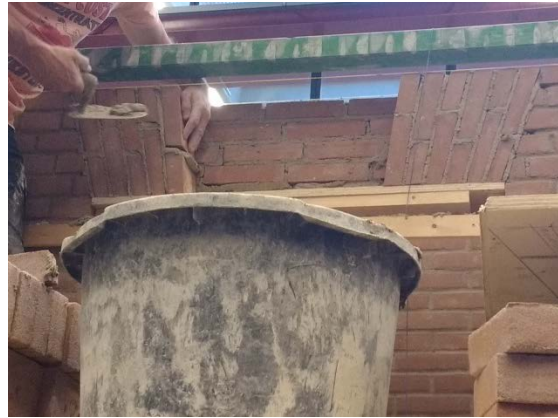
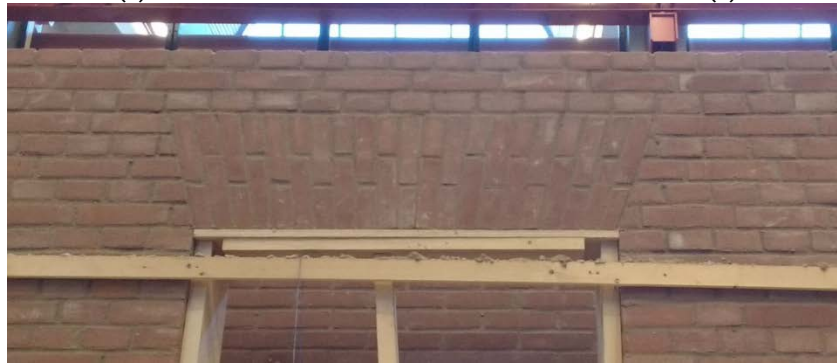
Figure 47 – Placement of pre-cut jack arch above window
