Reuse potential of the Van Brienoord arch bridge

*Fatigue and corrosion damage evaluation of
structural steel elements*

Master thesis

Delft University of Technology

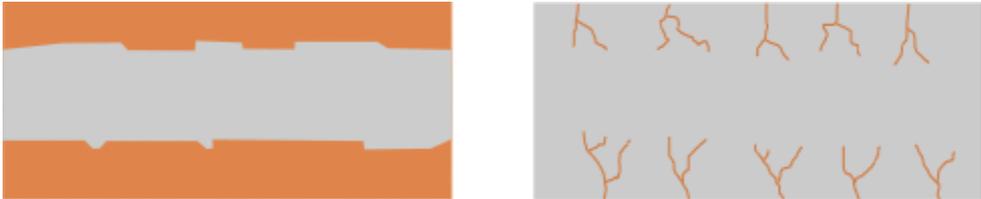
Figure 18 – Schematic of general corrosion (left) and local corrosion (right) (own figure).

Figure 18 below shows the difference between general and local corrosion (in this case cracks) at the point of failure of an element. The necessary material loss for a certain cross-section thickness is much larger for general corrosion than for local corrosion. The service life for general corrosion is thus longer than for local corrosion [43].

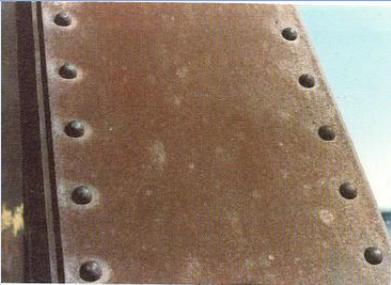
Type	Description	Example
Uniform corrosion	General corrosion over the entire surface of the member. Natural process that affects all bare metals exposed to the atmosphere.

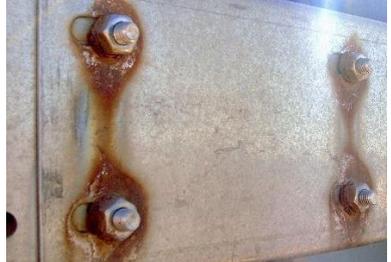
Galvanic corrosion	Occurs when different metals are connected to each other. Can have a beneficial effect in the case of zinc, which 'sacrifices' itself, keeping the steel unaffected.

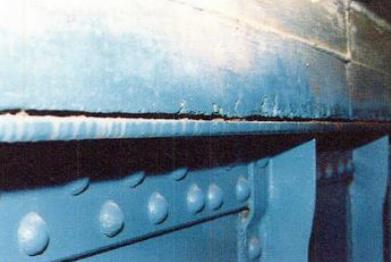
Crevice corrosion	Occurs in locations that are confined from the environment. One of the most common forms in bridges

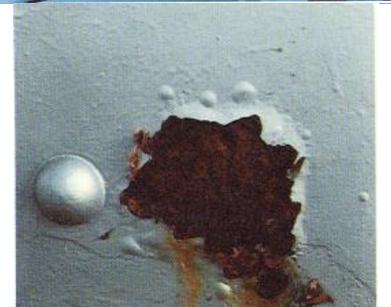
Underfilm corrosion	Type of crevice corrosion that occurs beneath paint layers that have defects. It attacks the surface between the metal and paint causing the paint to debond.

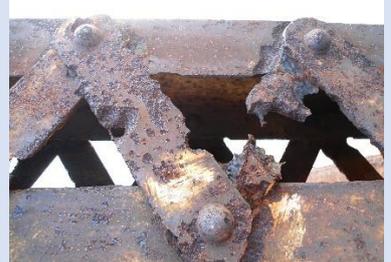
Pitting	Localized corrosion which can cause deep penetrations into steel surfaces. Can act as a stress raiser and possibly cause failure.

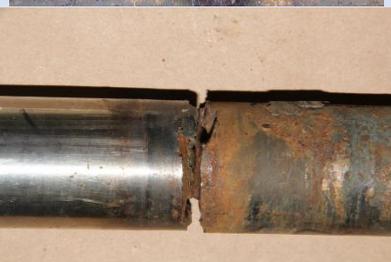
Corrosion fatigue	Cracking of steel caused by cyclic loads in a corrosive environment. Reduces the fatigue life of a member compared to non-corrosive environment.

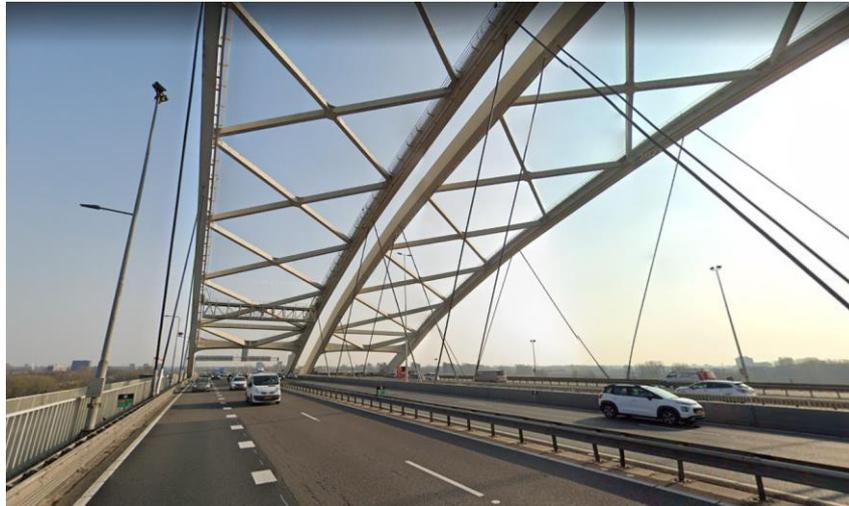
Figure 25. Two separated sections on the eastern Van Brienoord bridge, each with a slow lane [52].

There are six traffic lines present on the eastern Van Brienoord bridge. Up until the construction of the second, western arch in 1990 the eastern Van Brienoord functioned for traffic in both directions of the A16. The carriageway was divided into three lanes per direction. Since 1990 all six lanes were dedicated for traffic in the direction of The Hague. The division into three lanes remained; one section connected to the E19 and the other section connected to the A15 and A38 among others. Figure 25 below shows the division of the two sections [52].

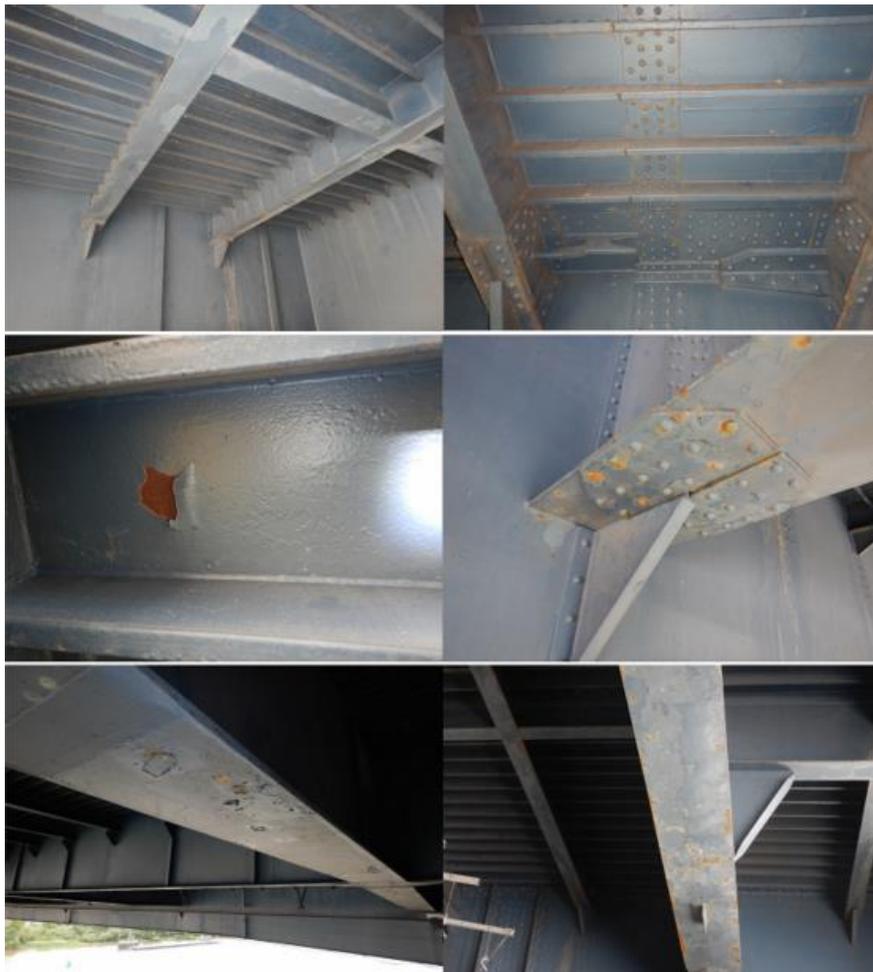
Figure 35 – General forms of corrosion present on underside of the eastern Van Brienoord [55].

In general, corrosion is present on steel elements of the underside. The conservation of the steel is peeling off locally. This can be found on the whole of the underside. Figure 35 shows some of the general corrosion damage present on the underside of the bridge.

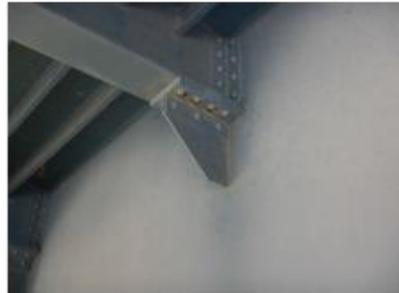
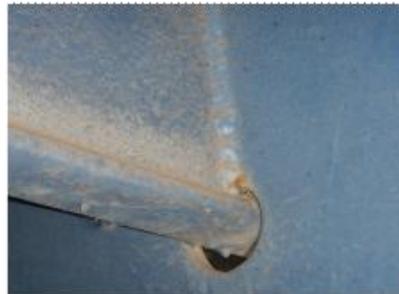
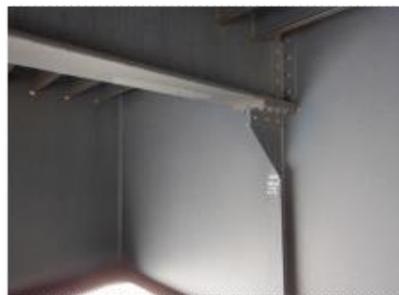
Figure 38 - Critical details of secondary crossbeam.

The secondary crossbeam are connected to the main girders and main stringer with rivets. Similar critical details are identified as with the primary crossbeam, see Figure 38. Again detail category 16 as shown in Table 6 corresponds to this connection type.

The longitudinal stiffeners also run through the web of the secondary crossbeams. The detail category as shown in Table 7 corresponds to this connection type.

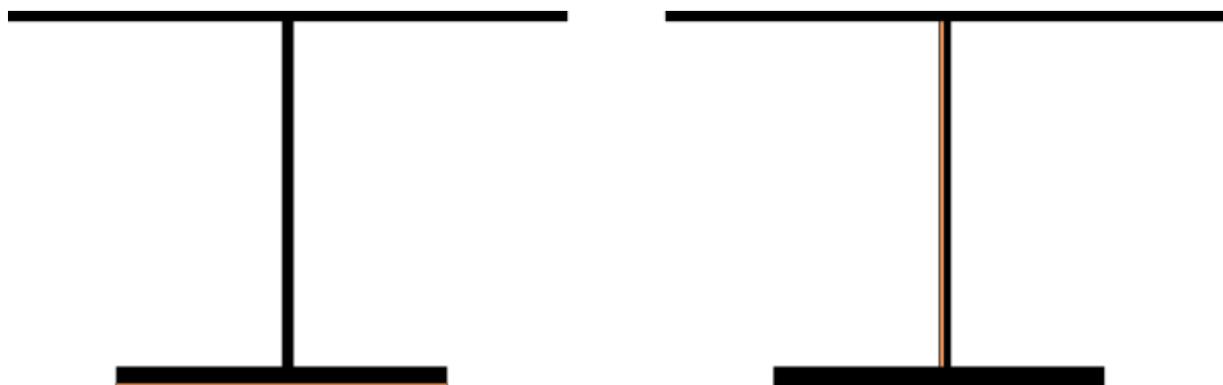
Figure 40 – Examples of thickness loss of cross section component.

When corrosion is observed on a structural element of a component thereof, the cross section will be reduced by a uniform corrosion depth on the sections corrosion is present, as shown in Figure 40. This is done for both corrosion depths as calculated by Kayser & Nowak and Kobus.

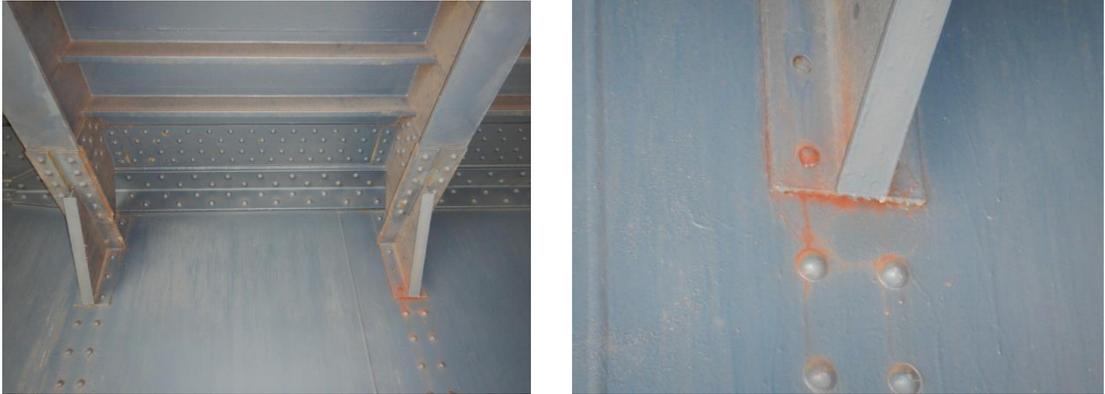
Figure 42 - Corrosion present on web of main girders.

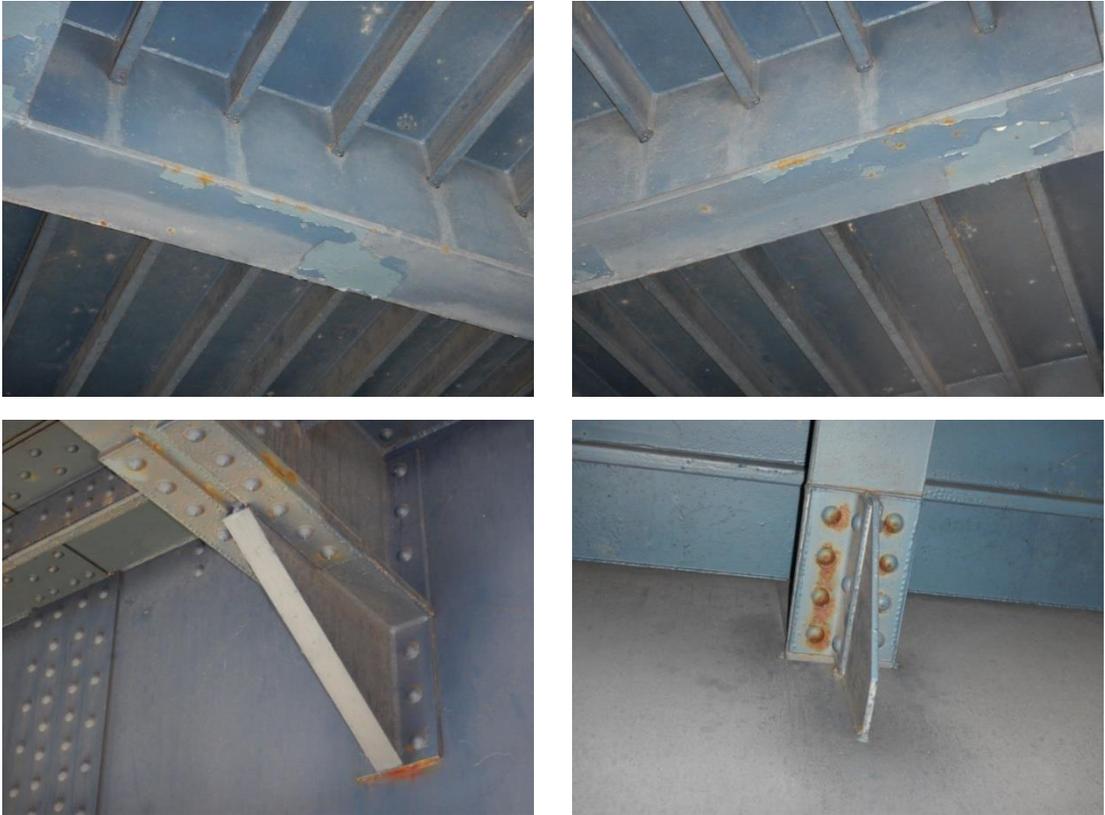
Figure 46 - Corrosion on the bottom flange of the secondary crossbeam.

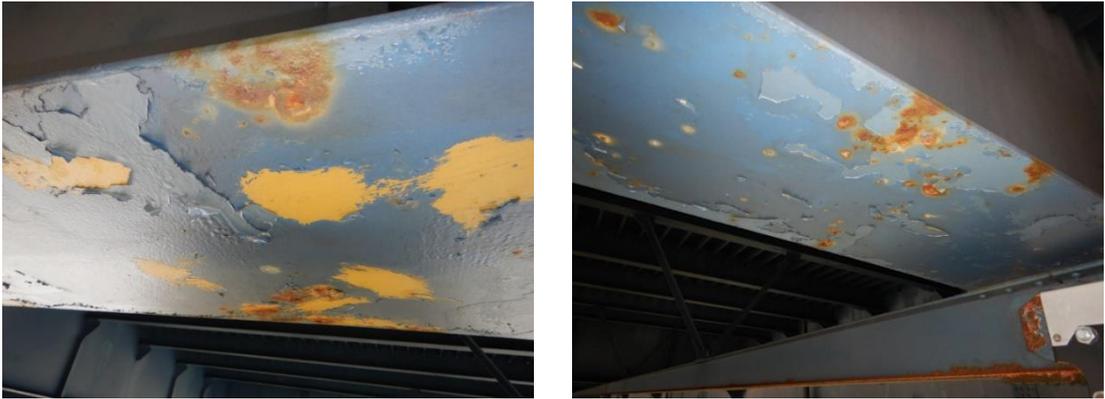
Figure 48 - Corrosion on the bottom flange of the main stringer.

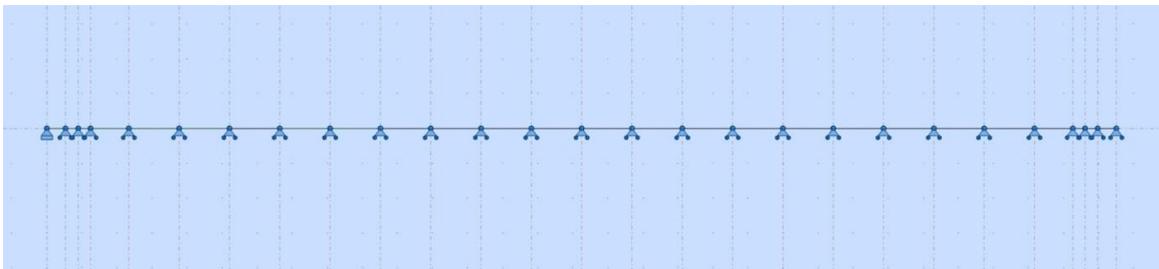
Figure 57 - Model of main stringer in Robot Structural Analysis.

The main stringer runs longitudinally in the center of the bridge deck along the whole span of the bridge. It is supported by the primary crossbeams every 14.35 meters. These crossbeams are modelled as elastic supports in the influence line analysis. The stiffness of the elastic support is expressed in the spring constant K . The spring constant K of the crossbeam follows from the deflection of the crossbeam under loading. Using the results from the primary crossbeam analysis, the spring stiffness is determined to be $K = 512 \text{ kN/mm}$. In further calculations on the main stringer the primary crossbeam is assumed to be infinitely stiff, resulting in the crossbeams being modelled as simple supports along the bridge span. The main stringer is modelled in Autodesk Robot Structural Analysis to obtain the longitudinal influence lines.
