## Durability of an UHPFRC under mechanical and chloride loads

Construction and Building Materials

Matos, A. M., Chaves Figueiredo, S., Nunes, S., Schlangen, E., & Barroso-Aguiar, J. L. (2021). Durability of an UHPFRC under mechanical and chloride loads. *Construction and Building Materials*, 311, 1-17. Article 125223. <https://doi.org/10.1016/j.conbuildmat.2021.125223>

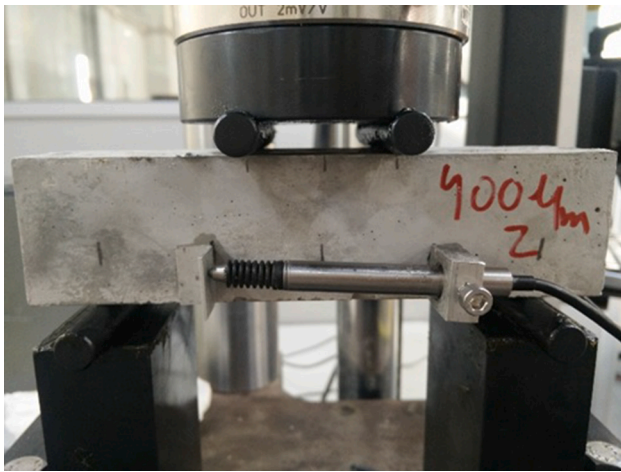
**Fig. 1.** Four-point bending test.

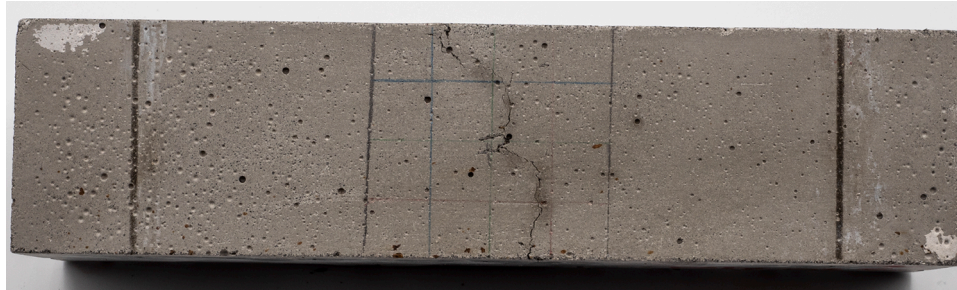
Fig. 11. Macro crack formation in softening stage (valid result).

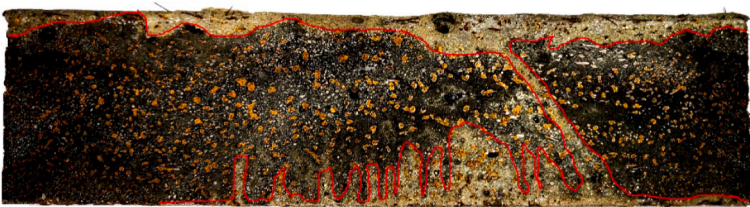
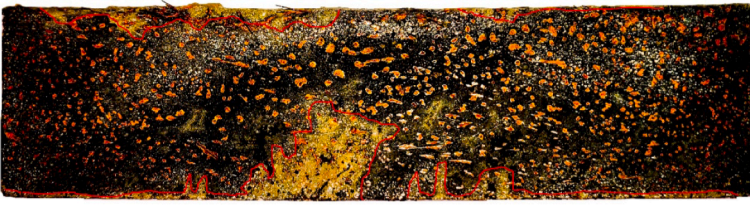
**Fig. 19.** Chlorides ingress of 3.0%-300-i specimens (penetration depth of chloride ions in lighter part).

Concerning loaded-cracked specimens, 3.0%-300-i, a different

chloride penetration pattern was observed, since these specimens present mainly micro-cracking, instated of an evident macro-crack as observed in series 3.0%-350-i and 3.0%-400-i. These micro-cracks promoted suction of aqueous chloride solution, giving rise to small penetration through them, as can be seen in Fig. 19 of Appendix C. The maximum chloride penetration depth was 18–19 mm, while in the non-cracked zone was 2 mm. It must be noted that, in 3.0%-300-i specimens, some chloride condensation occurred in the loaded surface of the specimens (see Fig. 19 of Appendix C), since it was not possible to protect this surface with the waterproof tape.
