# Exposing a Corroded Treasure: Historical Analysis of Corrosia in Almere

MSc Architecture, Urbanism and Building Sciences

AR2A011 Architectural History Thesis

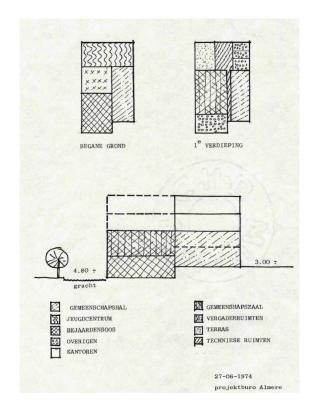
Programme proposition Corrosia (Rijksdienst voor de IJselmeerpolders & R. Blom van Assendelft en J. Koning Architecten, 1974-1983)

Illustrated above is the proposed programme by Projeckburo Almere from 1974. When juxtaposed with the final drawings for the construction permit, we see just how much more interwoven the programme became after Blom van Assendelft and Koning made the design. As a visual tool for comparing these two different plans, the style of the 1974 proposition has been recreated for the ground floor drawing, as illustrated below. Whereas the communal hall was originally proposed to be a separate entity in the building, it has instead been made into the inner street, connecting the separate programmatic functions.

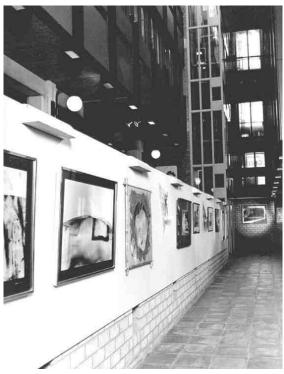
The interior street of Corrosia (Schutte, G., 1982)

The building features three straight voids extending to the roof, allowing natural light in through skylights. These voids also serve as passages for the stairs and elevator. Their straight alignment stands in stark contrast to the ground floor's inner street, characterized by its jagged and irregular layout.

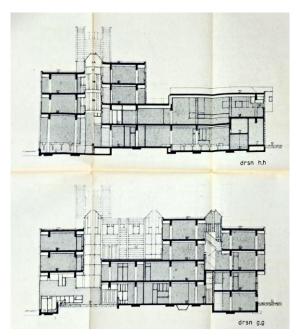
Cross sections of Corrosia (R. Blom van Assendelft en J. Koning Architecten, 1977)
