Testing and Diagnosis of High Voltage and Extra High Voltage Power Cables with Damped AC Voltages

Cichecki, P. (2018). *Testing and Diagnosis of High Voltage and Extra High Voltage Power Cables with Damped AC Voltages*. [Dissertation (TU Delft), Delft University of Technology].
<https://doi.org/10.4233/uuid:f50c2129-6771-468b-aa3c-7c1fdac4e425>

Proefschrift

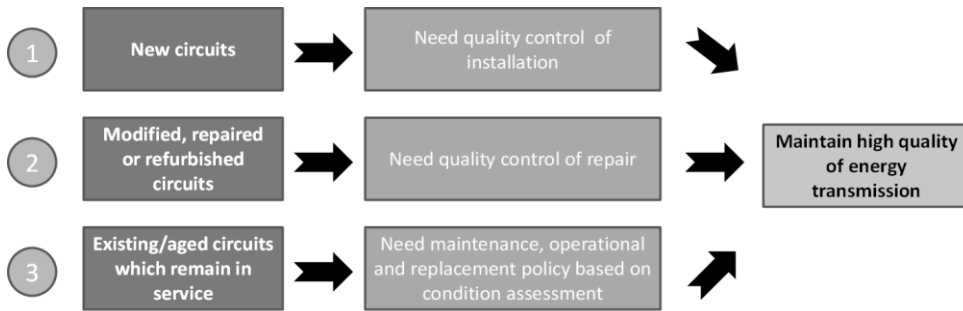
Figure 1.1: Approaches to maintaining power cable reliability.

Besides visual inspections of, e.g. oil pressure/leakages or loss of continuity of external sheaths performed as a part of periodical maintenance of transmission cable circuits, technical data concerning transmission systems have to be collected by on-site testing and diagnosis. Such methods are used for verification of the cable insulation quality in different life stages. It is achieved through on-site tests and diagnosis where different cable insulation problems, e.g. partial discharge activity due to an internal insulation defect or increased dielectric losses can be detected, recognised and localised. Respectively, the service situation of cable circuits and tasks set for the particular situation can be divided as presented in Figure 1.1.

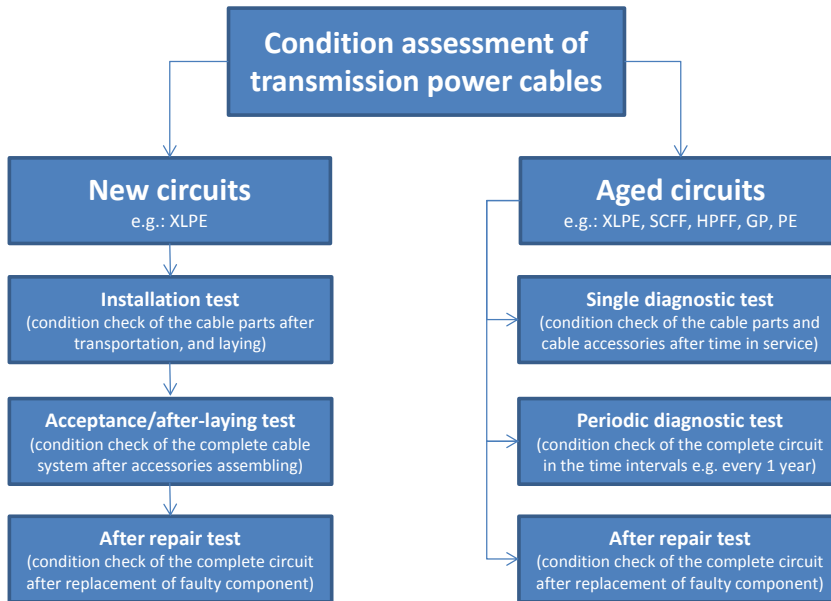
Figure 1.6: Basic overview of the on-site tests performed on transmission power cables to assess their condition.

One possible way to access the condition of power cables is on-site diagnostic tests [19]. The testing consists of several different on-site tests performed at different stages of service life of power cables. Figure 1.6 presents on-site tests, which are intended to reject faulty components or defective parts of the circuit after installation, assembling or repair, e.g. HV withstand test. There are also tests that give an indication of the insulation condition after service life time, e.g. after 40 years. The latter tests should have no impact on cable insulation and are called diagnostic tests.

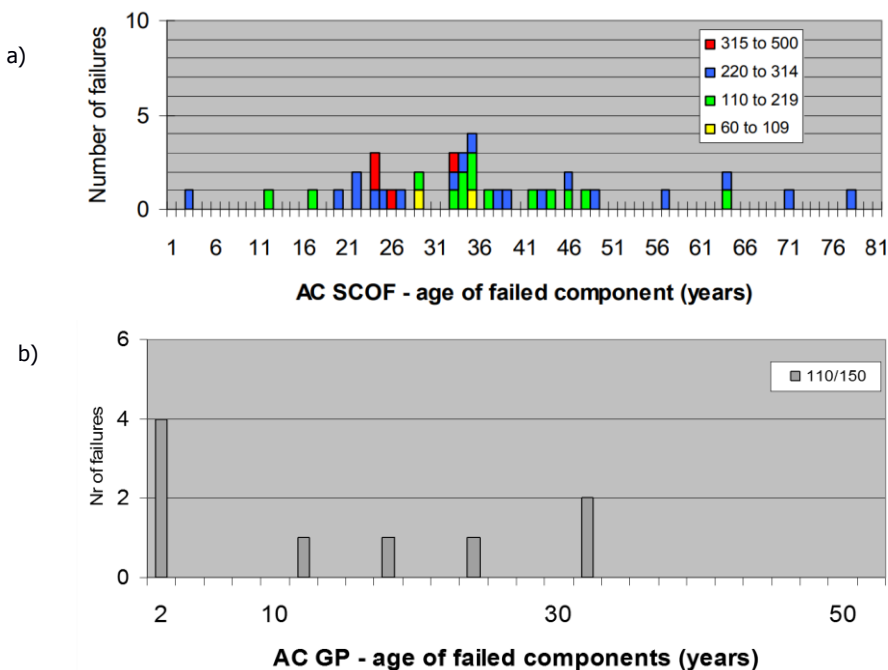
Figure 1.10: a) Trend in internal failures for Self-Contained Oil-Filled (SCOF/SCFF) HV power cables at different nominal voltage ranges [3]. b) Trend in internal failures for 110 kV and 150 kV gas-pressurised power cables in The Netherlands-situation till 2009 [11].

Evaluation of the actual condition could be difficult when based only on the statistically calculated failure probability due to the low number of failures in this case. In The Netherlands high voltage some power network operators apply non-destructive diagnostic tests to assess insulation of gas-pressurised cables, e.g. damped AC (DAC) testing and PD diagnosis, dielectric losses measurements or dielectric spectroscopy. The obtained diagnostic parameters are sensitive to both thermal and electrical processes in the cable insulation.

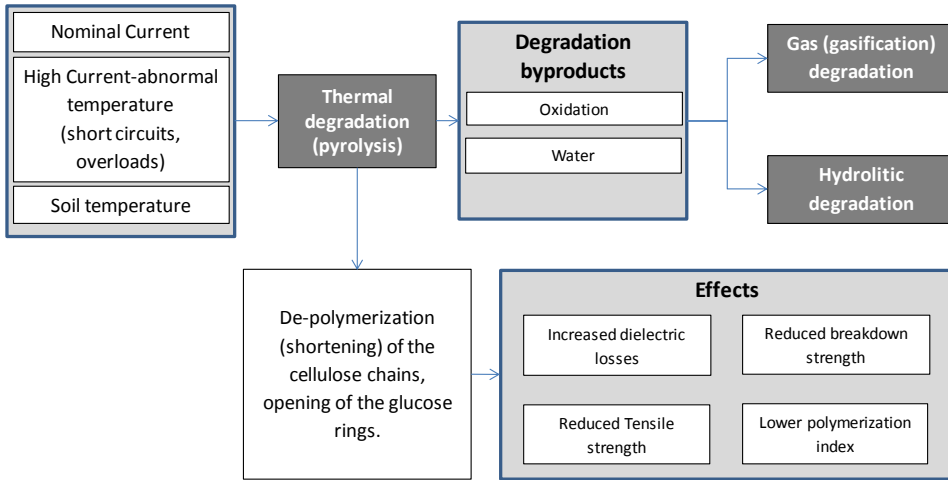
Figure 3.2: Thermal degradation in paper insulated cables.

Thermal degradation, which is also called “pyrolysis of cellulose”, in the absence of oxidizing agents and moisture, results in breaking of the glycosidic bonds and creation of openings of the glucose rings [29]. During thermal stressing of the paper structure, moisture is produced at the beginning of the process as an effect of the chemical decomposition of paper together with oxygen (de-polymerization) (Figure 3.2). Free glucose molecules, moisture, carbon oxides and acids are also formed during thermal stressing of paper over the years of service. In the later stages of degradation, moisture can also be absorbed, e.g. during formation of the acetic acid that consumes the moisture [30]. Under temperature stressing, due to the nominal current load or extensive over-loads or repetitive thermal cycles, a degradation effect is recognized mostly through the modification (scission) of the cellulose chain bonds. It results in a decrease in the average molecular weight of the chains, and therefore is followed by a reduction in the tension strength. As a result, the insulation paper loses mechanical strength, resulting in a lower degree of polymerization and lower breakdown strength. Thermal degradation is in some cases an “initiator” of the other two ageing processes called: gasification and hydrolysis or hydrolytic degradation. Pyrolysis can take place without access to oxygen or moisture. During normal operation when the temperature is below 140⁰C, pyrolysis processes are considered to be of little relevance.

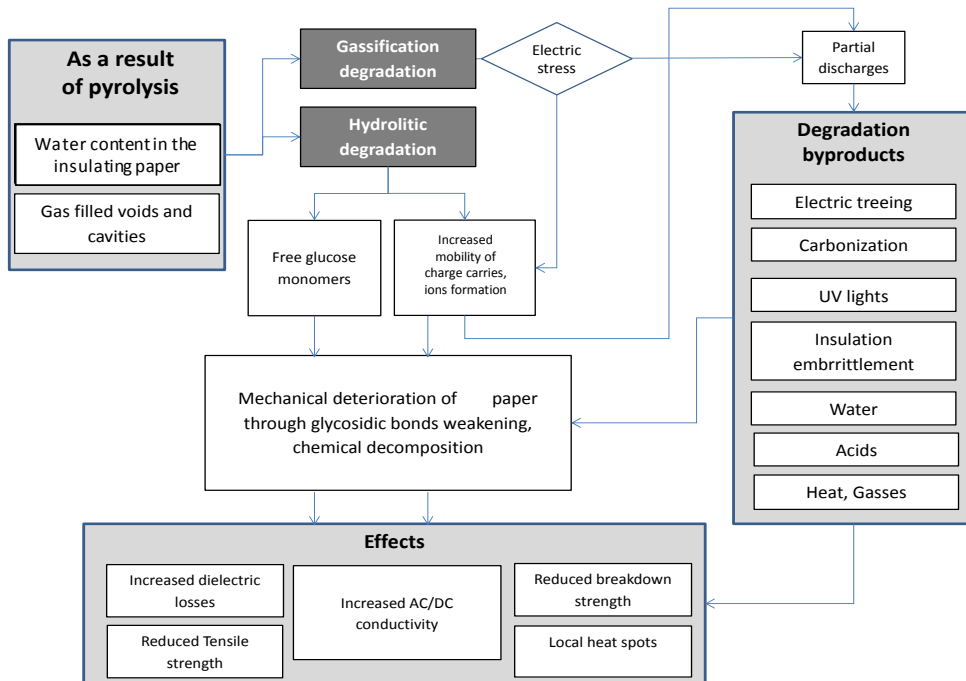
Figure 3.4: Hydrolysis and gasification degradation in paper insulated cables.

Gas content in paper and oil has an impact on the total volume of insulating paper-the radial and axial expansion. In SCFF cables, where the pressure of oil is only around 1 bar, which is not enough to act against the radial expansion of insulation, this effect may produce irreversible damage to the cable lead shield. Figure 3.4 presents this gasification process combined with hydrolytic degradation.

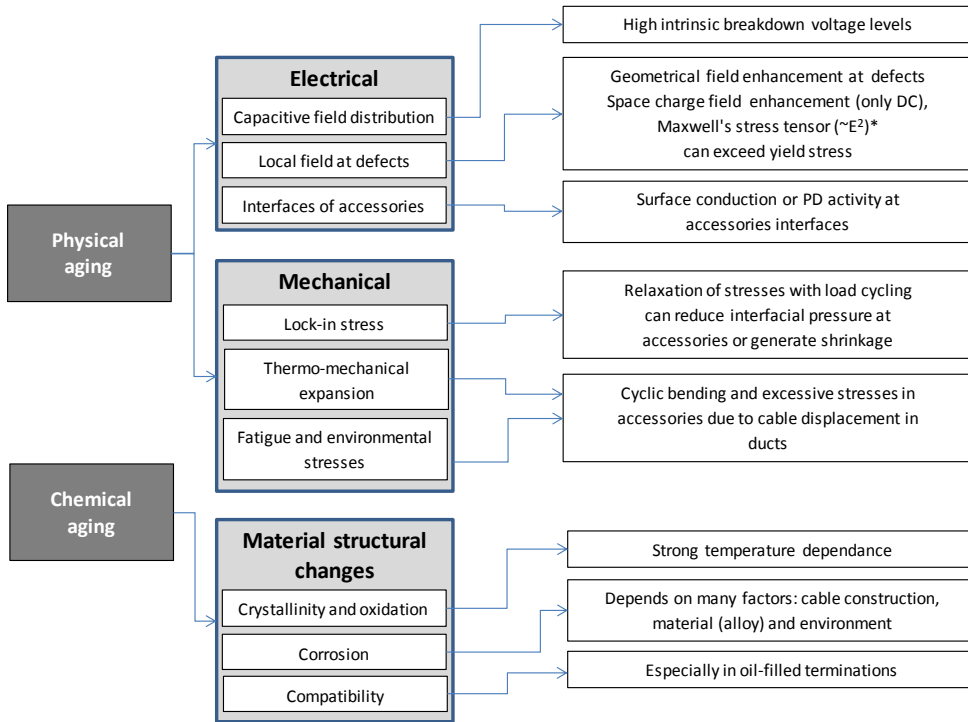
Figure 3.6: XLPE HV/EHV cables ageing factors and effects. (*)-Insulating materials with high permittivity and high breakdown strength would yield large electrical energy density. The stored energy W is expressed as a function of the dielectric permittivity ϵ and the square of the applied electric field E , $W = \epsilon E^2 / 2$ [34].

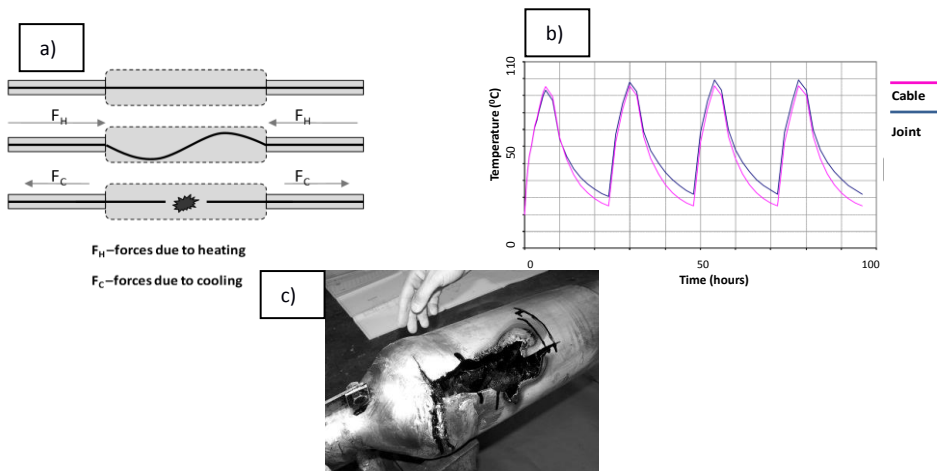
Figure 3.9: a) Experimental loading cycles (8 hours on, 16 hours off) on a 400 kV 2500 mm² Cu cable and joint [37]. b) Theoretical visualization of the effect of thermal cycling. c) Internal mechanical defect of the 110 kV SCFF cable.

- Back-to-back forces and shifting of cable body into joint body.
- Radial expansion resulting in an increased volume of insulation and forces to cable sheath.
- Displacement of the conductor against insulation, in the worst case scenario.

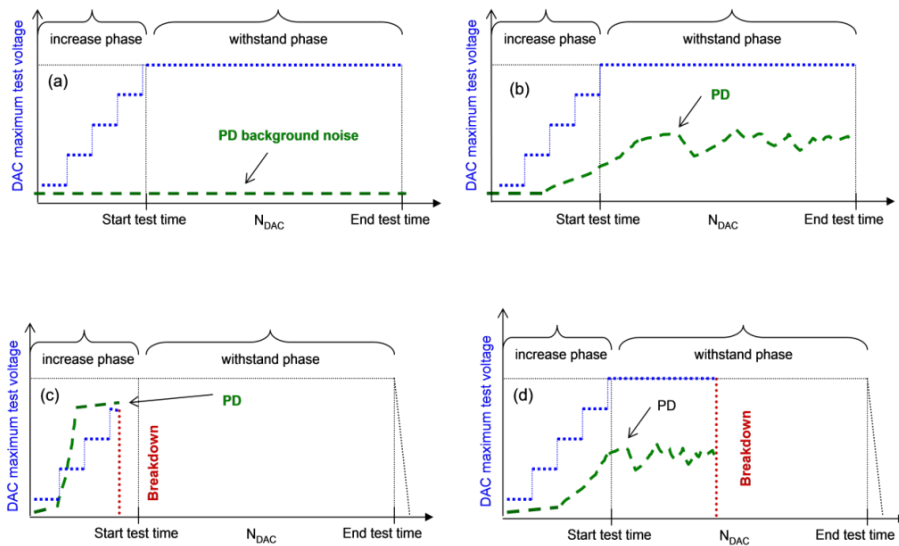
Figure 4.7: Monitored voltage withstand test and example of possible test scenarios. a) No breakdown, no PD detected above noise level, b) No breakdown, PD detected, c) Breakdown during voltage increasing, PD detected, d) Breakdown during voltage withstand test, PD detected [14].

Due to the additional information as provided by PD detection, these parameters can improve the evaluation of the insulation condition. If PDs are detected during voltage test execution, evaluation of the detected PDs is necessary. Expert knowledge about PD behaviour in different types of insulation with different PD behaviour is necessary to obtain a reliable picture of the tested object. Important aspects are background noise level at the test location, proper test setup installation, calibration and quality of the connection between the cable terminations and DAC test system.

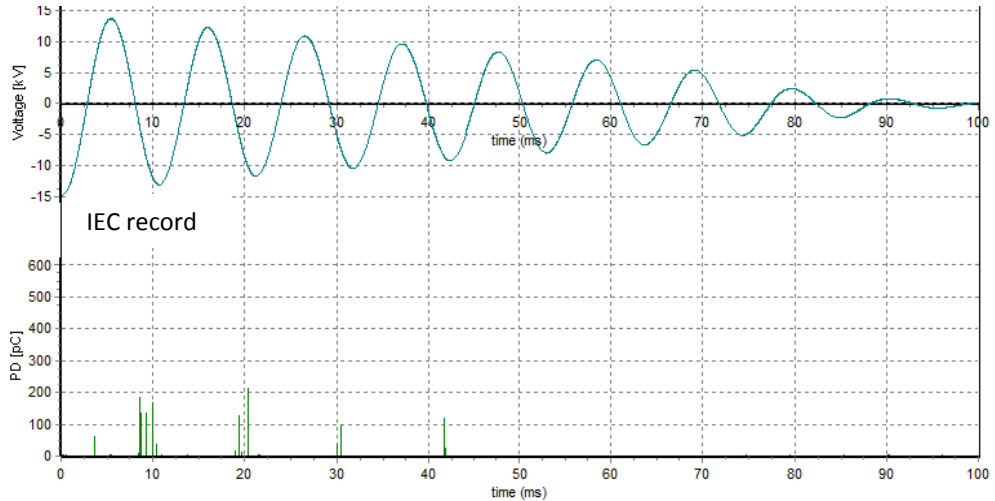
Figure 4.11a: IEC partial discharge record at DAC.

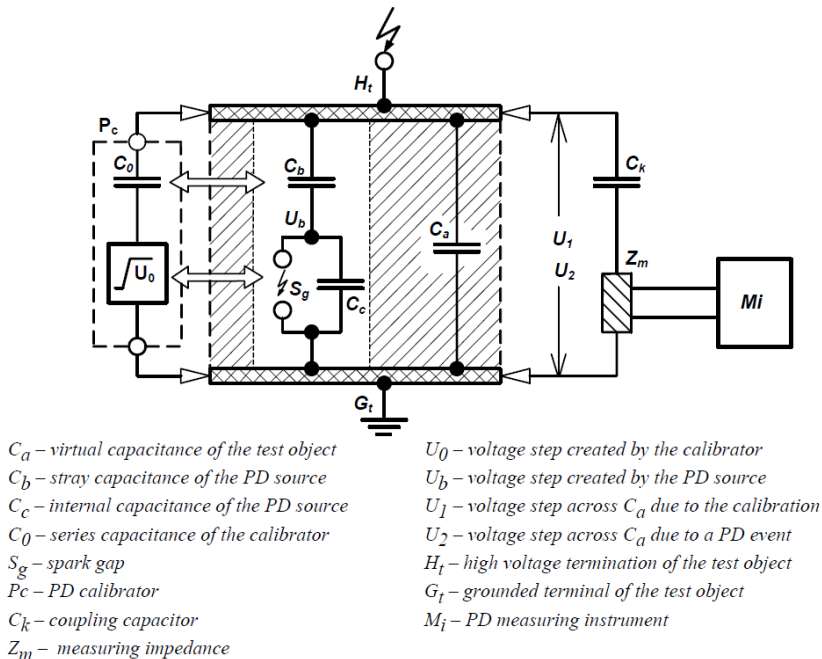
Figure 4.12: IEC 60270 circuit for calibration of apparent charge [53].

Figure 4.12 shows the circuit for calibrating apparent charge according to specifications described in [54].

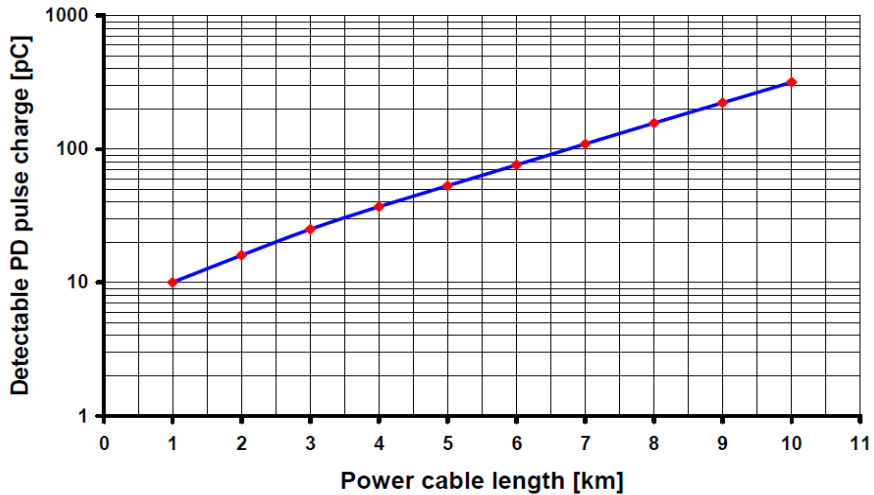
Figure 4.14: Example of PD detection sensitivity versus the cable length calculated on the basis of a reference value of 10 pC achievable for a power cable of 1 km length [48].

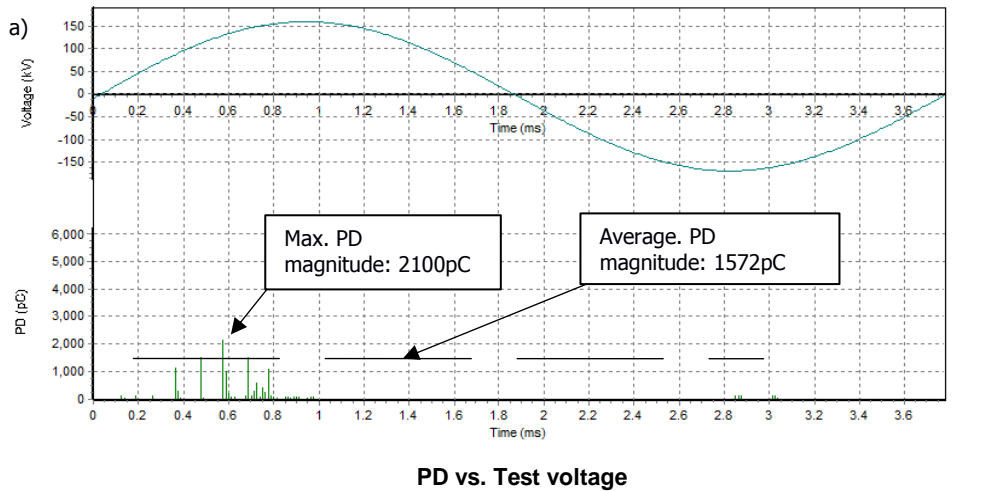
Figure 4.17: a) DAC PRPD at test voltage level of 150 kV . Maximum and average PD magnitude can be derived (selected for the one voltage period). b) q vs. V graphics obtained during site acceptance test on 110 kV XLPE power cable. Different PDIV has been observed for particular cable phases.

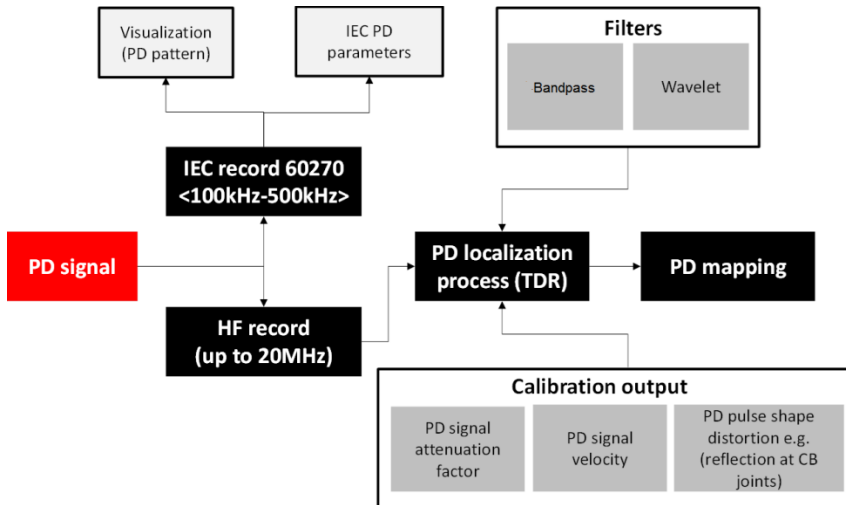
Figure 4.19: PD mapping process (PD localization process).

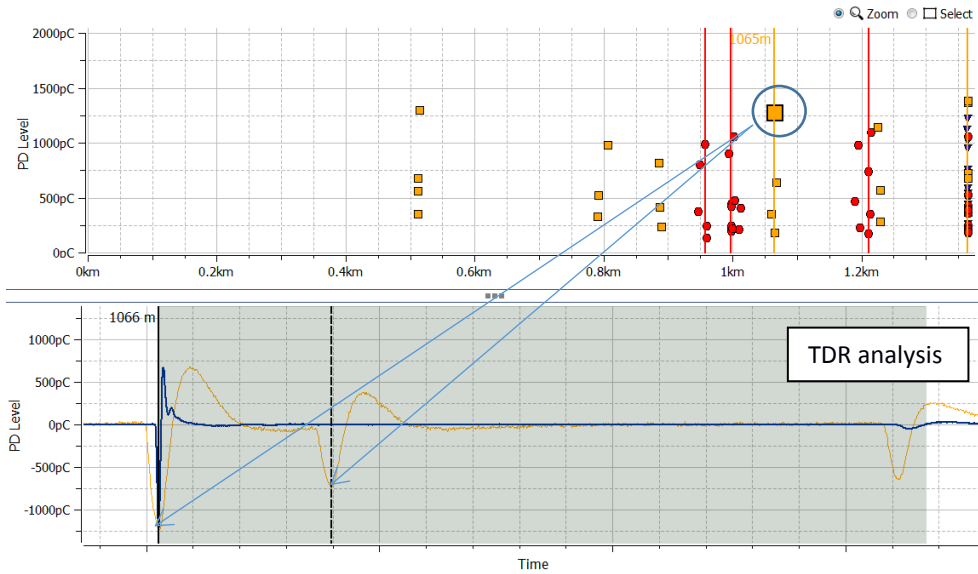
Figure 4.21: PD location (PD mapping) of 110 kV aged PE cable obtained during the maintenance test. Note: PD events localized in cable insulation are represented by: blue triangle (L1), orange square (L2), red dot (L3). Blue line is a calibration pulse.

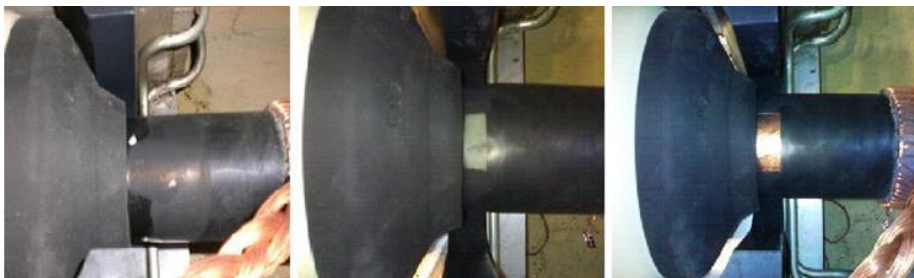
Initial situation

Removed insulation by scratching with the knife

This defect occurs between the cable insulation and the outer semi-conductive screen. This defect may occur due to poor contact between cable insulation and semi-conductive screen as a result of poor elasticity of stress-cone or wrong diameter size. The main reason of this defect is poor-workmanship but it can also be the low quality of manufacturing. When the material of the stress-cone is too stiff or the shape is not completely round, it may result in poor contact under the joint housing. Figure 5.5 shows defect no. 3.

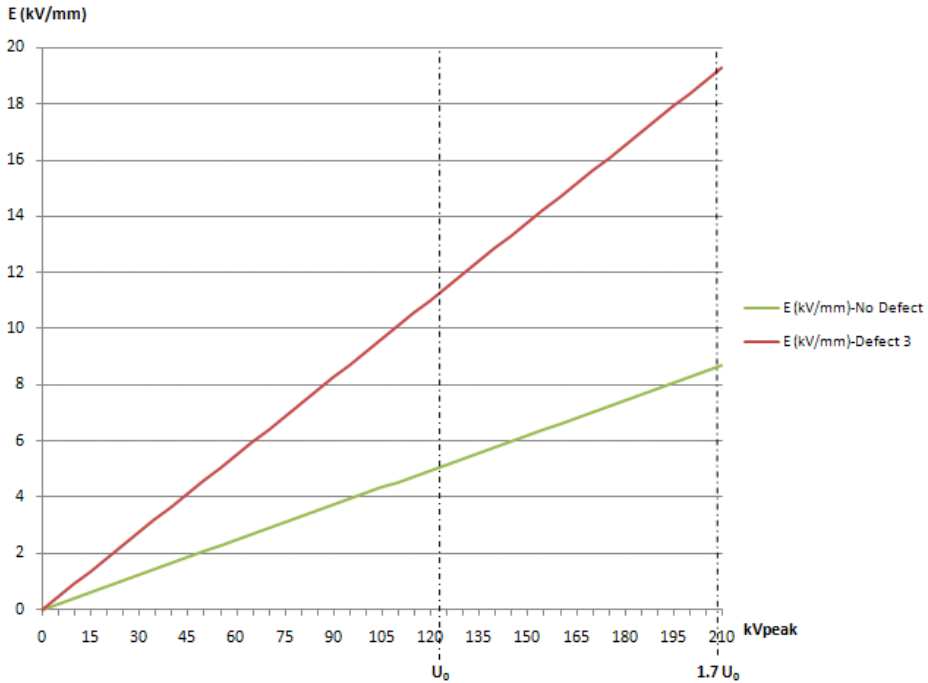
Figure 5.7: Plot of electric field as a function voltage applied for defect 3.

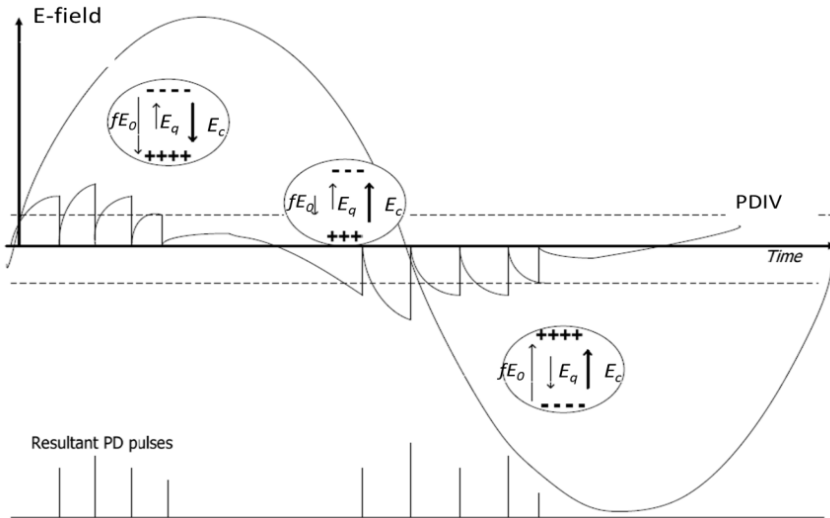
Figure 5.8: Partial discharge process in the gas filled cavity that depends on surface charge deposit in the cavity [58].

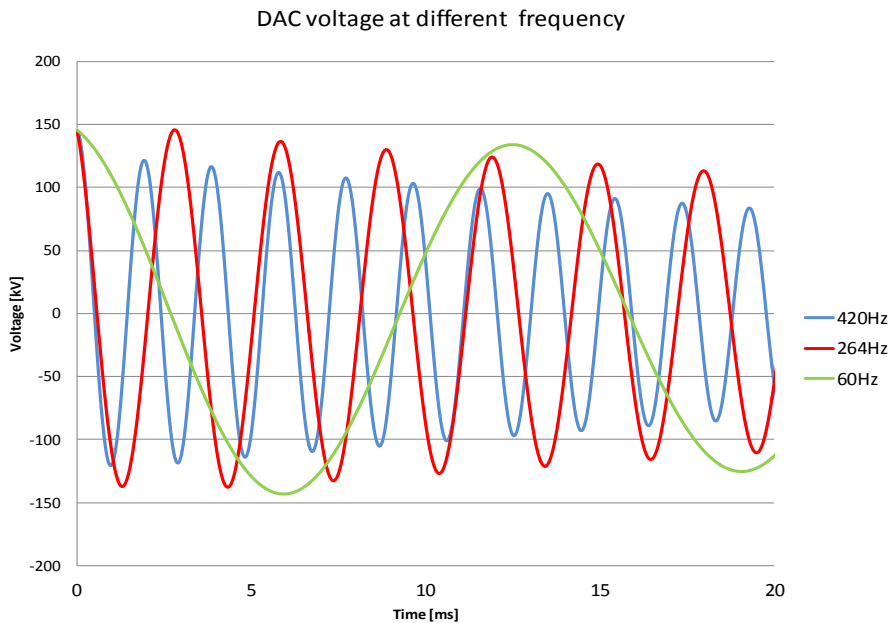
Figure 5.11: Three different DAC voltage frequencies applied for defect investigation.

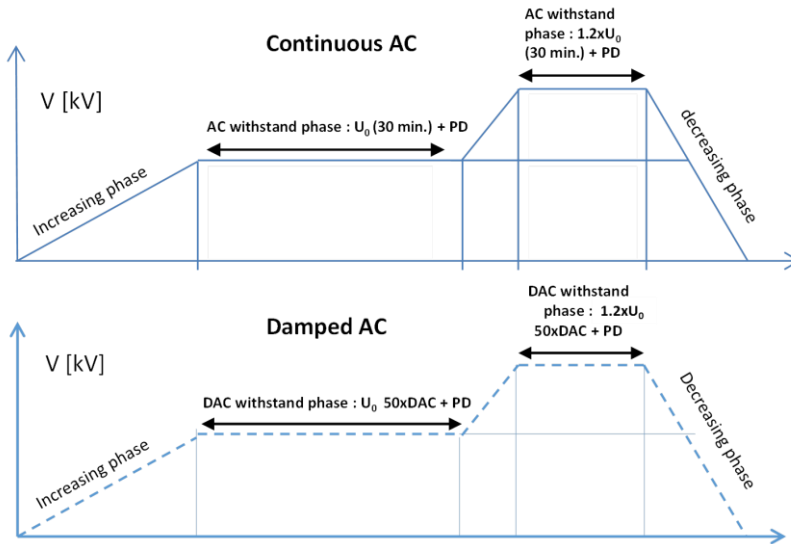
Figure 5.12: Acceptance test procedure with continuous 50Hz AC/DAC voltage.

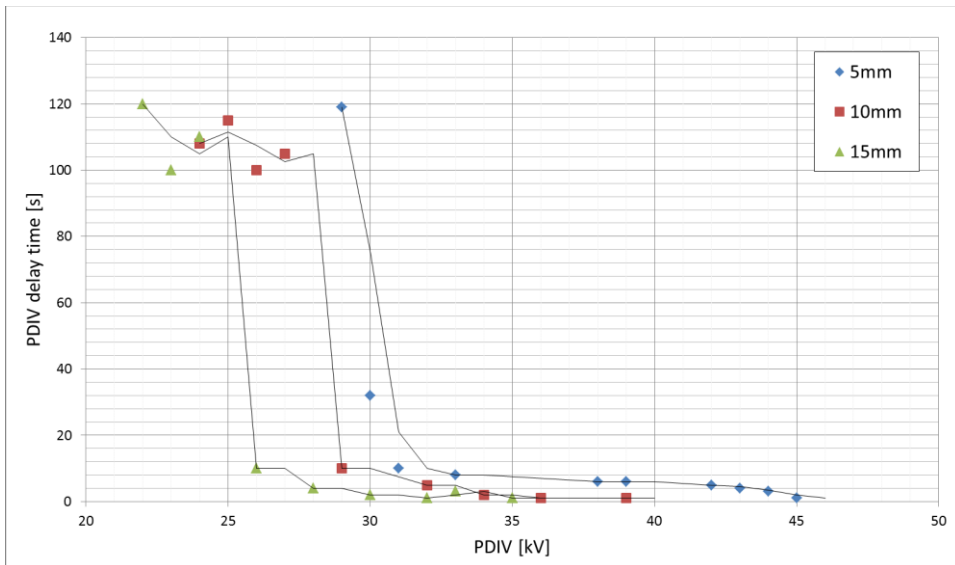
Figure 5.13: 50 Hz AC energizing. PDIV delay time (time necessary to record first PD) at different voltage levels

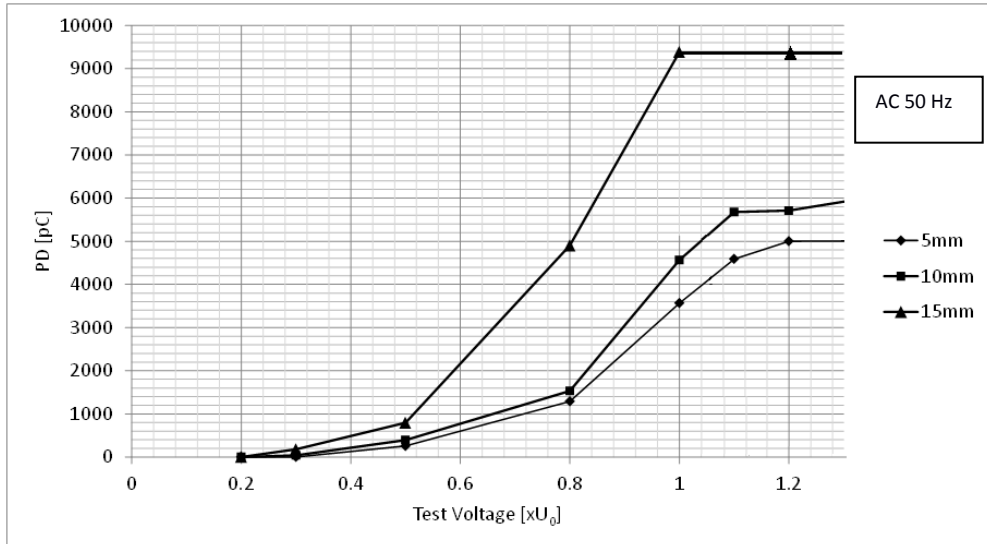
Figure 5.14: PD vs. test voltage for defect 1 at 50 Hz AC voltage. Note: values presented in the plot are the average PD magnitude obtained during 2 min. measurements.

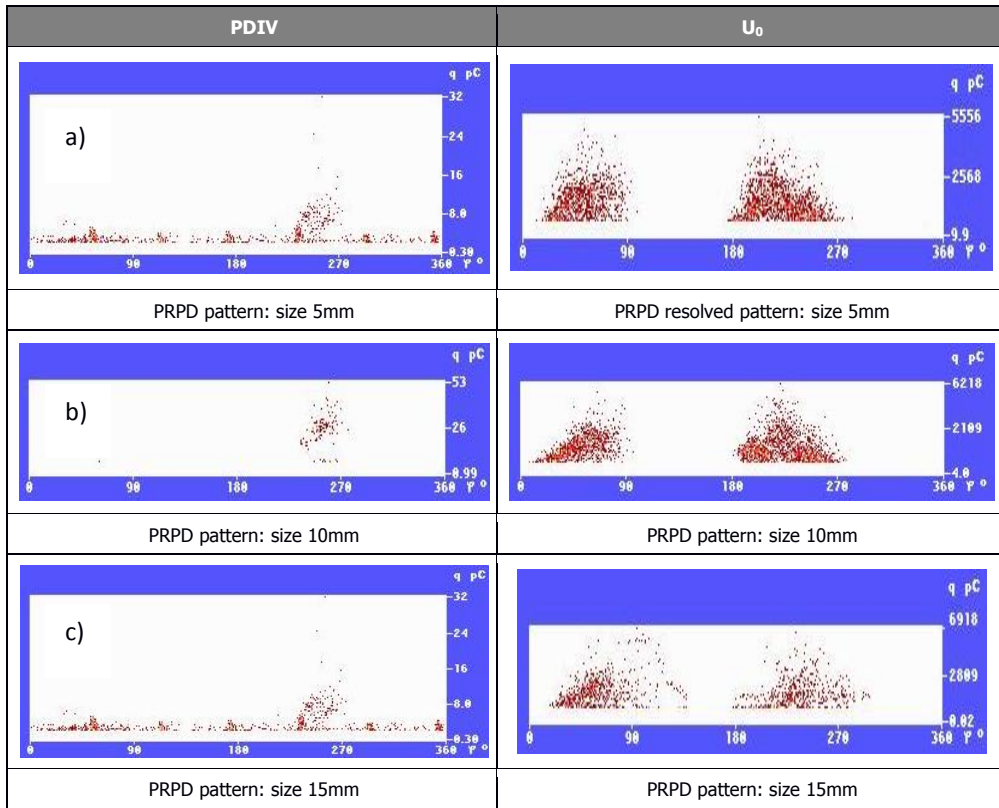
Figure 5.15: PRPD patterns at PDIV short delay PDIV/Max. PDIV left side and PRPD patterns at U_0 right side for different sizes: a) 5 mm, b) 10 mm, c) 15 mm.

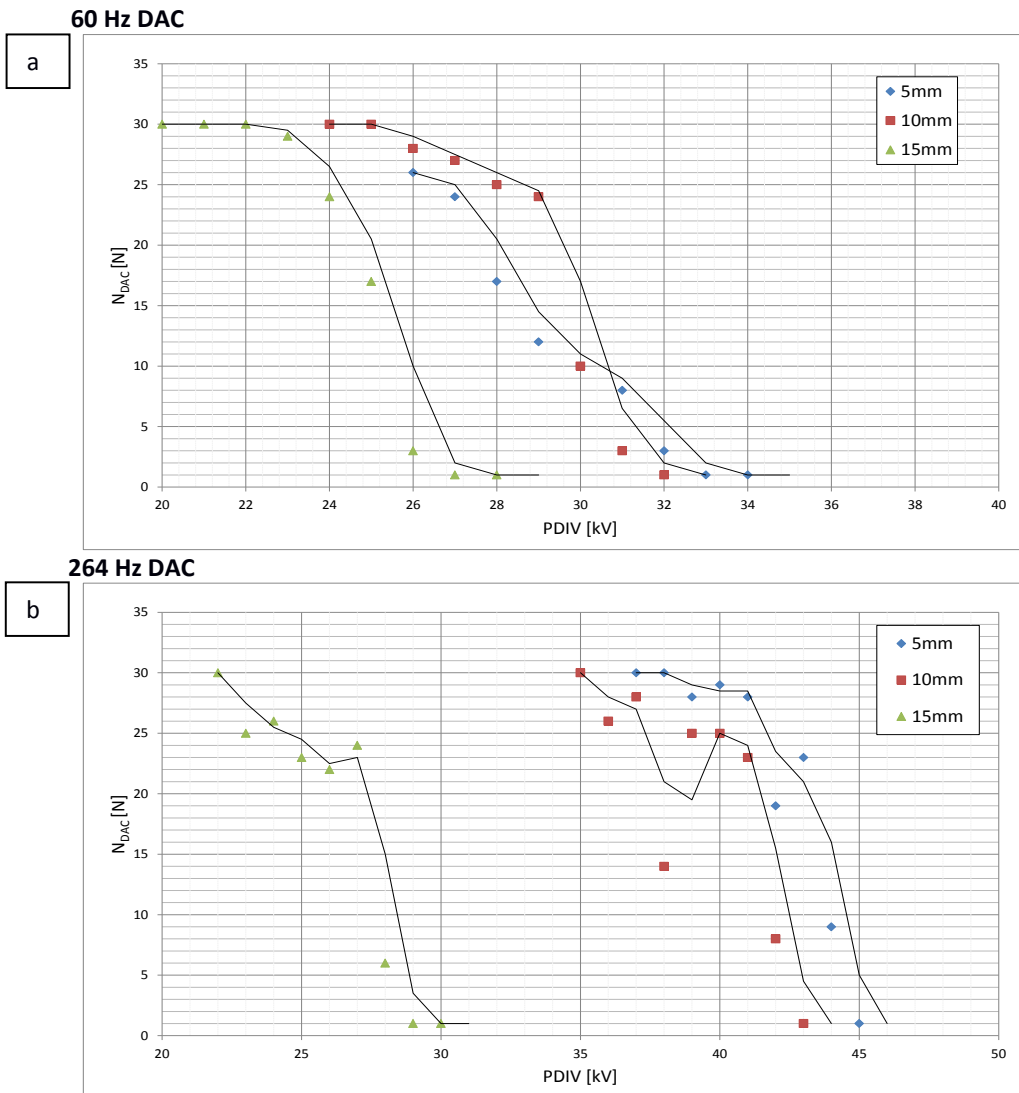
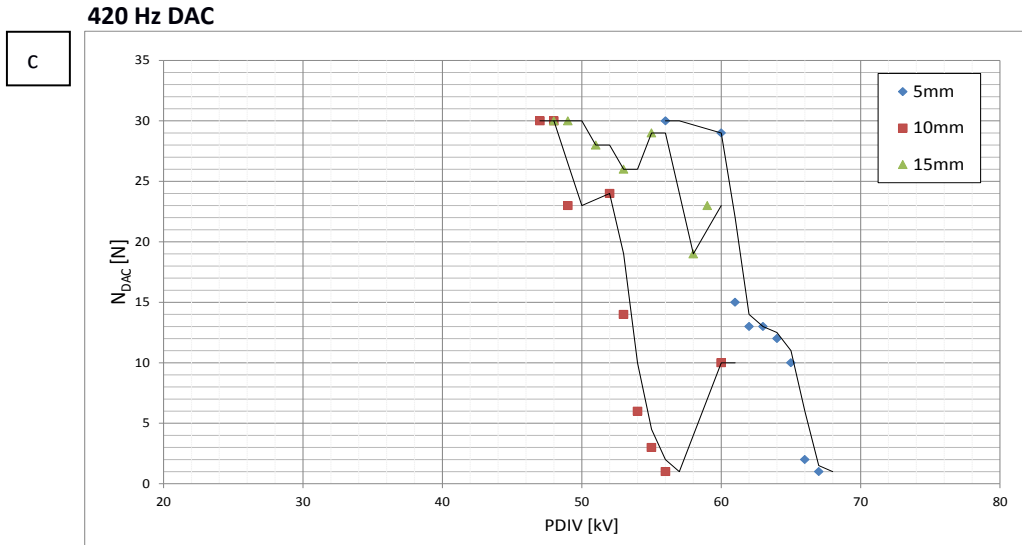
Figure 5.16: PDIV delay time (number of DAC excitations till PD occurrence) at different voltage levels for a) 60 Hz b) 264 Hz c) 420 Hz.

Figure 5.16 (continued): PDIV delay time (number of DAC excitations till PD occurrence) at different voltage levels for a) 60 Hz b) 264 Hz c) 420 Hz.

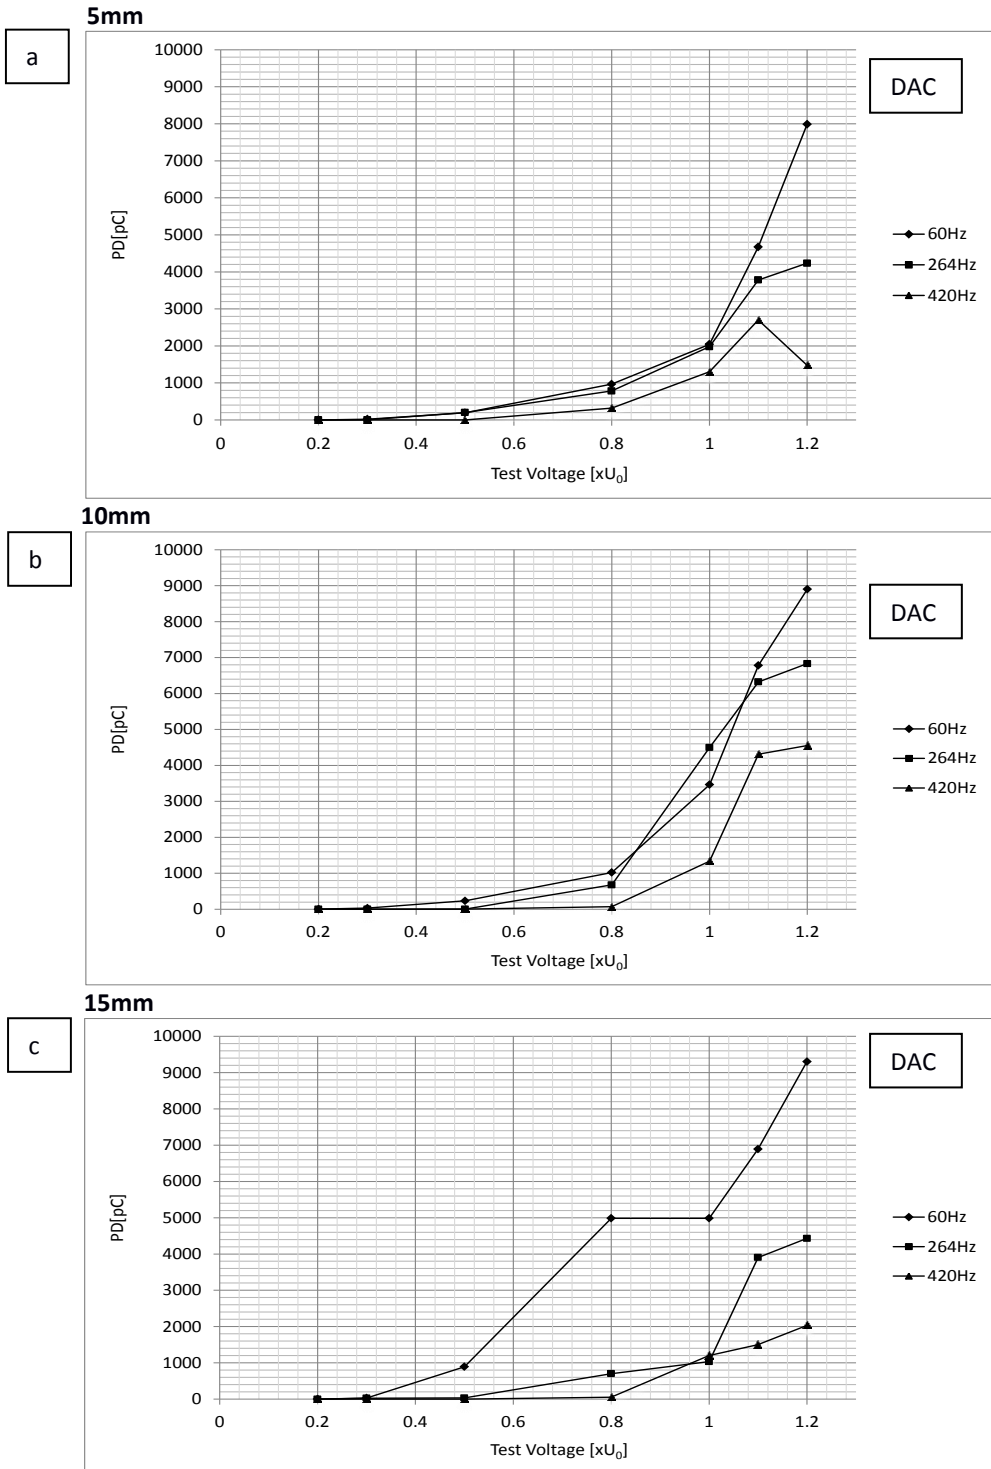
Figure 5.17: PD vs. test voltage for defect 1 at DAC voltage. a) 60 Hz, b) 264 Hz, c) 420 Hz.

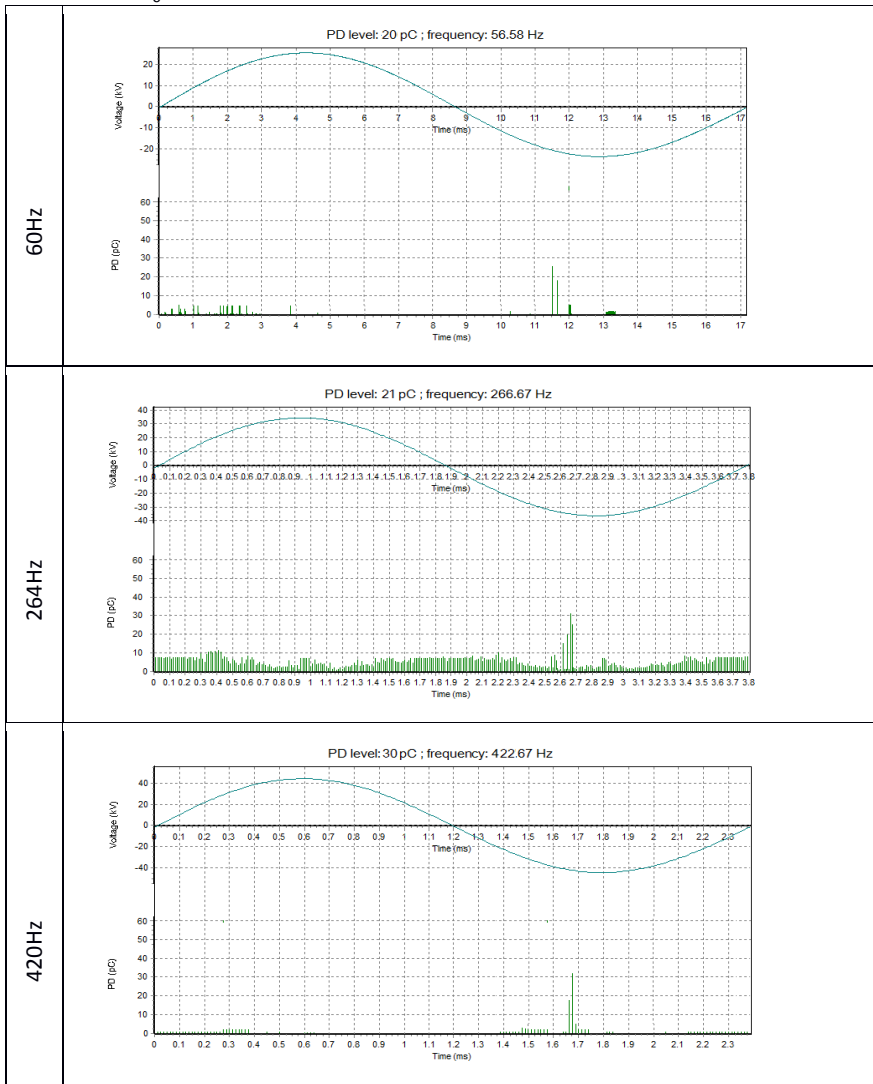
Figure 5.18: PRPD patterns for defect type 1, size 5 mm at PDIV. Note: These are random examples (single excitation) from the measuring process of 30xDAC excitations.

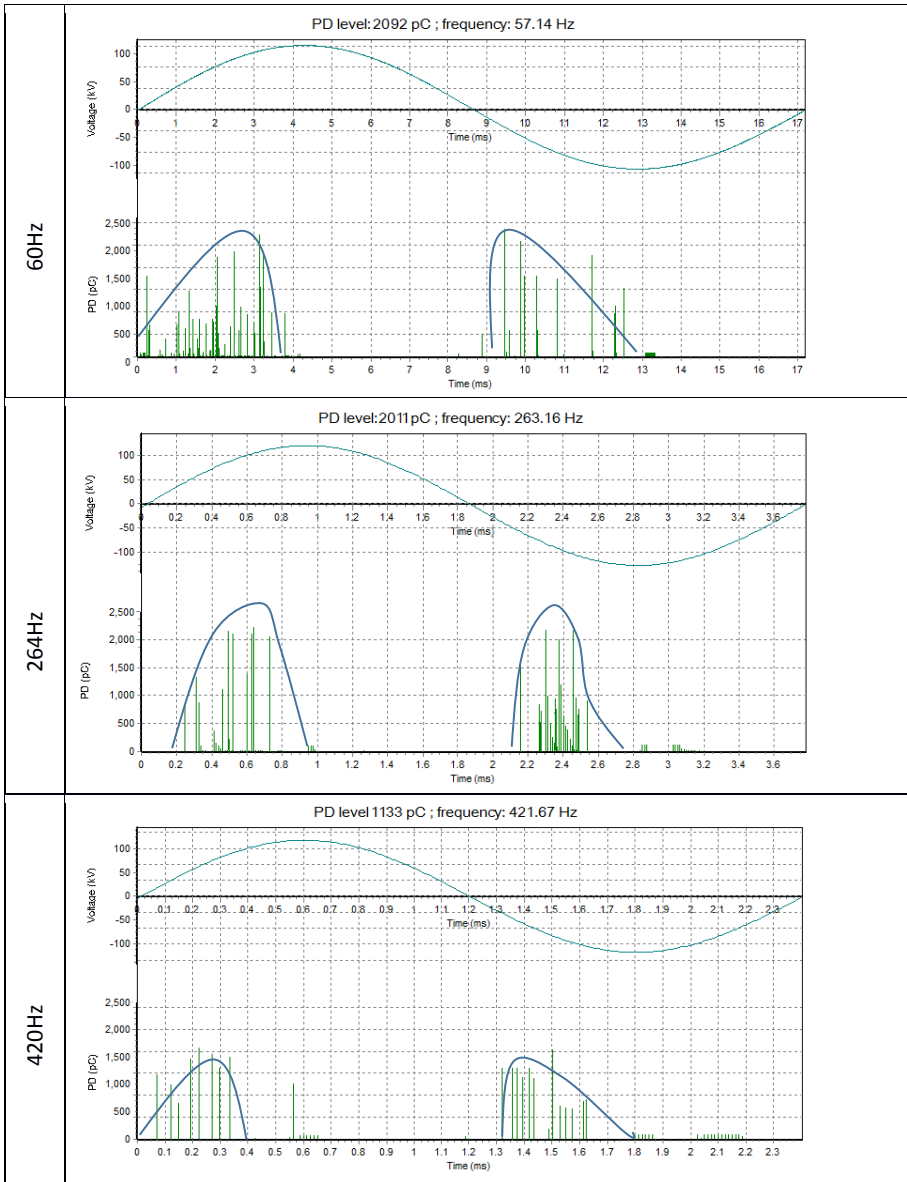
Figure 5.19: PRPD patterns for defect type 1, size 5 mm at U_0 . Note: These are random examples (single excitation) from the measuring process of 30xDAC excitations.

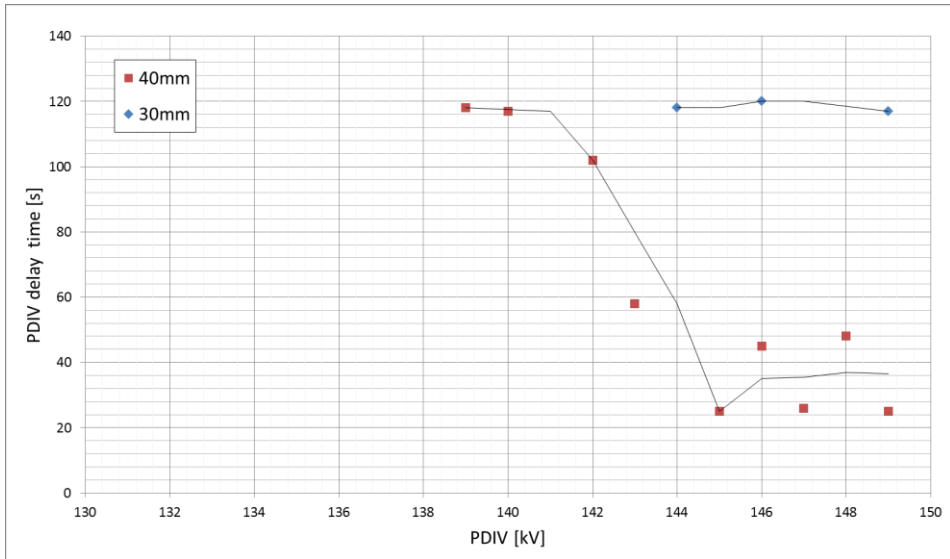
Figure 5.20: PDIV long delay time at different voltage levels. Only two sizes of defect type 2: 30 mm and 40 mm were detectable within 2 minutes of testing time.

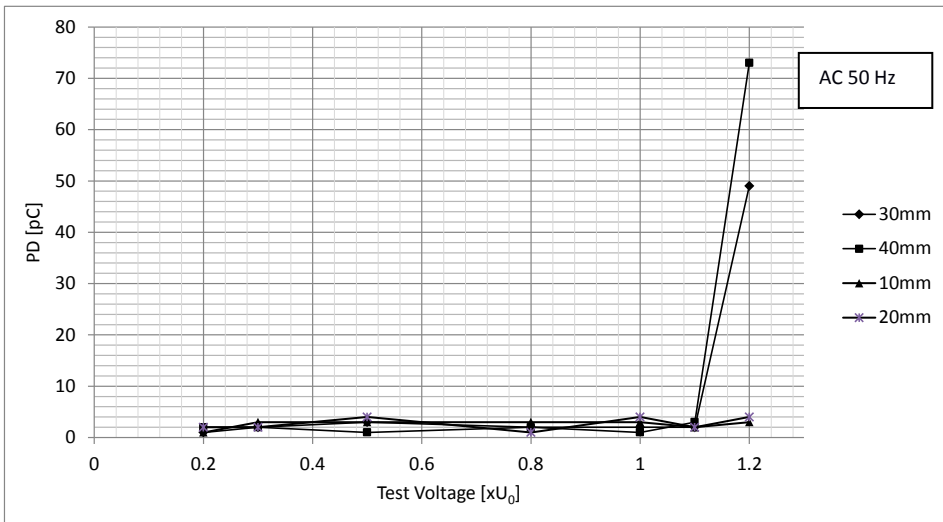
Figure 5.21: PD vs. test voltage for defect type 2 at 50 Hz AC voltage. Note: values presented in the plot are the average PD magnitude obtained during 2 min. measurements.

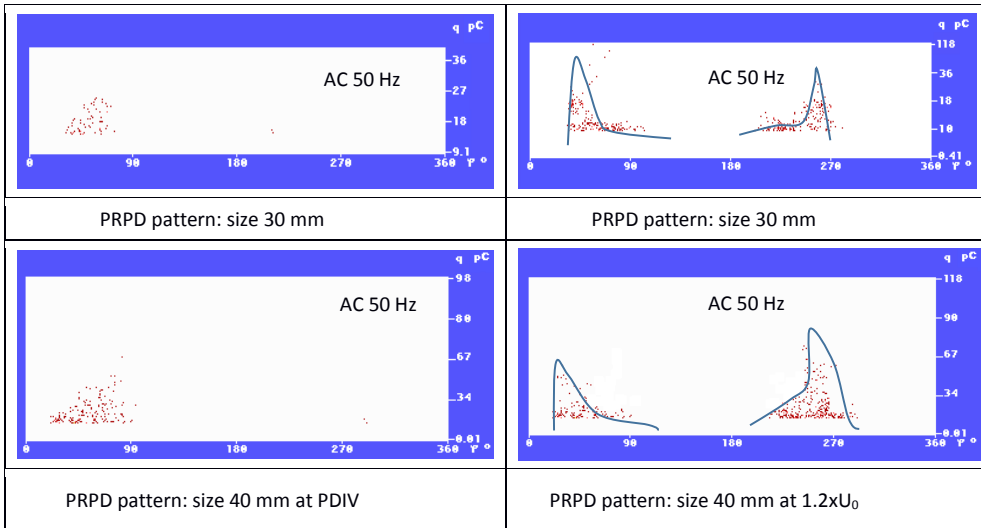
Figure 5.22: PRPD patterns at minimum PDIV on the left side and $1.2xU_0$ for defect 2 at two different sizes on the right side.

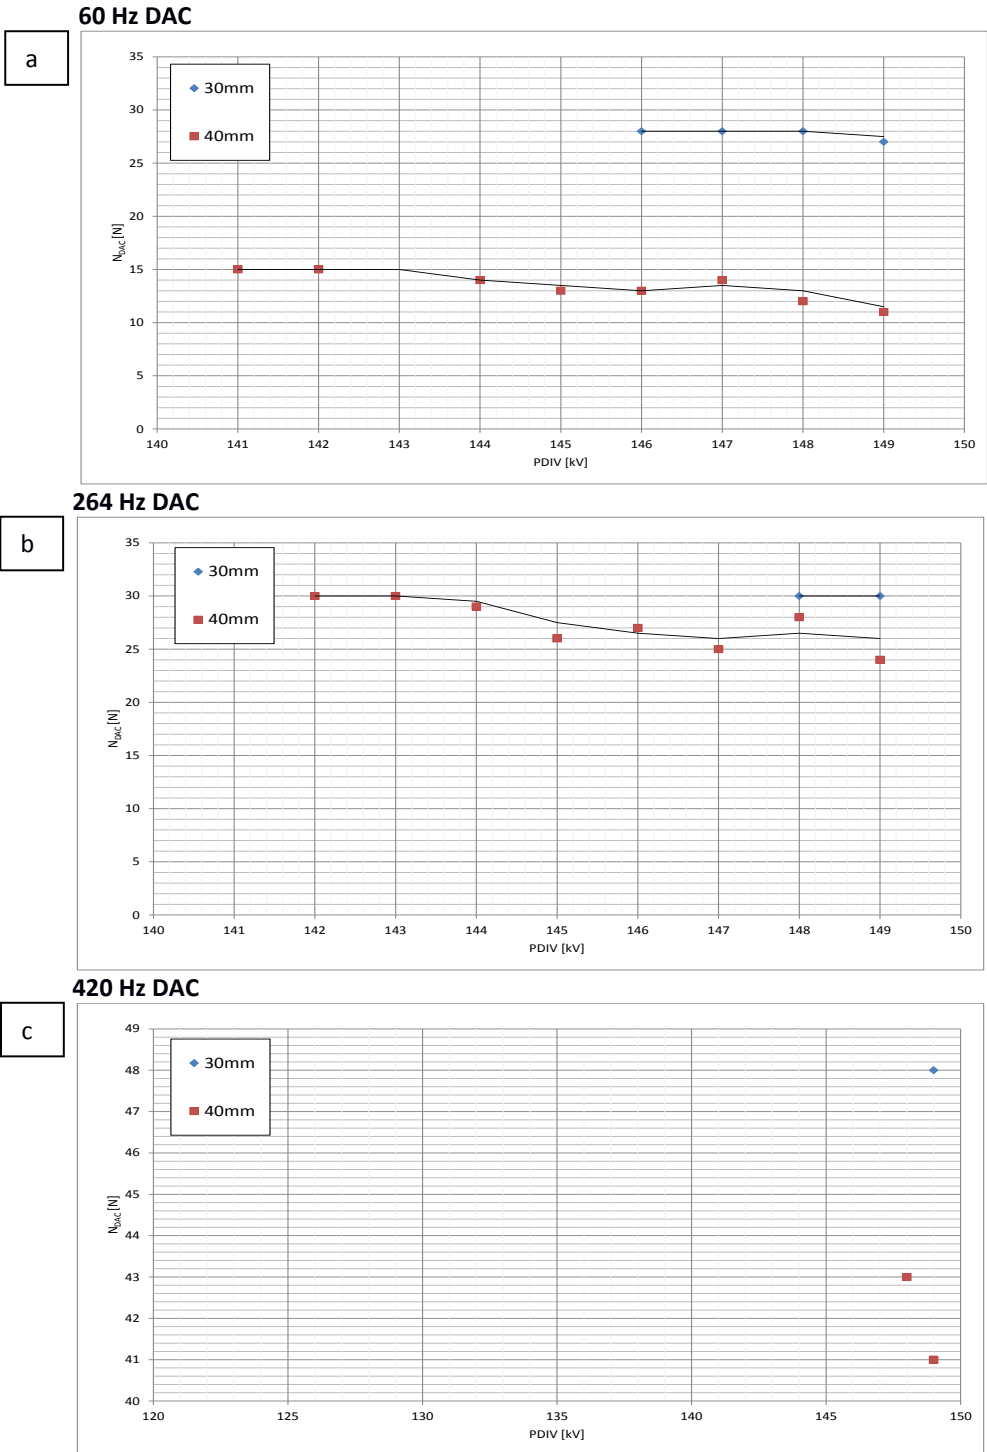
Figure 5.23: PDIV delay time (number of DAC excitations till PD occurrence) at different voltage levels a) 60 Hz, b) 264 Hz, c) 420 Hz.
