Testing and Diagnosis of High Voltage and Extra High Voltage Power Cables with Damped AC Voltages

Cichecki, P. (2018). *Testing and Diagnosis of High Voltage and Extra High Voltage Power Cables with Damped AC Voltages*. [Dissertation (TU Delft), Delft University of Technology].
<https://doi.org/10.4233/uuid:f50c2129-6771-468b-aa3c-7c1fdac4e425>

Proefschrift

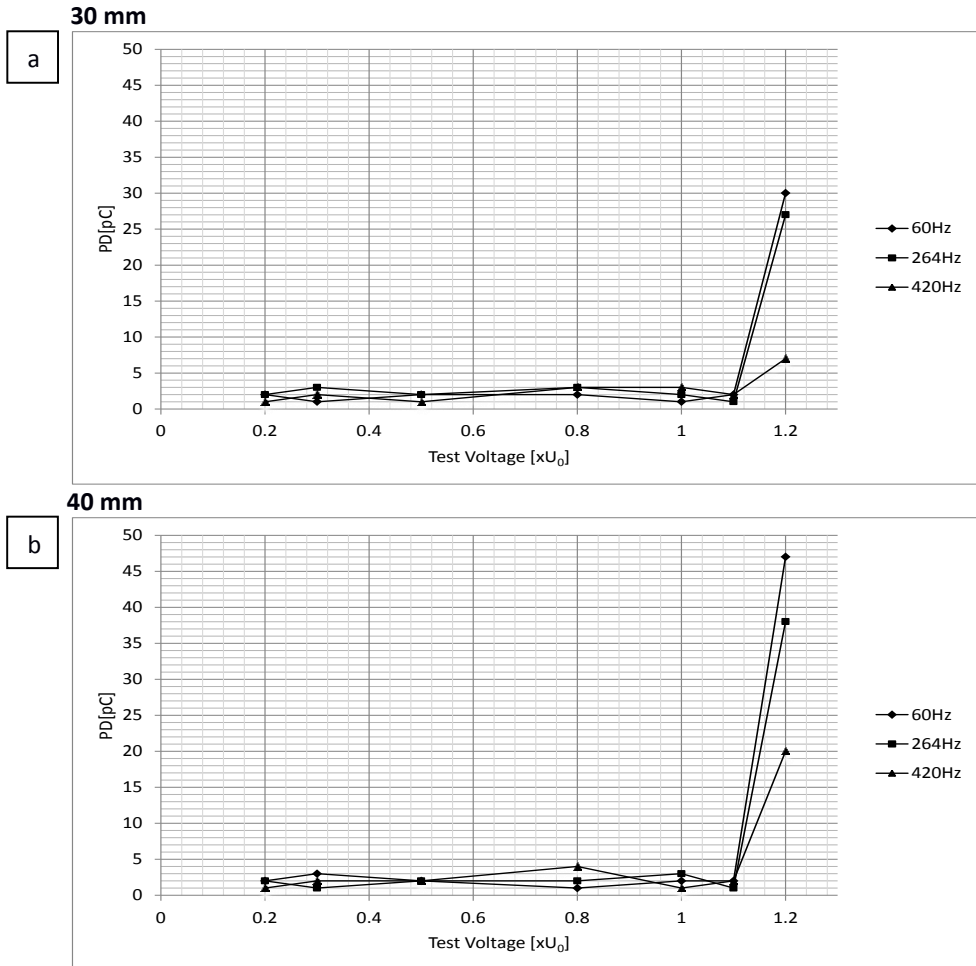
Figure 5.24: PD vs. test voltage for defect type 2 at DAC voltage a) defect size 30 mm. b) defect size 40 mm. Note: values presented in the plot are the average PD magnitude obtained for PD test procedure presented in Table 5.5.

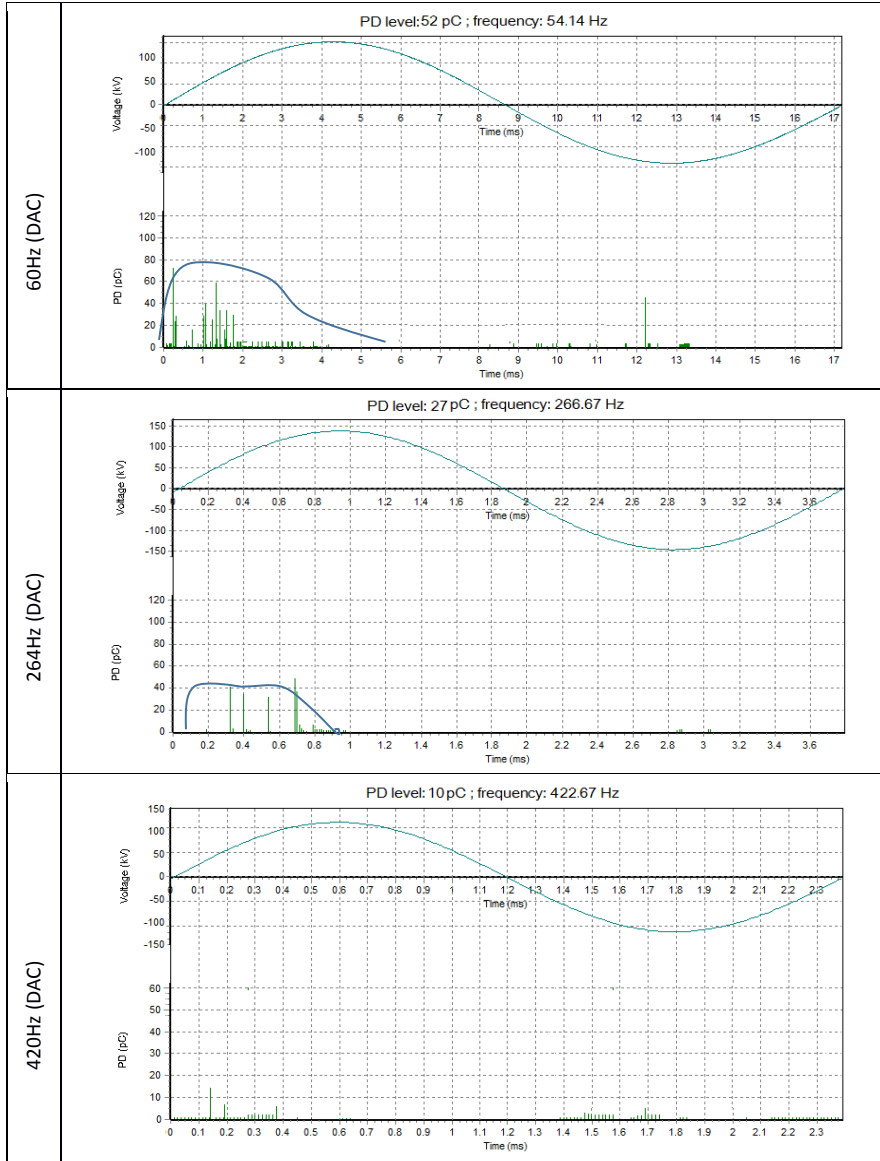
Figure 5.25a: PRPD patterns for defect type 2 (30m) at maximum test voltage level of $1.2xU_0$
 Note: These are random examples (single excitation) from the measuring process of $30x$ DAC excitations.

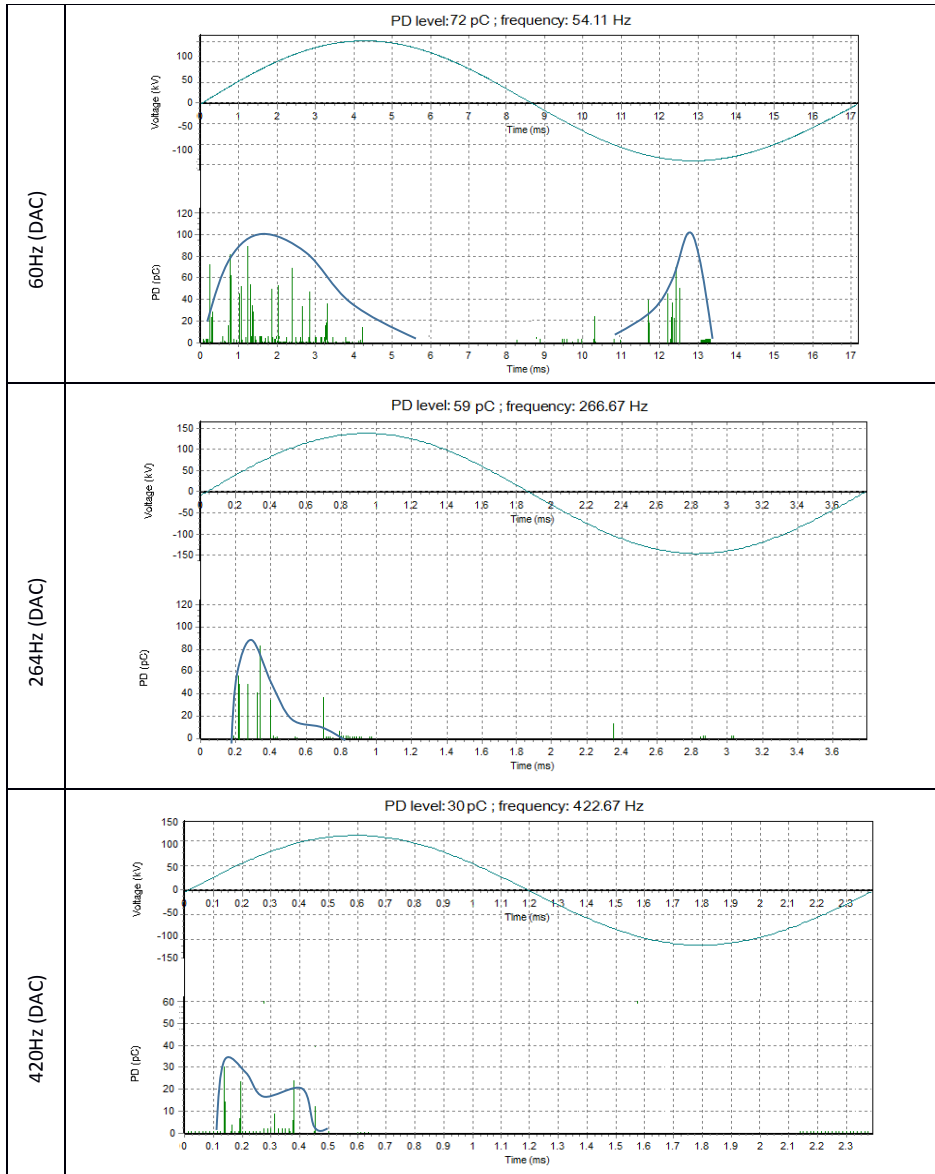
Figure 5.25b: PRPD patterns for defect type 2 (40m) at maximum test voltage level of $1.2xU_0$
 Note: These are random examples (single excitation) from the measuring process of $30x$ DAC excitations.

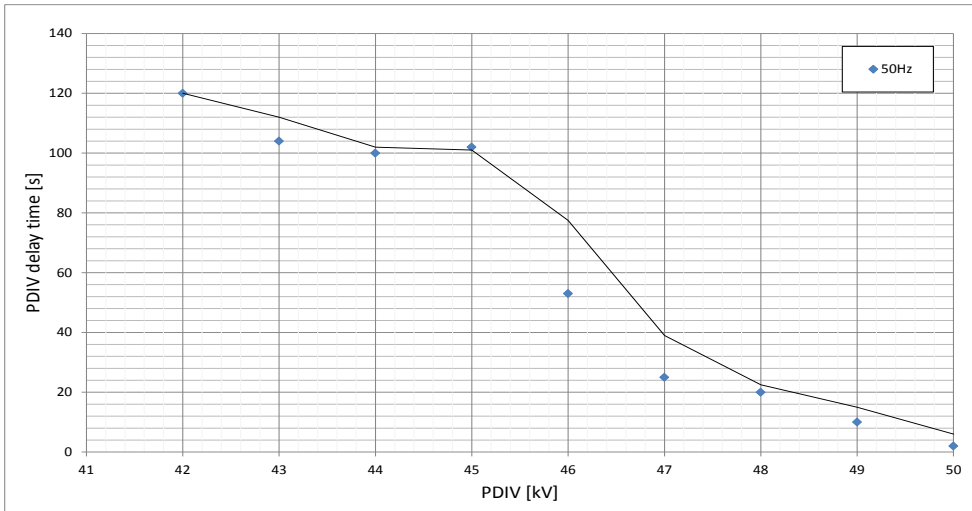
Figure 5.26: PDIV long delay time at different voltage levels.

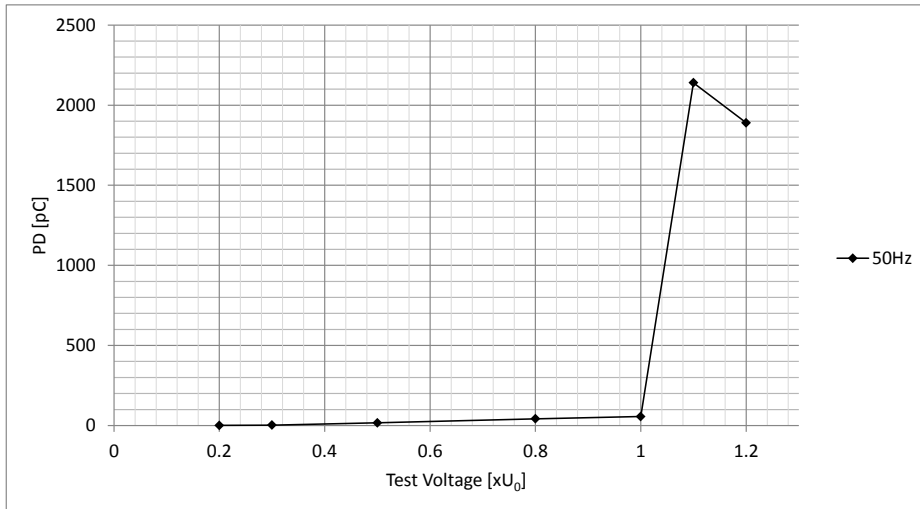
Figure 5.27: PD vs. test voltage for defect type 3 at 50 Hz AC voltage. Note: values presented in the plot are the average PD magnitude obtained during 2 min. measurements.

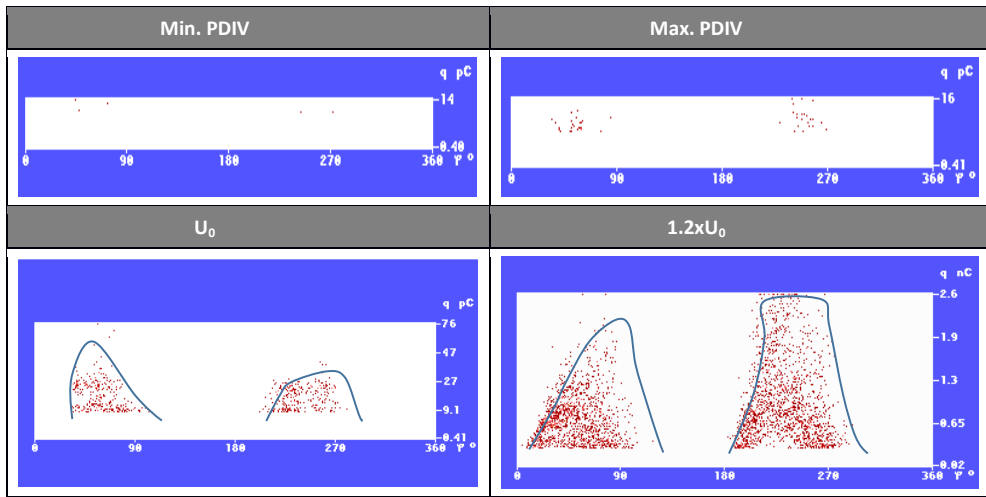
Figure 5.28: PRPD patterns at different test voltage levels of 50 Hz AC.

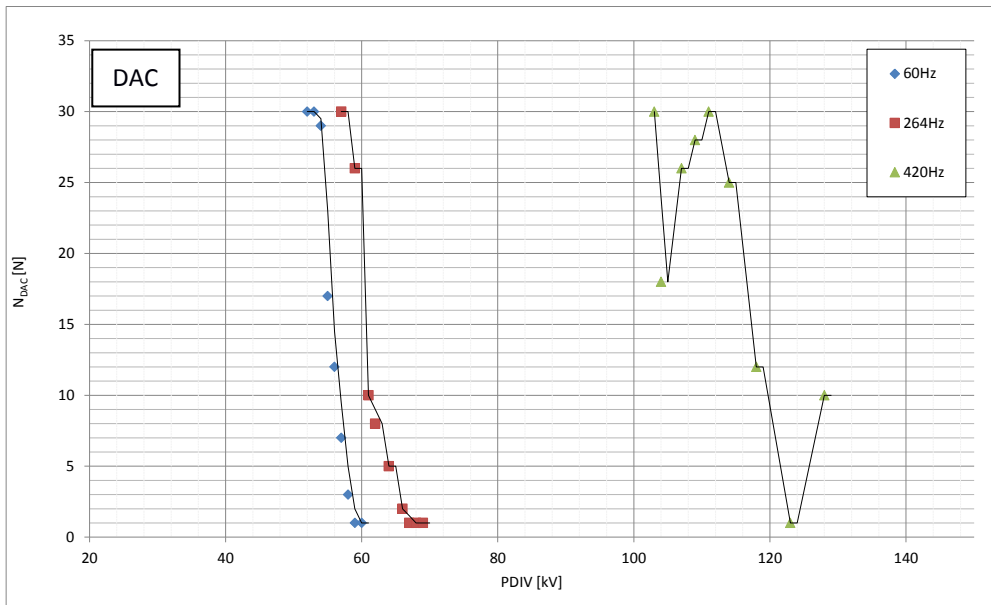
Figure 5.29: PDIV delay time (number of DAC excitations till PD occurrence) at different voltage levels and different DAC frequencies.

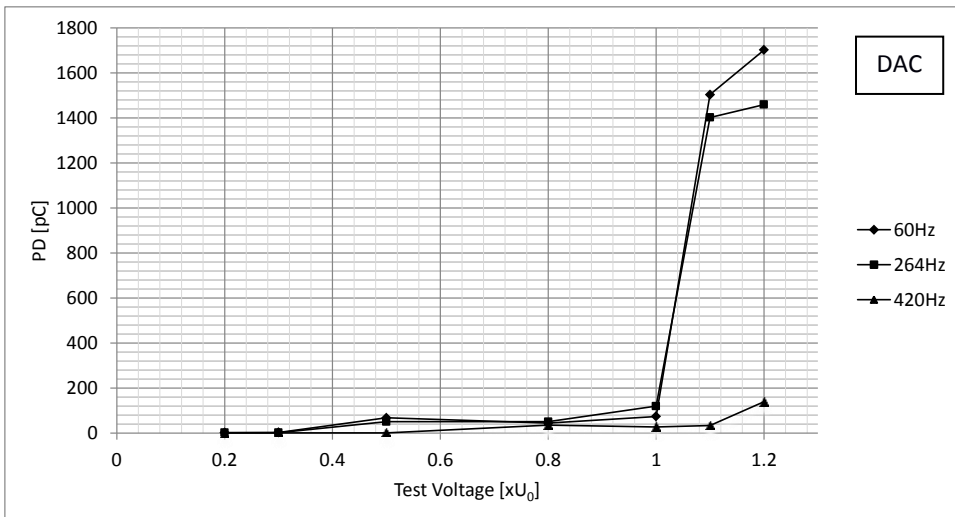
Figure 5.30: PD vs. test voltage for the defect type 3 at DAC voltage.

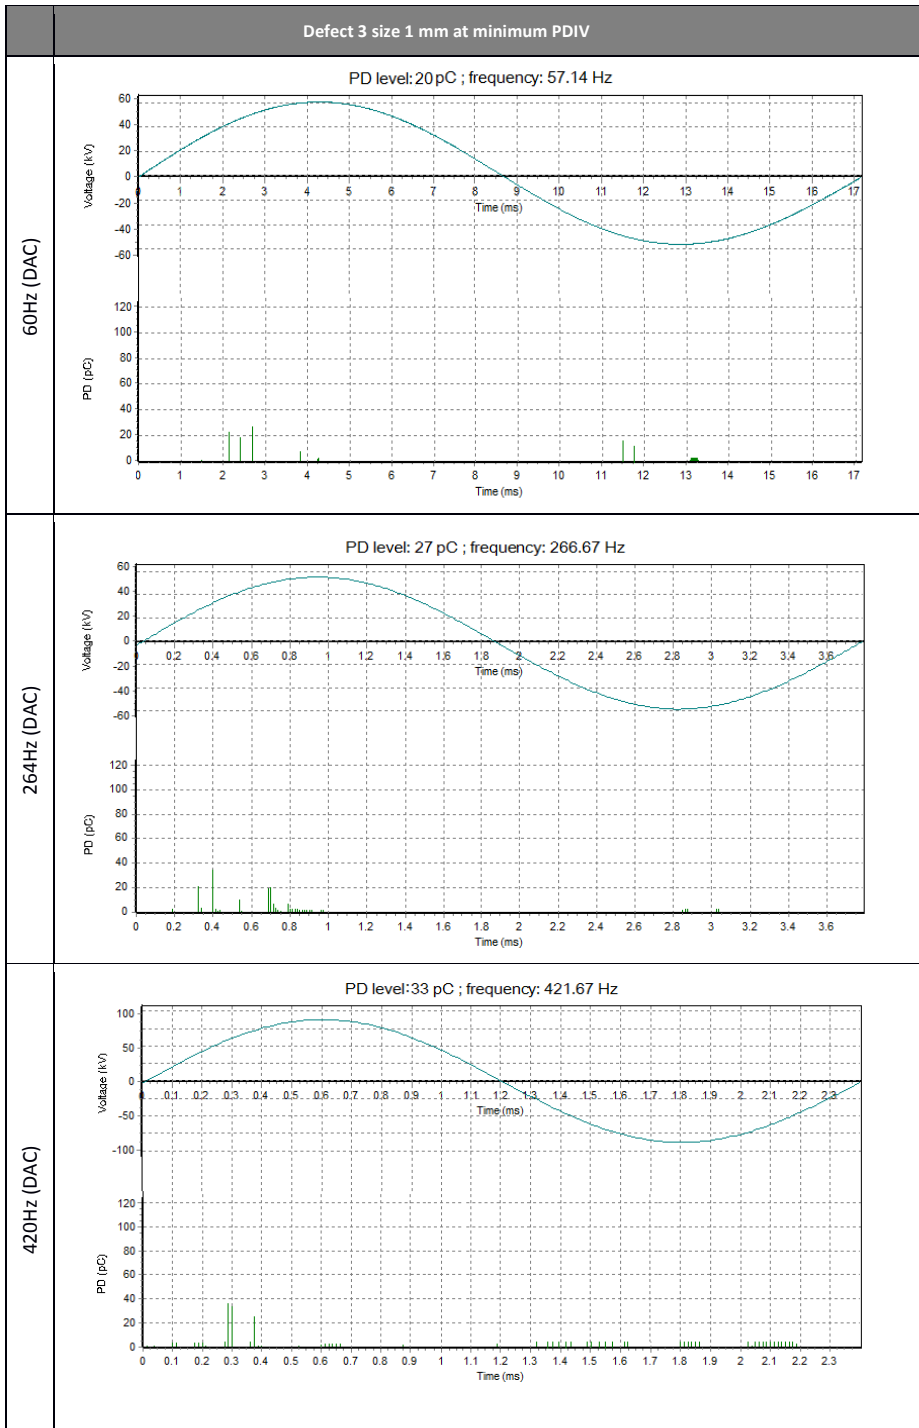
Figure 5.31a: PRPD patterns for defect type 3, size 1mm at minimum PDIV .Note: These are random examples from the measuring process of 30xDAC excitations.

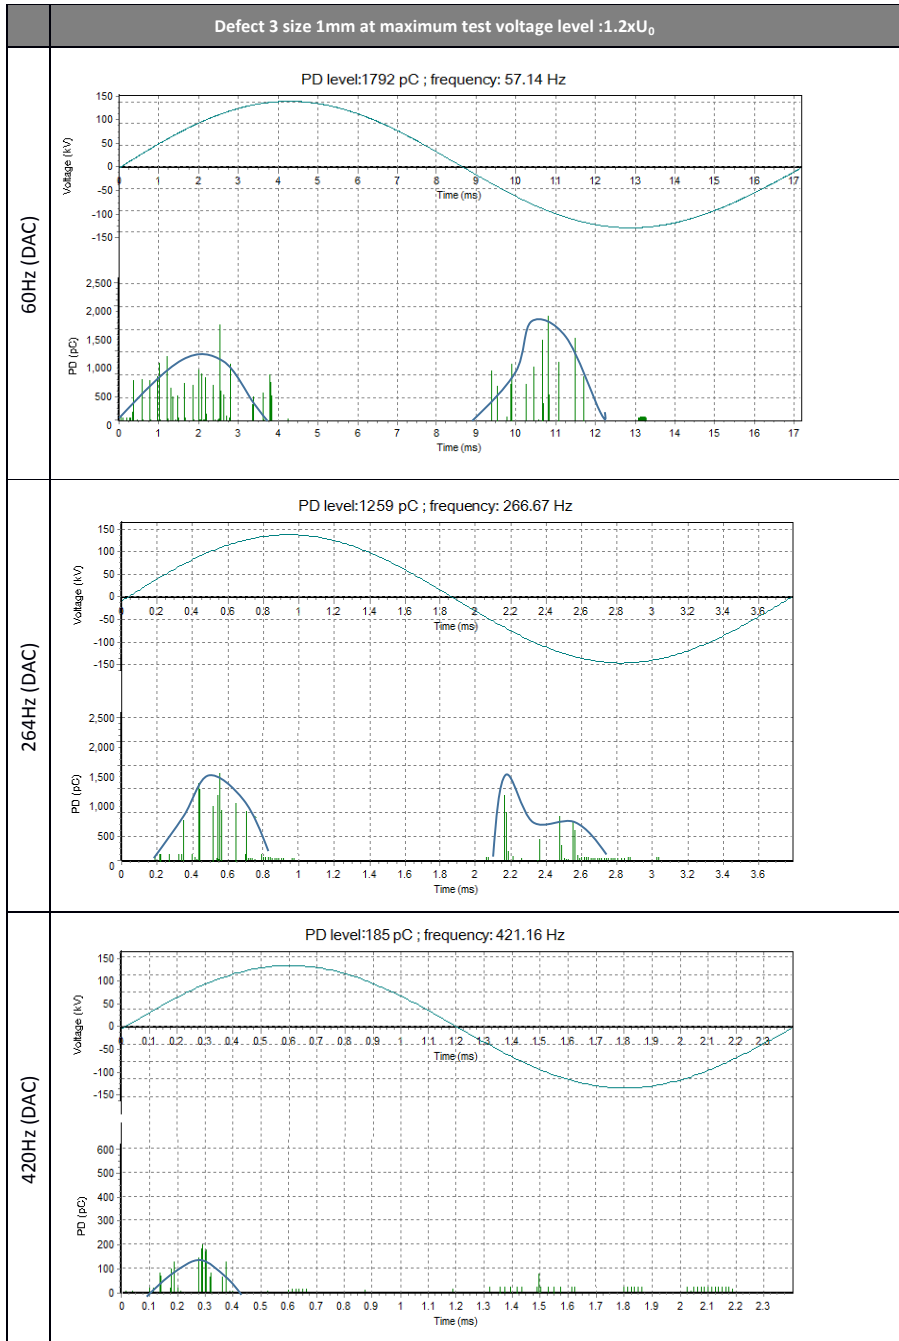
Figure 5.31b: PRPD patterns for defect type 3, size 1 mm at $1.2xU_0$. Note: These are random examples from the measuring process of 30xDAC excitations.

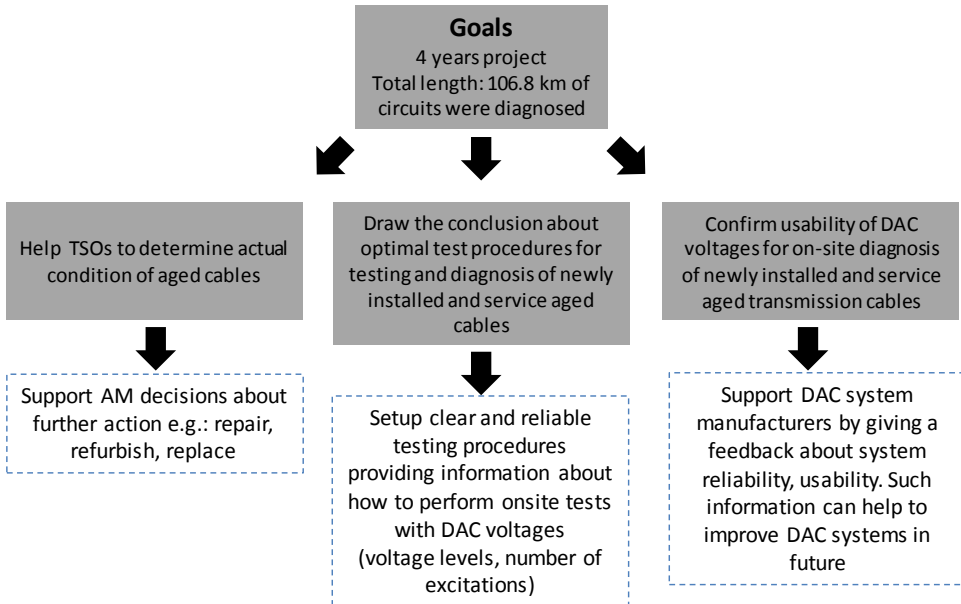
Figure 6.1: General aspects of on-site diagnosis research project performed on service aged transmission cables.

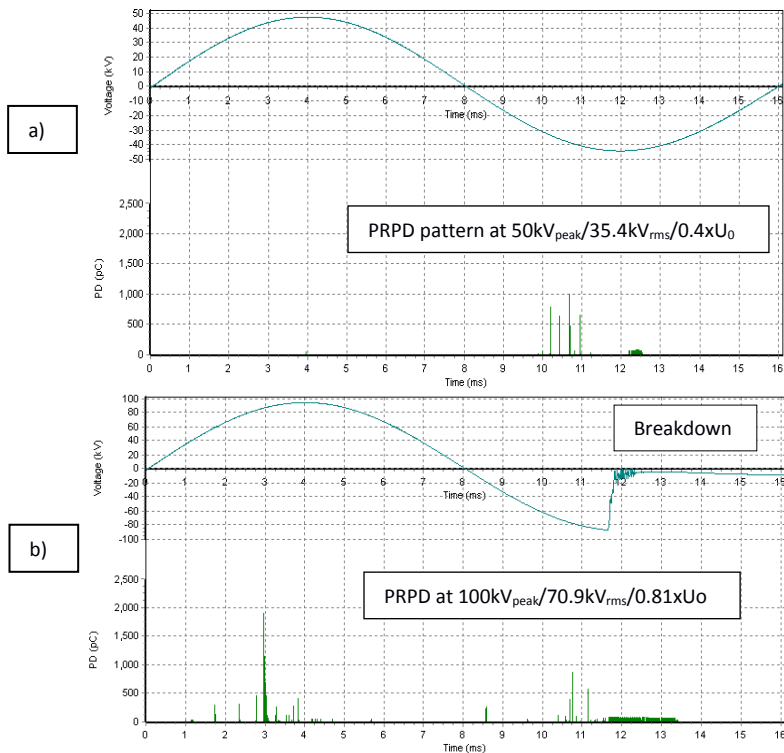
Figure 6.3: PRPD patterns for DAC voltages at a) $0.4xU_0$ b) $0.81xU_0$ 1st breakdown.

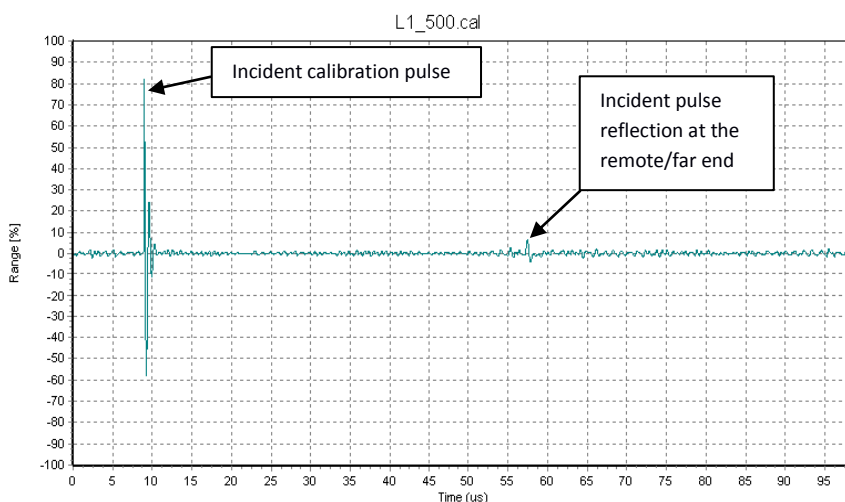
Figure 6.4: Example of calibration of 500 pC pulse. Clear reflection was observed at the remote/far end of cable phase.

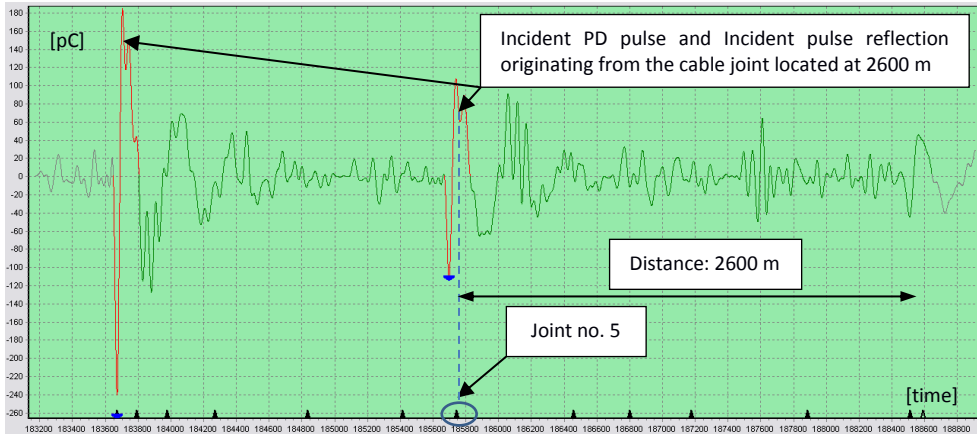
Figure 6.5: Example of TDR analysis of the first recorded PDs (cable phase L1). Partial discharge inception voltage = $0.4xU_0$. PD localised in vicinity of the joints no. 5. Black triangles represent joints positions.

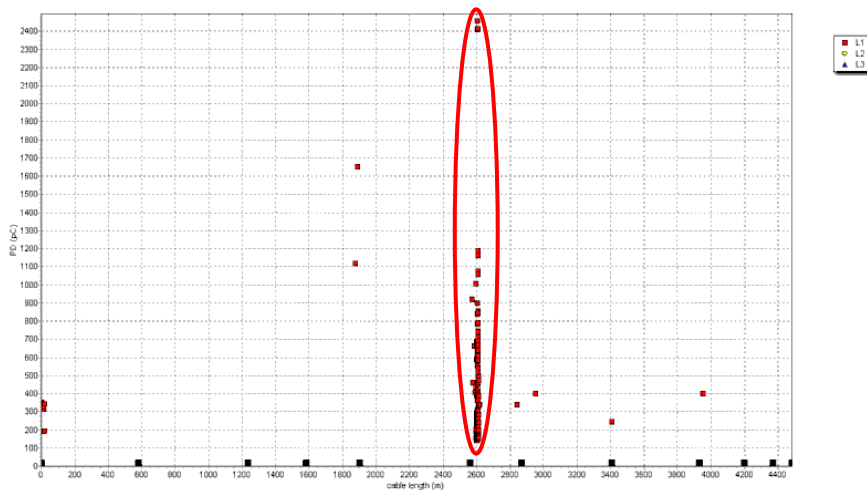
Figure 6.6: PD mapping showing faulty joint no. 5. Red dots represent PDs localised at 2600 m.

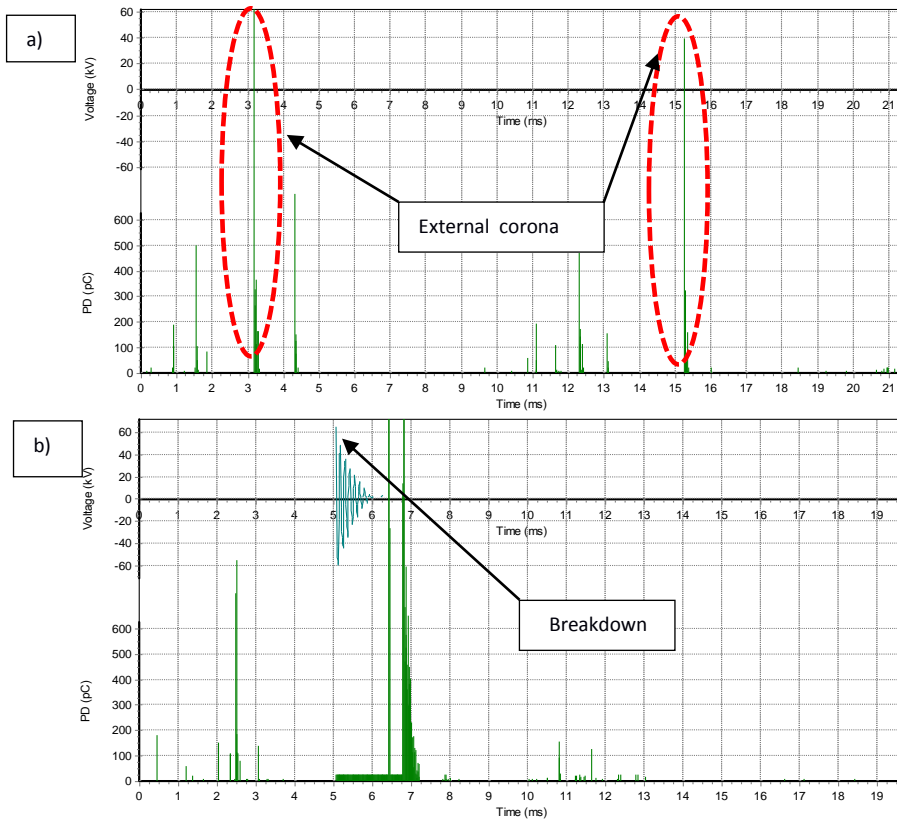
Figure 6.8: PRPD Patterns: a) Cable phase L2 with corona discharges b) Cable phase L1 in the moment of breakdown.

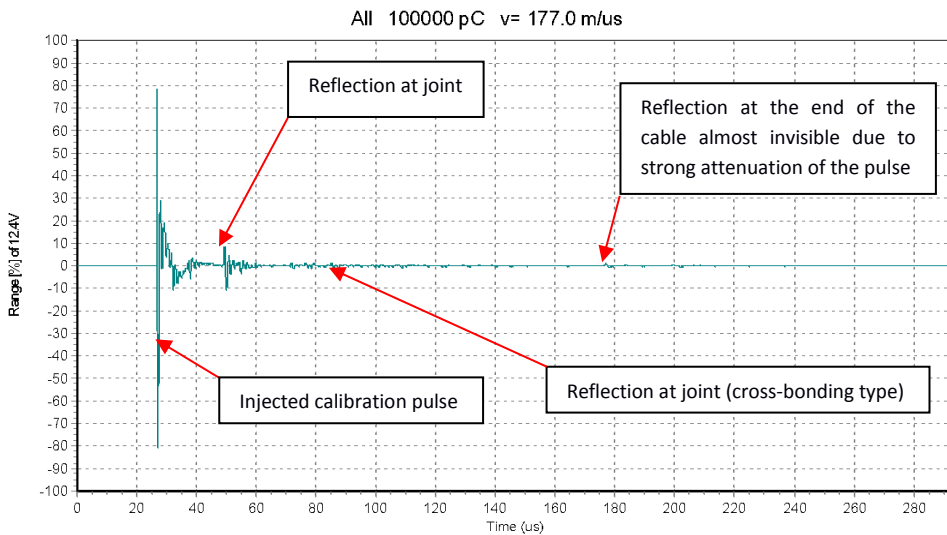
Figure 6.9: Calibration pulse showing the reflections at cross-bonding joints.

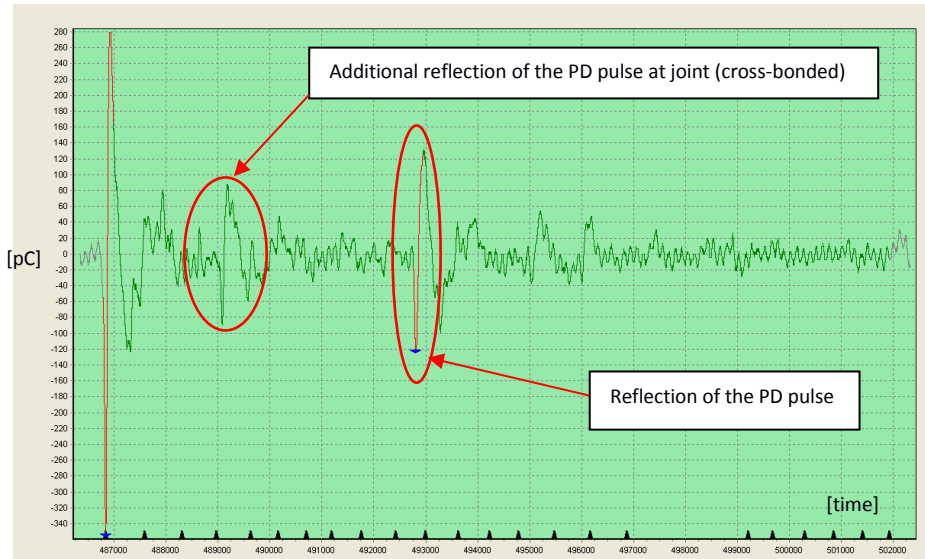
Figure 6.10: TDR screen showing the first detected pulse (original) and the reflected signals.

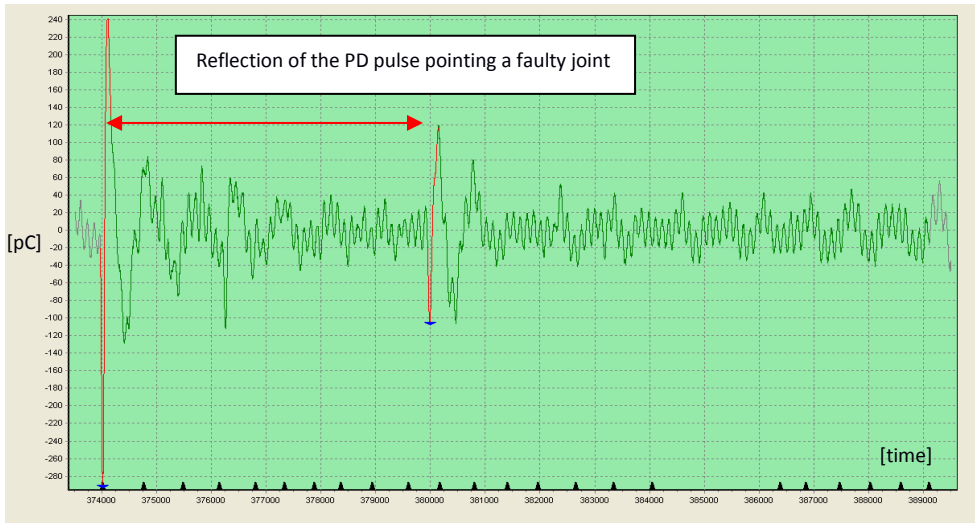
Figure 6.11: Example of TDR analysis of the recorded PD (cable phase L1) at test voltage of 60 kV_{peak}

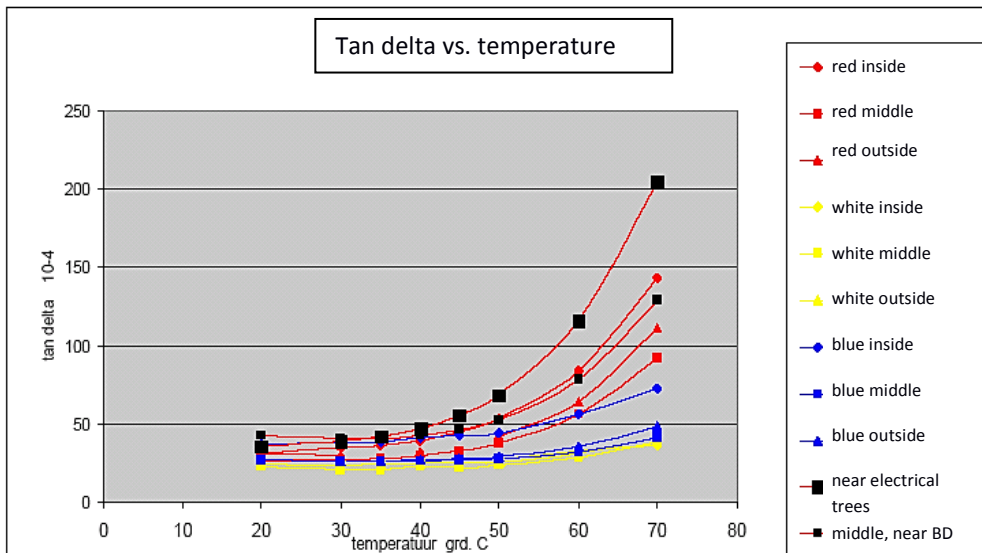
Figure: 6.17: Dielectric loss measurements for the paper samples taken from the faulty cable phase L1 and healthy cable phases L2 and L3. Plot description: red plots represent phase L1, yellow-L2, blue-L3.

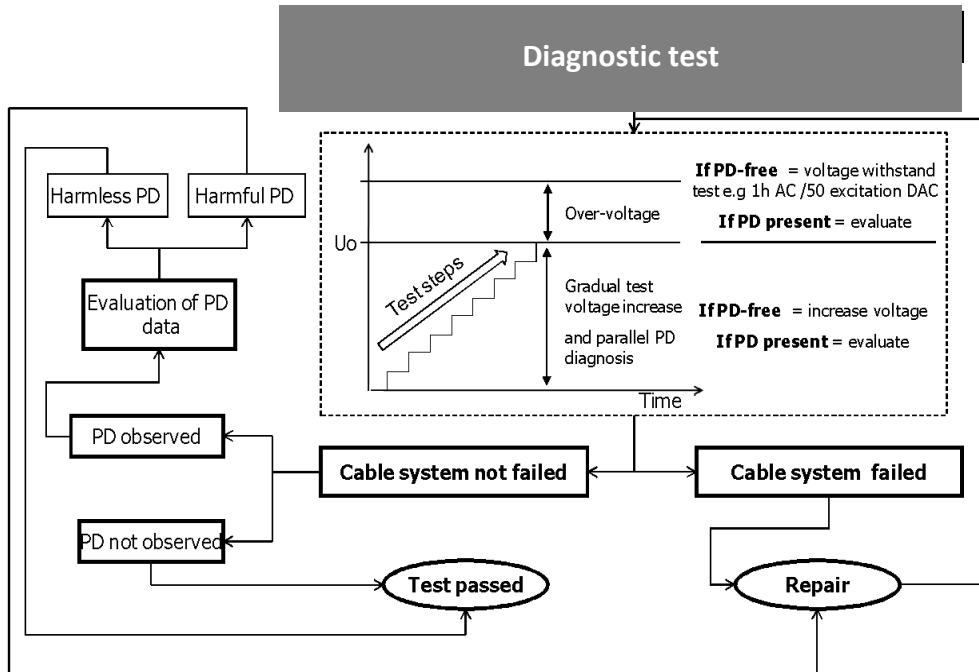
Figure 6.18: Flowchart presenting general procedure and decision process for the diagnostic tests performed with DAC voltages.

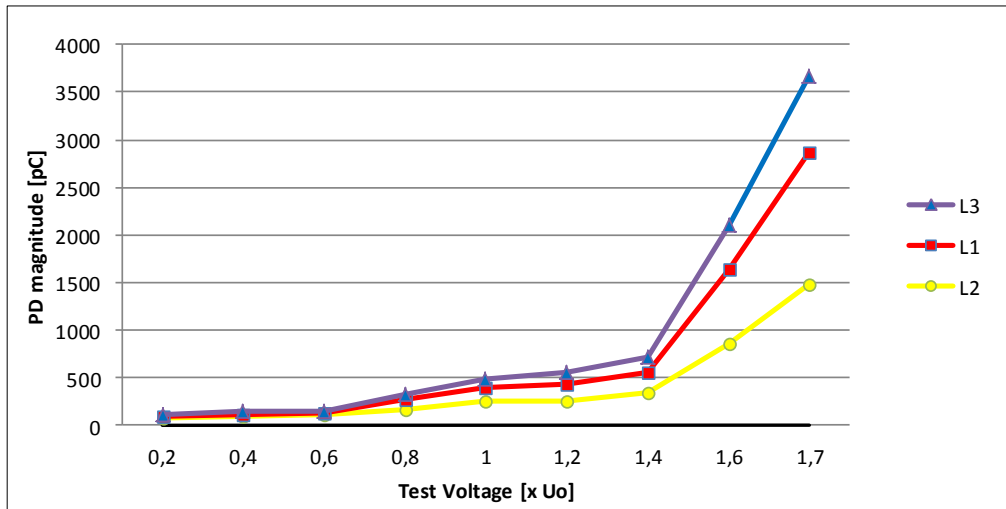
Figure 6.19: PD vs. Test Voltage of Circuit no. 4. Similar PD behaviour is observed. PDIV was similar for all phases but the highest PDs localised in cable joints were in range of 3,5 nC in cable phase L3.

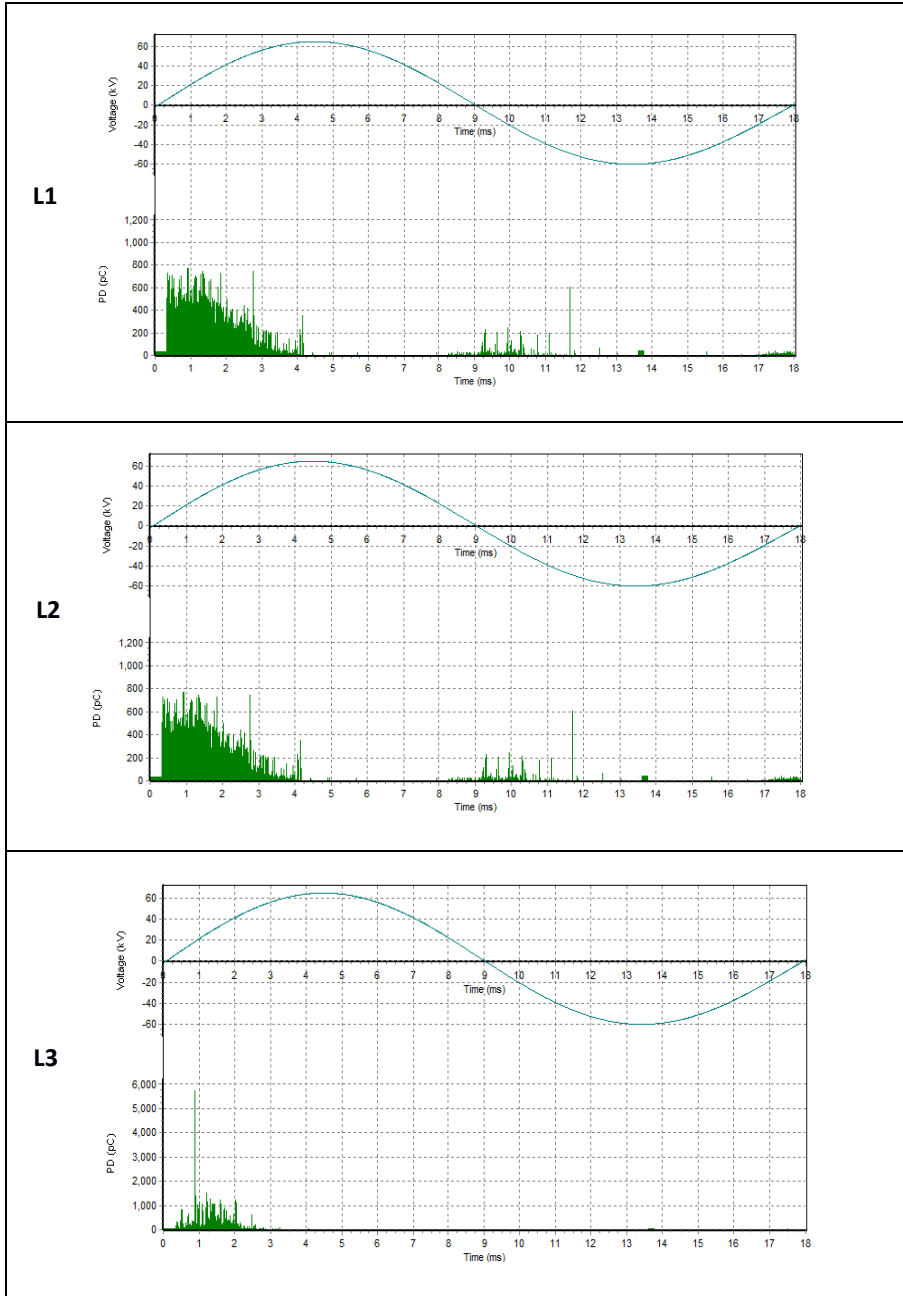
Figure 6.20: PRPD patterns for Circuit no. 4 phase L1 L2 L3 observed at $1.7 \times U_0$. Note: these are patterns taken from a random single DAC excitation.

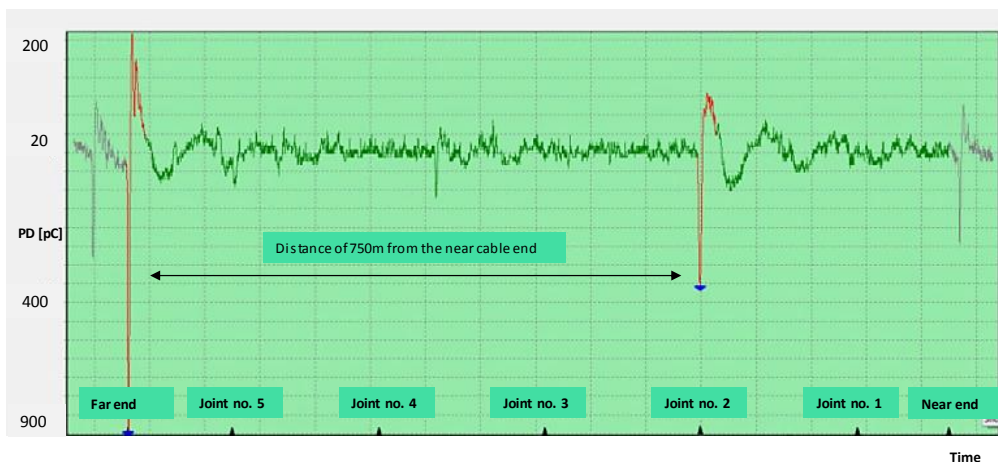
Figure 6.21: Example of TDR traces for PD pulse of 900 pC detected at $1.6xU_0$ in Circuit no. 4.

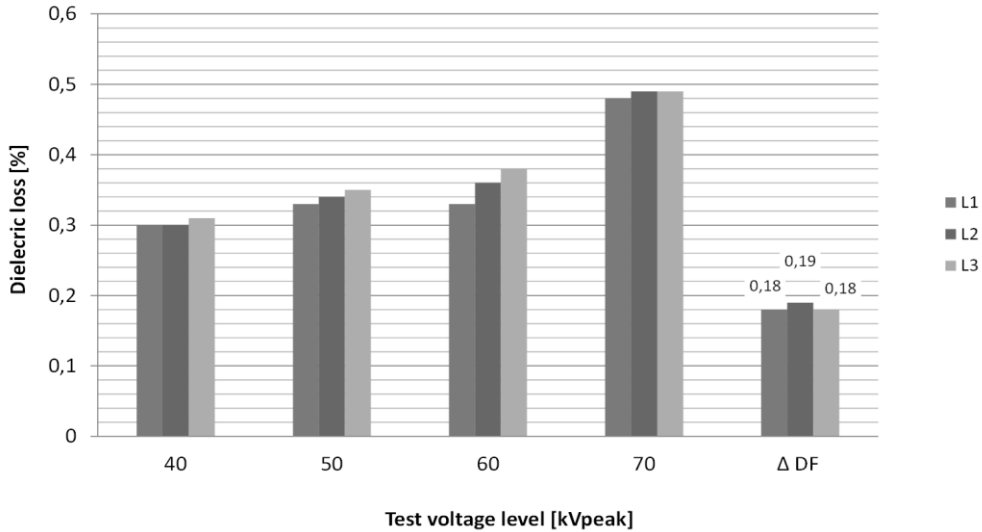
Figure 6.23: Dielectric loss and $\Delta tg\delta$ — measured between 40 kV (U_0) and 70kV ($1.7xU_0$) for Circuit no. 4 with DAC voltages.

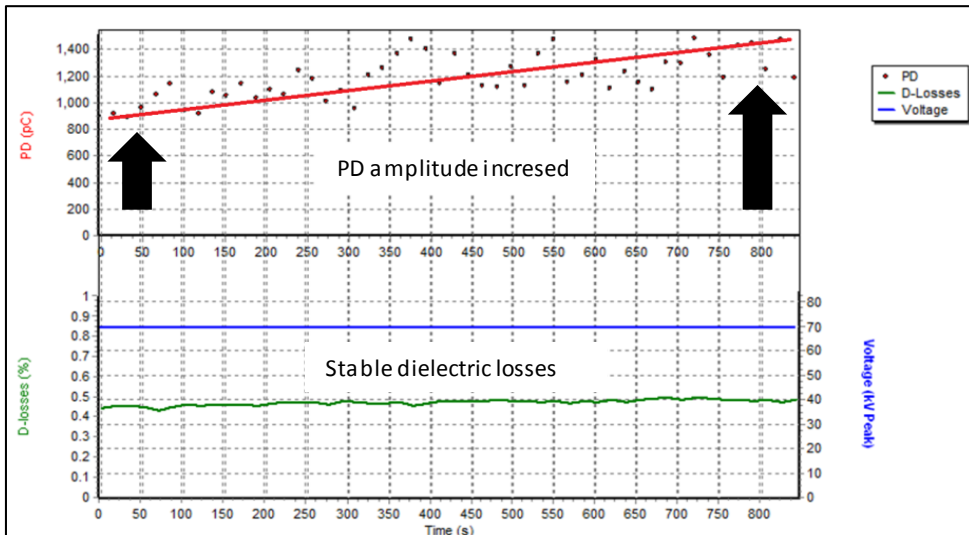
Figure 6.24: Voltage Withstand Diagnosis (VWD) results. Year 2008.

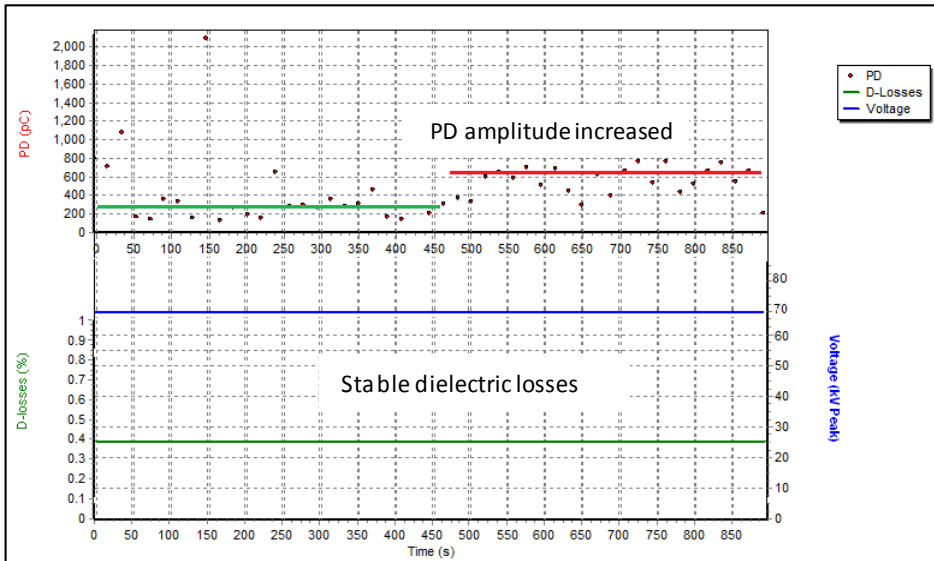
Figure 6.25: Voltage Withstand Diagnosis (VWD) results after repair. Year 2009.

As a result almost PD free conditions were obtained.

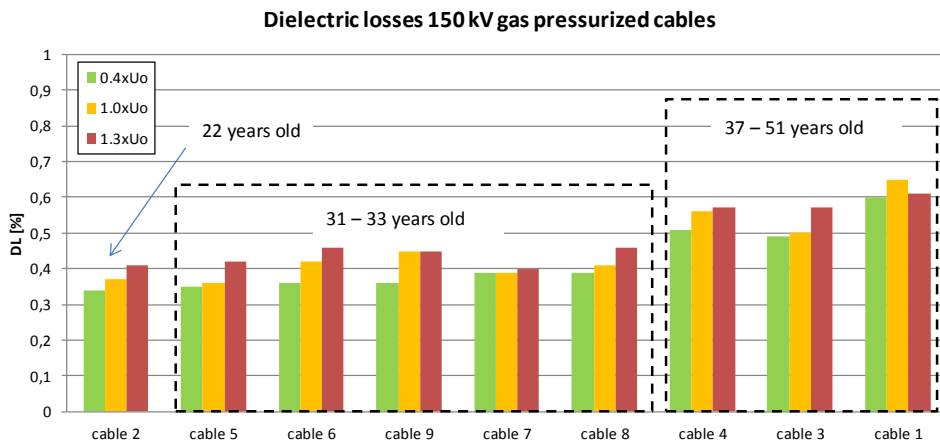
Figure 6.32: The average dielectric loss at three test voltage levels per tested 150 kV gas pressurised cable.

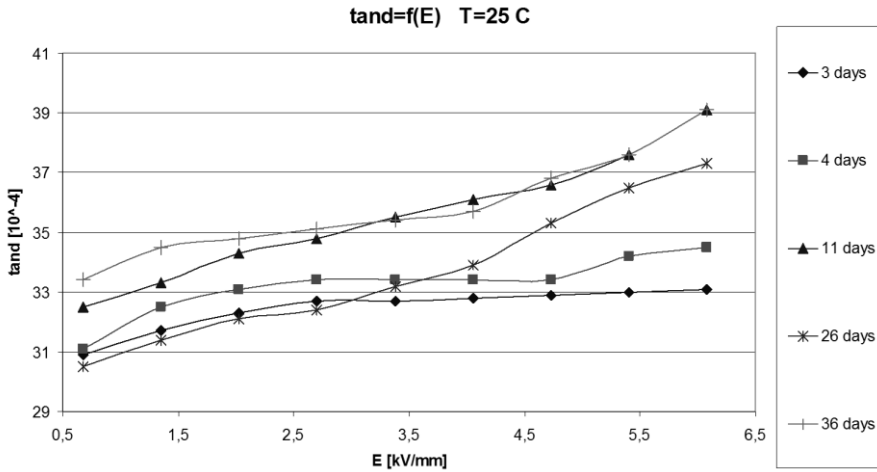
Figure 7.6: Example of dielectric loss behaviour as a function of applied electrical stress for samples subjected to ageing for different periods. Measurements were performed at a constant insulation temperature of 25°C.

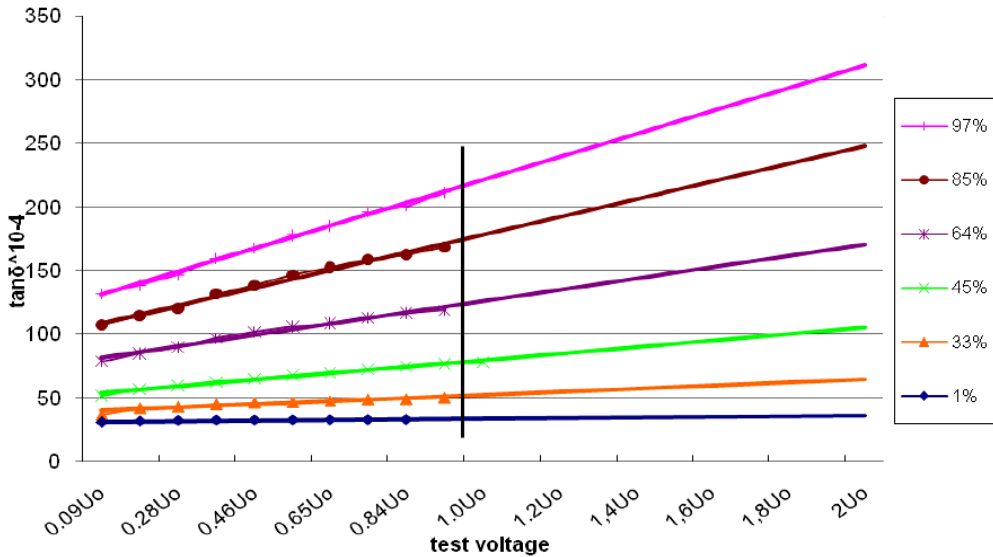
Figure 7.10: $\tan \delta$ as a function of applied test voltage for insulation samples at different life consumptions stages.

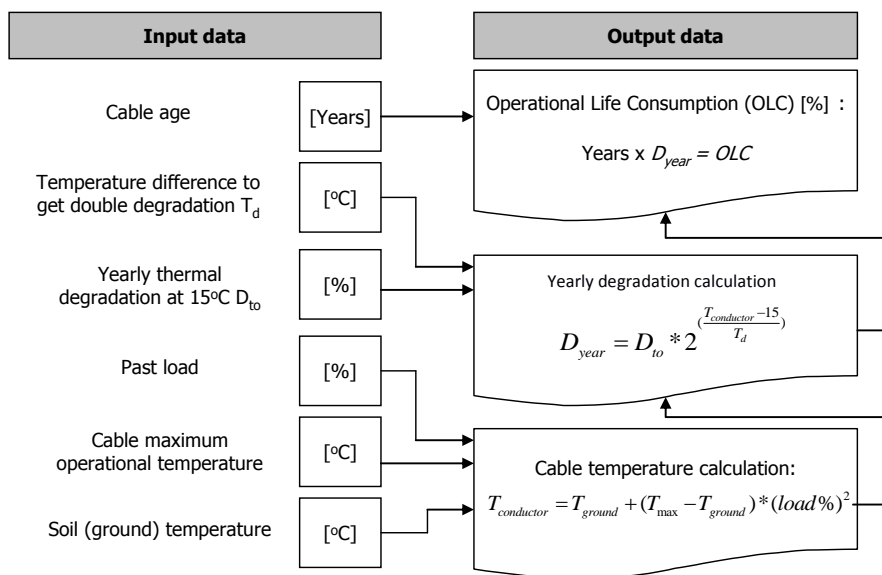
Figure 7.13: Calculation of the Operational Life Consumption.

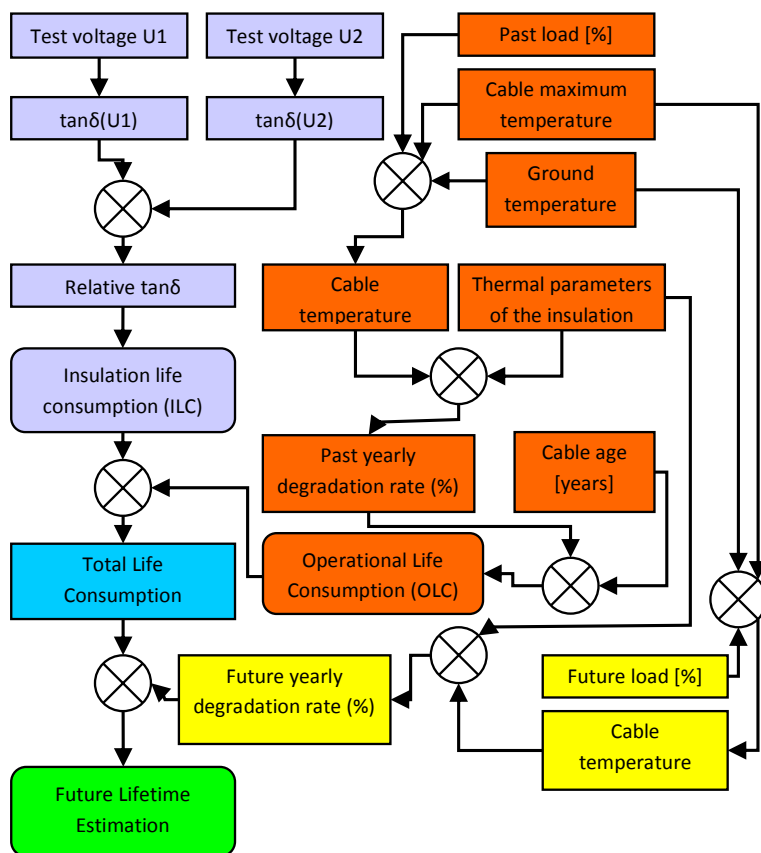
Figure 7.16: Construction of the Further Life time Estimation mode for gas-pressurised HV cables [67].

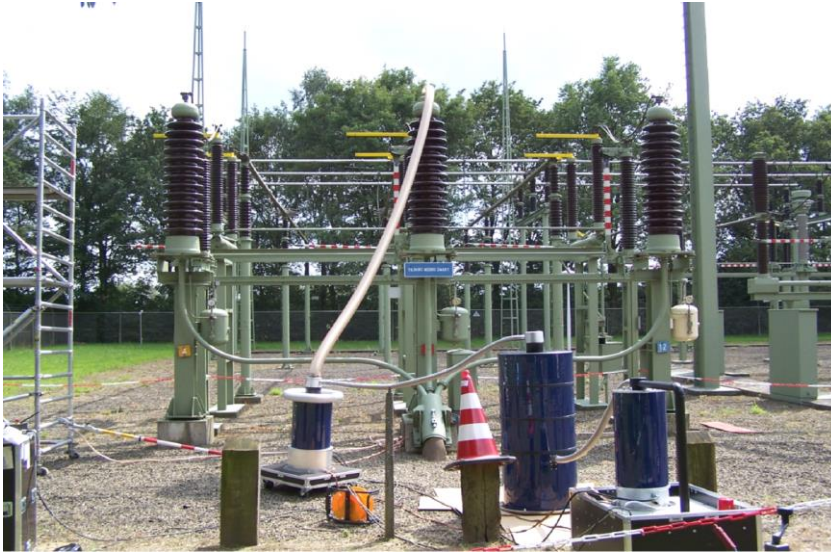
Figure 7.17: The DAC Diagnosis of the Circuit A.

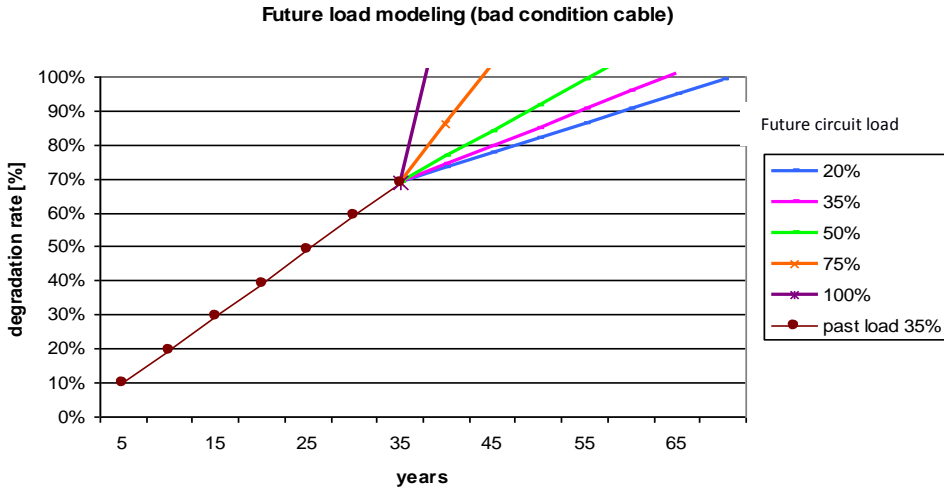
Figure 7.19: Future load profiles and expected life time for circuit A.
