Testing and Diagnosis of High Voltage and Extra High Voltage Power Cables with Damped AC Voltages

Cichecki, P. (2018). *Testing and Diagnosis of High Voltage and Extra High Voltage Power Cables with Damped AC Voltages*. [Dissertation (TU Delft), Delft University of Technology].
<https://doi.org/10.4233/uuid:f50c2129-6771-468b-aa3c-7c1fdac4e425>

Proefschrift

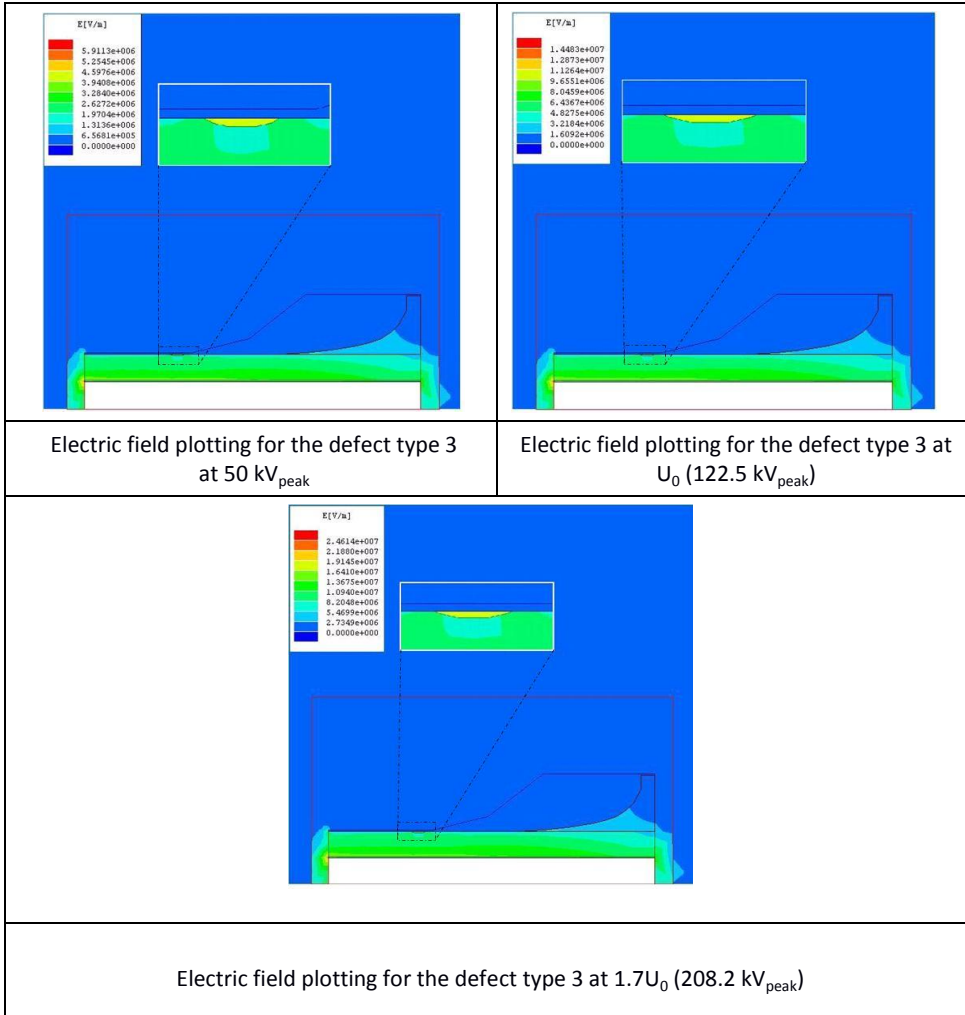
Electric field plotting for the defect type 3 at 50 kV_{peak}

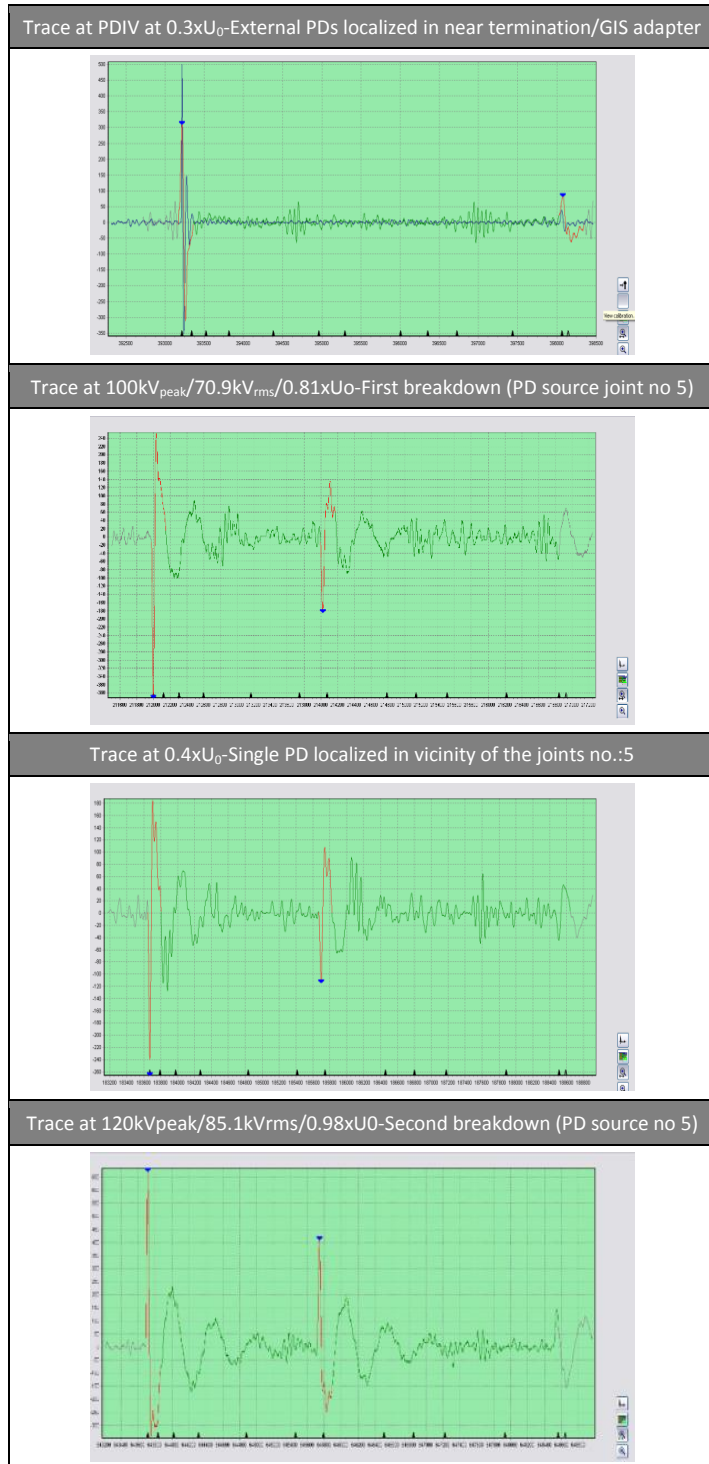
Appendix D: TDR traces at different DAC test voltages for cable phase L1 (Case study 1).
