Proceedings from the 14th World Conference on Timber Engineering

# TIMBER AS BRIDGE BETWEEN PAST AND FUTURE: STRUCTURAL UPGRADING AND CONSERVATION OF THE ANCIENT TIMBER AND MASONRY VENETIAN SAWMILL OF VALLARO (BRESCIA, ITALY)

**ABSTRACT:** This work presents an extensive static and seismic retrofitting intervention performed on a relevant historic case-study building, the Venetian sawmill of Vallaro (Brescia, Italy). This heritage construction from the end of the 19<sup>th</sup> century features three building portions, two realized in timber and one consisting of a masonry structure with timber floors and roofs. The building had been neglected for decades and was in a poor state of conservation, despite representing a valuable example of the typical historic architectures of the mountainous area in the Province of Brescia. With the support of the local municipality, a complete restoration of the sawmill has started, with the objective of transforming it into a territorial museum. To this end, a series of reversible and compatible timber-based interventions were planned in consultation with the local superintendence for architectural heritage. The structural design aimed at prese

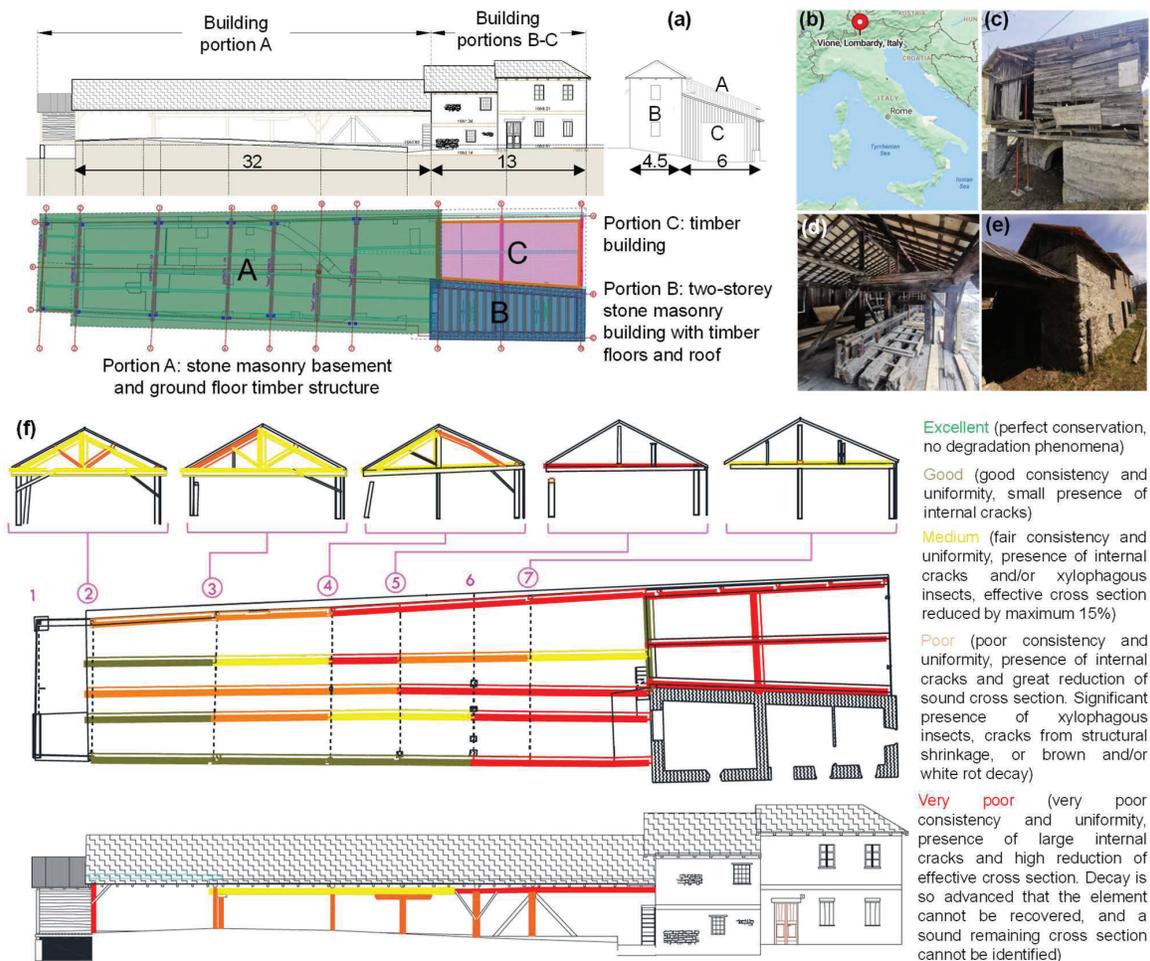
Figure 1. Plan and prospects of the case-study sawmill (a) and its location in Northern Italy (b); external (c) and internal (d) views of portion A of the sawmill before retrofitting; view of portion B (e); results of the assessment of the conservation of timber structural elements based on micro-drilling measurements (f), with classification of the conservation state following Italian standard UNI 11119:2004 [27], kindly provided by Ph.D. Eng. Dario P. Benedetti [28].

The Venetian sawmill of Vallaro, located in the municipality of Vione (Province of Brescia, Italy, Fig. 1b) and built in the late 19<sup>th</sup> century, has been selected for a full restoration plan by the local community, in order to transform it in a territorial museum. The building features three independent portions A, B, and C (Fig. 1a):

- Portion A (280 m<sup>2</sup>, Fig. 1c-d) consists of a single-storey timber structure featuring seven silver fir (*Abies alba Mill.*) and larch (*Larix spp.*) trusses, resting on a stone masonry basement with 50-60 cm thick walls;
- Portion B (50 m<sup>2</sup>, Fig. 1e) is a two-storey stone masonry structure with 50-60 cm thick walls and silver fir (*Abies alba Mill.*) timber floors and roof;
- Portion C (80 m<sup>2</sup>) consists of a prolongation of the roof structure of portion A, made entirely of silver fir (*Abies alba Mill.*).

The existing structure was the result of a series of interventions carried out over time, causing overlapping between original members and later included elements, often poorly implemented with incompatible or low-quality materials. These factors, along with the past neglect of the building in the last decades, have contributed to the apparent poor conditions of the sawmill from the conservation point of view (Fig. 1), with extended degradation phenomena caused by water infiltrations from the roof. In light of the visually observed poor state of the sawmill, several investigations were conducted to assess the conditions of the existing structural elements. In particular, detailed on-site inspections on the stone masonry in 10 different locations were undertaken, and micro-drilling measurements were carried out on the timber members in 41 locations to assess their state, by means of an IML-RESI Power Drill 400 having a 3-mm needle. This comprehensive on-site assessment allowed to reconstruct the conservation state of the main timber structural elements (Fig. 1f), following the classification of Italian standard UNI

11119:2004 [27]. The wooden roof structure of portion A, including the trusses and timber columns, was found in an overall poor state of conservation after the past neglect of the building; the ground timber floor featured some sounder elements, but part of it was strengthened in the past with an incompatible 20-mm-thick concrete slab. In portion B and C, the evident signs of decay in the timber elements were confirmed by the outcomes of the micro-drilling measurements, based on which a very poor state of conservation was assigned to these structural members.

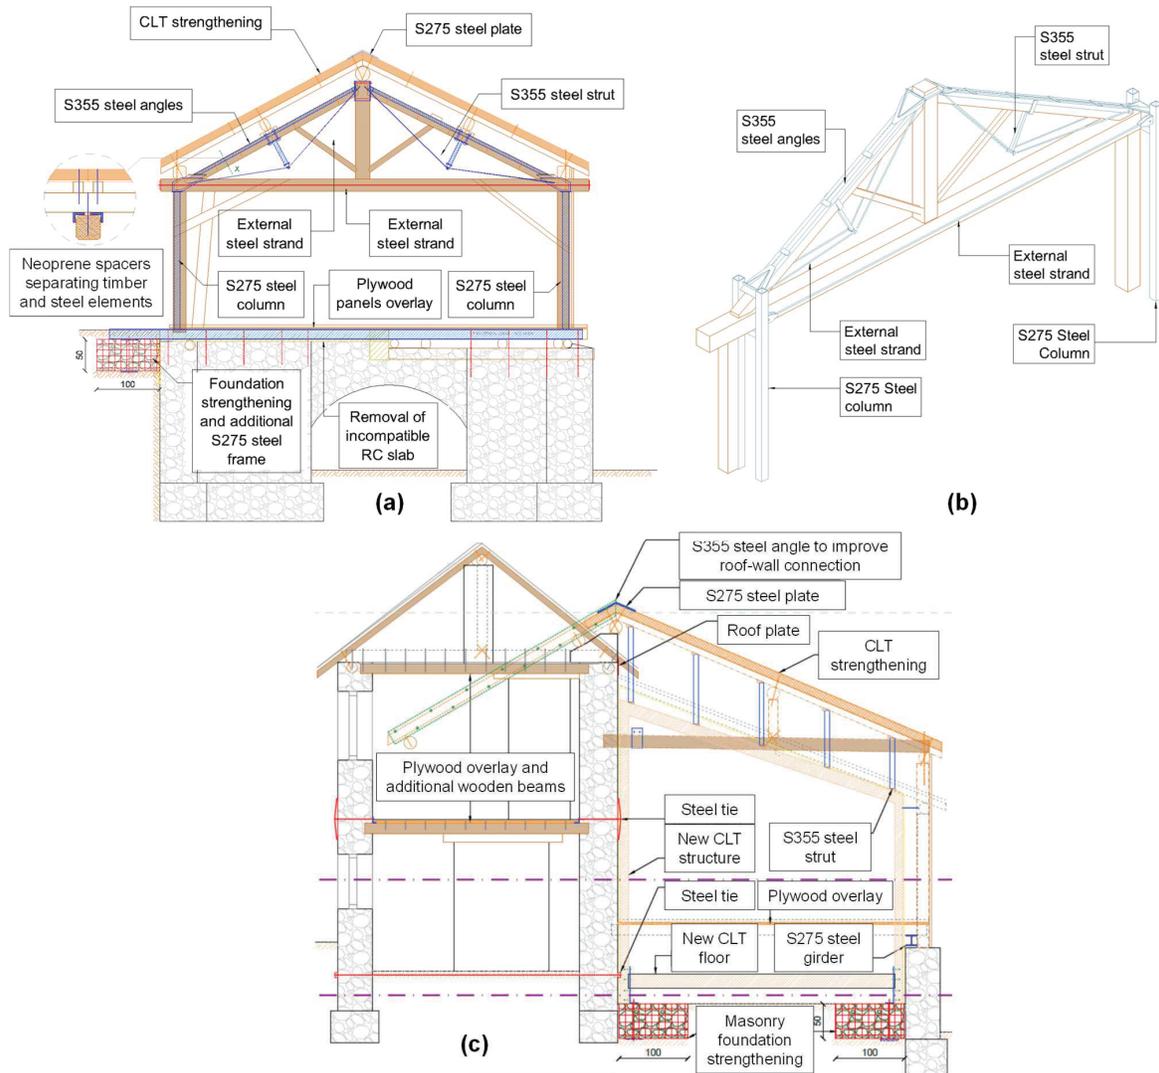
Figure 2. Representative overview of the designed integrated timber- and steel-based retrofits for the structural upgrading of the sawmill: interventions applied to portion A (a), including the principles adopted for strengthening the existing timber trusses (b), and to portion B (c) of the building.

The sawmill of Vallaro required extensive strengthening interventions because of the overall poor conditions of the building, combined with the prospective design loads following the Italian Building Code [29]. In particular, the prescribed crowd live load in museums would be 4.0 to 5.0 kN/m<sup>2</sup> [29], an unrealistic target for an existing building with floors in such conservation state, where the strengthening measures have not to be invasive, and preserve as much as possible the original appearance and historic value of the construction. Hence, in consultation with the local municipality and Superintendence for Architectural Heritage, it was first decided to limit the number of visitors present in the museum at the same time, in order to design the structural upgrading of the floor diaphragms for a target crowd live load of 2.0 kN/m<sup>2</sup>. However, the other site-related live loads are also quite large, given the building's location in the mountainous area of the Province of Brescia, at an altitude of approximately 1100 m above mean sea level: the snow load is 3.5 kN/m<sup>2</sup>, the wind load is 0.7 kN/m<sup>2</sup>, and the peak ground acceleration for earthquake loading is 0.1g [29]. Thus, measures to radically improve the static and seismic behaviour of the sawmill were designed, having as main goal the conservation of the existing timber members and the use of wood-based solutions (Fig. 2).

For portion A (Fig. 2a), given the low residual load-carrying capacity of the decayed timber columns, newly

integrated slender steel elements were designed, along with a new steel frame connected to the strengthened masonry foundations. In this way, both the static and seismic response of the structure could be improved. In consultation with the local Superintendence for Architectural Heritage, a wood-based solution was not adopted for this case, because it would have required very massive structural elements, which could have partly hidden the original appearance of the existing building. Instead, a timber-based strengthening was designed to preserve the wooden roof and enhance its structural response: 12-cm-thick C24 cross-laminated timber (CLT) slabs, along with additional steel strands, were adopted to improve the static behaviour of the roof, and enable its diaphragmatic action against lateral loads, while contemporarily preserving the existing wooden trusses. These were strengthened with particular care in minimizing the impact of newly added elements, and following the principles of similar successful past conservation interventions [5, 30]. Thus, through a combination of timber chocks, and steel ties, struts, and strands, the structural response of wooden trusses could be enhanced without the need for invasive interventions (Fig. 2b). Additionally, to guarantee sufficient ventilation around these existing ancient timber members, the steel angles around them were not in direct contact with the trusses, but slightly separated by means of neoprene spacers (Fig. 2a). Besides, also the ground timber floor was strengthened with 30-mm-thick plywood panels and additional wooden beams placed alongside the existing ones to improve the flexural and seismic response. All diaphragms were effectively connected to the masonry walls, by means of S275 or S355 steel angles and M14 or M20 threaded bars. All incompatible past interventions involving reinforced concrete elements, were demolished and integrated with new wooden or steel members, while the interior was restored and set up for the future museum activities (Section 4).

For portion B (Fig. 2c), flexural strengthening of the timber floors and roofs was necessary. This was realized by means of new timber beams of the same wood species, placed alongside the existing ones, and a 20-mm-thick plywood panels overlay fastened on them with 6×120 mm screws at 300 mm spacing. Besides, effective connections between horizontal and vertical structural elements were designed, including also new steel ties for an improved confinement of the stone masonry. In portion C, these measures were integrated with an entirely new prefabricated CLT structure, hosting the prospective location of the shop and café of the museum (Fig. 2c). The CLT module enables to support the existing wooden elements, which showed severe decay and excessive lack of load-carrying capacity. The designed solutions allowed to preserve as much as possible the original appearance and features of the sawmill, in spite of its poor conditions, while ensuring a safer, renovated environment for hosting a museum in this relevant, historic location.

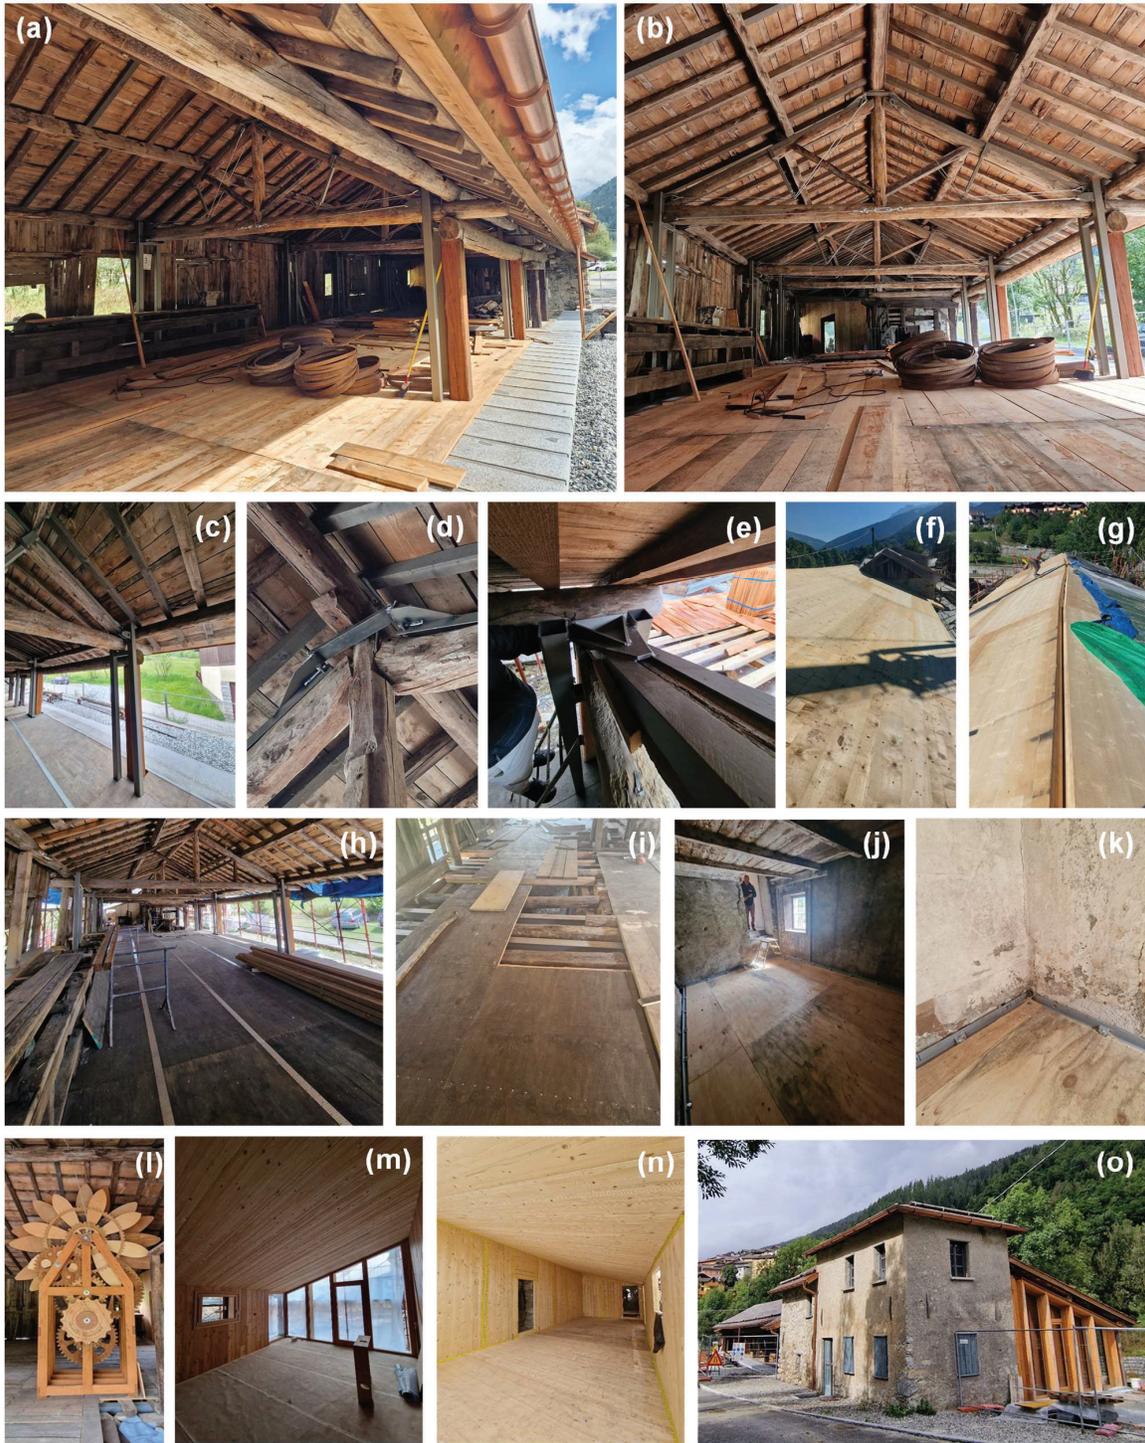
Figure 3. Implementation of the designed retrofitting solutions in the sawmill: renovated interior of portion A with recovered timber elements, strengthened trusses, and light steel frames (a, b); details of the designed timber-steel retrofits for the wooden trusses in portion A (c, d, e); static and seismic upgrading of the roof diaphragm of portion A with cross-laminated timber panels (f, g); installation of the plywood panels overlay for static and seismic strengthening of the existing timber floors in portions A (h, i) and B (j, k) of the sawmill, including timber-masonry connections with steel angles; preparations of the interior of the building to host the territorial museum (l); installation of the prefabricated cross-laminated timber module in portion C of the sawmill (m, n); view of the renovated building from outside (o), merging ancient and new timber elements and featuring new steel ties for the masonry walls.

The designed retrofitting solutions were implemented in the building in the attempt to minimize their impact on the ancient sawmill during renovation, and to mitigate the appearance of the strengthening measures after their installation. For instance, the light steel elements employed for recovering the trusses of portion A of the building, were painted with a grey colour resembling the shadows created by the natural light inside the construction (Fig. 3a-e). This system, cooperating with the CLT overlay for the roof's static and seismic upgrading (Fig. 3f, g), is sufficient to withstand the expected serviceability limit state loads, with the existing trusses only being activated in the resisting mechanism at

ultimate limit state. Furthermore, the plywood panels overlay installed for the static and seismic strengthening of all timber floors in portions A and B (Fig. 3h-k), was then covered with the existing, restored, 100-year-old planks, to maintain the original appearance of the sawmill, as shown in Fig. 3a-b. After retrofitting, the preparations to transform the interior of the sawmill into the planned territorial museum also started, with the installation of timber-based devices (Fig. 3l). Finally, the integration of the new prefabricated CLT module in portion C of the existing construction was successfully achieved (Fig. 3m-o), with the creation of a comfortable interior space and a minimal impact on the more ancient building portions, from both a structural and visual perspective (Fig. 3o).
