GROUTING FOR PILE FOUNDATION IMPROVEMENT

Grouting for Pile Foundation Improvement

Proefschrift

Keywords: grouting / pile foundation improvement / geophysical verification methods

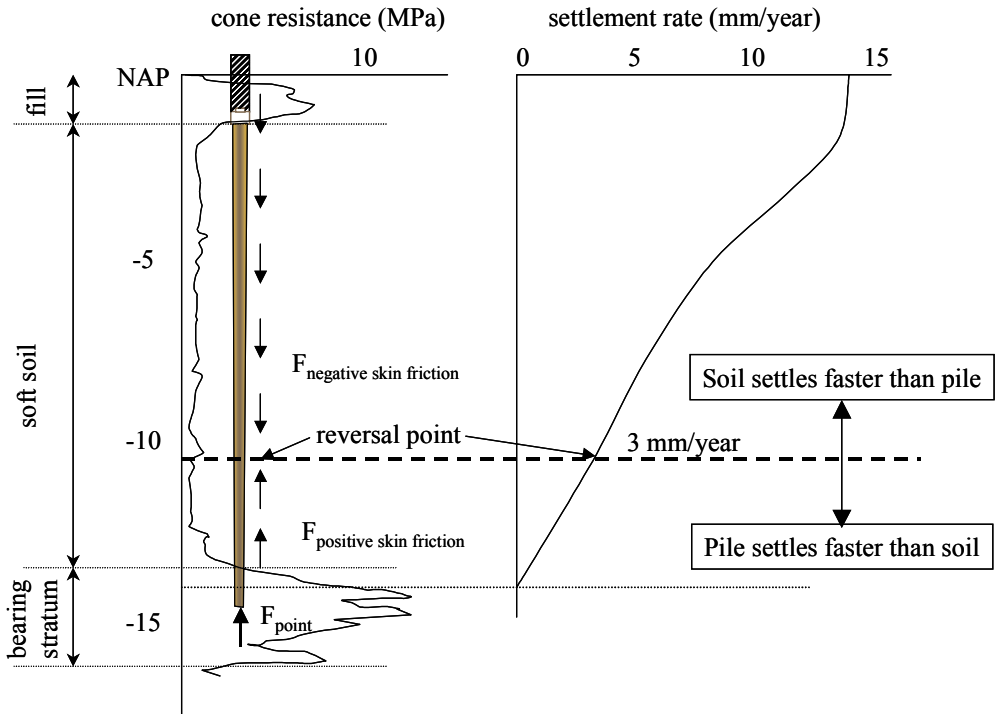
Figure 2.5 Point Resistance, Positive Skin Friction and Negative Skin Friction Graphically Explained (after Van Tol, 1996)

foundation layer in which the pile toes are driven and that is carrying most of the pile load is called the *bearing stratum*. The maximum bearing capacity of a pile is defined as the sum of the point resistance and the shaft resistance: $F_{max} = F_{point} + F_{positive\ skin\ friction} - F_{negative\ skin\ friction}$ (see Figure 2.5). The reversal point between positive skin friction and negative skin friction lies at a settlement rate of approximately 3 mm/year. If the settlement rate of the pile is 0 mm/year, the reversal point lies in the top of the bearing stratum. More information on pile bearing capacity calculations is given in the next sub-section.

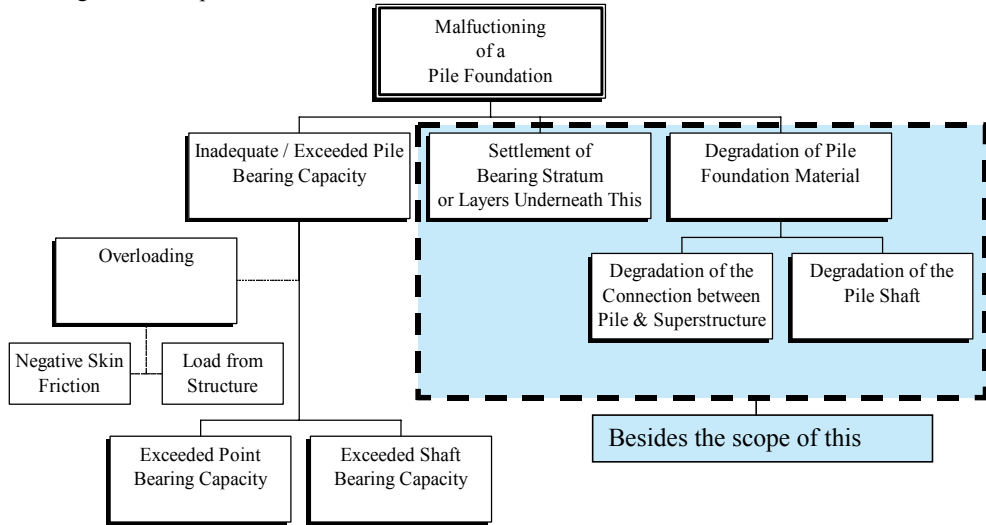
Figure 2.6 Mechanical Processes of Pile Foundation Degradation

1. inadequate/exceeded pile bearing capacity;
2. settlement of the bearing stratum or layers underneath this;
3. degradation of pile foundation material.

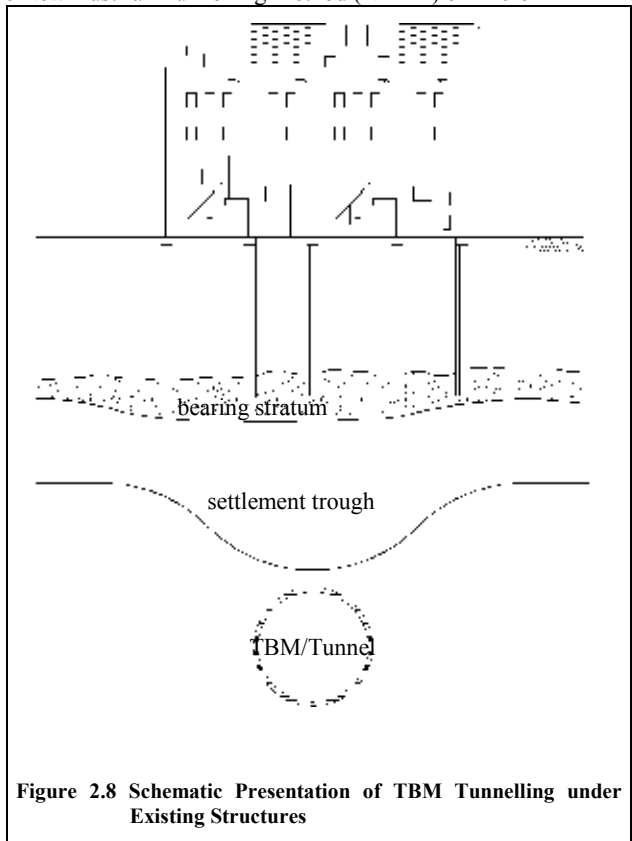
Figure 2.8 Schematic Presentation of TBM Tunnelling under Existing Structures

Tunnelling. TBM tunnelling (large diameters) and micro tunnelling can cause heave or settlement. When these techniques are used to create tunnels or other structures under existing structures, and the process is not properly monitored and performed, damage may occur. Peck (1969) has been breaking new ground on deep excavations and tunnelling in soft ground, and Sagaseta (1987) has given a fundamental analysis of undrained soil deformation due to ground loss. New and O'Reilly (1991) and Mair, Taylor & Burland (1996) reported on predicting the magnitude and effects of tunnelling-induced ground movement. Mair et al (1993) specifically reported on subsurface settlement profiles above tunnels in clay. For an extensive review of soft ground tunnelling and buried structures a reference to Fujita (1994) is made. Netzel & Kaalberg (1999, 2000) and Standing (1999) report on numerical damage risk assessment and the use of GIS applications for settlement risk management for tunnelling projects.

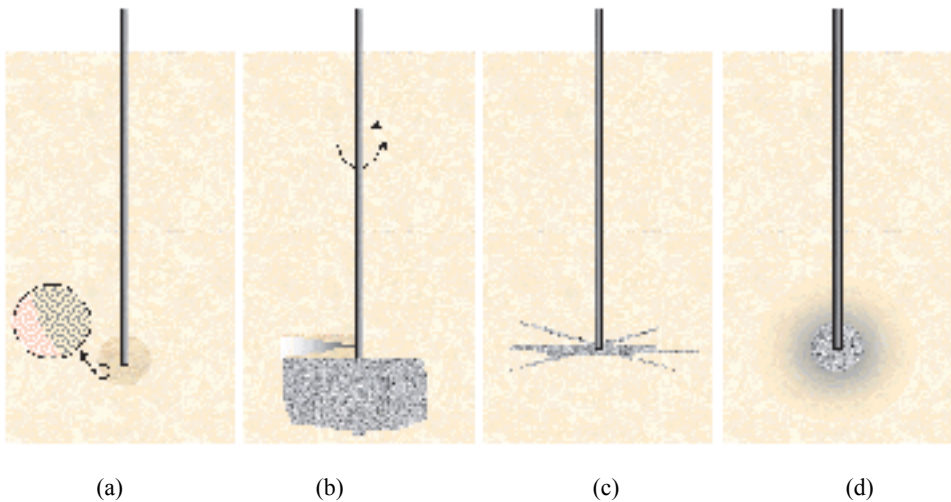
Figure 2.14 (a) Permeation Grouting (b) Jet Grouting (c) Fracturing (d) Compaction Grouting

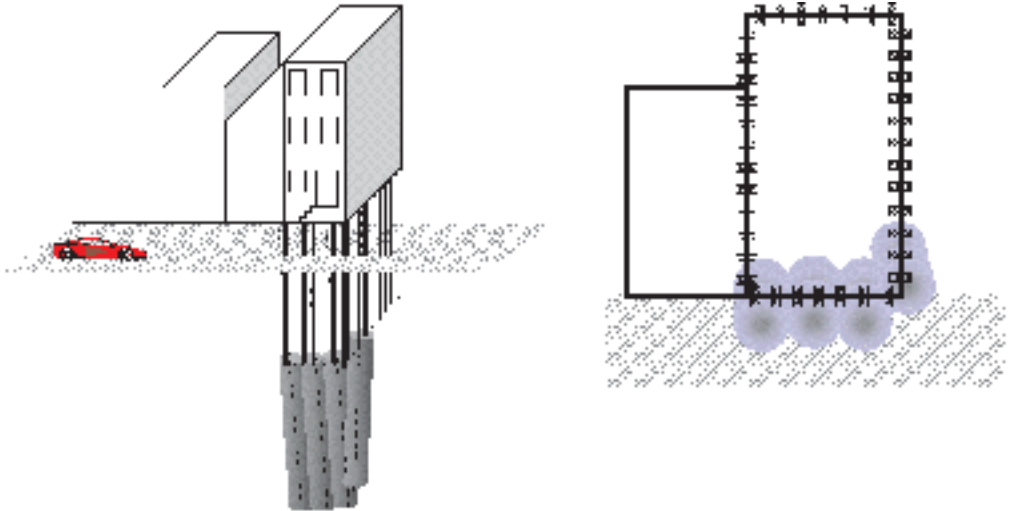
Figure 2.15 Example of Jet Grouted Piles to Extend a Pile Foundation

To create grouted piles for the purpose of foundation renovation, both permeation grouting and as jet grouting may be used. To extend a pile foundation, existing piles are elongated by adding grouted piles, to reach a deeper and firmer bearing stratum. An example is shown in Figure 2.15.

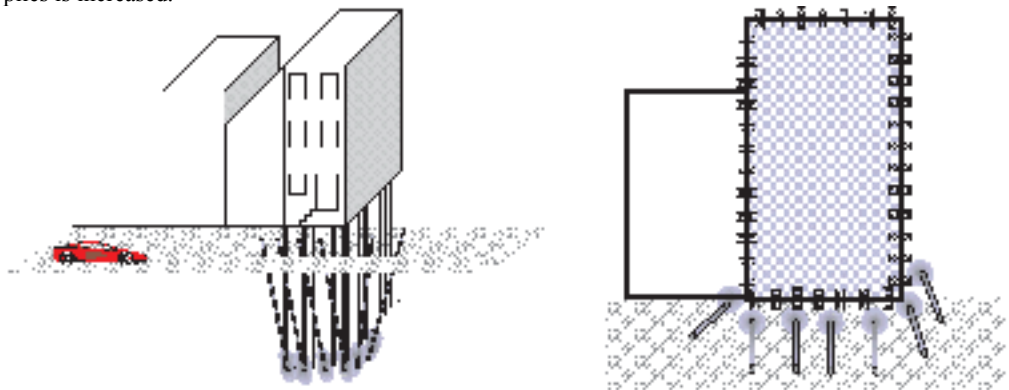
Figure 2.16 Example of Compaction Grouting near a Pile Foundation

When using compaction grouting, the aim is to increase the horizontal effective stresses in the soil, by injecting a relatively stiff grout into the bearing stratum, next to the pile toes. The soil is thus compacted, the effective soil stresses are increased and consequently the bearing capacity of the wooden piles is increased.

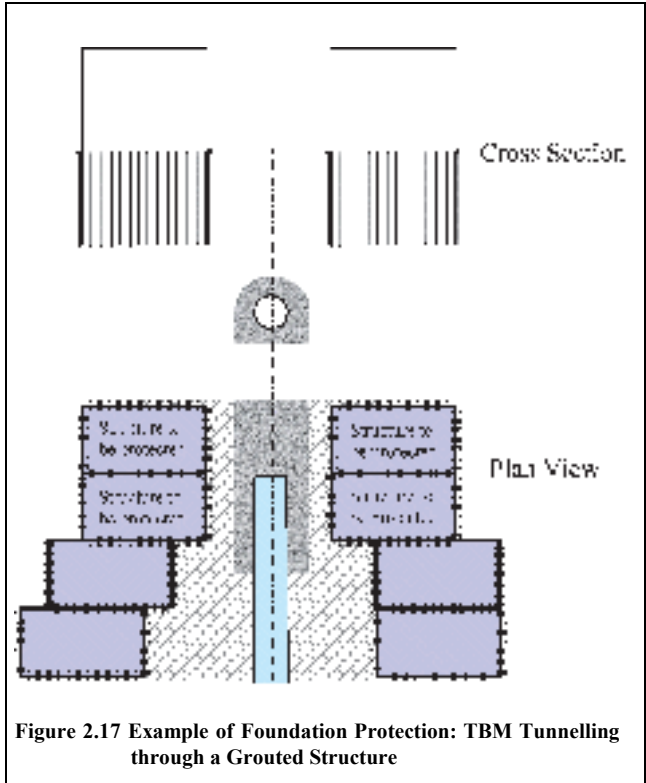
Figure 2.17 Example of Foundation Protection: TBM Tunnelling through a Grouted Structure

An example of foundation protection is shown in Figure 2.17. A permeation grouted or jet grouted structure is created in soft soil before the TBM arrives. When the TBM bores through the grouted structure, the settlement can be significantly reduced owing to the increased stiffness of the soil. Van der Stoel (1997b) has made Finite Element Method calculations using PLAXIS showing this reduction. The extent of the settlement reduction is dependent on the homogeneity, strength and stiffness of the grouted structure and therefore on the grouting process used.

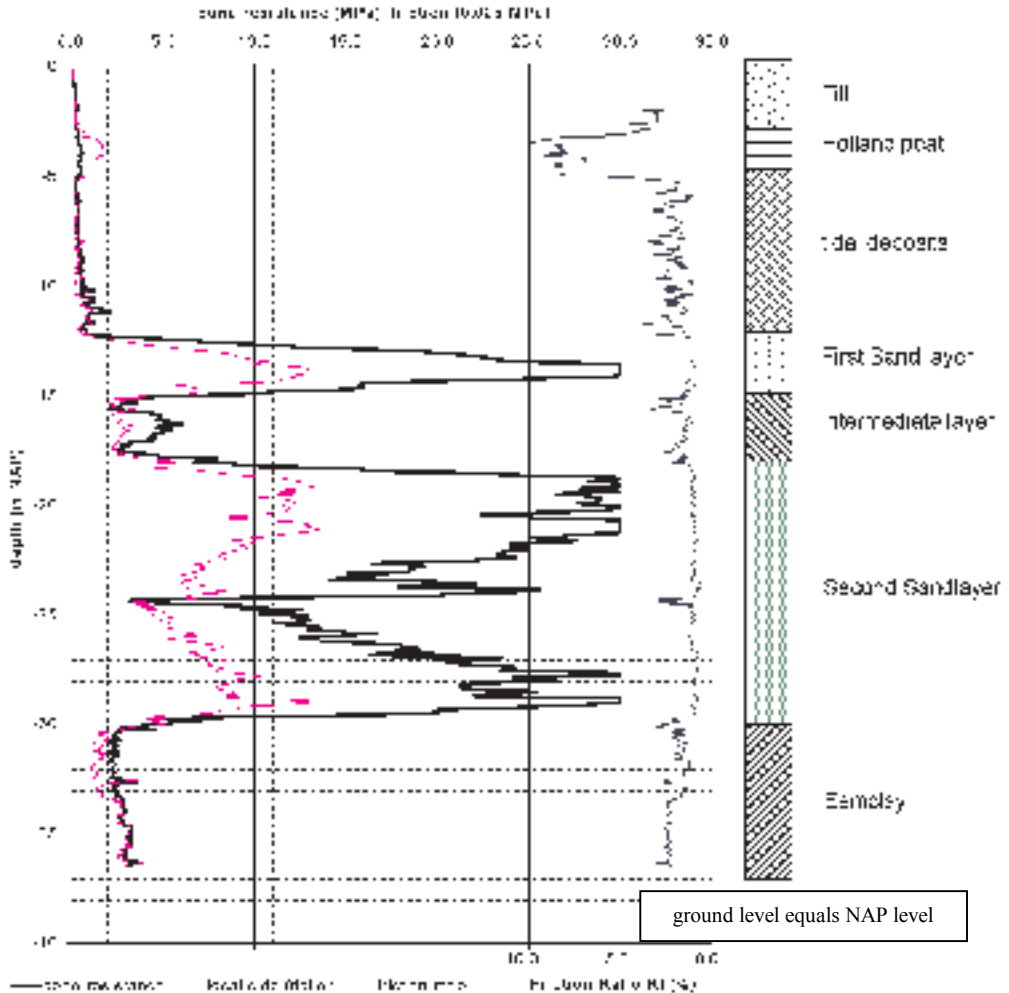
Figure 3.2 Typical CPT at Test Site

Figure 3.2 shows the result of a characteristic CPT, Figure 3.3 shows the grain size distribution of the sand layers and intermediate layer and Table 3.1 gives a summary of the different soil layers. The Dutch reference level for height measurements is *NAP**. A detailed description of the soil conditions, including a parameter set, is given in APPENDIX II.

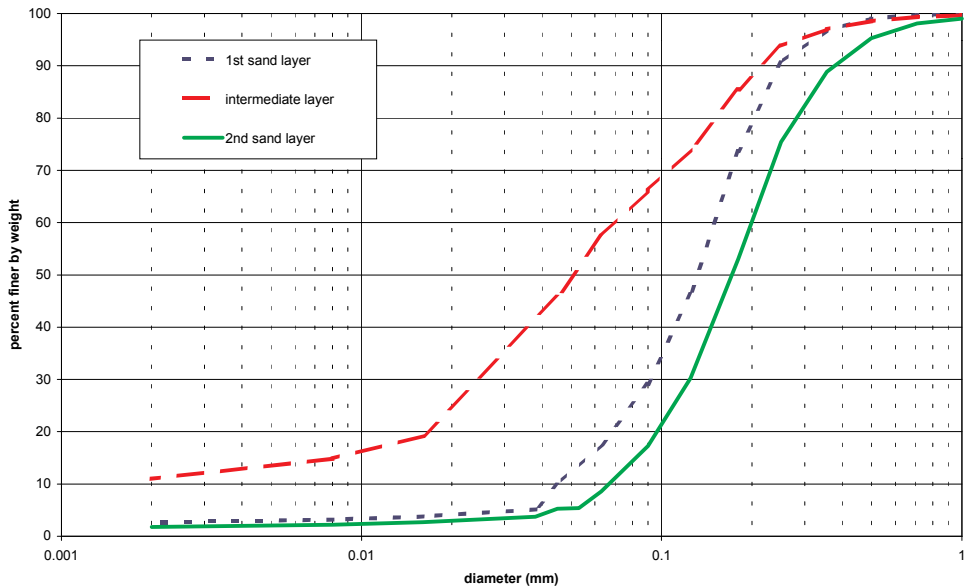
Figure 3.3 Grain Size Distribution of the Sand Layers and Intermediate Layer

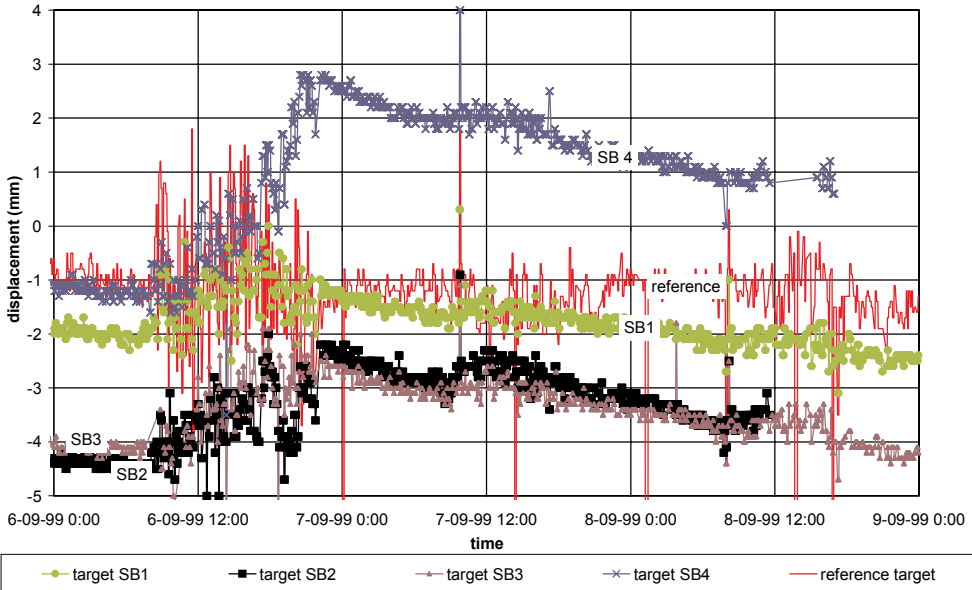
Figure 3.10 Target Readings of the Reference Beam

When comparing the corrected jointmeter readings with the corrected target readings it could be concluded that they are generally (90%) of the same magnitude. When no discrepancies between the jointmeter and the target readings, the jointmeters are used in the analysis, because they are more continuous and have a higher accuracy. To illustrate this principle of analysis an example is given here. In Figure 3.10 four targets on the reference beam and a reference target are shown. Throughout September 6th the reference beam, used to monitor the pile displacement of the permeation grouting piles, shows a total upward movement of 2 to 3 mm. The uplift is most probably induced by movement of the grouting rig next to the reference beam (to which the jointmeters are attached), causing some lateral squeezing of the peat layer on top of which the beam is positioned. In the next two days a clear consolidation effect can be noticed after the rig has moved away. The jointmeter readings were therefore corrected using interpolated results of reference beam target measurements.

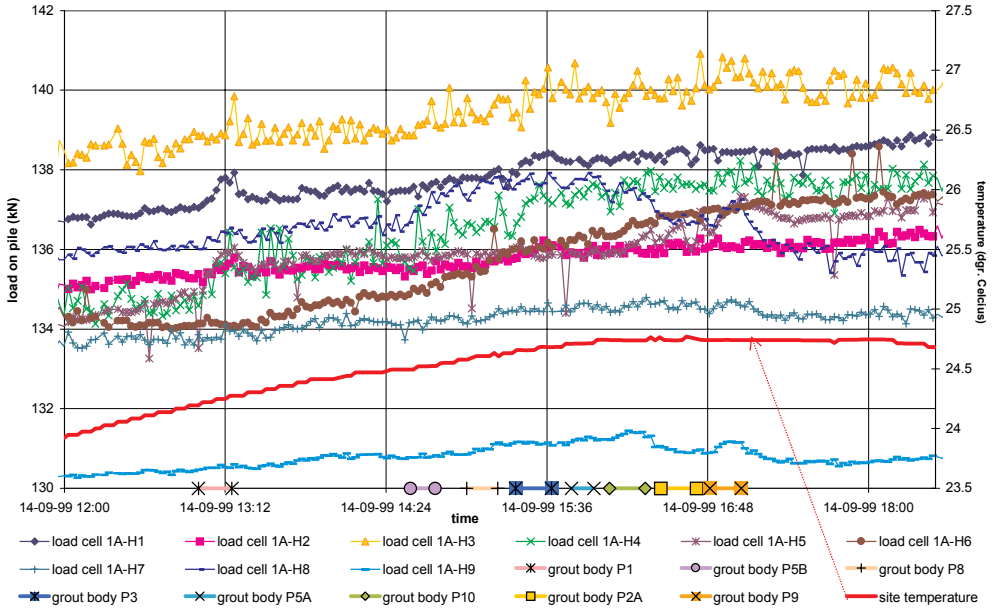
Figure 3.11 Load Cell Readings During Permeation Grouting

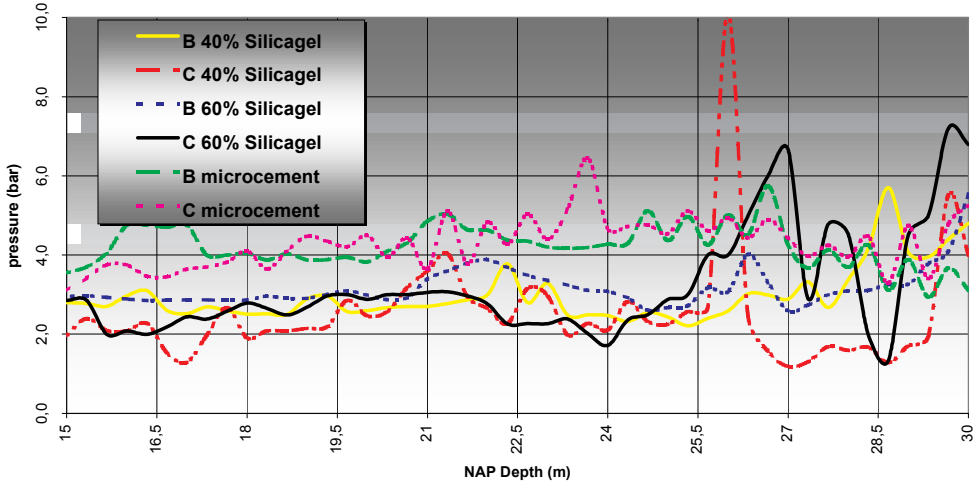
Figure 4.13 Groutability: Injection Pressure and Flow

Because of the great depth of injection and the pressure and flow restrictions, no problems were encountered concerning breaking out of the injection fluid at the surface. Figure 4.13 clearly shows that the average pressure needed to apply the micro-cement (4.2 bar) is higher than the average pressure needed to inject the 60% Silica gel (3.2 bar) or the 40% Silica gel (2.7 bar). This difference in pressure corresponds with the difference in (apparent) viscosity. The peak at NAP -26m for the 40% silica gel was caused by the gel setting before the grouting was finished.

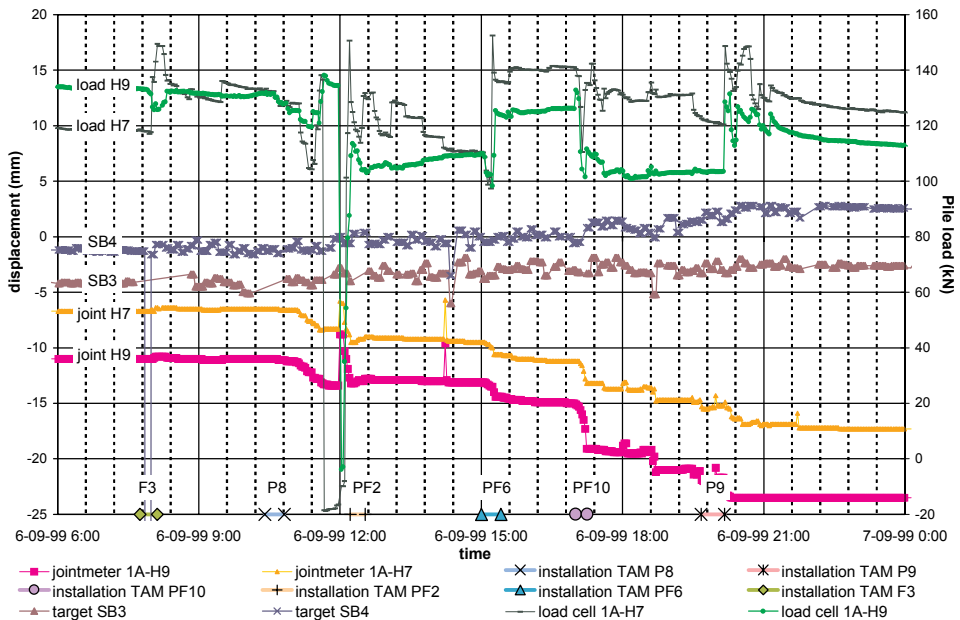
Figure 4.21 Load and Displacement of Piles 1A-H7 and 1A-H9 during TAM Installation

From Figure 4.20 it can be seen that Piles 1A-H7 and 1A-H9 show the largest displacement during TAM installation. The other piles show no significant response. The big displacement of piles H7 and H9 is more thoroughly examined in Figure 4.21.

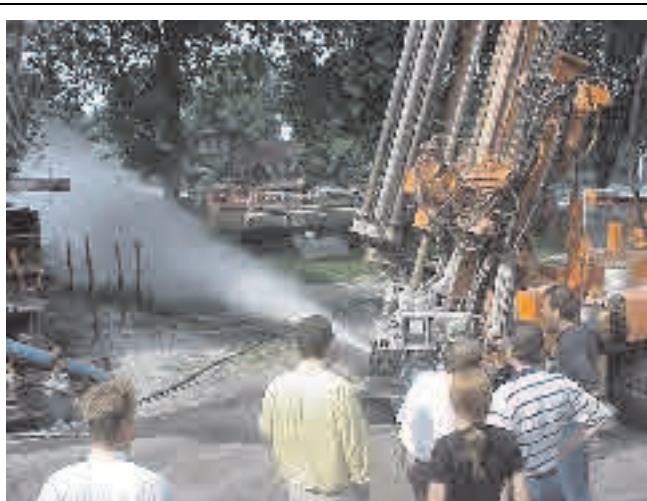
Figure 5.1 Jet Grouting: High Pressure Cutting with Water (Shown at Surface Level)

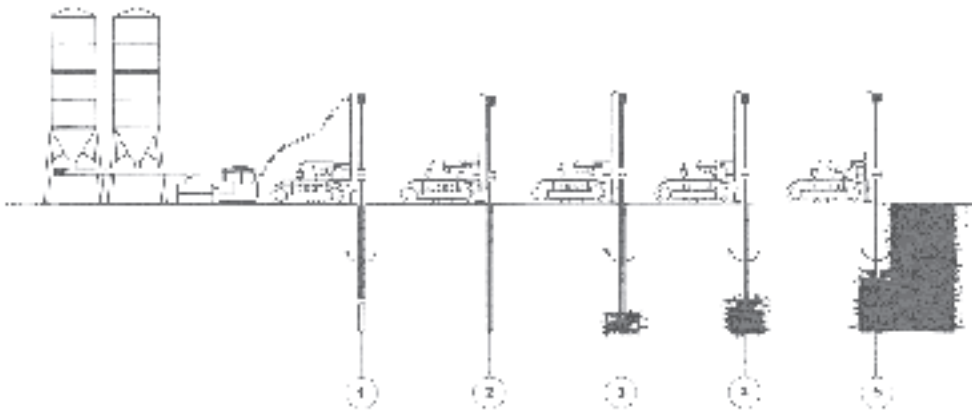
Figure 5.4 Jet Grouting Process

The soil is eroded, partly mixed with the cement grout and partly pushed to the surface along the string. This effluent that comes to the surface during jet grouting is called *spoil*. The mixture that remains in the soil hardens and forms a jet grouted column. Creating multiple columns next to each other creates a jet grouted element or structure (see Section 5.2.3 and 5.2.4).

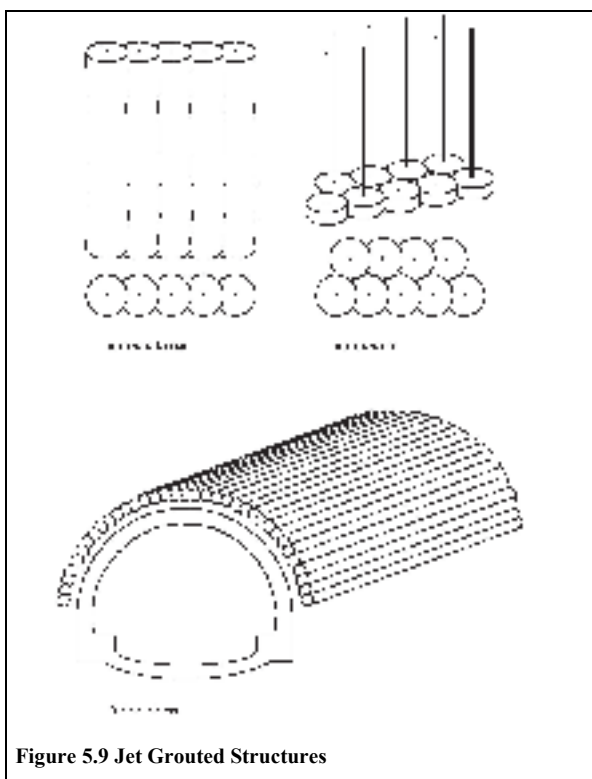
Figure 5.9 Jet Grouted Structures

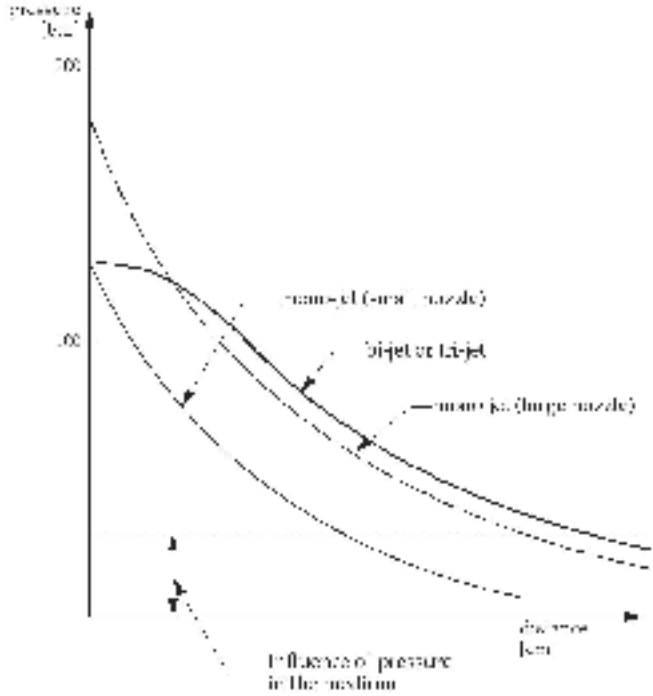
Figure 5.11 Relation Jet Grouting Pressure - Penetration Distance (De Vleeshauer and Maertens, 1999)

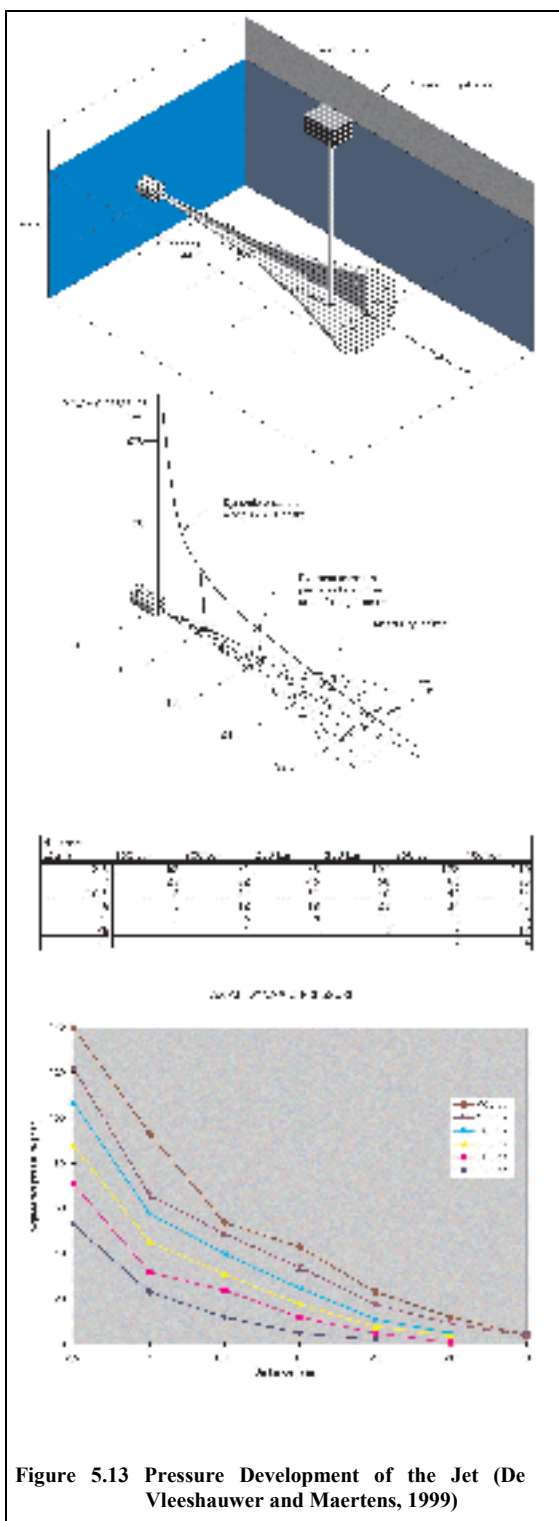
Figure 5.13 Pressure Development of the Jet (De Vleeshauer and Maertens, 1999)

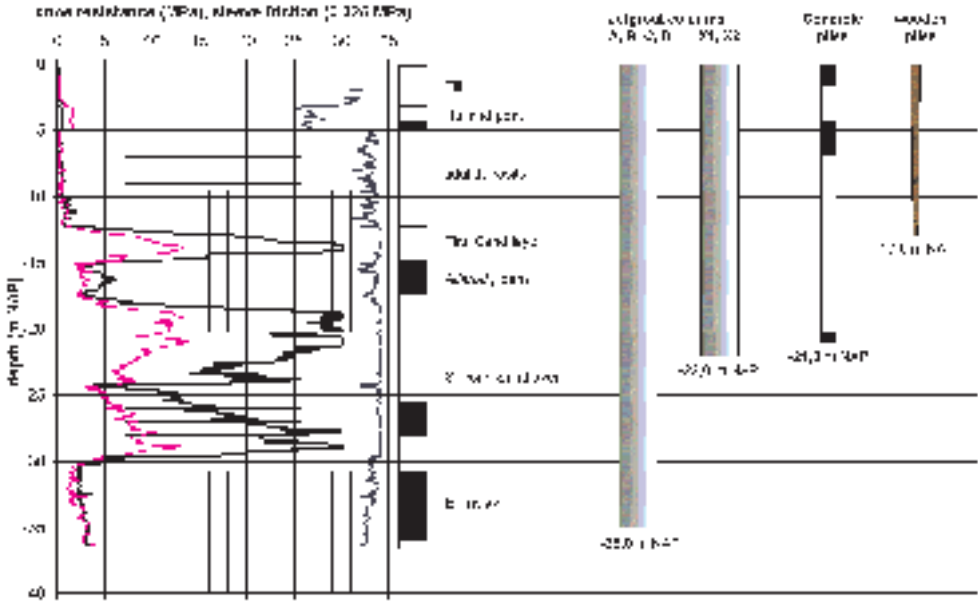
Figure 5.16 Detailed Test Set-Up: Cross Section of Columns A, B, C, D, X1 and X2 and Piles

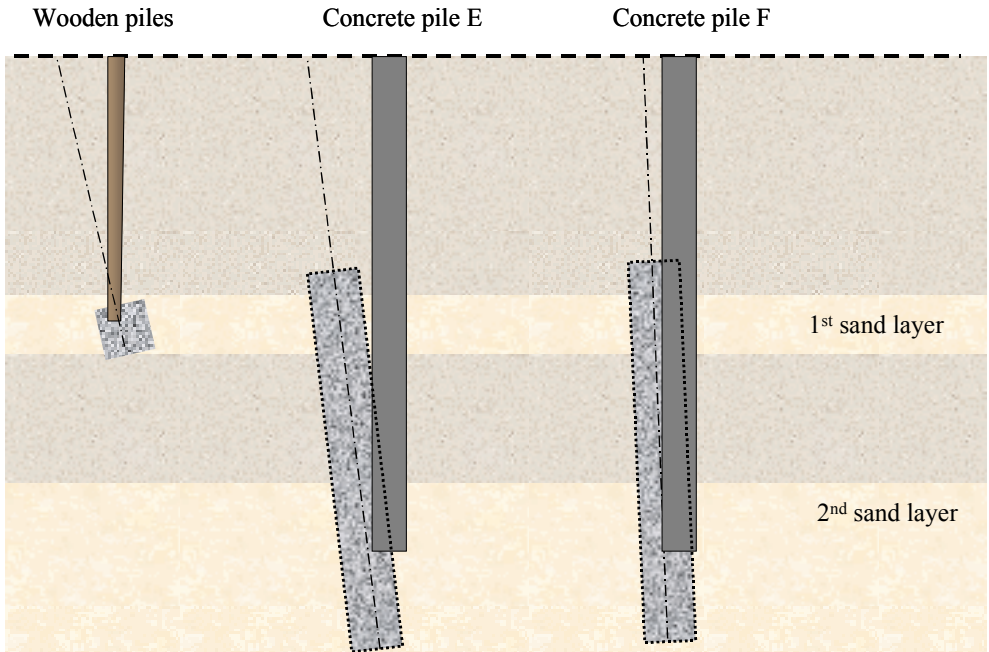
Figure 5.17 Cross Section of Jet Grouting for Foundation Renovation: Pile Extension Columns E, F and W

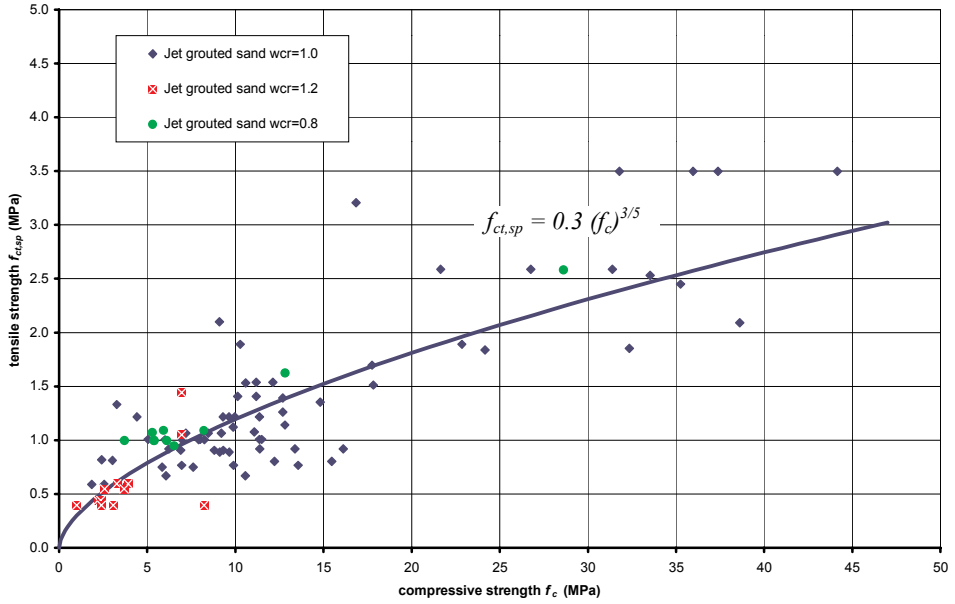
Figure 5.26 Tensile Strength $f_{ct,sp}$ vs. Compressive Strength f_c for Jet Grouted Sand Layers

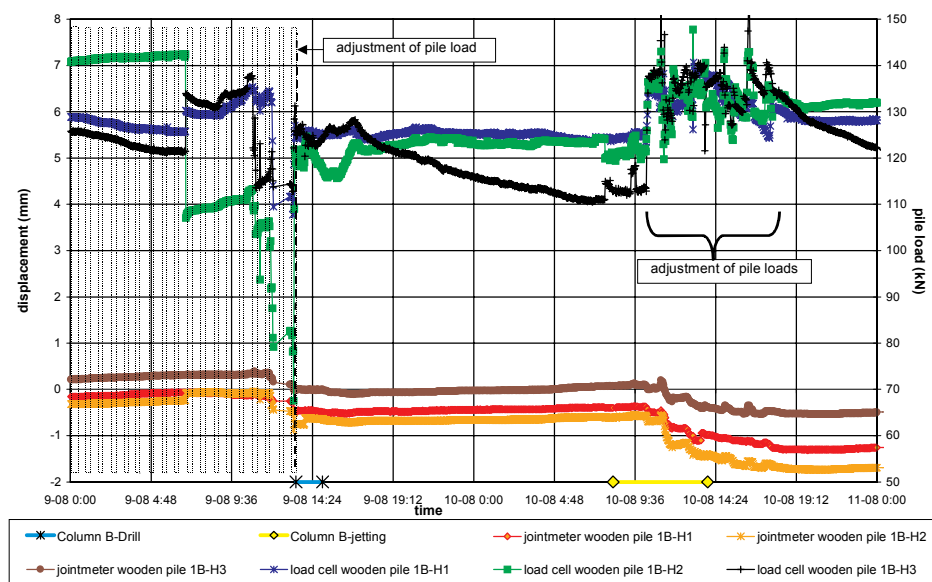
Figure 5.31 Displacement of Wooden Piles during Jet Grouting Column B

During **jetting** only small displacements (<2mm) of the wooden piles occurred. In Figure 5.32 a close up of Figure 5.31 for jetting column B, located closest to the piles, is presented. In the figure it is indicated each time the pile load is adjusted as a correction for the redistribution of loads and the relaxation that occurs as a result of pile settlement. During grouting column B, a 1 – 2 mm settlement of the wooden piles and concrete piles (Figure 5.33) occurred. The correlation between the displacement caused by drilling and jetting columns A-D and the distance between the pile and the edge of the column is further discussed in Section 5.9.

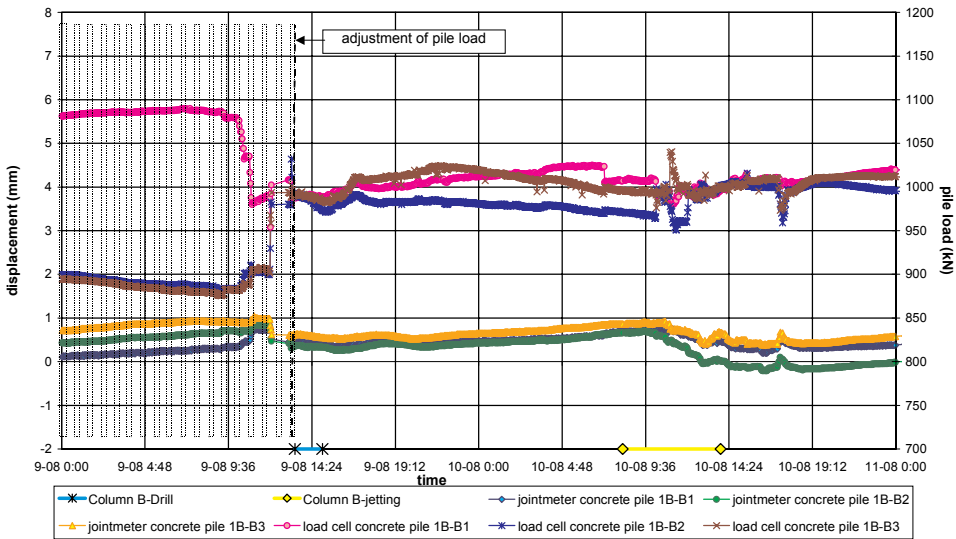
Figure 5.33 Displacement of Concrete Piles during Jet Grouting Installation (Column B)

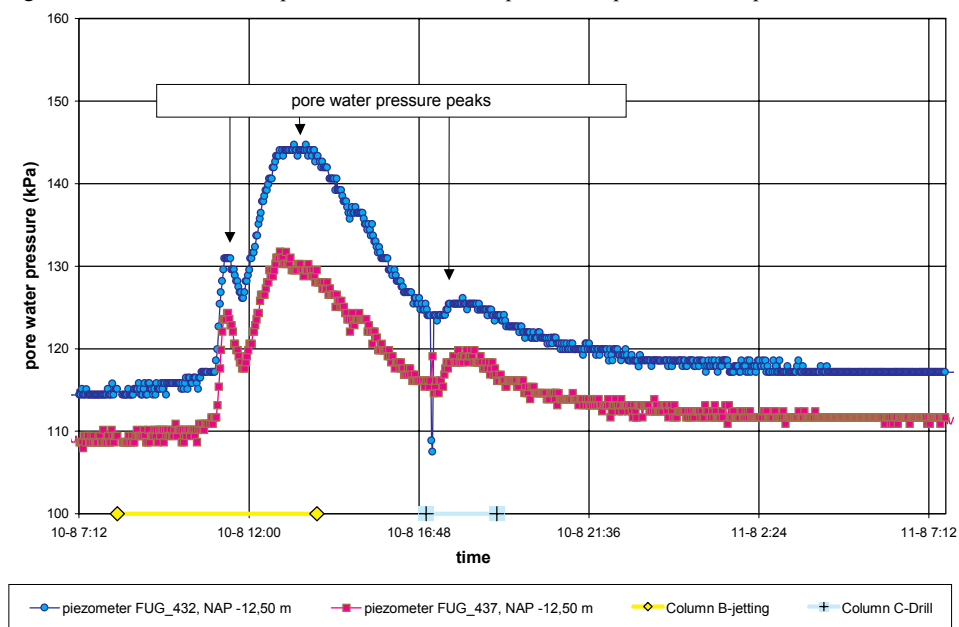
Figure 5.34 Piezometer during Jet Grouting Column B

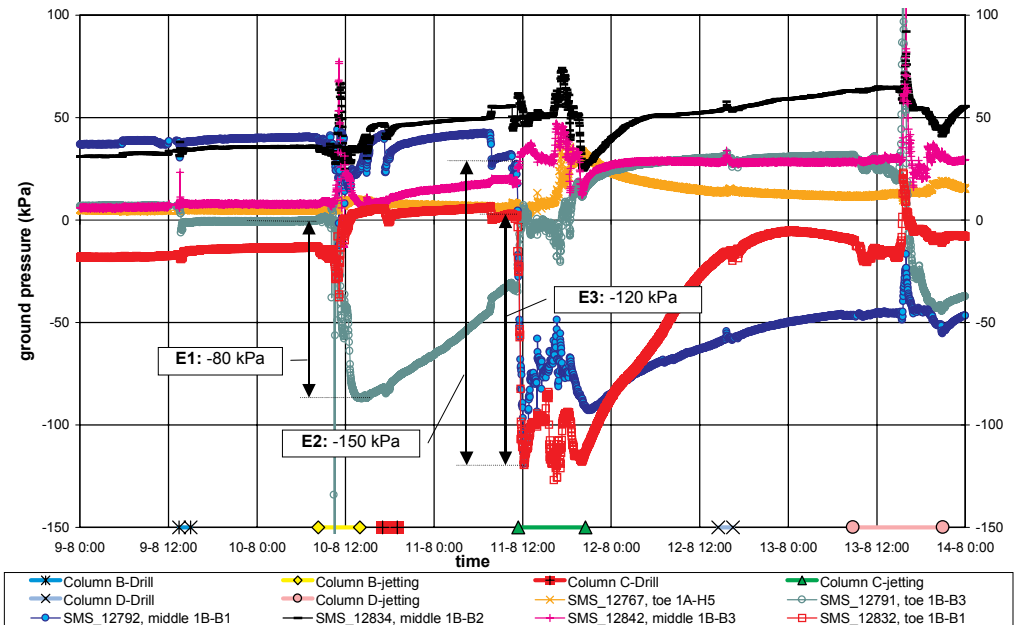
Figure 5.39 SMS in the Piles During Grouting Columns B, C and D

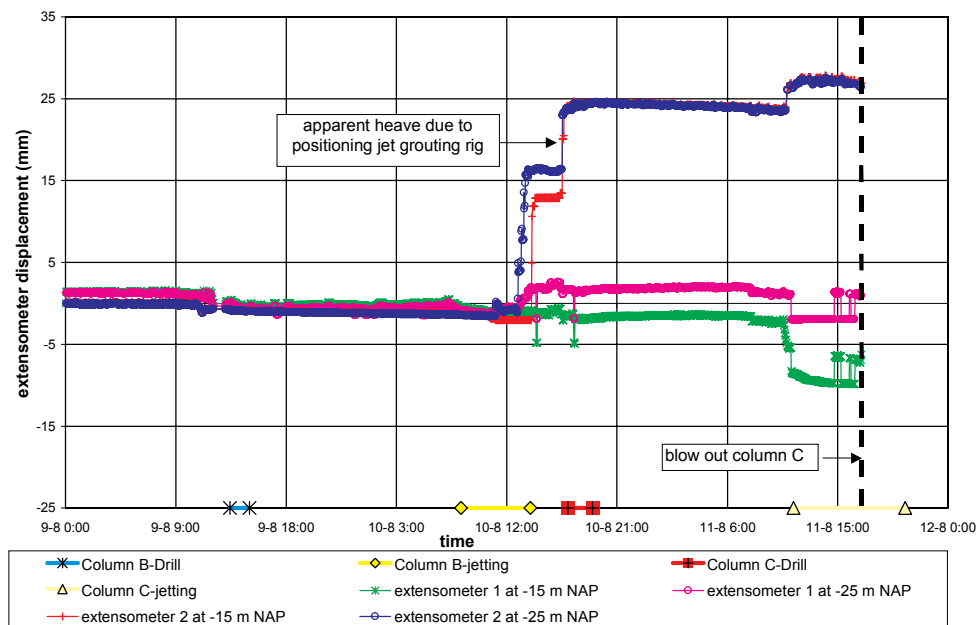
Figure 5.40 Extensometer Displacement during Jet Grouting Columns B and C

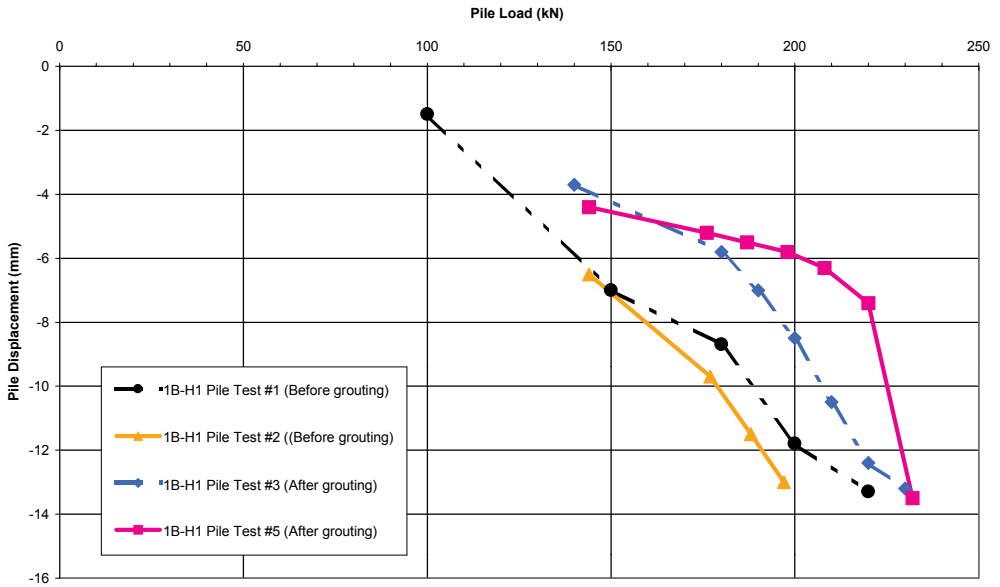
Figure 5.42 Example of Pile Load Test: Wooden Pile 1B-H1

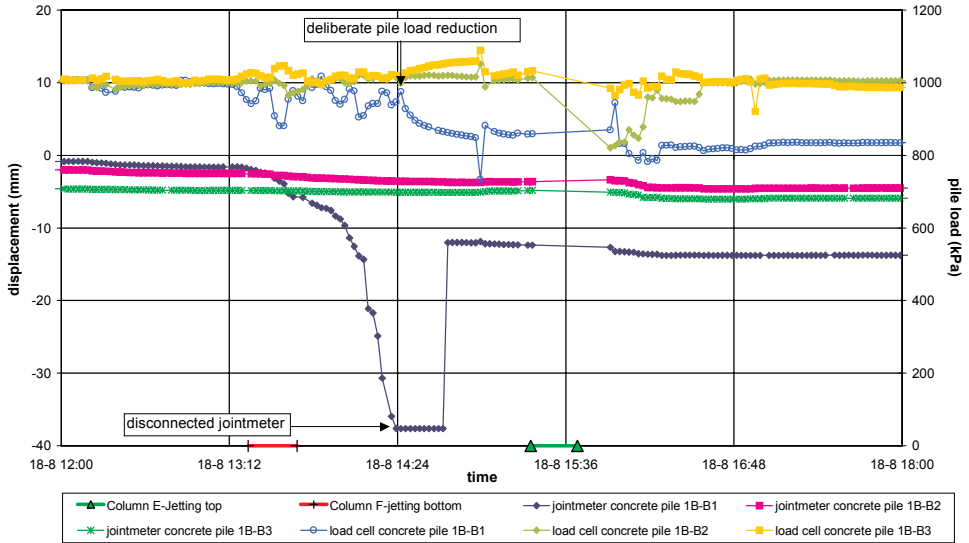
Figure 5.44 Displacement of Concrete Piles during Jet Grouting Column F (close up)

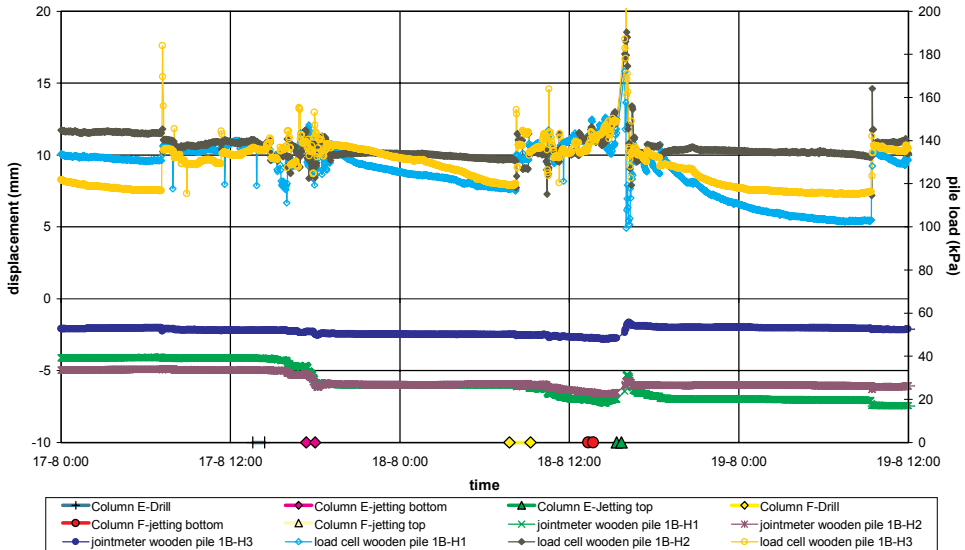
Figure 5.45 Displacement of Wooden Piles during Jet Grouting Columns E and F

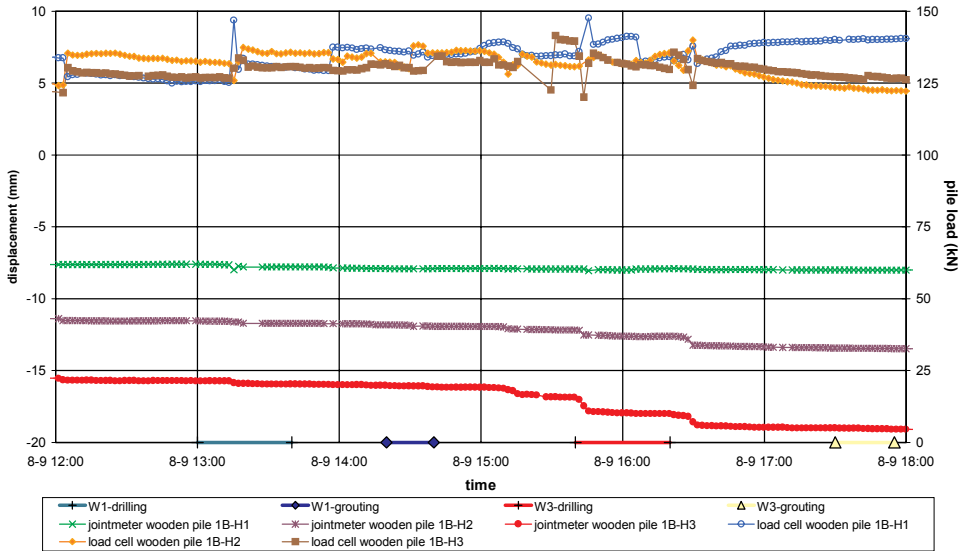
Figure 5.46 Displacement of Wooden Piles during Jet Grouted Columns W1 and W3

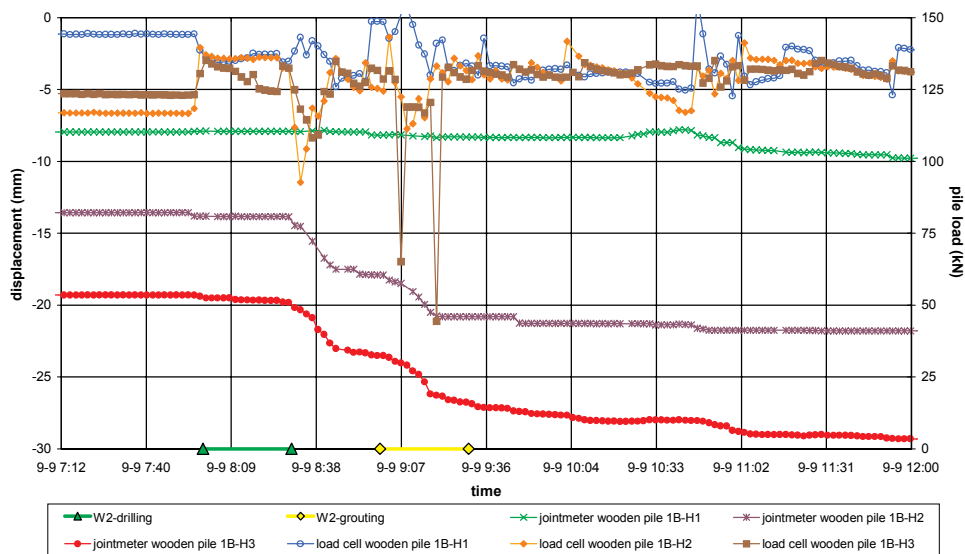
Figure 5.47 Displacement of Wooden Piles during Jet Grouting Column W2

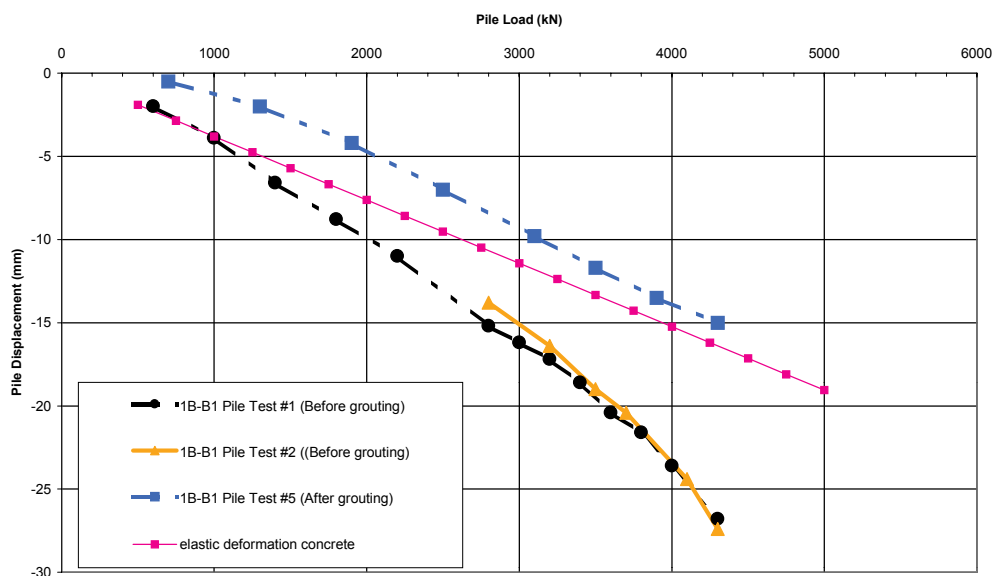
Figure 5.51 Test Results of Pile B1 and Elastic Deformation of a Concrete Pile with $E_c=30.000 \text{ N/mm}^2$

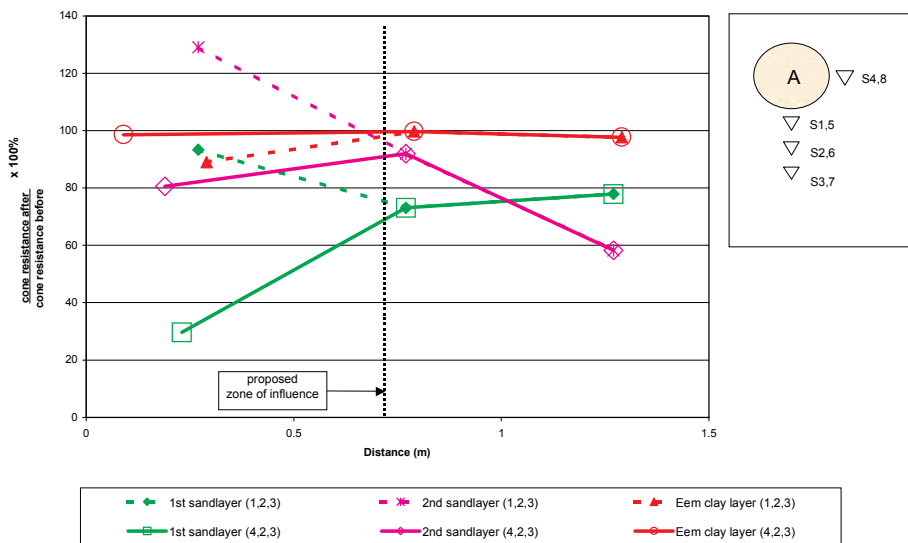
Figure 5.54 Reduction of Cone Resistance as Function of the Distance from the Column

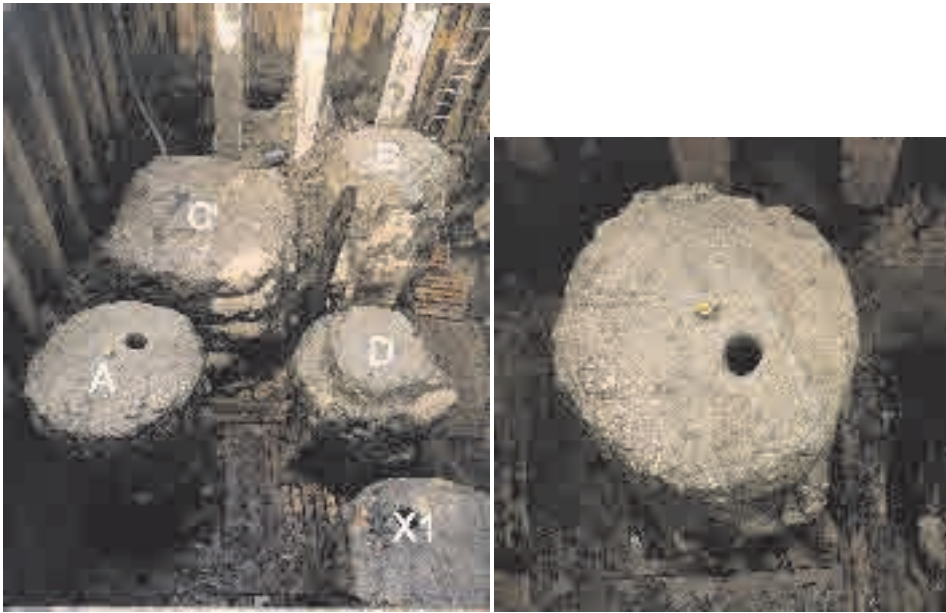
Figure 5.55 View of Excavated Site (left) ; Top View of Column A (right)

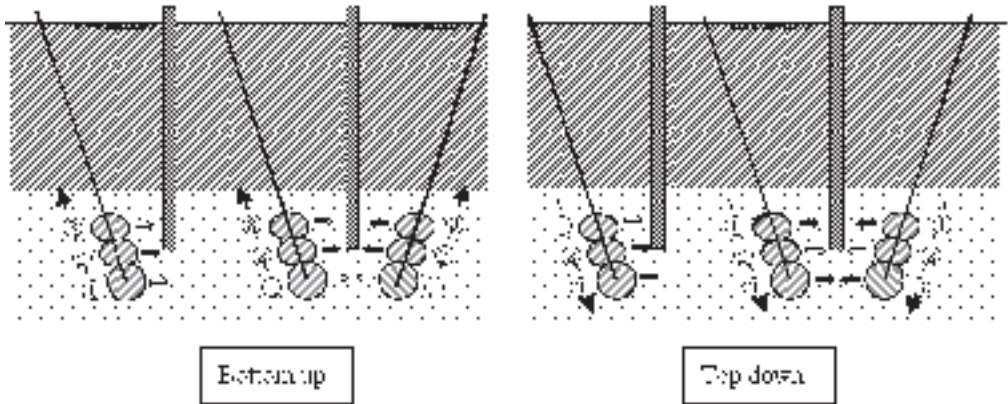
Figure 6.3 Bottom Up (left) and Top Down (right) Grouting of a Foundation Pile

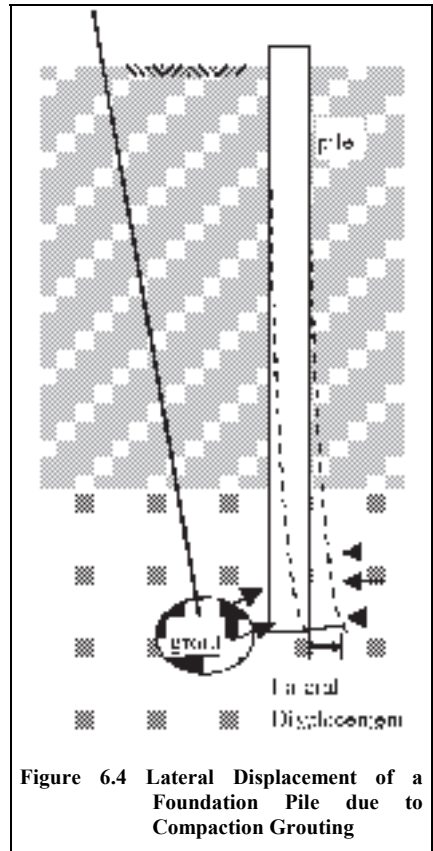
Figure 6.4 Lateral Displacement of a Foundation Pile due to Compaction Grouting

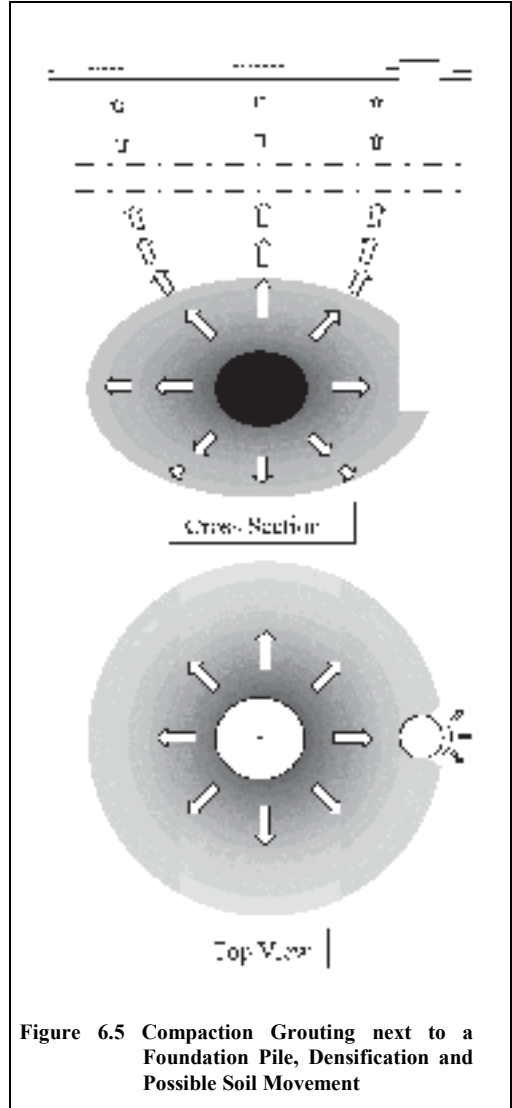
Figure 6.5 Compaction Grouting next to a Foundation Pile, Densification and Possible Soil Movement
