GROUTING FOR PILE FOUNDATION IMPROVEMENT

Grouting for Pile Foundation Improvement

Proefschrift

Keywords: grouting / pile foundation improvement / geophysical verification methods

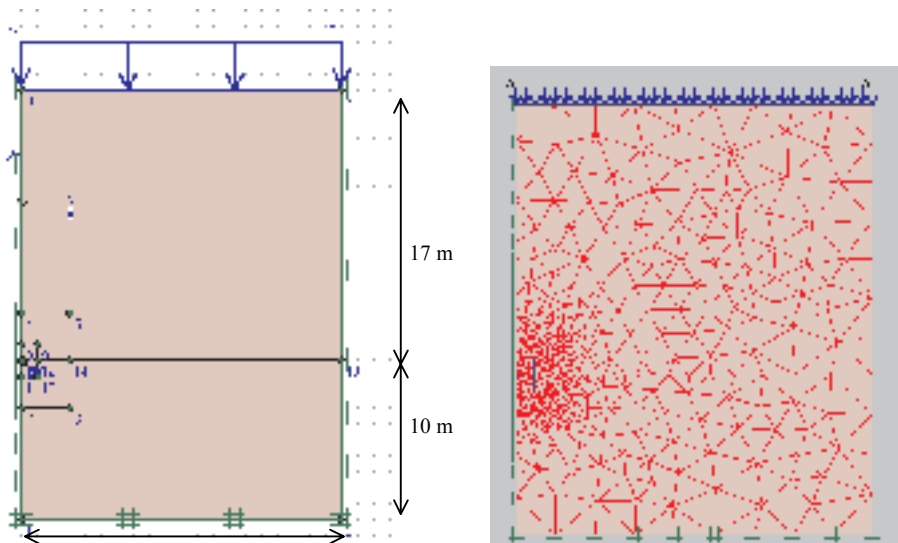
Figure 6.8 Geometry (*left*) and Mesh (*right*)

The Amsterdam soil was modelled using the PLAXIS non-linear hardening soil model. The soil parameters are shown in Table 6.1. The compaction grouting element was modelled using a tunnel element with an initial radius of 0.10 m, and a flexible lining, located at 17 m depth in a 17 m high, 20 m wide axi-symmetric mesh (Figure 6.8). By gradually increasing the pore water pressure inside the tunnel (grouting) element in accordance with a *phreatic line* calculation, the element was “inflated”.

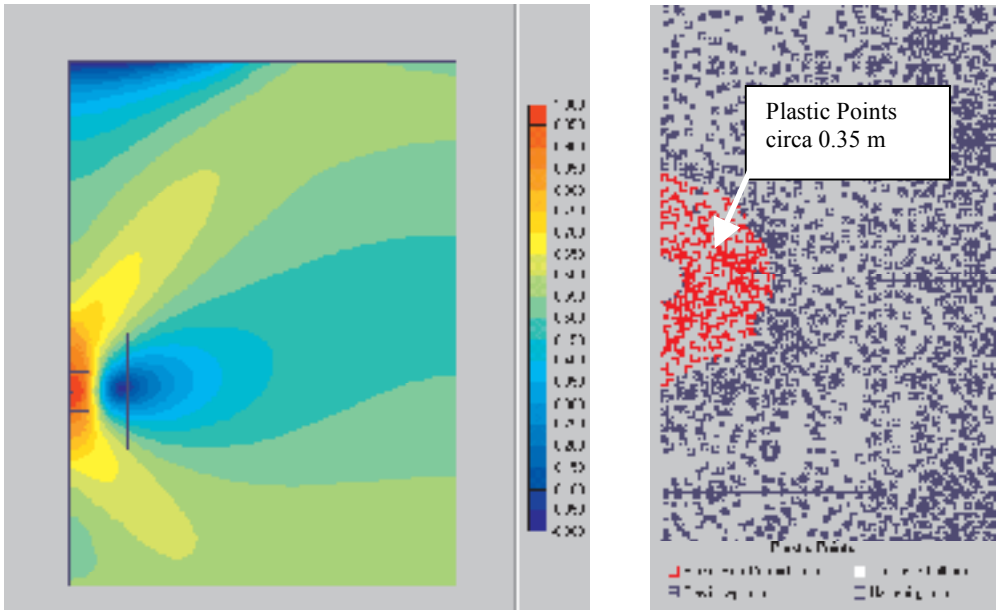
Figure 6.9 Relative Shear Stress at Failure (*left*) and Plastic Points (*right*)

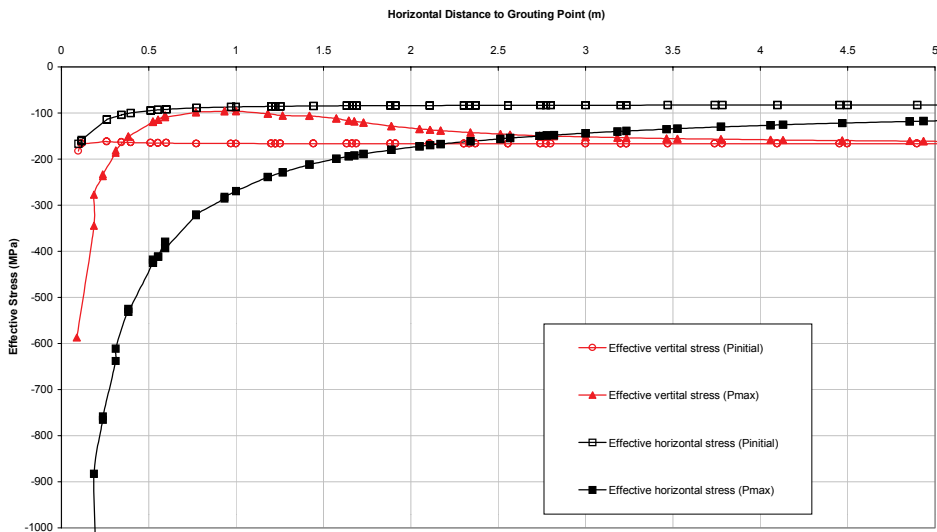
Figure 6.10 Effective Stresses next to a Compaction Grouting Element

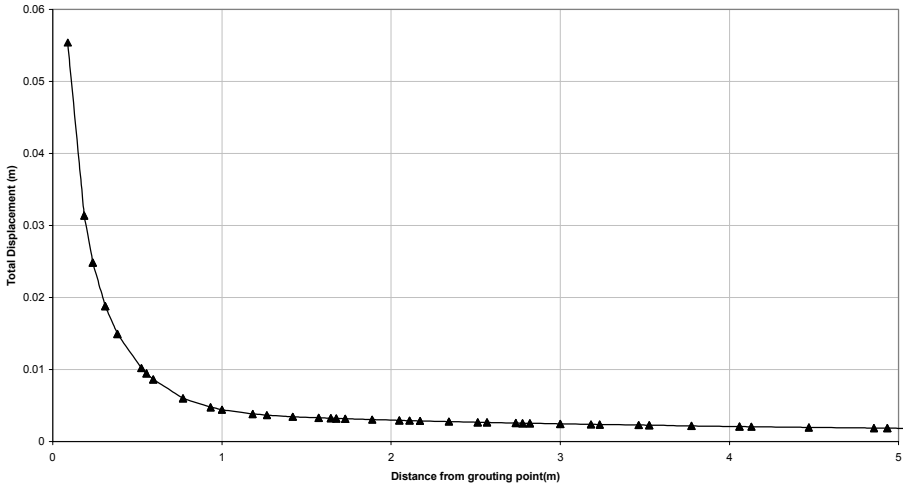
Figure 6.11 Total Displacements next to a Compaction Grouting Element

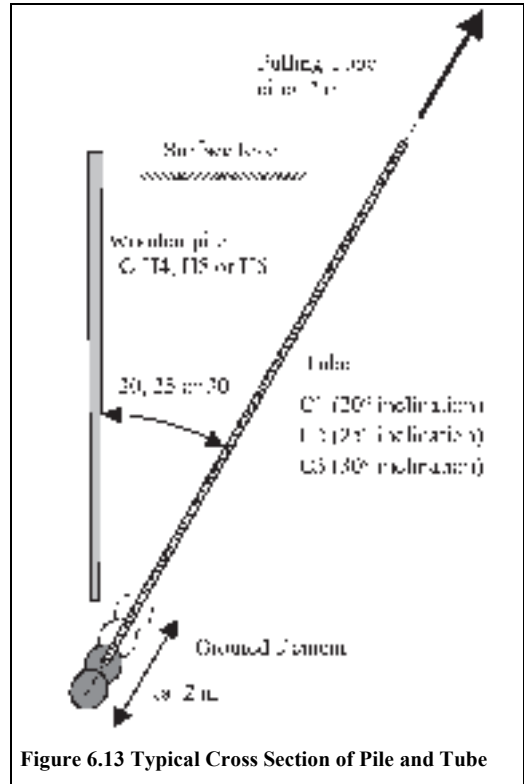
Figure 6.13 Typical Cross Section of Pile and Tube

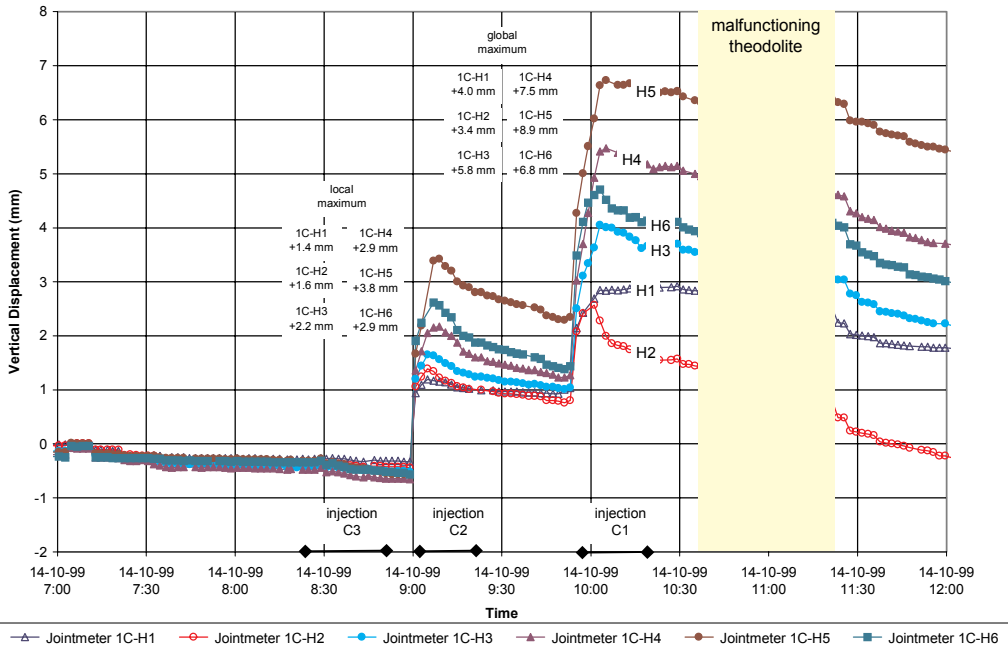
Figure 6.21 Displacement of the Piles During Grouting

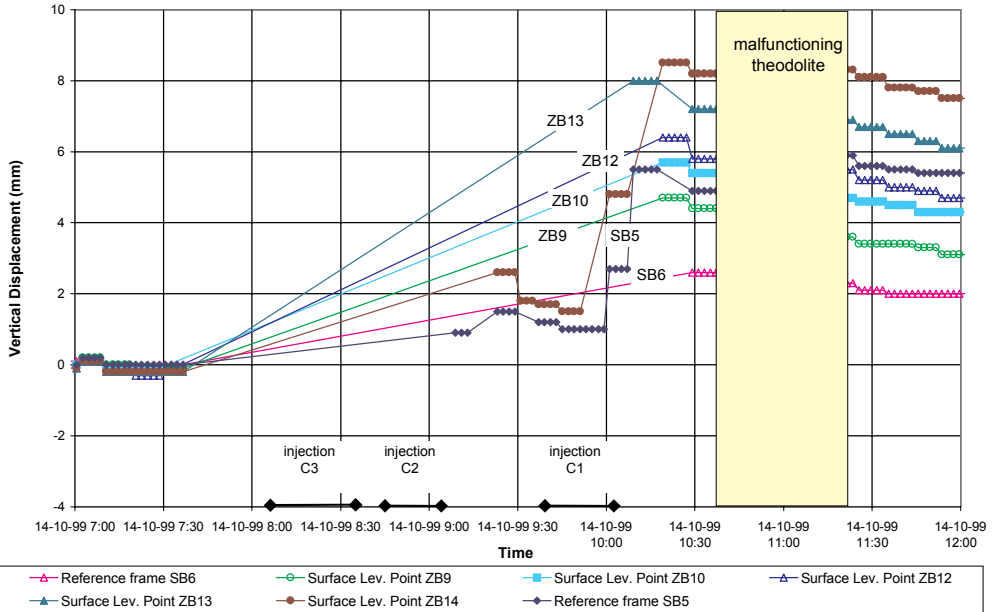
Figure 6.24 Surface Levelling Point during Grouting

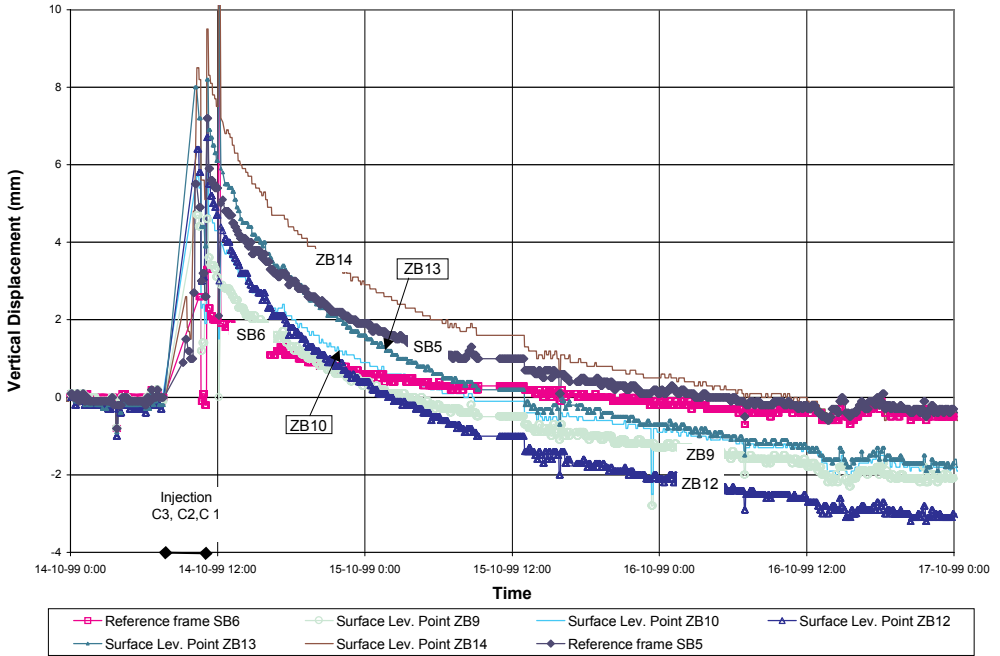
Figure 6.25 Surface Levelling Point during and 2.5 Days after Grouting

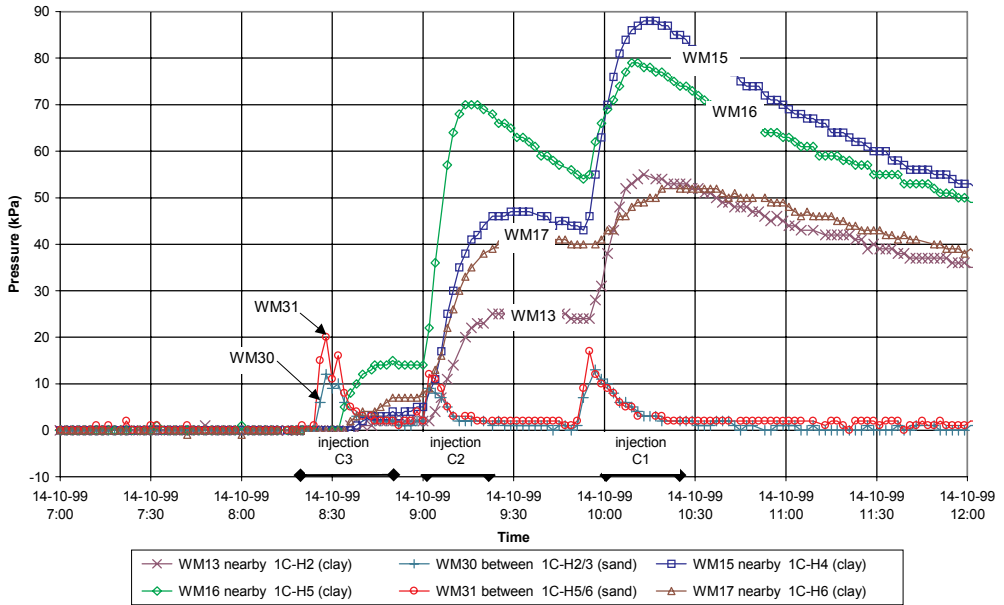
Figure 6.27 Piezometer Readings during Compaction Grouting

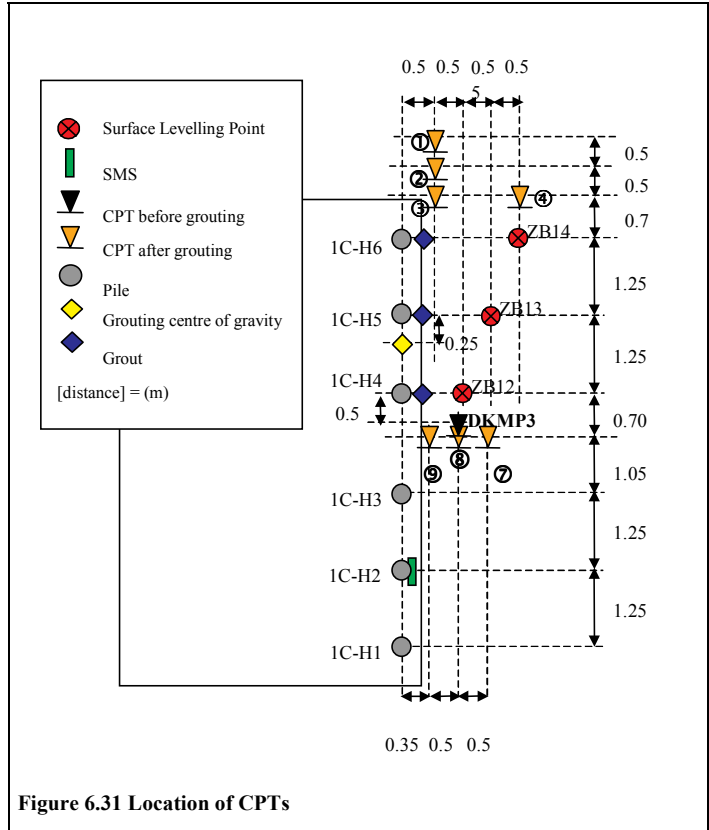
Figure 6.31 Location of CPTs

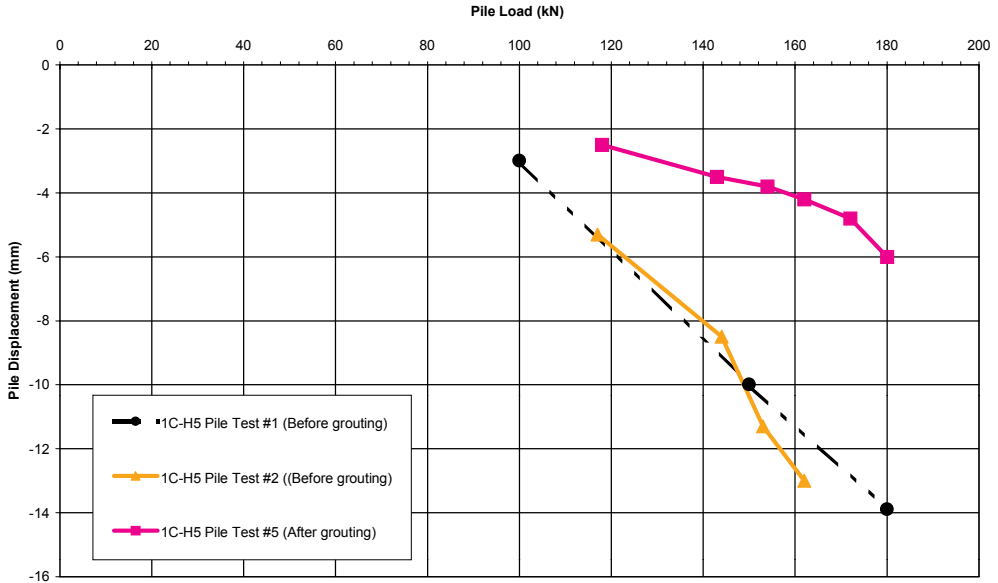
Figure 6.32 Example of Pile Load Test: Wooden Pile 1C-H5

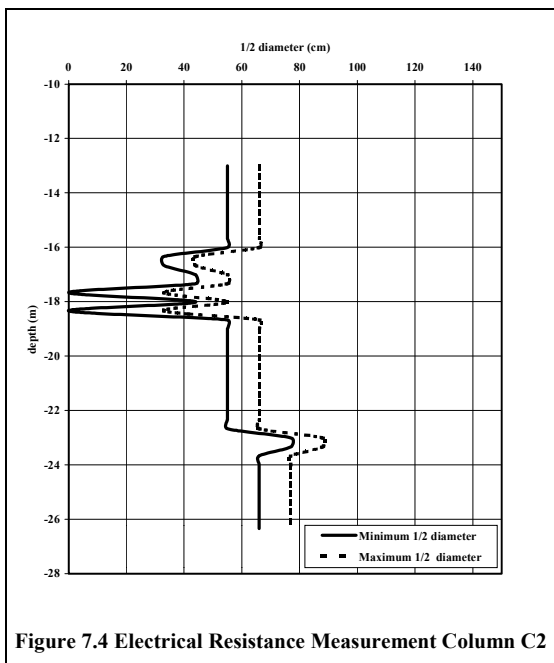
Figure 7.4 Electrical Resistance Measurement Column C2

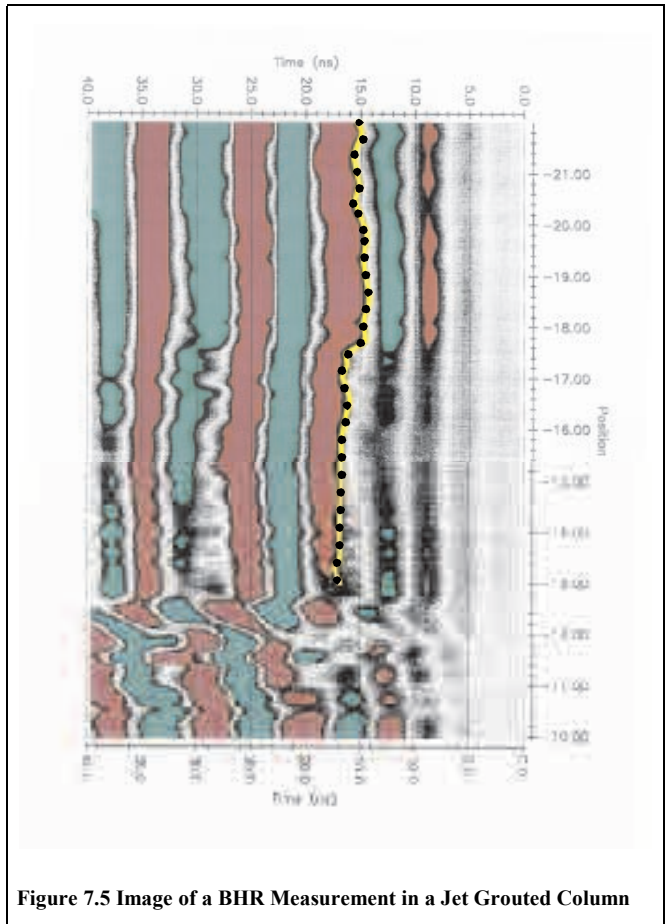
Figure 7.5 Image of a BHR Measurement in a Jet Grouted Column

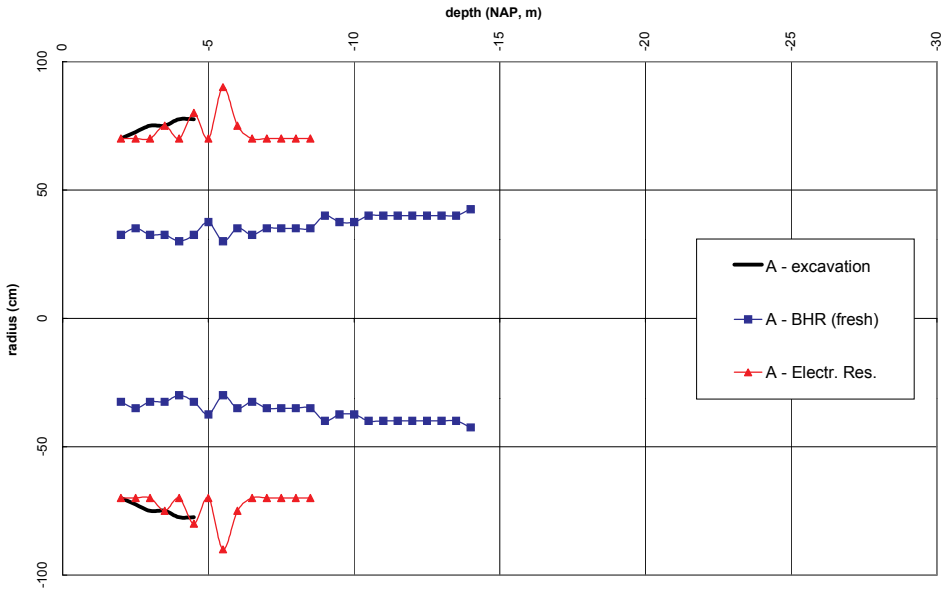
Figure 7.6 Interpreted Electrical Resistance Measurement and BHR Measurements Column A

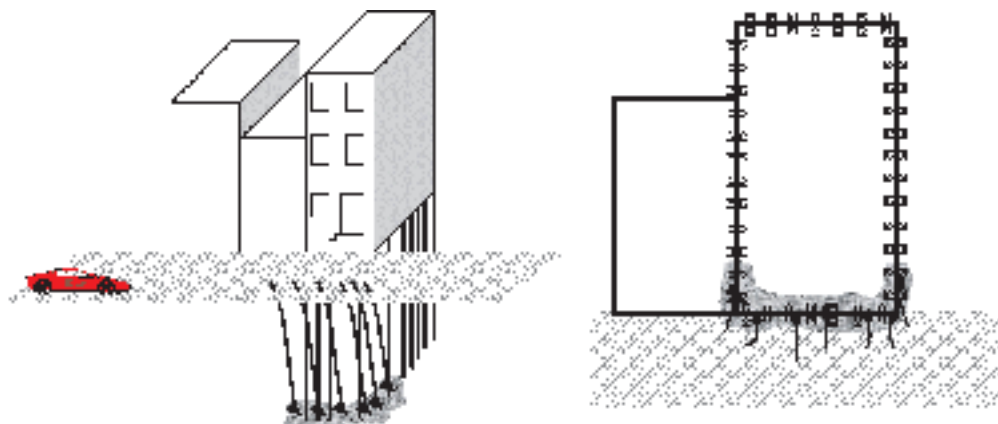
Figure 8.1 Schematic Presentation of Permeation Grouting Wooden Pile Foundation (Façade Only)

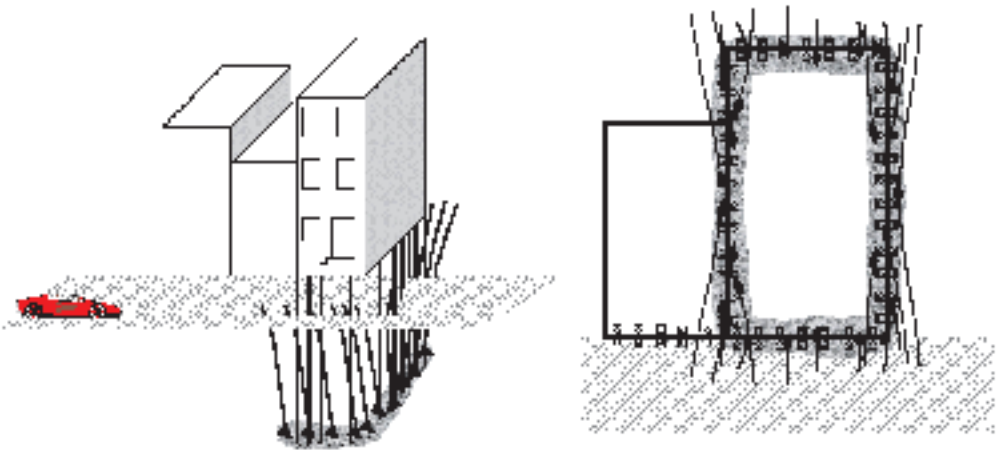
Figure 8.3 Schematic Presentation of Permeation Grouting Wooden Pile Foundation (Whole Structure)

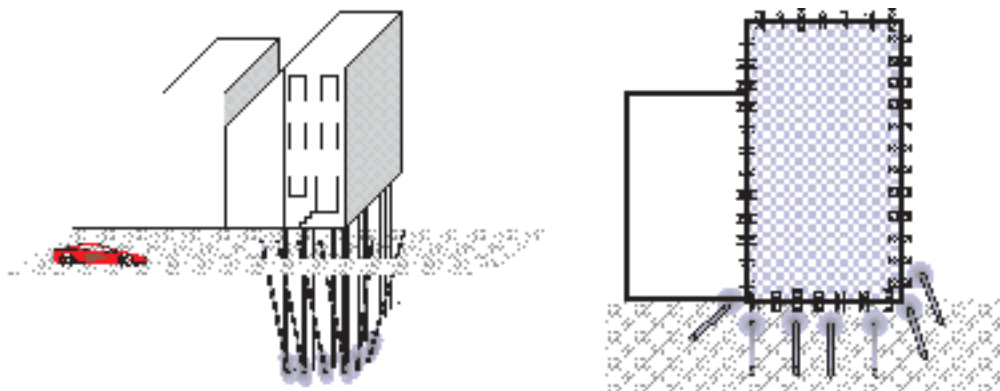
Figure 8.4 Example of Compaction Grouting used on a Typical Amsterdam Structure

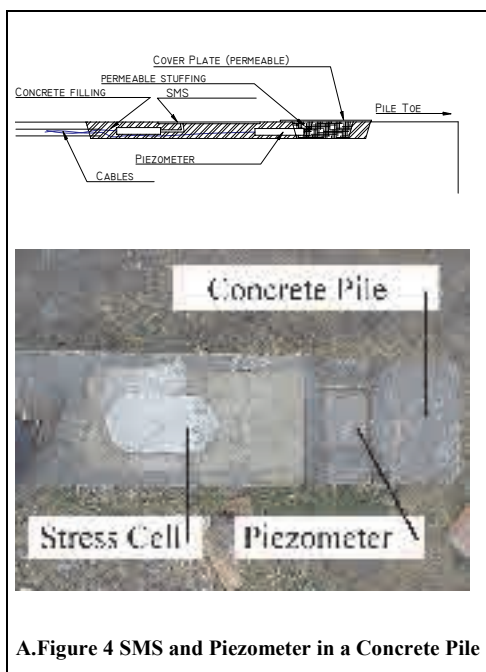
A. Figure 4 SMS and Piezometer in a Concrete Pile

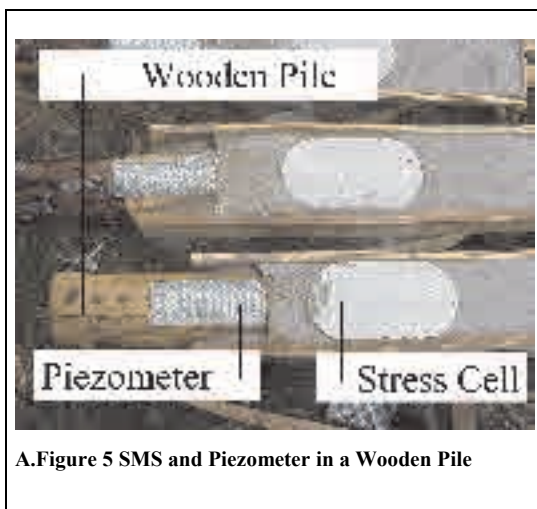
A. Figure 5 SMS and Piezometer in a Wooden Pile
