**RILEM TC 277-LHS report**

**lime-based mortars for restoration—a review on long-term durability aspects and experience from practice**

# RILEM TC 277-LHS report: lime-based mortars for restoration—a review on long-term durability aspects and experience from practice

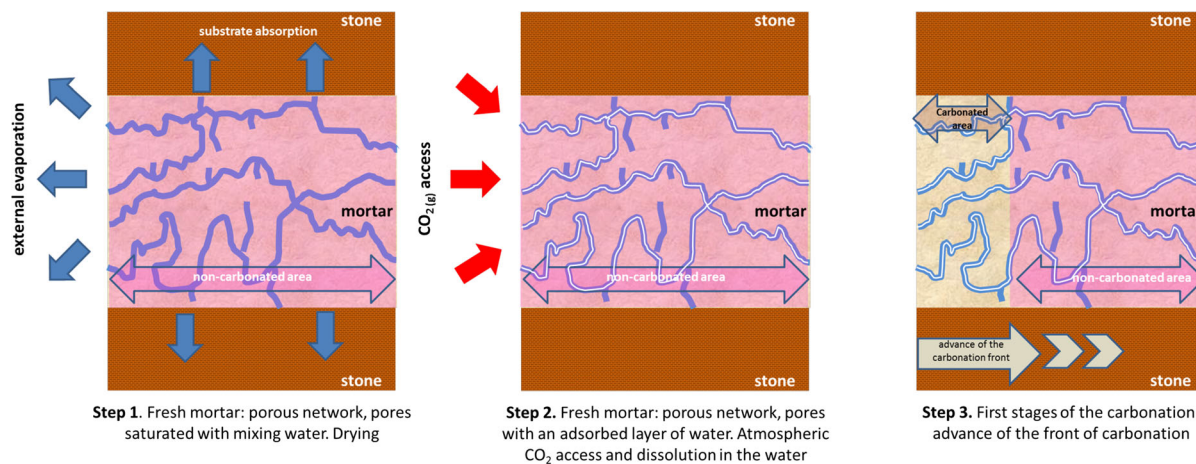
**Fig. 1** Scheme of the carbonation process of an air lime bedding mortar of stone masonry. Step 1: drying; Step 2: CO<sub>2</sub> access and dissolution in the adsorbed layer of water; Step 3: carbonation front advance

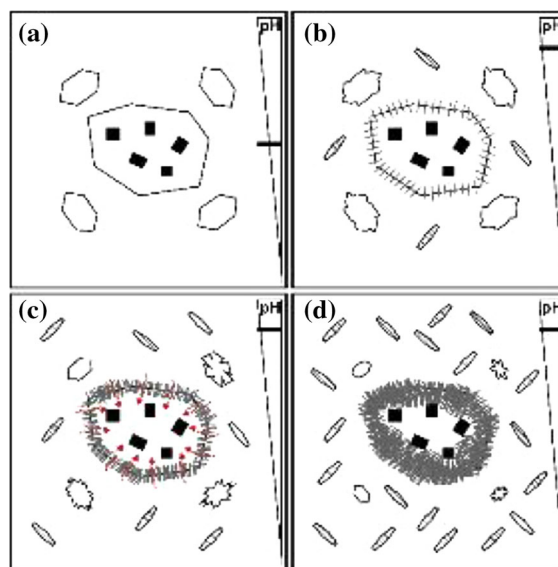
**Fig. 2** Scheme of the pozzolanic reaction process: **a** Initial state (portlandite crystals depicted as hexagonal polygons, pozzolanic particle depicted as a large polygonal shape with non-reactive mineral constituents in black); **b** Initial dissolution period (C-S-H crystals depicted as grey lines, C-A-H crystals depicted as elongated textured polygons); **c** Induction period (red dashed arrows indicating water diffusion through osmosis); **d** Main reaction period

form hydrated reaction products (calcium silicate and calcium aluminate hydrates) with marked binding properties related to their crystalline structure [44]. Pozzolanic reaction processes can be subdivided into three reaction stages (Fig. 2) [45], namely initial

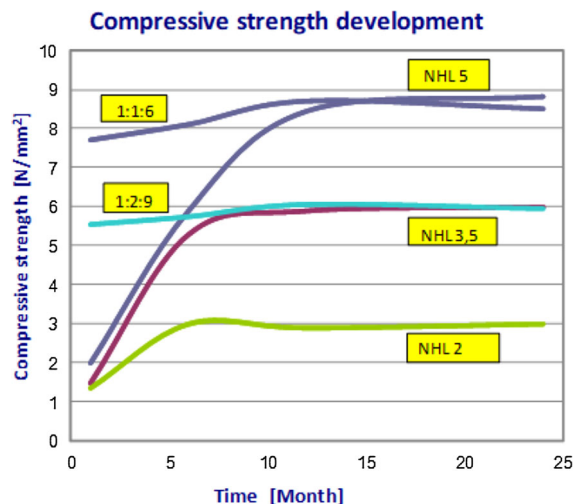
**Fig. 6** Slow strength development for the NHL mortars and quick hardening of the cement-lime mortars: NHL mortars, 1:2.5 (NHL: sand) in vol.; cement-lime mortars e.g. 1:1:6 (cement: lime: sand), in vol.; curing conditions 20 °C and RH 90% [99]

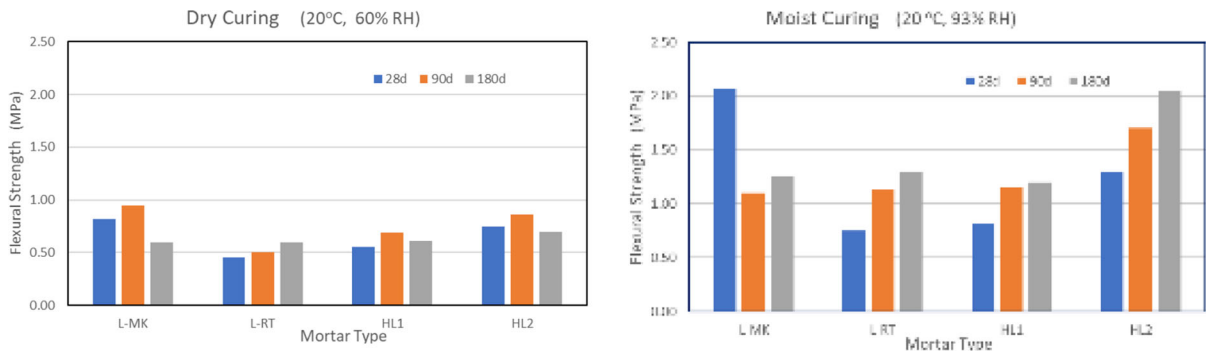
**Fig. 9** Flexural strengths values for Lime-Metakaolin (L-MK), Lime-Rhenish trass (L-RT), and two types of Natural Hydraulic Lime (HL1 and HL2) mortars, for 2 curing conditions: dry curing and moist curing (adapted from [58])

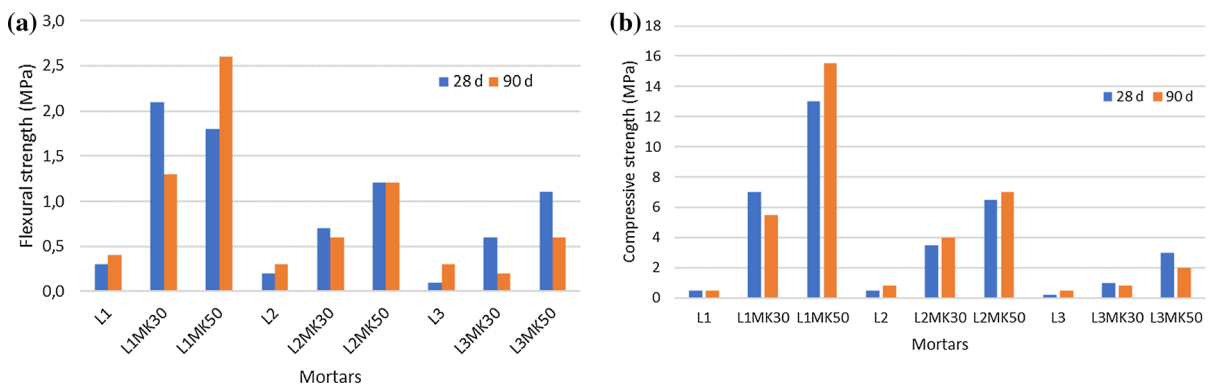
**Fig. 10** Flexural a) and compressive b) strengths of air lime-metakaolin mortars with ratio b/a 1:1, 1:2 and 1:3 (wt) and ratio MK/L 0, 0.3 and 0.5 (adapted from [68])

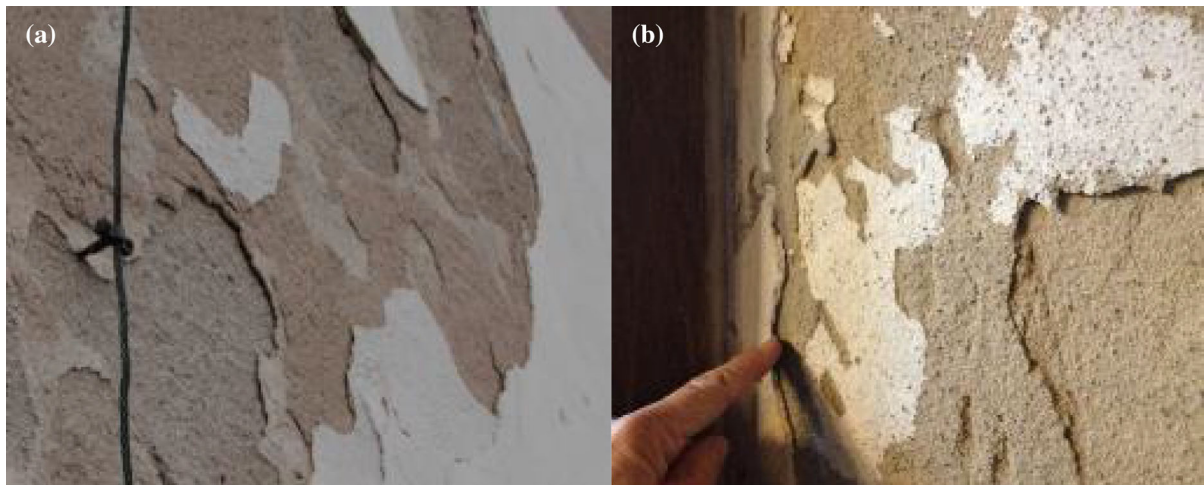
**Fig. 17** Typical forms of layering in renders and plasters. Separate render layers coming off due to freezing temperatures in a saturated and porous render (a), [110]; similar damage, due to salt crystallization in a plaster, applied on a wall with capillary rising damp (b)

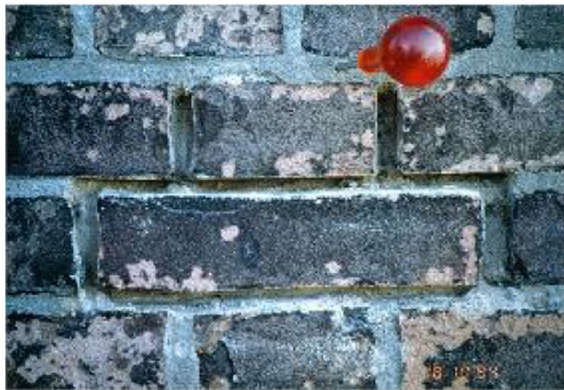
**Fig. 18** Weak, decayed trass lime re-pointing

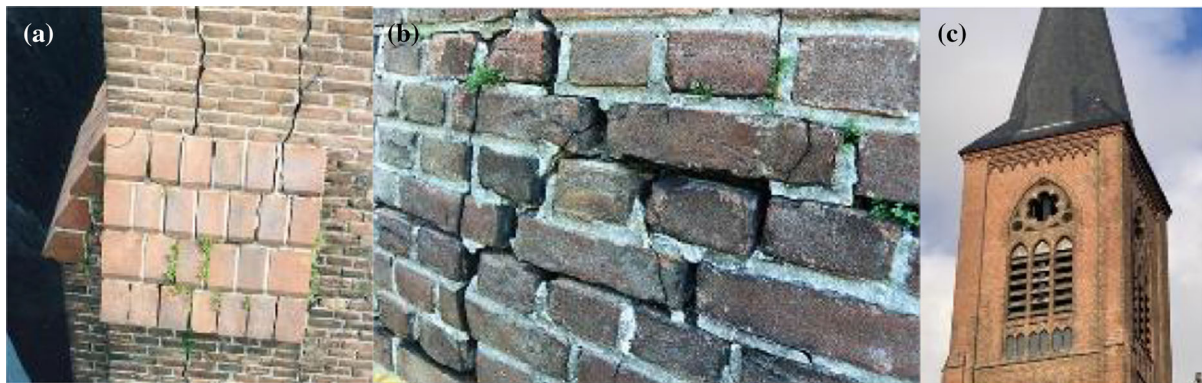
**Fig. 19** Cracks in masonry, caused by expansion of bedding mortar, deeper in the wall section, due to formation of thaumasite (a); push out of the pointing is a secondary effect (b); situation several years after repair: no recurrence (c)

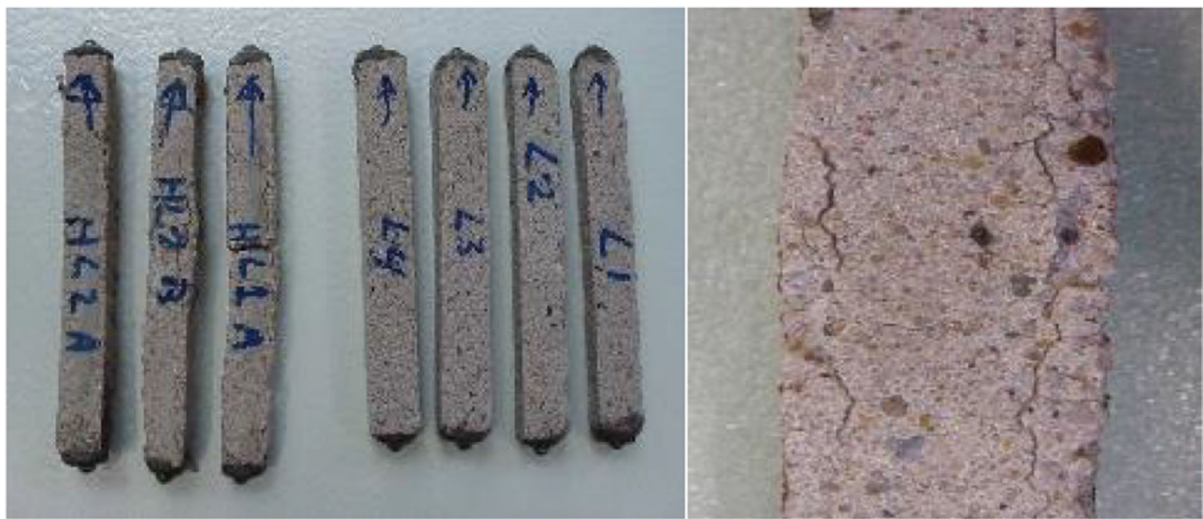
**Fig. 20** Mortar prisms after 15 weeks in sulfate solution. Natural Hydraulic Lime based (NHL) specimens with clear expansion and deformation and Hydrated lime based (CL)

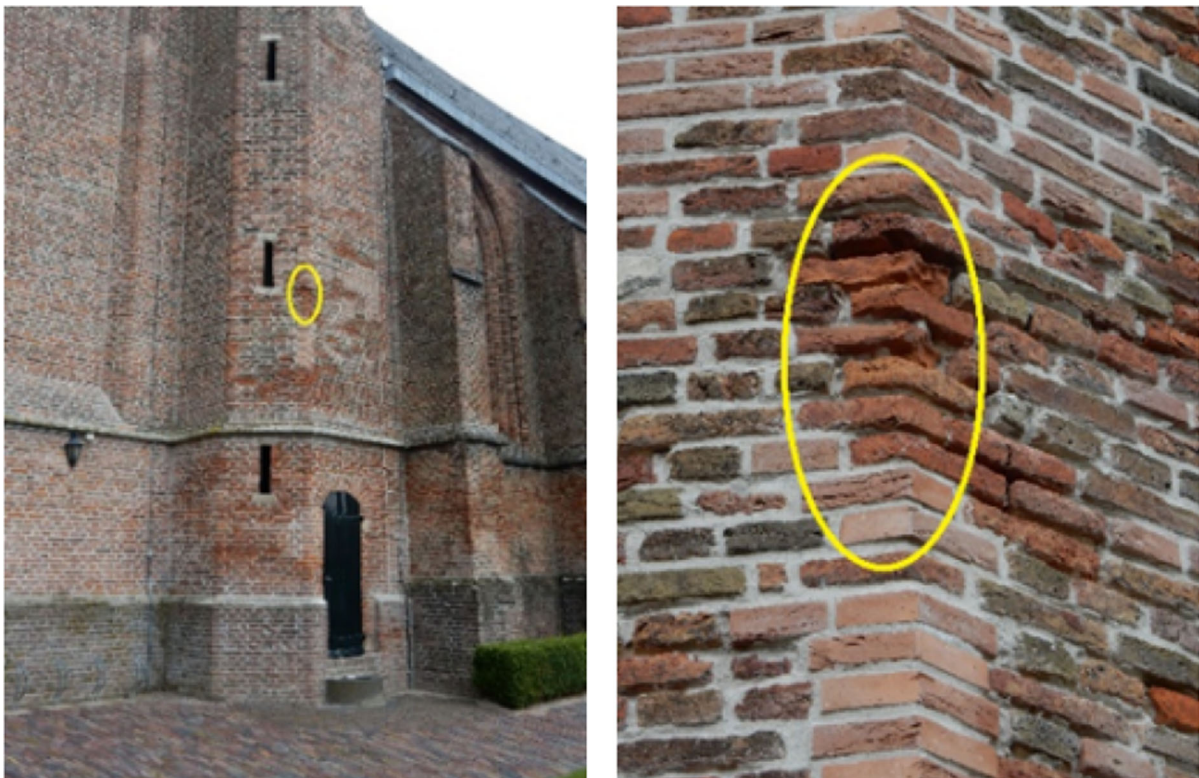
**Fig. 21** Situation of the damage in 2016. Left, the reddish parts of the masonry indicate where the repointing is damaged. Right, detail of one of the spots with damaged repointing

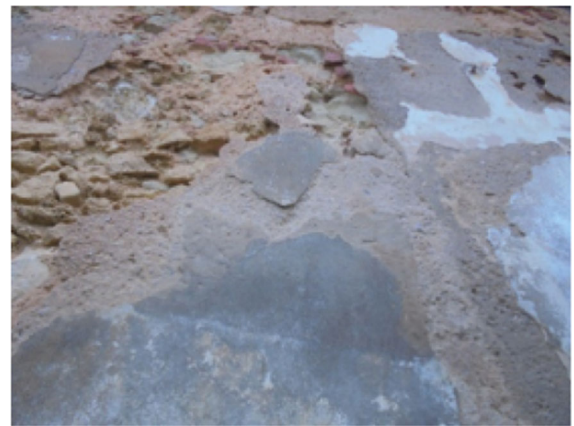
**Fig. 24** Detail of the degradation showing cementitious repair mortars

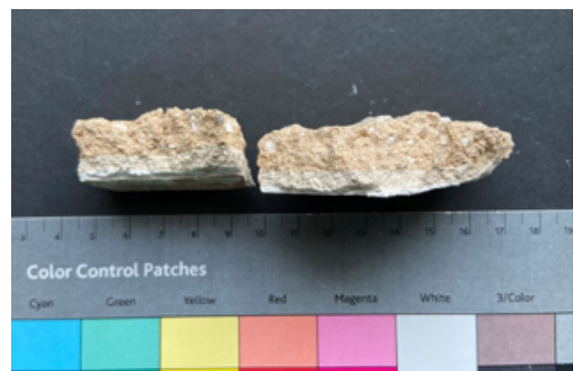
**Fig. 25** Samples of the old lime render in two coats

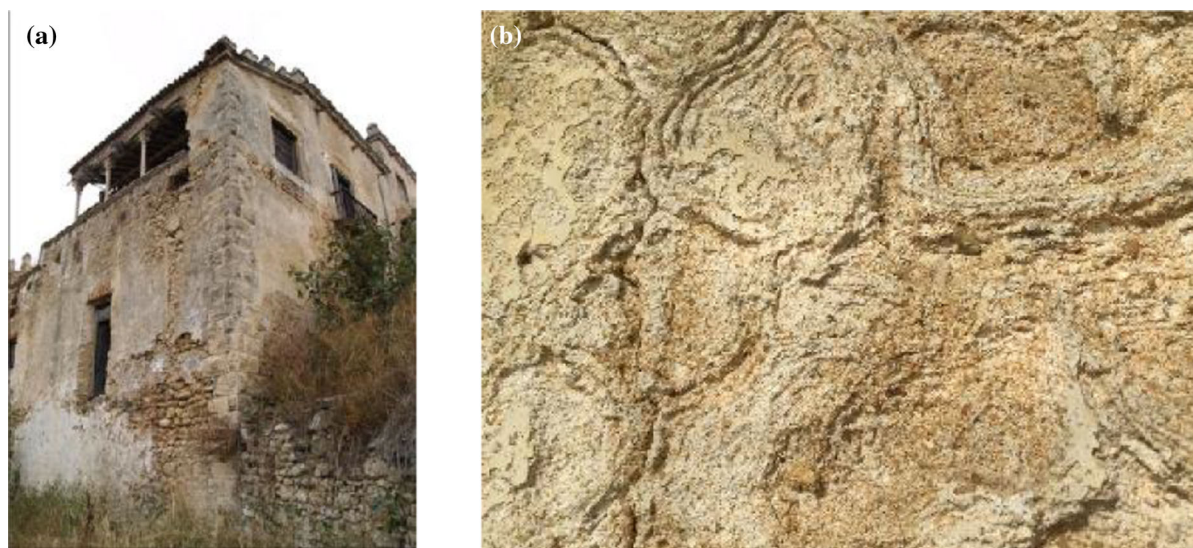
**Fig. 27** Valflores Palace in St. Iria da Azoia, Loures, Portugal (a), and Liesegang phenomenon in a rendered façade (b)

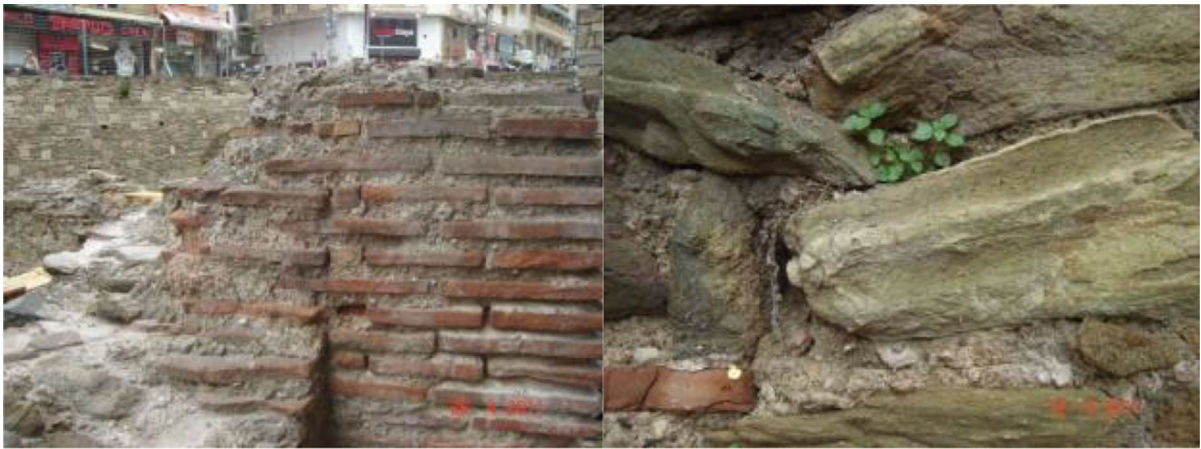
**Fig. 29** Deterioration problems of the masonries before the intervention works

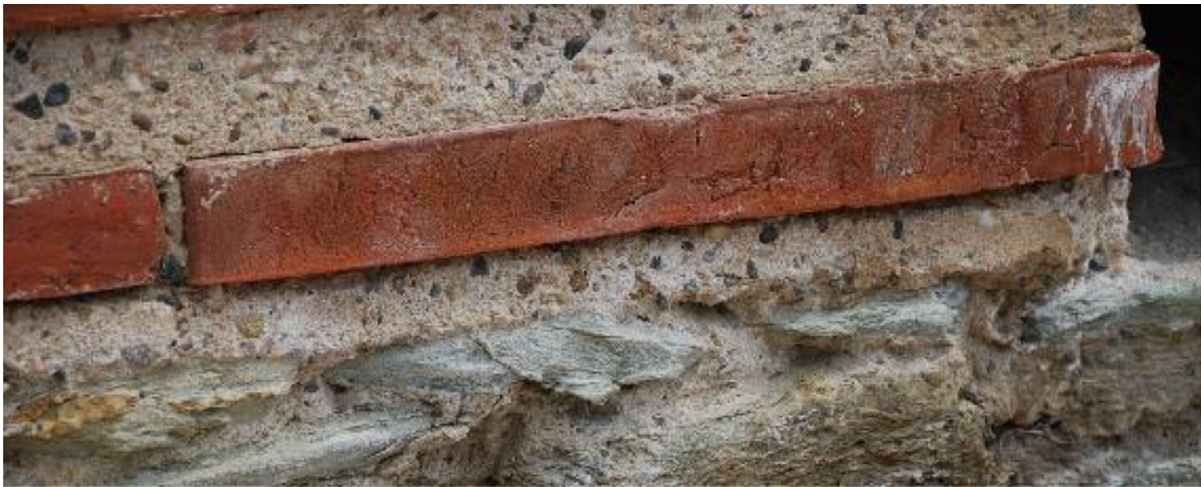
**Fig. 30** Repair mortar in a mix structural system of Galerius Palace in Thessaloniki, Greece

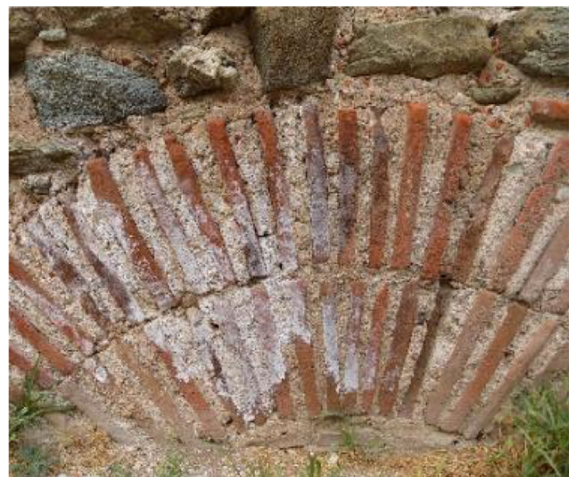
**Fig. 31** Efflorescence near to the ground level
