Durable past – sustainable future

Rob van Hees
Silvia Naldini
Job Roos

TU Delft OPEN
Publishing

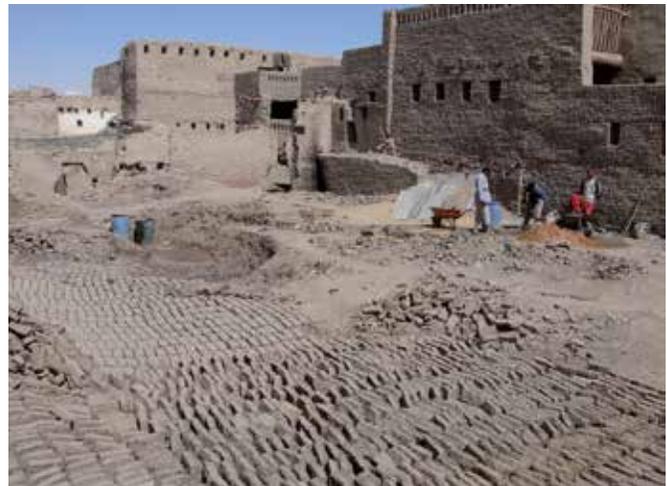
FIG. 2.1 Fabrication of brick, Qasr in Daklah (Egypt) / photo: D. Schultz

To make adobe brick, sand, clay, straw and often animal excrements are mixed. After mixing, either the material is shaped by hand to form bricks (adobe bricks or green bricks) or moulds can be used. The resulting bricks are baked in the sun [FIG. 2.1].

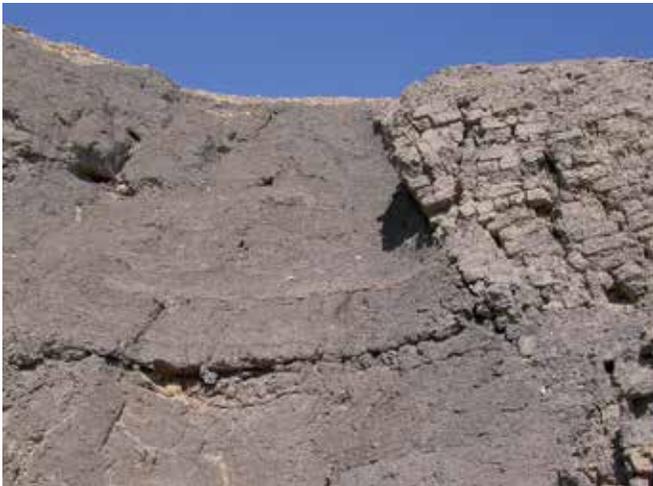
FIG. 2.3 Mastaba, Meidum, adobe (Egypt), detail / photo: D. Schulz

Depending on the local environmental conditions adobe may even show a considerable service life, as is the case of the mastabas, the tombs of the Egyptian kings, from the times before the Old Kingdom; many of them are surviving after thousands of years [FIG. 2.2, FIG. 2.3].

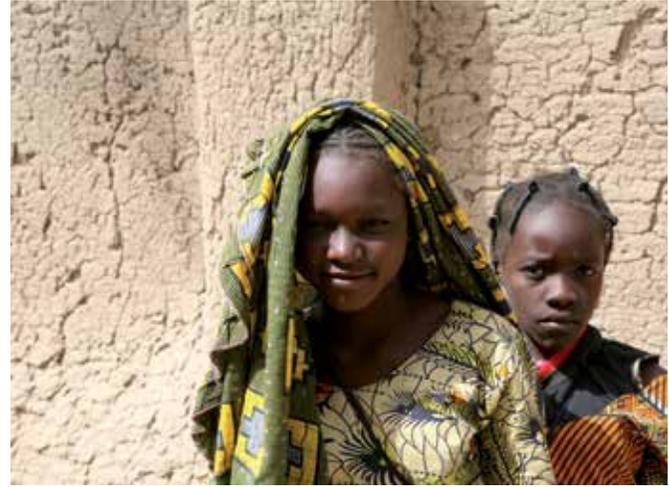
FIG. 2.6 Crack patterns, like crazing, can easily occur in the adobe rendering of external walls (Mali, Africa) / photo: L. Edelbroek

In the very warm and dry period from November to May, the adobe plaster is due to undergo a strong drying shrinkage, resulting in the occurrence of crack patterns (crazing), which makes – as already explained – a regular maintenance most necessary [FIG. 2.6].

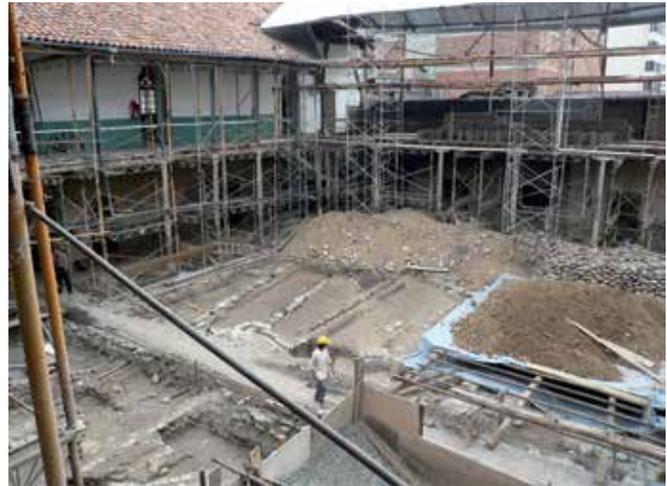
FIG. 2.9 Use of adobe in a restoration in Cuenca. The old material of a collapsed wing of the building is collected for re-use (house in Cuenca, Ecuador) / photo: R. v. Hees

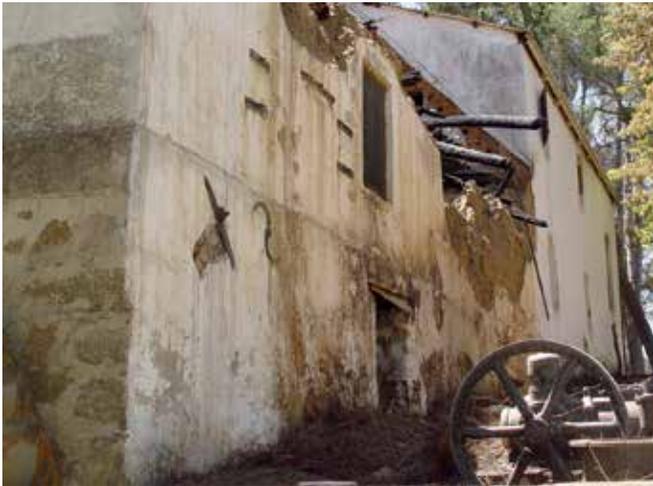
FIG. 2.16 Lack of maintenance (dwelling, Genadendal, South Africa) / photo: L.Verhoef

The technical part of the project consisted in a careful implementation of new materials and construction elements where the traditional ones had suffered from severe deterioration caused by the natural environment and lack of maintenance [FIG. 2.16]. The weak soil had been the origin of settlement cracks, and large floods, made more severe by the location, surrounded by hills, had led to moisture related decay at the lower parts of the walls.

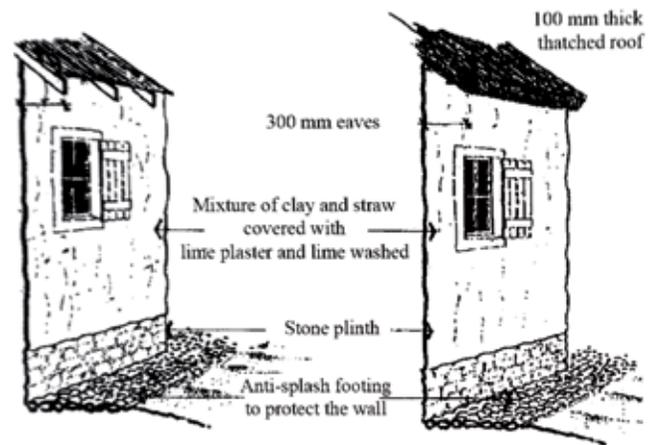
FIG. 2.17 Drawing showing the construction method and the materials used in Genadendal (South Africa) [Du Preez et al., 2009, p. 92]

Protection of the adobe masonry against rainwater was achieved by the use of lime-based renders, as well as by the construction of a cobblestone plinth [FIG. 2.17]. Further, an improved drainage system allowed the buildings to better withstand the water flowing from the surrounding hills.

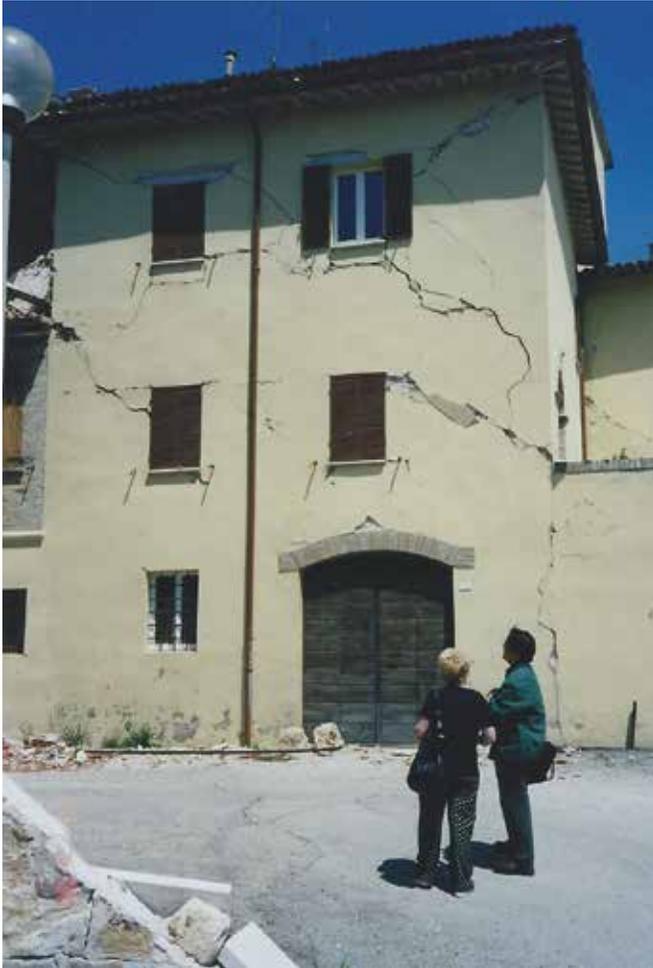
FIG. 3.1 Typical earthquake damage pattern: diagonal cracks in two different directions and X shaped cracks (house, Umbria, Italy) / photo: R. v. Hees

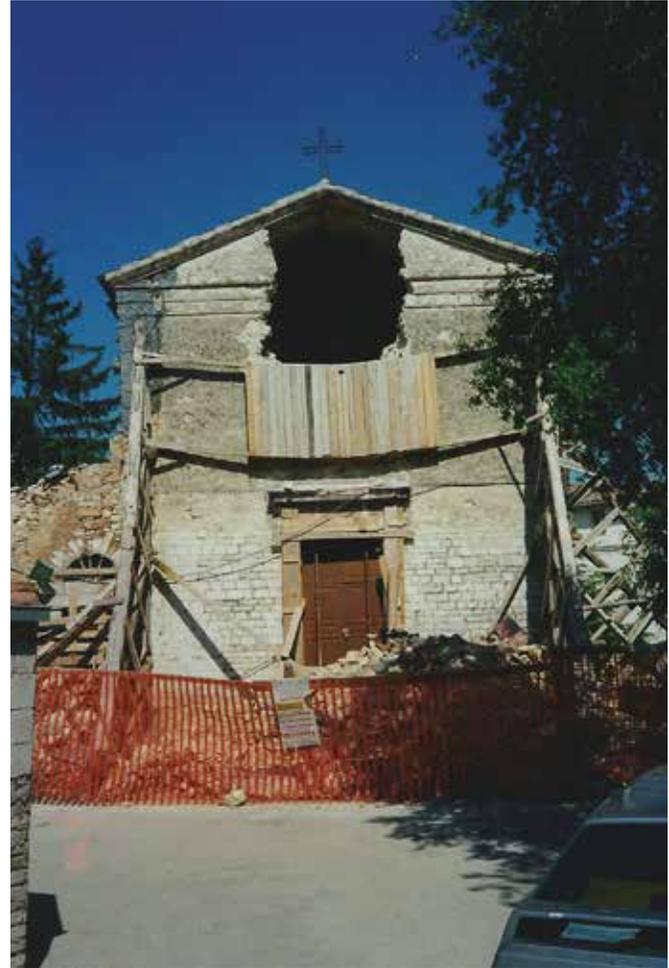
FIG. 3.2 Collapse of the central part of a slender wall (house, Umbria, Italy) / photo: R. v. Hees

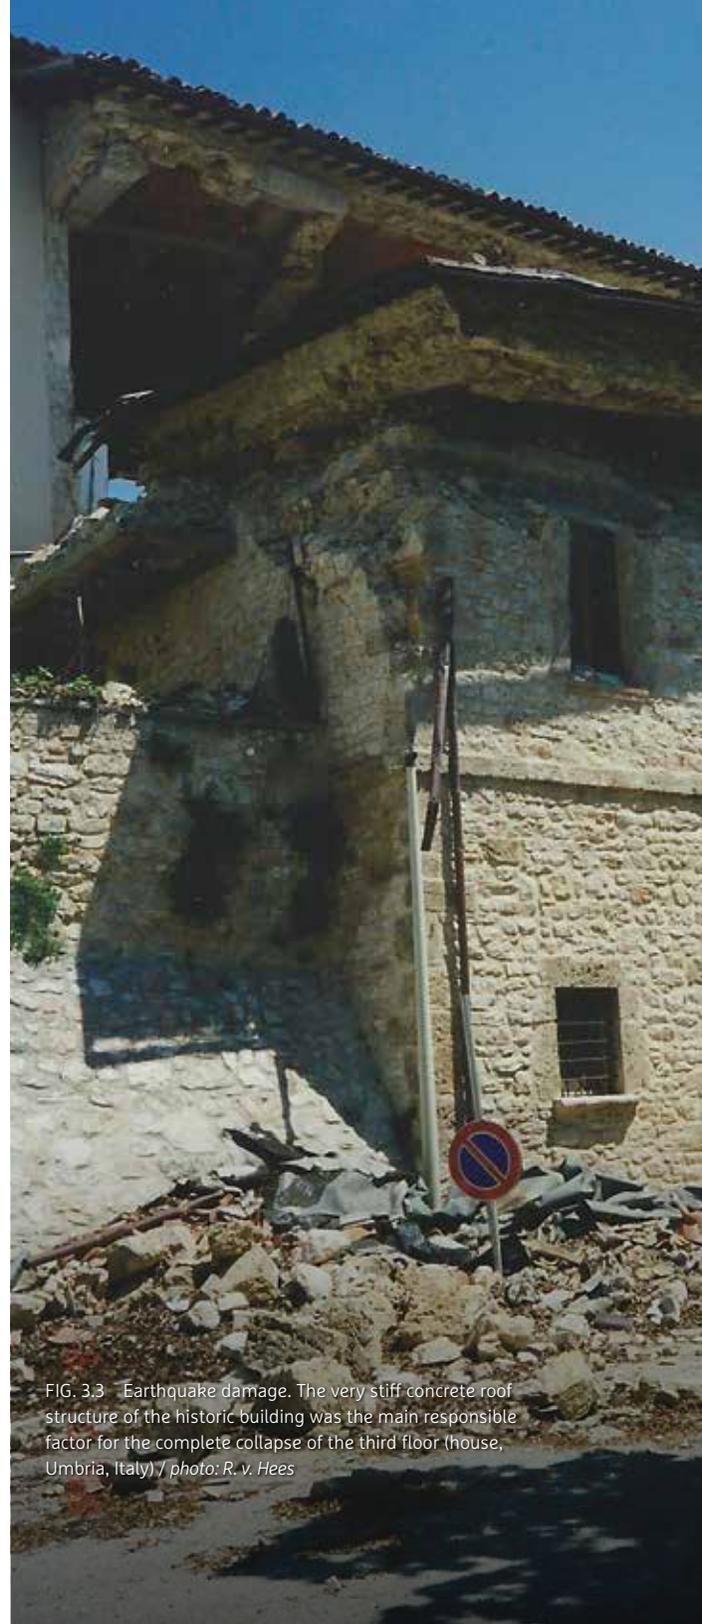
FIG. 3.3 Earthquake damage. The very stiff concrete roof structure of the historic building was the main responsible factor for the complete collapse of the third floor (house, Umbria, Italy) / photo: R. v. Hees

Some of the severely damaged buildings suffered the consequences of 'anti-seismic' interventions with non-compatible materials and construction parts. An example of this approach is the concrete roof of a historic building, which had been added as an anti-seismic measure, but turned out to enhance risk dramatically, during the next earthquake, when it even caused the collapse of the whole third floor (FIG. 3.3).

The collapse was due to the fact that the roof construction was far too stiff in relation with the relatively weak historic masonry wall construction. Instead of the new roof being an effective kind of confinement of the walls, as it had been assumed, it led to their failure.

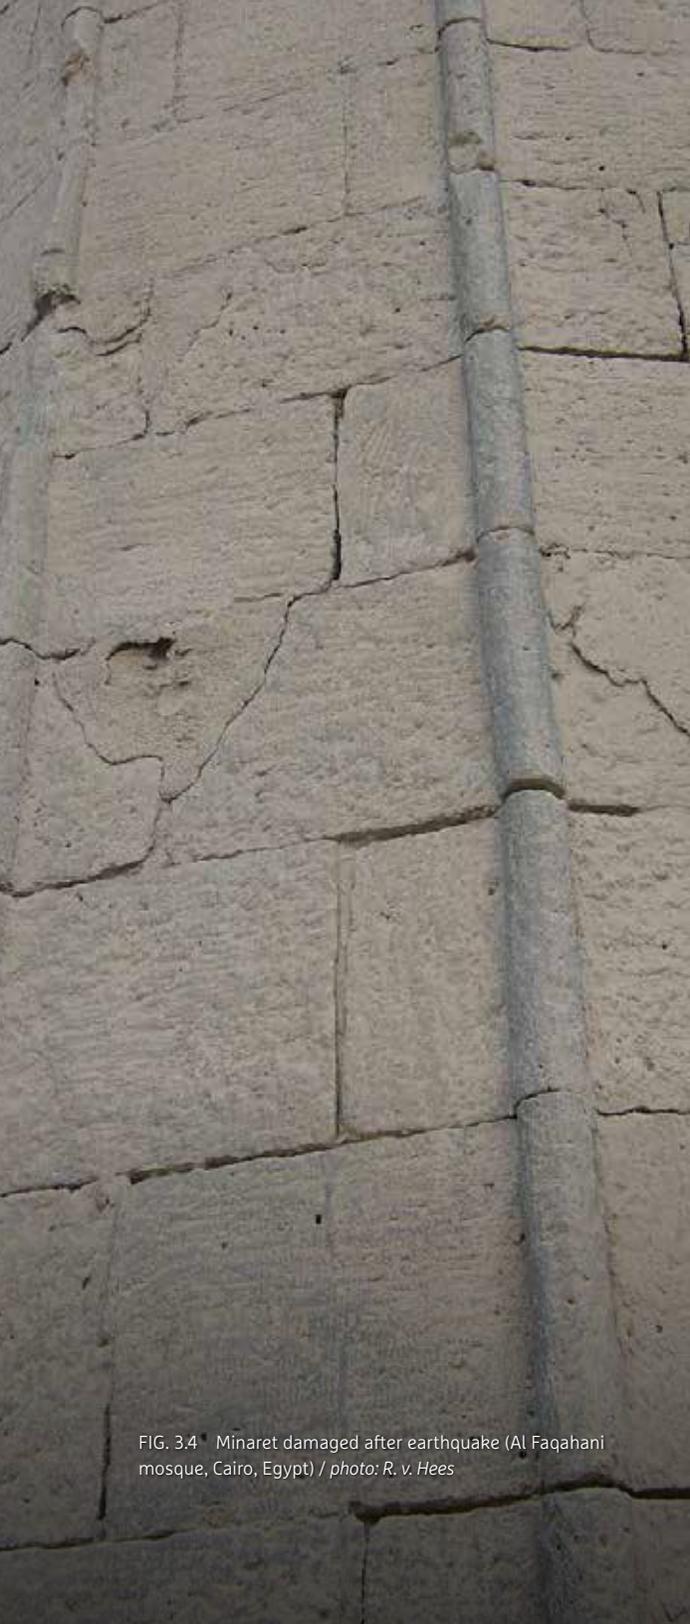
FIG. 3.4 Minaret damaged after earthquake (Al Faqahani mosque, Cairo, Egypt) / photo: R. v. Hees

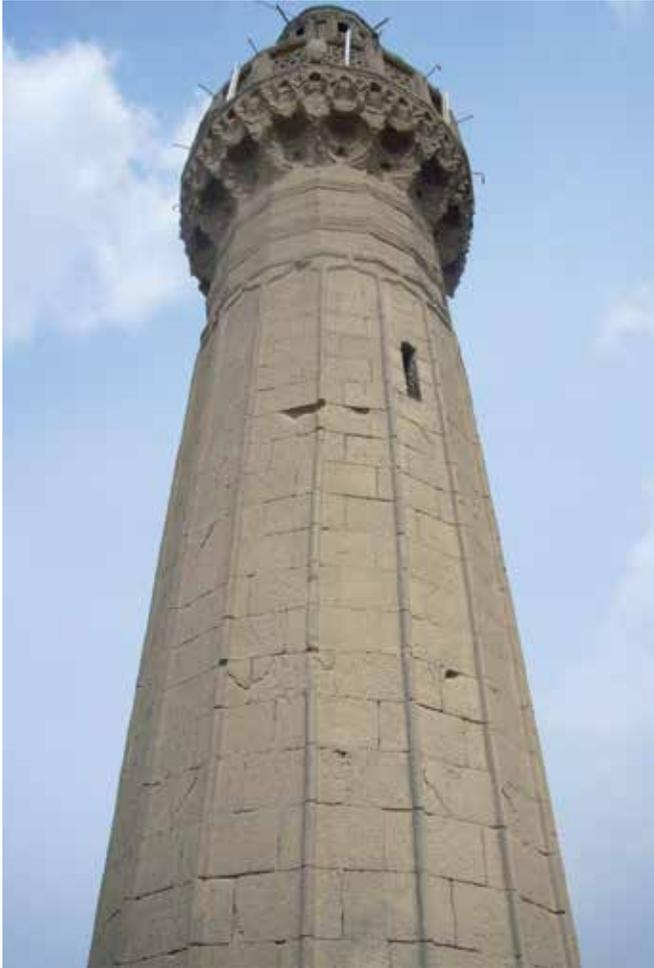
FIG. 3.5 Diagonal cracks in different directions, visible after the 1992 earthquake (minaret, Al Faqahani mosque, Cairo, Egypt) / photo: R. v. Hees

The city of Cairo (Egypt) is situated in an earthquake zone. The 1992 Cairo earthquake had its epicentre near Dahshur, a royal necropolis, situated at the west bank of the Nile, ca. 35 km south of Cairo and a magnitude of 5.8 on the Richter scale. Although this value is not extremely high, the earthquake was unusually destructive. It caused about 545 deaths and made 50000 people lose their home. For Cairo, this was the most damaging seismic event since 1847⁷. Some examples of structures suffering from earthquake damage, are the minaret of Al Faqahani mosque [FIG. 3.4, FIG. 3.5] and the nearby sabil, a historic public drinking fountain [FIG. 3.6].

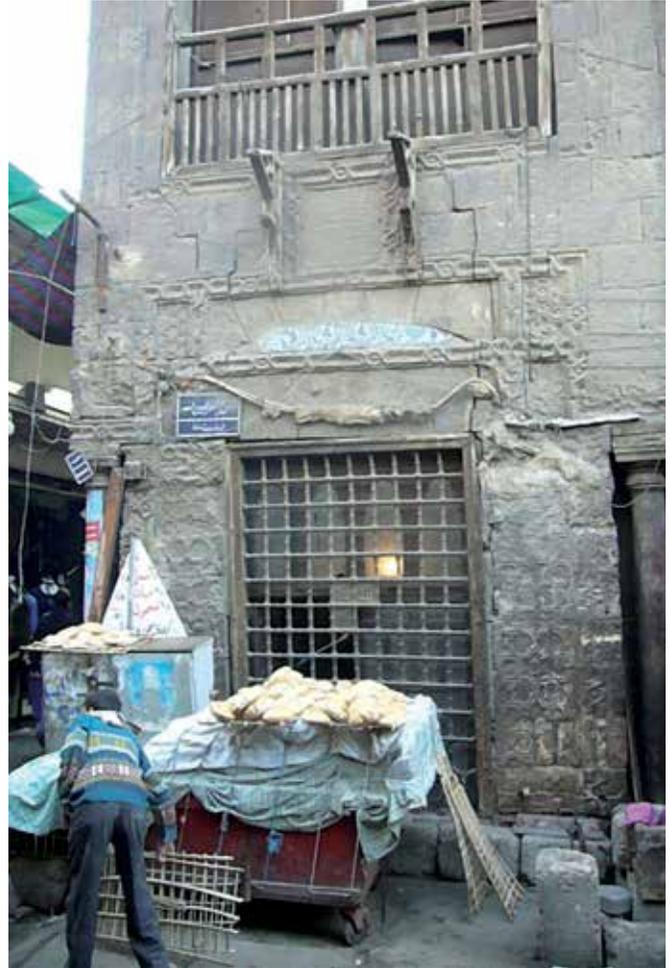
FIG. 3.6 Damage due to seismic activity (former sabil building, public drinking fountain, near Al Faqahani mosque, Cairo, Egypt) / photo: R. v. Hees

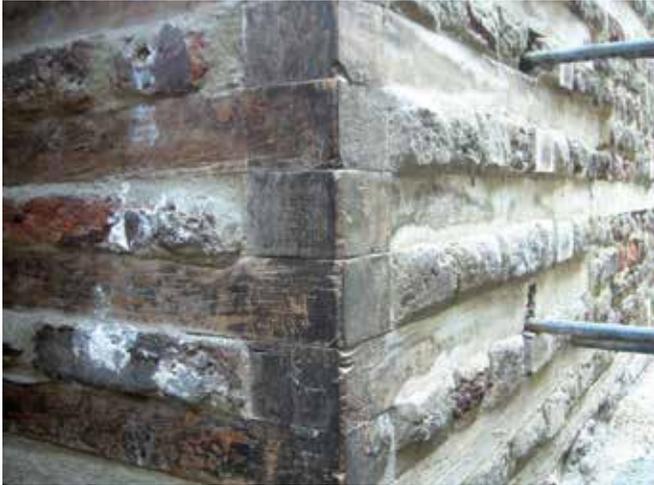
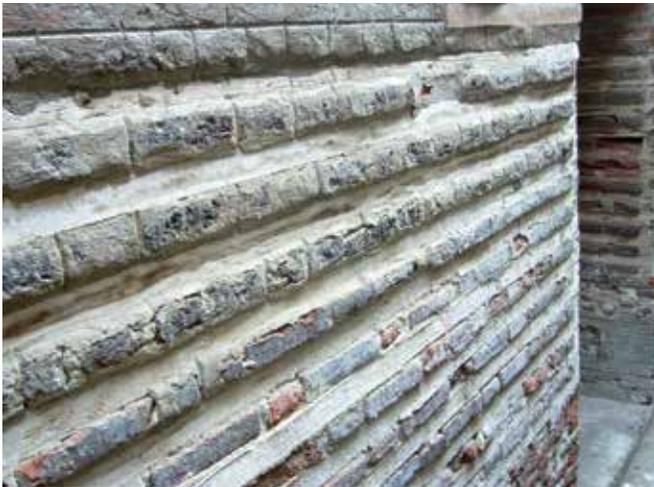
FIG. 3.7 Combination of brick and timber layers in the lower part of masonry walls (building, Coptic quarter, Cairo, Egypt) / photo: R. v. Hees

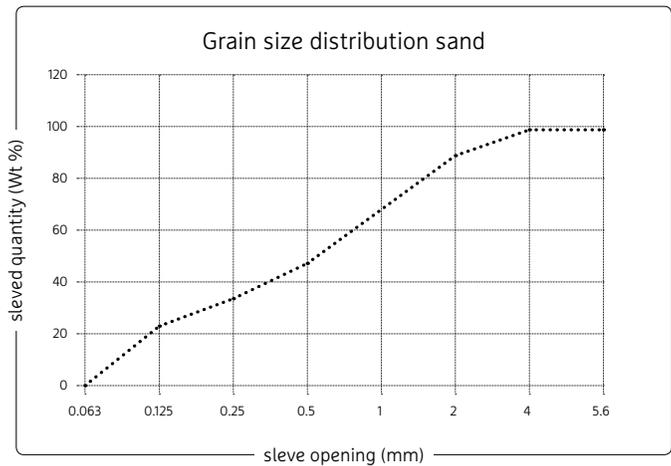
FIG. 4.4 Grain size distribution traditional crushed limestone sand; note the high percentage (ca. 25%) finer than 0.125 mm [Hees v. 2005]

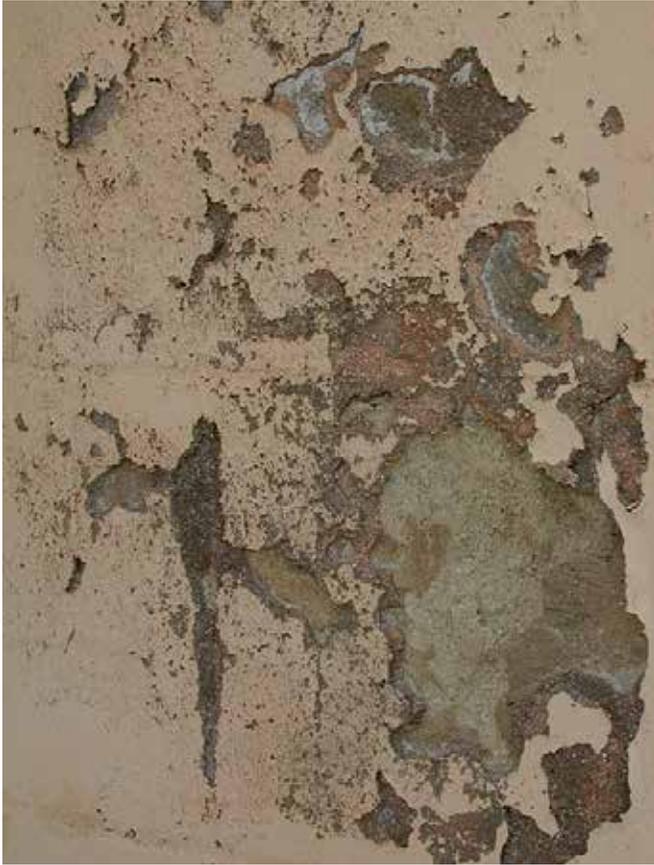
FIG. 4.5 With the use of 'better', more durable materials, sometimes damage is induced: here the plaster shows loss of cohesion (building, Curaçao, Caribbean) / photo: R.v.Hees

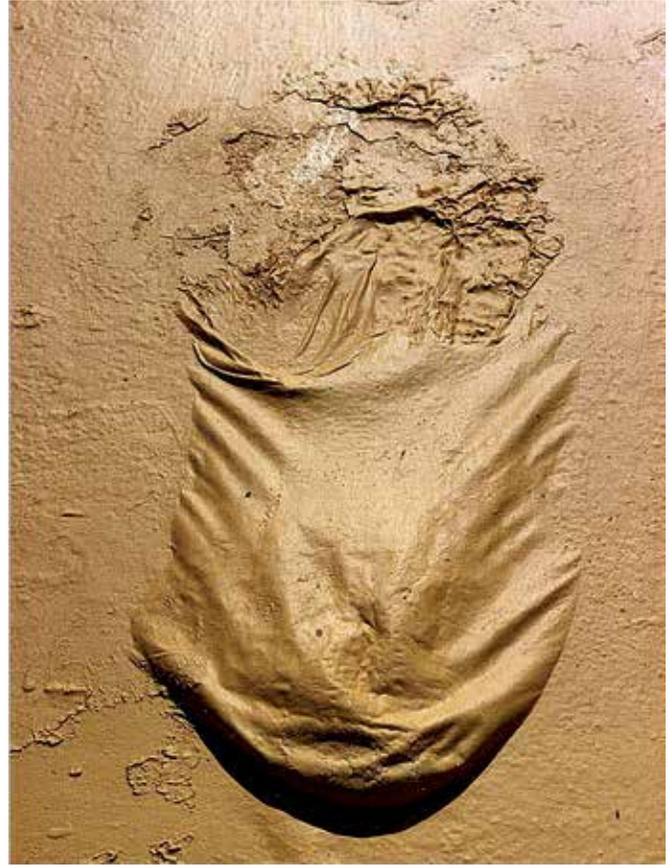
FIG. 4.6 Blistering of latex paint (detail of a painted plaster, house, Curaçao, Caribbean) / photo: R.v.Hees

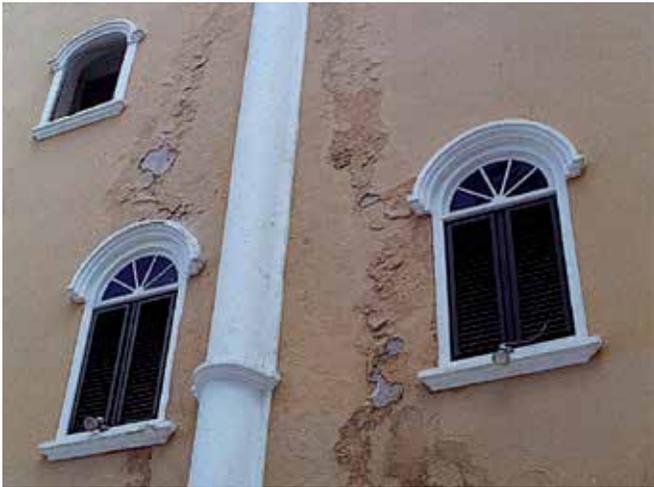
FIG. 4.7 Damage to the plaster (synagogue, Curaçao, Caribbean) / photo: R. v. Hees

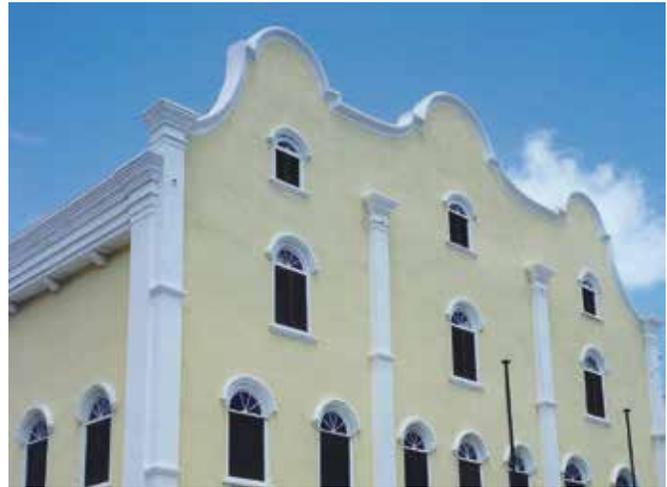
FIG. 4.8 Façade furnished with a salt resistant render system in 1994, situation 6 years later (synagogue, Curaçao, Caribbean) / photo: R. v. Hees

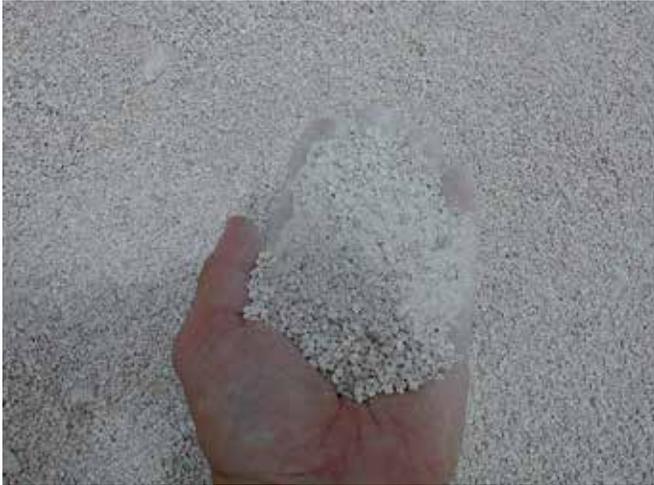
FIG. 4.9 The crushed limestone sand from the mine company at Curaçao, with quite some very fine grains / *photo: R. v. Hees*

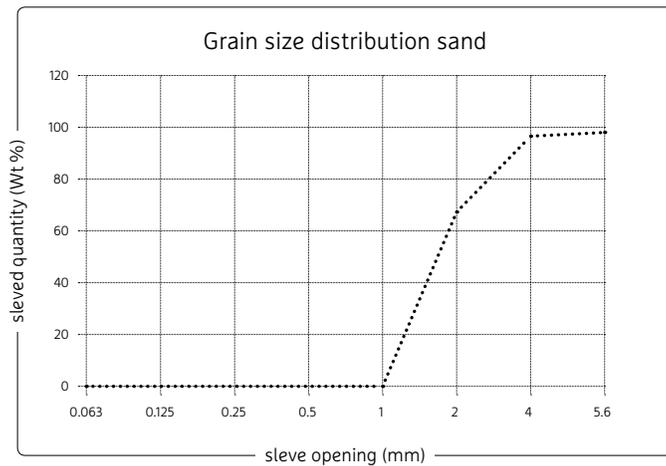
FIG. 4.11 Grain size distribution of traditional crushed limestone sand, where the fractions smaller than 1mm have been taken off. This sand would result in plaster mortars with a more favourable pore size distribution, able to mitigate the effects of crystallization damage up to a certain extent [Hees v. 2005]

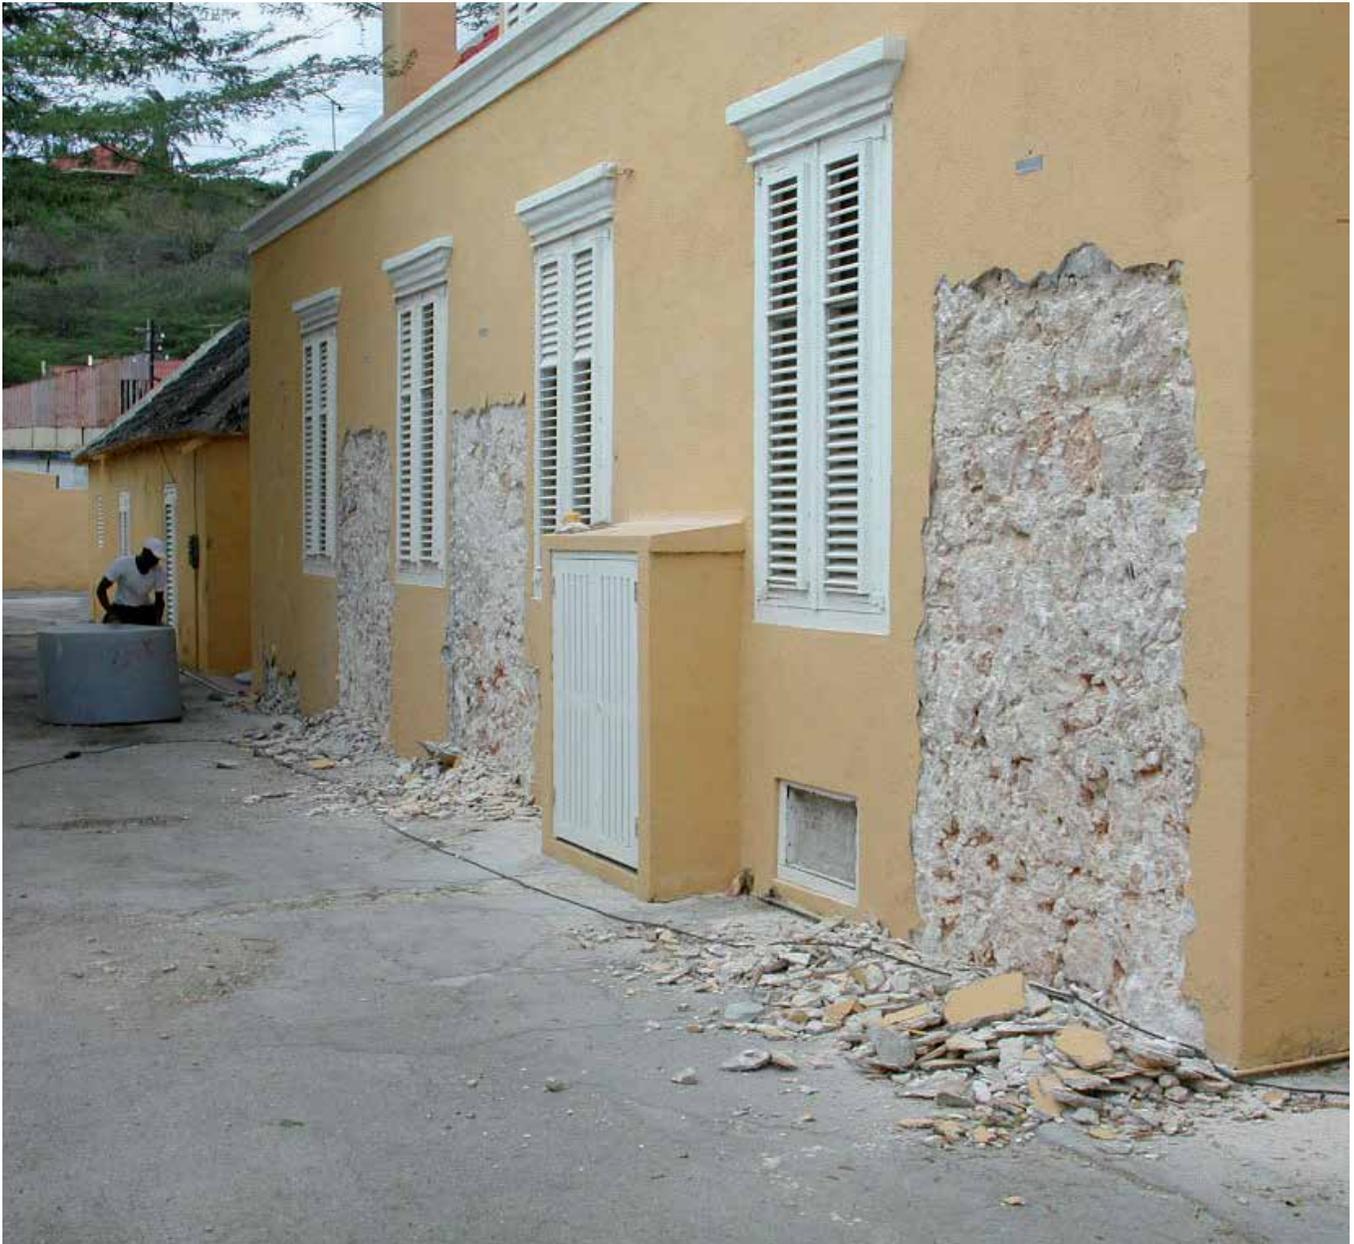
FIG. 4.12 Preparation of test panels (house at Charloo, Curaçao, Caribbean) / photo: R. v. Hees

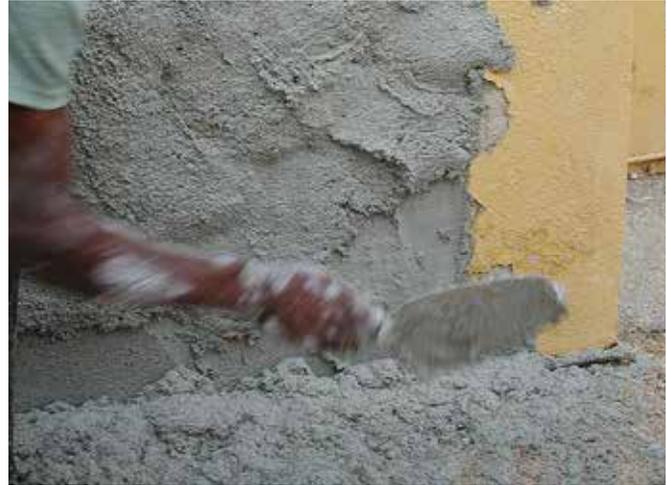
FIG. 4.14 Application of new render (house at Charloo, Curaçao, Caribbean) / photo: R. v. Hees

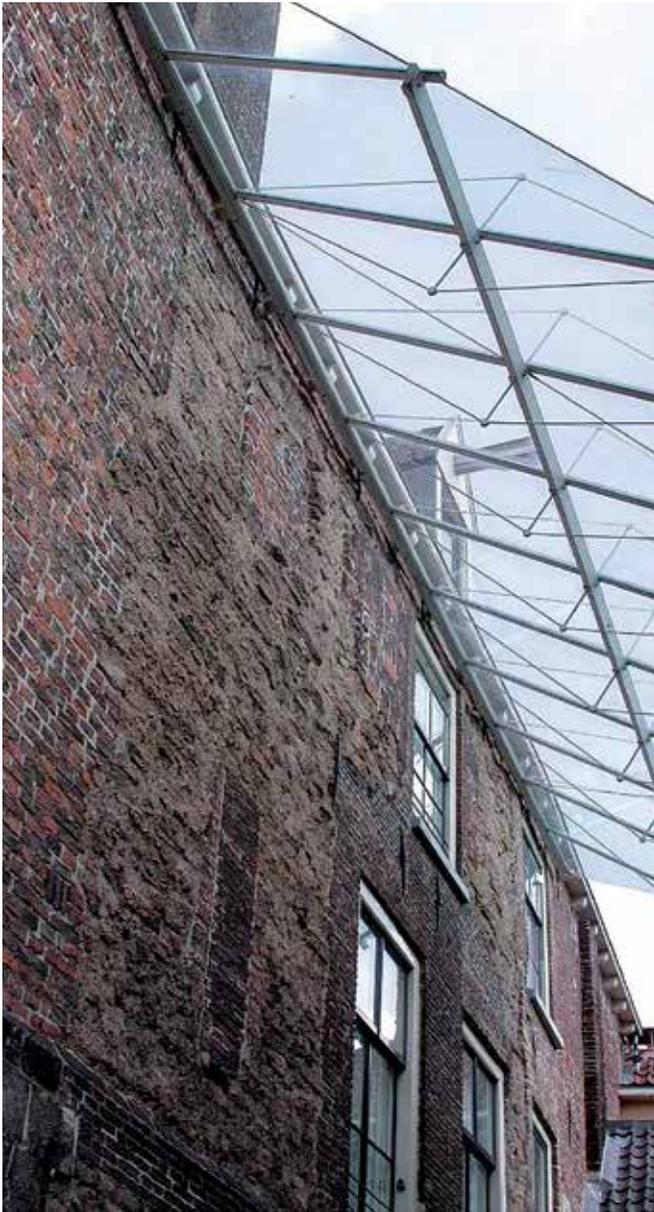
FIG. 6.3 Transparent roof construction as a protection for the tuffstone in the historic wall (house, Sandrasteeg, Deventer, The Netherlands) / photo: R. v. Hees

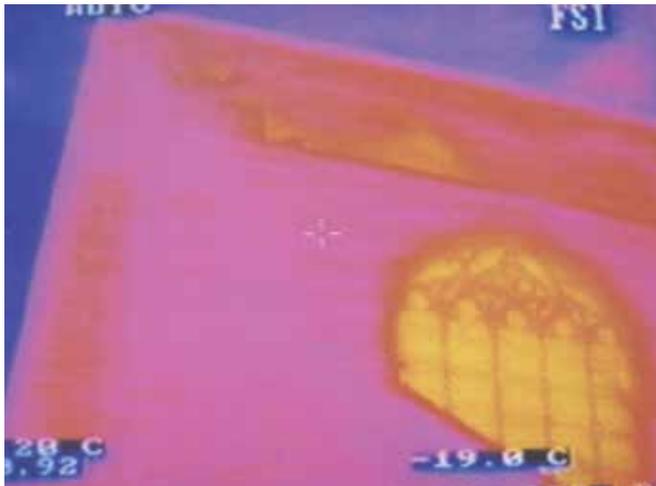
FIG. 6.5 Infra-red thermography photo, showing the heat losses mainly through windows and roof construction (Peter's church, Leiden, The Netherlands) / photo: R. v. Hees

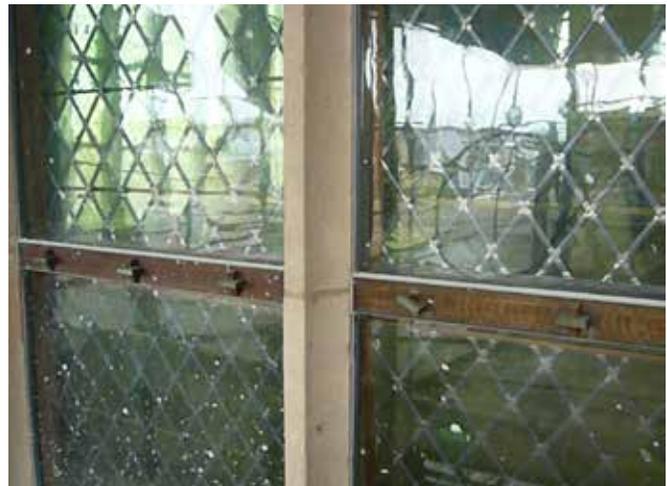
FIG. 6.6 Test panels for external glazing in front of the stained-glass windows (Peter's church, Leiden, The Netherlands) / photo: R. v. Hees

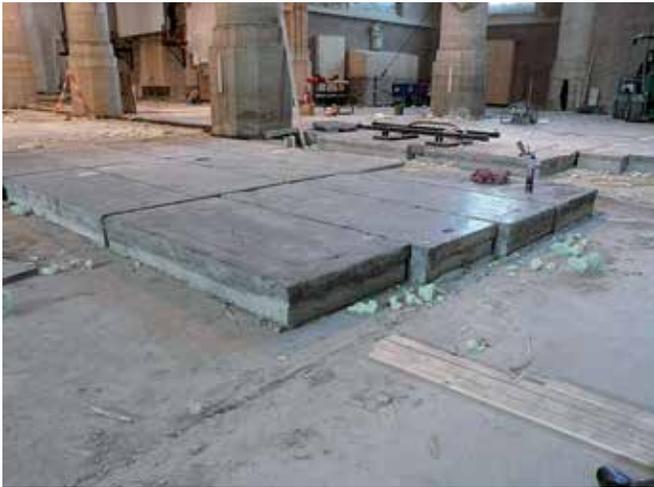
FIG. 6.7 The *petit granit* gravestones furnished with concrete layer to enhance thickness, lying on the special floor where the heating pipes run (Peter's church, Leiden, The Netherlands) / photo: R. v. Hees

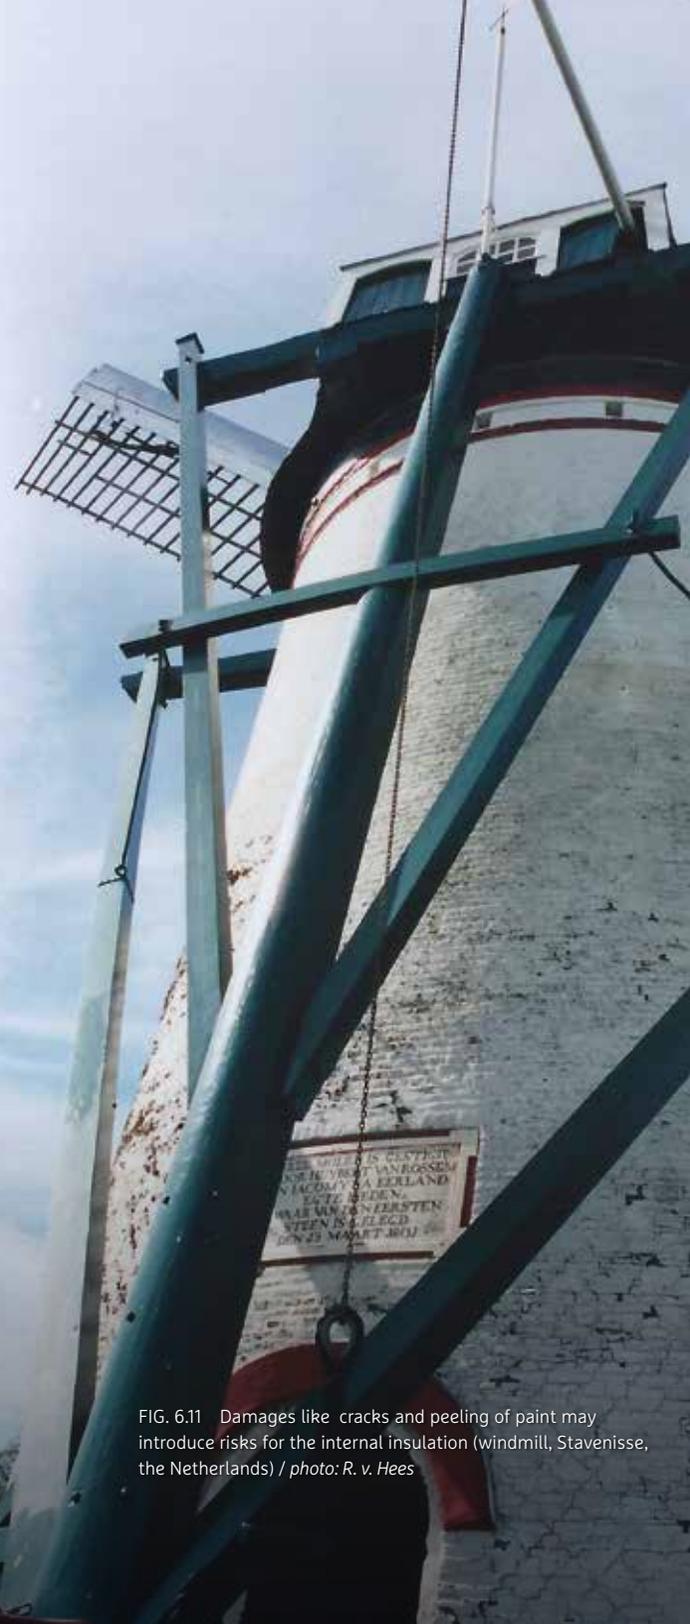
FIG. 6.11 Damages like cracks and peeling of paint may introduce risks for the internal insulation (windmill, Stavenisse, the Netherlands) / photo: R. v. Hees

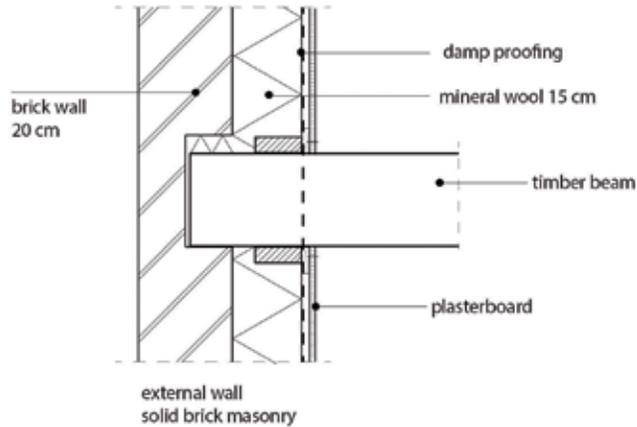
FIG. 6.12 Proposed solution of internal insulation of a wall in a historic building with timber beams. The idea is to prevent water vapour from reaching the beam ends by a very good damp proofing, which should be sealed hermetically all around the timber beam / drawing: L. Miedema

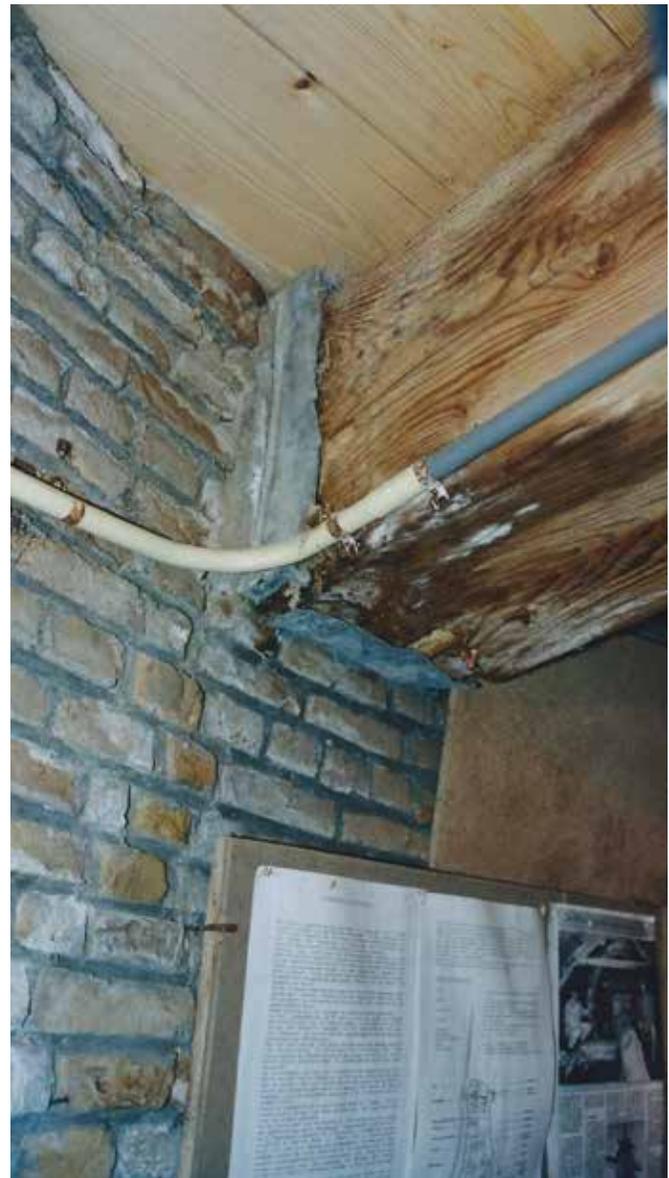
FIG. 6.13 Timber beam in an external wall, showing rot even though it seems well protected by the lead; NB this underlines that drying, which is in this case very difficult, is the most important issue in order to prevent moisture problems from becoming severe (windmill, Stavenisse, the Netherlands) / photo: R. v. Hees

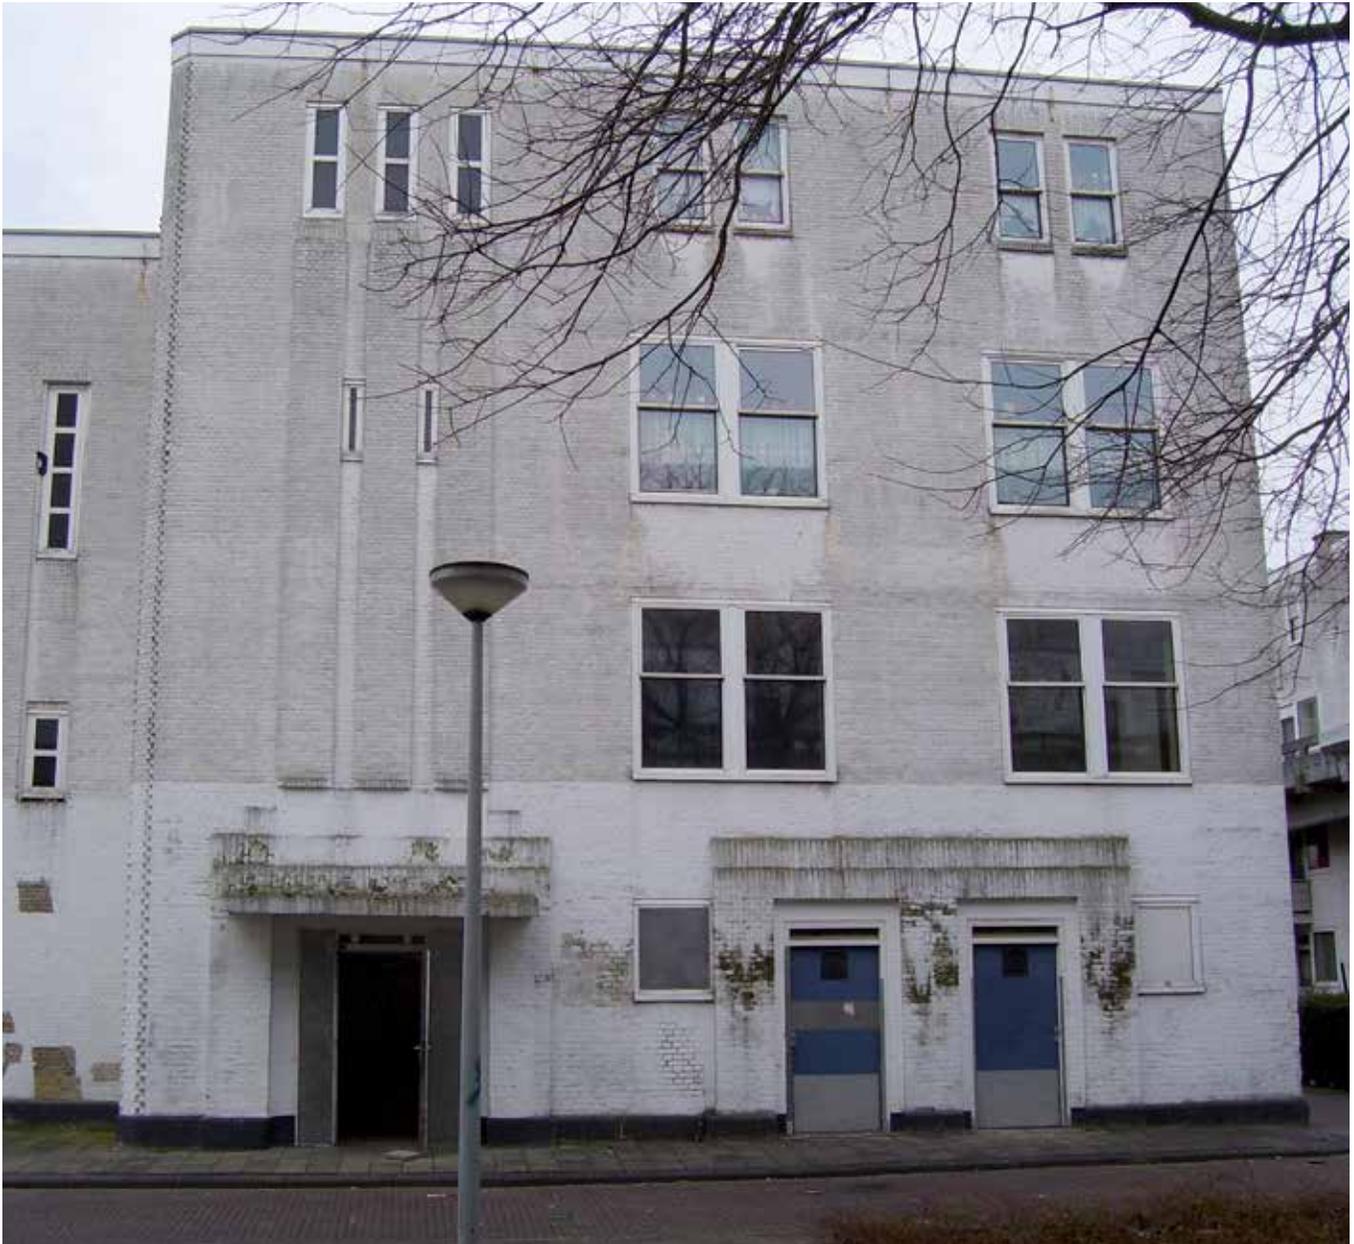
FIG. 6.15 Façade of one building showing damage (2009); to the left: paint removal - try out (Justus van Effen complex, Rotterdam, The Netherlands) / photo: A. Acquebord

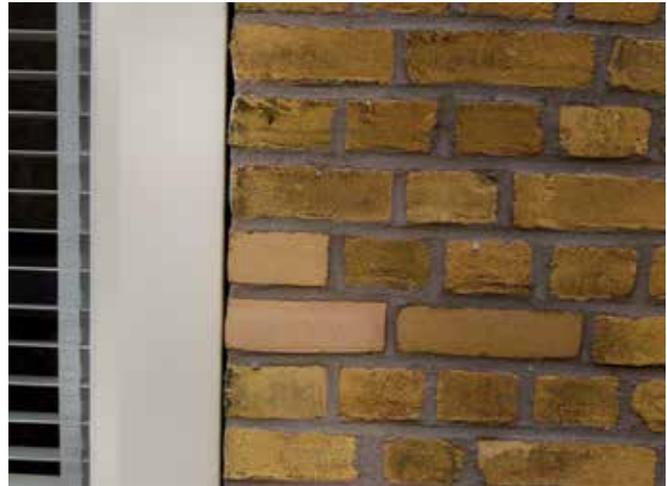
FIG. 6.17 Detail of wall with new bricks (house, Justus van Effen complex, Rotterdam, The Netherlands) / photo: S. Naldini

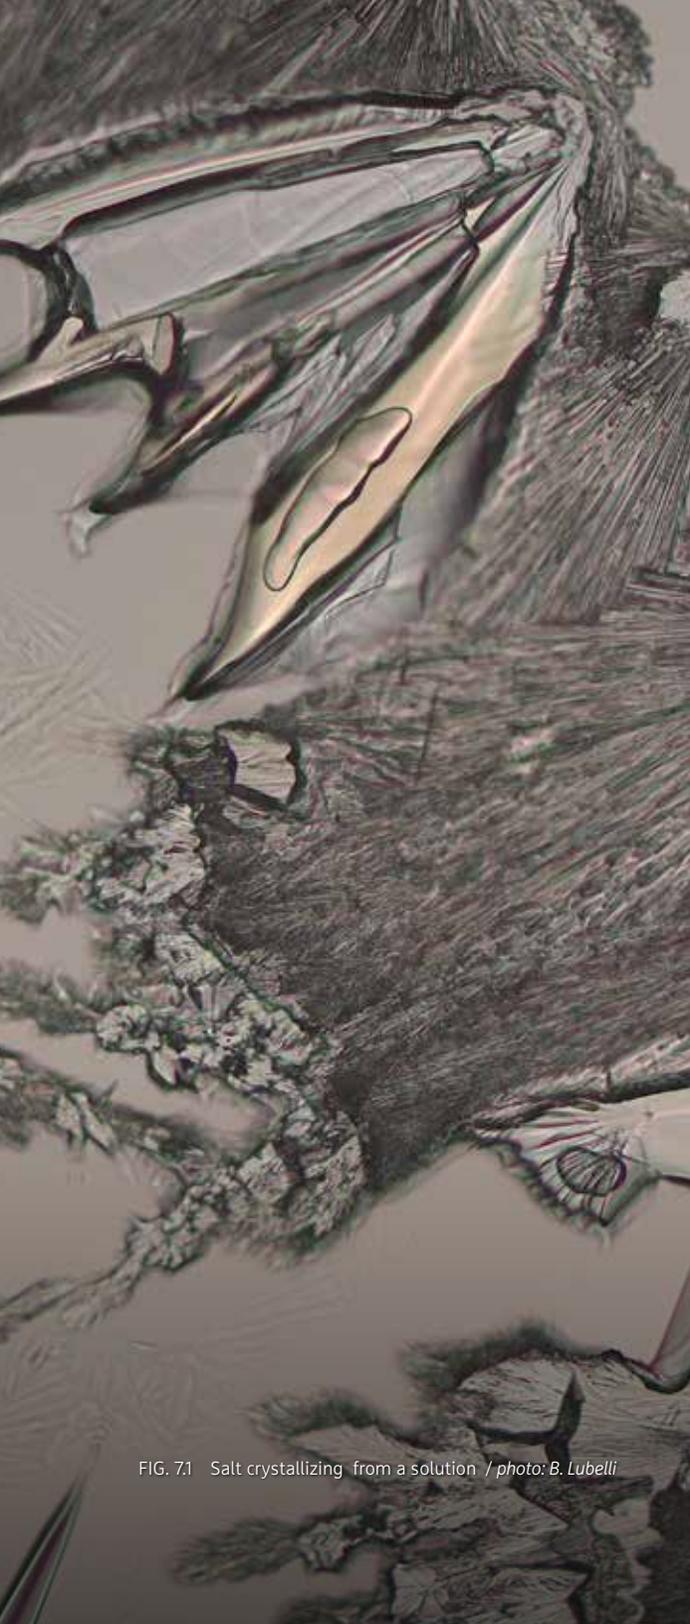
FIG. 7.1 Salt crystallizing from a solution / photo: B. Lubelli

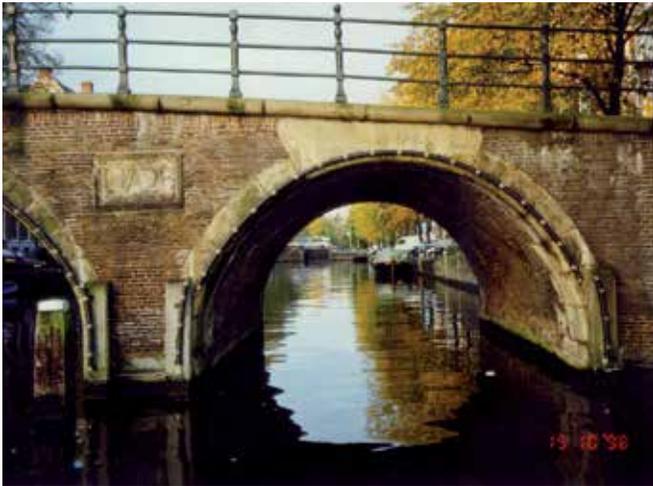
FIG. 7.2 Self-healing in lime mortar (canal bridge in Amsterdam, The Netherlands) / photo: R. v. Hees

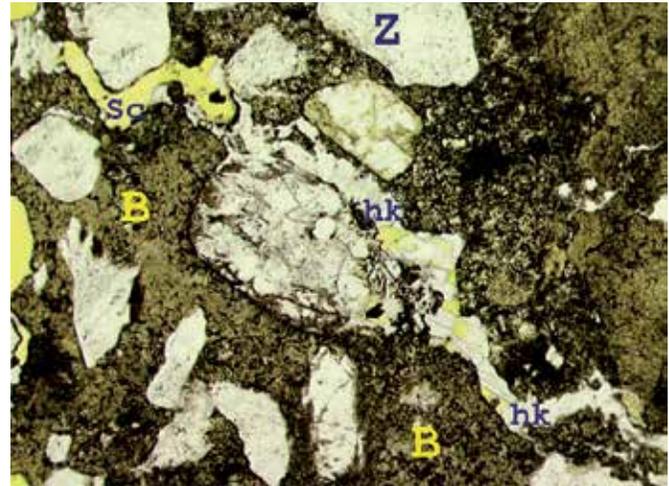
FIG. 7.3 Thin section of mortar showing a crack filled with precipitated lime (canal bridge in Amsterdam, The Netherlands) / photo: R. v. Hees

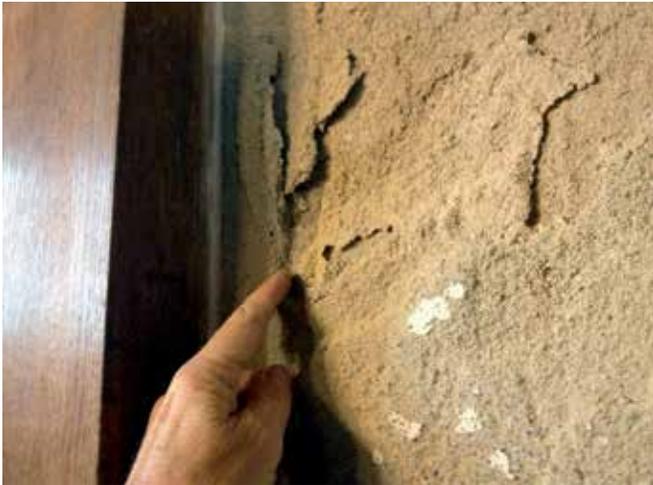
FIG. 7.4 Exfoliation and crumbling of plaster applied on a salt loaded substrate / photo: R. v. Hees

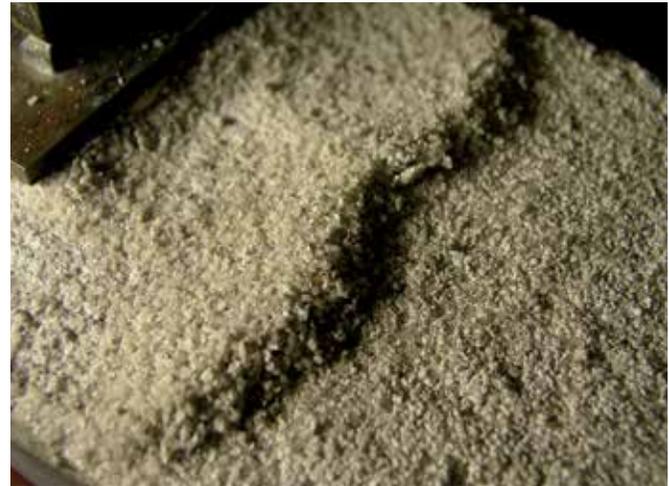
FIG. 7.7 Sanding of the outer layer of the mortar in the presence of NaCl after 6 RH cycles / photo: s Barbara Lubelli
