Durable past – sustainable future

Rob van Hees
Silvia Naldini
Job Roos

TU Delft OPEN
Publishing

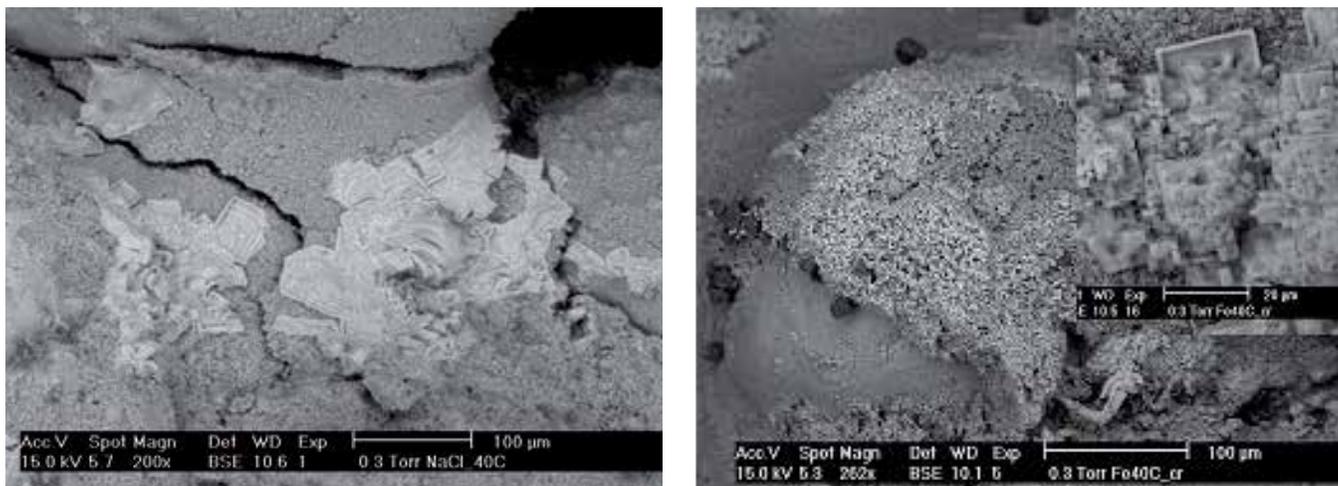
FIG. 7.8 Effect of crystallization inhibitor (sodium ferrocyanide) on the crystal habit of sodium chloride: sodium chloride crystallizing in the absence (left) and in the presence of inhibitor (right). In this case the inhibitor was added to the contaminating salt solution / *photo: s: Barbara Lubelli*
