Building Historical Survey Water tower

Tala Wadeh

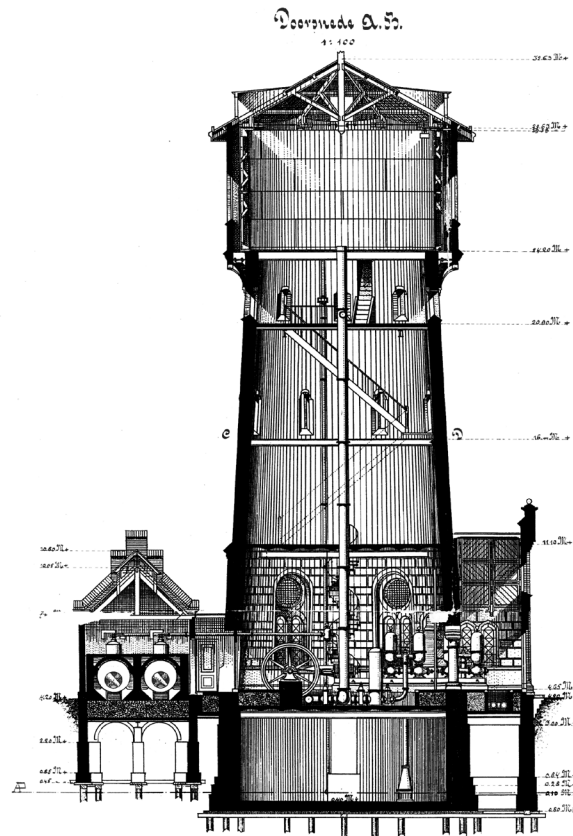
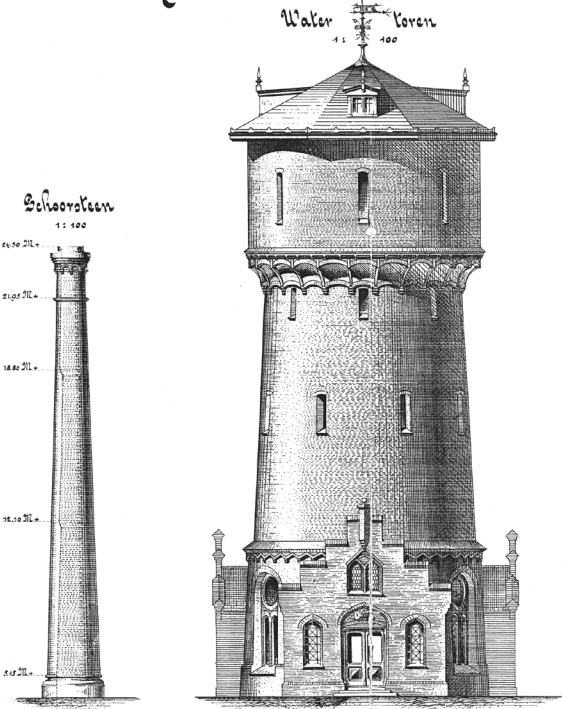
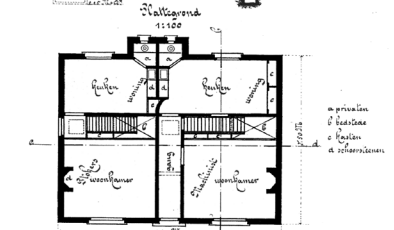
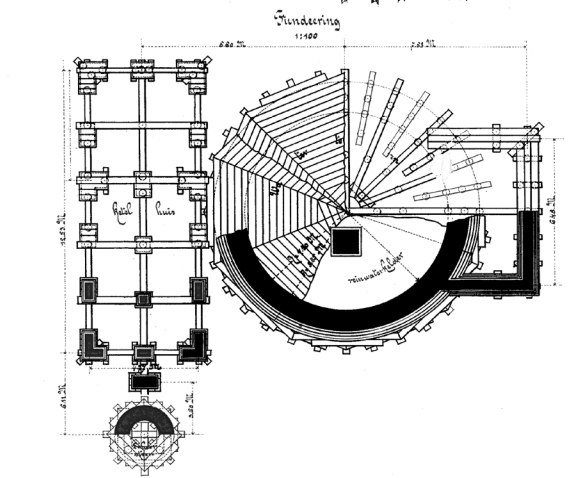
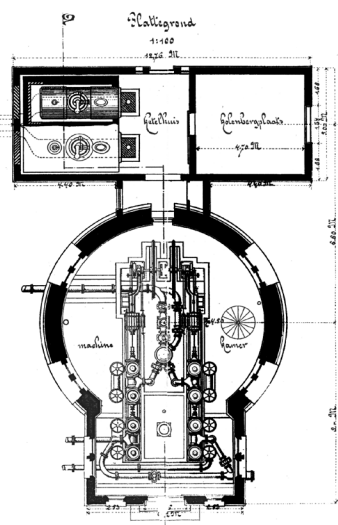
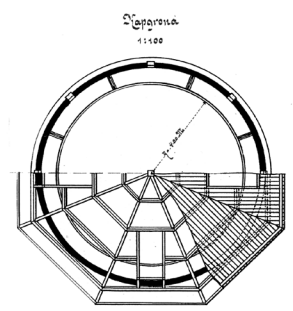
WATERLEIDING-SLIEDRECHT

Waterkoren, Kachelhuis met Schoorsteen en Machiniekoning

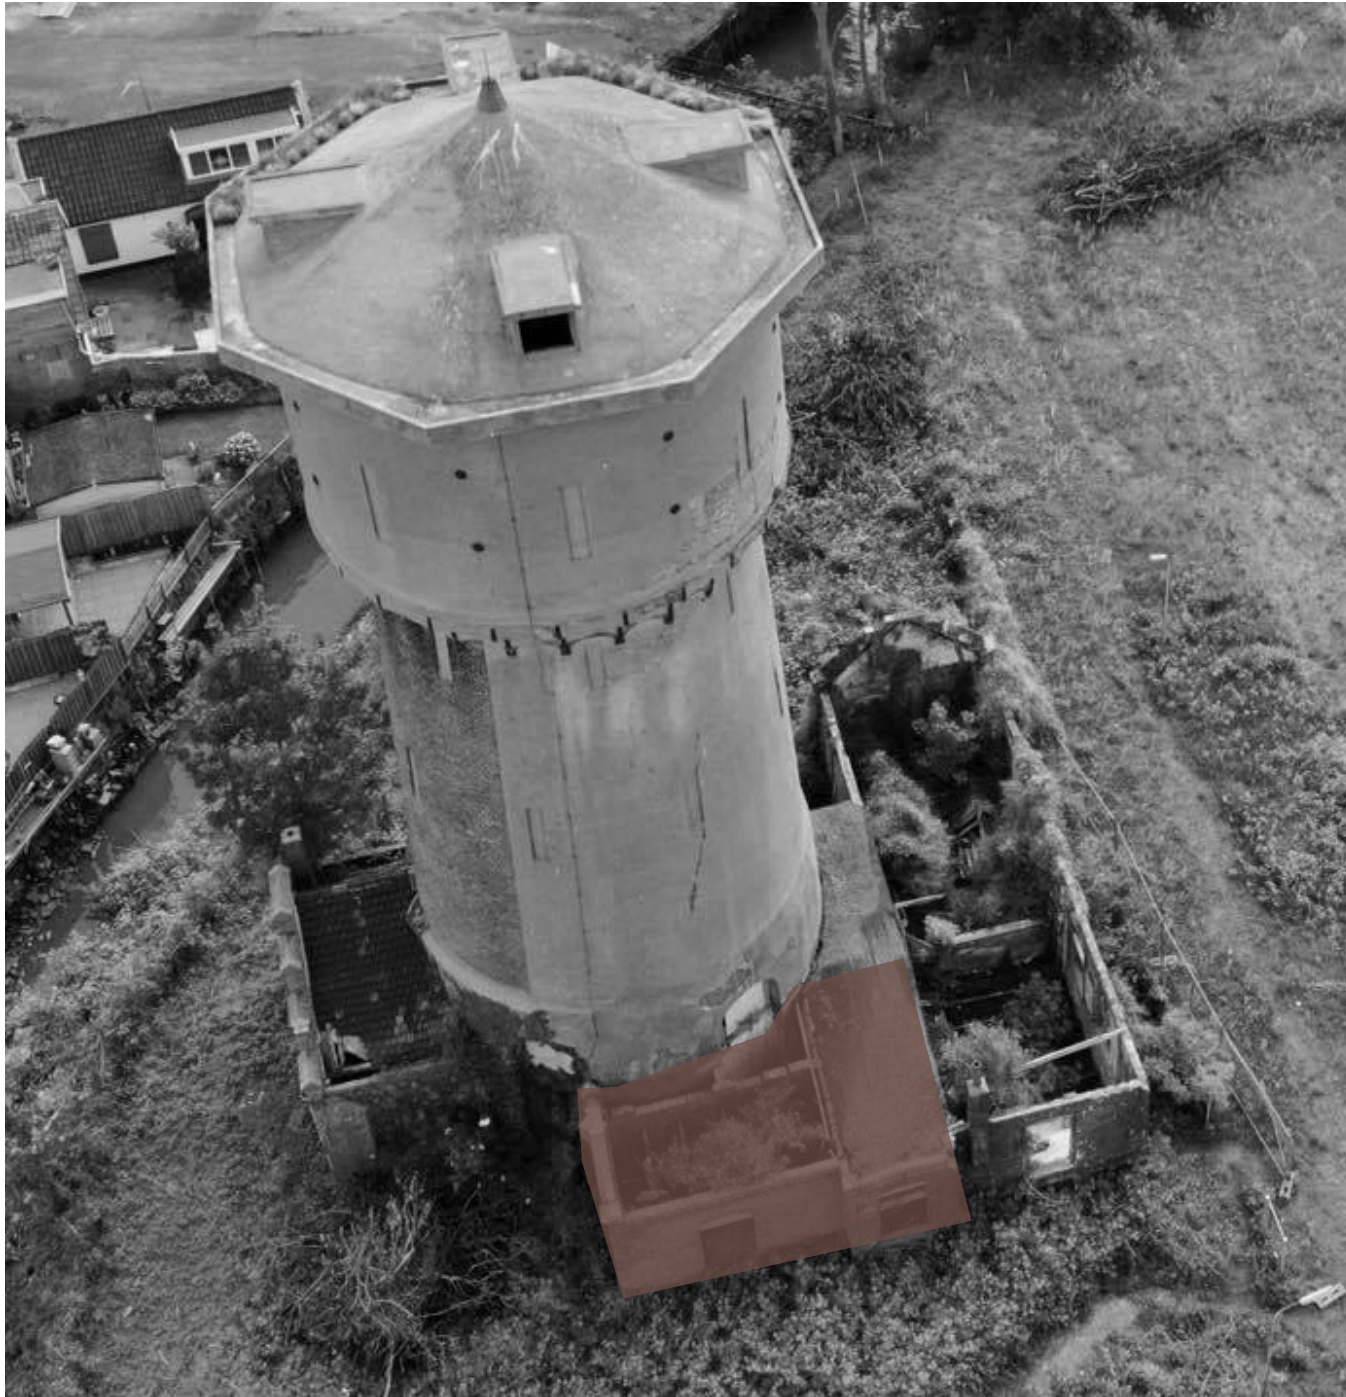
Current State of the Water Tower

The tower itself remains in relatively good condition from the outside, though some structural concerns are evident. The transition between the base and the main shaft is marked by decorative brickwork, while the water reservoir's projecting masonry is supported by a steel framework filled with masonry trough vaults. The exterior also features various windows, including arched openings in the machine room, slot-like ventilation windows in the shaft, and tall slits near the top. However, many of these openings have been sealed off—either bricked up or covered with wooden boards—reducing their functional and aesthetic impact. Cracks in the masonry indicate localized structural weakening, and moisture-related damage is evident in certain areas.

Inside, the tower's architectural grandeur remains partially intact. The most striking interior feature is the transition from the entrance hall to the main tower, marked by dividing arches and a central cast-iron column with a decorative capital. The original steel floor structure above the machine room, composed of steel I-beams and masonry trough vaults, is still in place. However, much of the tower's operational heart—the pump installations and mechanical systems—has been lost over time.

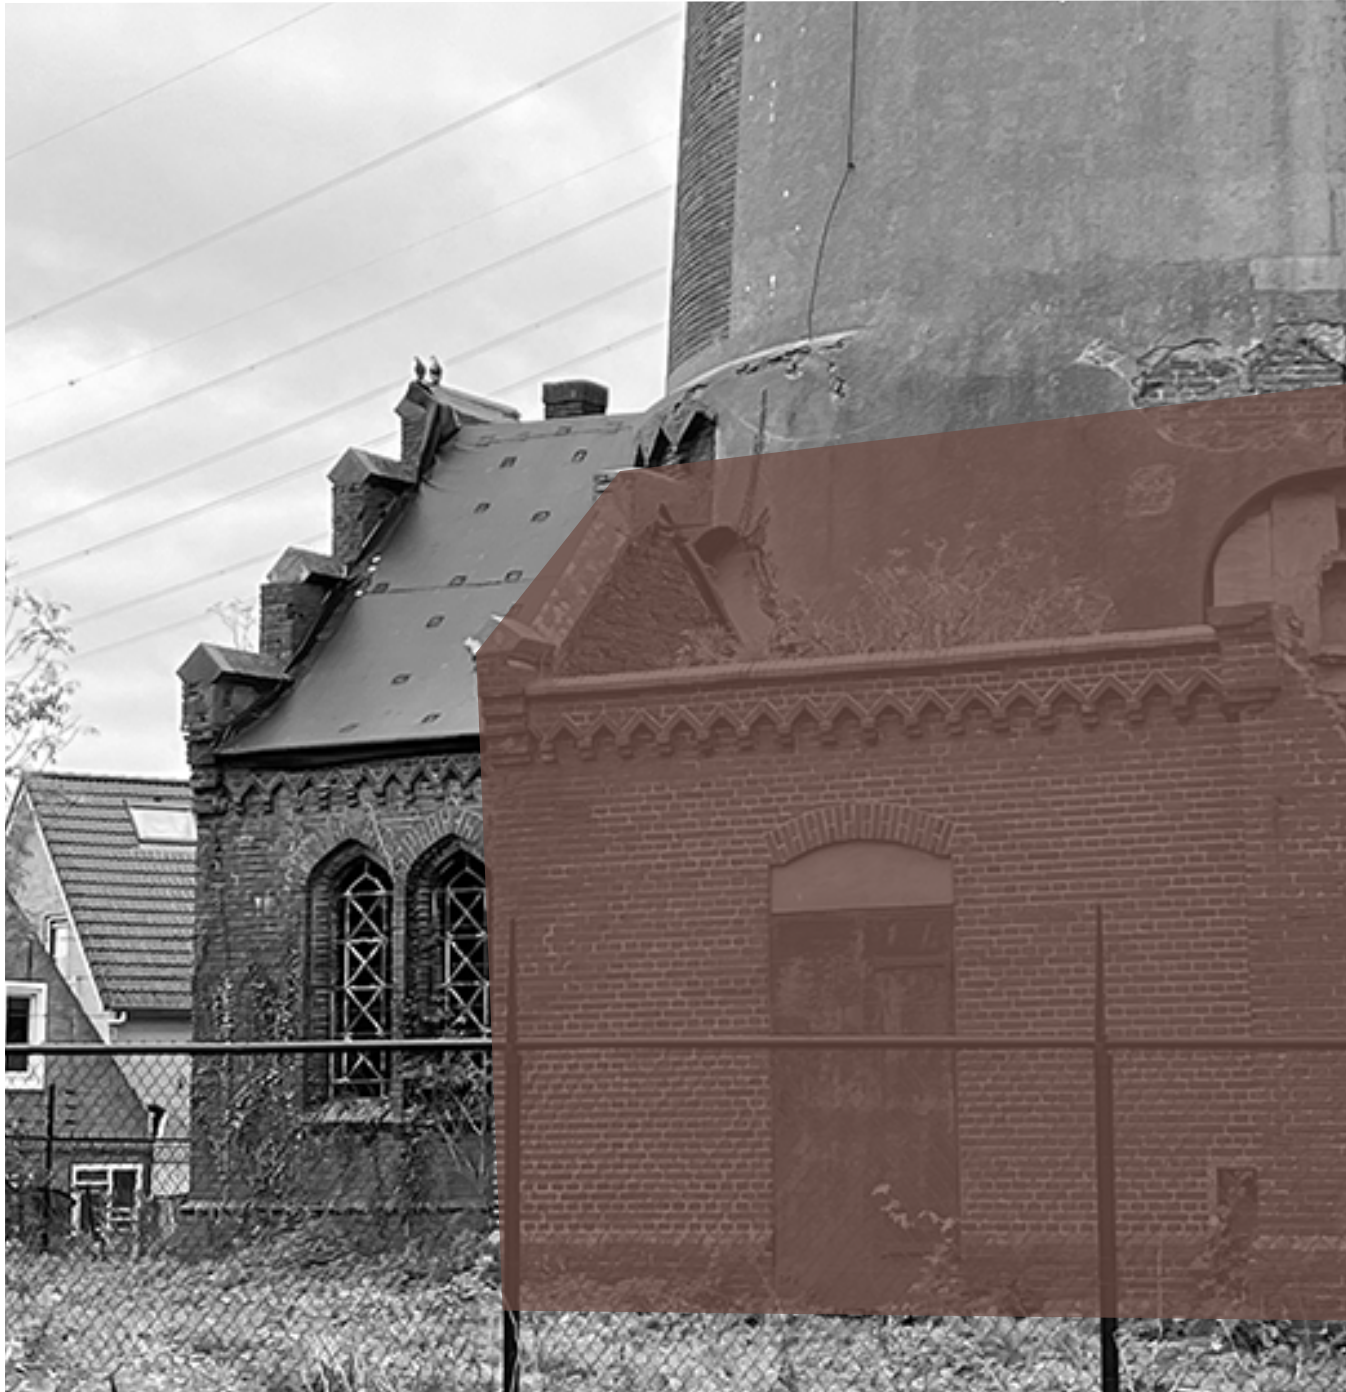
Annex Buildings: Boiler House and Outbuildings

Unlike the main tower, the annex buildings, including the former boiler house, are in a state of ruin. These single-story structures, featuring simple segment-arched windows, were built with an execution that differs slightly from the original plans. They once had decorative brickwork along the roofline and a prominent chimney on the west facade. However, years of neglect have left these buildings severely damaged. The boiler house, once a key component of the water supply system, recently had its roof removed due to safety concerns. Its walls are heavily deteriorated, suffering from extensive moisture damage. Wooden doors are missing, and window frames are either severely decayed or completely gone.

Nature has begun reclaiming the site, with vegetation overtaking the annexes, further destabilizing the remaining walls. Without intervention, these structures may not withstand further exposure to the elements.

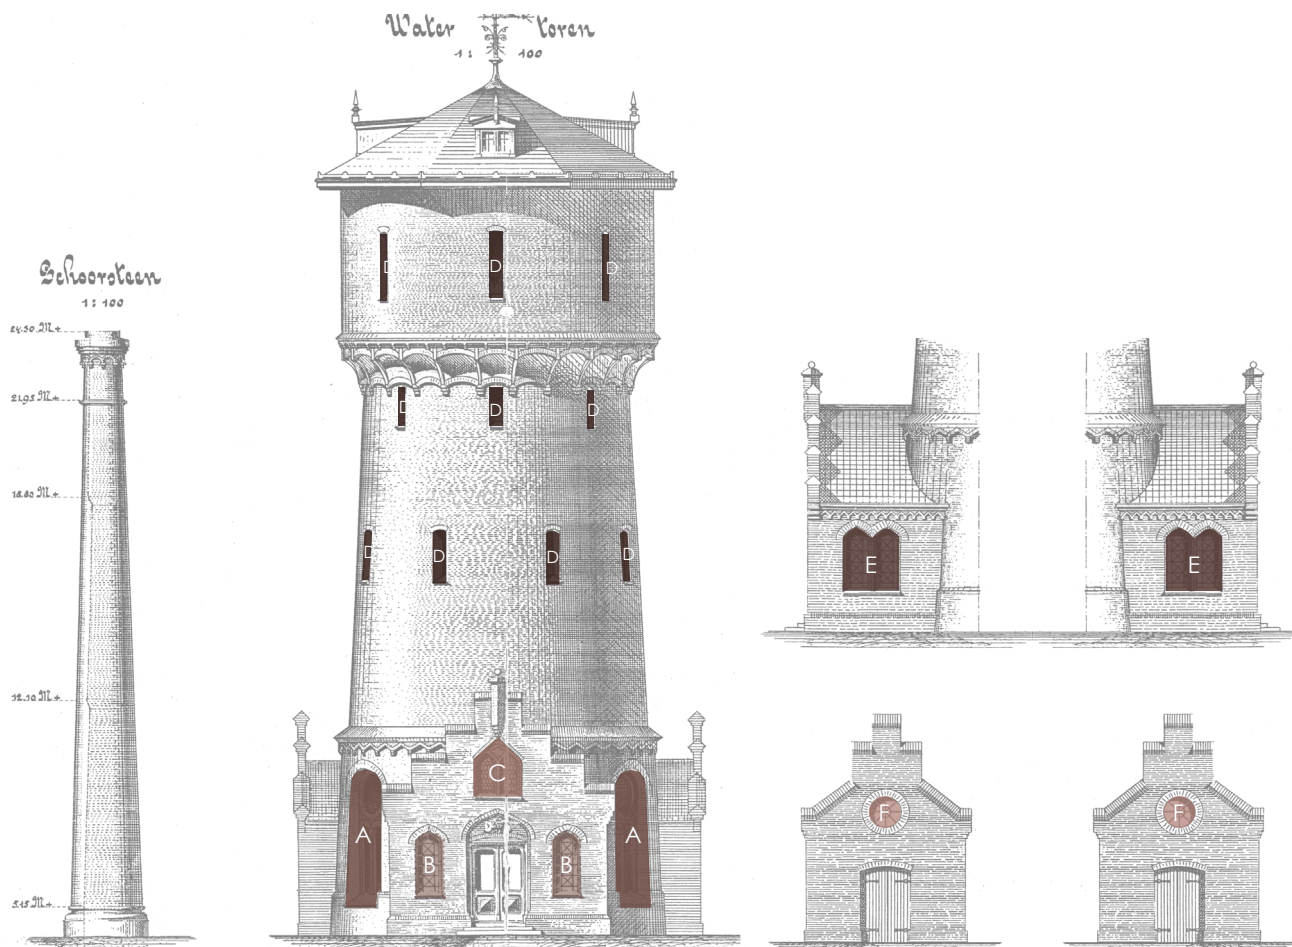
Current Condition

The exterior of the water tower remains in generally fair condition, but signs of weathering and deterioration are evident:

- **Brick Damage** – Some sections of the facade show signs of moisture and frost damage, resulting in cracks and masonry erosion.
- **Moisture Issues** – The foundation and lower parts of the tower exhibit moisture problems, likely due to the high groundwater level and prolonged exposure to the elements.
- **Biological Growth** – Moss and algae growth are visible on parts of the facade, indicating increased moisture retention.

Despite these issues, the tower remains a powerful example of industrial heritage and an important landmark in Sliedrecht. Restoration and repurposing plans could help restore the exterior to its historical glory while preserving its characteristic elements.

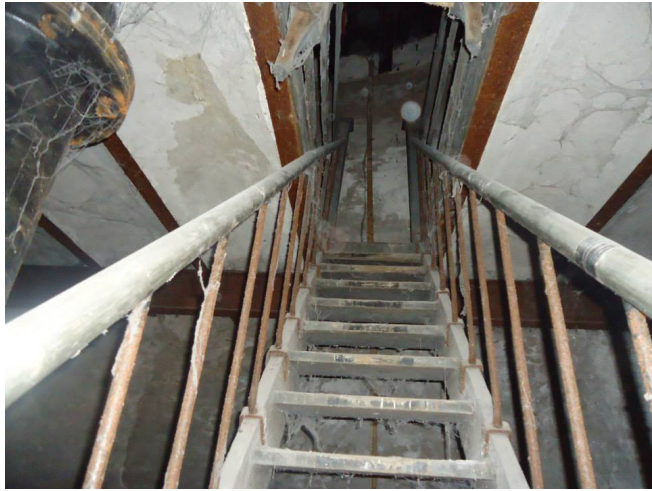
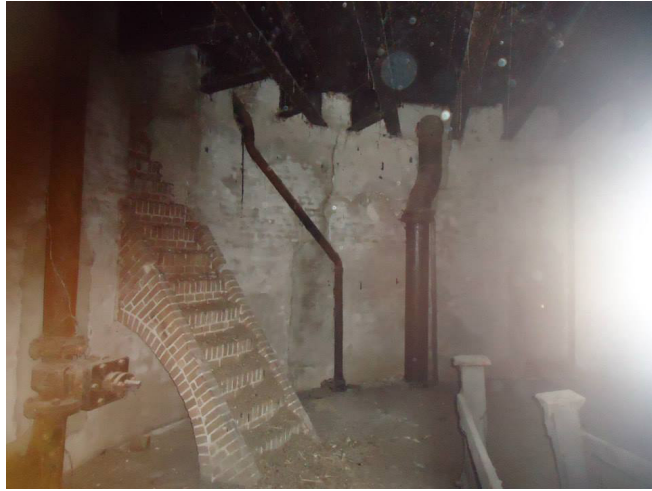
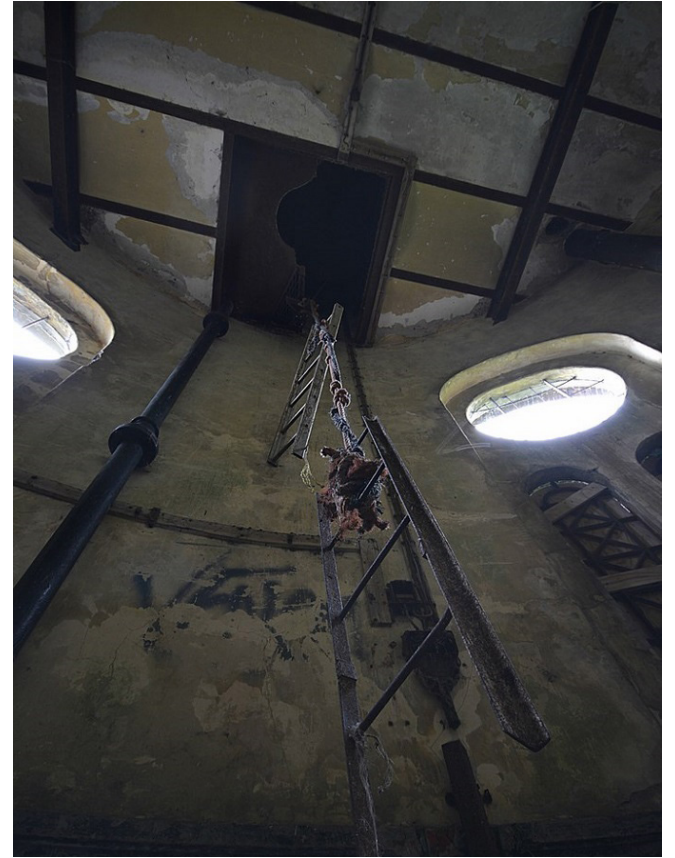
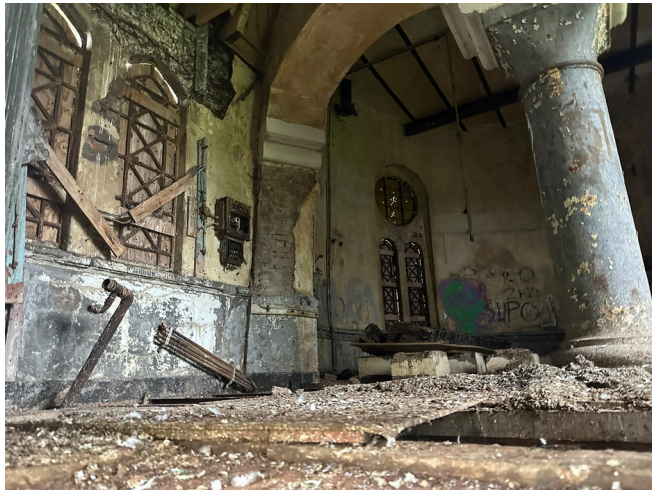
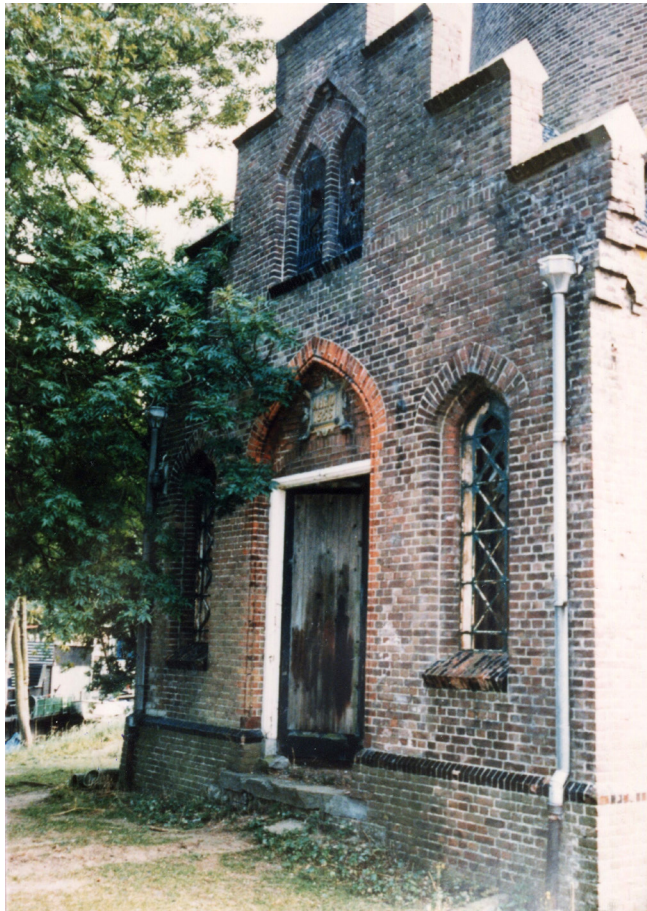
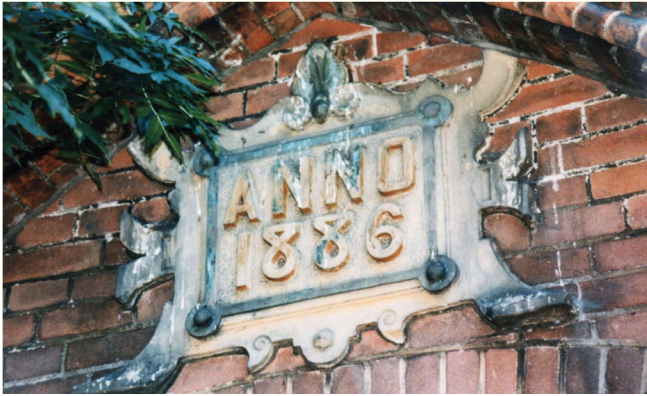
Current Condition and Conservation Challenges

The interior of the water tower remains largely in its original state but presents several restoration challenges:

- **Moisture and Rust Formation** – Prolonged exposure to moisture has led to rust damage on metal components such as staircases and support beams.
- **Deteriorating Masonry** – Some brick walls show signs of water infiltration and temperature-induced damage.
- **Limited Accessibility** – The steep staircases and ladders make the tower difficult to access for visitors without modifications.

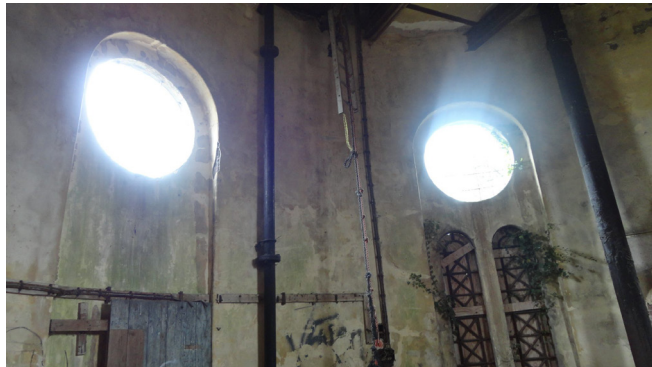
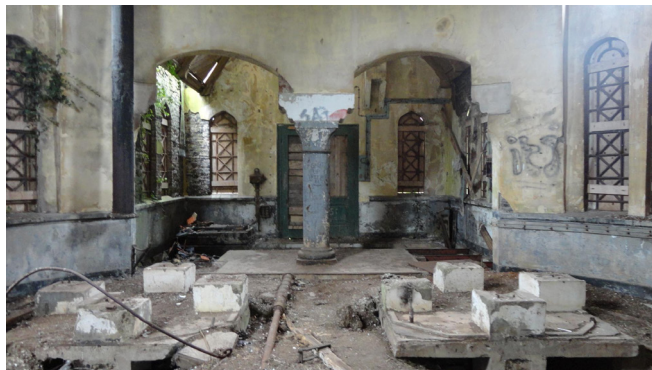
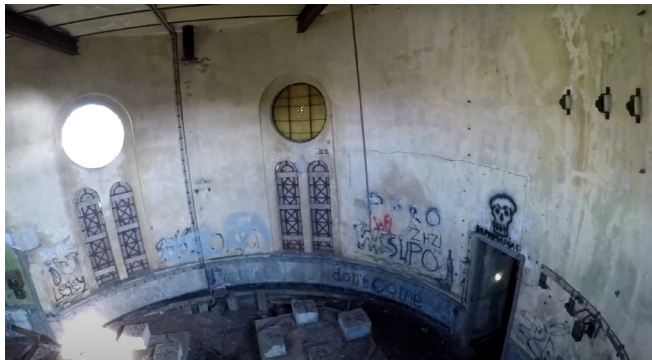
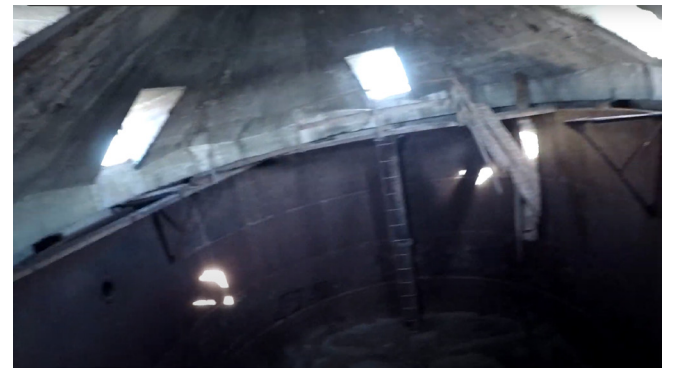
3. Upper Level – Water Reservoir

- The most impressive space in the tower, housing the 300 m³ iron water reservoir.
- The reservoir is made of riveted iron plates and rests on a structure of metal beams and brick supports.
- Features a domed ceiling with ventilation openings to minimize moisture buildup.

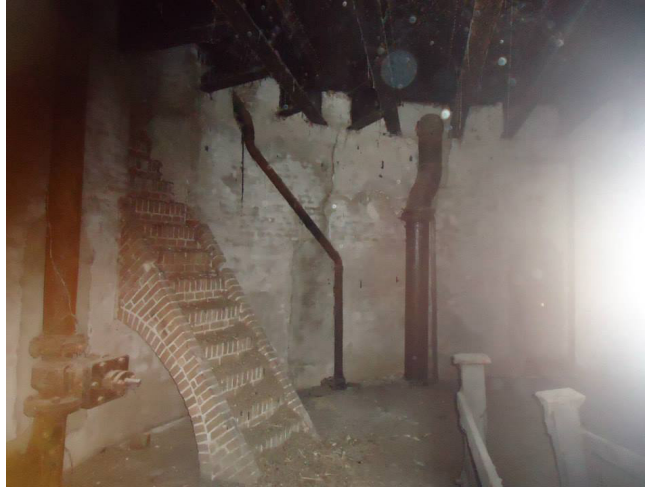
Material Use and Finishing

The interior is primarily functional and minimally finished, with an emphasis on durability and ease of maintenance:

- **Brick Walls** – The interior walls remain uncoated, revealing the original red brick, with some cement repairs visible.
- **Metal Staircases and Platforms** – Made of cast iron and steel, showing signs of oxidation and wear.
- **Wooden Elements** – Some old wooden planks and beams remain, mainly in the connecting corridors and original technical spaces.

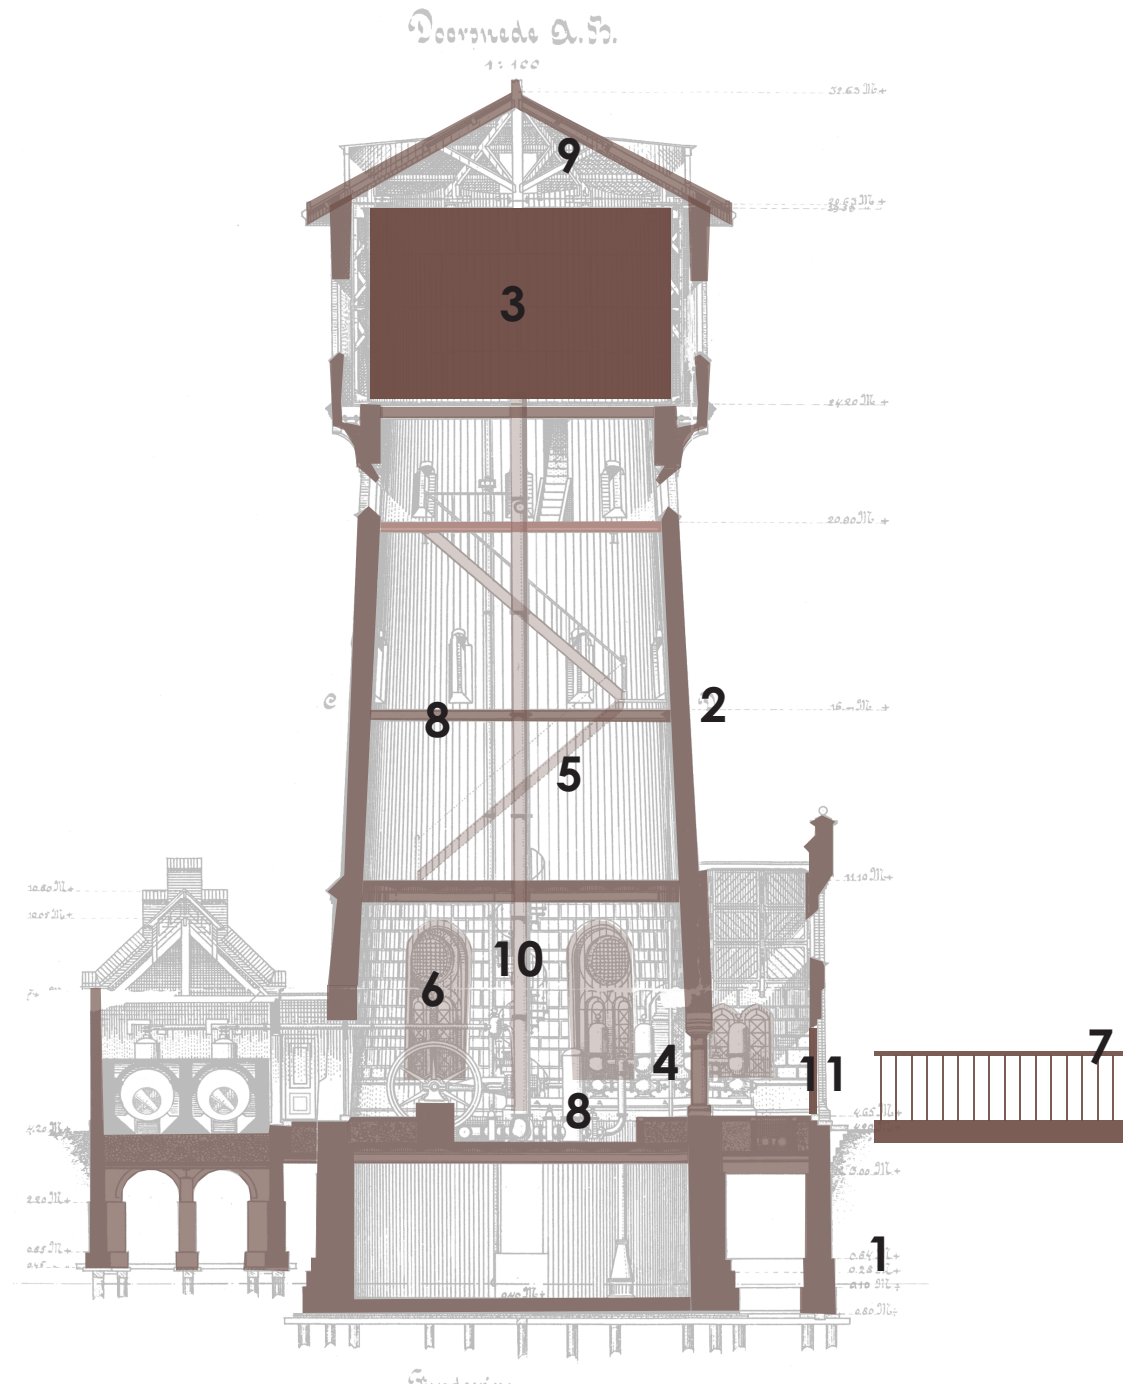
- very high value
- high value
- medium value

1. Foundation and Construction
2. Brick Façade and Masonry
3. Iron Water Reservoir (300 m³)
4. Machine Room
5. Metal Staircases and Ladders
6. Window and Ventilation Openings
7. Wooden Drawbridge Over the Zaaigat
8. Internal Load-Bearing Structure
9. Roof Structure and Materials
10. Water Overflow System
11. Entrance and Doorway Features
12. Surroundings and Urban Integration
