# Traditional wooden foundation piles in Amsterdam and Venice: techniques for the assessment of their state of conservation

This study explored the most employed techniques for the assessment of the state of conservation of traditional wooden foundation piles in Amsterdam and Venice. The techniques were evaluated for their relevance and effectiveness in assessing decay impact on centuries-old waterlogged wooden piles. The techniques adopted in Amsterdam and Venice were complementary. In Amsterdam, underwater micro-drilling was employed to accurately estimate the amount of decay and the remaining strength of the piles. In contrast, the techniques in Venice were based on microscopic and mechanical testing of small wood samples to provide a detailed decay analysis. The successful use of underwater micro-drilling in Amsterdam, which allows for fast and accurate pile decay assessment, presents an opportunity to enhance the piles conservation database of Venice. Adopting this technique in Venice could support more timely and effective preservation strategies.

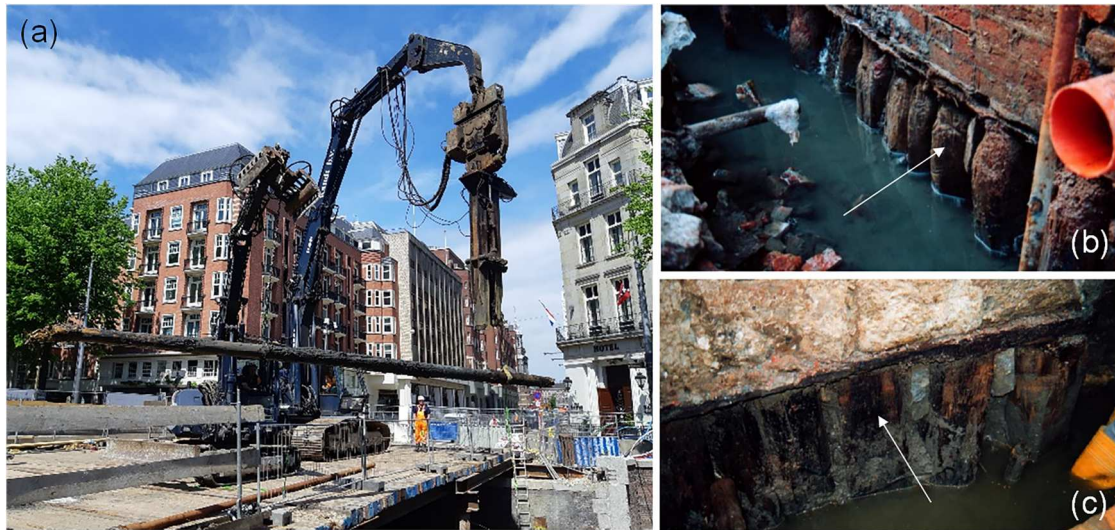
**Figure 1.** (a) Wooden foundation pile retrieved from the historical foundation of a bridge in the centre of Amsterdam; (b) foundation piles in Venice, visible after lowering the water level of the canal; (c) rough-hewn piles (rectangle shaped) in a foundation in Venice.

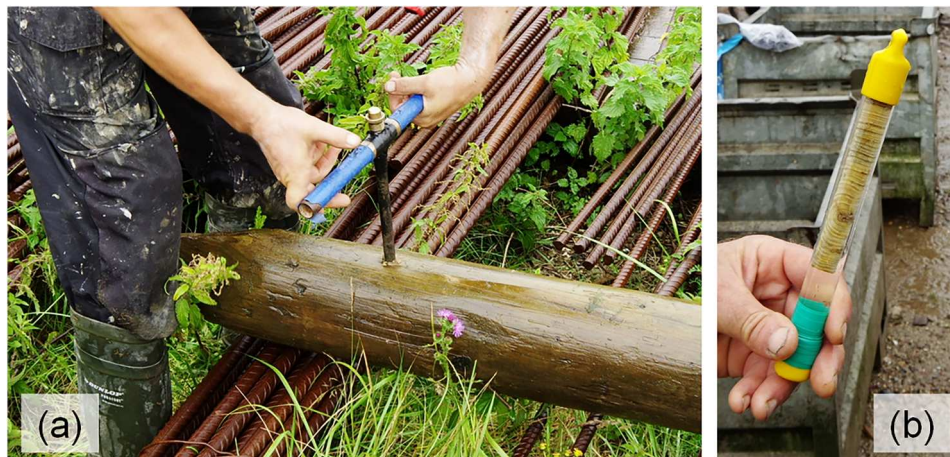
**Figure 2.** Sample collection: (a) extraction of a drill core from the tip of a retrieved timber foundation pile in Amsterdam, and (b) drill core collected in a plastic tube filled with water.

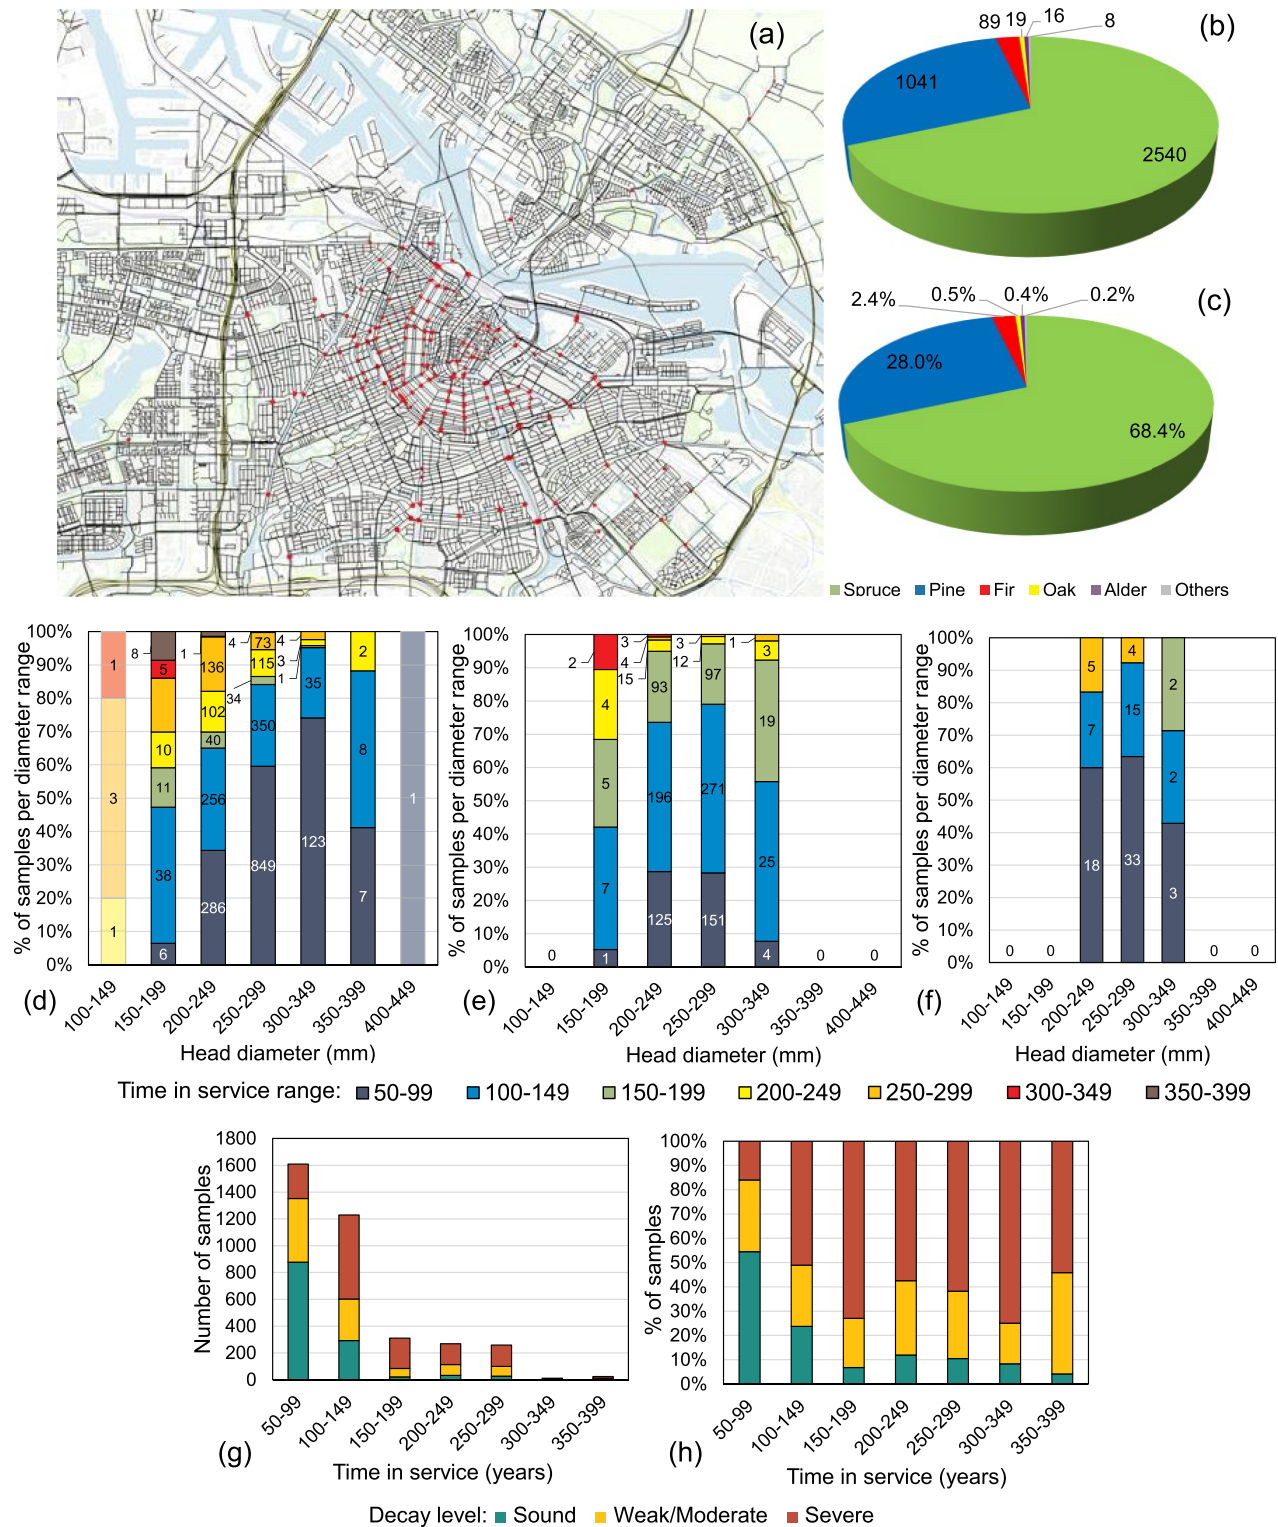
**Figure 3.** Sample collection: (a) map of Amsterdam with locations (in red) of the bridges in which drill cores were taken from the wooden piles, (b) wood species distribution of 3713 samples per number of drill cores, (c) per percentage of wood species. Distribution of the % of (d) spruce, (e) pine, (f) fir samples, based on head diameter of the piles for 7 ranges of time in service. The number in the rectangles represents the sample number of each range. Decay classification for 3711 drill cores: (g) number of samples, and (h) percentage of samples for each time-in-service group.

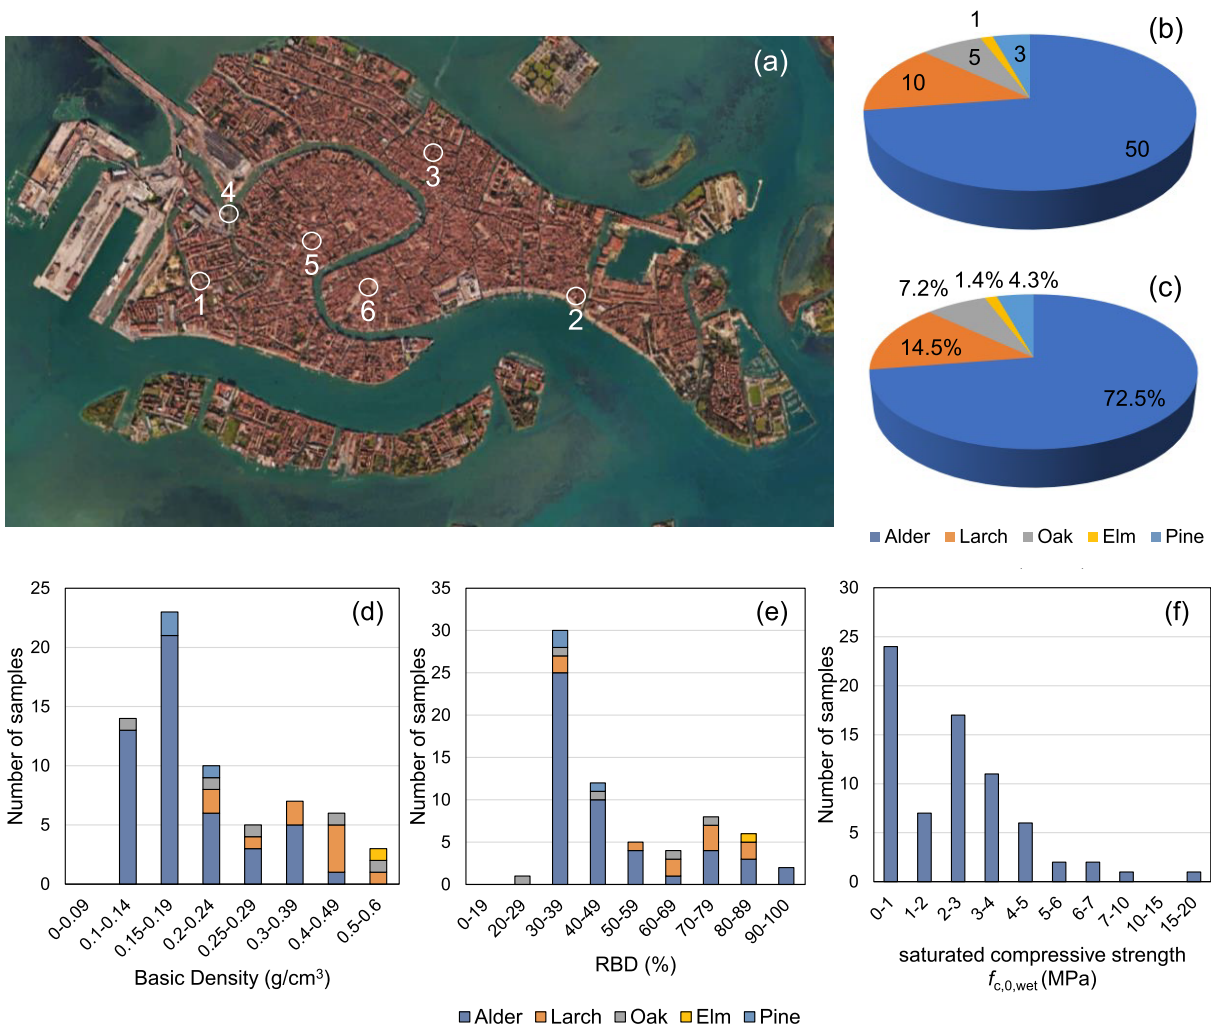
**Figure 4.** Sample collection: (a) map of Venice with historical sites: (a1) Church of Santa Maria Maggiore, (a2) Rio Ca' di Dio & San Martino, (a3) Rio Acque Dolci, (a4) Santa Chiara, Belfry of (a5) Frari, and (a6) Santo Stefano. Wood species distribution for all 69 wooden piles sampled: (b) per number of samples, (c) percentage of wood species. Distribution of samples based on: (d) basic density, (e) residual basic density (RBD), and (f) distribution of saturated compressive strength ( $f_{c,0,wet}$ ) for all the wood species of wooden foundation piles in Venice.

BD and RBD of all the samples are presented in Figure 4d and e, respectively. The majority of the samples exhibited BD ranging from 0.1 to 0.25 g/cm<sup>3</sup> and RBD between 30% and 50%, indicating significant levels of decay with extensive destruction of the wood tissue. The samples examined across all studies in Venice were collected from various positions along the piles. Overall, the results revealed a relatively uniform level of decay along the length of the piles. The outcomes of the compression tests conducted under saturated conditions are shown in Figure 4f. These tests included 65 samples measuring 20 × 20 × 35 mm<sup>3</sup> from Santa Maria

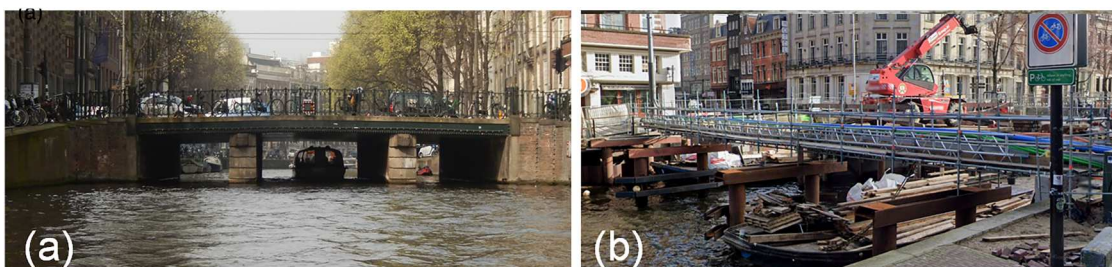
**Figure 5.** Bridges where the piles samples were collected: (a) Bridge 30 and (b) Bridge 41 in the historic city centre of Amsterdam.

The materials comprised 55 spruce (*Picea abies*) and 5 fir (*Abies alba*) wooden foundation piles, which were part of the foundation system of the piers of two bridges (called bridge 30 and 41) in the city of Amsterdam that were planned to be demolished and reconstructed (Figure 5). The retrieved full-

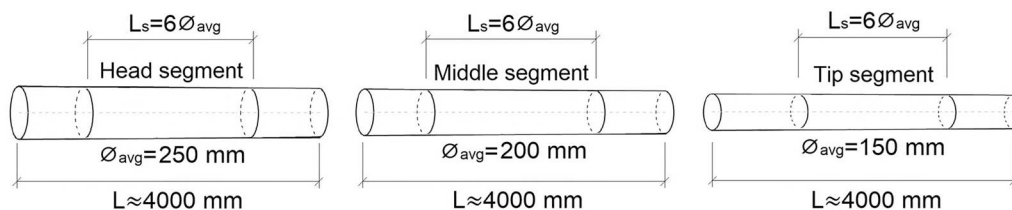
**Figure 6.** Cutting scheme and subdivision of the full-scale pile into head, middle and tip segments.

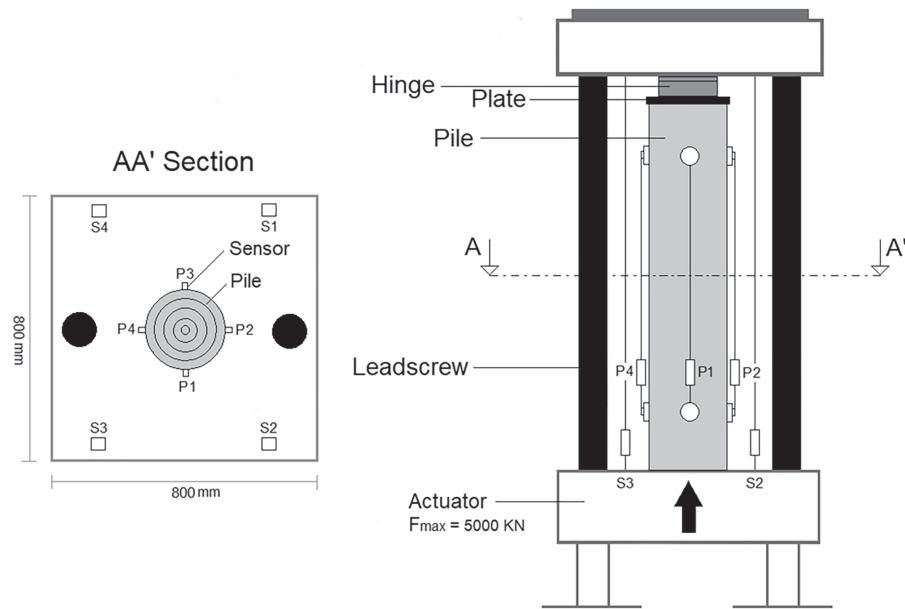
Name	Description	Sensor Type	Stroke (mm)
Actuator	Vertical actuator. Max force 5000 kN.	Hydraulic actuator	+/- 100
$S_1, S_2, S_3, S_4$	Vertical displacement between top and bottom steel plates of the compression machine	Linear potentiometers	+/-50
$P_1, P_2, P_3, P_4$	Deformation of the wooden pile measured on each side of the pile. The sensors span 2/3 of the length of the pile.	Linear potentiometers	+/-20

**Figure 7.** Compression test for a wooden pile segment tested at TU Delft and data measurements details.

Compression tests were performed to determine the short-term wet compressive strength ( $f_{c,0,wet}$ ) of the pile segments in direction parallel to the grain in submerged conditions. To this end, a displacement-controlled test setup was used, where the pile segments were subjected to an axial load in direction parallel to the grain according to the EN 14251 standard (2003), as in Pagella *et al.* (2022a, 2022b). A hinge, mounted on a steel plate, was placed on top of the specimen to have a uniformly distributed compression load on the pile. Four linear potentiometers were screwed to the segment to measure its deformation, along its lateral surface, at  $90^\circ$  from each other, and with a variable length equal to  $2/3$  of the length of the specimen (Figure 7). The tests were conducted at a displacement rate of 0.02 mm/s until the peak load was reached. After the peak load (reached at approximately 5 min according to the EN 408 standard 2012) the test continued

at a higher speed until cracks were visible, and to show the post-peak behaviour of the pile (EN 14251, CEN 2003). Then,  $f_{c,0,wet}$  was derived from the ratio between the maximum force reached in compression and the average cross-sectional area of each specimen.

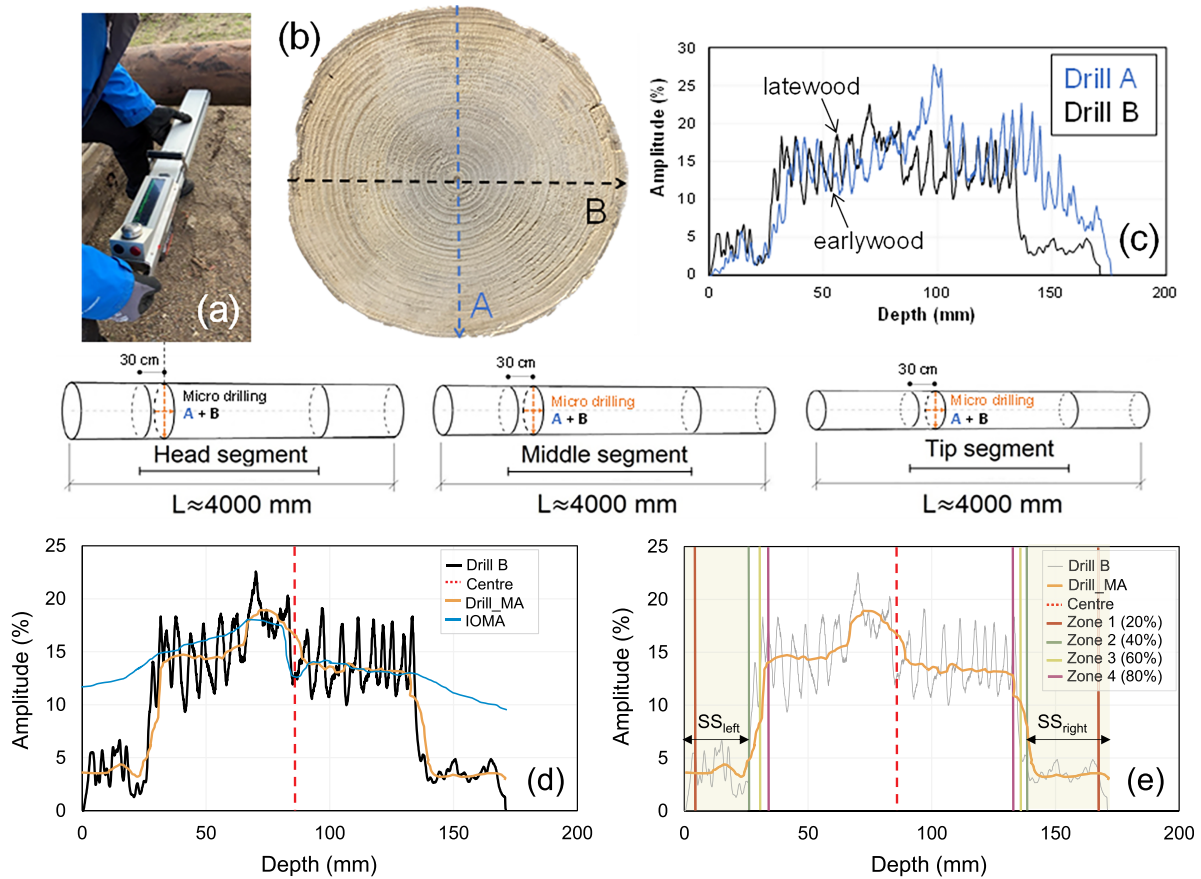
**Figure 8.** Test procedure: (a) micro-drilling measurements on a wooden pile, (b) drill A and B performed 30 cm from the head of the pile segment, (c) micro-drilling signal plotted as resistance (% of the maximum output engine power) vs distance (mm), (d) example of the analysis of the drilling signal (Drill B) with drilling moving average (Drill\_MA) and IOMA from which the zones are calculated, and (e) 4 zones and soft shell ( $SS_{left}$  and  $SS_{right}$ ) associated to zone 1 + 2.

A TU Delft-developed algorithm analyses micro-drilling signals A and B (Figure 8(c)), to assess degraded portions of historical pile cross-sections. The calibration and validation of the approach are described in Ravenshorst *et al.* (2024), and Pagella *et al.* (2024d). The algorithm utilizes Moving Average and Incremental Outwards Moving Average (IOMA) of the drilling signal to identify specific zones based on signal amplitude differences, assuming the centre of the pile is sound wood (Figure 8(d)). Four zones (z1-z4) are determined on each side of the signal, representing different 20% (z1), 40% (z2), 60% (z3) and 80% (z4) of maximum IOMA values on each side. The soft shell, indicative of degradation, is calculated as the sum of zones 1 and 2 (Ravenshorst *et al.* 2024). The total soft shell of a decayed cross-section is averaged from measurements on both sides, aiding in determining the remaining sound cross-sectional area (Figure 8(e)). Subsequently, the total soft shell of a decayed cross section was calculated as the average of the 4 lengths of the soft shell (SS), corresponding to left and right sides of micro-drilling signal A+B. From this, the average length of the soft shell ( $a_{SS}$ ) was calculated with

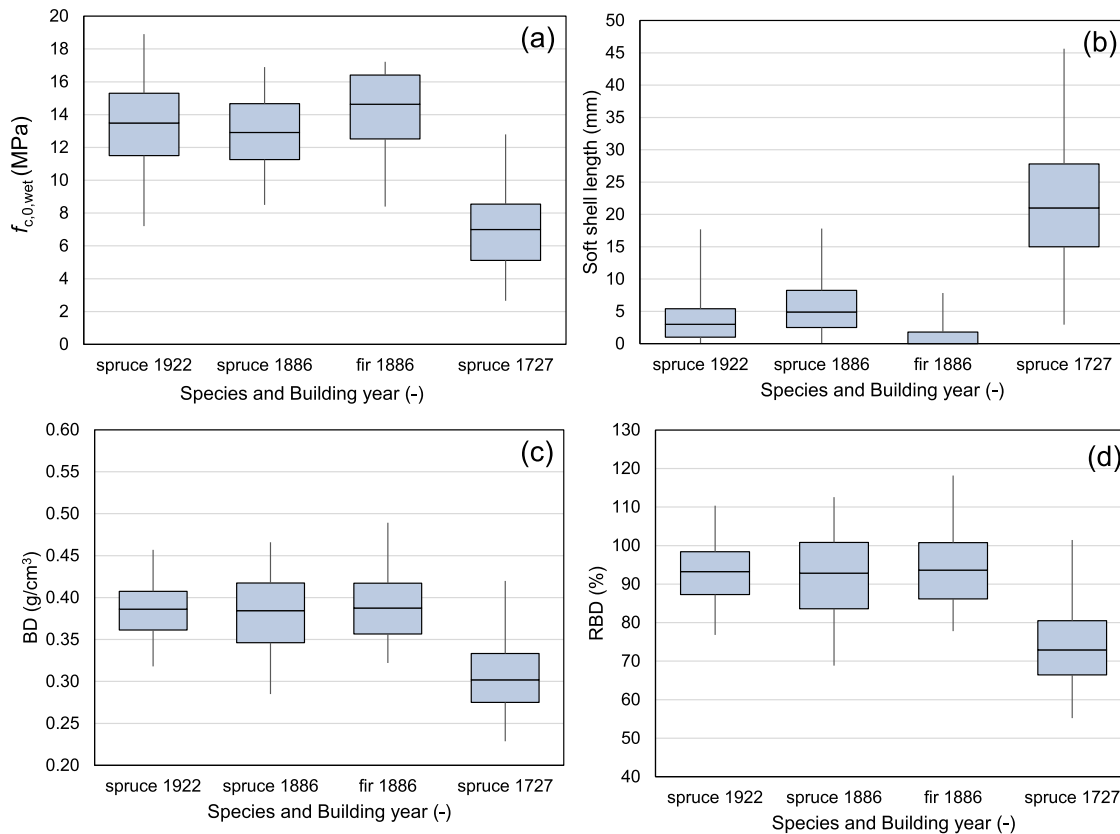
**Figure 9.** Box plots for (a)  $f_{c,0,wet}$ , (b) soft shell length, (c) BD, and (d) RBD of spruce and fir pile segments divided in 3 building years (1922, 1886, 1727).

The results of large-scale mechanical testing are presented in Figure 9, including a total of 201 pile segments extracted from 60 full-length spruce and fir piles. No significant difference in the mechanical properties was found between spruce and fir from building years 1886 and 1922, after carrying out a statistical analysis (two-sample t-test, one-tailed) two different groups (e.g. representing two different building years) to determine whether the mean value of one group was significantly greater or less than the other. However, the results are not included in this paper due to length constraints.

1727. The average values of BD (Figure 9(c)) and RBD (Figure 9(d)) of piles from 1727 were also lower, confirming the presence of decay. The micro-drilling analysis conducted on head, middle-part, and tip of the pile segments, and supported by the TU Delft-developed algorithm (Pagella *et al.* 2024b), highlighted that the spruce pile segments from 1727 had a rather constant soft shell along the length of the pile. The soft shell was also measured in piles from 1922/1886, but on average limited to 5 mm. Finally, fir pile segments from 1886 exhibited minimal bacterial decay. This may be attributed to the inherently higher resistance of fir to decay (Klaassen *et al.* 2005, Mirra *et al.* 2024), the limited number of tested fir piles, or the fact that they exclusively dated back to 1886.

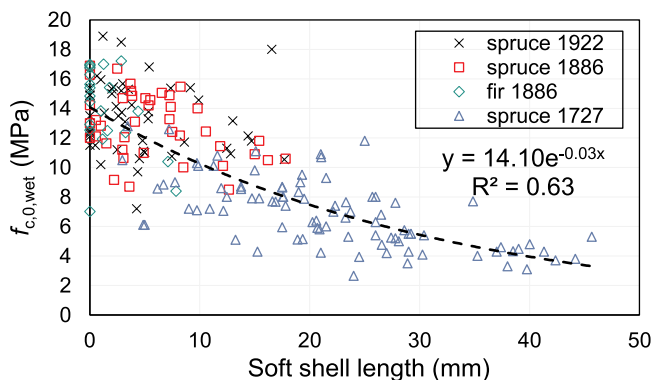
**Figure 10.** Relationship between  $f_{c,0,wet}$  and the length of the soft shell of all the historic spruce and fir segments in Amsterdam.

The remaining short-term compressive strength was well correlated with the soft shell length, as shown in Figure 10, especially for piles from 1727, which exhibited a larger soft shell length, spanning from ca. 10 to 45 mm. The relationship between remaining compressive strength and soft shell of the piles can be implemented in future research, to build damage accumulation models taking into account the effect of decay over time on the strength properties of wood (Van de Kuilen 2007, Pagella *et al.* 2024d). This gives the possibility to have a direct estimation of the remaining short-term compressive strength from in-situ underwater micro-drilling of the piles.

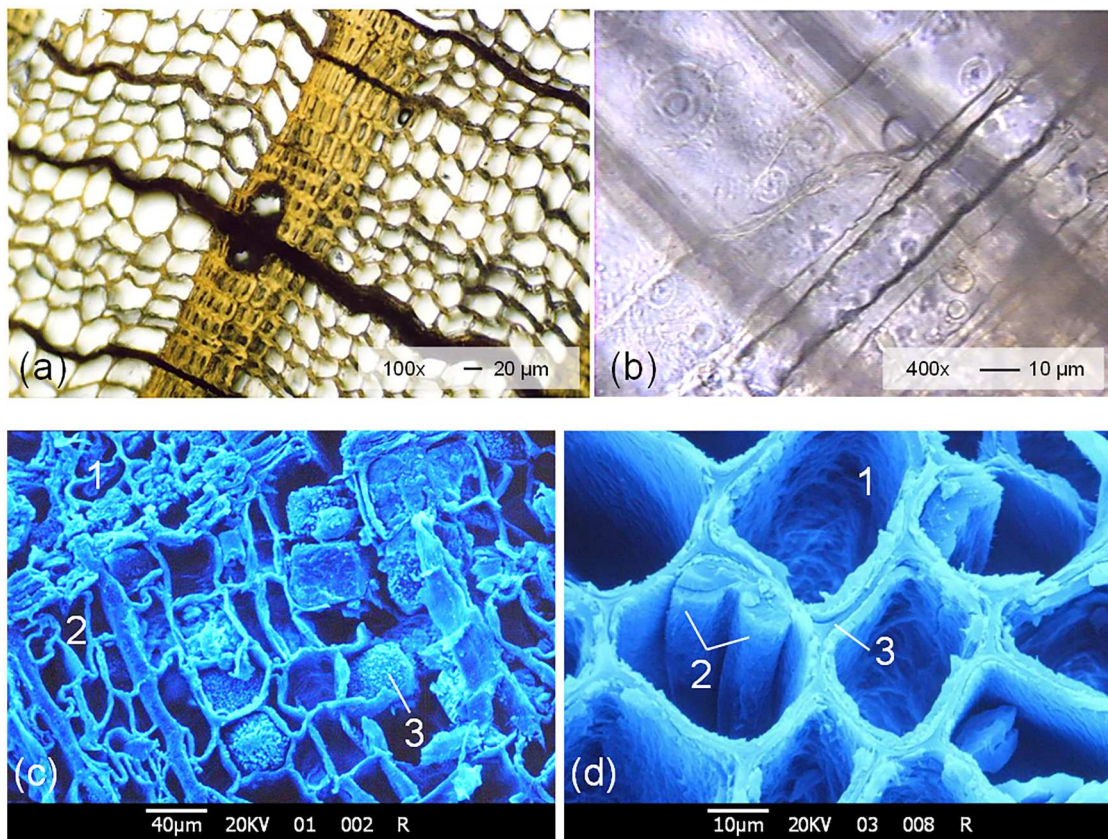
**Figure 11.** Example of species identification of Larch (*Larix decidua* Mill.): (a) cross section with abrupt transition between earlywood and latewood, (b) radial section with heterocellular rays and characteristic pits in marginal tracheids. (c), (d) SEM of larch pile RSG1, characterized by collapsed cells with thin walls in the (c1) latewood and (c2) earlywood, showing severe degradation, (c3) possible presence of what appear to be calcium carbonate crystals in the tracheids based on comparable literature pictures from University of Padova (However, this has not been verified with tests). (d1) signs of tunnelling in the cell, suggesting the attack of tunnelling bacteria, (d2) accumulation of silty and clayey material, and (d3) detachments of cell wall from the compound middle lamella, indicating the effect of erosion bacteria.

In general, softwood such as larch was more degraded than hardwoods, due to its inherent non-durable sapwood (Klaassen *et al.* 2005). Figures 11a, b show an example of species identification of a sample of larch viewed with the microscope. Figures 11c, d show SEM images of a severely degraded larch pile. In contrast, light decay was observed in all oak, elm and alder, suggesting a good conservation of these piles. Only larch and willow showed moderate to severe bacterial decay. No correlation was found between the extraction depth of the samples and the decay level, in line with the literature (Klaassen *et al.* 2005, Björdal and Elam 2021, Mirra *et al.* 2024) where bacterial decay is in general uniformly distributed along the pile.

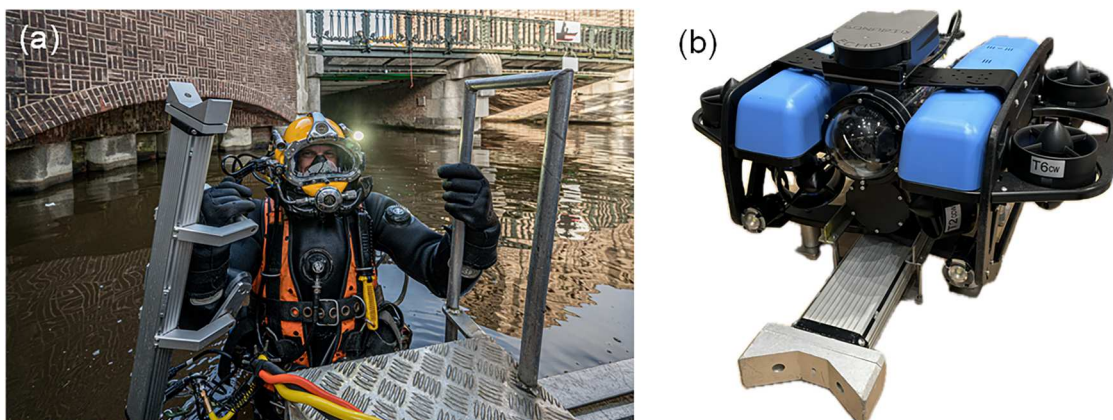
**Figure 12.** Micro-drilling conducted underwater on wooden piles by: (a) diver, and (b) prototype of ROV incorporating a micro-drilling tool developed by Baars-CIPRO (Baars-CIPRO 2024).
