KATOENVEEM

MERWE-VIERHAVEN, ROTTERDAM

MSc III Heritage & Architecture

Architectural, Building Technology & Cultural Value Analysis

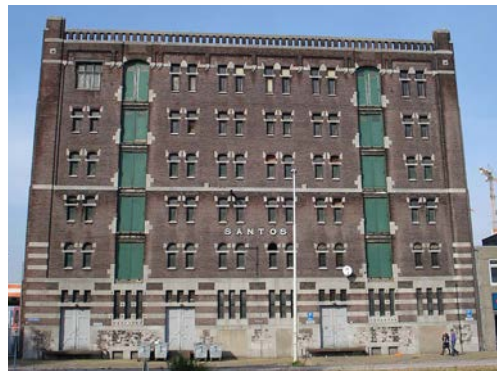
SANTOS

Architect(s): J.P. Stok & J.J. Kanthers
Location: Brede Hilledijk 95, Rotterdam
Completed in: 1903
LxWxH: 34.5x32.4x24.5
Original function: Warehouse for coffee
Architectural style: Pure eclecticism
Construction: Brick, steel and wooden floors

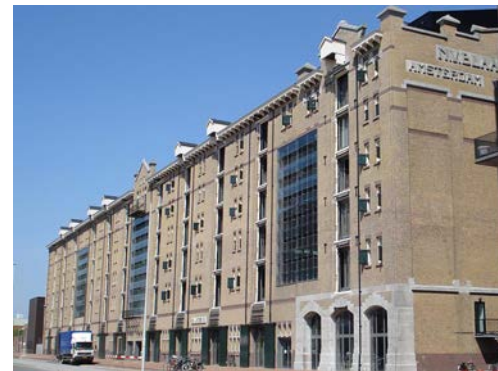
JOBSVEEM

Architect(s): J.J. Kanthers & Fr. Eriksson
Location: Lloydstraat 22, Rotterdam
Completed in: 1914
LxWxH: 130x25x24.6
Original function: Warehouse for goods
Architectural style: Influenced by rationalism
Construction: Cast iron, reinforced concrete, brickwork and wooden floors

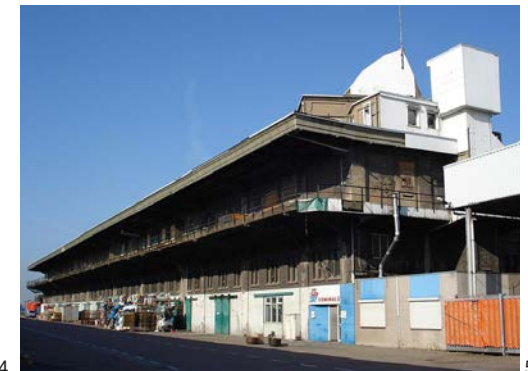
KATOENVEEM

Architect(s): J.J. Kanthers
Location: Keilestraat 39, Rotterdam
Completed in: 1920
LxWxH: 138x43x12
Original function: Warehouse for cotton
Architectural style: Influenced by functionalism
Construction: Concrete (hennebique)

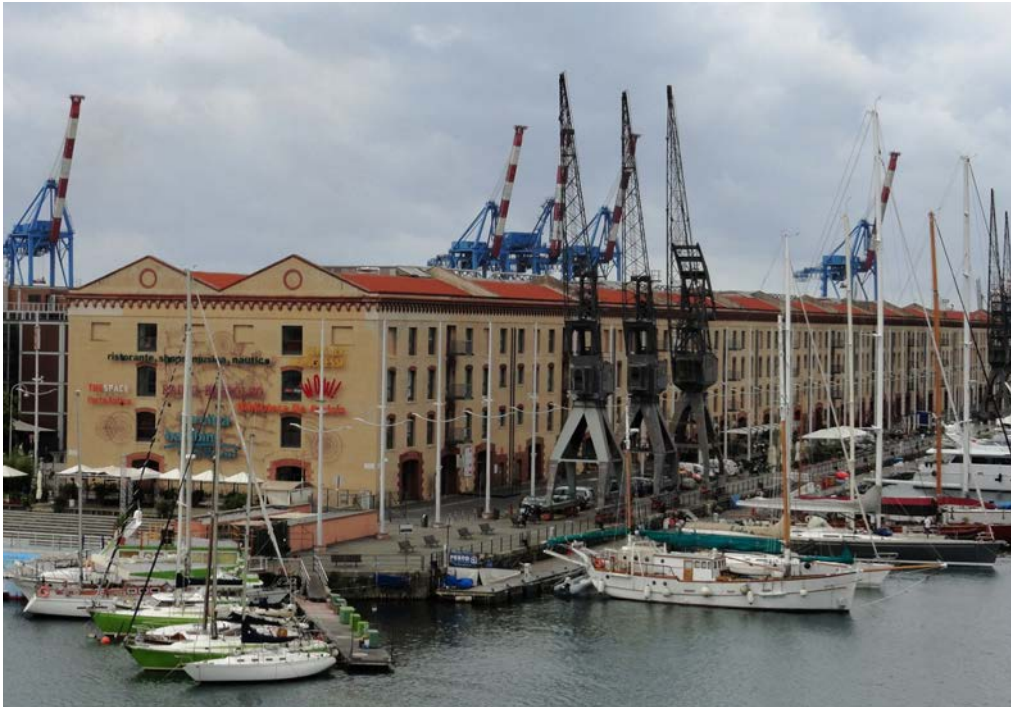
1 The Magazzini del Cottone, Genoa, Italy

A building that is similar due to its former function and electrical system is the Magazzini del Cottone in Genua, Italy. This building, built at the end of the 19th century, used an electrical system to transport goods from ships and indoors, with 7 electric wall cranes, 12 raised cranes positioned on rails and 7 freight elevators³. There is no information about any electrical system inside the building, which means that workers had to carry loads inside the building themselves. Later on, in 1926, an additional building was constructed next to Magazzini del Cottone specifically for the storage of cotton. The building was also connected to a railway system. After WWII the two buildings were used only for the storage of cotton, and connected by metal bridges. The building was renovated from 1992 on and is used for various cultural and recreational activities.

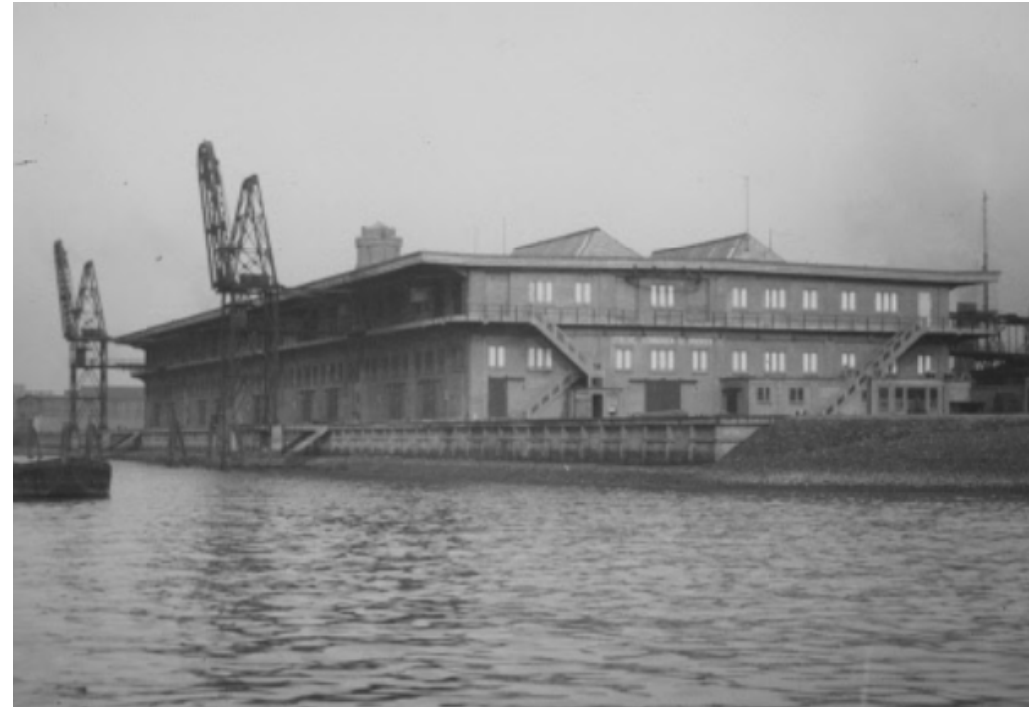
2 Katoenveem as seen from the entrance to Keilehaven, Rotterdam, Netherlands

more advanced. Katoenveem had 2 electric wall cranes, but worked with hoists on rails, that carried the load all the way inside the building to a desired location. This means that workers did not have to carry any goods themselves, but only had to guide them. Another difference between the two buildings are the overhangs or balconies present at Katoenveem, which were part of this electrical transportation system that had to be hung from the ceiling. The balconies were also used by the workers to guide the cotton bales between inside and outside. Magazzini del Cottone has smaller balconies or openings in the wall to bring in the goods from outside. Also, construction method for the buildings is different, as the Magazzini del Cottone has a cast iron construction, while Katoenveem uses reinforced concrete (see chapter structure).

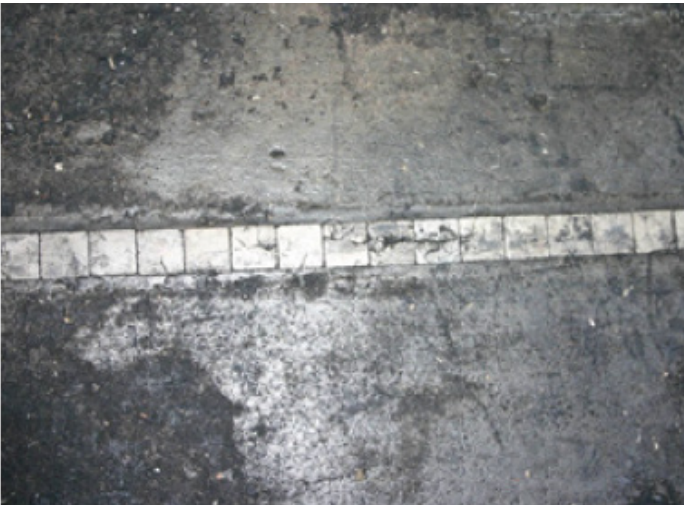
Image 3: Organisation of Storage

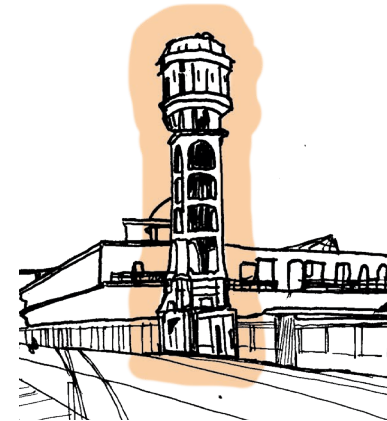
4. Water tower

The watertower served as an important element in the fire safety of Katoenveem, as it was connected to the sprinkler system in the building. The water tower was demolished in 1966. The pedestal of the water tower was demolished much later, in 1988², together with the small office building located next to the watertower.

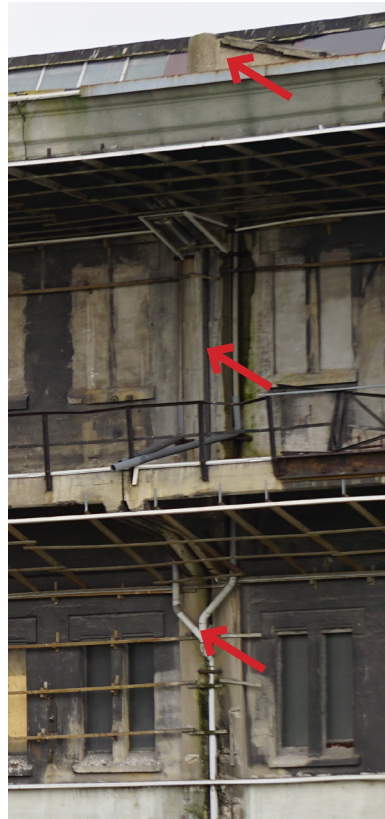
The building consists of five compartments (A, B, C, D, and E), the partitions walls serve as dilations walls. Each compartment has its own walls, therefore on the place of the dilations, the walls are double. In between these walls is a void. The compartment walls extend above the roof construction and the cavity in between them is also visible. Every compartment has its own drainage.

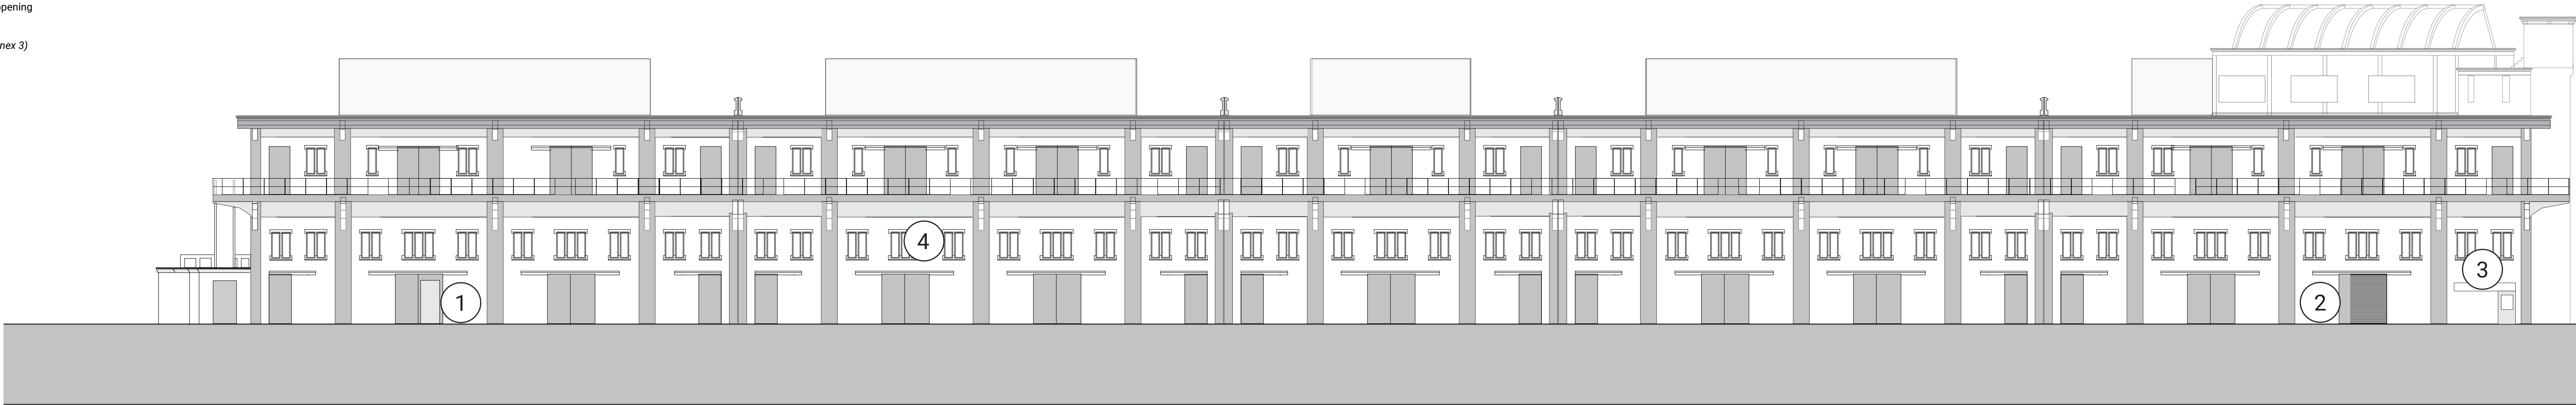
CURRENT SITUATION SOUTH FACADE

- 1. Door cut into existing steel doors
- 2. Replacement of existing steel doors by roller shutter
- 3. Newly added office window opening
- 4. Closed openings

Most changes can be related to doors. The east and west facade have been changed because of the implementation of large garage doors. Almost all doors on the south façade are still the original ones but along the water most doors have been closed off or replaced.

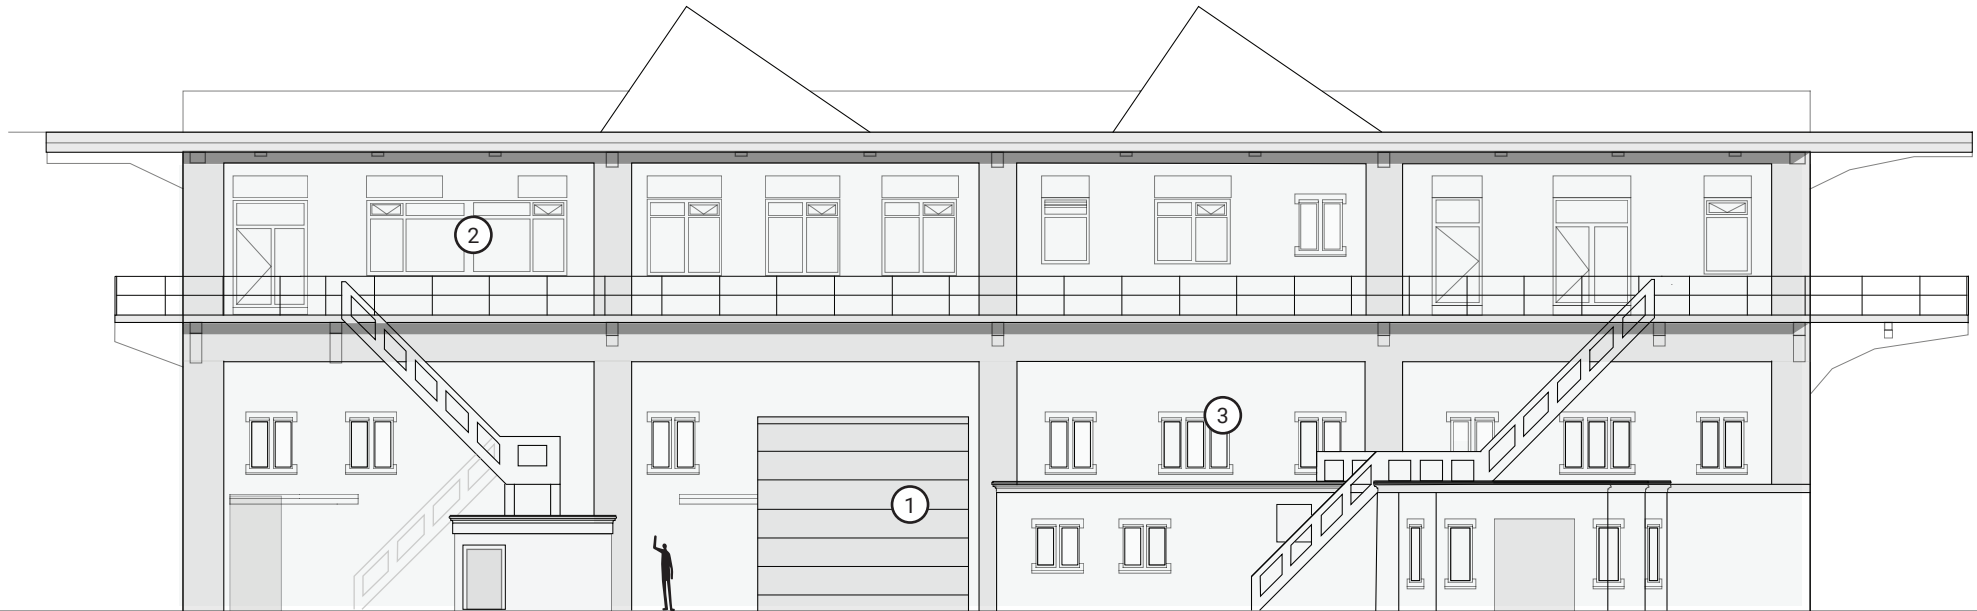
CURRENT SITUATION WEST FACADE

- 1. Non original garage door
- 2. New office openings
- 3. Closed openings

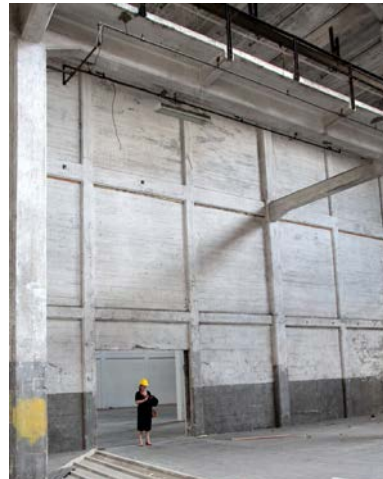
COLOUR - intended
The finish in the second hall from the west side seems to be the most original one. The walls in that hall are ochre yellow with a grey plinth on the ground floor and first floor to about hip height. The finish with such a plinth is also visible in several other rooms.⁴ Why this was done is unknown but since the cotton bales were stacked much higher a functional reason does not seem likely.

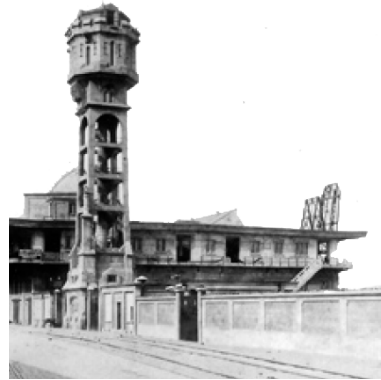
WATERTOWER - intended
The water tower used to be located next to the main building. It was highly decorative and stood firmly as the focal point of the entire building. Although it had a specific function it has clearly visible ornaments.

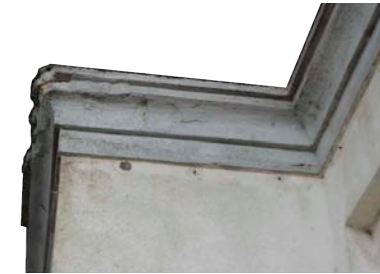
DETAILED CORNICE - intended
The pumping station is equipped with a detailed cornice. But unlike the detailed windows on the main building, the windows of the pumping station have no details at all.¹ The roof of the main building also has a detailed cornice.

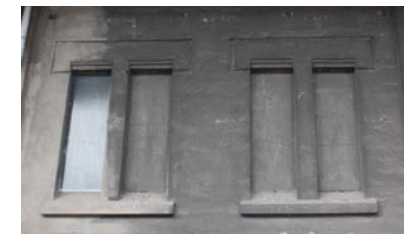
WINDOW DETAILS - intended
The window frames are made of concrete and cement.² On the exterior Kanter designed details around the windows to imitate a natural stone lintel.¹ The detail was not needed for functional reasons thus it is an intended ornament.

difference in the main supporting structure and the walls with no supporting function. The window frames are made of concrete and cement and recessed in the facade. On the exterior Kanter designed details around the windows to imitate a natural stone lintel. The detail was not needed for functional reasons thus it is an intended ornament.

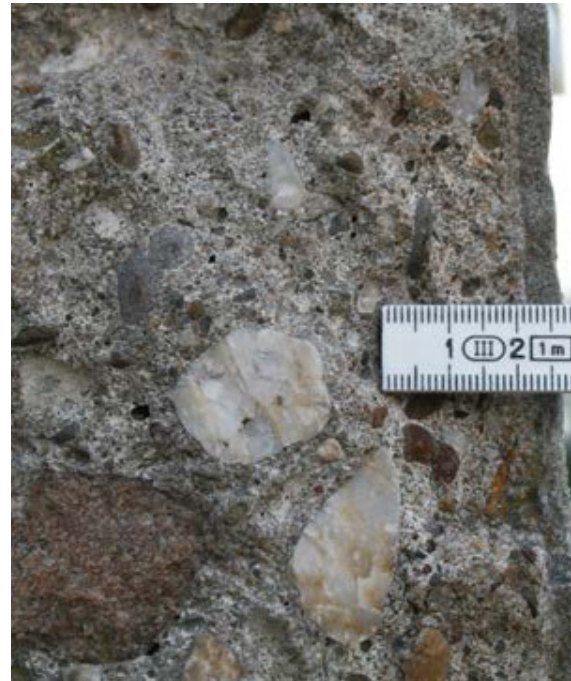
Picture of a concrete sample of the St Jobsveem, Rotterdam. A aggregate of gravel and different fractions can be seen. Which are not been graded well.

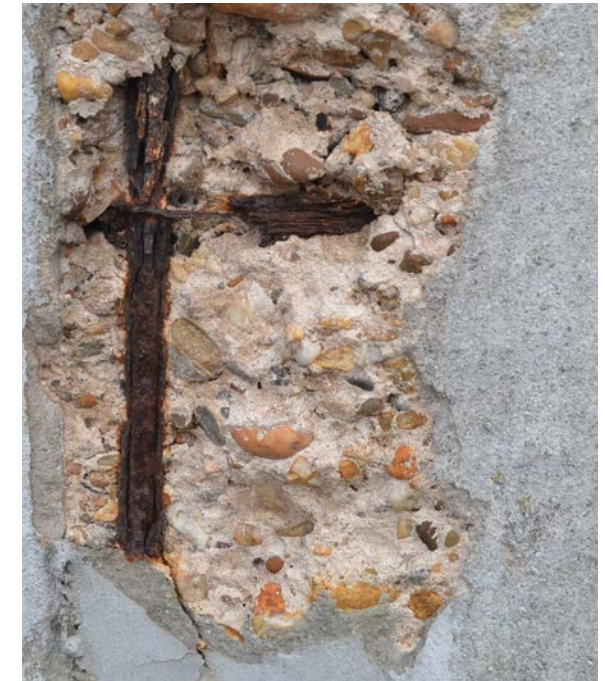
Picture of a concrete sample of the Katoenveem, Rotterdam. We observe a aggregate of rounded stone with white to brown color spectrum. Some stones have a more orange yellow character. The size of the aggregate is uneven. In the upper part possibly some air bubbles are seen.

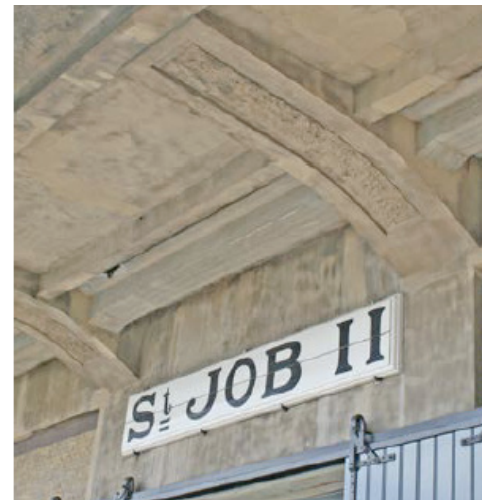
Image 1 - St Job Groundfloor facade underside of cantilever (source: Heinemann 2013, p.259)

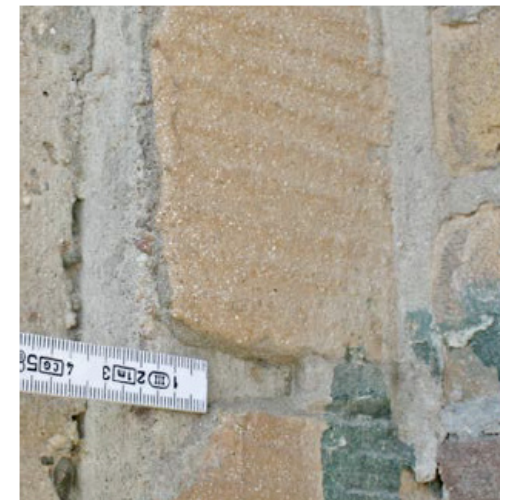
Image 2 - St Job Groundfloor, Material sample (source: Heinemann 2013, p.259)

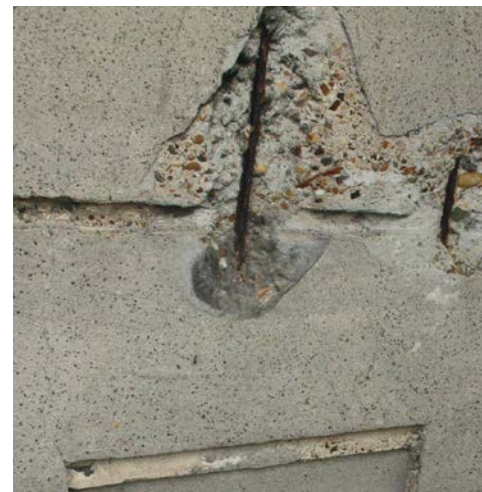
Image 3 - Detailed picture of facade material. (source: Charlotte de Boon 16-09-'16)

The katoenveem is rendered in a sandy cement³. We assume that

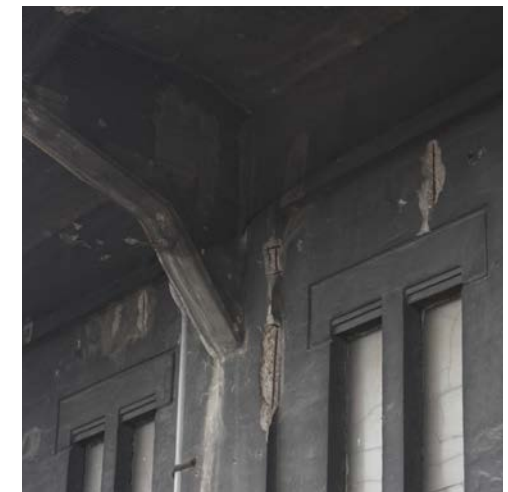
Image 4 - Detailed picture of window articulation at south facade (source: Charlotte de Boon 16-09-'16)

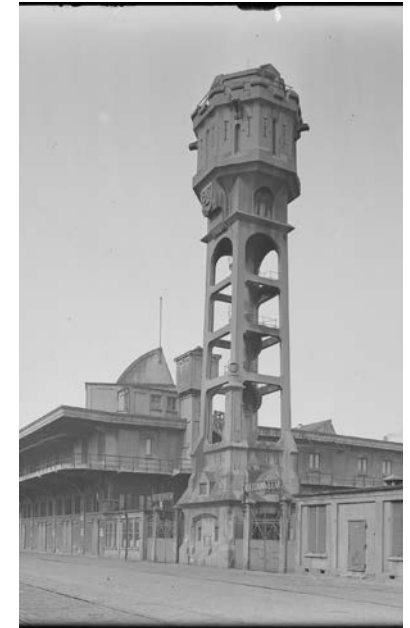
3. Katoenveem's water tower.

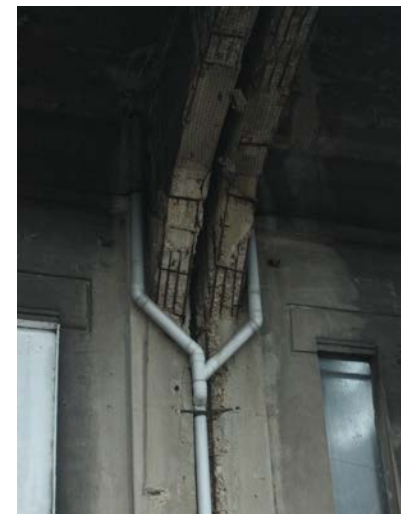
Dilatation between compartments

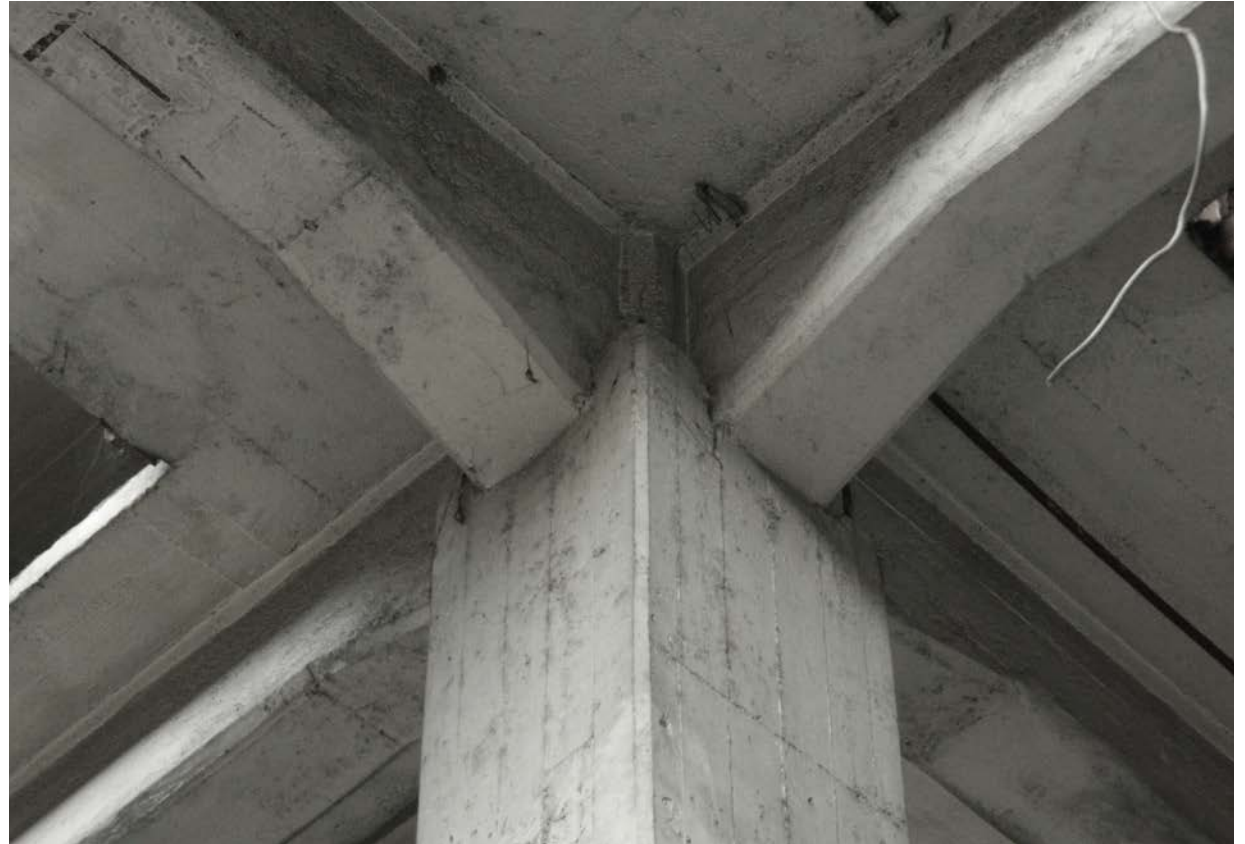
Beam column connection

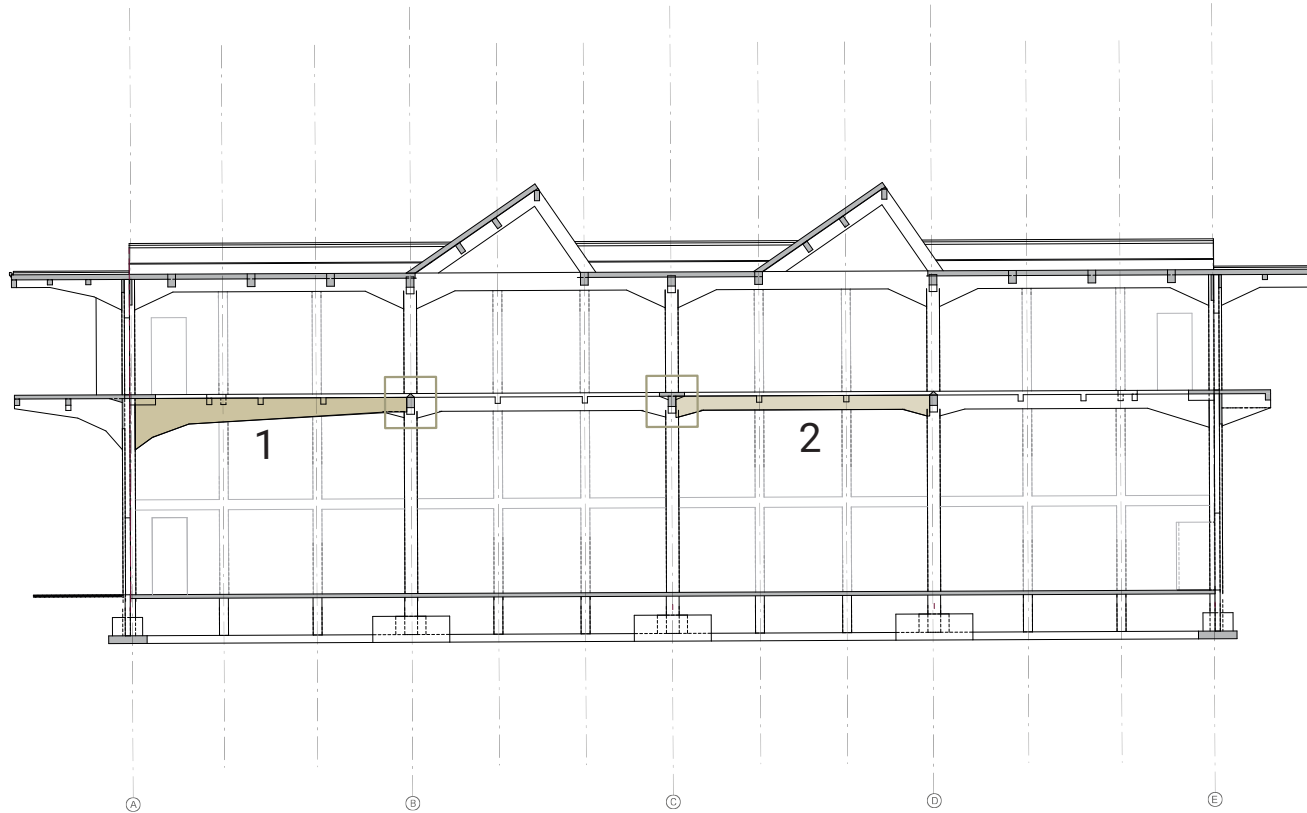
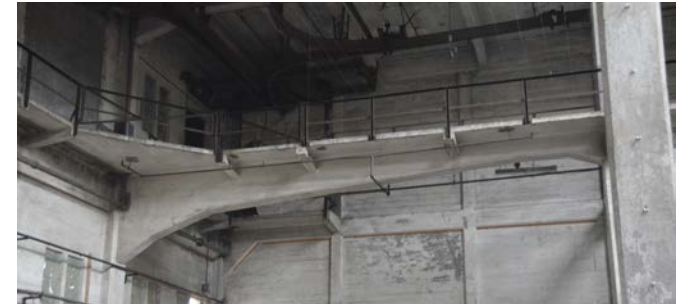
Beam 1

The silhouette of the beam is determined by the rotational forces created by the attached balcony beams.

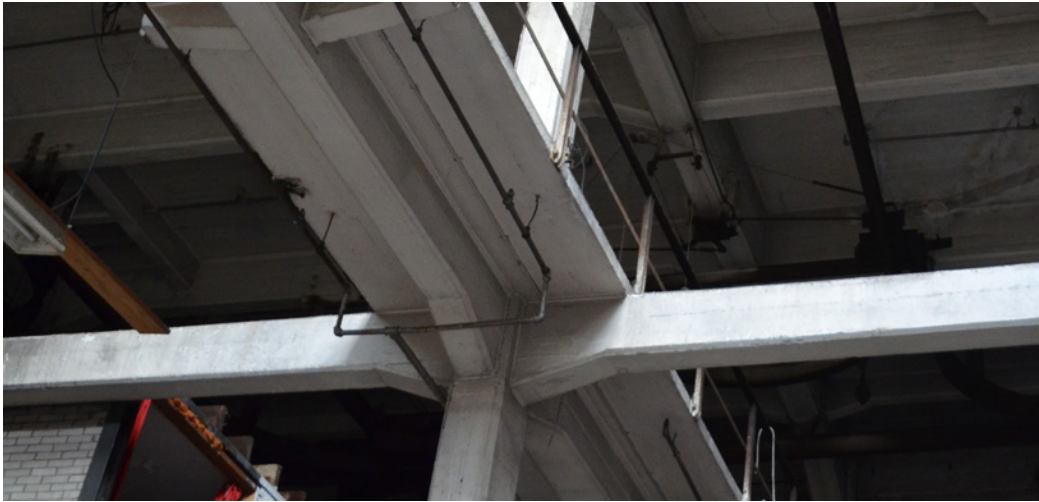
Walkway beams and non walkway beams

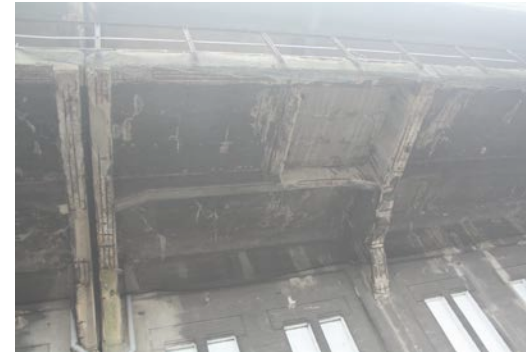
Roof structure within structural grid. Primary beams and secondary beams.

In the drawing we see the order of beams that are part of the roof construction. The primary beams follow the grid in both horizontal and vertical directions. This is an exception on the typical hennebique system, described at the beginning of the chapter, where the transfer of forces is designed in only one way. Resulting in a more clear hierarchy in primary and secondary beams. The secondary beam order is purely designed to support the conveyor system and roof lights.

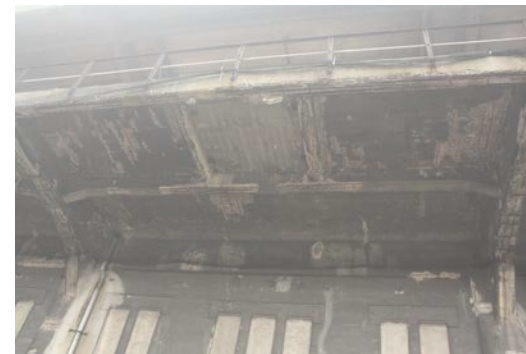
On the south side of the building you can see some cross beams. This will provide the structural support to make openings in the gallery balcony, intended for the transport from the conveyor system to the trains. These openings are the only exceptions in the structural order. Conceivably, the dimensions are related to the length of train wagons¹

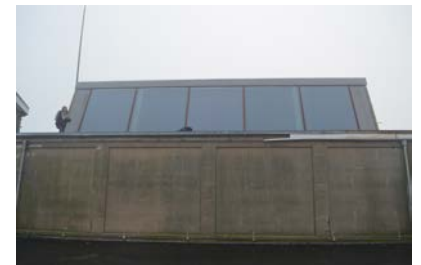
The roof lights are placed within the structural grid and follow the direction of the plot. The size of the roof lights is determined by the compartments. The support is provided by triangle truss structure, integrated into one whole beam.

The arc form of the rooflight, where the sample room is placed, is the exception in the roof landscape of the building. It differs in orientation to the other roof lights. The sample roof is made of shell roof construction which was not very common building method for the 1920's.

Roof scape of the Katoenveem

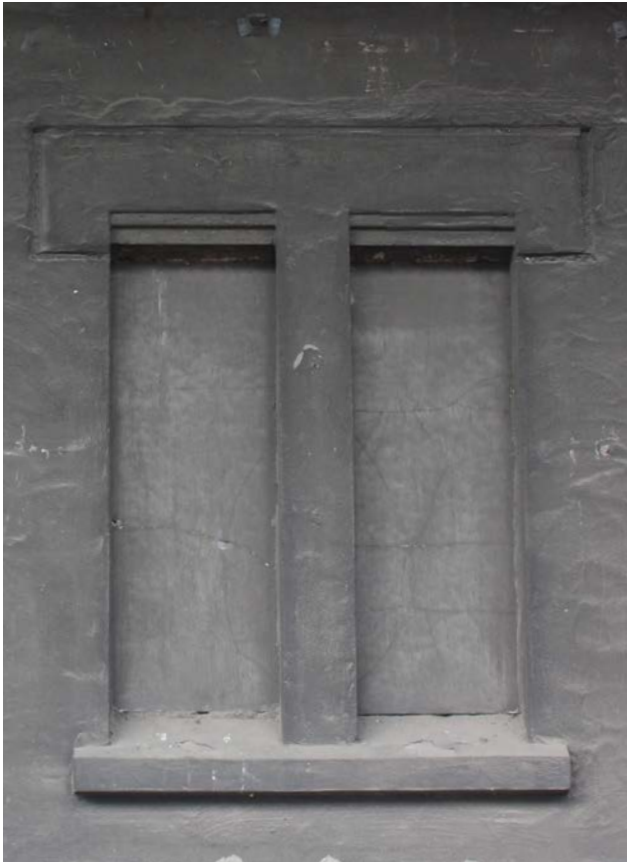
All window articulation is cast within the structural formwork. The expression of the window is made by line work cast in the surface. Suggesting a lintel.

The window detail is simply made because of the functional character, just to close the void. The cement window frame holds the glass. The question remains if the glass can easily be replaced?

1. Articulation in concrete face. To suggest a constructive lintel.
2. Original: wired glass
3. Angled windowsill - part of formed concrete
4. Water leaking gap
5. Exterior material : light cement layer 10mm
6. Cement window frame

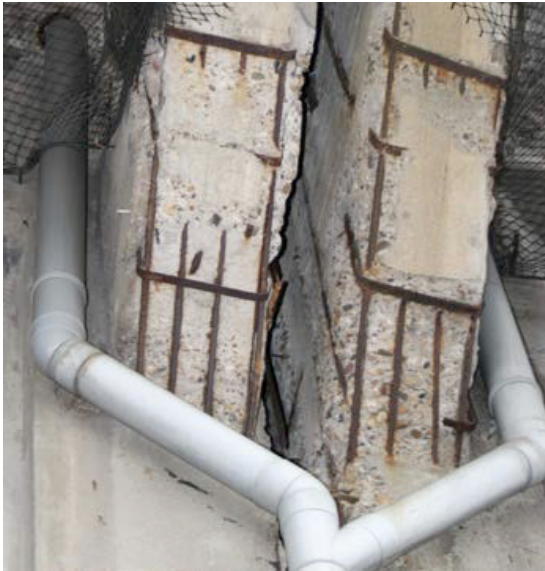
Image 1 - Typical reinforcement of the Hennebique system with horizontal strips.

hold the horizontal bars was typical Hennebique but was unusual.¹ The strips were later replace by round bars. This development you can see in the way the more specific elements were constructed. On image 3 the reinforcement of the stair is shown, you see smaller round bars in the horizontal direction. In the walls the use of stirrups in both horizontal and vertical direction are used. Common problem of the stirrup use is the embedment in the concrete resulting in the damage shown.

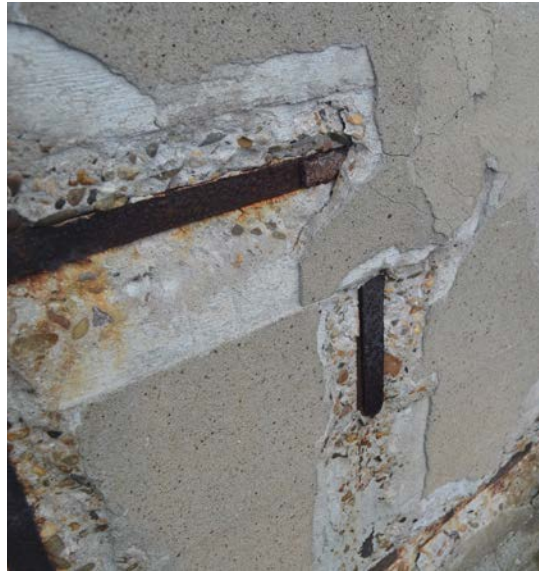
Image 2 - Wall reinforcement.

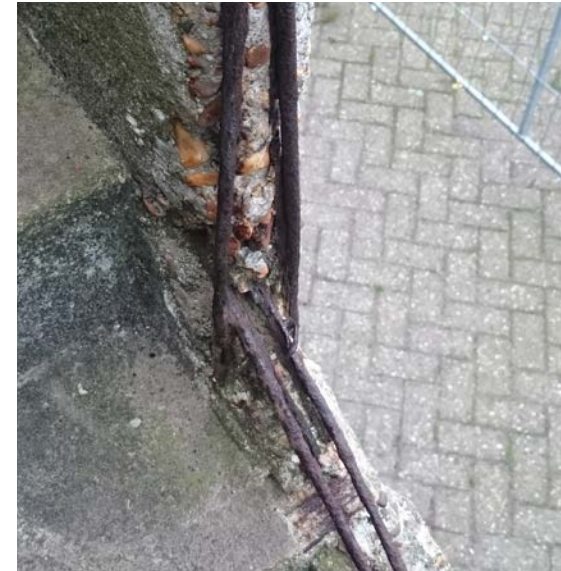
Image 3 - Reinforcement of exterior stair.

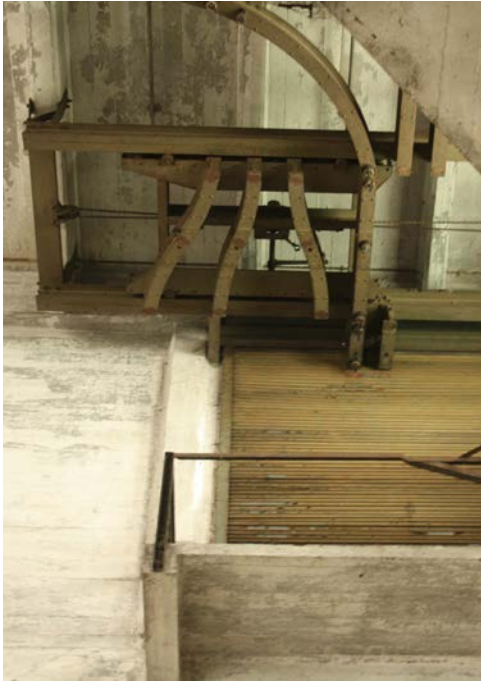
Image 1 - Rail changing system

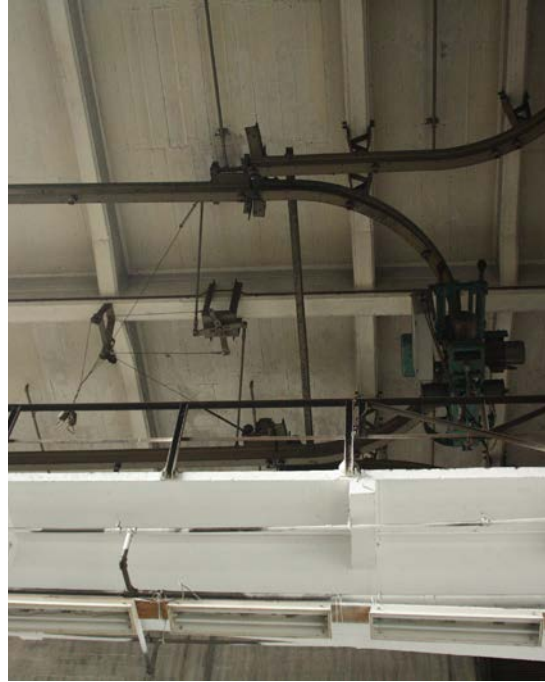
Image 2 - Rail changing system and operating cables

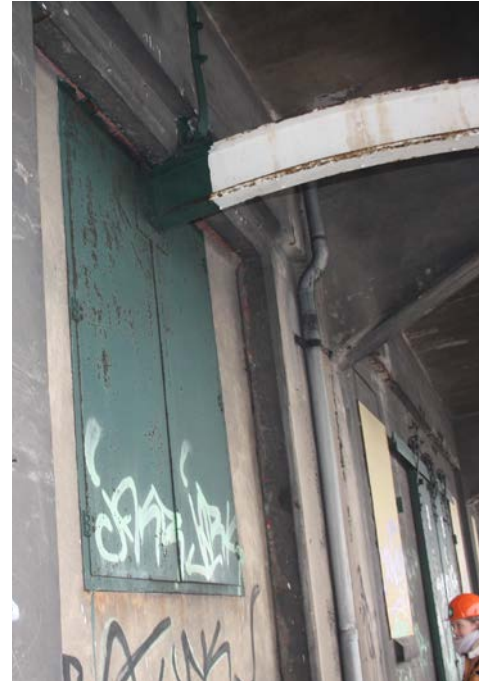
Image 3 - Rail through doors

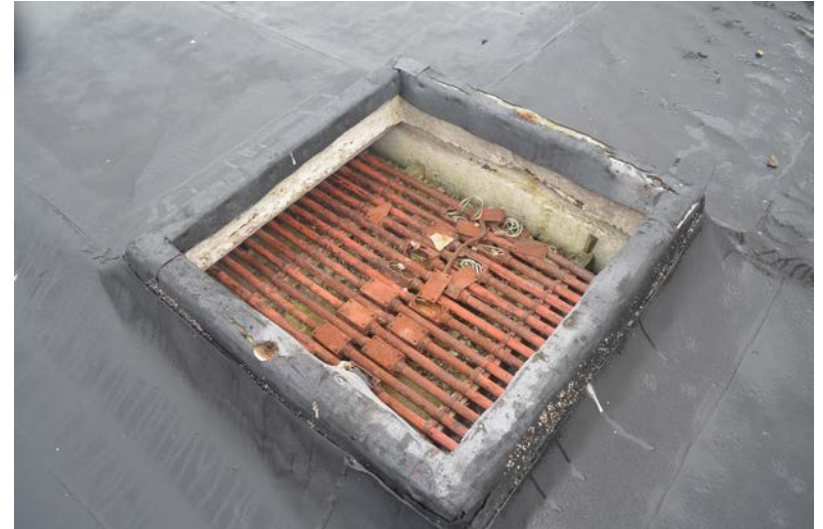
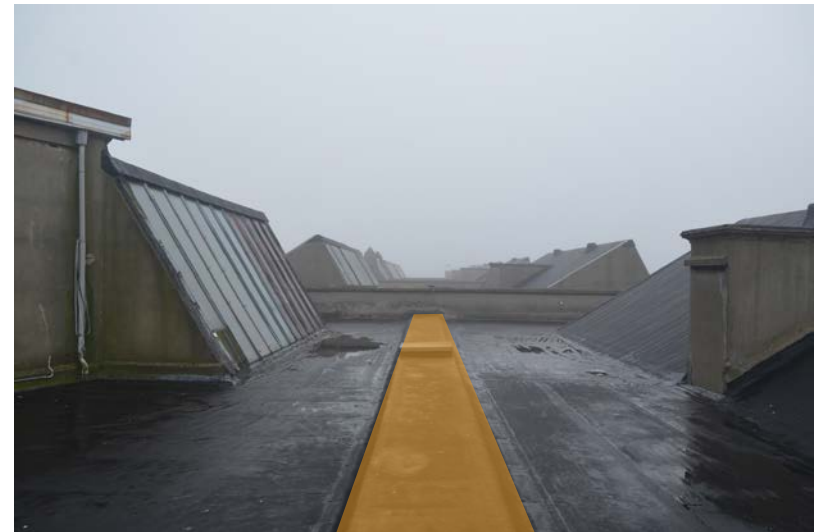
Drawing by L. van Straalen

Along the roof an electricity gutter provides the distribution of electricity for every compartment without breaking the fire protection walls.

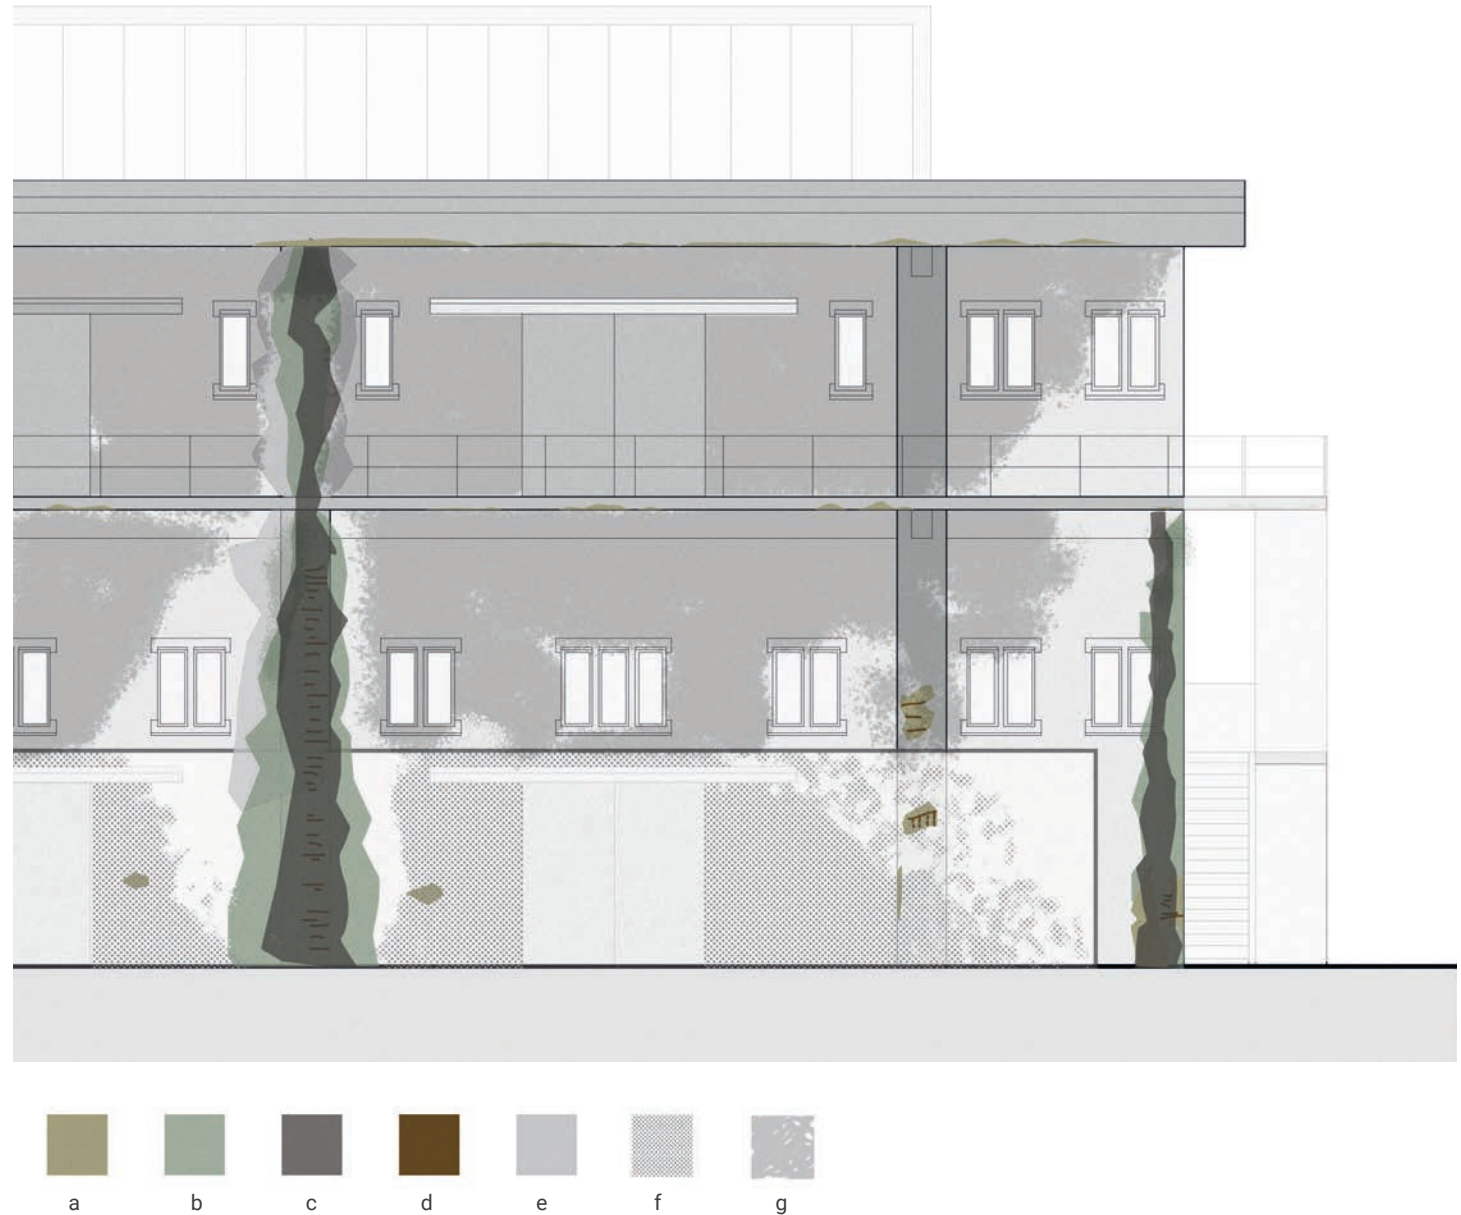
- a. Spalling of concrete
- b. Green; Linchen, moss, Algae.
- c. Wet Surface
- d. Rust in reinforcement
- e. Areas of salt damage
- f. White paint previous conservation attempts
- g. Black surface; industrial deposit of air pollution.

Damages inventory obtained by visual inspection of the building
Drawing by L. van Straalen

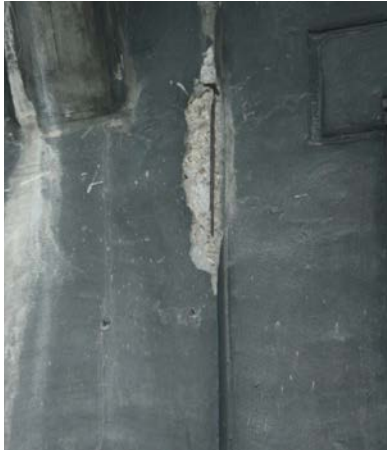
1 Spalling of concrete

Spalling of concrete [1] is a result of carbonation induced corrosion of the reinforcement. Due to contact with water the reinforcement starts to rust [2]. This not only negatively effects the loadbearing capacity of the construction as the diameter of rebar is reduced, but also the stresses that are caused by the rust can cause the surface to crack [3]. Cracks first appear parallel to the corroding reinforcement. This later leads to spalling of concrete and further exposure of the already damaged reinforcements.¹ Since the damage is caused by a presence of water, it is important to have a flawless drainage system. There

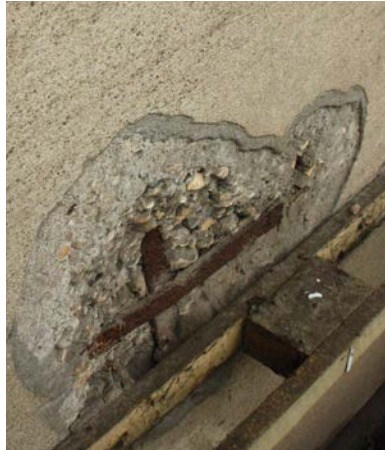
2 Corrosion of the reinforcement

is a lot of leakage from rainwater pipes, which further accelerates the deterioration of the material. The proximity of the site to river however also affects the building due to (salt) water spray. Water carried in small particles through the air enables salts to easily reach the building. Since the prevailing wind direction in the Netherlands is southwestern (see annex 2), wind often blows over the water towards Katoenveem and thus causes the damage to spread. The type of damage caused by salts [4] can be different from carbonation induced corrosion, as the reinforcements shows rather 'pitted' type of damage and

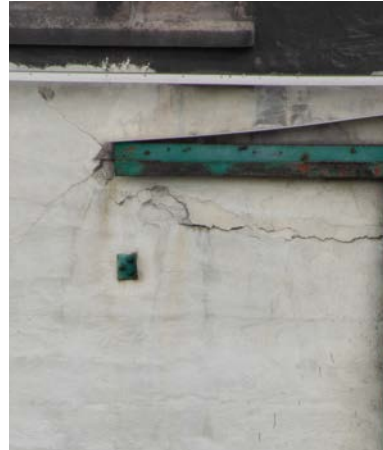
3 Cracks

a rust layer is not always formed.² The reaction with salts does not increase the volume of reinforcement, and therefore cracks and spalling are not always present. However, the structural strength of the concrete can be severely affected.

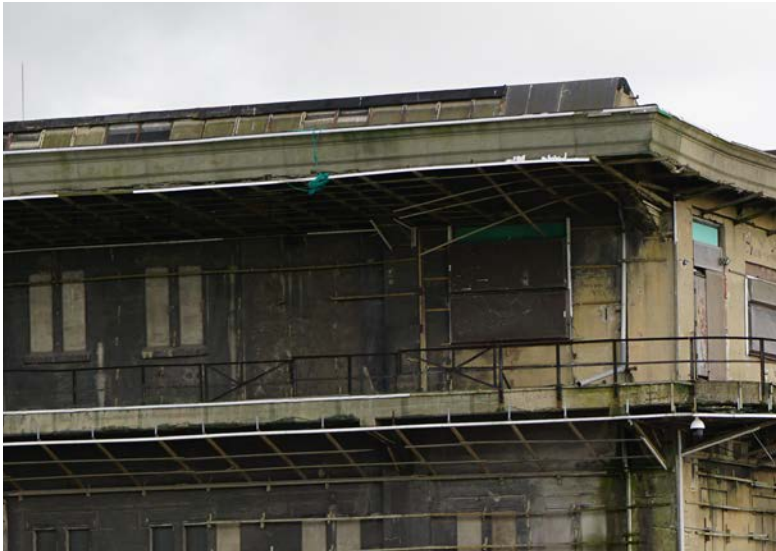
1

1. It is not visible what is behind the plate, this makes it difficult to estimate the appearance of the original facade. As we can see from pictures, there is a deviation in the grid, instead of a triple window, there is a double window. This part of the facade differs from the grid. An assumption of this deviation is there was perhaps a different function behind this part of the facade. The building is known for its function-led design choices.

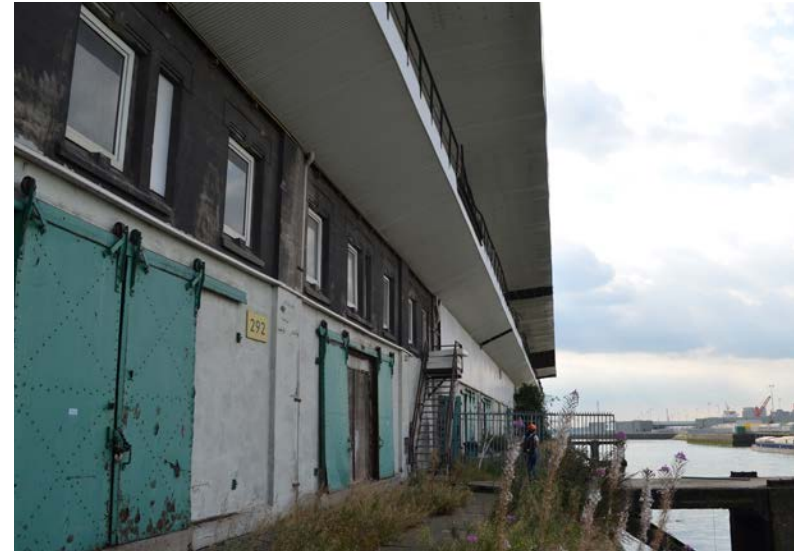
2

2. Photos of the past show the windows are not original. This makes sense because the window frames are more modern and interrupt the rhythm of the original window frames.

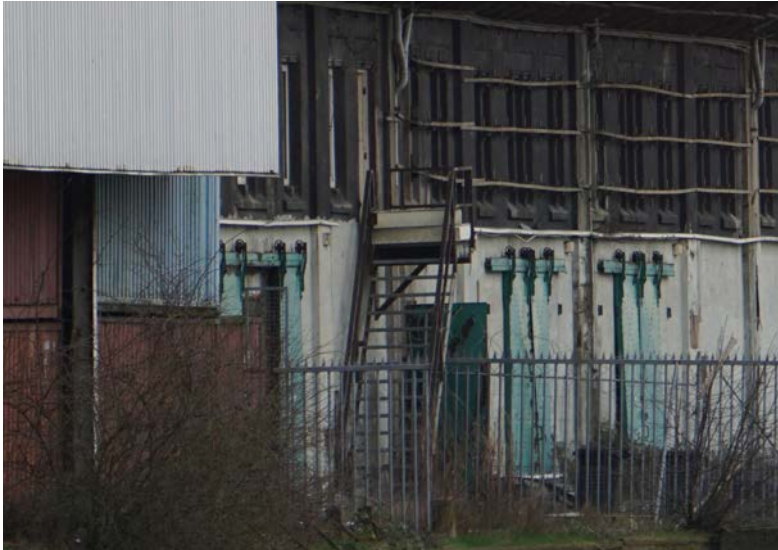
1

3. These stairs is very likely not original. It connects to one of the newly installed windows and was probably placed when Atelier van Lieshout took over the building. It probably served as an emergency staircase.

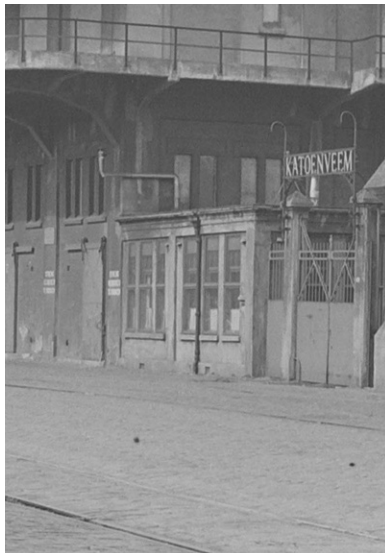
1

1. Office. Photographs from the past show that there used to be an office building against the east facade. The contours of this building are still clearly visible on the facade. In my own interpretation, the office building should have looked something like the one on the next page.

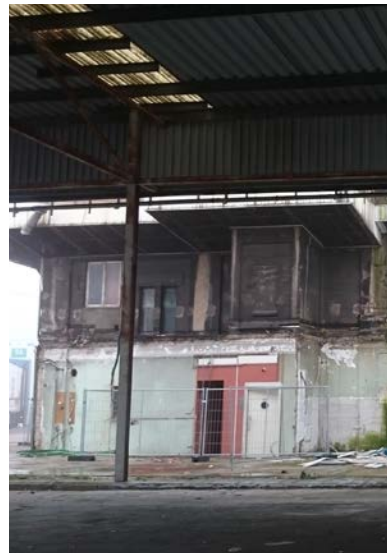
2

2. Openings that interrupt the rythm. These openings are not original, this can be concluded from photos of the past. For the façade fragments that cannot be found in photos can be argued that they are not original by the fact they deviate from the grid that Kanter designed.

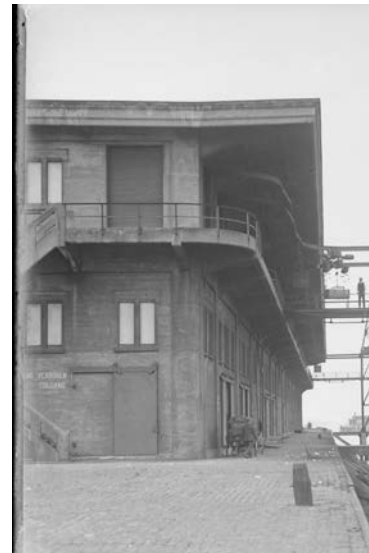
3

3. Elevator shaft with spiral staircase. The elevator shaft and stairs are now covered with metal sheet for protection. Historical photographs show us what the elevator shaft and stairs looked like. For example, there are some windows with the same ornaments on top of each other on the lift shaft and the spiral staircase will look a lot like the other stairs Kanters designed.

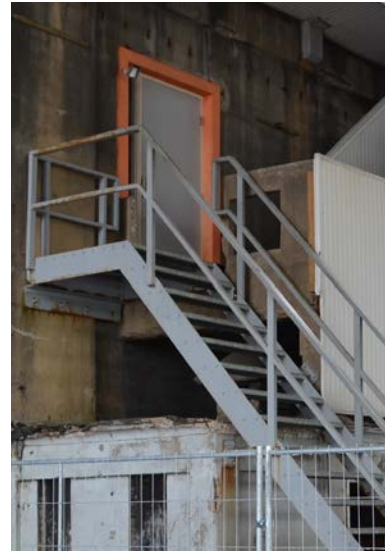
3

5. The garage door is not original, it passes right through the window frames. It is likely Atelier van Lieshout made this opening to get large artworks in and out of the building. During the time that this art studio was located in Katoenveem, many adjustments were made to the building.

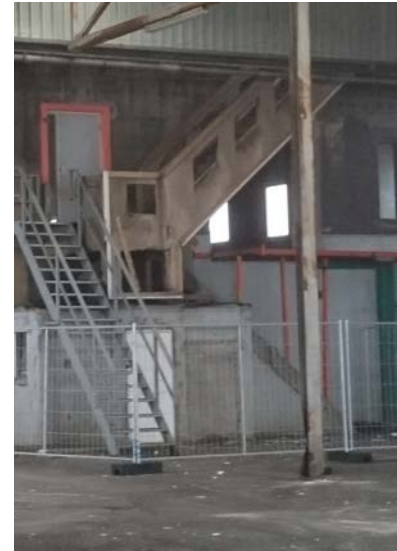
4

6. The original staircase is badly damaged.
