KATOENVEEM

MERWE-VIERHAVEN, ROTTERDAM

MSc III Heritage & Architecture

Architectural, Building Technology & Cultural Value Analysis

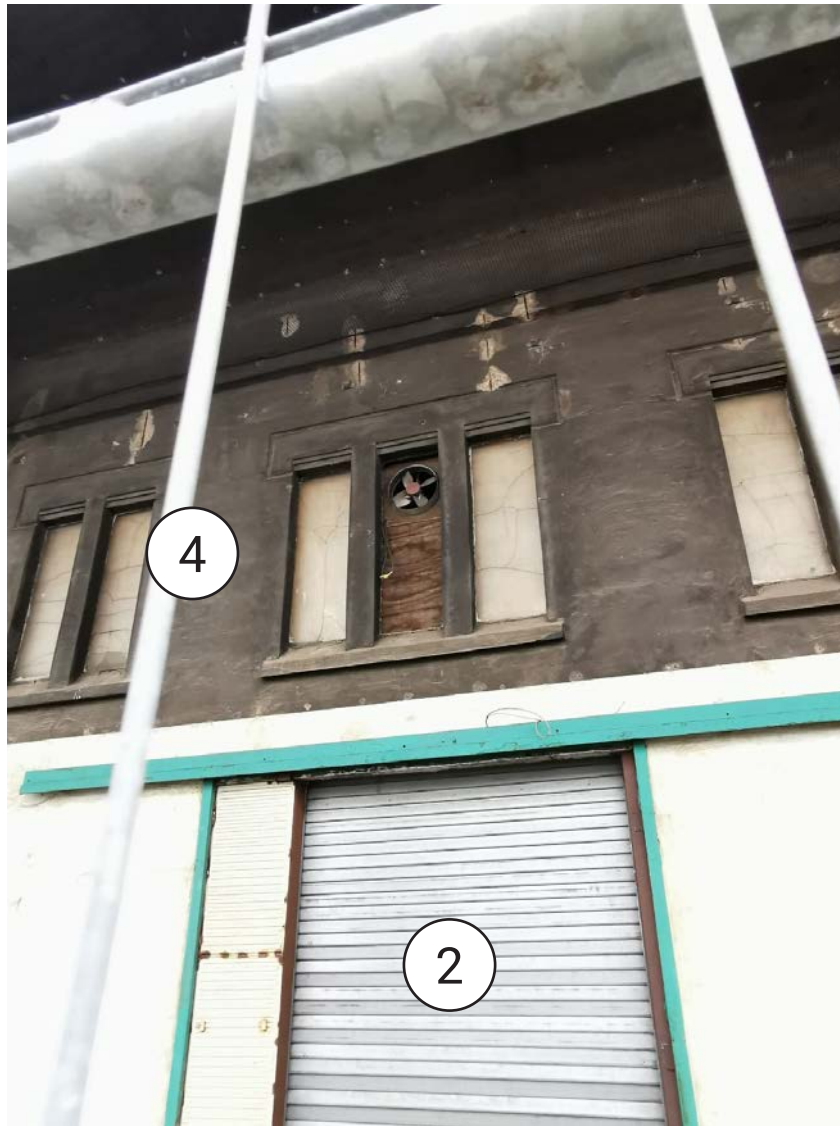
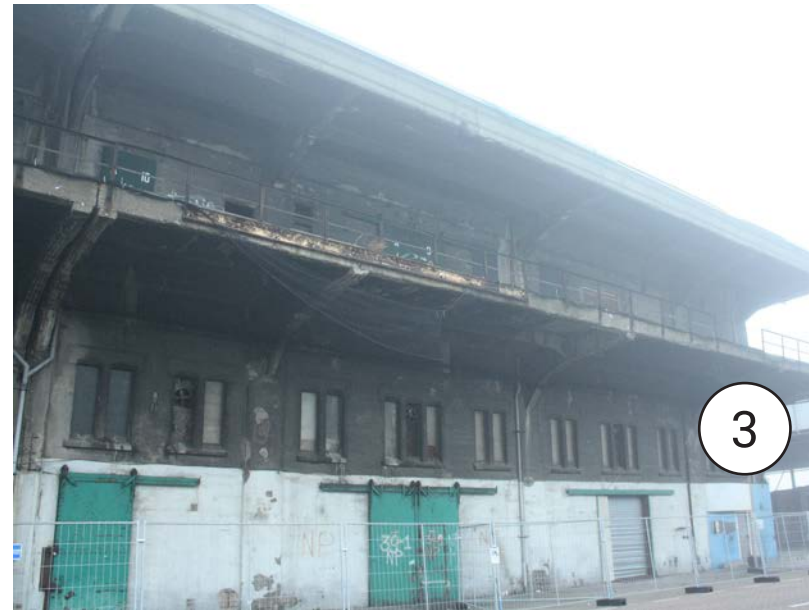
There are some interventions found in the south facade. The new openings are changed for a new office in the corner of the facade. Changes 1 and 2 are made in existing openings. Change 3 is more radical in its outline. Most of the existing window openings are closed in a practical way because of damage to the existing glass.

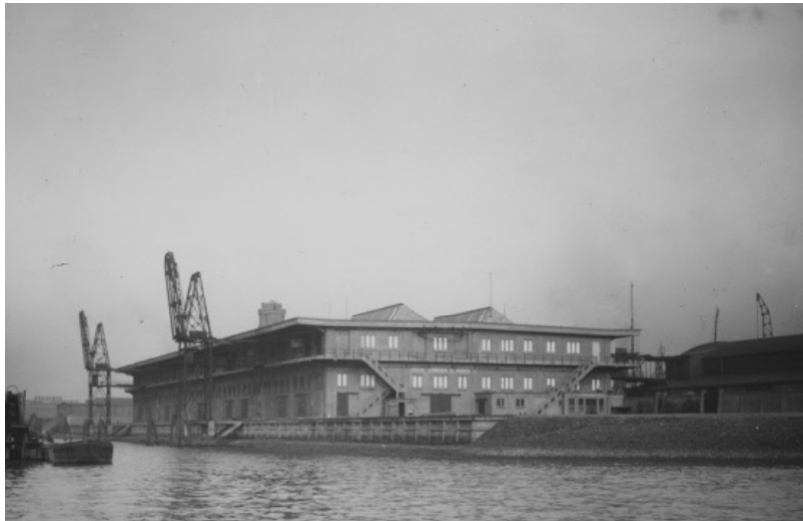
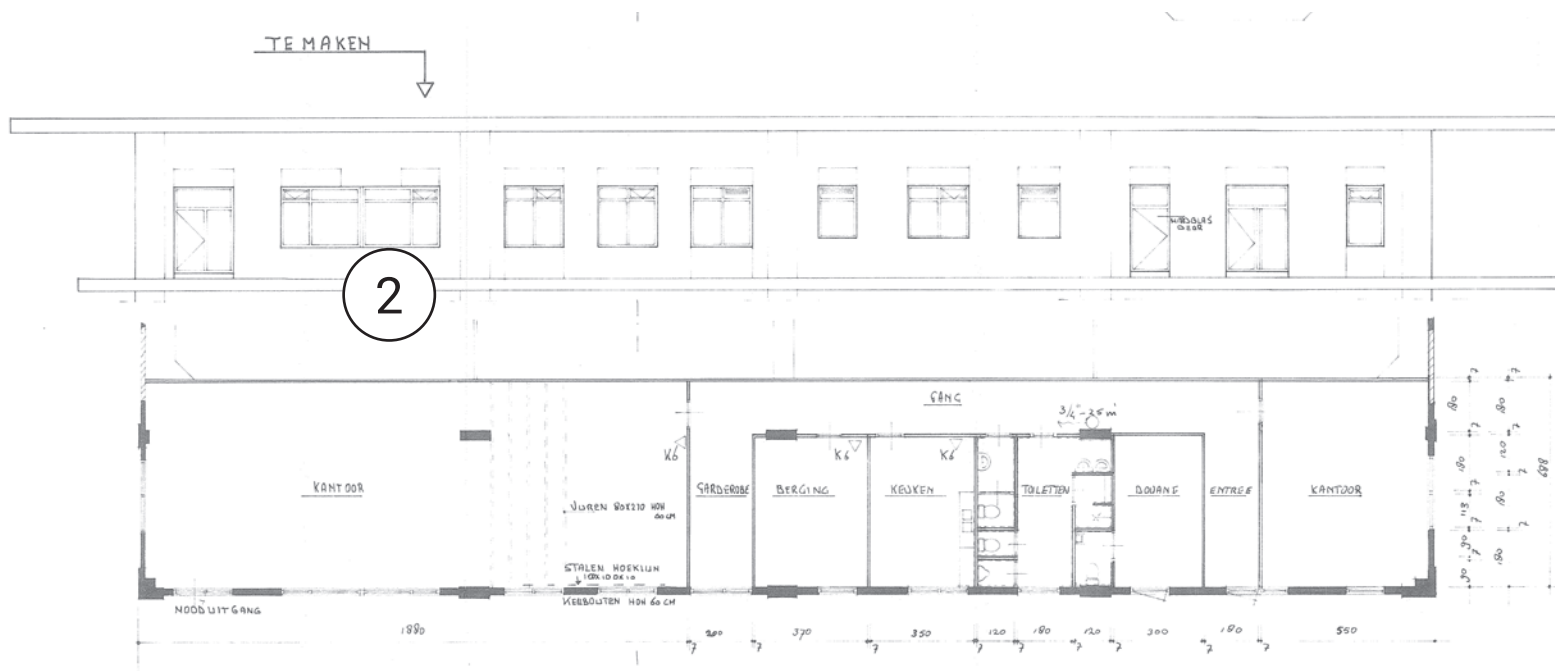
A large new garage door is made into the facade.(1) On the upper floor a new office space is created behind the facade. Here new openings (2) are made with different contours than the existing windows. The rest of the openings are closed. (3)

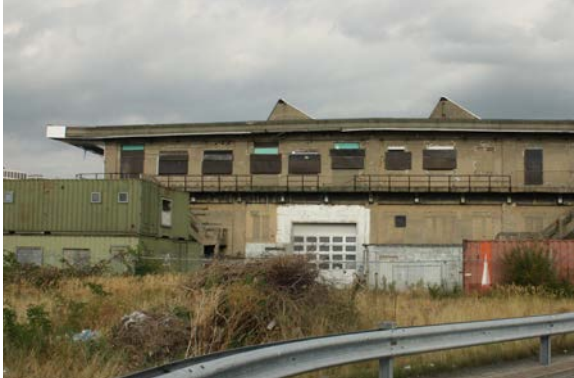
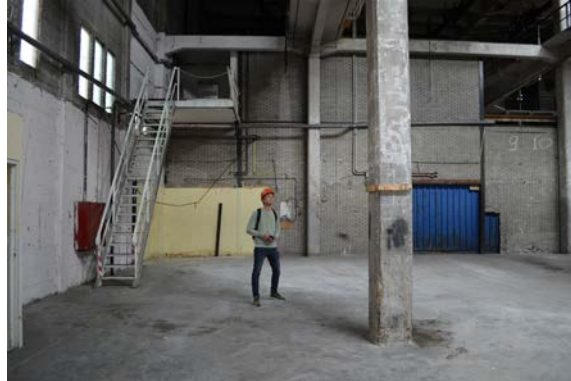
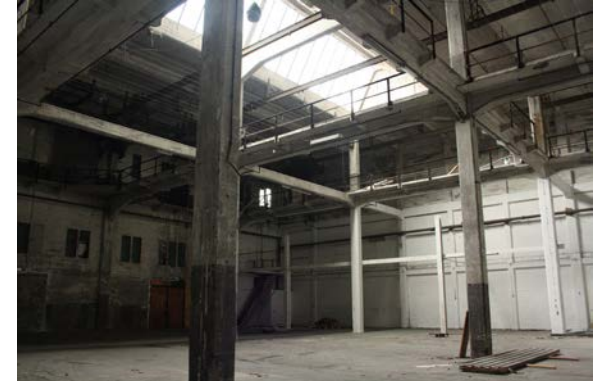
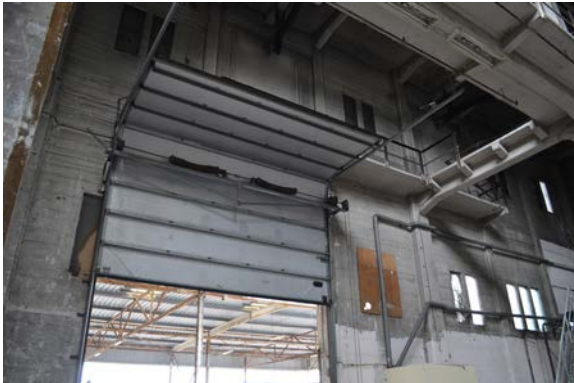
On the east and west facade large garage doors have been implemented. The exterior picture is of the west side, the interior picture is of the east side.

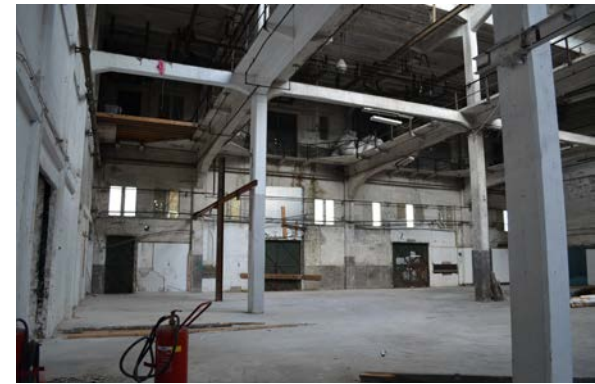
The second compartment has added steel columns and beams between the concrete beams. Also a wooden stair has been added. Furthermore wooden beams have been placed on the walking paths, as visible in the lower picture.
