Proceedings from the 14th World Conference on Timber Engineering

Mechanical properties of secondary lumber of Norway spruce

Florian Böhm¹, Sajjad Jubair², Andriy Kovryga³, Jan-Willem van de Kuilen⁴

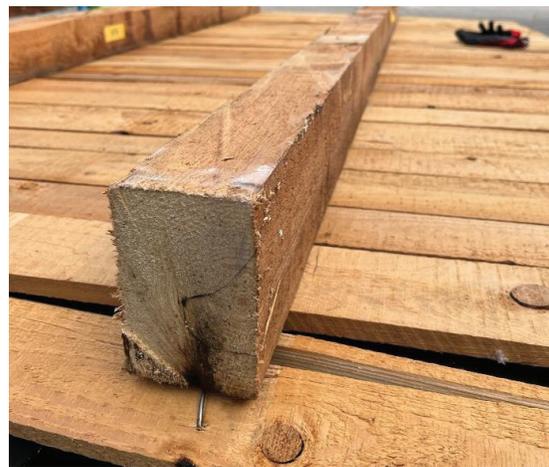
Figure 1. Recovered rafter fixed to deconstructed roof element initially erected in 1956. The cross-section of the rafter was 75x115 mm².

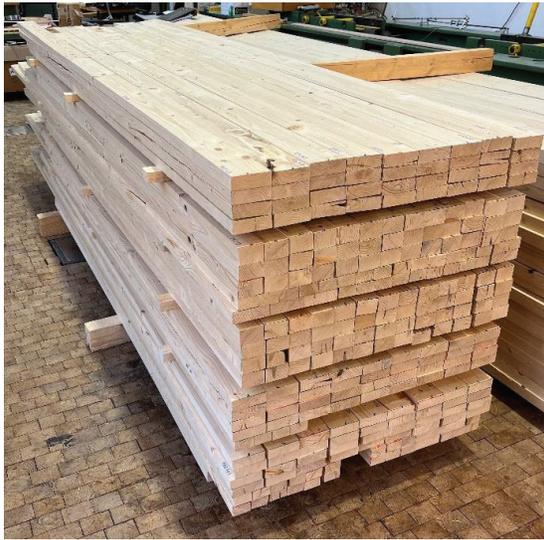
Figure 2. Final battens and boards after processing.

and not only over the standardized length of the bending test samples. Therefore, the number of fastener holes in each batten was counted. Second, the record and assessment of fastener holes were conducted over 400 mm in the middle of the sample. The recording and assessment length was divided into eight zones, each with a length of 50 mm (Figure 7). Fastener holes were categorized into the following two groups. Since no impact on the mechanical properties is expected from fastener holes smaller than 2 mm, this group of fastener holes was neglected. The first group (Group 1) contained fastener holes with a diameter between 2 mm and less than 5 mm. The second group (Group 2) contained all fastener holes with diameters larger than 5 mm. Fastener holes of Group 1 were assigned to one of the eight assessment zones (Z1-Z8). The exact position of the fastener holes of Group 2 was recorded, and an additional assignment to one of the zones was conducted. Fastener holes generally do not run vertically or horizontally through the battens. Therefore, the same fastener holes can appear on opposite or adjacent surfaces in different zones. Due to this, fastener holes were always allocated to the stamped top side of the batten (Figure 2).

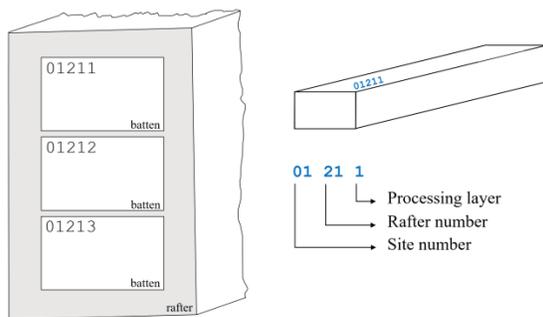
Figure 3. Representation of the systematic sample coding by stamping.

whether the batten was cut from the rafter's built-in upper (compression) or lower (tensile) site. Furthermore, the battens were stamped on the edge of one of the flat surfaces, indicating the reference surface for further investigations (Figure 3).

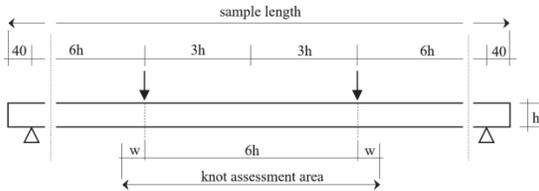
Figure 4. Graphical representation of the knot assessment area, where w is the width, and h is the height in millimetres.

The battens were visually graded in the area between the loading heads and an additional length similar to the battens' width (Figure 4). The weakest point was placed inside the bending test specimen during the sample preparation.

The bending properties of the battens, both edgewise and flatwise, were evaluated through four-point bending tests following the EN 408:2012 [26] standards. The samples were cut to the dimensions depicted in Figure 4. The distance between the supporting points was set at eighteen times the sample height (18h) plus an additional 40 mm on each side. Before the bending tests, the samples were conditioned at a temperature of 20°C and a relative humidity of 65%. After conducting the bending tests, a clear wood specimen was sliced across the entire cross-section near the point of failure. This wood slice was then oven-dried at 103°C until it reached a consistent mass. The wood's moisture content and density were calculated by weighing the samples and determining their volume through gravimetric measurements.

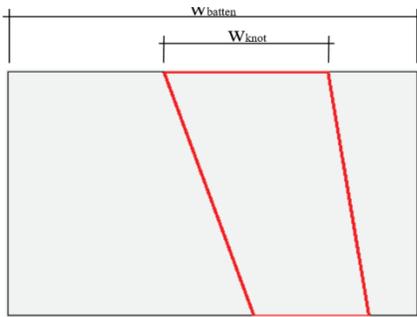
Figure 5: Visualisation of the knot cross-section (red) in relation to the batten's cross-section (grey/black) for a vertical running knot, where w is the width

software developed and hosted by Holzforschung München of the TUM. This software displays the cross-section of each knot in relation to the cross-section of the batten (Figure 5). Using this information, the proportion of the knot's width in relation to the width of the batten can be calculated. Additionally, the software can identify knots extending from one batten's edge to the opposite edge (Figure 6).

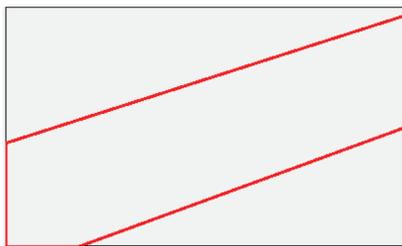
Figure 6: Visualisation of knot cross-section (red) in relation to the batten's cross-section (grey/black) for a knot, running from one edge to the opposite one

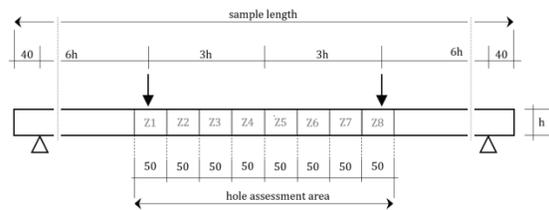
Figure 7. Graphical representation of the knot assessment area, where Z indicates the assessment zones, each with a width of 50 mm, and h represents the height in millimeters.

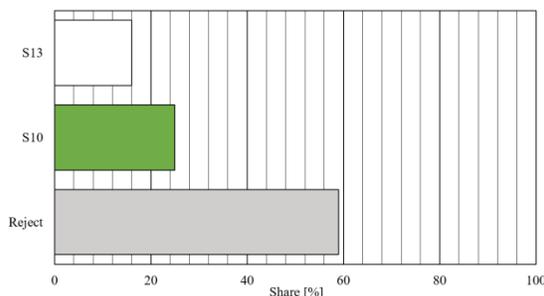
Figure 8. Share of the visual grades S10, S13, and Reject according to the visual grading of the battens according to DIN 4074-1:2012

The assignment of the 44 investigated battens according to the German standard DIN 4074-1:2012 [19] for visual strength grading of softwood resulted in a total yield of 41%. The yields to the individual visual grades are shown in Figure 8. The yields to S13 account for 16%, whereas 25% of battens were assigned to S10. The share of rejects is with 59% high, as one or more requirements on the sorting criteria were not met.

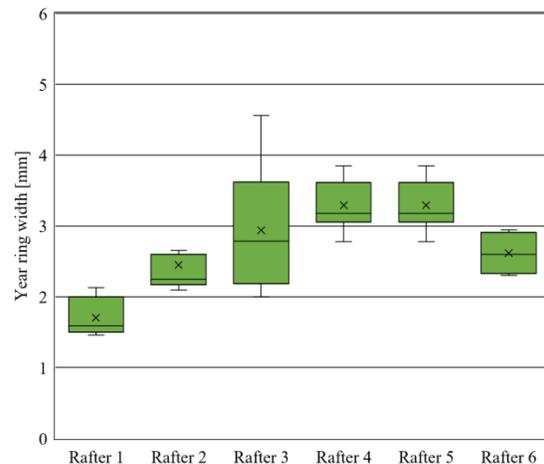
Figure 9. Boxplot of the growth ring width in millimeters for each rafter

The average growth ring width of each rafter shown in Figure 9 was between 1.7 mm (Rafter 1) and 3.4 mm (Rafter 4). The results indicate that the growth ring width of all rafters was quite similar, without significant outliers.

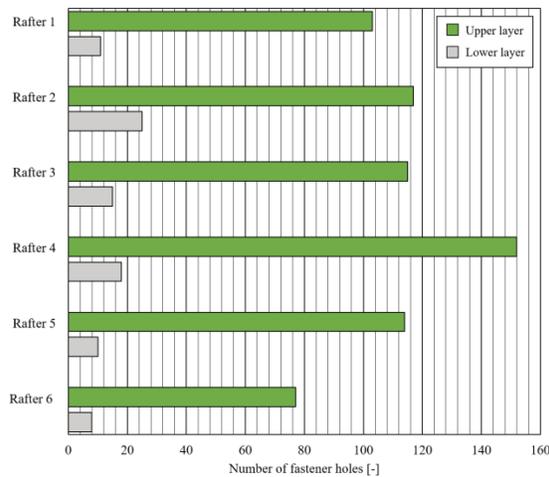
Figure 10. Number of fastener holes of Group 1 per rafter, displayed for battens cut from the built-in upper and lower layer of the rafter.

However, as shown in Figure 10, the results indicate that the fastener holes of Group 1 fasteners highly impacted the battens cut from the build-in upper layer of the recovered rafter compared to battens cut from the built-in lower layers. On average, each rafter 113.0 fastener holes occurred in battens cut from the upper layer. In contrast, each rafter 14.5 fastener holes were found on average for battens cut from the lower layers.

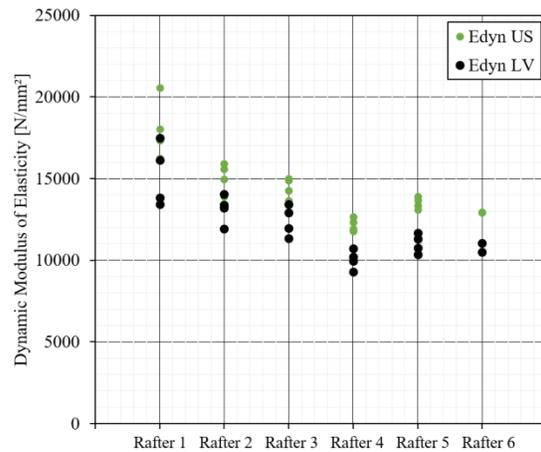
Figure 11. Dynamic Modulus of Elasticity (E_{dyn}) of the battens, measured through longitudinal vibration ($E_{dyn,LV}$) and ultrasonic measurement ($E_{dyn,US}$), grouped by the corresponding rafter.

The results of the non-destructive testing, which included longitudinal vibration (LV) and ultrasonic measurement (US), are displayed in Figure 11. For $E_{dyn,US}$, the average value across all battens was 14,505 N/mm², while for $E_{dyn,LV}$, the average was 12,230 N/mm². The coefficient of variation (COV) was 15% for $E_{dyn,US}$ and 17% for $E_{dyn,LV}$, indicating that these values are consistent with the ranges found in previously conducted tests. However, for each rafter's battens, the values for $E_{dyn,US}$ were about one-fifth (13-23%) higher than those achieved for $E_{dyn,LV}$. On average, the results for $E_{dyn,US}$ were 16% higher. This observation that the values of $E_{dyn,US}$ are higher than those of $E_{dyn,LV}$ is consistent with previous test results. When we compare the measured values to the data presented in

EN 338:2016 [27] Table 1, we find that the battens generally exceed the thresholds for the mean value of C24 (11,000 N/mm²). Additionally, the data in [28] indicates that the MOE for Norway Spruce is typically higher than the values specified in the standard.

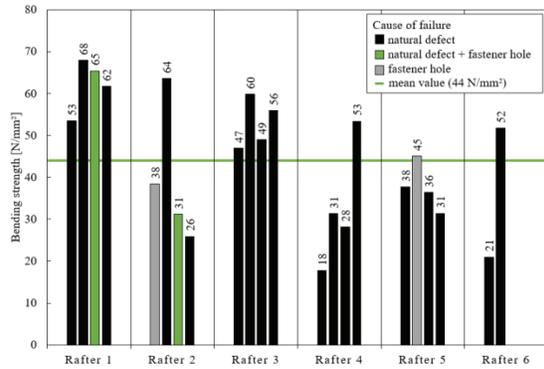
Figure 12. Bending strength for flatwise bending each batten, grouped by the corresponding rafter.

The results for the four-point bending test in a flatwise direction revealed for the 22 samples a mean bending strength of 44 N/mm² (COV 34%).

Figure 12 shows the cause of failure during flatwise bending. As for fresh-sawn wood, natural defects, especially knots, caused failure in most cases (82%). For 9% of the samples, fastener holes contributed together with natural defects to failure. In just 9% of the tests, fastener holes were the crucial single criteria for failure. As highlighted in Figure 12, although fastener holes caused the failure or contributed to the failure of the battens, high strength (31 N/mm², 38 N/mm², 45 N/mm², and 65 N/mm²) could be achieved.

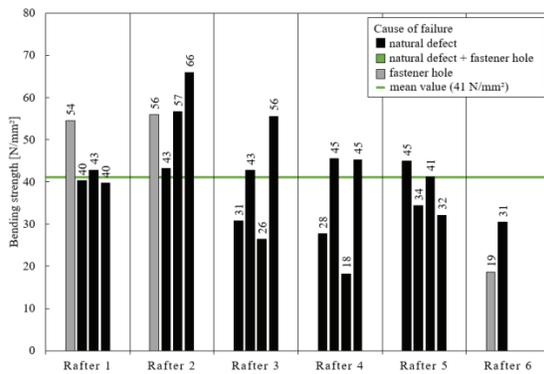
Figure 13. Bending strength for edgewise bending each batten, grouped by the corresponding rafter.

Figure 13 shows the results of the edgewise four-point bending test and the corresponding cause of failure. A mean bending strength of 41 N/mm² (COV 31%) was achieved. Like the flatwise bending test results, 86% of the battens failed due to natural defects, especially knots. Two of the three battens where fastener holes were the crucial single cause of failure showed bending strength well above the mean value (54 N/mm² and 56 N/mm², respectively). However, one of these battens failed with a bending strength of about 19 N/mm². For this batten, fastener holes in the zone subjected to tension stresses

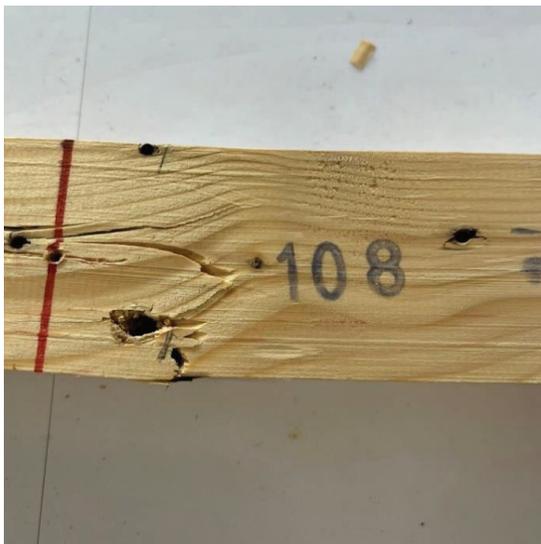
Figure 14. Picture of failure area of a batten that failed due to fastener holes subjected to tension during the edgewise bending test

during the edgewise bending test caused the failure (Figure 14).
