**Detection of Disaster-Prone Vernacular Heritage Sites at District Scale  
The Case of Fındıklı in Rize, Turkey**

International Journal of Disaster Risk Reduction

# Detection of disaster-prone vernacular heritage sites at district scale: The case of Fındıklı in Rize, Turkey

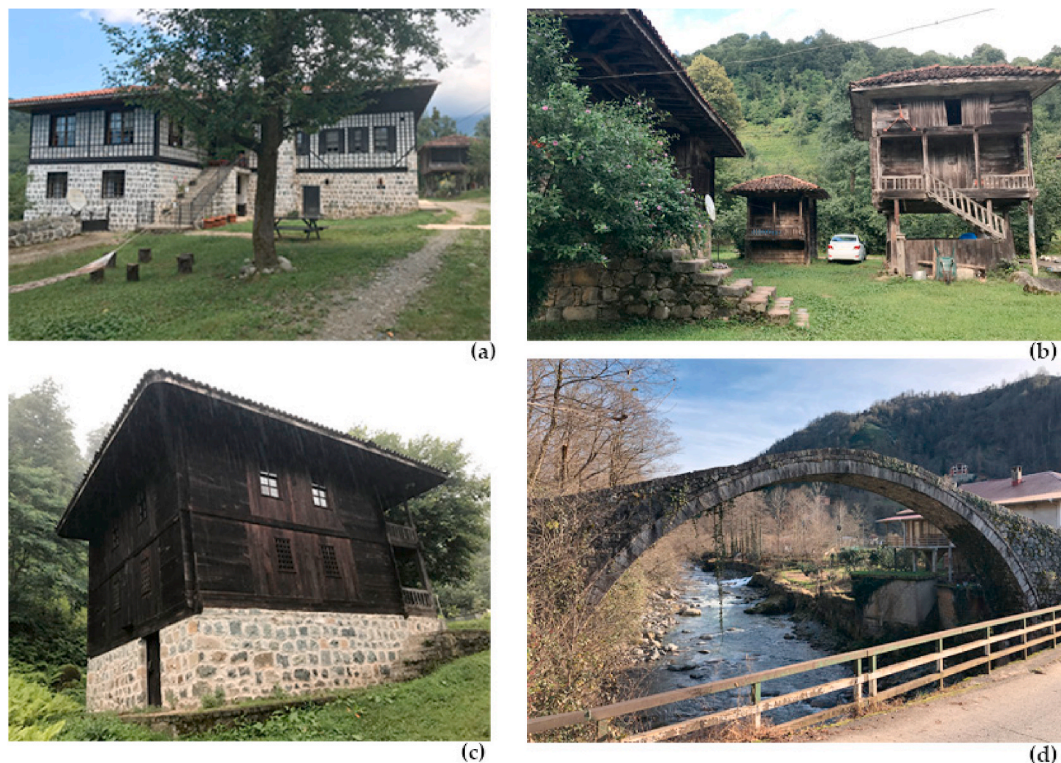
Fig. 2. Typical vernacular heritage in the region with (a) stone-infilled timber mansion, (b) timber house and storage houses, (c) timber mosque, and (d) stone bridge.

Fındıklı in Rize is rich with vernacular built heritage, such as mosques, stone bridges, traditional stone-infilled timber houses (Fig. 2), mills, barns, kilns, and archaeological sites; natural heritage, such as waterfalls, plateaus, and forests; and intangible heritage, such as timber artisanship, stone masonry, coppersmithing, basket making, weaving, hawk eagle raising, and corn bread making, in addition to other representations of the area's food culture [53]. The coastline settlements are more densely populated except during the summer months, especially July and August, when the population migrates toward higher plateaus for agricultural activities and animal breeding [54].

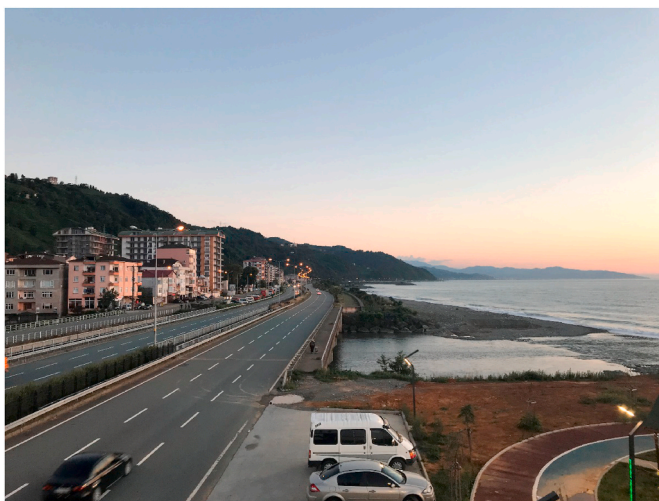
Fig. 5. The Karadeniz Sahil Yolu (Black Sea Seaside Highway) in Fındıklı of Rize. The photograph was taken by the first author, Gül Aktürk, on July 1, 2019.

The infilling project of the coastline of the Black Sea, known as Karadeniz Sahil Yolu (Black Sea Seaside Highway) (Fig. 5), connects the coastal cities of the Black Sea region in Turkey [73]. Although the highway officially opened in 2007, the foundation of this infrastructure was initiated by Russians after their invasion of the city of Rize in 1916 during the Ottoman Empire period, with the opening of a one-way road. The construction of the highway not only obstructed the sea access of local residents but also caused the destruction of historically important coastal settlements. As part of this project, the city grew toward the sea

and rocks were used to claim new lands. A new coastline was created to support the creation of additional public spaces [73].

On this new territory, the maps reveal the extension of harbor facilities with new seawalls along the coast. The erosion of rocks underneath the infrastructure has become an issue of land reclamation in the coastal area of Rize [43]. Coastal planning and developments along with river modifications increased the risks of flooding on coastal lowlands and riverine areas. Both coastal and inland flooding are affecting the surrounding settlements and infrastructure. Although the geographical location of the vernacular heritage in the hinterland seems to be far from these developments, the pressure of the coastal and central area are reflected on the hinterland, as a result of construction in the hinterland due to land scarcity on the coast and the drastic reduction of the riverbed to allow urbanization.

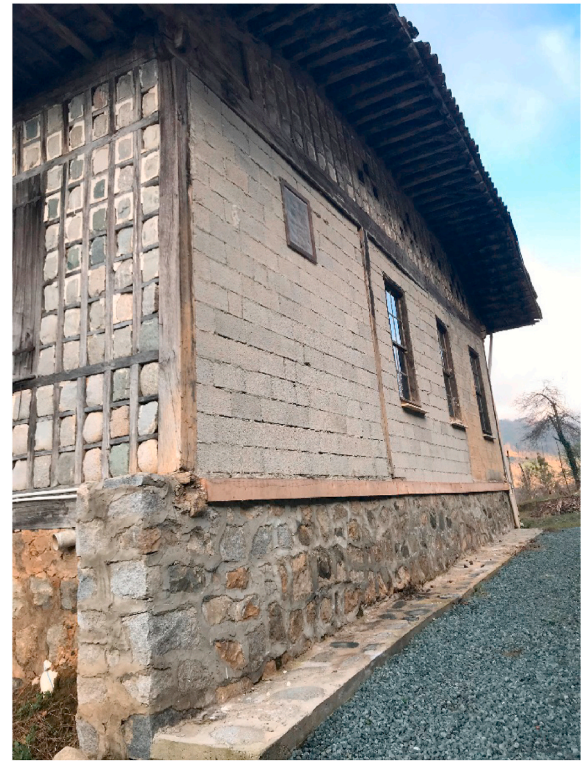
**Fig. 9.** The degradation of the rear façade of the Sevkety Atac House due to landslides in Çağlayan Village in Fındıklı of Rize. The photograph was taken by the first author, Gül Aktürk, on January 12, 2019.

In interviews, locals mentioned damages on vernacular buildings, e. g., façade deterioration and loss (Fig. 9). The maps from the institutions
