Forensic Analysis of Levee Failures: The Breitenhagen Case

International Journal of Geoengineering Case Histories

ABSTRACT: *Forensic analysis of past failures is valuable to improve our understanding of levee behavior. In this article a new systematic approach of forensic analysis for levee failures is proposed and applied to the Breitenhagen levee breach that occurred along the river Saale in Germany in 2013. The purpose of this study is to identify the cause of the breach based on the proposed approach, even though limited data is available. Based on the information prior, during and after the breach of the levee, a slope stability model is developed for the entire event. First, results from this model are obtained based on the expected values of the uncertain parameters and the best estimates of the situation. Uncertainty of the model is included in the calculation subsequently by defining possible failure scenarios. The most likely failure scenarios are derived from the data and included into the model so that it is possible to eliminate or validate all possible causes by means of a sensitivity calculation. It is concluded that the levee breach is likely caused by locally we

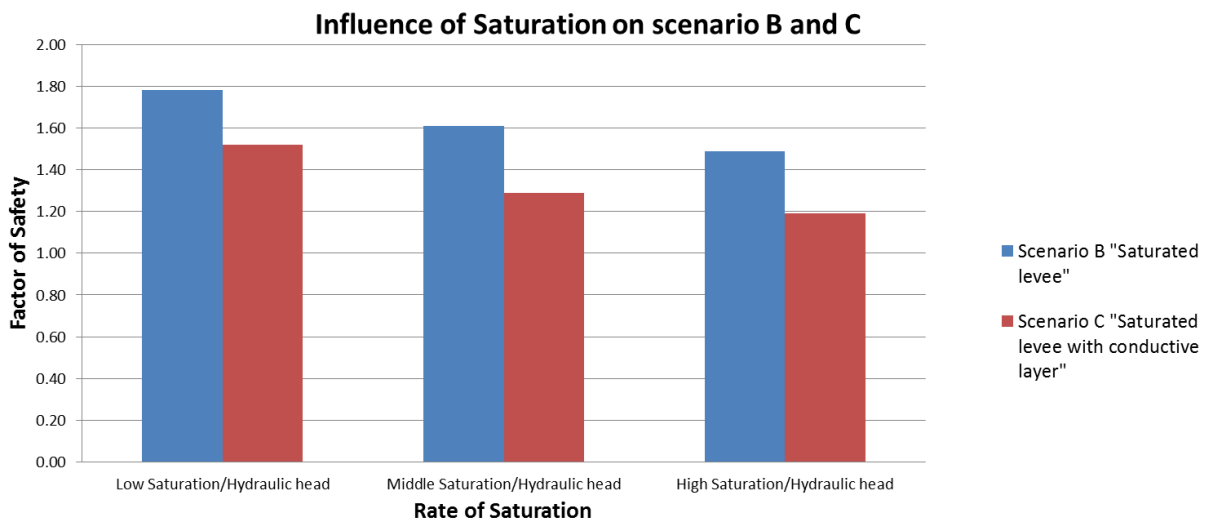
Figure 12. Blue: Influence of the saturation of the levee on the FoS. Red: Influence of the saturation when the local high water pressures in the conductive layer are introduced.

The FoS is negatively correlated with increase in water pressures, because the effective stresses are reduced, which in turn causes the shear strength to decrease. Due to the rising phreatic line, the range of FoS is in between 1.78 and 1.49 (Figure 12). The analysis of the increased potential head in the conductive layer around the tree roots results in FoS of 1.52, 1.29 and

1.19. The lowest factor of safety is found for the highly saturated cross-section in combination with the conductive layer. All models, yield safe values for the FoS.

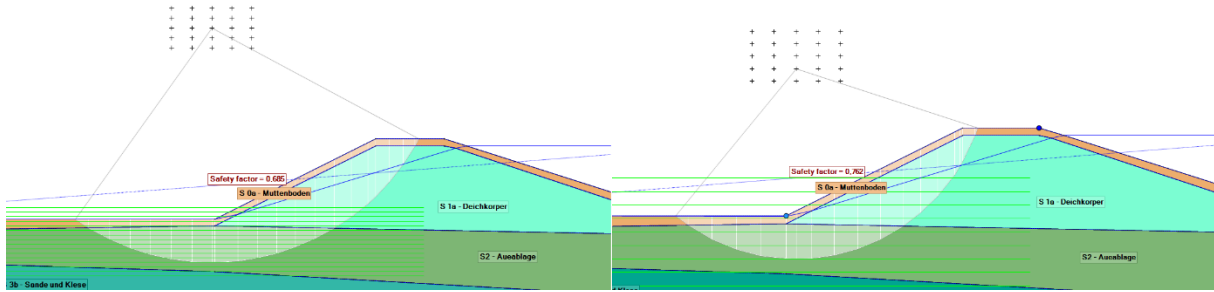
Figure 16 Left: View of scenario A. “Base model” using the Bishop slip circle and low values of POP resulting in $FoS=0.69$ (undrained soil behavior). Right: Scenario A. “Base model” using the Bishop model and low values of cohesion resulting in $FoS=0.76$ (drained soil behavior).

Varying the cohesion, which is the dominant parameter of the drained soil model, the FoS covers a range between 0.76 and 2.18 (Figure 15). The undrained shear strength has a high variability, due to the uncertainty of the previous stress history and related overconsolidation state (the POP, pre-overburden pressure, was used to describe this uncertainty). The results of the calculations greatly reflect this uncertainty in the calculated FoS ranging from 3.13 and 0.69. The parameters S and m, used to model undrained shear strength, result in large variation in FoS, but do not result in values below 1, which would represent failure of the levee. The calculation using the low cohesion values and the Bishop model show similarities with the actual slip circle and do not reach the sand layer underneath the cohesive layers (Figure 16).
