Forensic Analysis of Levee Failures: The Breitenhagen Case

International Journal of Geoengineering Case Histories

ABSTRACT: *Forensic analysis of past failures is valuable to improve our understanding of levee behavior. In this article a new systematic approach of forensic analysis for levee failures is proposed and applied to the Breitenhagen levee breach that occurred along the river Saale in Germany in 2013. The purpose of this study is to identify the cause of the breach based on the proposed approach, even though limited data is available. Based on the information prior, during and after the breach of the levee, a slope stability model is developed for the entire event. First, results from this model are obtained based on the expected values of the uncertain parameters and the best estimates of the situation. Uncertainty of the model is included in the calculation subsequently by defining possible failure scenarios. The most likely failure scenarios are derived from the data and included into the model so that it is possible to eliminate or validate all possible causes by means of a sensitivity calculation. It is concluded that the levee breach is likely caused by locally we

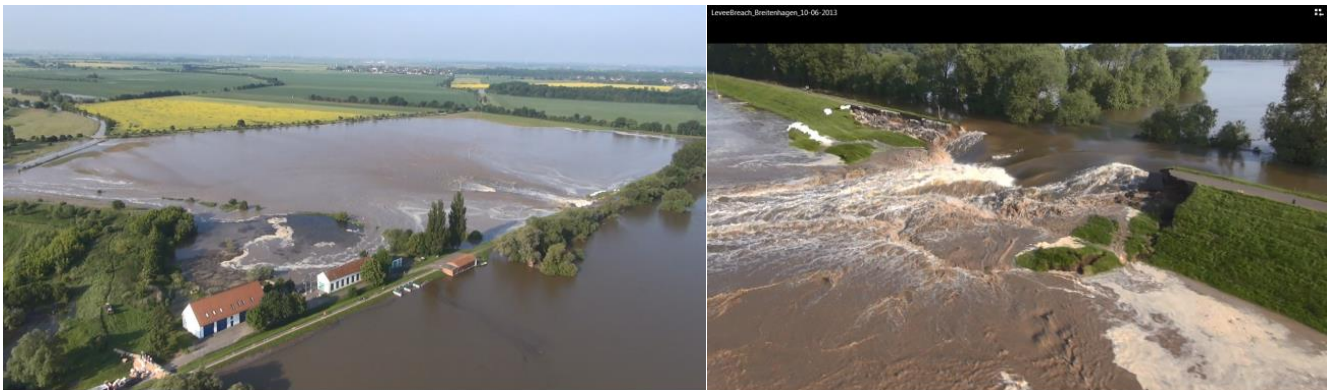
Figure 1 Left: Overview photo of the landside while the flooding evolves, Right: Overview photo of the breach on June 10th 2013 (Weichel, 2013).

During the floods of the Saale River in June 2013, the east embankment breached near Breitenhagen (Saxony-Anhalt, Germany) (Figure 1 and Figure 2) (Grubert, 2013). The breach of the levee caused a lot of economic damage that was financially covered by the state of Saxony-Anhalt (Drews, 2017). The failure appears to be the result of slope instability due to the long lasting high water level in both the Elbe and the Saale (Drews, 2017; Grubert, 2013). Historical documents indicate that the levee was built in the second half of the 19th century (Sixdorf, 2016). The overview photo shows a grassy levee with a paved road on top of the levee which can be used by heavyweight traffic (Figure 2). Trees grow along the length of the levee in the floodplain of the Saale. The overview photo also shows a pond near the location of the breach at the river side of the levee (Figure 2).

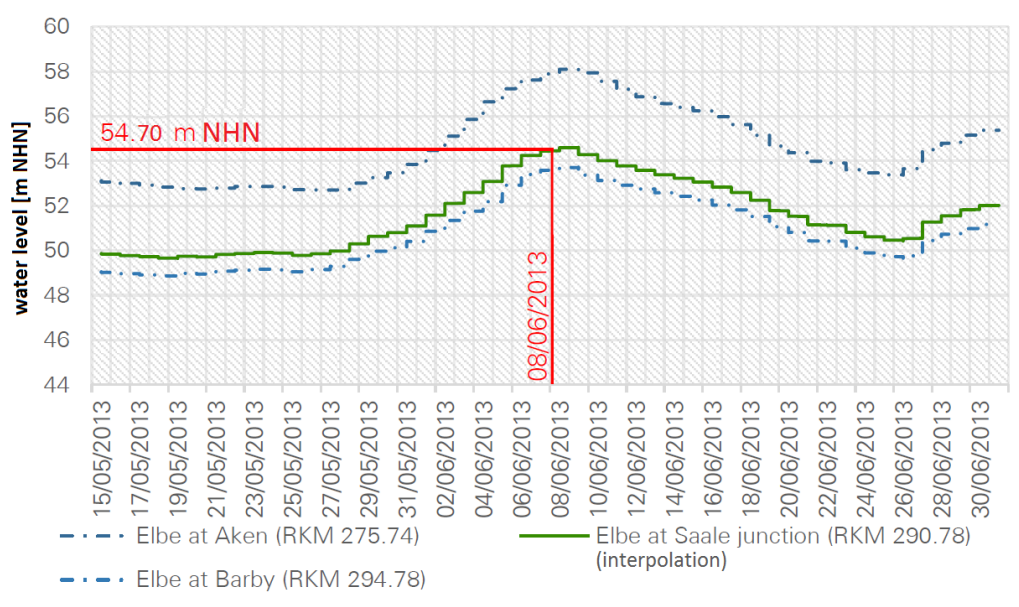
Figure 3. Graphs with water levels over time of the Elbe and Saale near Aken and Barby. Water level at Elbe and Saale junction, RKM 290.8, is $\text{NHN}+54.7\text{ m}$ (Drews, 2017; Grubert, 2013)

In the summer of 2013 both the Elbe and the Saale river experienced high water levels due to heavy rainfall upstream. The peaks of the high water levels met each other at the intersection of the Saale and the Elbe near Breitenhagen. The actual water height was not measured at the location of the breach, but the water levels were measured at the nearest upstream and downstream measurement station and the levels at Breitenhagen were interpolated (Figure 3) (Drews, 2017). The elevation of the (water) level is expressed as a standard reference level called the NormalHohenNull (NHN) which is approximately equal to mean sea level. The breach occurred just at the moment that the water levels in both rivers reached their peak on June 8th, 2013. It appeared that the water levels of 2013 were the highest water levels ever measured in both the Saale and the Elbe (Drews, 2017). Both water levels have a return period of 100 to 200 years (Drews, 2017; Elbe, 2014).

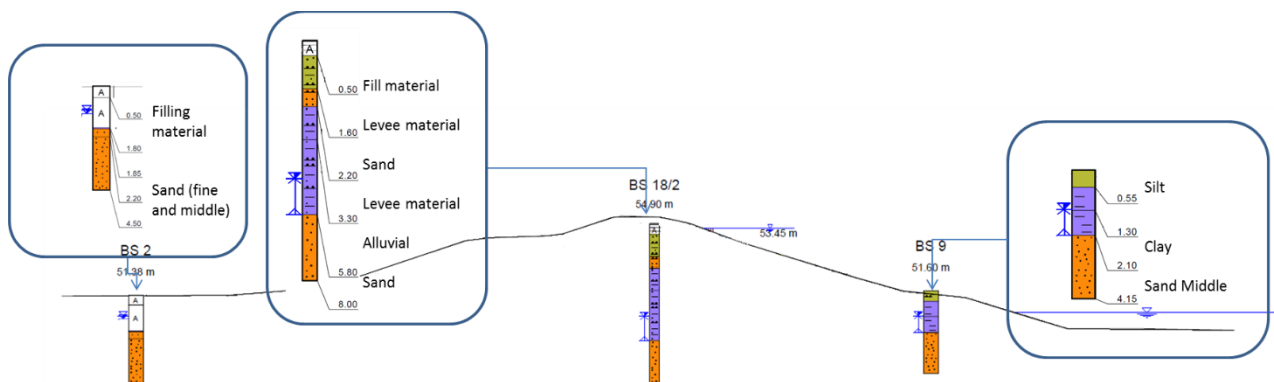
Figure 4 Cross-section of the levee (right is riverside) near the location of the breach (length marker +590 m), with the water levels, groundwater levels and the results of the borings (titled BS2, BS18/2, BS9 taken about 10 m in distance of the start of the breach (Grubert, 2013). The borings were taken both before and after the breach of 2013.

The stratigraphy is reconstructed using the borings that were completed over five cross-sections, including samples at the toe and the crest of the levee (Grubert, 2013). The borings were positioned near the location of the breach (length marker +600 m). In total twelve borings were completed to a depth of approximately 3 m to 4 m. The borings show little variation in width over the cross-section (Figure 4).

The cross-section generally consists of two layers (Figure 4 and Table 2) (Grubert, 2013). The top layer of the levee consists of largely homogeneous cohesive material (clay-like). A few inclusions of locally mixed-grained soils are identified. The bottom layer consists of a sand layer that can be found throughout the cross-section at an approximate elevation of NHN+49.5 m about 5.5 m deep from the surface (Table 2). This layer likely functions as an aquifer. The identified soil types are characterised by the typical characteristic parameters listed in Table 3 (Grubert, 2013; Schneider & Albert, 2014).

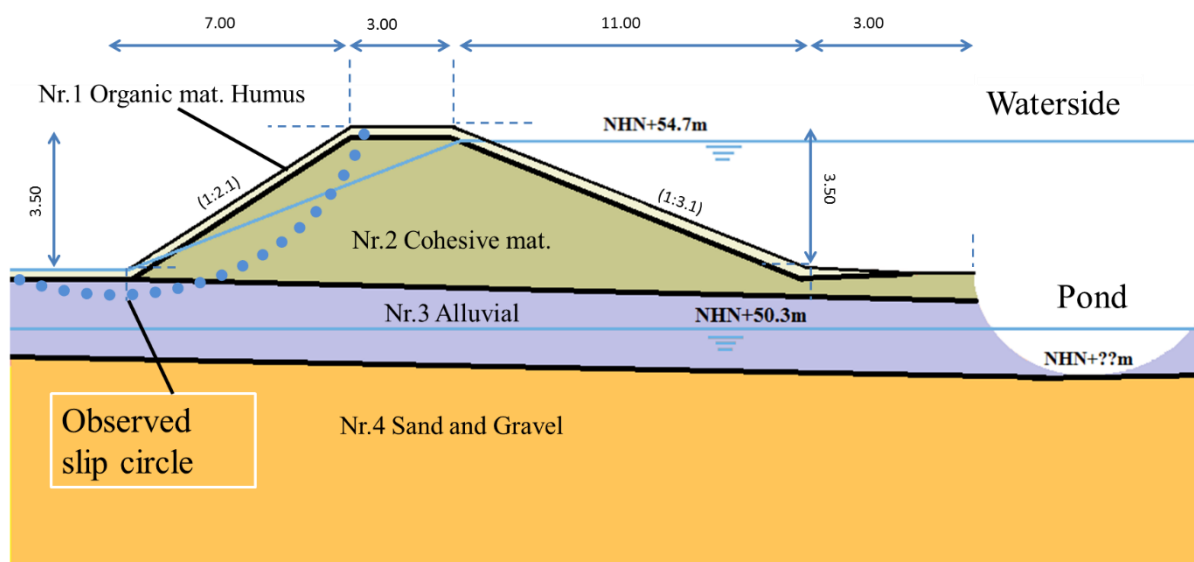
Figure 5. Dimensions of the Breitenhagen levee including simplified soil layering flood level and assumed aquifer level (pre-failure, left side is landside, right is the waterside). The 2013 high water level is NHN+54.7 m, the measured groundwater level is NHN+50.3 m. The soil modelling is based on the forensic engineering report (Grubert, 2013), incorporated with maximum occurred flood level, and soil types (Grubert, 2013).

The dimensions of the cross-section of the levee are mapped at the location of the breach (Figure 5). The measurements show that the levee is about 3.50 m high with a crest width of 3.00 m. The landside slope is 1:2.1 and the waterside slope is 1:3.1. The distance between the waterside toe and the pond is about 3.00 m.

The data collected prior to the breach provide an indication of the condition of the levee prior to the breach. The overview photo shows a pond in front of the levee possibly caused by an earlier breach (Figure 2). This indicates the possibility of a direct connection between the outside water level and the aquifer below the levee. The photos show a row of trees at the riverside toe of the levee which might influence the conductivity of the levee due to the intrusion of the roots inside the levee, or might indicate the presence of a more conductive layer inside the levee (Figure 2). The slope of the levee is very steep (about 1:2.1 vertical to horizontal) with a gradient that exceeds the friction angle of most soil types. The slope at the landside is prone to instability (Figure 5).

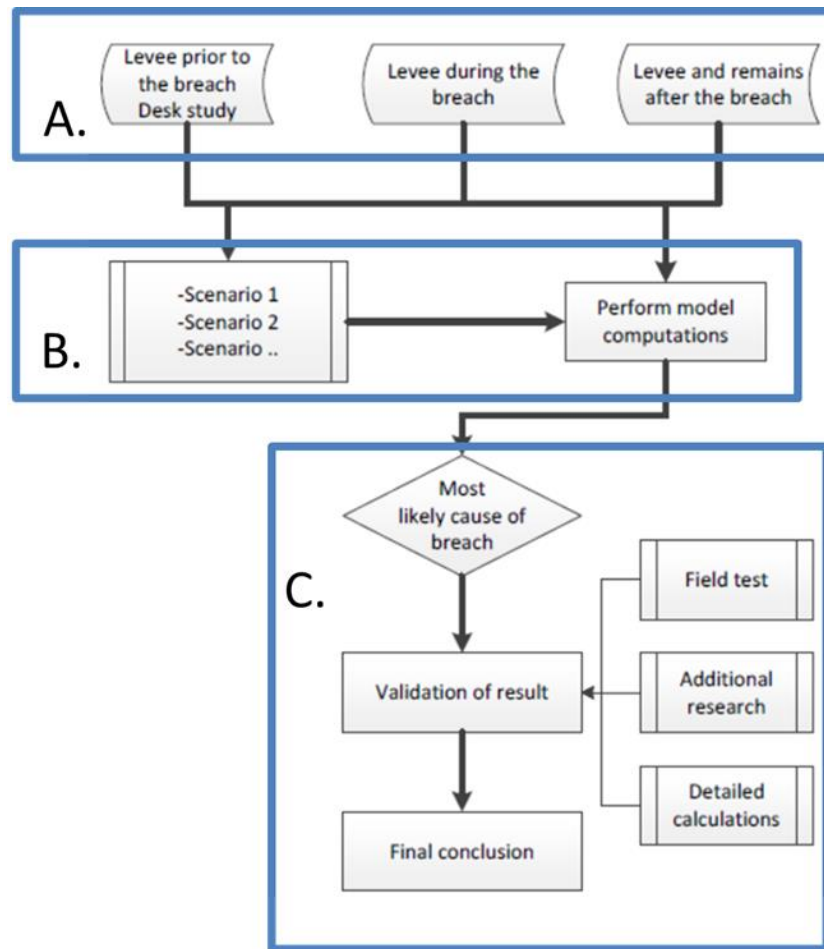
Figure 8. Generic approach for levee forensic analysis based on Borsje, et al. (2014) Step A.: Collecting information for exploring possible scenarios; Step B.: Evaluate with a computational model; Step C.: When results do not identify the cause, additional information can be gathered.

To identify the most likely cause of a levee failure, a systematic approach for forensic analysis of levee failures is suggested. In order to make the generic forensic analysis approach more applicable to levee failures, the standard three steps of forensic engineering as proposed by TNO (see section 3.1) are adapted into three more specific steps for levees (A, B and C, see Figure 8).

In step A, the collected data that are typically relevant for levee breaches, are sorted in three ways, i.e. data collected prior, during and after the failure as shown in Figure 8. This provides a clear overview of which data are relevant in terms of factors that are of influence on the performance behavior and a first impression on the performance behavior of the levee during extreme circumstances. A distinction is made between input parameters (which are considered as possible causes e.g. pore water pressures and shear strength of the soil) and model choices (e.g. LEM and (un)drained soil behavior). With the data during and after the failure, possible failure scenarios are determined and the behavior of a levee is studied.

In step B, a sensitivity analysis is used to validate or eliminate possible causes contributing to the levee failure (hindcasting) (Figure 8). Using the data and additional literature, the best estimate scenario and expected values for the input parameters are modelled (further referred to as "base model"). During the process of developing a "base model", all the individual uncertainties are identified and introduced as scenarios (in terms of input parameter and modelling choices). During the sensitivity analysis, the expected values of the still uncertain input parameters are replaced one by one by realistic upper and lower limit boundary values.

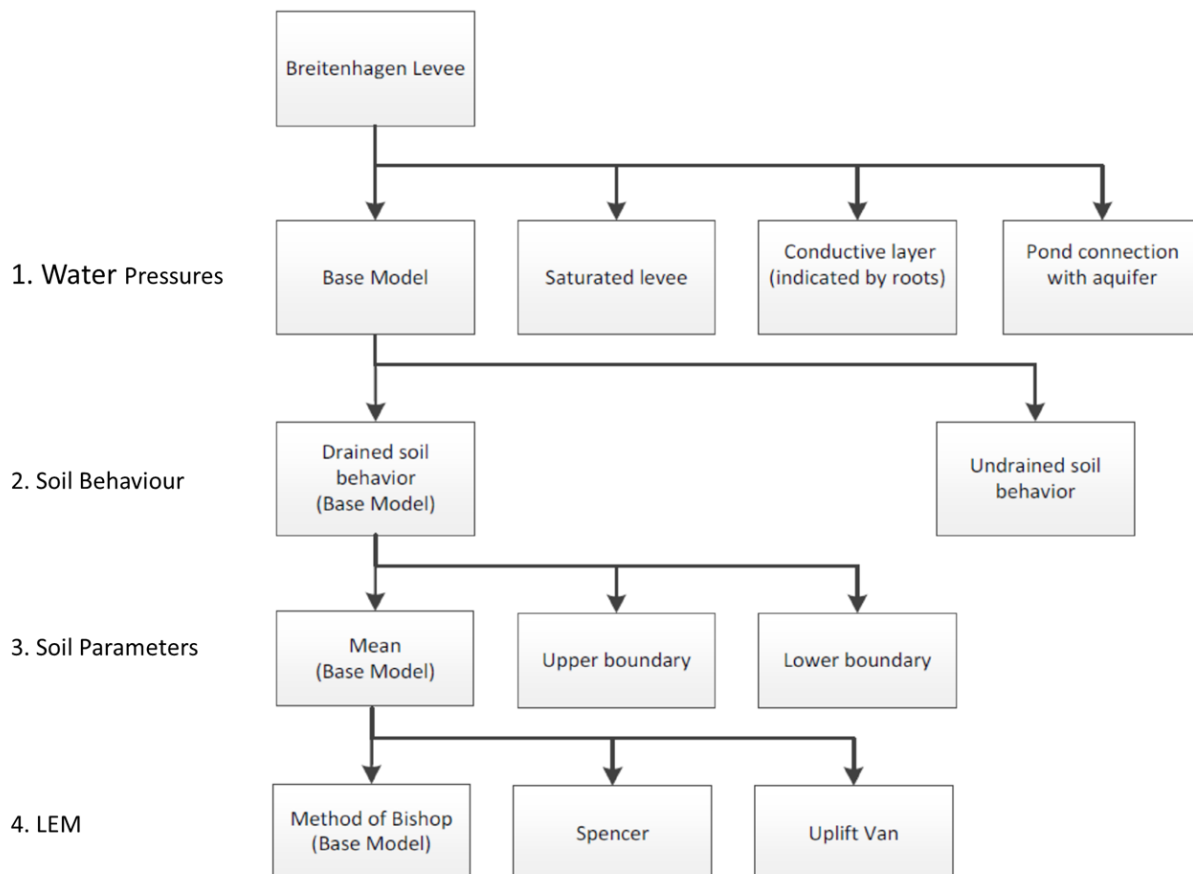
Figure 9. Overview of all factors of influence to vary in the sensitivity analysis one by one. Level 1.: Water pressure scenarios. Level 2.: Soil reaction behavior scenarios. Level 3.: Soil parameter scenarios. Level 4.: LEM scenarios.

The next step is to identify the individual influence of the uncertain factors (level 1 to level 4) and verify whether the calculated slip circle naturally matches the actual observed slip circle (Figure 11) and doesn't intersect with the sand layer. For the input parameters, the lower and upper limit boundary values are introduced, one by one, into the “base model” (Figure 10, Table 4 and Table 5). The actual input values and factors are introduced and discussed in the next section. The results that are expressed as factor of safety (FoS) show a range of possible outcomes, related to each individual factor of influence. Additional analyses on combinations of possible causes are executed. Thus, an overview of stability with one or more dominant contributors is developed. When the related FoS is below a value of one, the situation is considered to be unstable and the scenario is identified as a possible cause of failure.

With the selected scenarios introduced in the previous section, a sensitivity analysis was conducted in order to find the most likely causes of the failure (Figure 9). In the following paragraphs, the results related to the scenarios of water pressures are presented, followed by the influence of the soil response behavior (drained and undrained), the influence of the different shear strength parameters and the influence of the different LEM. In order to highlight the potential of further research, the results of the more prominent combinations of possible causes are presented as well. In total 32 scenarios and different combinations are taken into account. The model of the best-estimate situation represents the base of the sensitivity analysis (referred to as “base model”) and is presented in the first paragraph. In the last paragraph an overview of all results is given.

Three different LEM are used in the assessment on the levee strength, i.e., Bishop, Uplift Van and Spencer (Figure 9 level 4) in the D-Geo Stability software (Deltares, 2016). All three LEMs are applied to the “base model”. The sensitivity analysis is used to establish the influence of different LEM. The FoS determined with the help of the Bishop, Uplift Van and Spencer model covers a range between 1.55 and 1.61. All models result in approximately the same slip circle (Figure 11, Figure 17). The Spencer method shows the most realistic geometry of the slip circle (i.e., the slip circle doesn’t intersect the sand layer).

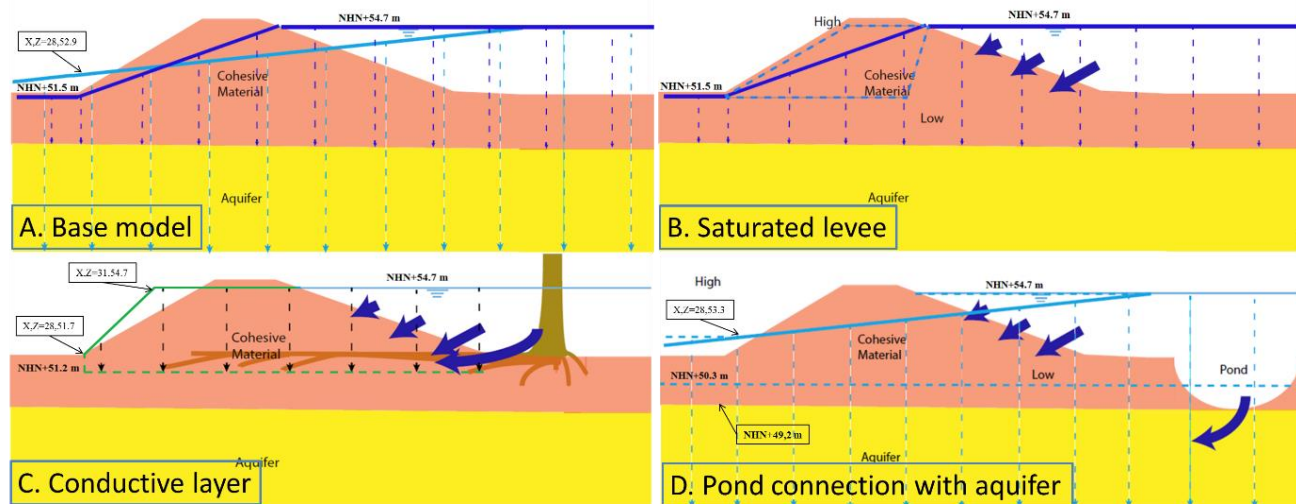
Figure 10. View of the four possible scenarios derived from the data analysis. Scenario A: Best estimate of phreatic line inside the levee (solid dark blue) and best estimate hydraulic head in the aquifer (solid light blue), called "Base model". The river head (NHN+54.7m) and locally heightened polder head (NHN+51.5m). Scenario B: Infiltration of water through the levee slope which is called "Saturated levee" (dashed light blue lines); Scenario C: Infiltration through a conductive layer related to the tree roots which is called "Conductive layer, indicated by the tree roots" (situated at NHN+51.2m) (the hydraulic head in green is the head at the location of the roots, the phreatic line is the same as the Base model. Inside the levee, water pressures in the levee are interpolated between the phreatic line and the green line); and Scenario D: Infiltration through the connection between the outside water level and the aquifer which is called "Pond connection with aquifer" (polder head of NHN+51.5m) with an upper and lower head (dashed light blue lines);

In the scenario of the “Saturated levee” (scenario B), the only phenomenon that is taken into account is the development of the phreatic line in the levee body (Figure 10). The development of the phreatic line in the levee itself is caused by the infiltration of the high water wave from the river in the levee body. Due to the low permeability of the cohesive material, the infiltration of the water in the levee is a relatively slow process. The intrusion length of the high water wave is limited by the width of the levee. The extreme low and high boundary of the phreatic line are based on standard phreatic models to represent infiltration (upper extreme boundary) and transient (lower extreme boundary) flow are suggested by literature (TAW, 2004). The models incorporate the influence of the dominant factors that influence the phreatic lines, i.e. infiltration and groundwater flow in order to simulate the transient flow and the different possibilities of steady state flow.

In the scenario of the “Conductive soil” (scenario C.), the roots inside the levee indicate a more conductive layer due to a relatively large permeability (Figure 10). Therefore, the intrusion length of the water wave is increased in this layer. This causes a local increase in water pressure. Moreover, the velocity of the high water pressure wave in the conductive layer is relatively fast compared to the levee body. In this area, the water potential equals the outside water level. At the inside toe of the levee, the potential inside the rooted area is limited by the covering soil. The analysis of Scenario C. is executed as a direct relation to Scenario B. to show its influence on the upper, mean and lower bound of the phreatic line. The water pressure inside the levee is interpolated between the phreatic line and the hydraulic head inside the conductive soil layer.

In the scenario of the “Pond connection with aquifer” (scenario D), the pond in front of the levee might introduce a connection between the aquifer layer and the outside water level (Figure 10). This causes a local increase in water pressure in the aquifer compared to the water pressure corresponding to the phreatic line. Because of a relatively large leakage length of the outside water level, the water pressures inside the aquifer might cause a shear strength reduction at the landside. The weight of the blanket layer limits the hydraulic head in the aquifer. The water pressure inside the levee and the blanket layer is interpolated between the phreatic line and the (limited) hydraulic head at the interface between sand and clay.

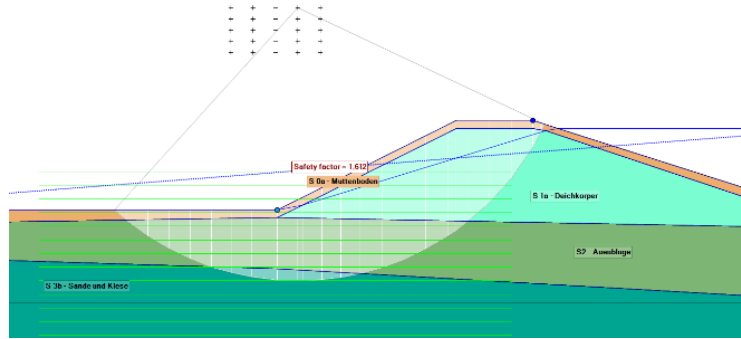
Figure 11 View of the LEM calculation using Bishop stability model with drained soil behavior (FoS=1.61).

The “base model” (scenario A) represents the best estimate scenario with the expected values of input parameters. The “base model” functions as the basis of the sensitivity analyses (Figure 9). The LEM calculation is executed using the Bishop method and drained soil behavior. The Bishop method is used as best-estimate since this method reflects the circular observed slip circle relatively well. The results of the simulation of the best estimated situation show a FoS=1.61 [-], which is considered stable (FoS>1.0). The shape of the slip circle shows realistic similarities with the actual slip circle (Figure 11). However the slip circle starts at the riverside of the top of the levee, instead of the landside. Also the slip circle intersects the sand layer, which is not considered realistic.

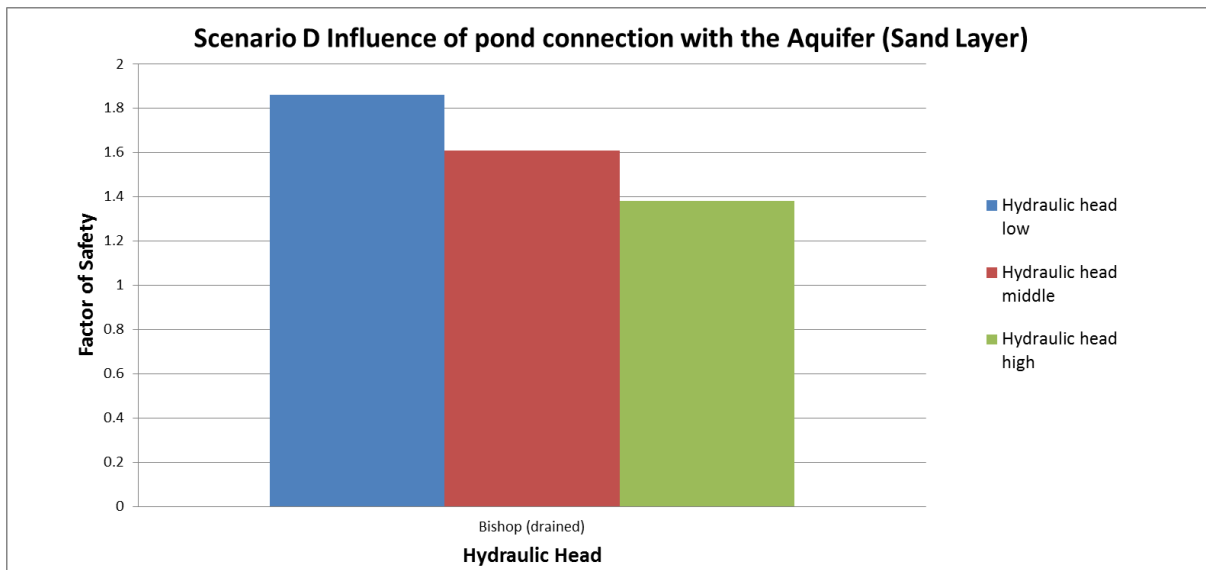
Figure 13. Influence of the rise of the hydraulic head in the aquifer with three different levels in hydraulic head in scenarios D.

The stratigraphy shows an aquifer below the levee which might be in direct contact with the water level at the riverside by means of a pond in front of the levee (Figure 10). Similar to the phreatic line, the different water pressures in the aquifer influence the shear strength as well. For the analysis of the contribution of the aquifer to the cause of failure, the model uses three scenarios for the water pressure. The results are shown in Figure 13.

Due to the rise of the hydraulic head in the aquifer, the range of the FoS overall is between 1.86 and 1.38. The shape of the slip circle shows realistic similarities with the actual slip circle. However the slip circle still intersects the levee crest instead of starting from the landside of the levee.

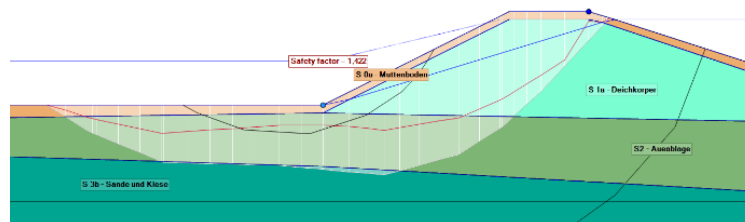
Figure 14 View of scenario D: “Pond connection with aquifer” output. The high hydraulic head is included and the Spencer model is used (with drained soil behavior) which results in FoS=1.42.

Introducing undrained soil behavior for the clay, scenario D, results in FoS between 1.66 and 1.28. The slip circle of the actual failure (Figure 6) and the calculated slip circle (for example with the use of Bishop with undrained soil behavior and Spencer with drained soil behavior) differ in geometry. The slip circle of the Spencer method seems to show more realistic geometry of slip circle than the Uplift Van method and Bishop’s method in case of low effective soil pressures at the interface between sand and clay (Figure 14).

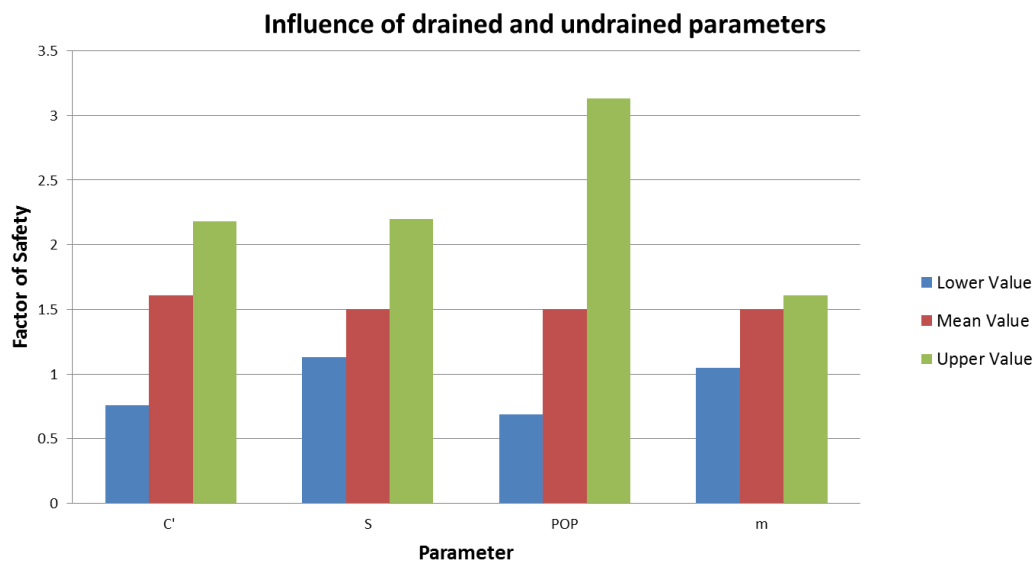
Figure 15. Results of the sensitivity analysis of drained parameter cohesion and undrained parameters.

Varying the cohesion, which is the dominant parameter of the drained soil model, the FoS covers a range between 0.76 and 2.18 (Figure 15). The undrained shear strength has a high variability, due to the uncertainty of the previous stress history and related overconsolidation state (the POP, pre-overburden pressure, was used to describe this uncertainty). The results of the calculations greatly reflect this uncertainty in the calculated FoS ranging from 3.13 and 0.69. The parameters S and m, used to model undrained shear strength, result in large variation in FoS, but do not result in values below 1, which would represent failure of the levee. The calculation using the low cohesion values and the Bishop model show similarities with the actual slip circle and do not reach the sand layer underneath the cohesive layers (Figure 16).

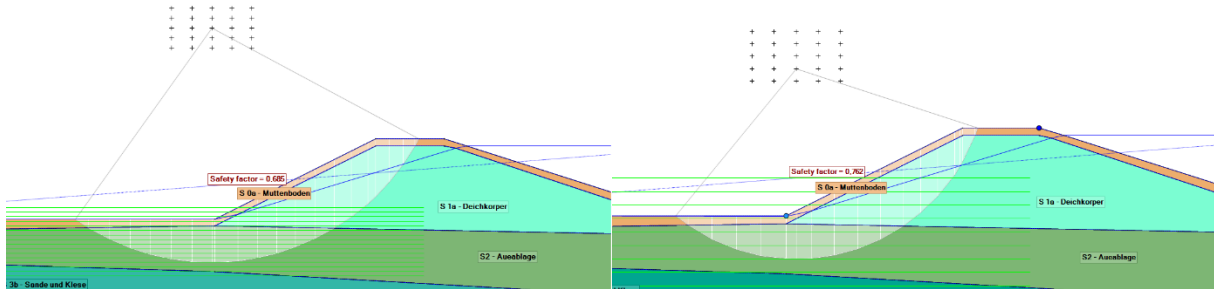
Figure 16 Left: View of scenario A. “Base model” using the Bishop slip circle and low values of POP resulting in $FoS=0.69$ (undrained soil behavior). Right: Scenario A. “Base model” using the Bishop model and low values of cohesion resulting in $FoS=0.76$ (drained soil behavior).

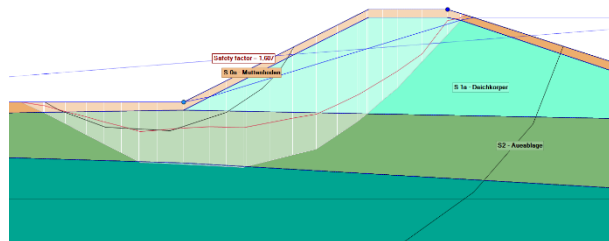
Figure 17 View of scenario A. “Base model” using the Spencer method presenting the calculated critical slip circle ($FoS=1.61$).
