# Manyame Catchment: A Risk Assessment

MDP | Zimbabwe

Student numbers: 4498968, 4742737, 4743784, 4258576, 4304098

Delft University of Technology

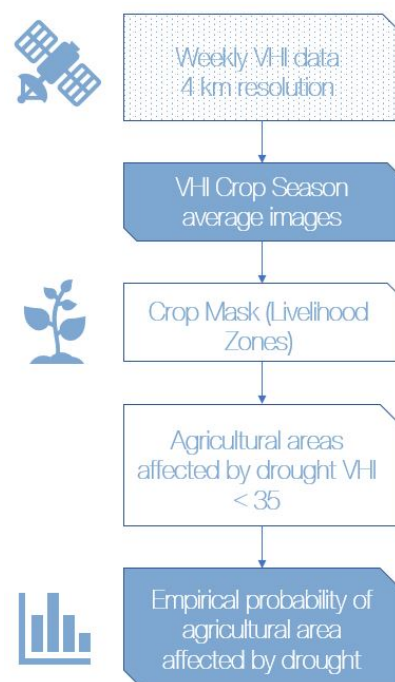
Figure 9: Process of Developing Agricultural Drought Risk

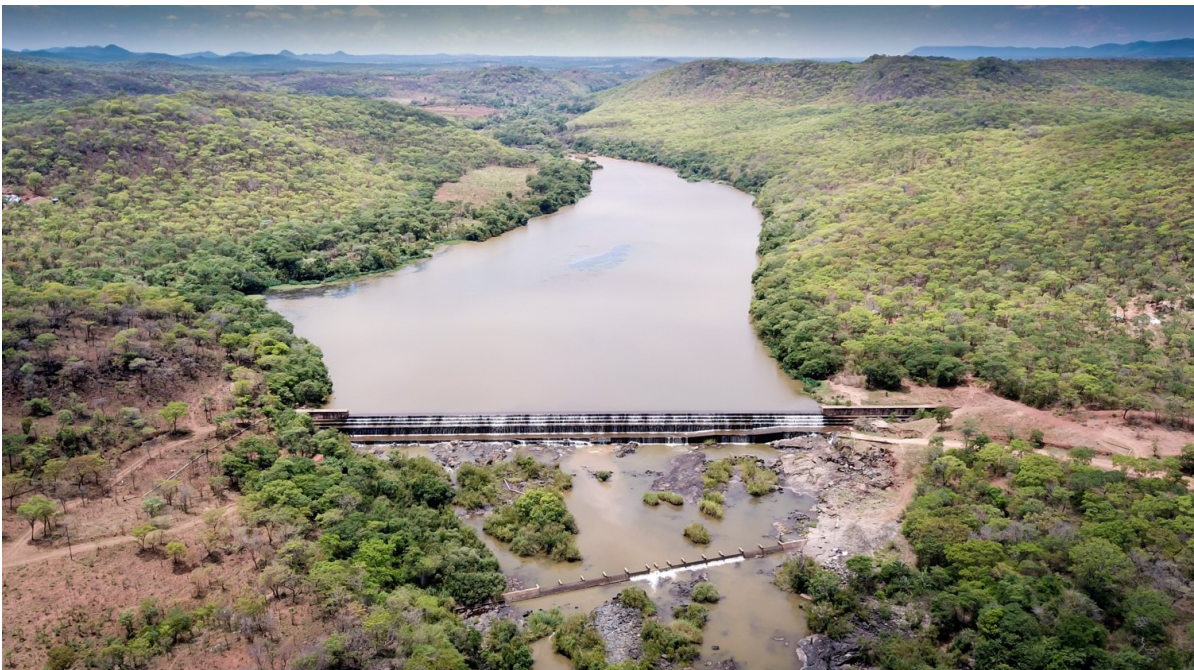
Figure 17: The Manyame Balancing Weir located in the MMSC

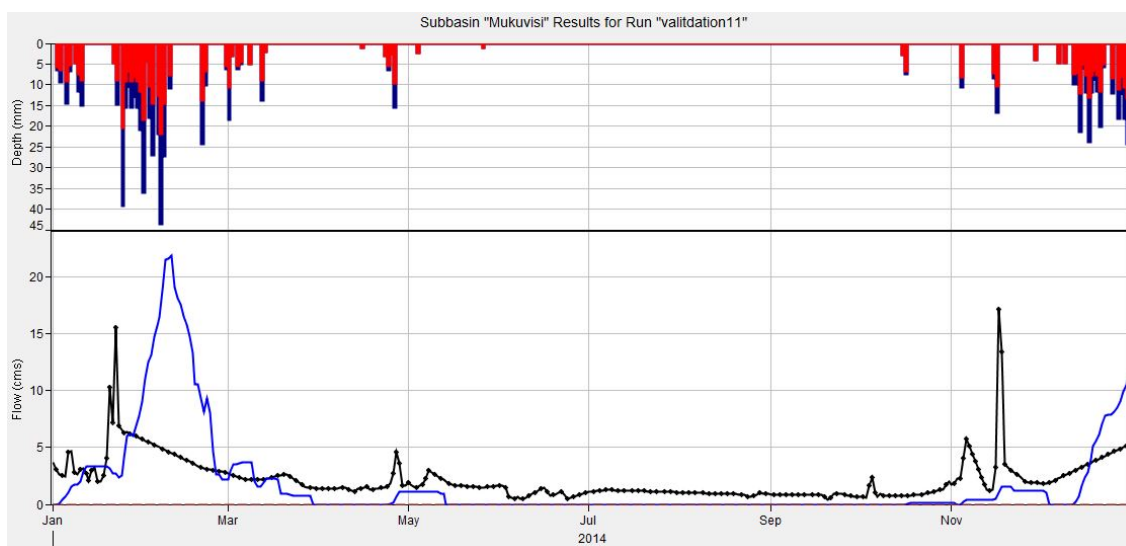
Figure 21: Validation Mukuvisi sub-catchment

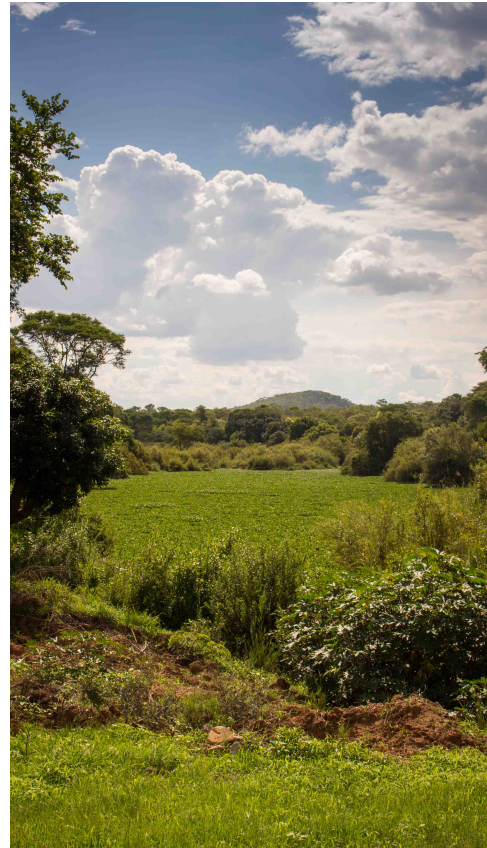
Figure 27: The Manyame River upstream of Lake Chivero covered with water hyacinths

Besides the positive effect on the removal of nutrients, water hyacinths have also been reported to have accumulated zinc, nickel and copper in their roots at a concentration factor up to 20 000 times more than in the river itself [55]. A study done by Rommens [74] on the impact of water hyacinth in Lake Chivero, Zimbabwe found that the highest removal capacity was for ammonium at 1.5% followed by total nitrates and phosphate with 0.1 and 0.025% respectively. Therefore, water hyacinth prefer the uptake of ammonium over nitrate. The low removal capacity for phosphate could explain the continuous presence of phosphates throughout the catchment. In this study, it also mentions that at the time of the study only 3.2% of the lake was covered by water hyacinth so that the overall impact on improving the water quality of the lake was low. Despite this low percentage of water hyacinth, Rommens [74] found that the water quality improved between the inflow and outflow of Lake Chivero. The Manyame River is also completely covered with water hyacinth around Chitungwiza (2) (upstream of Lake Chivero) (see Figure 27), therefore the inflow into Lake Chivero could also be partially remediated before it enters the lake. The sample point for our research was near the spillway of the lake (see Table 6.1), after the remediation would have occurred.

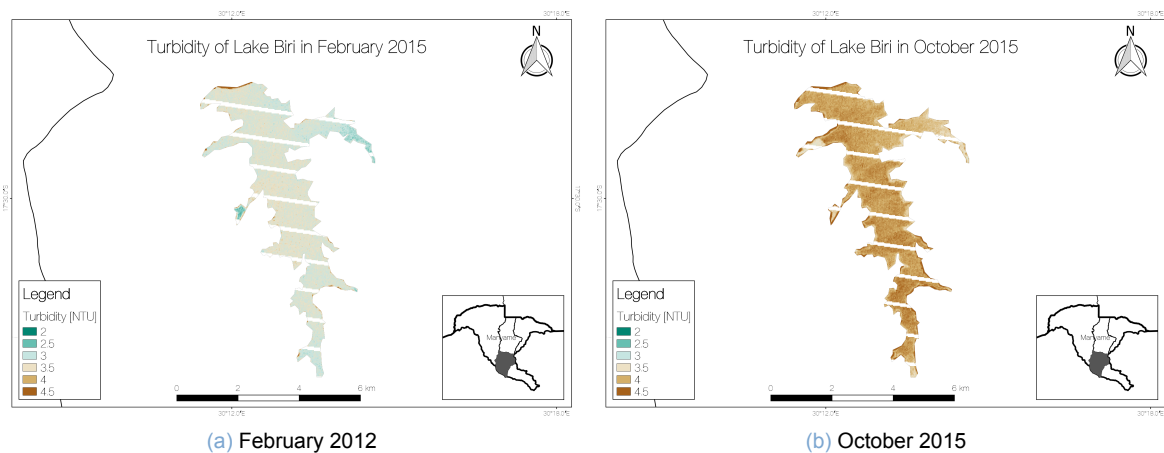
Figure 29: Turbidity of Biri Dam for February 2015 and October 2015

In Figure 29, the turbidity of Biri Dam for both February and October 2015 are shown.

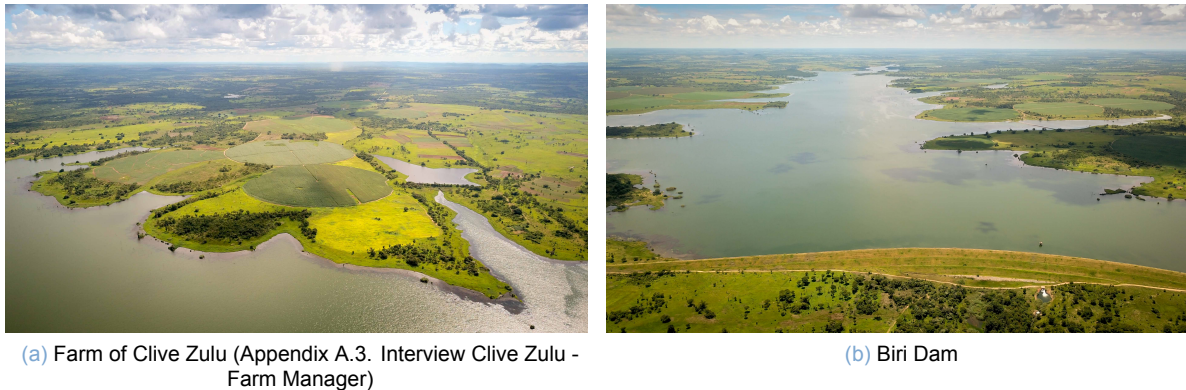
Figure 40: Biri Dam from the sky

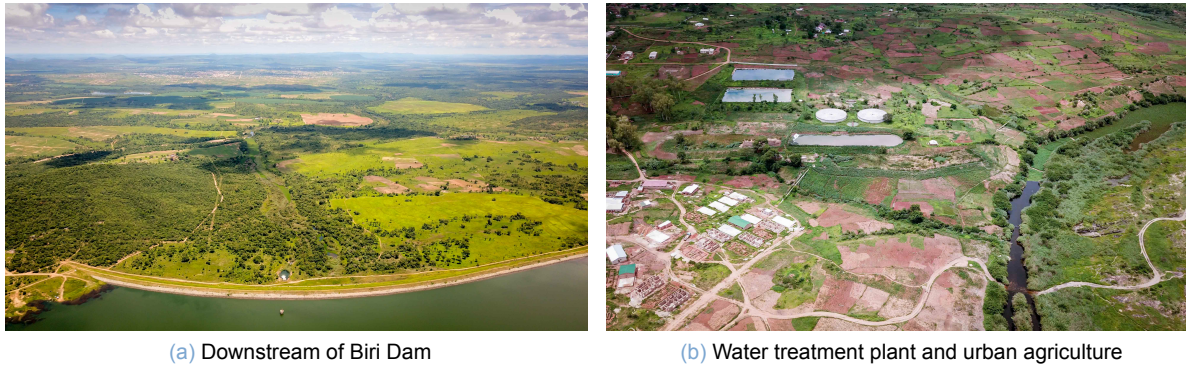
Figure 43: Downstream of Biri Dam from the sky

Another cause for the underutilization of Biri Dam is the poor water quality. Around Biri Dam and downstream there are many tobacco farms, however there have been complaints about the water quality. This is due to the fact that the water in Biri Dam contains high levels of chlorine (see Chapter 6), which affects the tobacco crops. This means that they do not want to use the water as it decreases the value of the crops. Instead, they end up growing dry-land tobacco which is not as economical (see Appendix A.6. Interview Bilton M. Simango – MMCC). Furthermore, as the MMSC is mainly focused on farming, the downstream users of the water are also affected by the poor water quality from the dam and the sewage effluent from Chinhoyi also influences the water quality (see Figure 43). Therefore, the following two sections include a more in-depth analysis on the two major concerns regarding the water quality. These are namely the source of pollution affecting Biri Dam and the influence of sewage effluent on the water quality downstream of the dam.

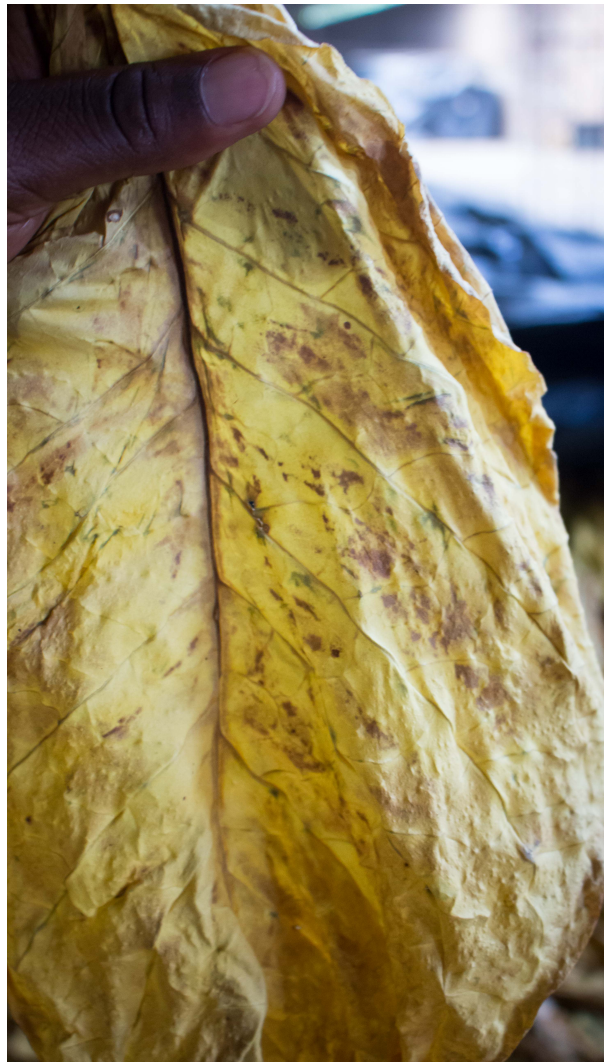
Figure 44: 'Burn' marks on the tobacco leaves

From our interview with an affected farmer, Clive Zulu, it was found that the issues of the chlorine resulted in the retardation of growth in the seedlings and the final harvested tobacco leaves had small 'burn' spots on them as is shown in Figure 44 (Appendix A.3. Interview Clive Zulu - Farm Manager). The 'burn' spots are most likely due to chlorine bleaching from the irrigation of the tobacco through a central pivot system.

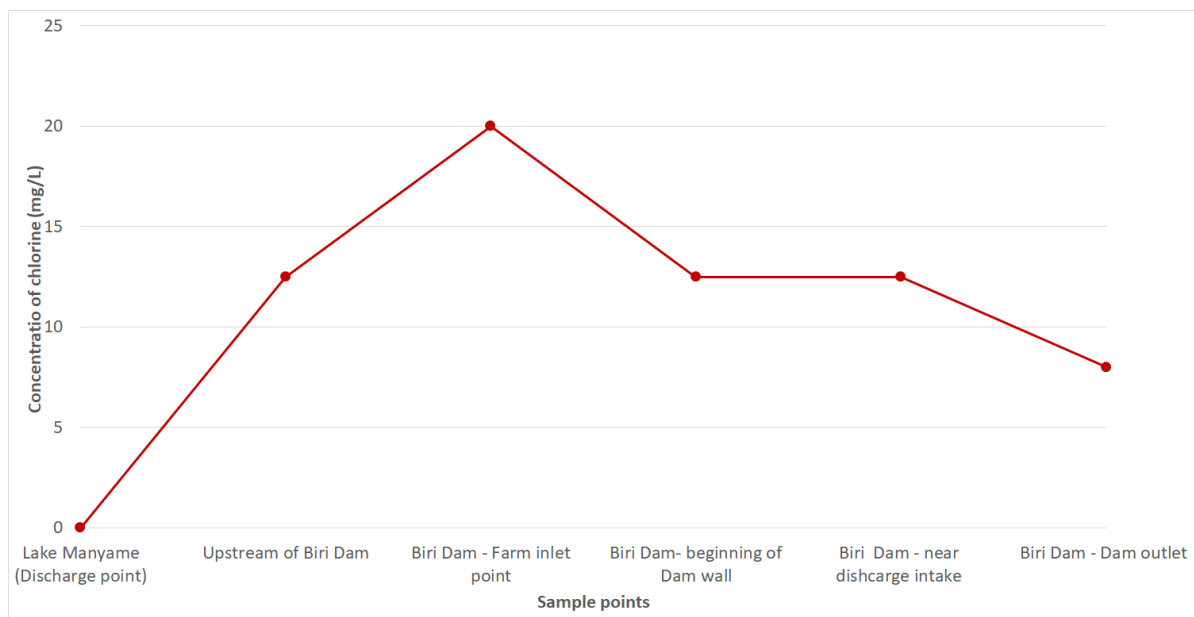
Figure 45: Concentration of chlorine found in various sample points upstream and surrounding Biri Dam

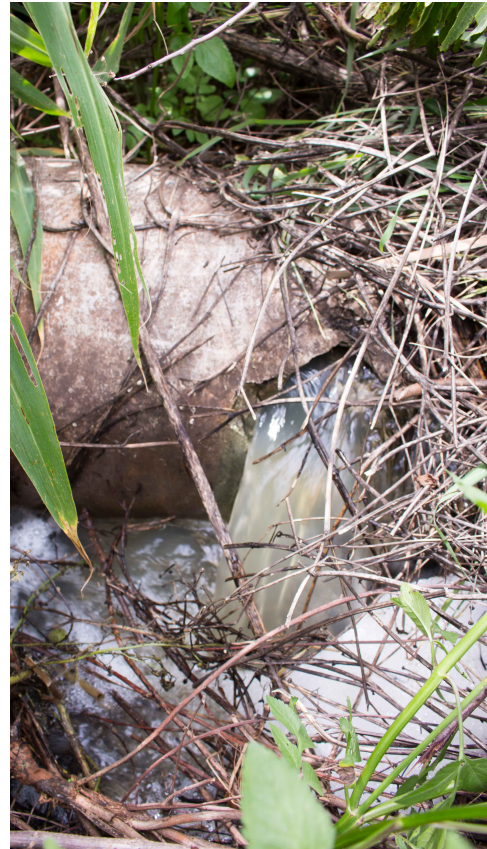
Figure 46: Leaking sewage effluent pipe in Chinhoyi (sample location 2)

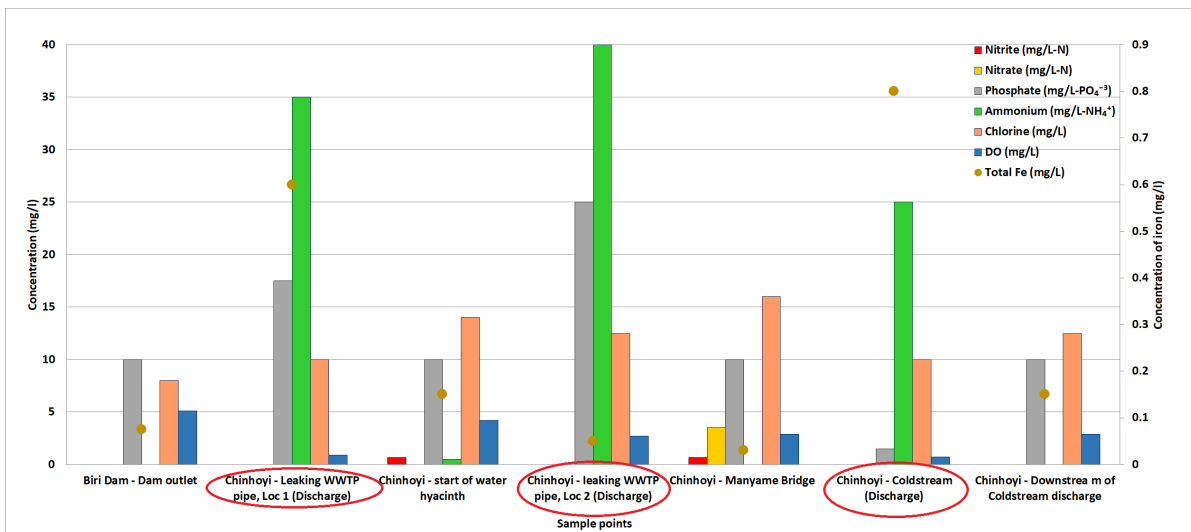
Figure 49: Overall concentration of most important parameters tested for the sewage effluent streams and Manyame River around Chinhoyi, MMSC

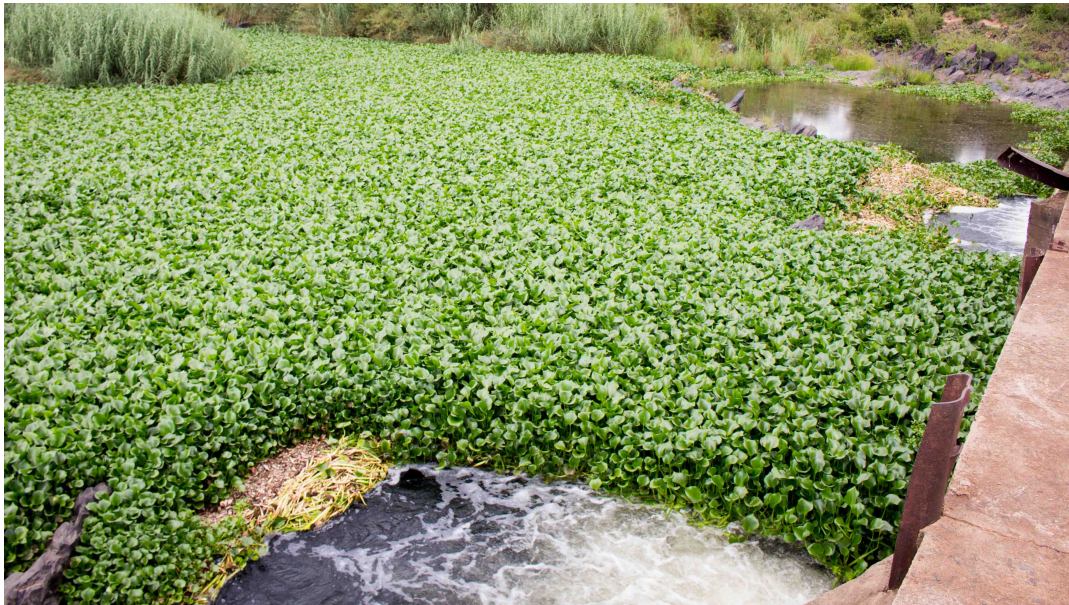
Figure 50: Weir aeration between sewage effluent discharge and Manyame Bridge, Chinhoyi

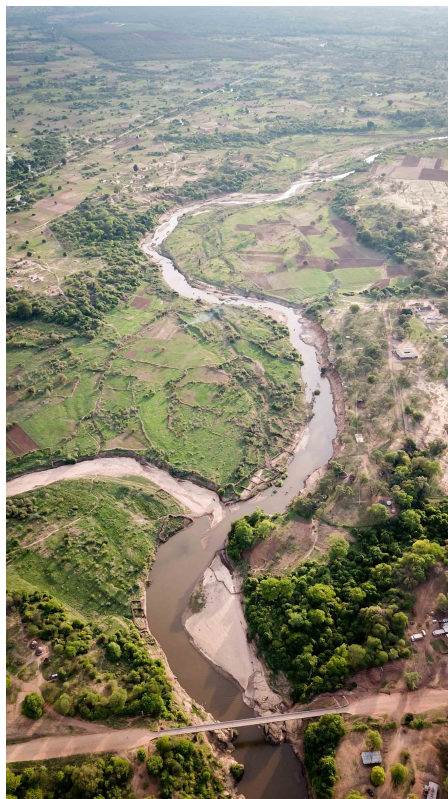
(a) Manyame River with the dry Panhame flowing into it

Figure 52: Manyame River from the sky around Mushumbi pools

In Mushumbi Pools two main rivers, the Manyame and Panhame meet (see Figure 52), resulting in dangerous flooding when it has rained heavily and upstream dams are filled up and therefore unable

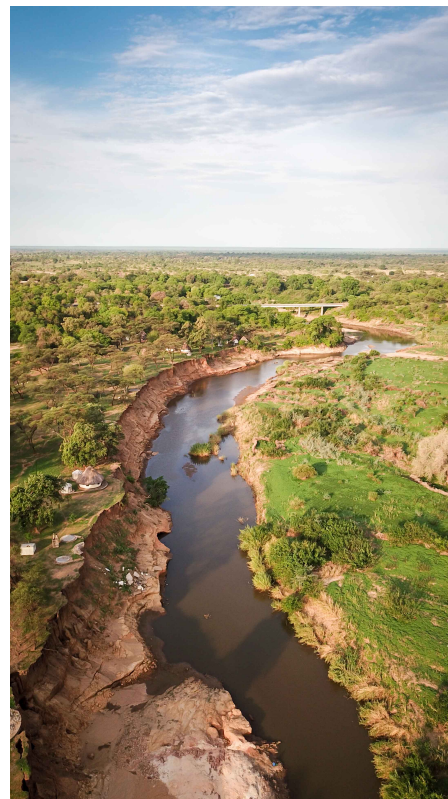
(b) High bank erosion around Mushumbi pools
