Data Analytics for RCF Damages on the Dutch HSL Track

Master of Science

in Construction, Management and Engineering

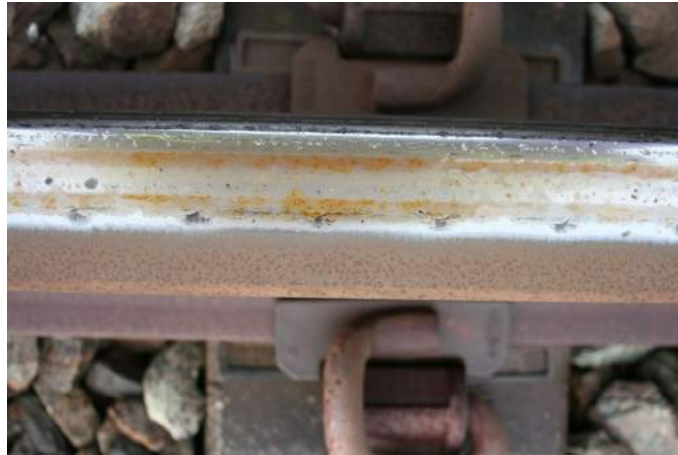
Figure 2: Example of RCF at a rail, which is visible as small cracks at the rail surface.

Rail infrastructure maintenance companies cope with several issues to keep their tracks at top condition in order to provide safe and comfortable traffic conditions regarding their tracks. One of these issues is coping with rolling contact fatigue (RCF) which is an issue related to the small wheel-rail contact area where the loads of the train are being transferred to the rails. Every cycle of a train wheel will result in a stress cycle in both the wheel- and rail materials, this will eventually lead to material fatigue during its lifetime (Dollevoet, 2010). This material fatigue can be visible as cracks in the rails which can lead to various problems like delays or even rail breaks. Therefore it's desirable to control the rail conditions, detect early defects and treat them before they grow into serious defects. An example of RCF damage at the HSL-South can be seen in Figure 2.

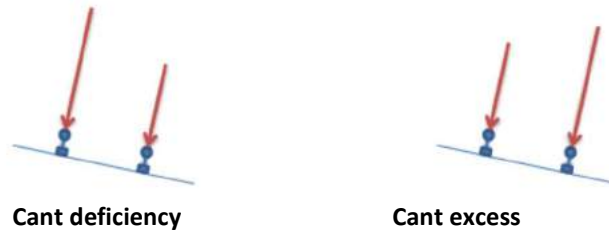
Figure 10: Different distribution of the vertical loads in a curve on the rails for cant excess and cant deficiency.

Another effect of cant excess is the different distribution of the vertical loads on the legs as shown in Figure 10. For cant excess more loads are transferred to the inner leg of the curve. The train will shift to the inner leg when the lateral acceleration to the lower leg exceeds the shear resistance.

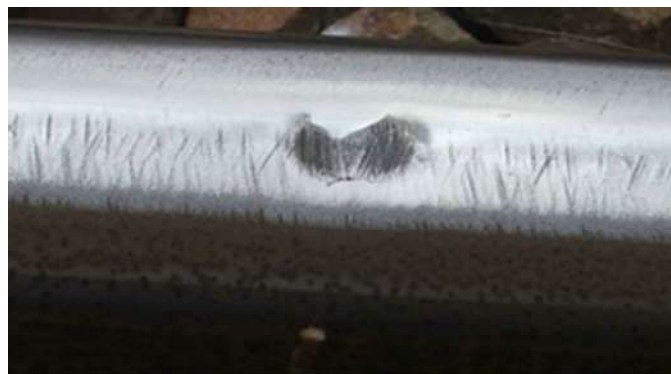
Figure 13: Example of a squat on a rail. Source: http://file.scirp.org/Html/4-7401350_31574.htm

As squats are being associated with high-frequency vibrations of the wheel-rail system which can be registered by axle box acceleration (ABA) measurements, a finite element model has been described by (Molodova, Li, Núñez, & Dollevoet, 2014b), where is shown that (ABA) measurements can be used for the detection and assessment of severity of squats. The early detection of squats has by ABA measurements has been further reported in other papers by the same group (Molodova, Li, & Dollevoet, 2011), (Molodova, Li, Núñez, & Dollevoet, 2014a) and (Z. Li, Molodova, Núñez, & Dollevoet, 2015). Other methods like video images are more prompt to contamination and other effects that compromise the quality of the detection (Faghih-Roohi, Hajizadeh, Núñez, Babuska, & de Schutter, 2016). Squats in rails can be treated by grinding or milling the rails.

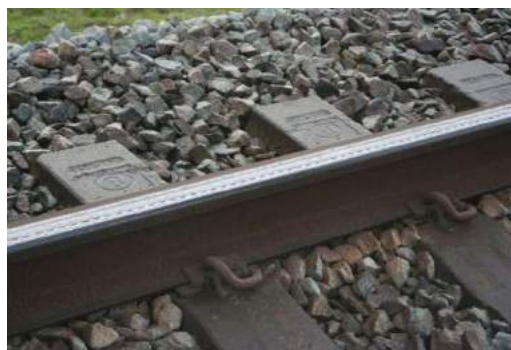
Figure 16: Example of short-pitch wave corrugation at the HSL-Zuid at the Hoofddorp location taken in November 2014.

Short-pitch corrugation can be characterized by the irregular sequence of bright ridges and dark hollows which appear at the running surface (Esveld, 2001). An example of short-pitch can be seen in Figure 16. The pitch most often varies between 3- and 8 cm. Short-wave corrugation regarding curves has been reported by (Torstensson & Nielsen, 2009), where is shown that the magnitude of corrugation can vary among the curve after grinding. (Grassie, 1996) reported in a study regarding short-pitch corrugation for the British railways that it is caused by differential wear among the rail surface.

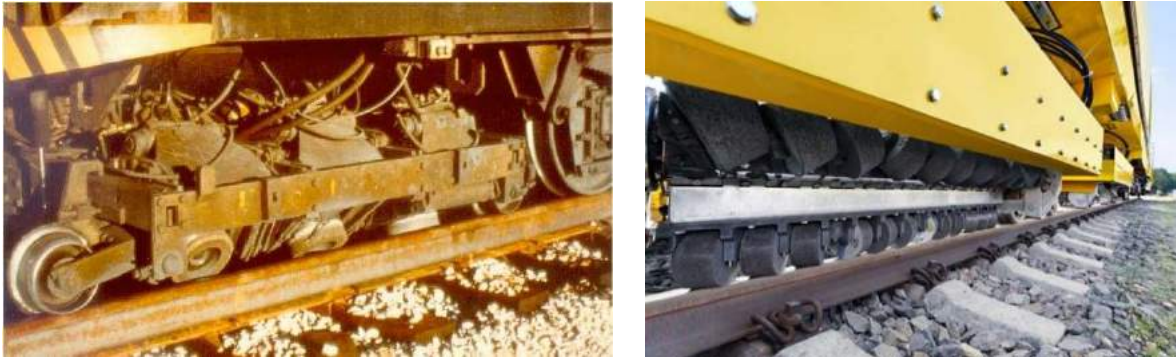
Figure 21: Example of both the rotating stone technique and the high-speed grinding technique. Source: http://www.vossloh-usa.com/en/rail_infrastructure/rail_services/rail_services.html

Two types of rail maintenance are considered in this paragraph, grinding using rotating stones and high-speed grinding, this because both techniques have been used at the HSL-South. These techniques are shown in Figure 21. Other methods for preventive and corrective rail maintenance are: planing, milling and grinding using oscillating stones but will not be extensively evaluated as for the HSL case study these have not been used.

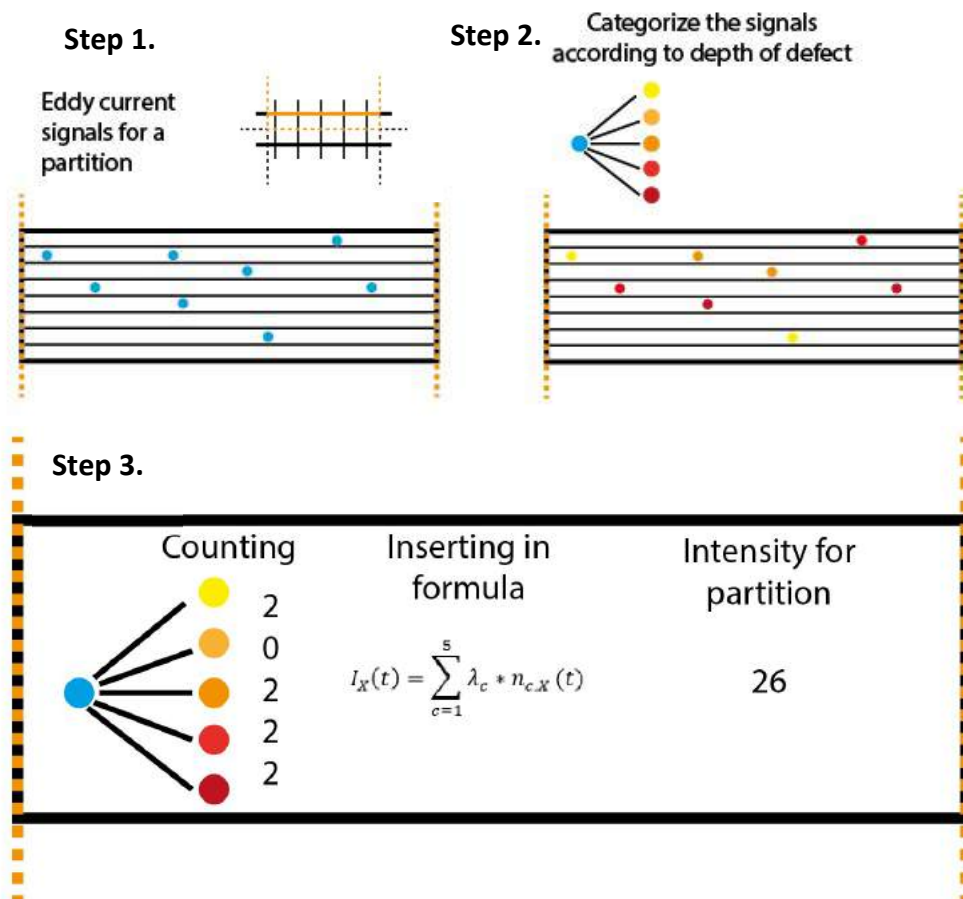
Figure 26: Overview of the steps taken to determine the intensity for a certain partition. The first step is the partitioning. The second step is measuring the partition. The third step is to determine in which category each signal from the measurement fits. The fourth step is counting how many signals there are for each category. The final step is using this input in the formula and determining the intensity for this partition.

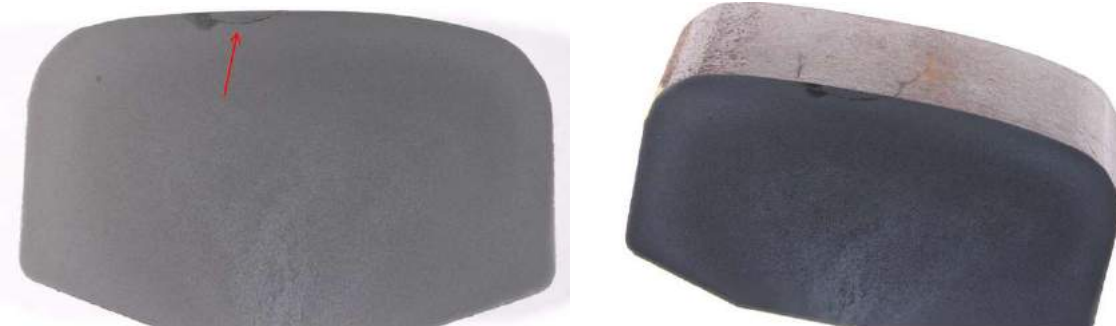
Figure 34: Pictures of the examined rails with damages. The cracks don't grow into the rails but stay relatively close to the surface. Source: (Künstner & Harrer, 2016)

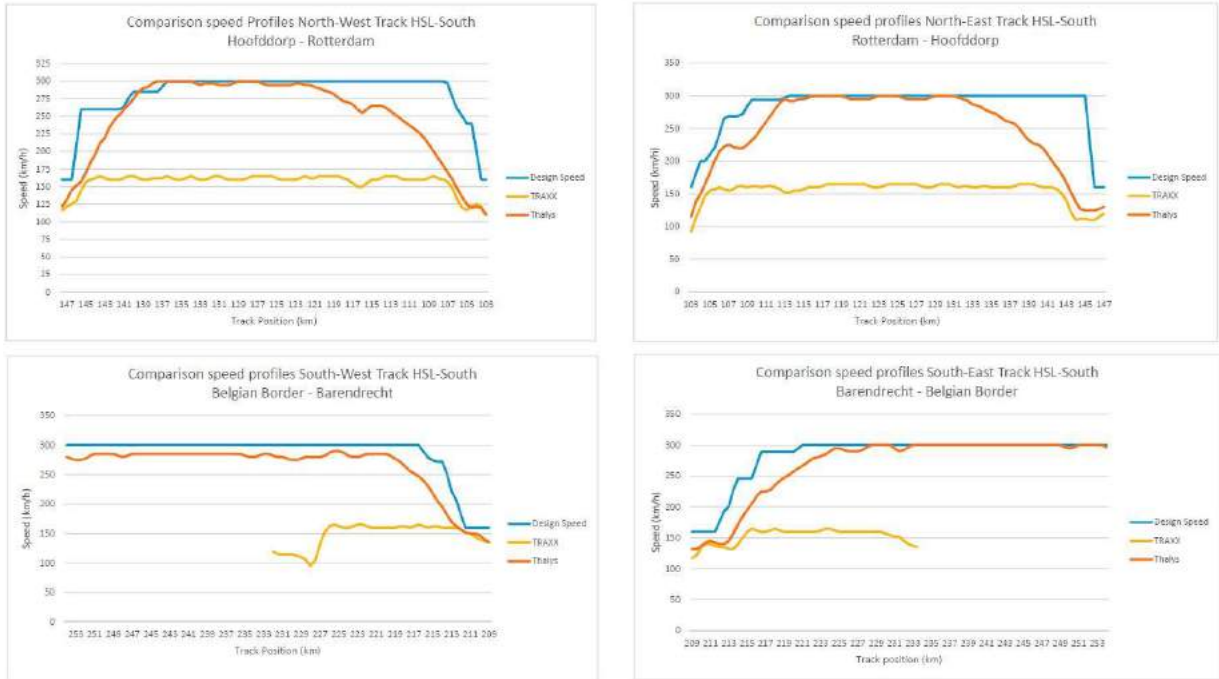
Figure 36: Comparison of the different speed profiles among the four major sections of the HSL. Note that there is only a speed profile for the TRAXX for half the southern section of the HSL this is because the TRAXX enters or comes from the turnout around kilometre 233.

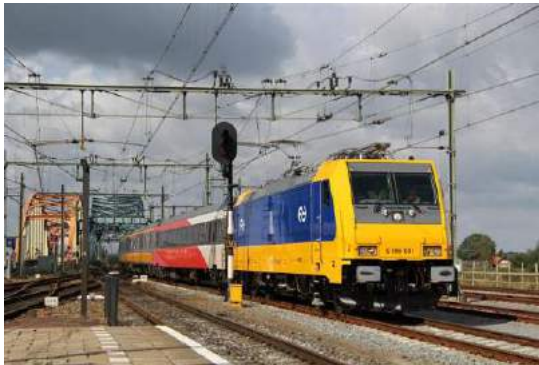
Figure 55: A TRAXX F140MS2 in service, carrying also one Fyra wagon. Source: <http://www.martijnvanvulpen.nl/materieel/elektrische-locomotieven/254-traxx-f140-ms2>

The TRAXX F140 MS2 are replacing the V250 but were already using the tracks during the time the Fyra was still being tested. The Fyras' operating speed was at 250km/h.

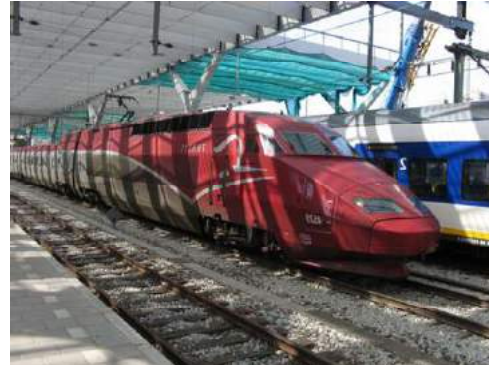
Figure 55: A Thalys PBA in Rotterdam Central Station. Source: <http://www.treinenweb.nl/materieel/THALYS>

Also the TGV Thalys PBKA and PBA (Figure 55) are using the tracks they serve the international services from Amsterdam to Belgium and France. Currently, they are being used on a service between Amsterdam and Brussels 3 times a day, Amsterdam and Lille 2 times a day and Amsterdam to Paris 9 times a day. The manufacturer of the train is GEC Alstom. The trains have been manufactured between 1995 and 1997. The main difference between the two types is the shape of the head of the locomotive, the newer PBKA type has a rounder shaped head than the PBA. The Thalys carries 8 wagons and has two locomotives. The four axles of both locomotives are powered, the total number of powered axles is thus eight. The operating speed for the Thalys is 300km/h.

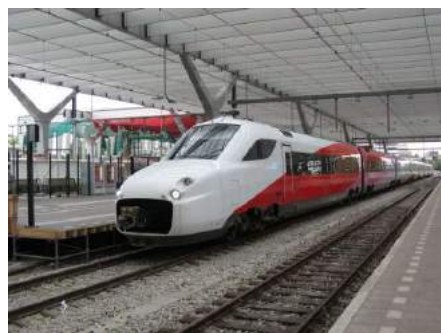
Figure 56: Fyra V250 in Rotterdam Central Station. Source: <http://www.treinenweb.nl/materieel/V250>

In 2004 NS and NMBS/SNCF ordered the Fyra V250 (Figure 56) trains to provide the service over the HSL-South and HSL-4 in the Netherlands and Belgium. The initial delivery was planned for 2007. But this was delayed several times due to problems with ETCS specifications.

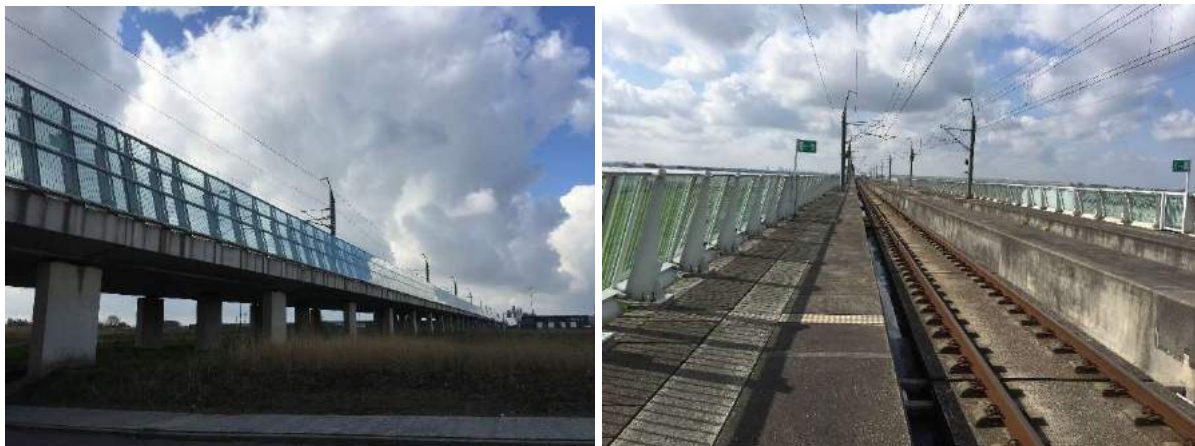
Figure 62: Two pictures of viaduct Bleiswijk, taken by the author during a site visit in March 2016.

There is one major viaduct among the HSL-South. The viaduct is called viaduct Bleiswijk and is located at the northern part of the HSL. The total length of this viaduct is 5898m. The viaduct starts at kilometre 111.349 and ends at 117.247. Viaduct Bleiswijk is raised a few meters above ground level and can be seen in Figure 62.

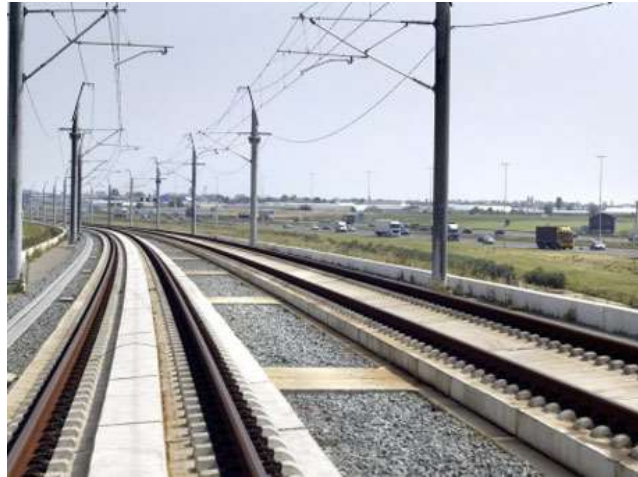
Figure 63: Rheda 2000 superstructure at a curve in the HSL-South. Source: <http://www.rgprojecten.nl/images/projecten/rheda2000/HSL-002.jpg>

Rheda 2000 is a type of slab track which has been used in most parts for the HSL-South with exception of the transitional zones to the ProRail-, Belgian- and maintenance yard tracks. In total about 88km's of track has been constructed using the Rheda2000 superstructure. Figure 63, shows the Rheda 2000 superstructure at the HSL.

The Rheda 2000 system has been installed first in the German high-speed line between Leipzig and Halle. Characteristic for the Rheda tracks is that the sleepers are cast into the concrete. For the HSL instead of a single sleeper, a variant with two blocks has been used. The advantages of Rheda track compared to conventional ballast track are that it needs less maintenance, is relatively light, smaller construction height and larger lateral stiffness. Disadvantages compared to ballast track are: larger temperature effects, longer construction time, limited adjusting possibilities and measures required in relation to noise and vibrations (Sectie Weg- en Railbouwkunde, 2014).

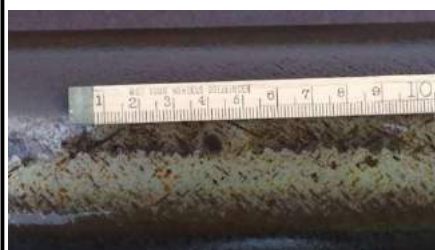
Figure 66: Close-up of the damages with size measurements at the hotspot Zoetermeer

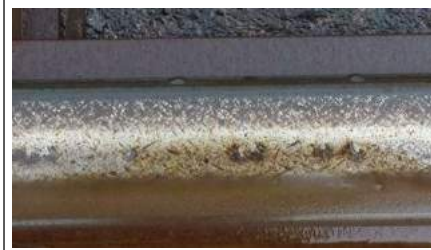
Figure 67: Close-up of the damages at Zoetermeer, we see the cracks here at the rail head.

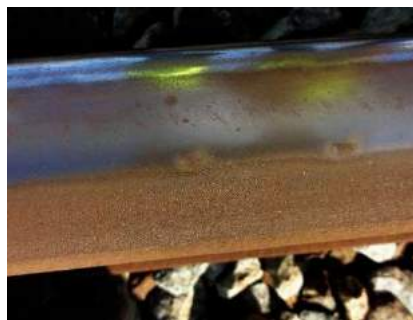
Figure 69: Close-up of the damages, the damages are lying at the border of the running band at the field side of the rail head.

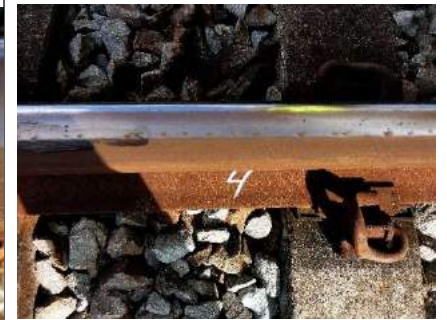
Figure 70: The damages at Hoofddorp, with a repeating pattern between the distance.

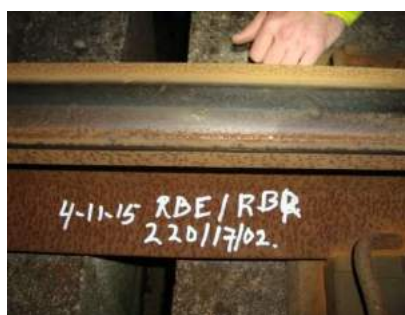
Figure 74: Close-up of the damages at this hotspot at the southern HSL-tracks. Notice that there seems to be two-point contact as both a running band at the rail-head can be seen as a contact area around the flange of the rail.

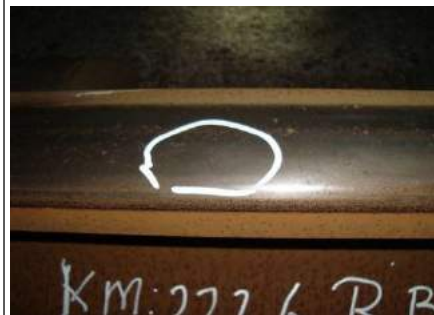
Figure 75: Close-up of a single crack at the gauge-side of the rail head.

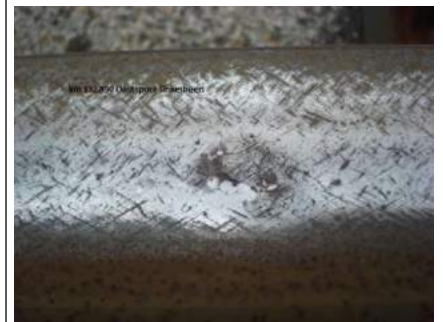
Figure 79: Picture of the damages at Rijpwetering. Here we see a wider running band with the same grinding marks and a crack in the middle of this running band.

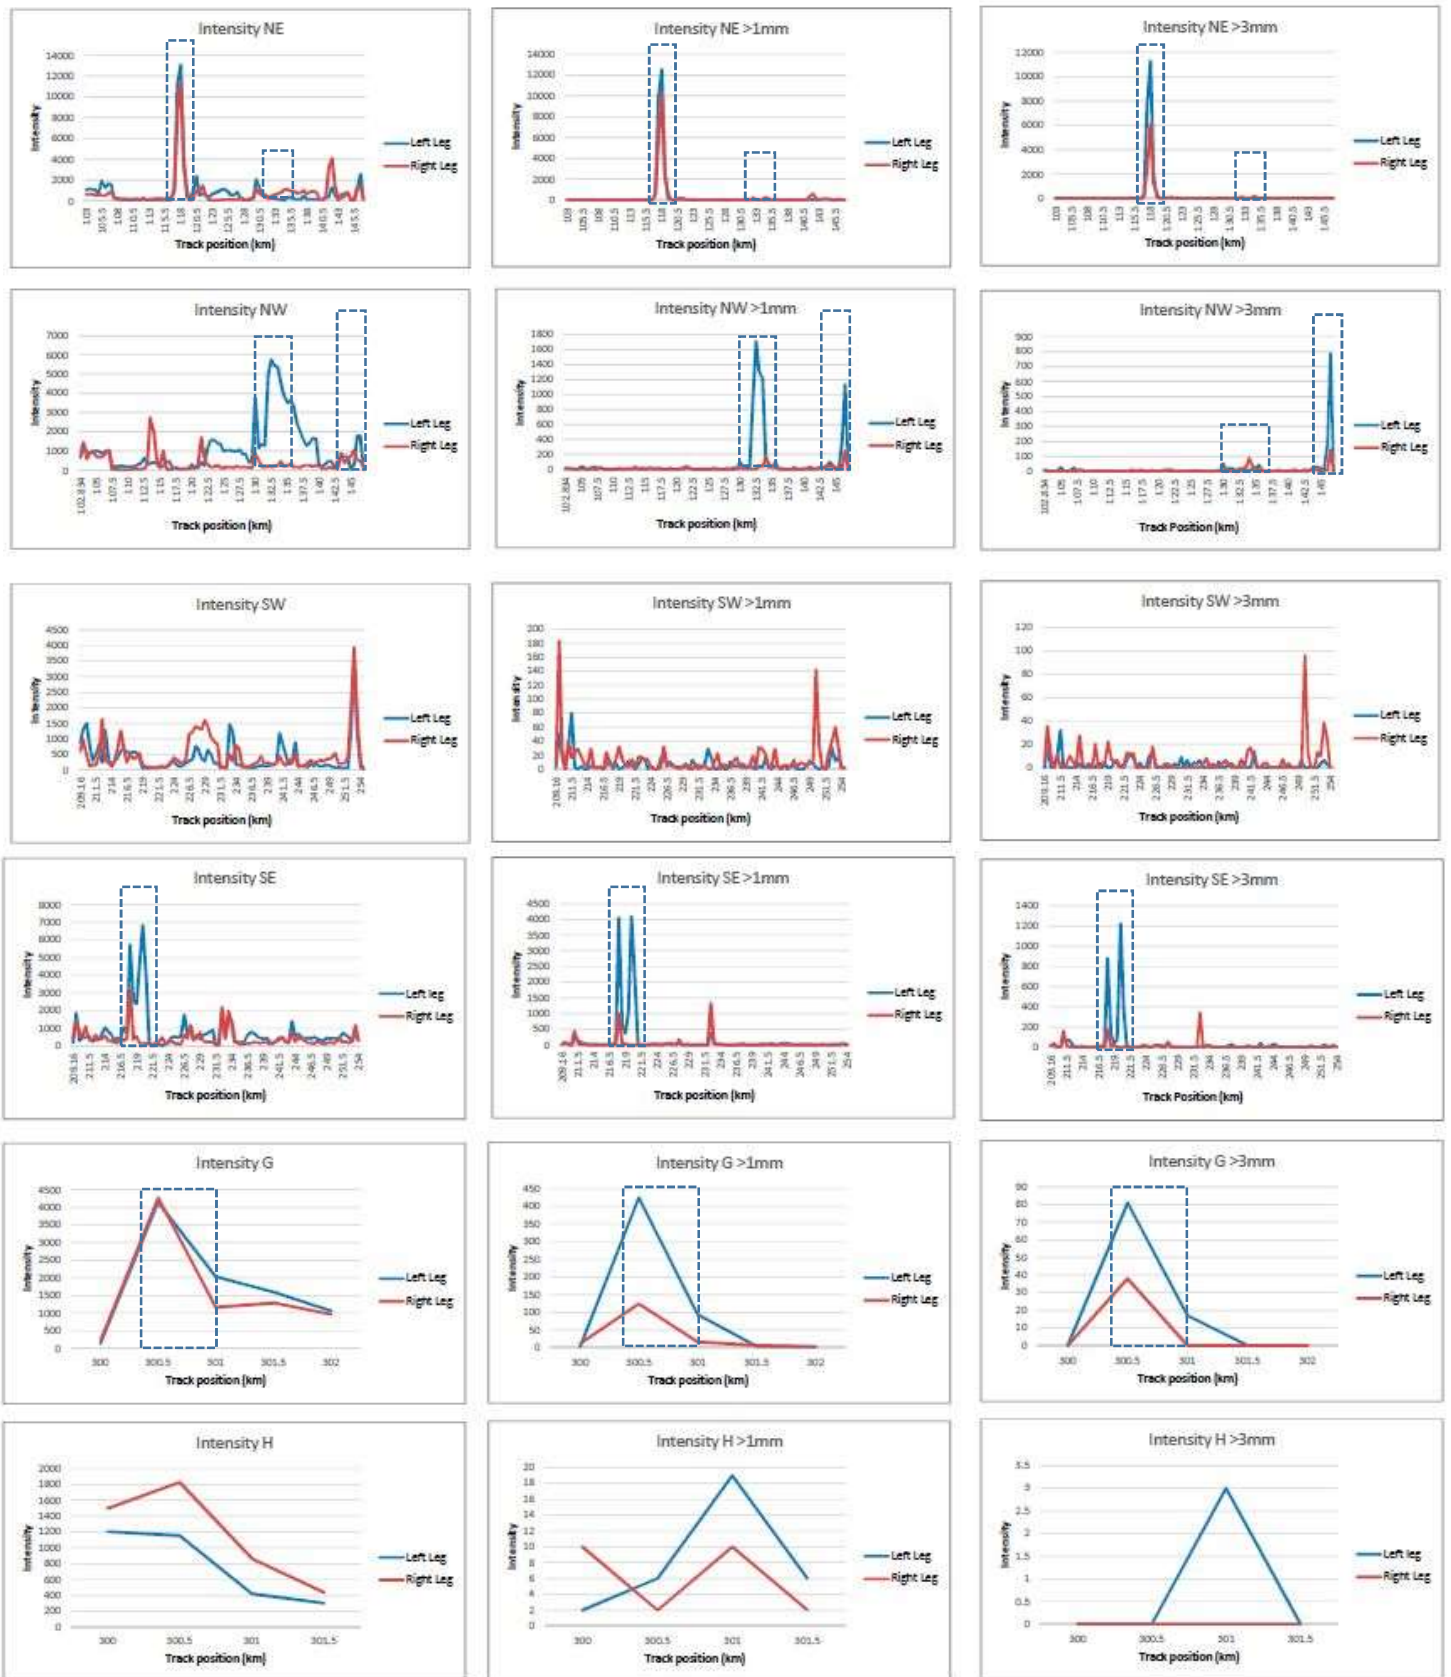
Figure 80: Overview of the different intensity distributions for all the sections of the HSL. The marked areas are the six hotspots.
