Measurement Report on the Transition between Flexural and Shear Failure on RC Beams without Shear Reinforcement

Report 25.5-16-04
Project C33B89
Date November 2016
Status Draft
Version 0.01

Measurement Report on the Transition between Flexural and Shear Failure of RC Beams without Shear Reinforcement

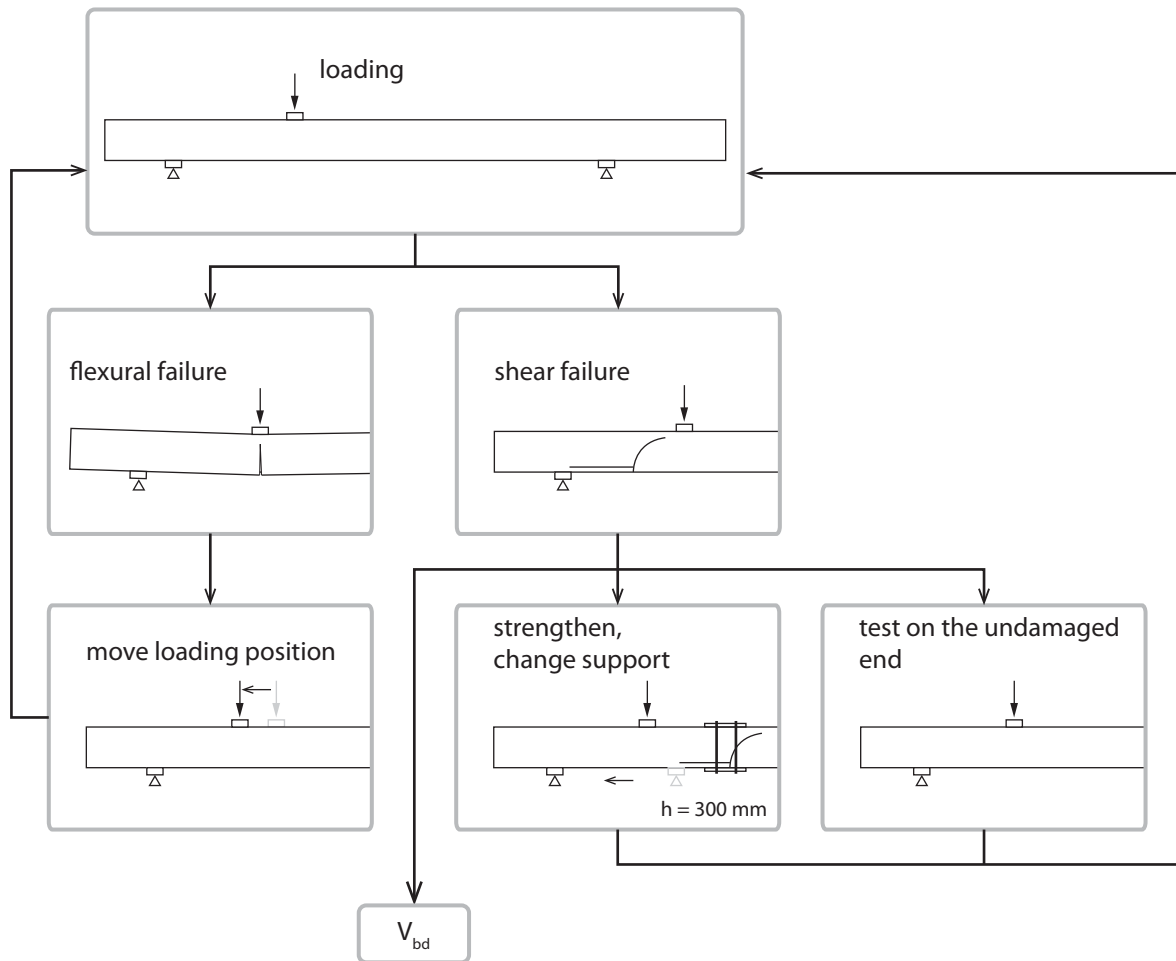
Fig. 3.1.2. Flow chat of the test program for a given beam configuration.

In the v_{min} study, the target of the experimental research is to find out the minimum shear force which can still cause shear failure. To serve this purpose, on the specimens with the same reinforcement ratio, more than one test were executed. The test series started from placing the point load at a location relatively further away from the support so that flexural failure is obtained. This is judged by the yielding of the longitudinal reinforcement up to certain strain. The specimen was unloaded afterwards, and the point load was moved to the next loading position which is usually closer to the support. A second test is carried out at the newer position. In case of shear failure, the loading plate will be moved further. This procedure was repeated until shear failure was obtained, which affected the integrity of the shear span of the specimen. After the first shear failure, more tests were executed with the point load located between the last flexural failure and the first shear failure. So that a refined critical position is obtained eventually. A summary of the loading procedure is given in Fig. 3.1.2.

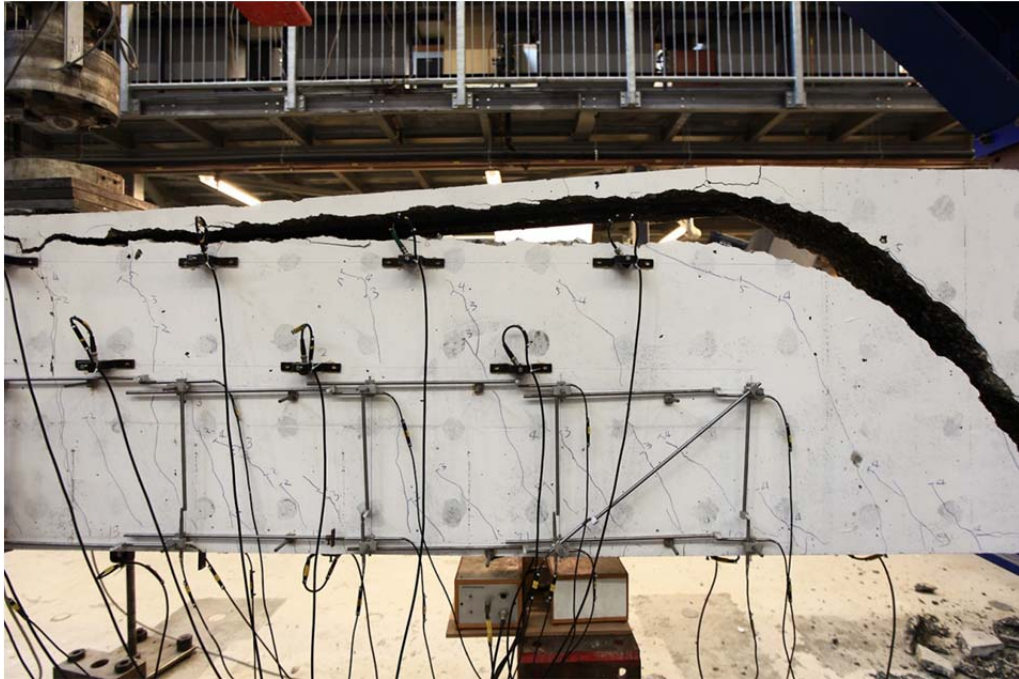
Fig. 3.2.4. Acoustic emission sensors and the LVDT grid for the deformation field.

- Crack opening in an LVDT array, which consists of longitudinal LVDTs' at the level of tensile reinforcement, and at the mid-height of the specimen. Vertical LVDTs' in between.(Fig. 3.2.4)

In the test series A to C, the vertical LVDT's were installed after the formation of a major flexural crack to measure the additional shear displacement in the target cracks. In the other tests, the LVDT array shown in Fig. 3.2.4 was used. Since in those test, DIC was adapted to track the whole deformation field of the surface. It was thus not necessary to track the shear displacement of specific cracks separately.

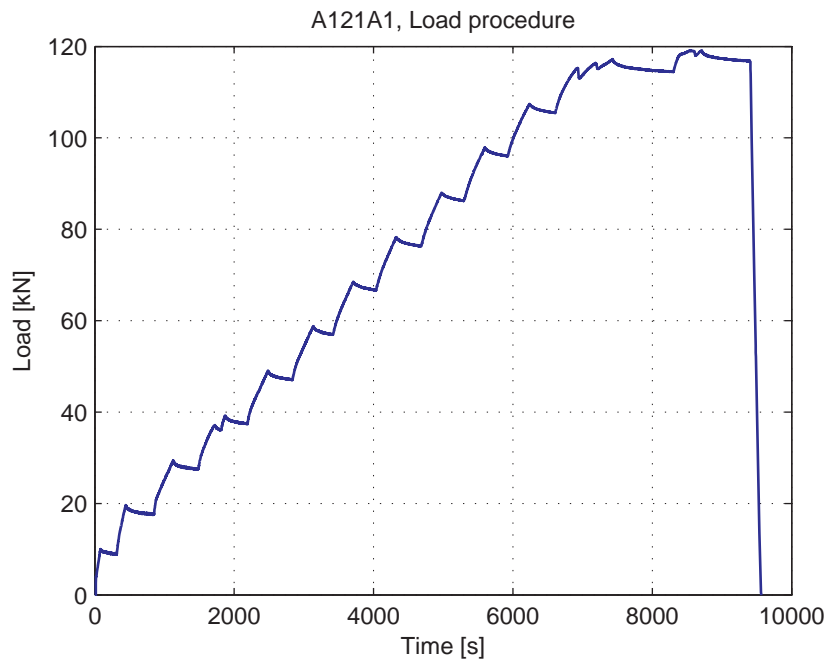
Fig. 5.1.3. Load-Time curve

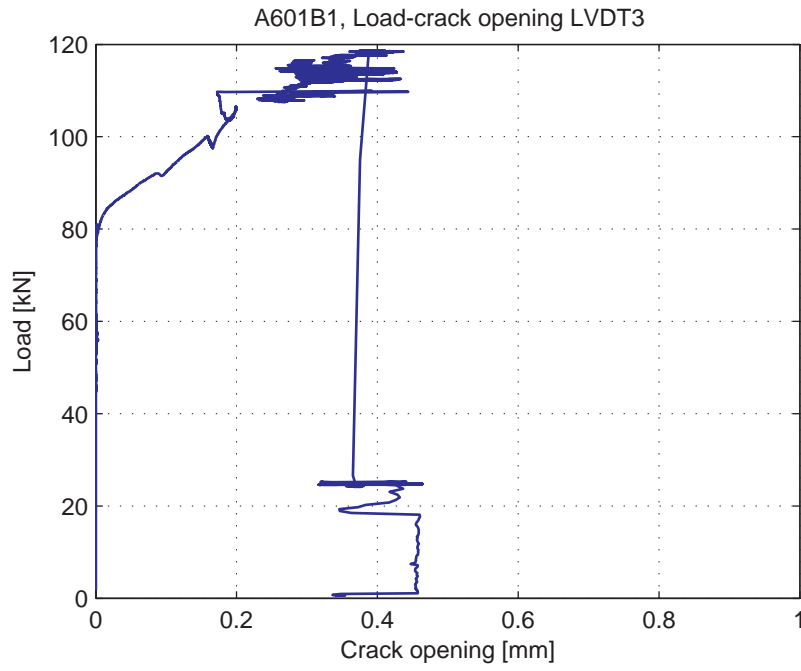
Fig. 5.33.7. Load-Crack opening for LVDT3

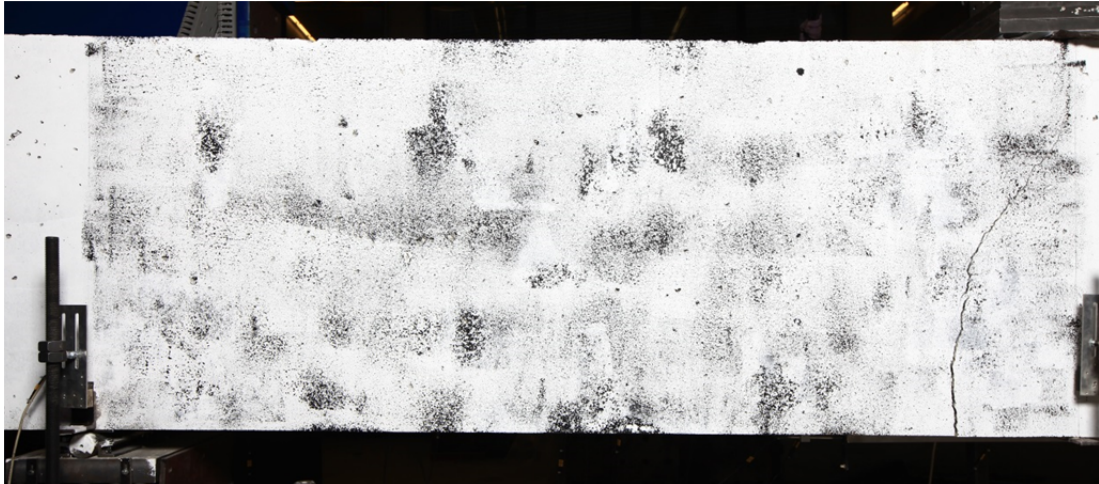
Fig. 5.83.1. Crack pattern after failure north side

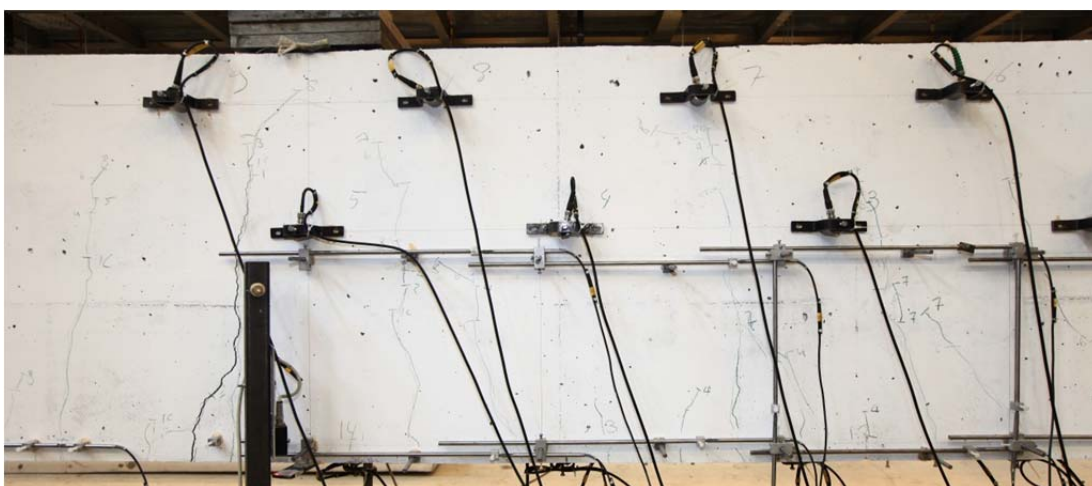
Fig. 5.92.2. Crack pattern after failure west side

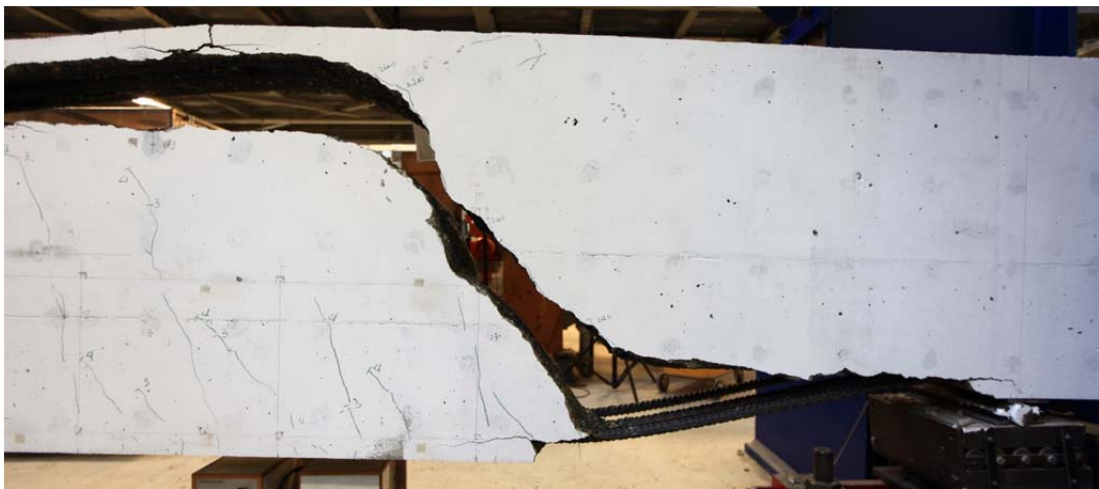
Fig. 5.107.2. Crack pattern after failure and part of LVDT layout at west side of beam
