Delft screw injection pile tests factual report

Delft Screw Injection Pile Tests

Factual Report

24th November 2024

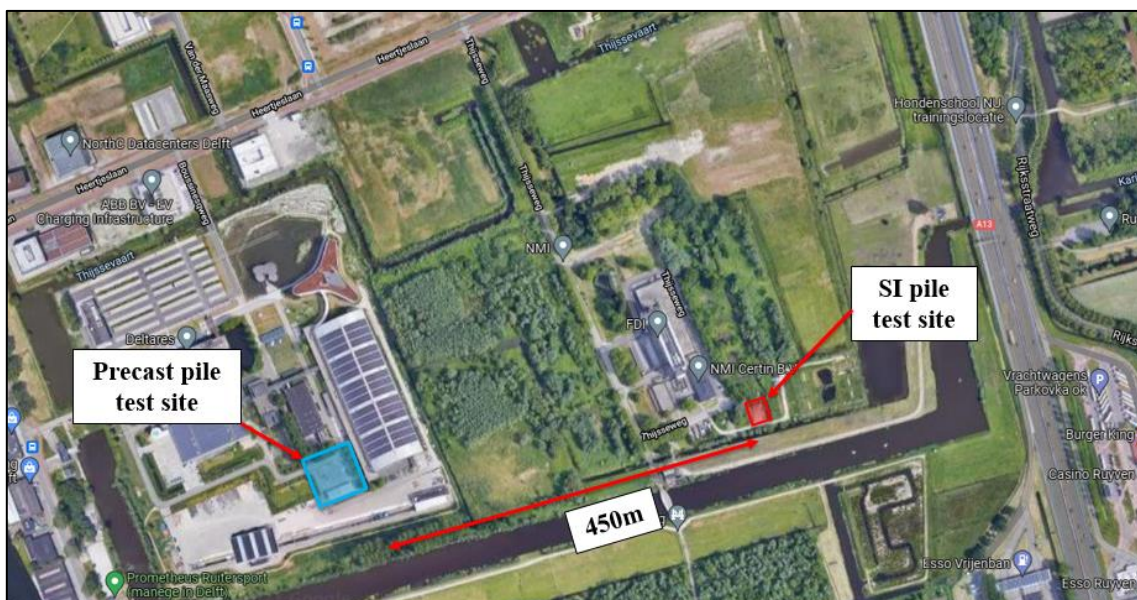
Figure 2.1: Location of the 2020/21 precast pile test site on the Deltares campus along with the SI pile test described in this report

The test site was a greenfield site owned by TU Delft (Figure 2.1), next to a showcase location for flood defence systems called Flood Proof Holland. Prior to load testing, no other land use was recorded at the pile test site. The site is also located close to the Deltares campus where tests were performed on three driven precast piles in 2021 as part of the InPAD project.

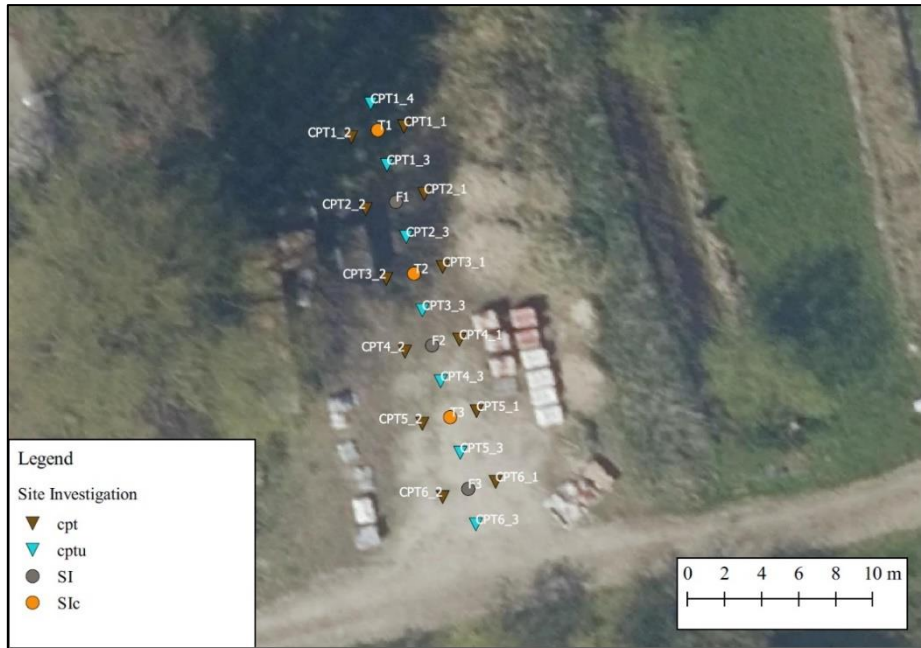
Figure 2.2: Site plan including the executed site investigation

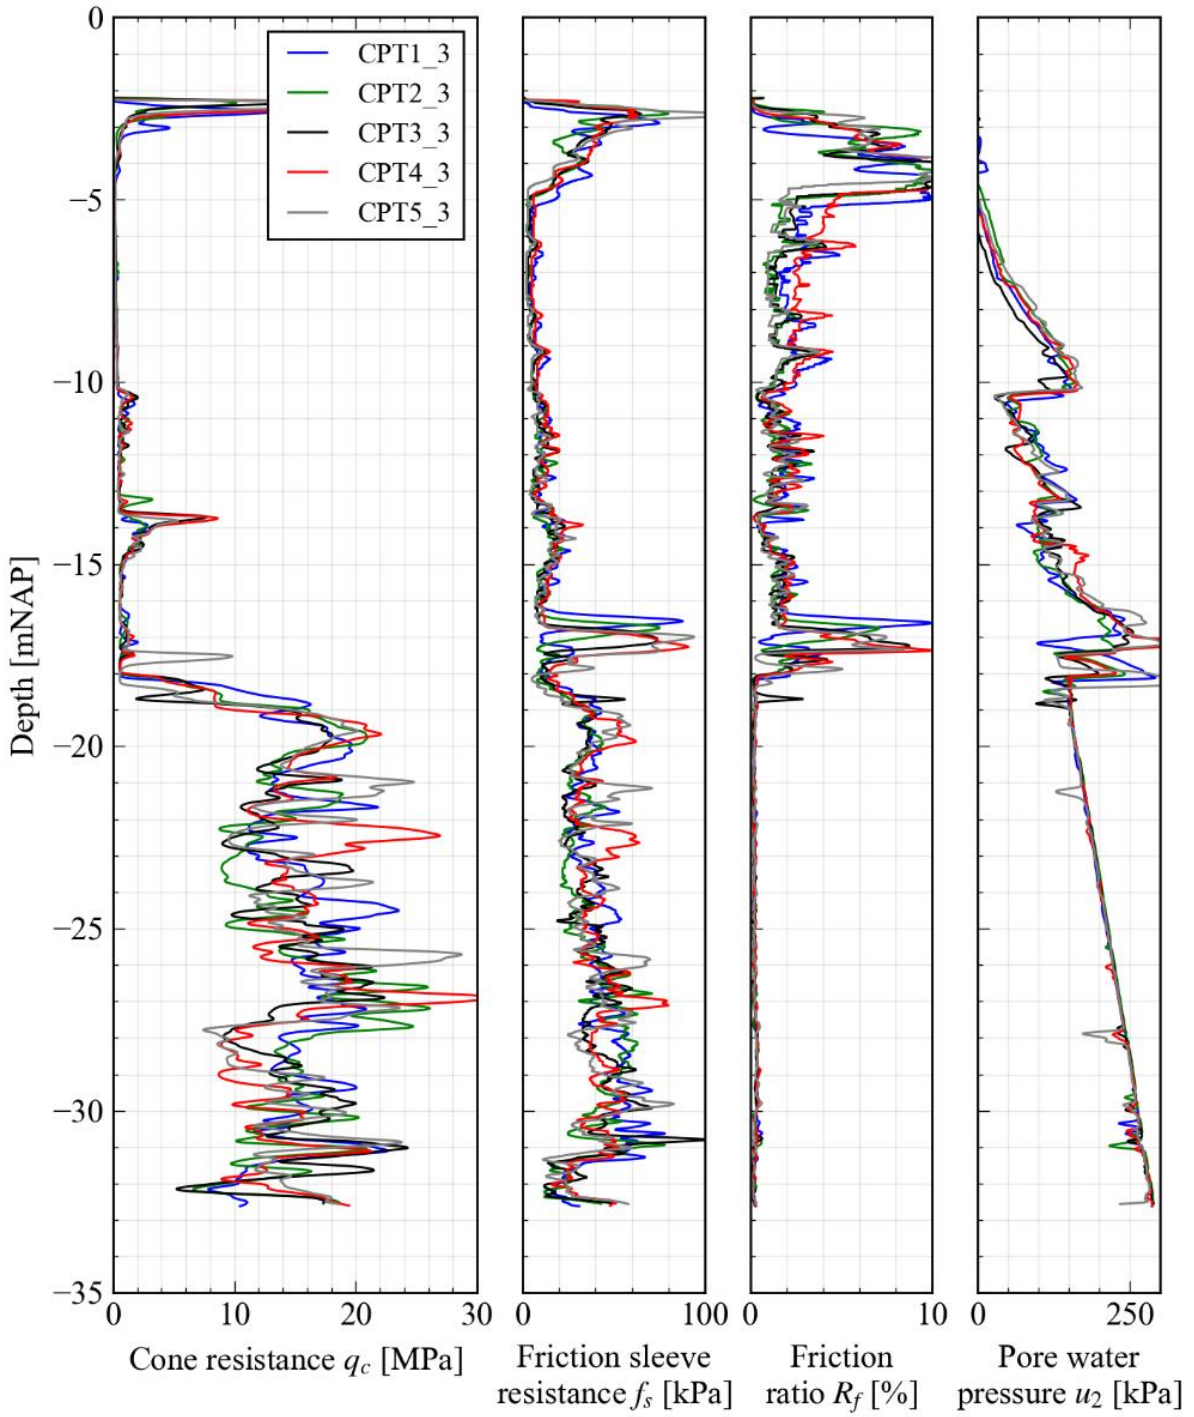
Figure 2.3: CPTs executed along the centreline of the pile test site

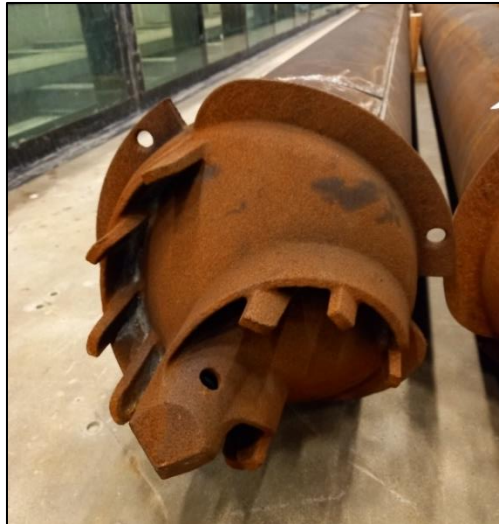
Figure 3.1: Screw tip of the SIc piles. The same tip was also used for the SI piles

All six piles were designed and manufactured by Funderingstechnieken Verstraeten B.V., Oostburg. Both pile types have near-identical screw tips (see Appendix D.6, Appendix D.6 and **Figure 3.1**), with three grout injection outlets facing transversally from the pile. The purpose of this screw tip is to mix the soil and grout and provide a strong grout body along the pile, whilst reducing the installation resistance. Both piles used the same grout mix: Webertec GM42 CEM III/B (with limestone filler) with a target water-cement factor of 1.5. Water from an adjacent canal was used.

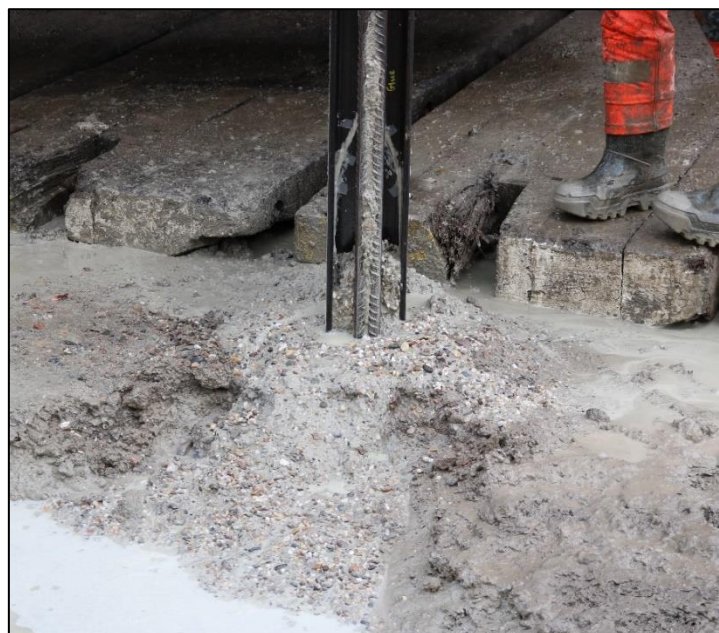
Figure 3.6: Pile F2 following installation, showing the coarse aggregates surrounding the pile

A large number of concrete aggregates was observed around the head of pile F2 following installation (**Figure 3.6**), suggesting some segregation of concrete aggregates within the concrete mix. This was not observed for piles F1 and F3, however, the strain measurements (Section 5) and the sonic integrity tests (Section 4.4) do not suggest significant differences between the three piles. As a result, the degree of segregation is believed to be relatively minor.

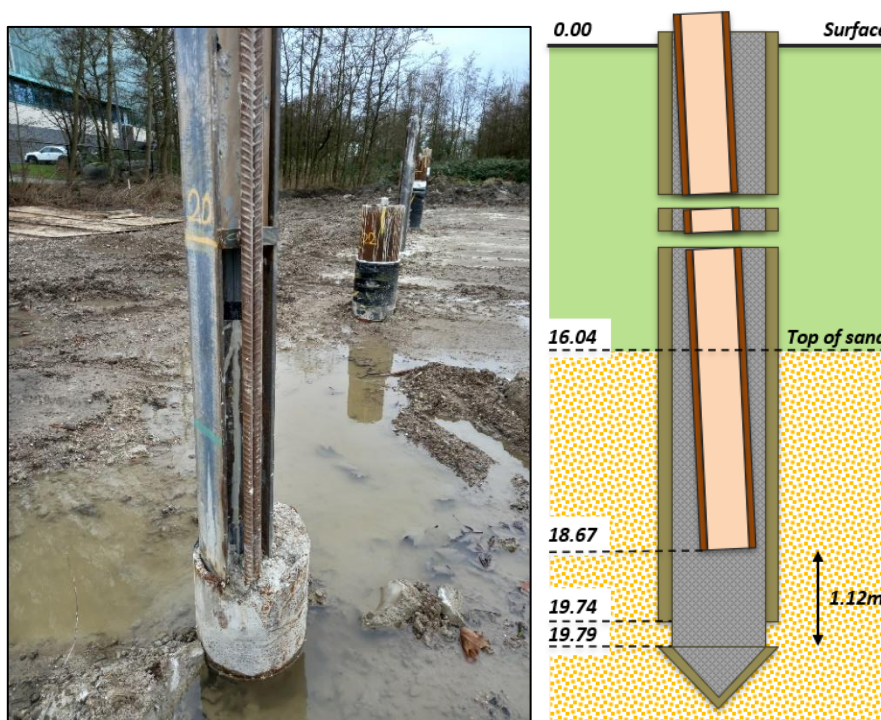
Figure 3.7: Inclination in reinforcing with respect to the stuck casing of pile F3

Pile F3, the last pile to be installed, encountered difficulties during the withdrawal of the auxiliary tube. After the reinforcing and concrete was placed in the pile, withdrawal of the casing commenced using anti-clockwise and clockwise rotations of the auxiliary tube in combination with a pull-up force. After five metres of extraction, it was observed by the drillmaster that the reinforcing was also being pulled up upwards with the pile, possibly caused by cohesive or arching forces through the concrete between the reinforcing and the auxiliary tube.

Following installation significant inclination in the reinforcing at the surface was also observed (**Figure 3.7**).

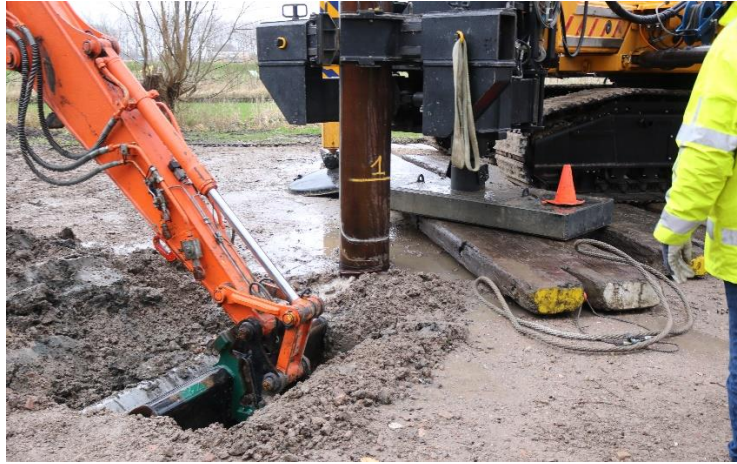
Figure 3.8: Trench in front of pile to collect outflowing grout

In total, 35 grout samples were collected, 19 directly from the grout mixing plant (incoming grout) and 16 coming from the annular space around the pile (outcoming grout). The outcoming grout was collected from a trench dug adjacent to the pile (**Figure 3.8**), a trench which was periodically emptied if overflowing with grout.

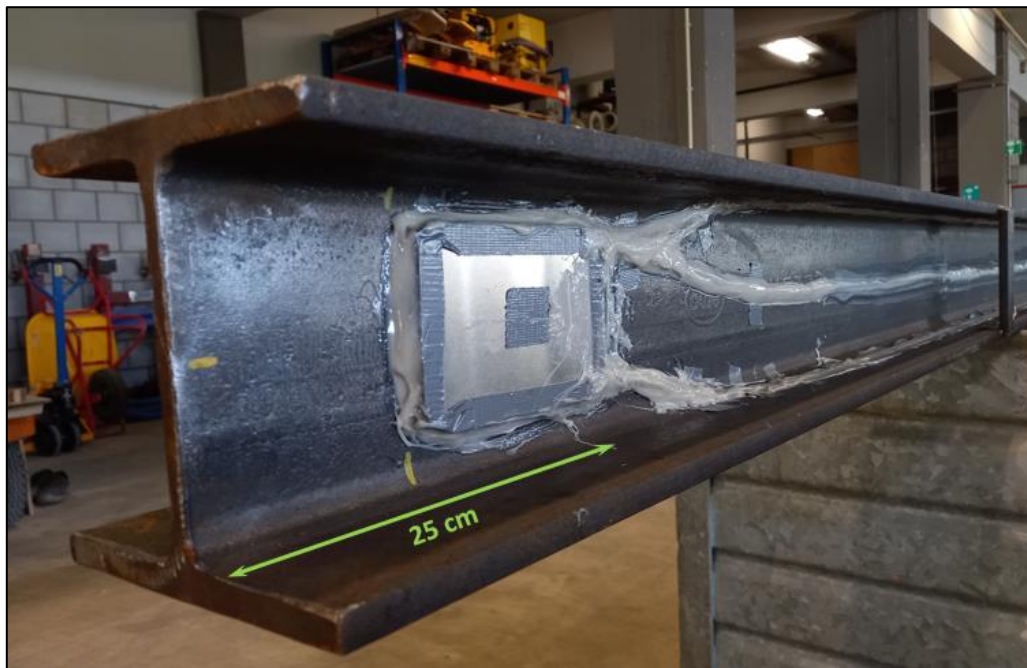
Figure 4.4: Protective cassette at the bottom of the reinforcing of the SI piles. The lowermost measurement was therefore roughly one pile diameter from the base of the reinforcing

The SI piles were instrumented on the reinforcing along three axes, labelled A, B and C (**Figure 4.3**). Using the two optical fibres in each cable, a connection was made at the bottom of the pile and placed in a protective cassette (**Figure 4.4**). As a result, six strain profiles could be obtained, i.e. two on each of the three axes. An advantage of the configuration was its redundancy in the event of fibre breakage, allowing for a continuous loop to be formed across the remaining measurement axes in the event one or more of the axes broke.

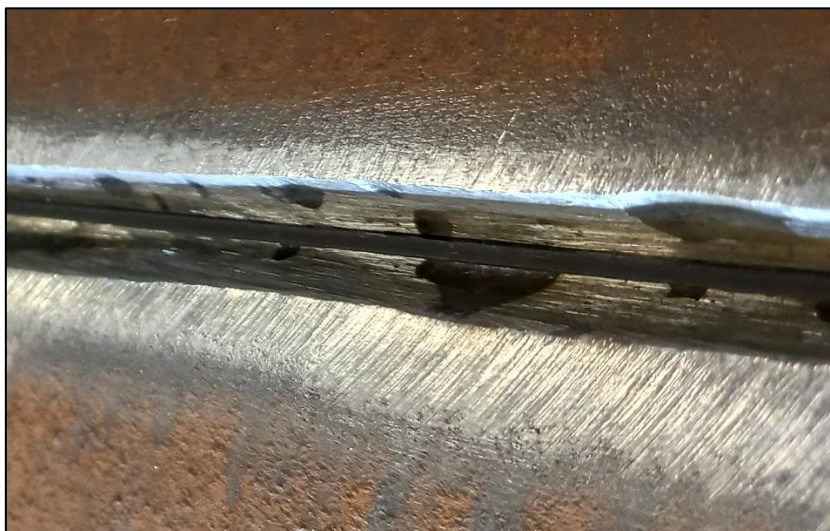
Figure 4.6: Fibre optic cable within the prepared groove of the SIc pile

One fibre optic cable was instrumented on the SIc pile in pre-formed axially opposing grooves on the outside of the pile (Figure 4.6). The grooves were roughly parabolic in shape, 5mm at their deepest point. At the bottom of the pile, the groove looped around the tube, transitioning from one side to the other (**Figure 4.7**), allowing for a continuous strain distribution to be obtained on axially opposing sides of the pile. The lowermost measurement was approximately 35 cm above the pile base.

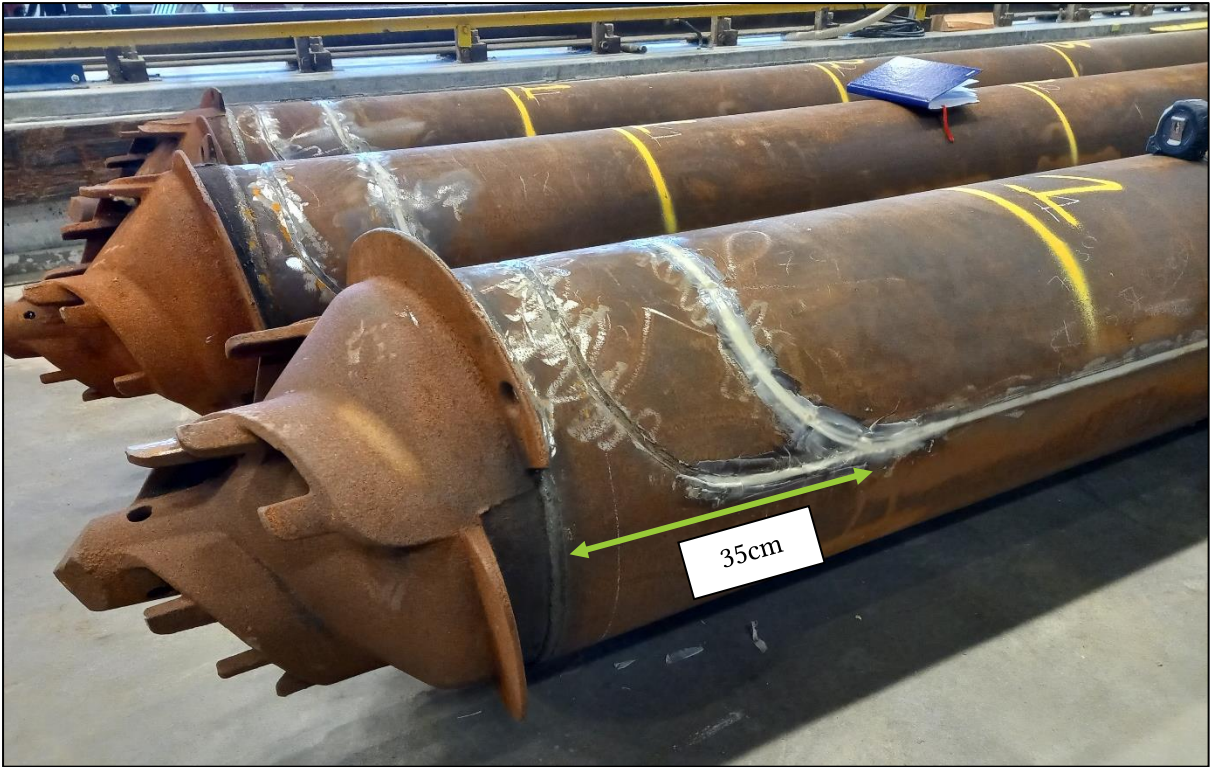
Figure 4.7: Grooves prepared at pile tips, showing the glued-in-placed FO cable transitioning from one side to another. Two grooves were created at the pile tip, although only one groove was ultimately used. The distance to the last possible FO reading is shown

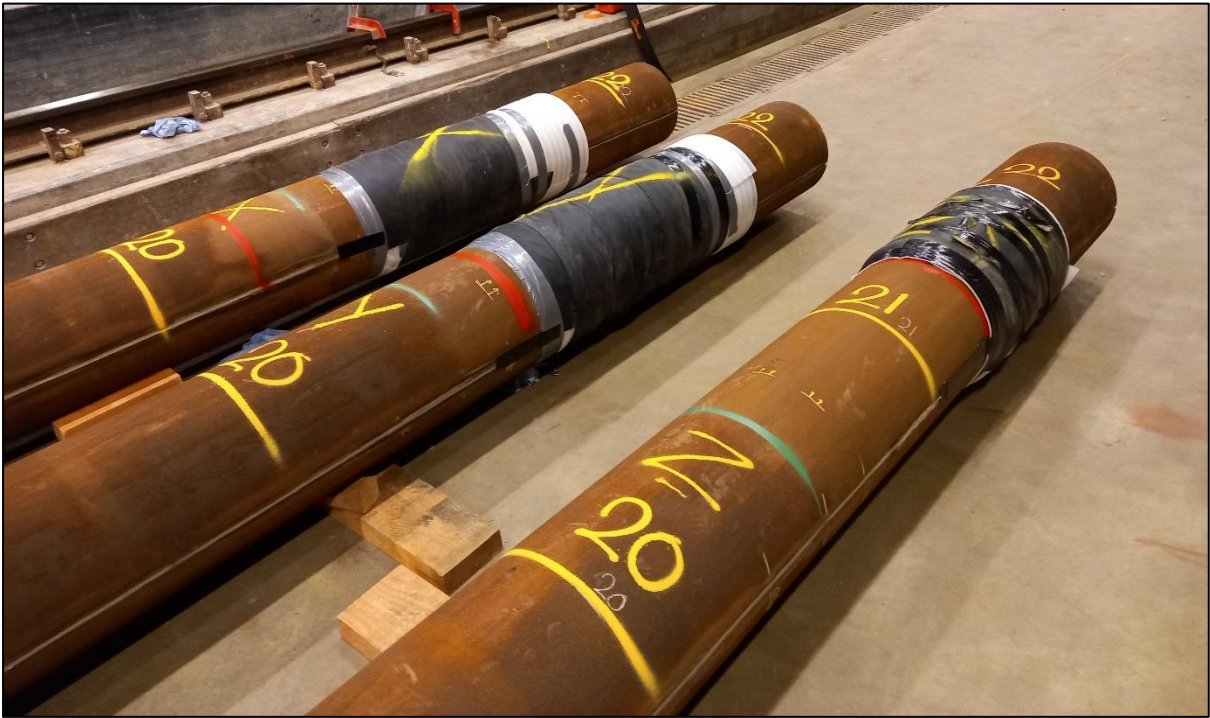
Figure 4.8: Protecting the loose fibre optic cables at the pile heads using foam and rubber mats

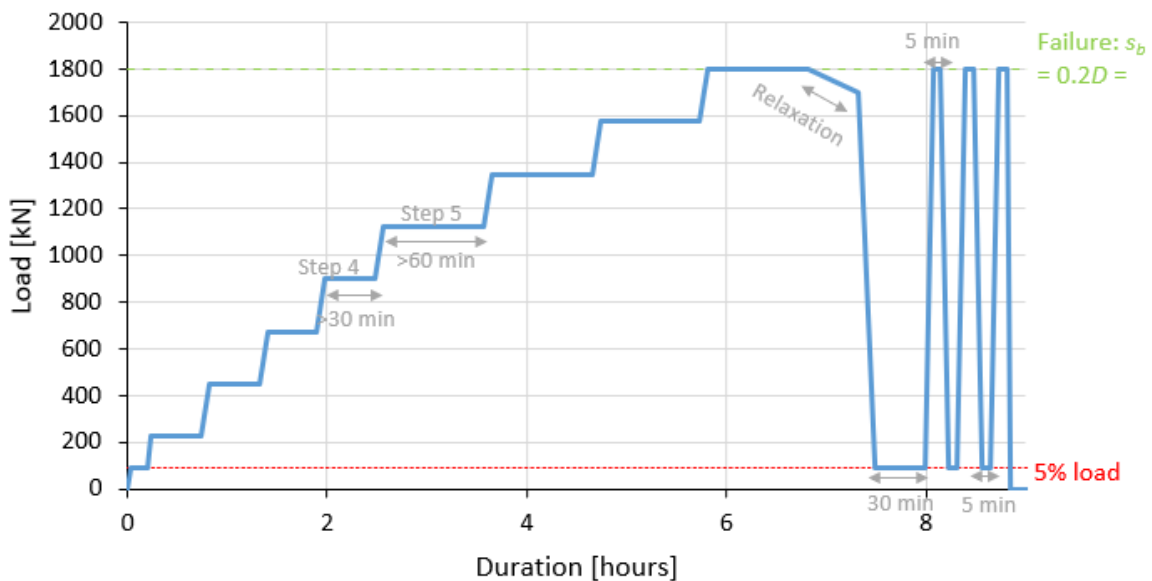
Figure 4.10: Schematic of the load test procedure. Note: the number of steps and duration may vary depending on the creep criteria

Once the failure criterion was attained, a “relaxation phase” was carried out by stopping the hydraulic pumping system and letting the pile displace under the gradually decreasing load until an equilibrium was attained. This step lasted up to thirty minutes or until an asymptotic trend became clear in the settlement readings.

Following the completion of the main test, the load was reduced to the 5% load over a period of 10 minutes, with load held at 5% load for 30 minutes. Subsequently, up to three unload/reload cycles to the failure load were carried out to investigate the effect of cyclical loading on the shaft friction of the pile. To facilitate strain measurements at the peaks and troughs of the load cycles, the load was held for five minutes.

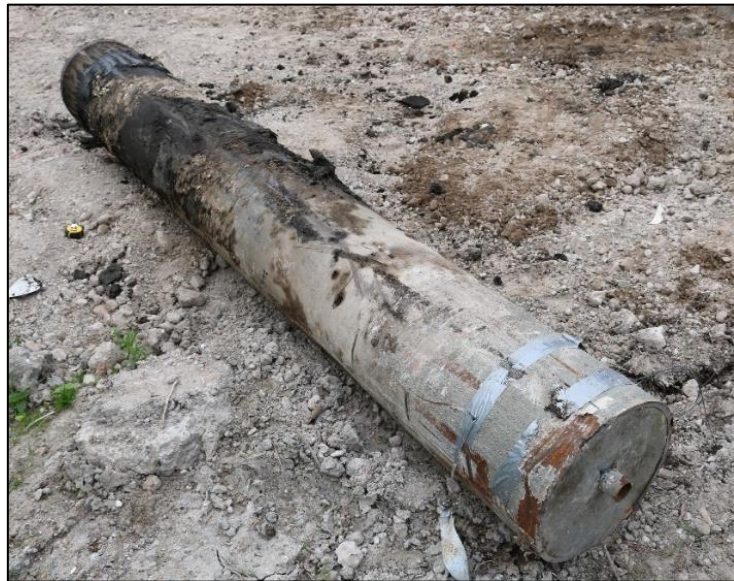
Figure 4.12: Head of pile T1 after extraction. No clear evidence of grout was present at the head of any of the SIC piles

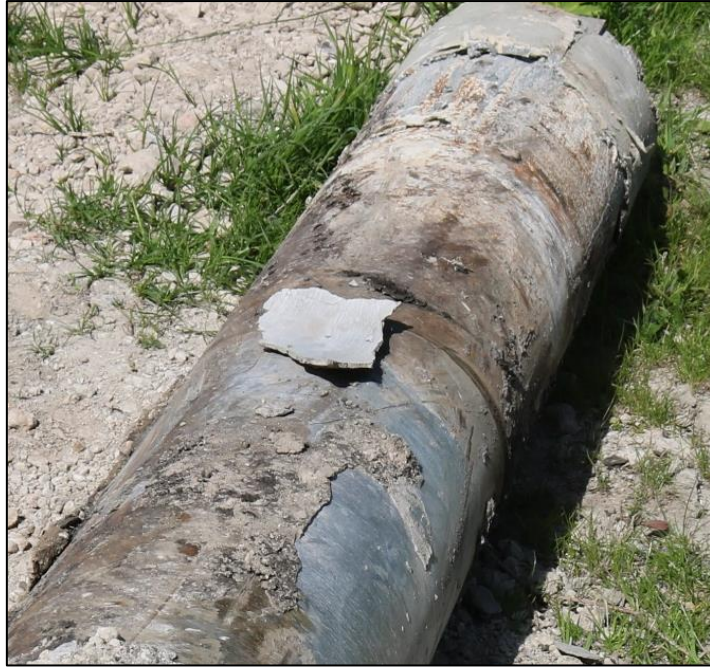
Figure 4.14: Close-up of the head of pile F3, with one of the broken pieces placed on top of the pile

On pile F3 (with the lost casing), a thin film of grout less than 0.5 cm in thickness was present in some spots (**Figure 4.14**), although this grout layer was easily removable with light force. Unlike the tube of the SIC piles, much of the corroded layer of the casing was absent, possibly because of abrasion during the attempted extraction of the casing.

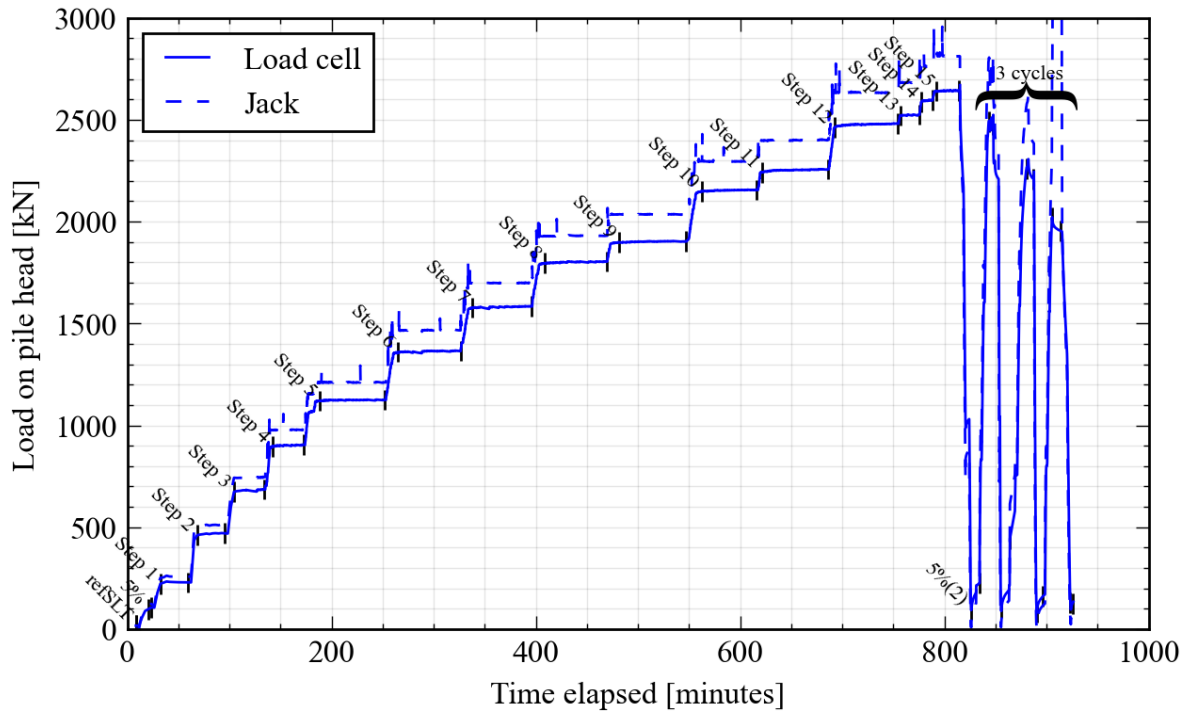
Figure 5.1: Plot of load exerted on pile head against the time elapsed for T1. The load given by the jack have been derived from the measured hydraulic pressure

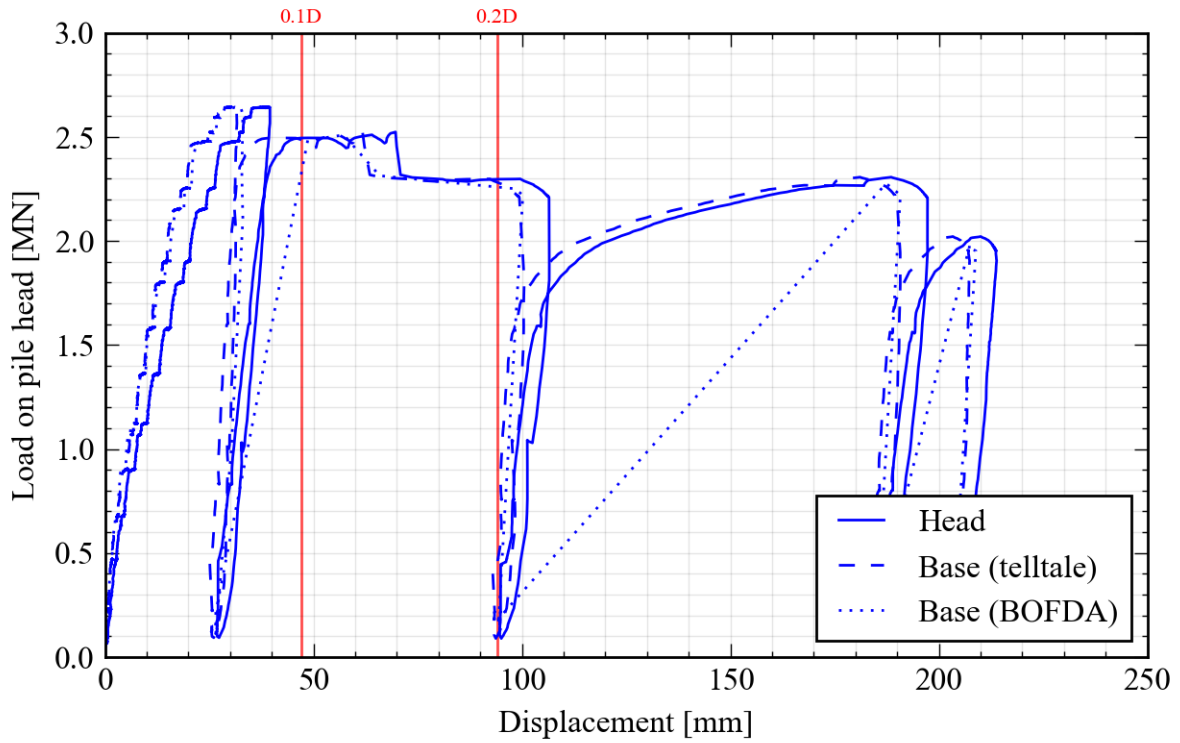
Figure 5.5: Plot of load versus displacement for T1

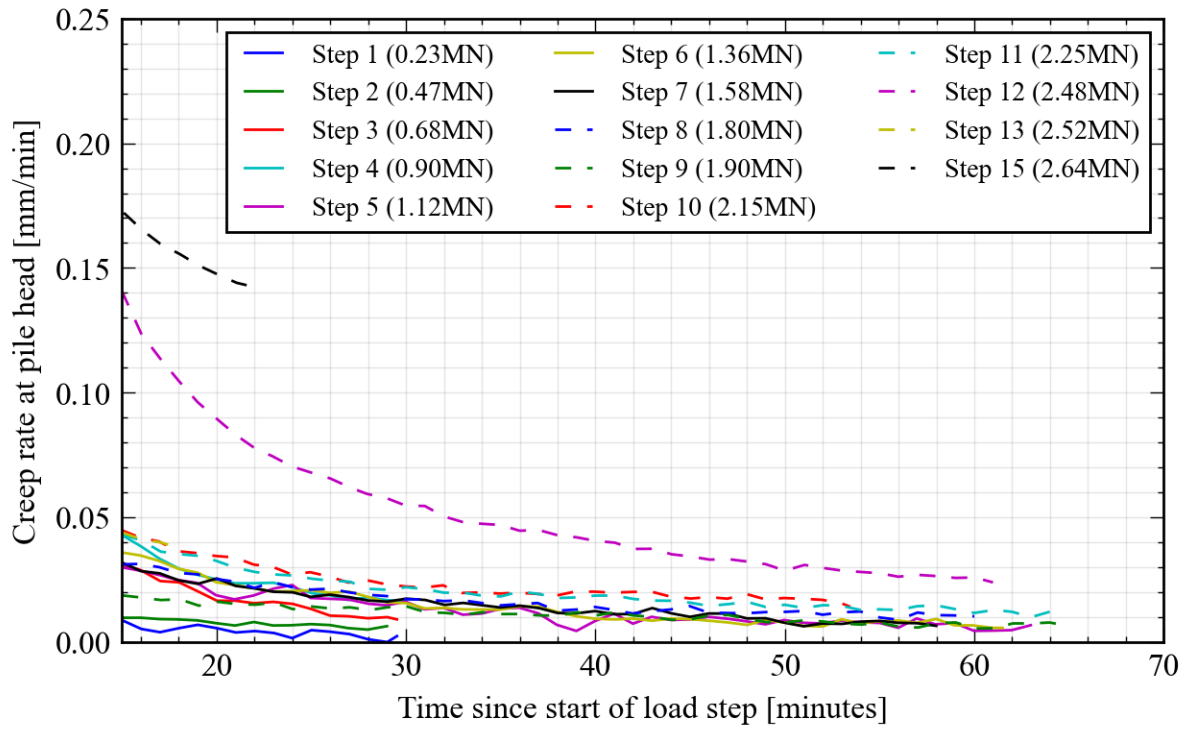
Figure 5.7: Creep rate versus time across selected loading steps for T1

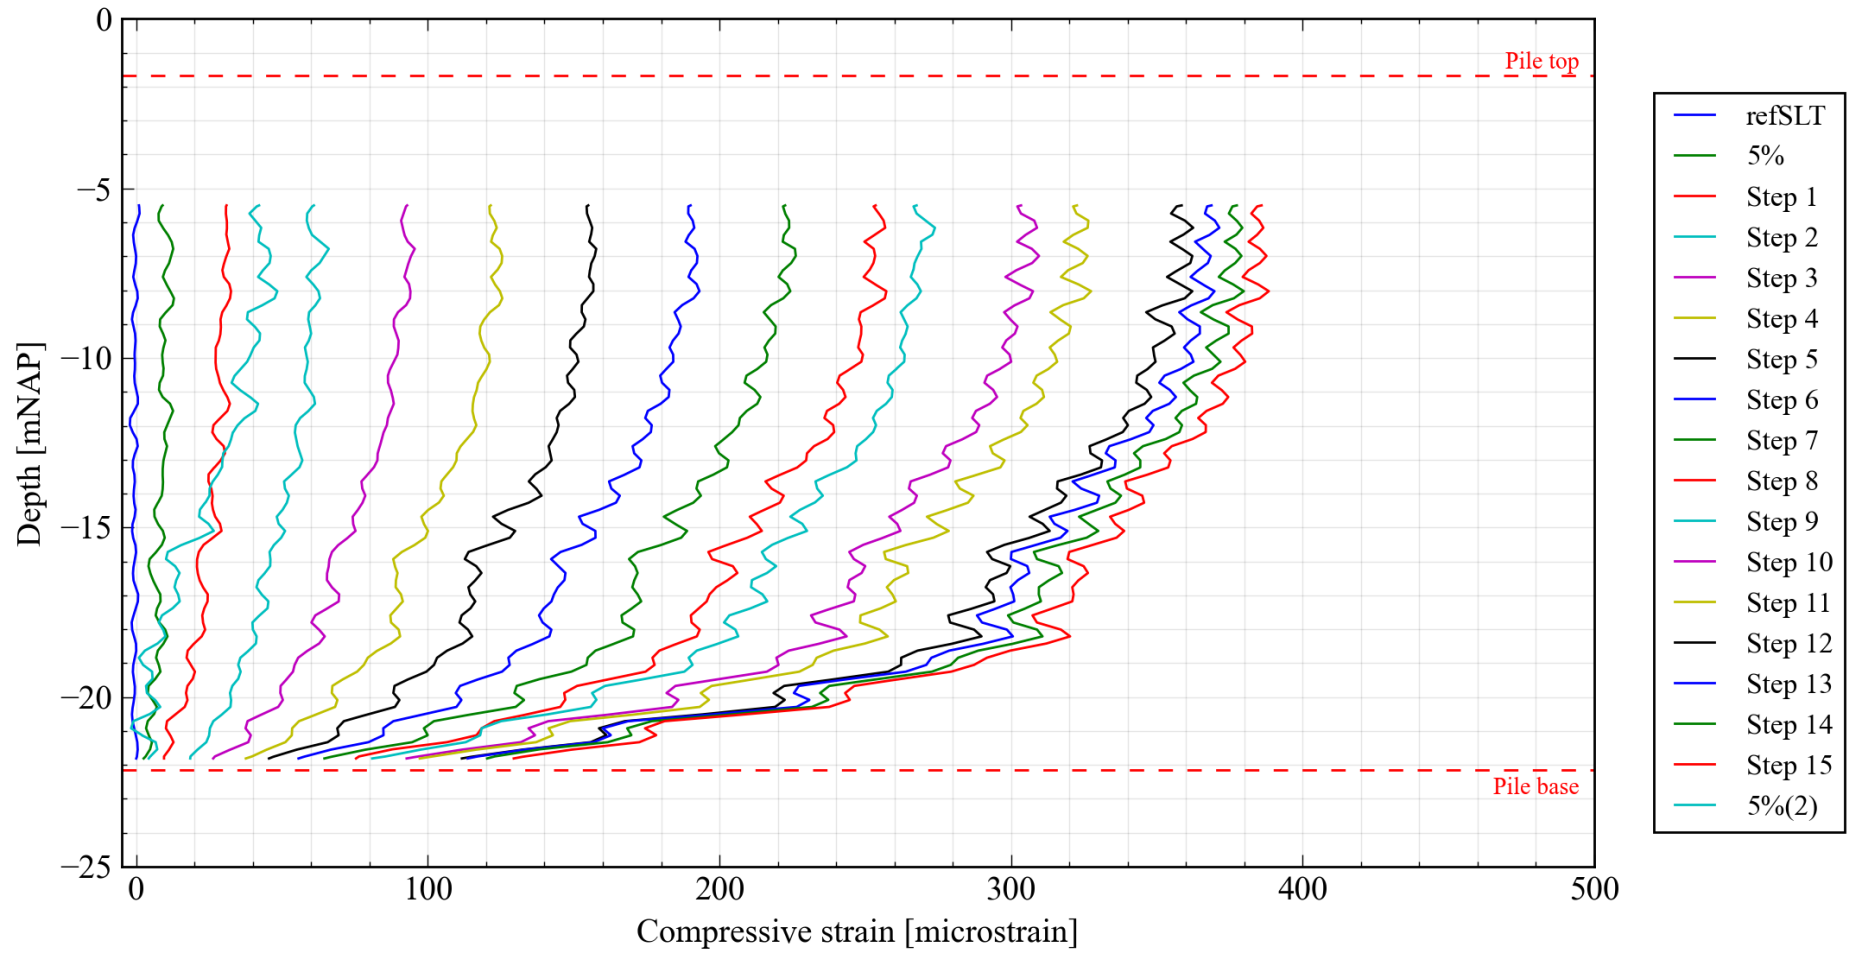
Figure 5.11: Average strain measurements in pile T1 at the end of each load step

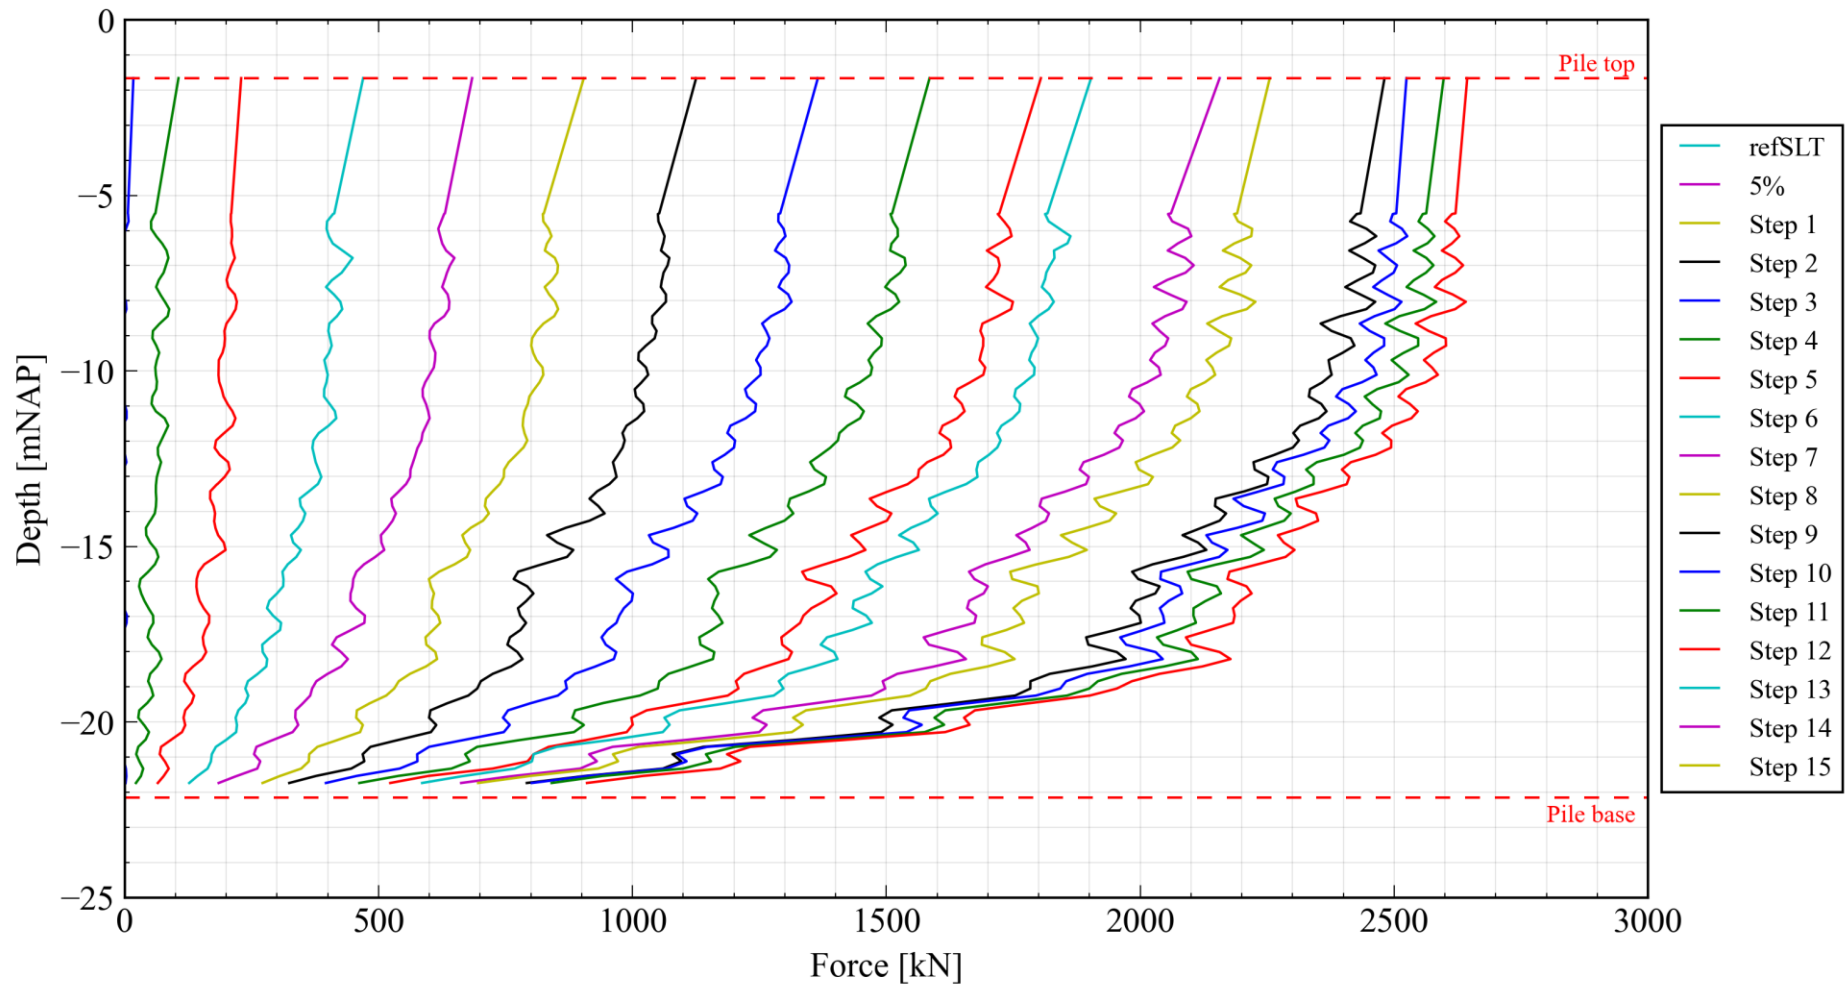
Figure 5.12: Normal force measurements in pile T1 at the end of each load step, including the load measured by the load cell. For more details on strain-to-force conversion, see Section 6.1

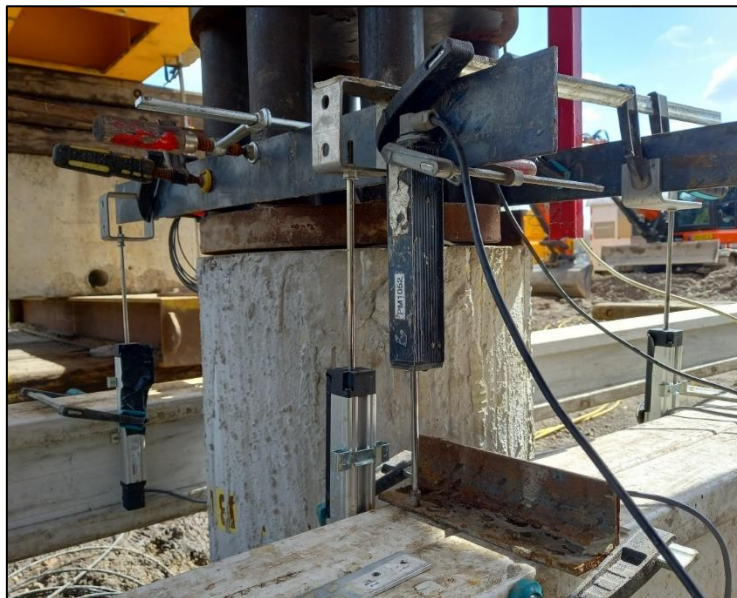
Figure 5.13: Position of additional potentiometer at the north-western side of pile, placed in the opposite direction of the normal potentiometers

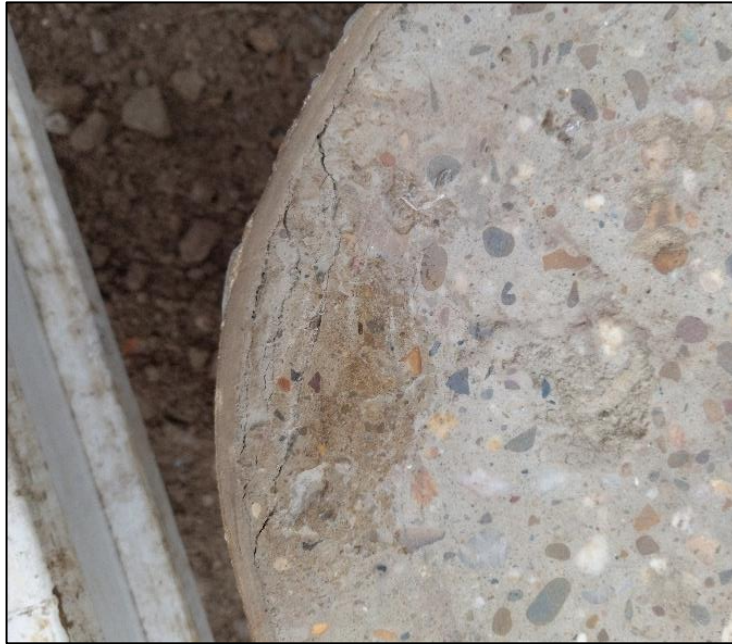
Figure 5.14: Cracking in the head of pile F1 on the surface of the pile head, at its north-western side

The test concluded after the second unload/reload cycle at 01:55 due to insufficient stroke remaining in the jack. Significant inclination at the pile head could be visibly seen towards the end of the test, with comparatively low displacements exhibited by PM SE and a minor degree of cracking at the north-western side of the pile (**Figure 5.14**). This was partially restrained by the cardboard mould surrounding the pile cap and so it is believed this crack was just superficial in nature.

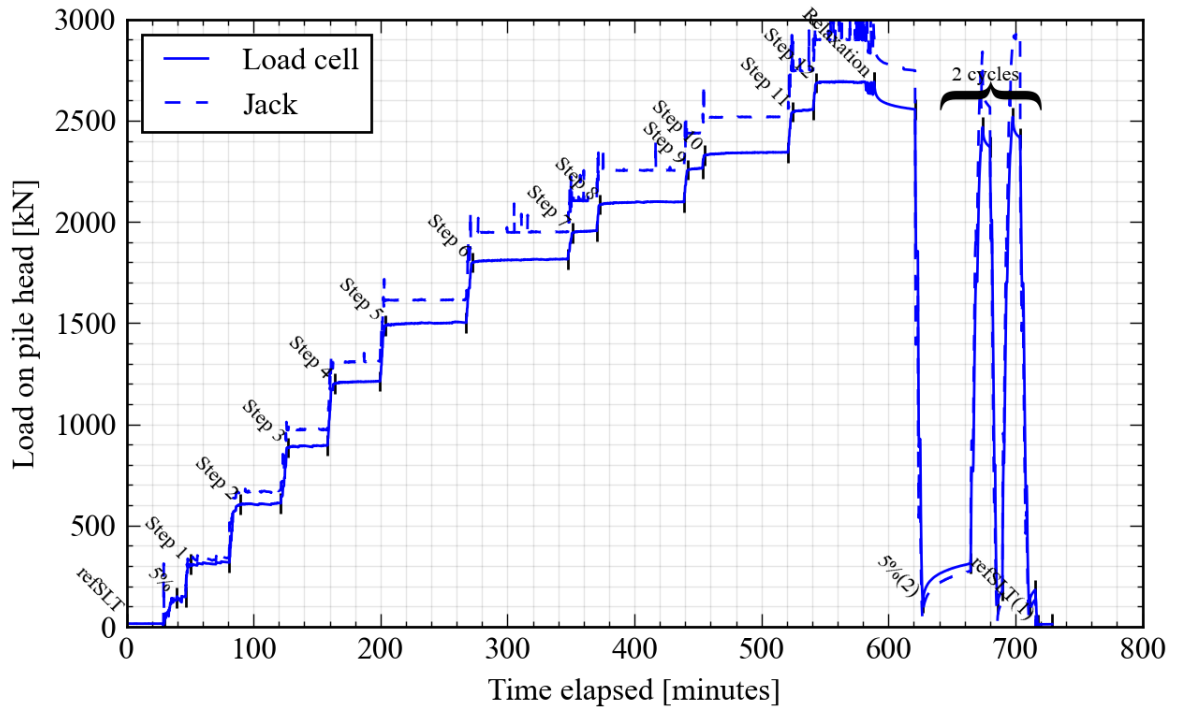
Figure 5.15: Plot of load exerted on pile head against the time elapsed for F1

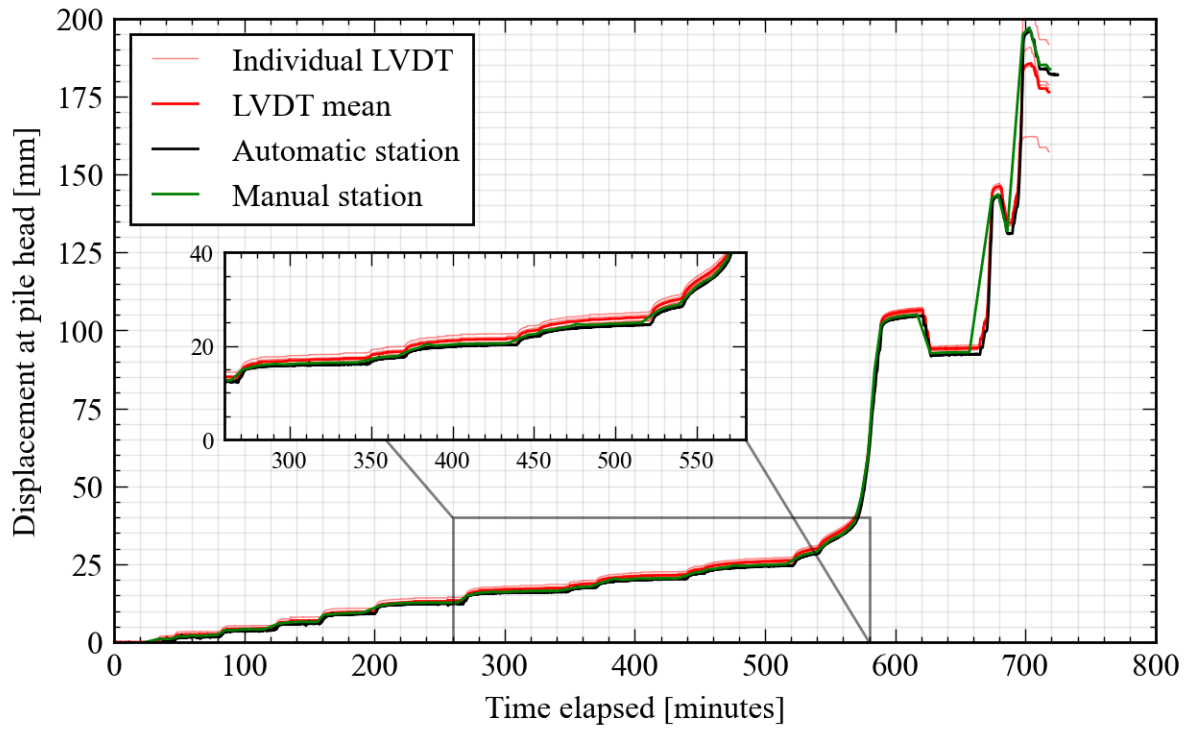
Figure 5.17: All settlement at pile head readings for pile F1

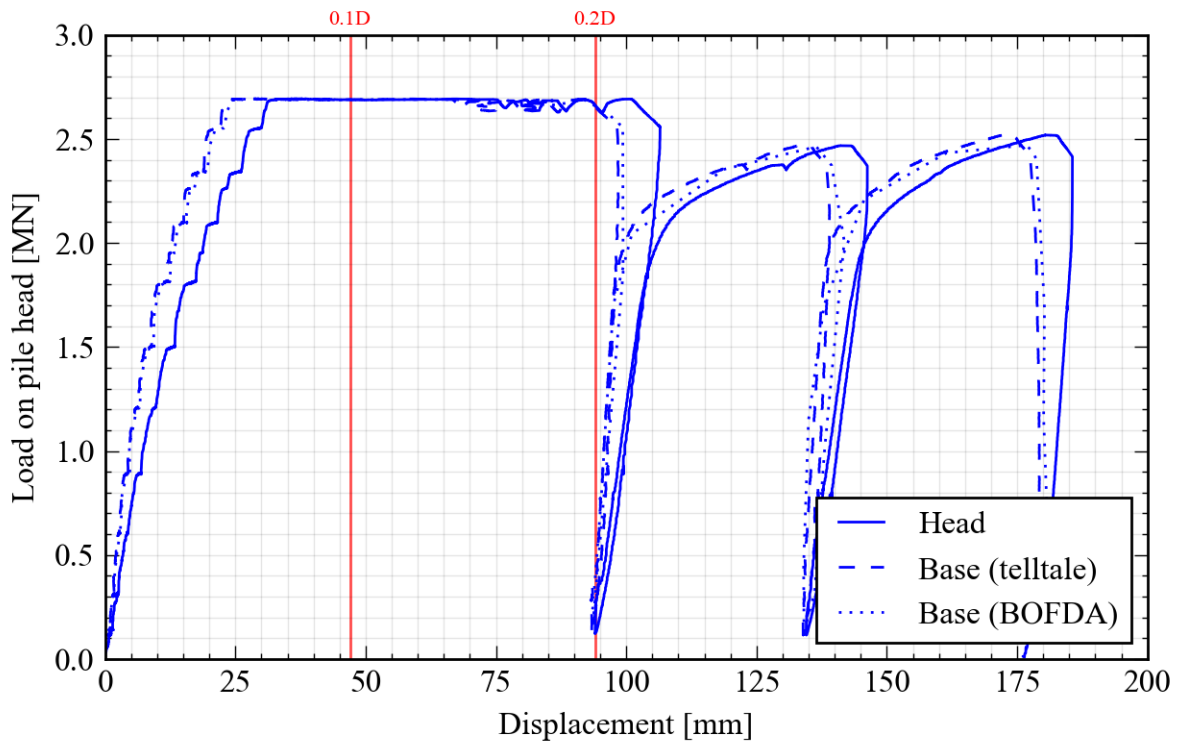
Figure 5.20: Plot of load versus displacement for F1

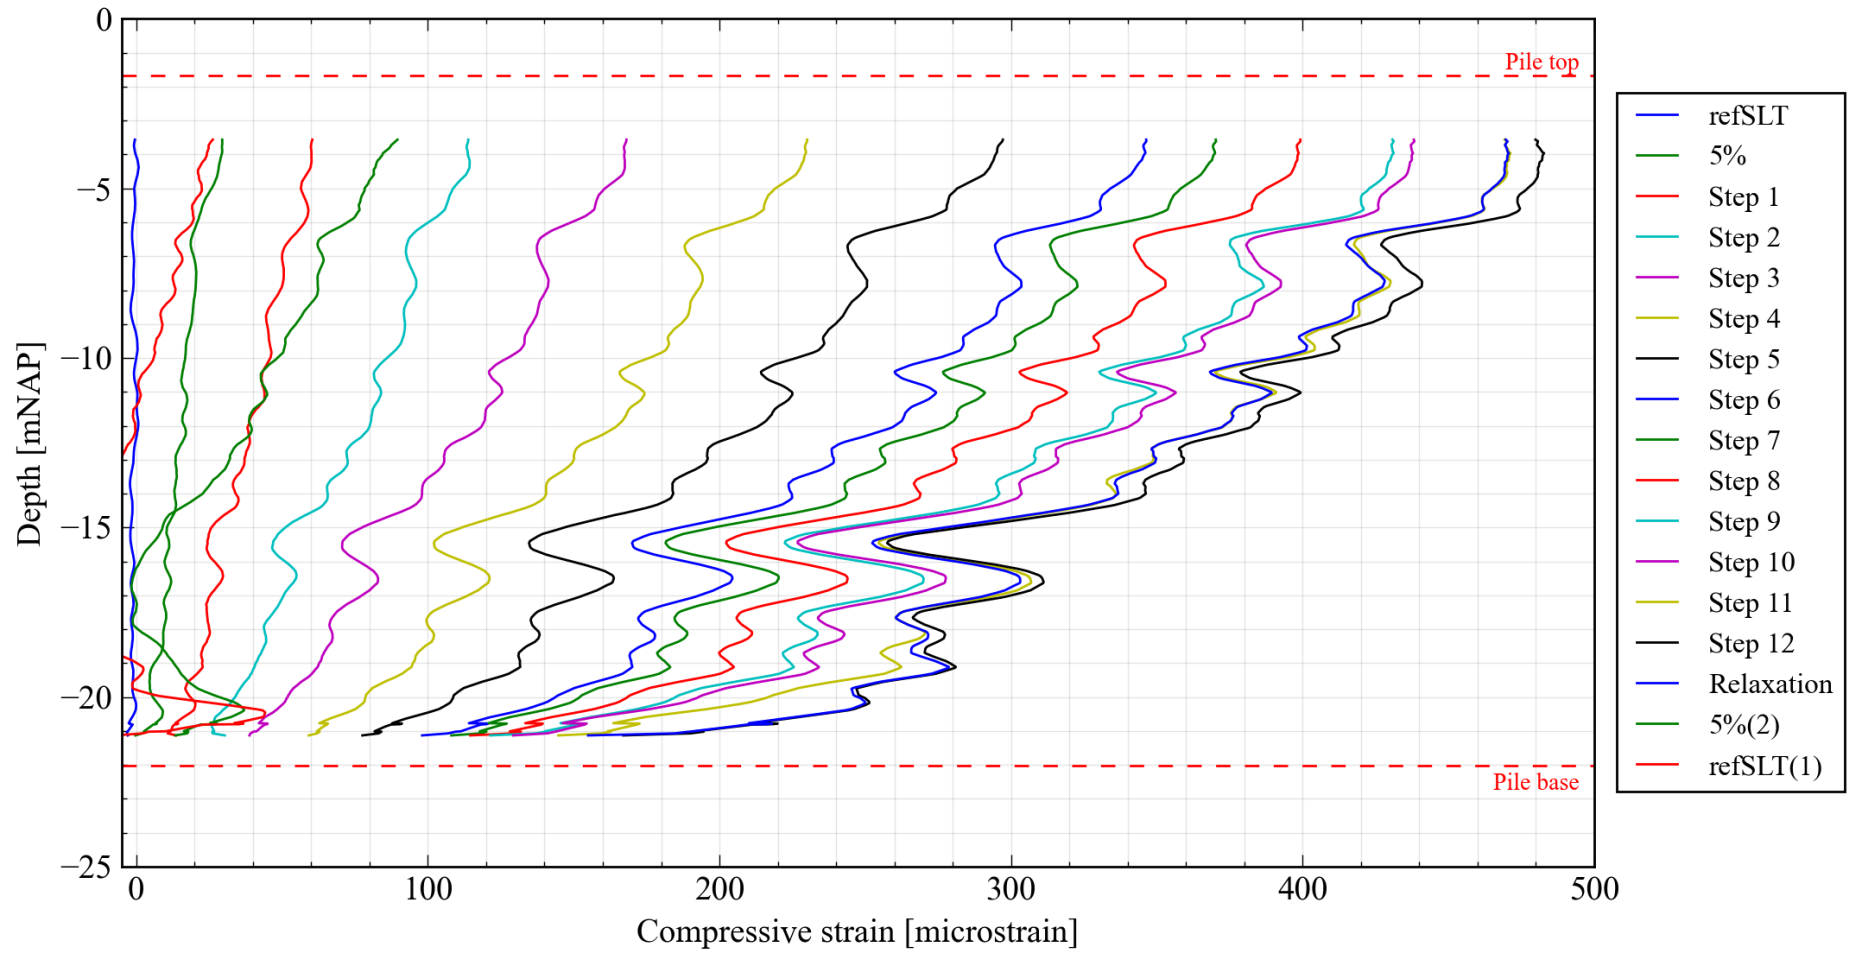
Figure 5.26: Strain measurements in pile F1 over the course of the load test
